①
UNDERWATER FACILITIES
INSPECTIONS
AND
ASSESSMENTS
AT

NAVAL AIR STATION
WHIDBEY ISLAND,
OAK HARBOR, WA

FPO-1-83-(41)

SEPTEMBER 1983

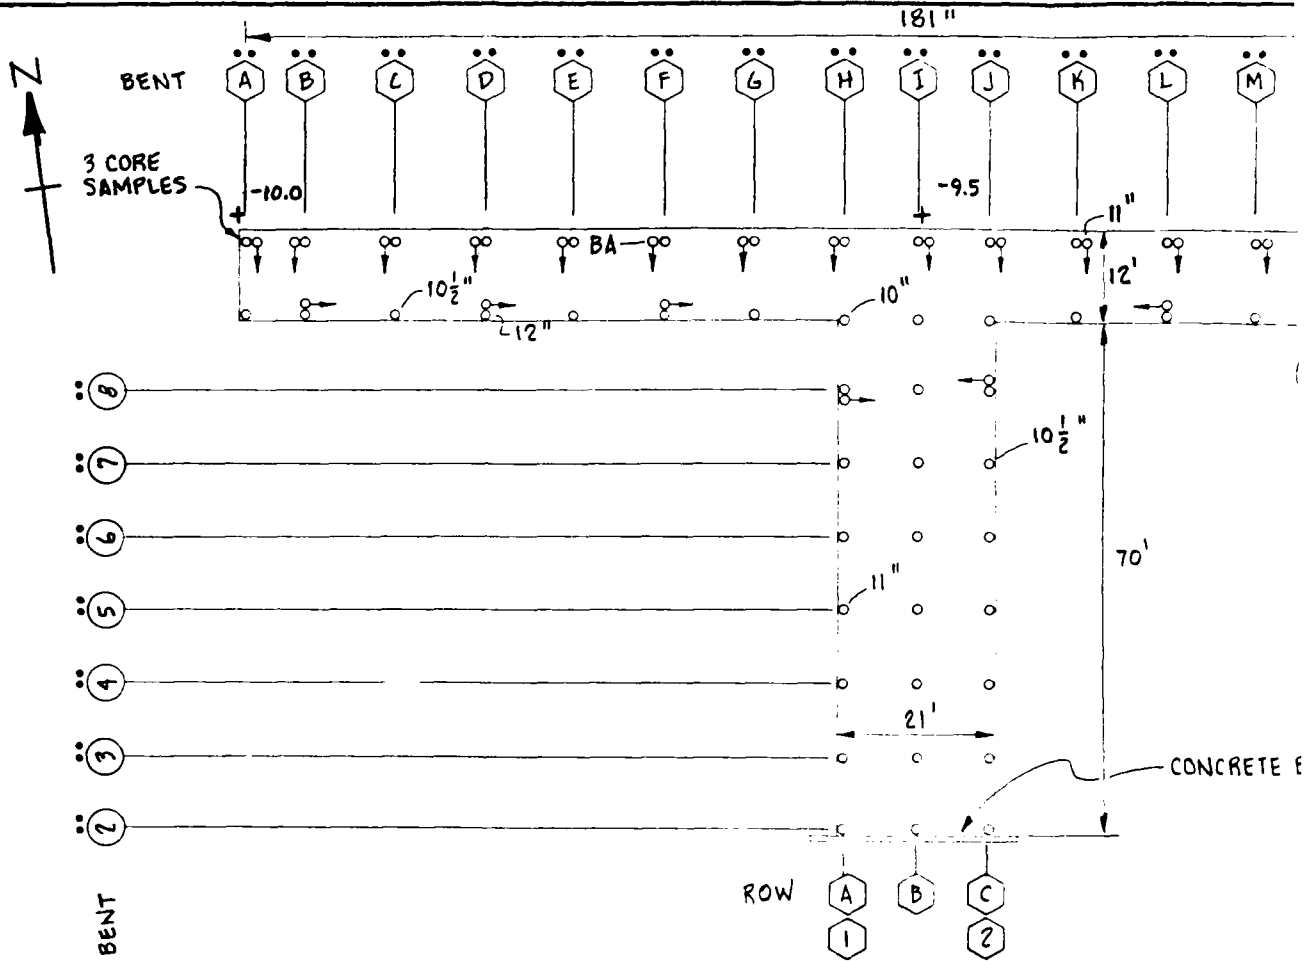
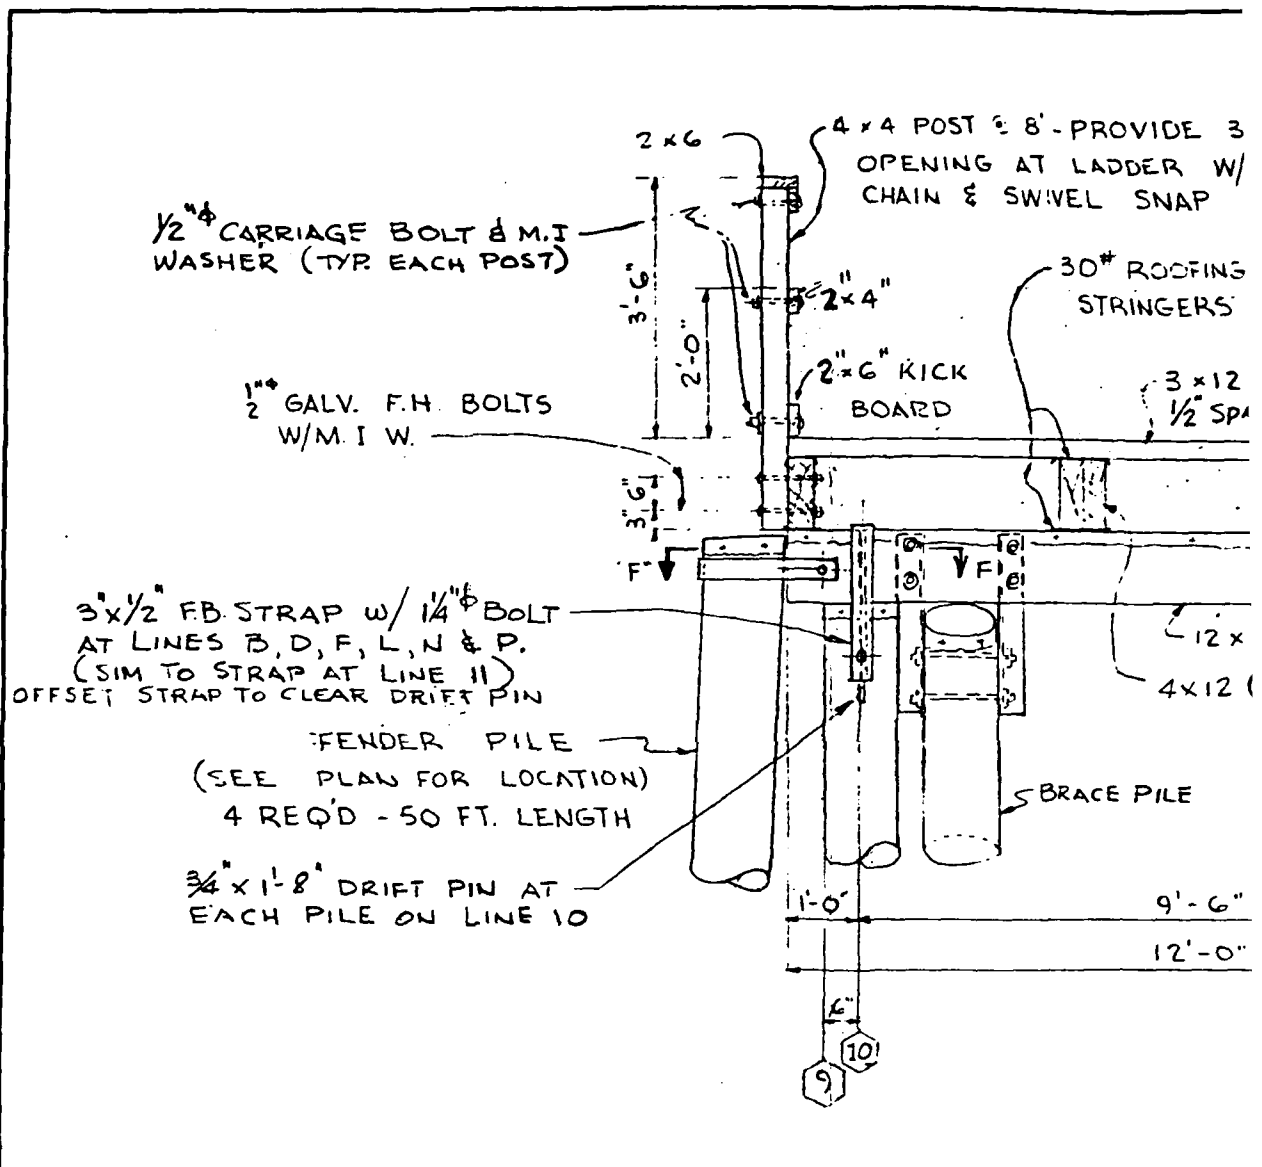
GRAPHIC SCALE	CHILDS ENGINEERING CORPORATION 801 333 WEDFIELD MA	CHESAPEAKE DIVISION NAVAL FACILITIES ENGINEERING COMMAND WASHINGTON D C	
AS SHOWN		NAVAL AIR STATION FUEL PIER	WHIDBEY ISLAND, WA FIG NO 6

The pier was constructed circa 1968 and is an open pier type structure with a timber deck system supported by treated round timber piles. The approach portion of the pier is 21' wide and extends offshore 70'. The pierhead is 181' long and is 12' wide. There are a total of 55 vertical and 25 battered piles associated with the pier and a 7-pile dolphin located to the east of the pierhead (see Figures 6 and 7).

are broken approximately 3' below MLLW. It appears the breaks are the result of impact from a berthing vessel (for location see Figure 6.

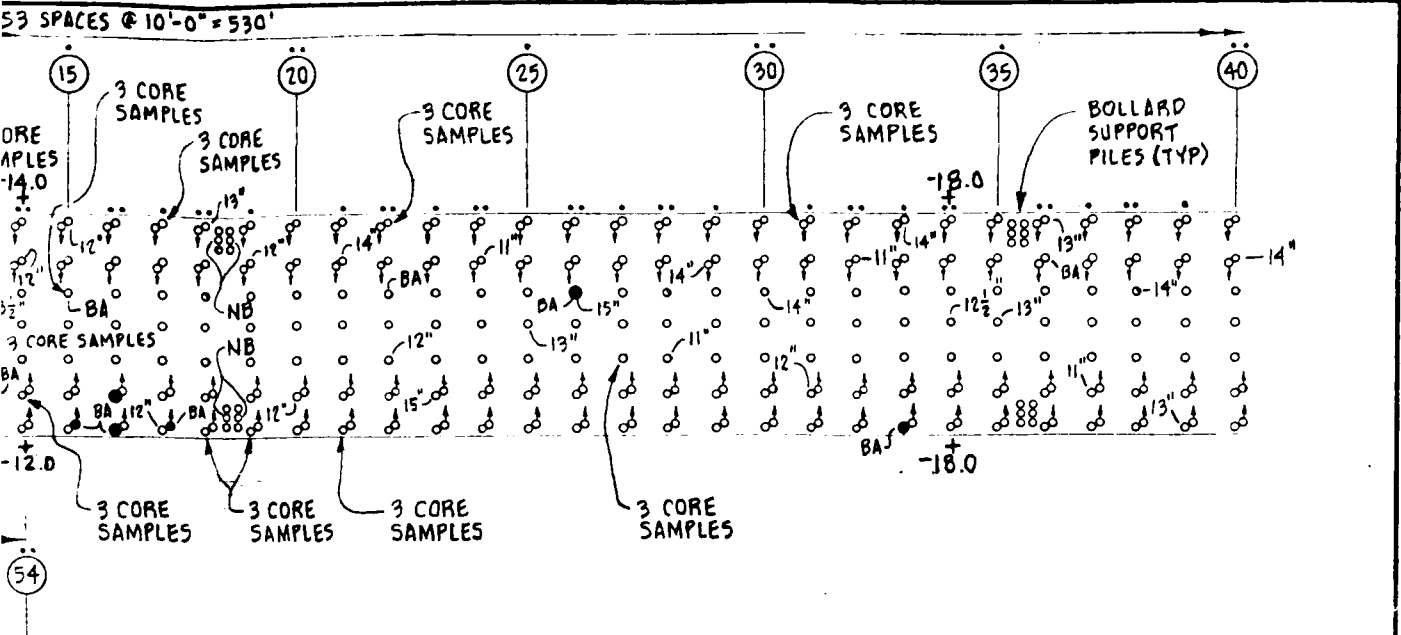
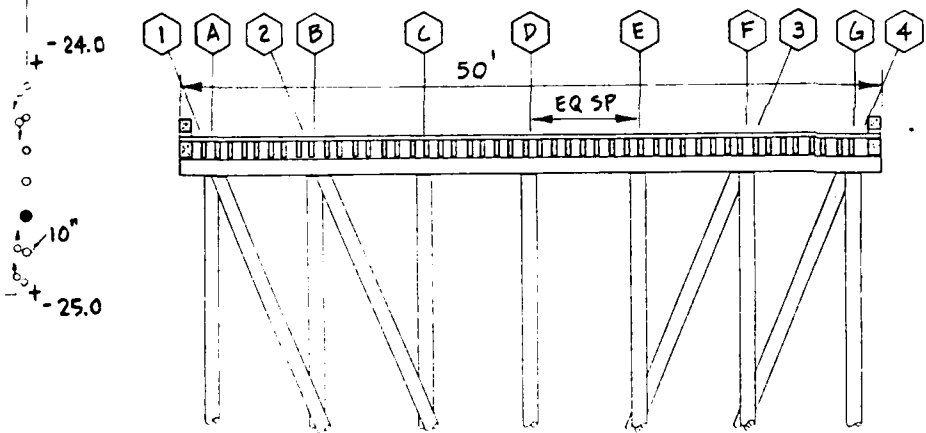
GRAPHIC SCALE	CHILD'S ENGINEERING CORPORATION BOX 333 MILFIELD, MA	CHESAPEAKE DIVISION NAVAL FACILITIES ENGINEERING COMMAND WASHINGTON, D.C.	
		NAVAL AIR STATION MAIN PIER (FINGER PIER)	WHIDBEY ISLAND, WA FIG. NO. 8
AS SHOWN

The Main Pier is in fair condition. Localized structural damage has reduced the pier's live-load capacity.

The pier is approximately 530' long and 50' wide. Typical pile bents include 7 vertical piles and 4 battered piles. There are approximately 364 vertical piles and 196 battered piles associated with the pier. An additional 36 vertical piles provide support for the mooring bollards (see Figure 8).

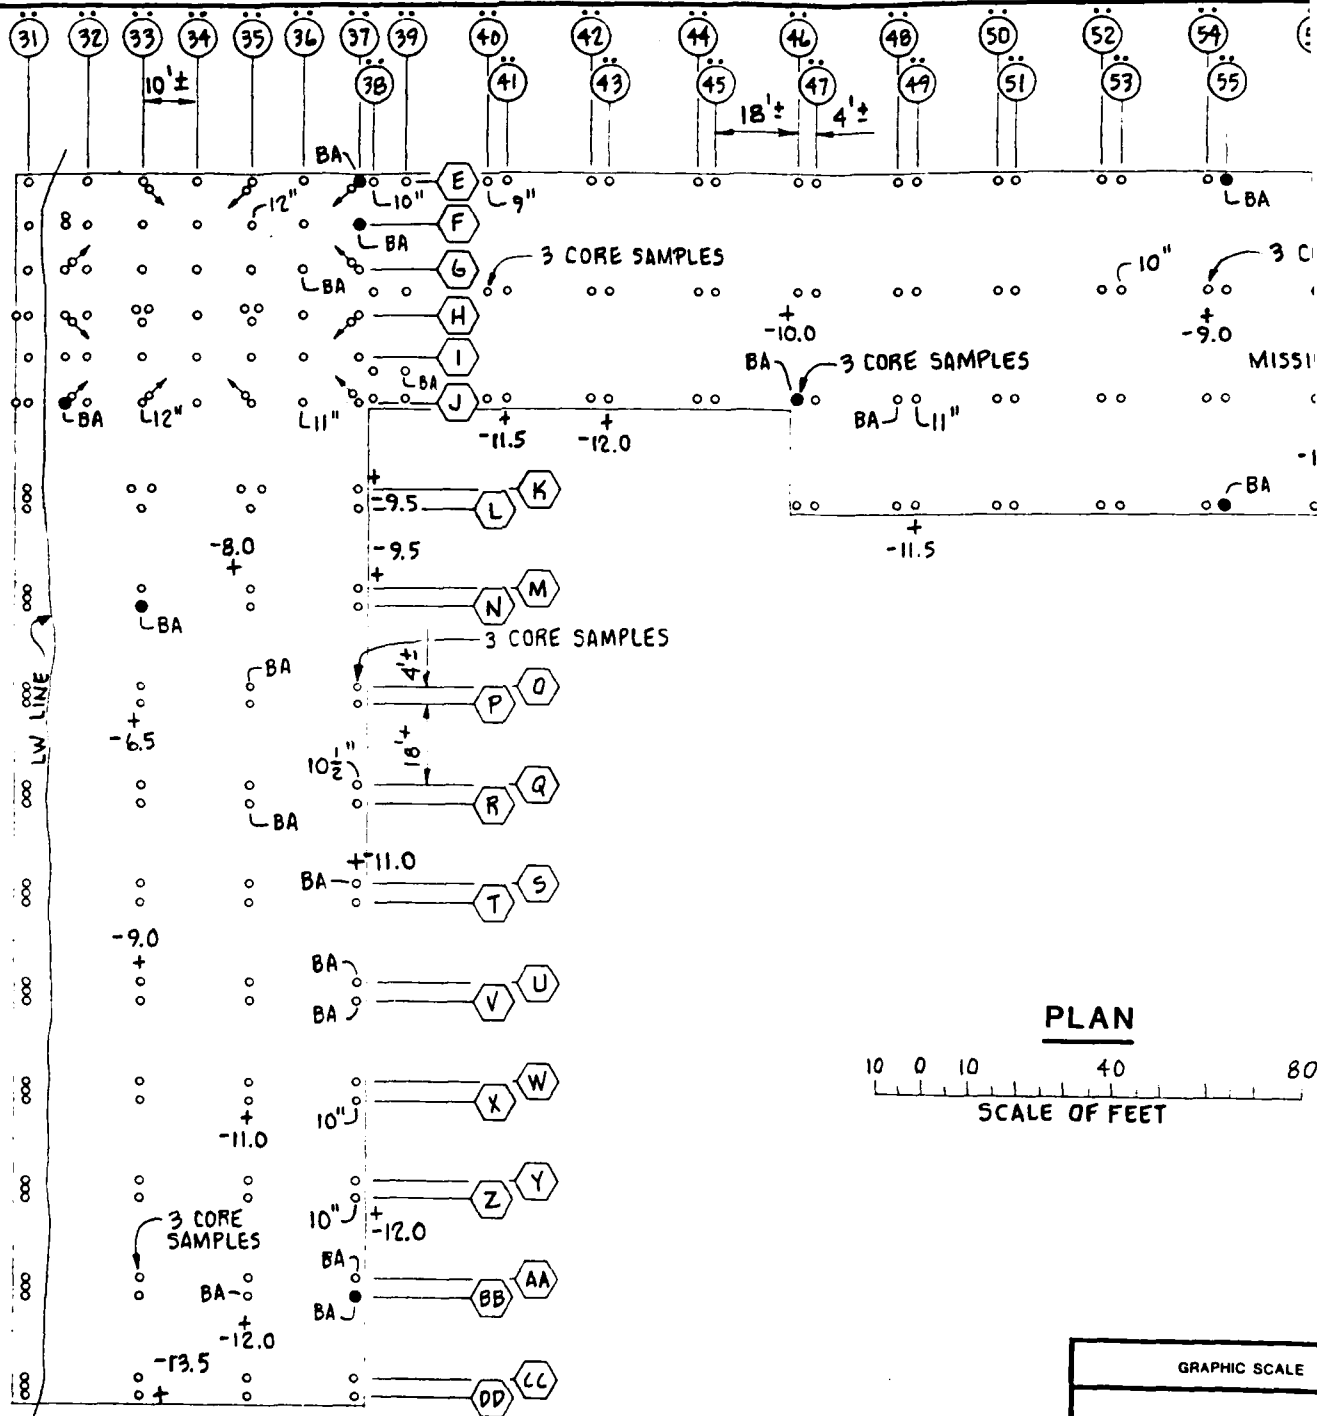
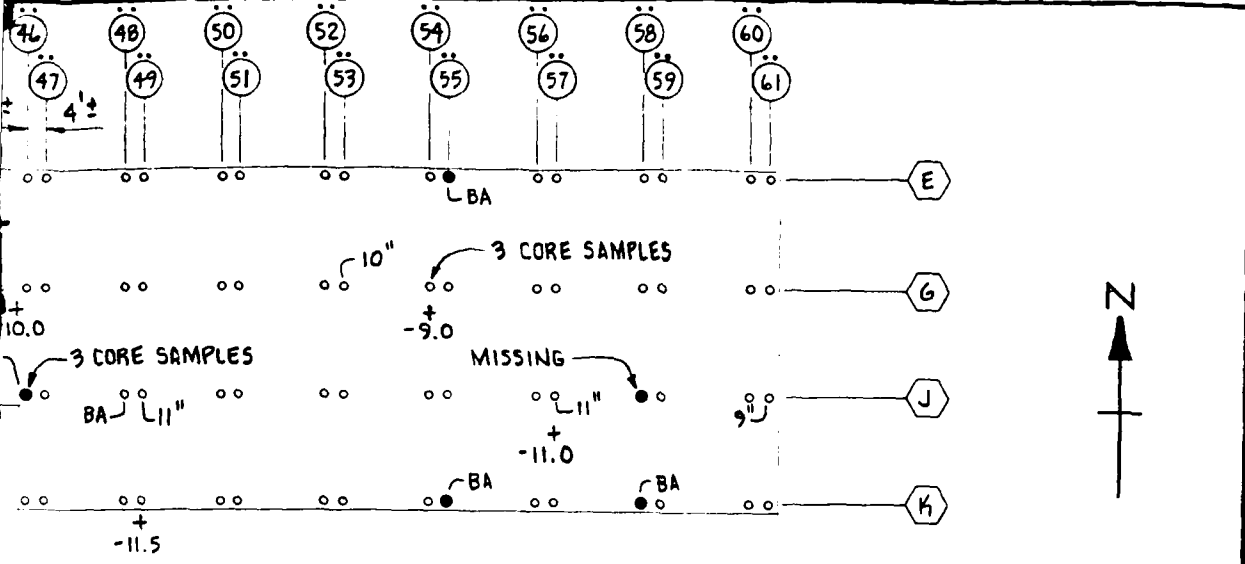
GRAPHIC SCALE	CHILDS ENGINEERING CORPORATION BOX 333 MEDFIELD MA	CHESAPEAKE DIVISION NAVAL FACILITIES ENGINEERING COMMAND WASHINGTON D C	
		NAVAL AIR STATION WHIDBEY ISLAND, WA	FIG NO 9
AS SHOWN		BOAT HOUSE

The Boat House is in fair condition. Marine borer attack has rendered several piles structurally deficient.

The facility is an "L" shaped structure with principal east-west dimensions of approximately 325' long by 70' wide and north-south dimensions of 220' long by 75' wide. There are approximately 261 vertical piles supporting the Boat House structure (see Figure 9).

The major structural anomaly associated with the piles is marine borer attack. Piles which are severely damaged as a result of borer attack and no longer structurally functional are: (see Photo #9)

The observed marine borer attack is a serious problem for the timber pile-supported structures. The presence of the borers indicates that the preservative treatment may have lost its effectiveness. Piles in the Fuel Pier, Main Pier and Boat House should be protected from further borer attack by wrapping the piles in protective plastic jackets.

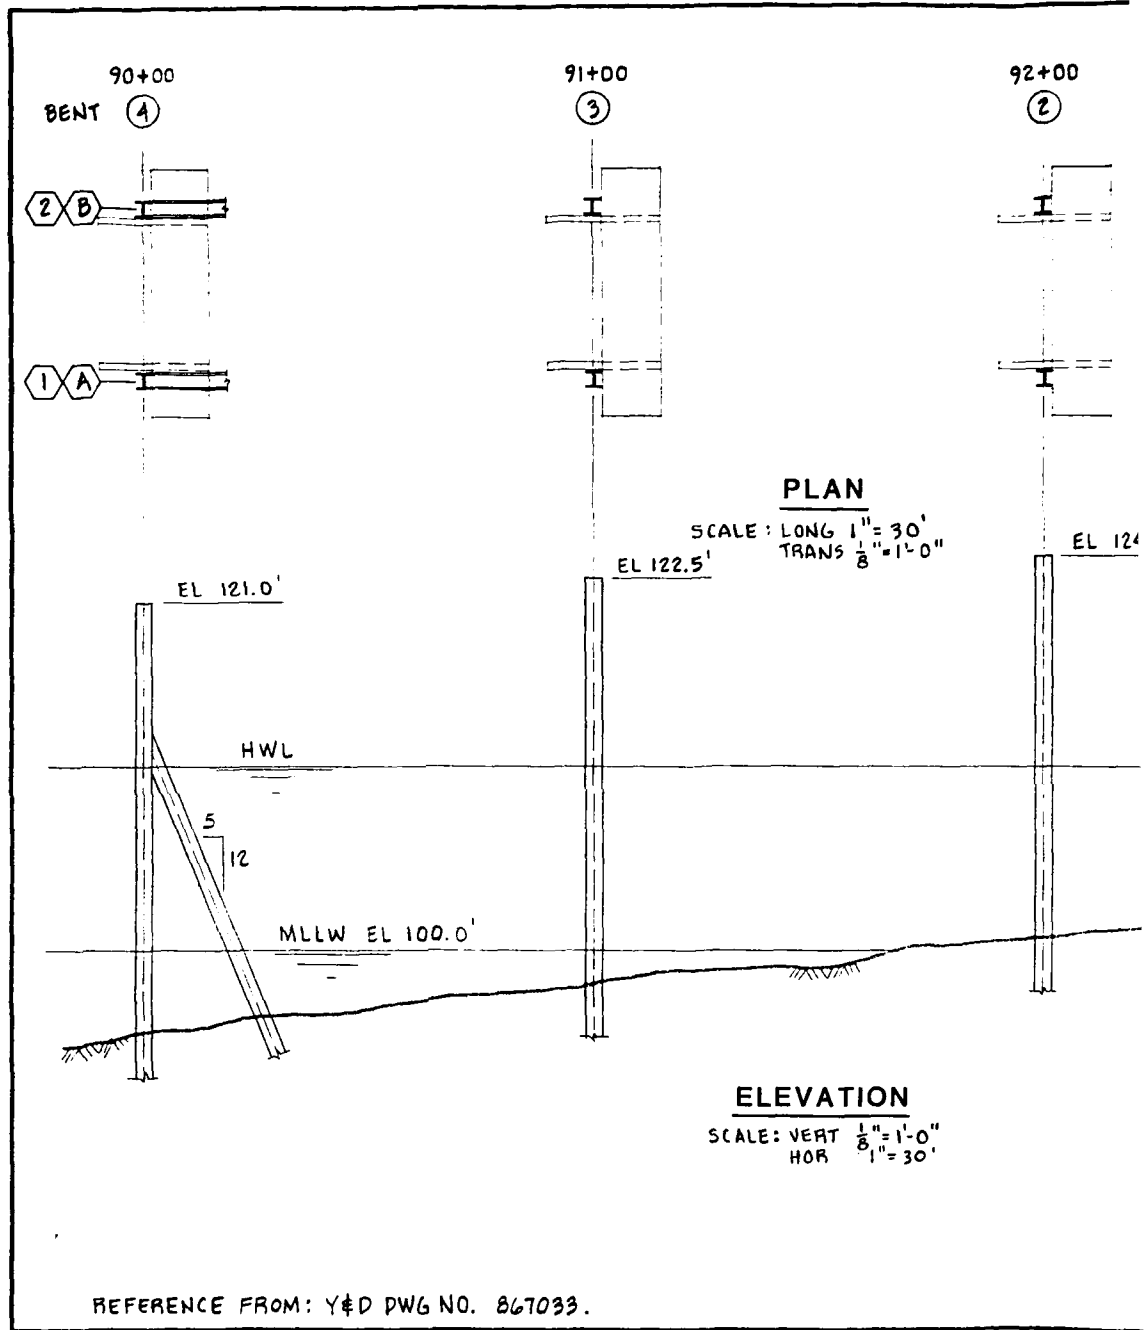
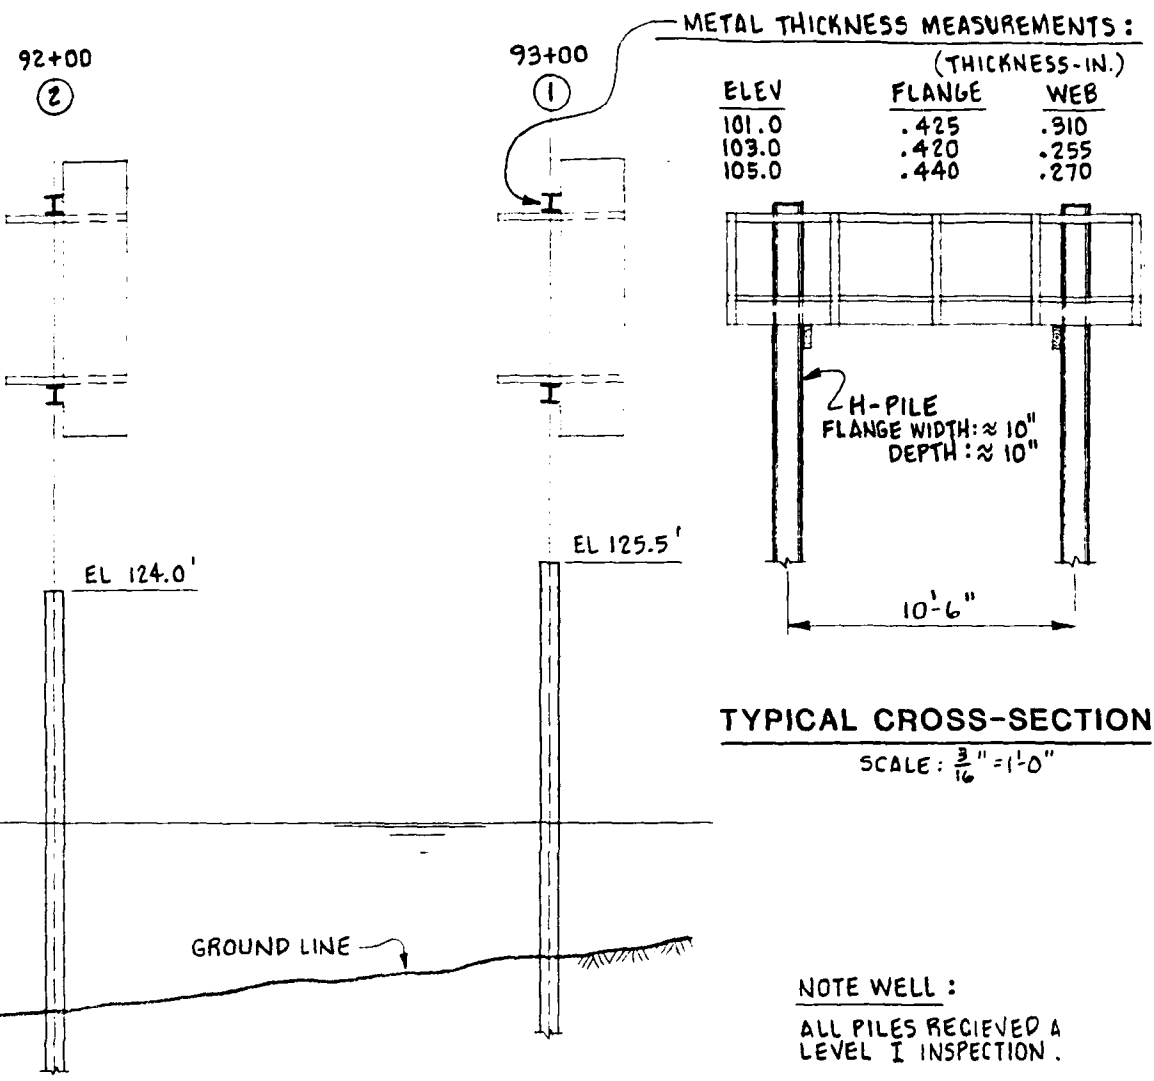
The portion of the Approach Lights system which extend below high water level includes four (4) pile bents. Three of the bents are composed of two (2) steel H-piles supporting a working platform and a bar of lights, while the fourth bent has two (2) vertical steel H-piles and two (2) battered steel H-piles (see Figure 10).

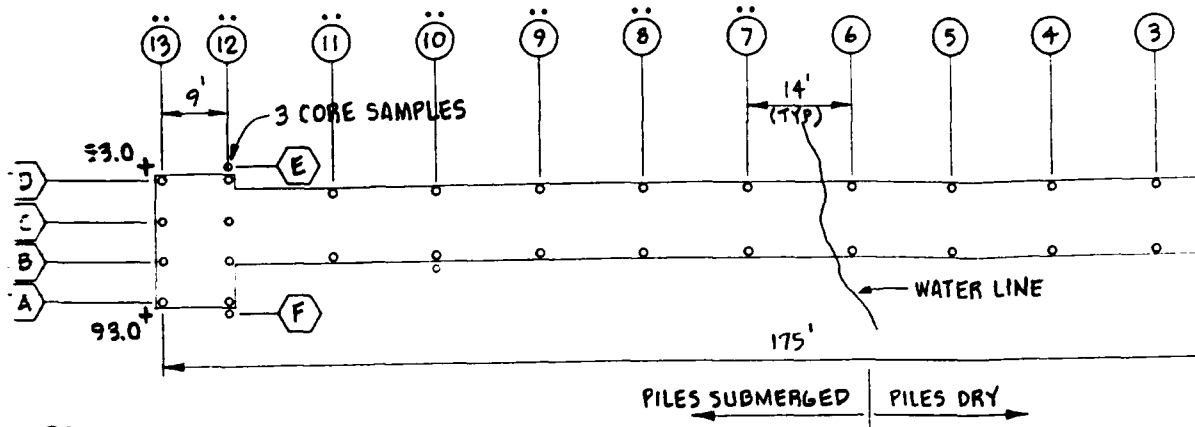
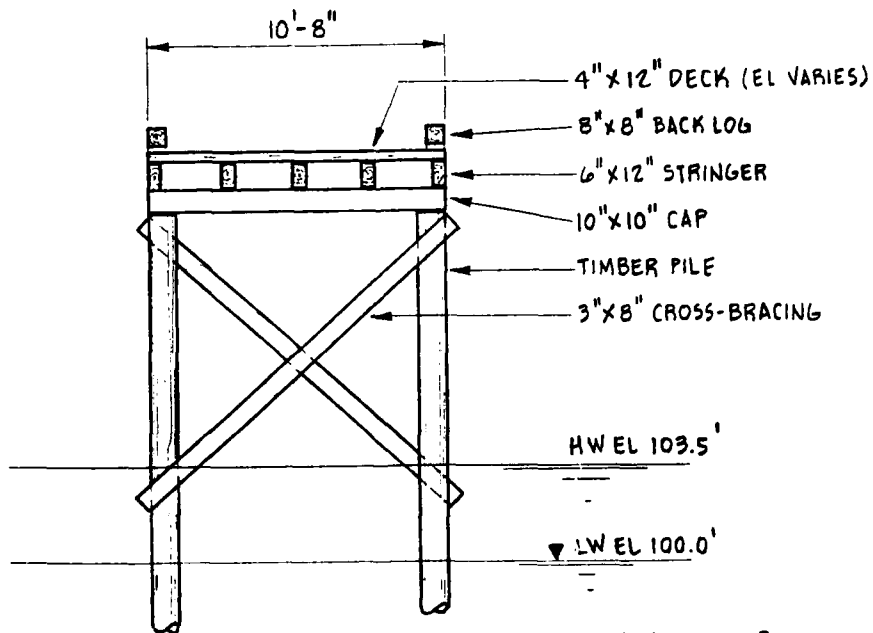
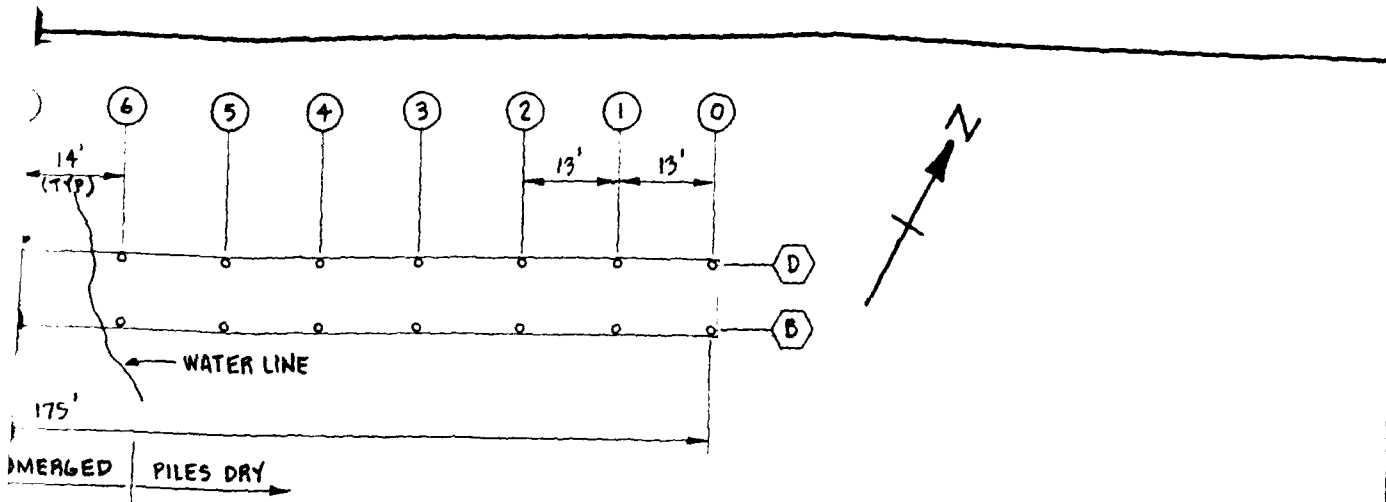
GRAPHIC SCALE	CHILD'S ENGINEERING CORPORATION BOX 333 MEDFIELD, MA	CHESAPEAKE DIVISION NAVAL FACILITIES ENGINEERING COMMAND WASHINGTON, D.C.	
AS SHOWN		NAVAL AIR STATION PUMPING STATION PIER	WHIDBEY ISLAND, VA FIG NO 11

The Runway Approach Lights and the Pumping Station Pier facilities are in good condition with no significant structural anomalies noted.

The pier was constructed circa 1956 and is an open pier-type structure approximately 175' long and 10' wide. A timber deck system is supported by a total of 35 vertical treated round timber piles (see Figure 11).
