UNDERWATER FACILITIES
INSPECTION AND ASSESSMENT
AT

NAVAL SUPPLY CENTER
SAN DIEGO,
CALIFORNIA

F P O - 1 - 83 - (43)

Sept., 1983

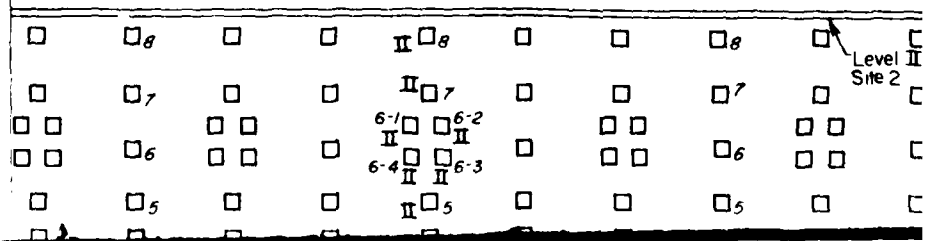
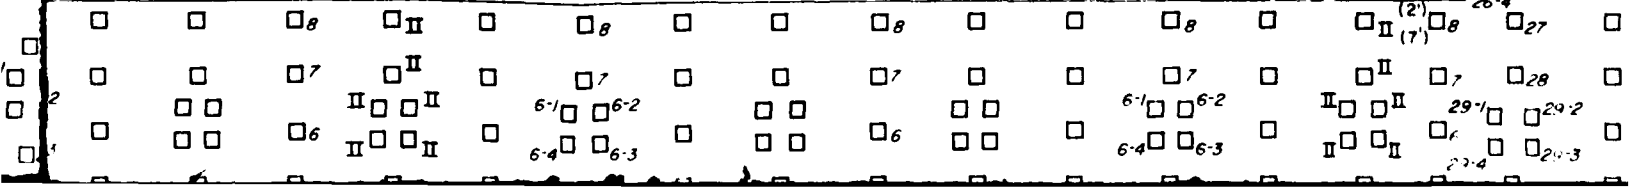
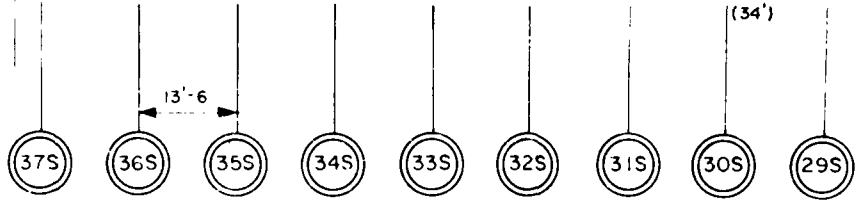
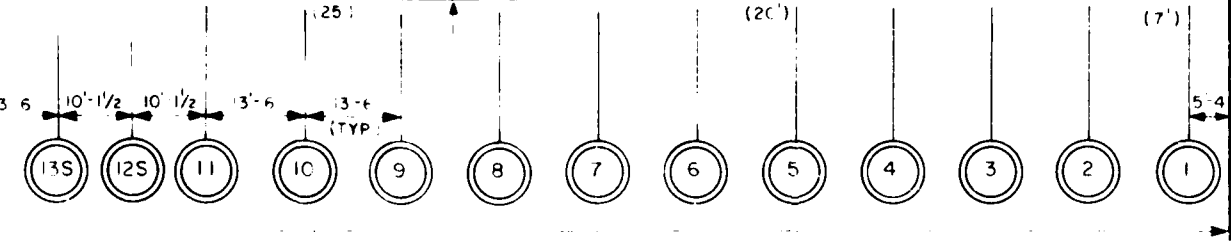
Pile lengths along the berth faces were found to be approximately 30 - 35 feet, mudline to cap. Detailed measurements of pile length were taken at intervals throughout the structure and are shown on Drawings 1 and 2. At several locations around the concrete bulkhead, the individual piles were not visible to inspection because of build up of the rip-rap toe (See Drawing 3).
