# **SEPTEMBER 1983**

**OCEAN ENGINEERING** AND CONSTRUCTION PROJECT OFFICE CHESAPEAKE DIVISION NAVAL FACILITIES ENGINEERING COMMAND WASHINGTON, D.C. 20374

FPO-1-83 (25)

CHESNAVFACENGCOM REPORT FPO-1-83(25), "PWC YOKOSUKA FLEET MOORINGS INSPECTION REPORT",

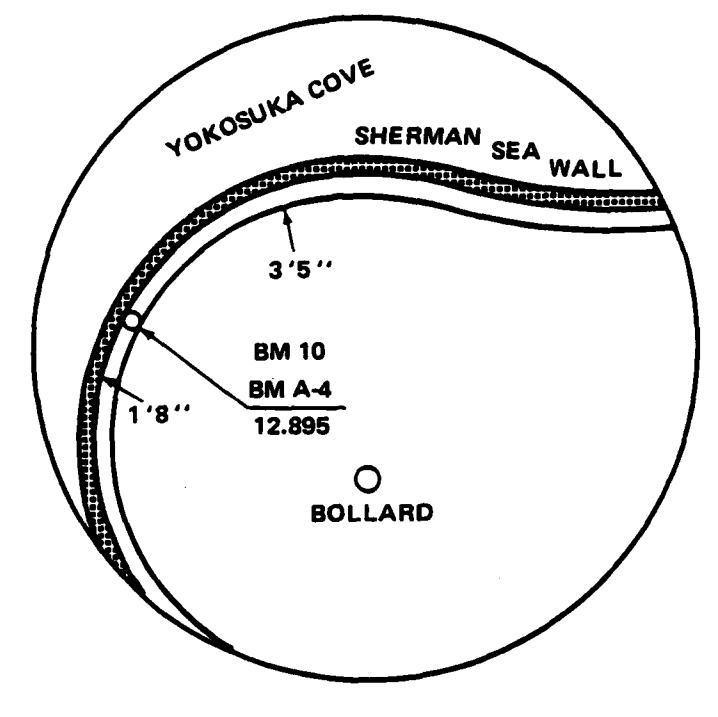
FIGURE B-2. BLCWUP OF THE SITE OF BENCHMARK B-10.

ON TOP OF THE BRASS RIVET OF TRIANGULATION STATION #10 150' WEST OF PONTOON #5 ON SHERMAN SEAWALL.
