ST JULIENS CREEK OCEAN CONSTRUCTION EQUIPMENT INVENTORY 1/2

RUG 83 CHES/NAUFAC-FFO-1-83(24)-UOL-1

The purpose of this document is to present the anticipated needs of the OCEI Support Facility at St. Juliens Creek over the next five years. It is a planning document designed to provide sufficient background and data so that the reader can effectively utilize the proposed recommendations and conclusions. The scope of the document is intended to provide the information required to justify appropriation requests.

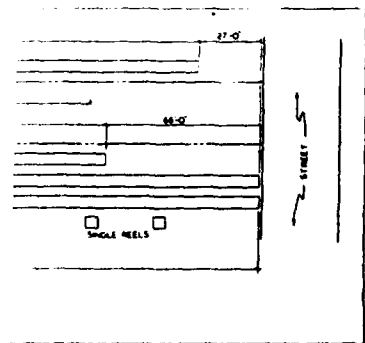
The area is flat and surrounded by woods on the east and south sides. A paved road runs along the north side, providing access from the main road. Various types of material, belonging to other users, are stored on the area's wide west side. A dirt road provides access through the interior of the area. (See Figure 3-23.)

Figure 3-23: View of Cheatham Annex temporary storage
 area as seen from north end (Spring 1983).
 Note rough access road.

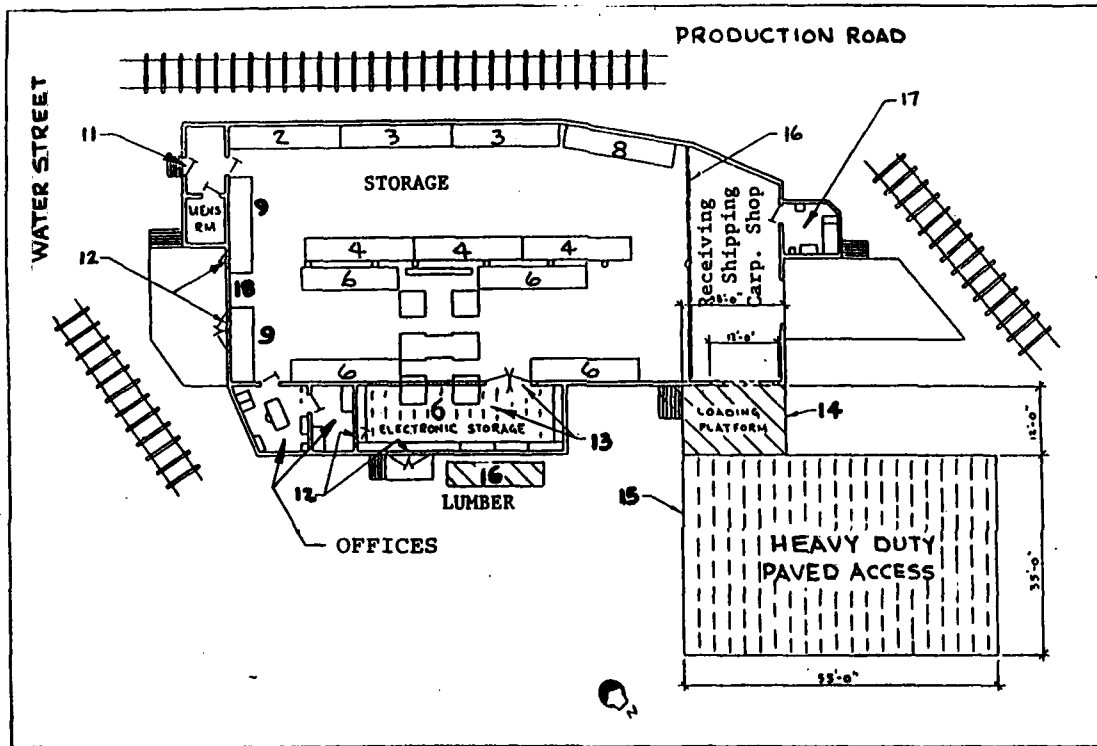
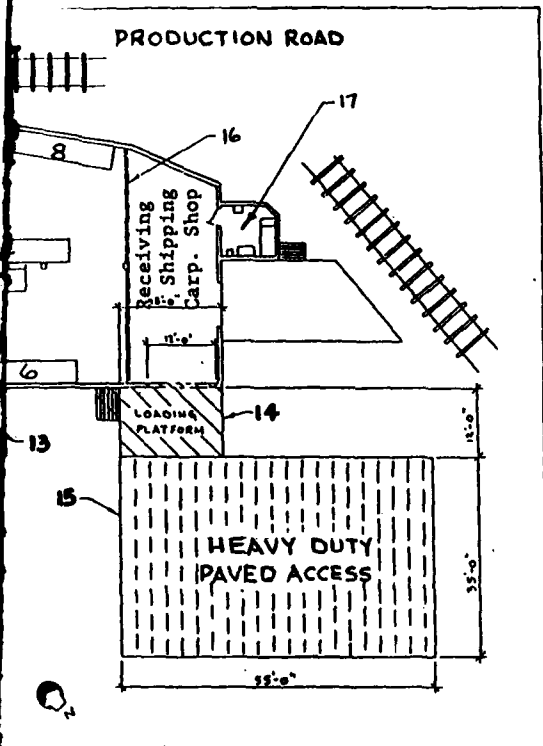
Proposed repairs to Building 43 are detailed in Table 4-1. Double doors and windows in Building 43 leak water and contribute substantially to overall heat loss from the building. The older doors which will not be closed up or replaced should be weatherstripped and have new hardware installed to assure closure for tightness and security.

The interior steam system leaks and may be corroded enough to be dangerous and subject to rupture. New two inch steam supply lines, valves and fittings should be installed to the existing heat coils. The piping will need to be rerouted to avoid interference with the proposed new overhead door located at the southwest platform.

layout of building 43 showing re-arrangement of enlarged cargo door, and loading platform and hardstand as environmentally controlled electronic storage, carpenter shop/shipping receiving area and covered lumber

11. New Front Door
12. Walled up doors
13. New Wall & Doors
14. New Cargo Door & Loading Platform
15. New Hardstand
16. Walled off Shipping Receiving Carpenter Shop & Covered Lumber Storage
17. Environmental Control in Office.
18. Move Main Breaker Inside

Bldg. 43 RECOMMENDED REPAIRS				
FY/FND	Problems	Repairs	Figure #/ Legend #	* Est. Cost
85/OMN	Heat system dangerously rusted	Provide new 2" lines, valves & fittings	4-1	\$ 6,700
85/OMN	Doors & windows leak	Weatherstrip doors repair windows		1,070
85/OMN	Poor Security	Replace front entry & provide locks	11	810
*Estimated costs reflect FY escalators.

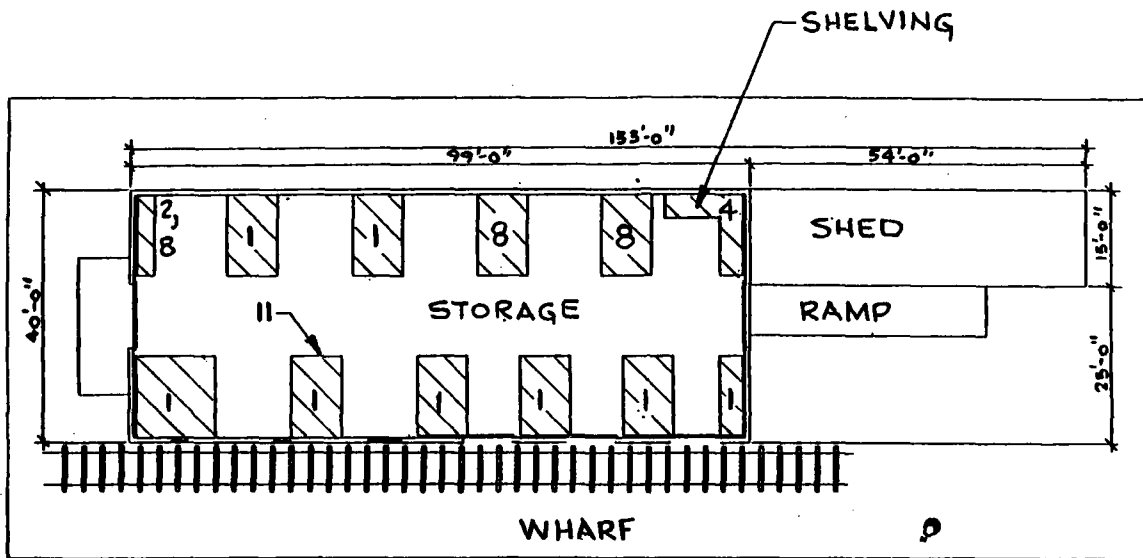
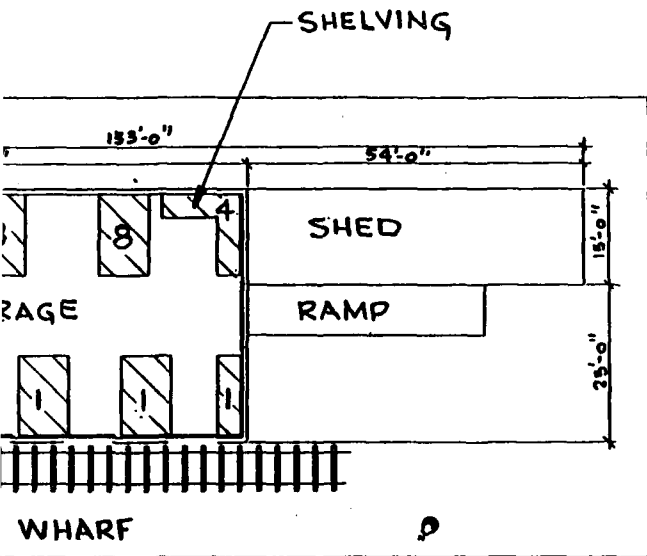
Modifications proposed to update and improve the safety, habitability and efficiency of Building 45 are given in Table 4-4. Electrical power (110/220V, 3 phase) will be brought into the building and new lighting will be installed and wired. Although there are existing fixtures and wiring (non-operational), it is in poor condition and is outdated and will be scrapped. Heating will be installed in the form of two 250,000 BTU/HR steam unit heaters and associated plumbing and controls. The units will tap off the existing available steam feeder located at the northeast end of the shed.

Figure 4-2: Proposed layout of building 45 showing re-arrangement of storage

Bldg. 45 RECOMMENDED MODIFICATIONS/ADDITIONS				
Figure #/ Legend #	Est. Cost	FY/FND	Problems	Mods/Additions	Figure #/ Legend #	Est. Cost
4-2	\$17,350	85/OMN	Need to hang salvage gear	Install padeyes	4-2	\$ 1,730
	1,630	85/OMN	Need storage space	Provide rack and pallet storage	11	7,715
	1,955	86/OMN	Wiring old	Rewire, hook up power		7,400
	10,260					
	3,260					
	8,560					
*Estimated costs reflect FY escalators.

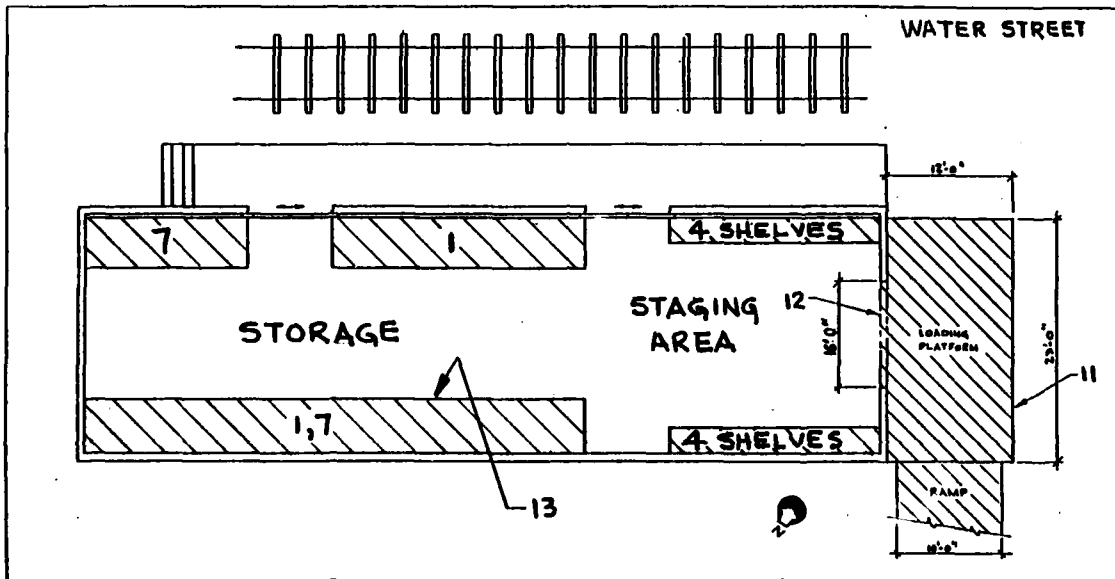
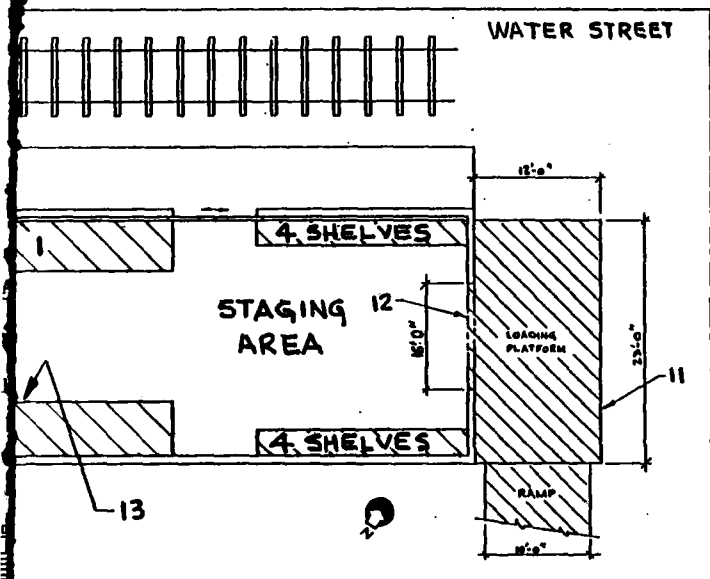
Figure 4-3 presents the floor plan of Building 83-Y showing the proposed layout. The building will be used as a primary staging area and to store machinery, equipment spares and other materials which do not require environmental control, but need to be out of the weather. This plan takes advantage of the building's proximity to the Hardstand and pier.

Figure 4-3: Proposed layout of building 83Y showing re-arrangement of storage, the addition of a large cargo door, loading platform and ramp on the east end.

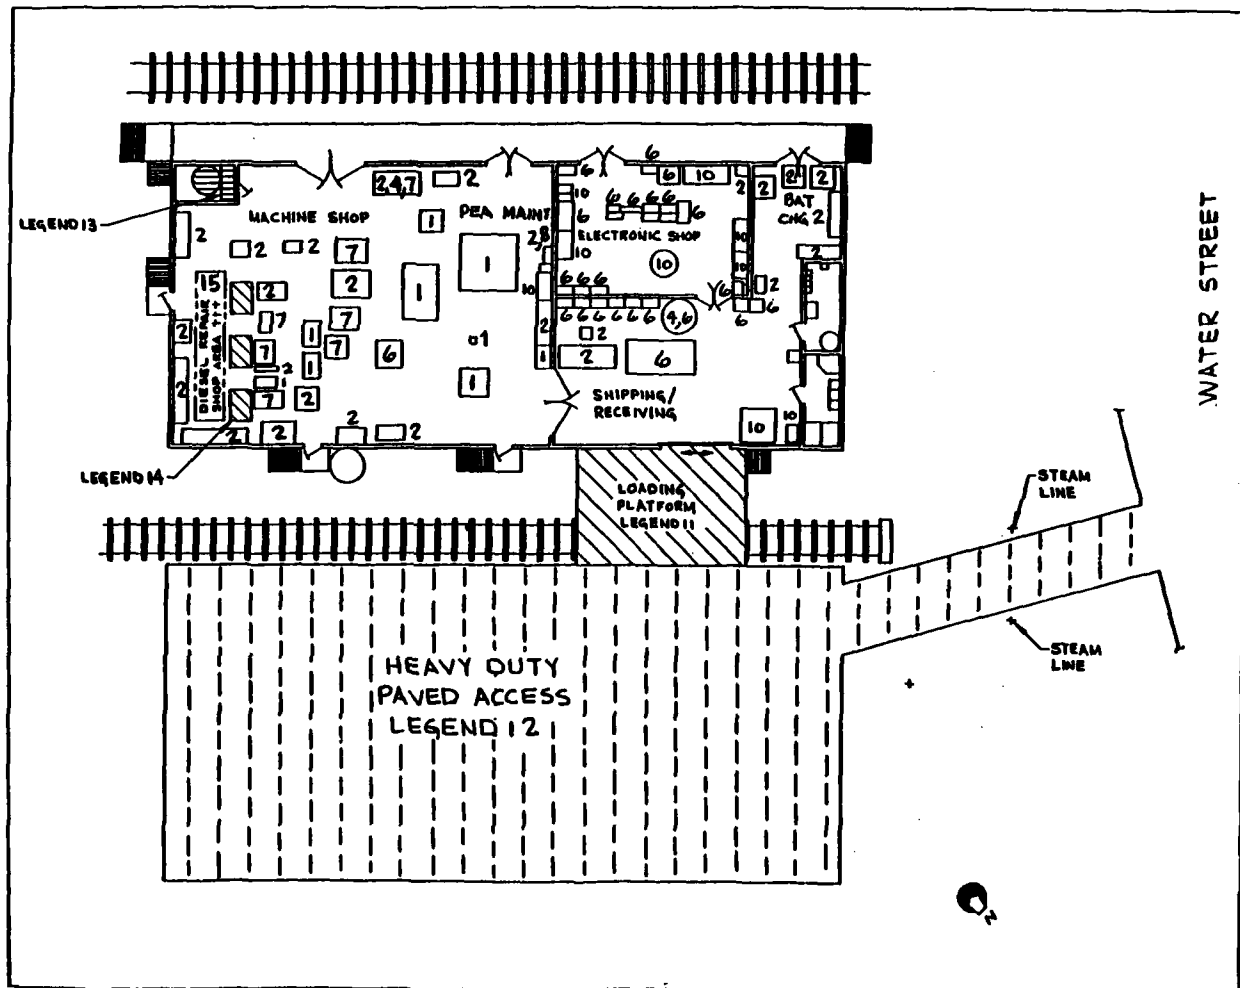
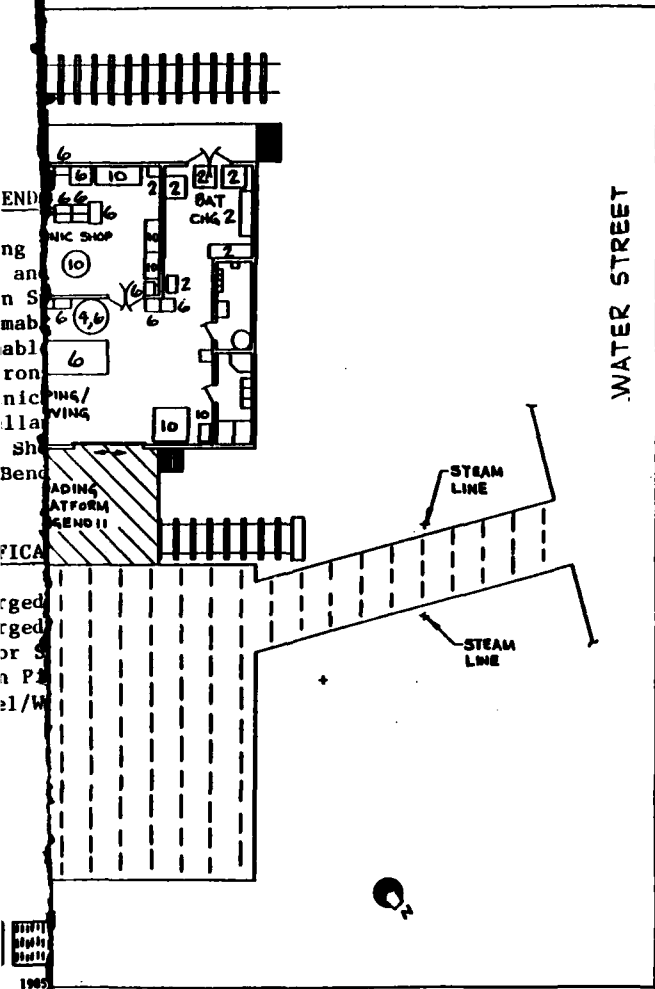
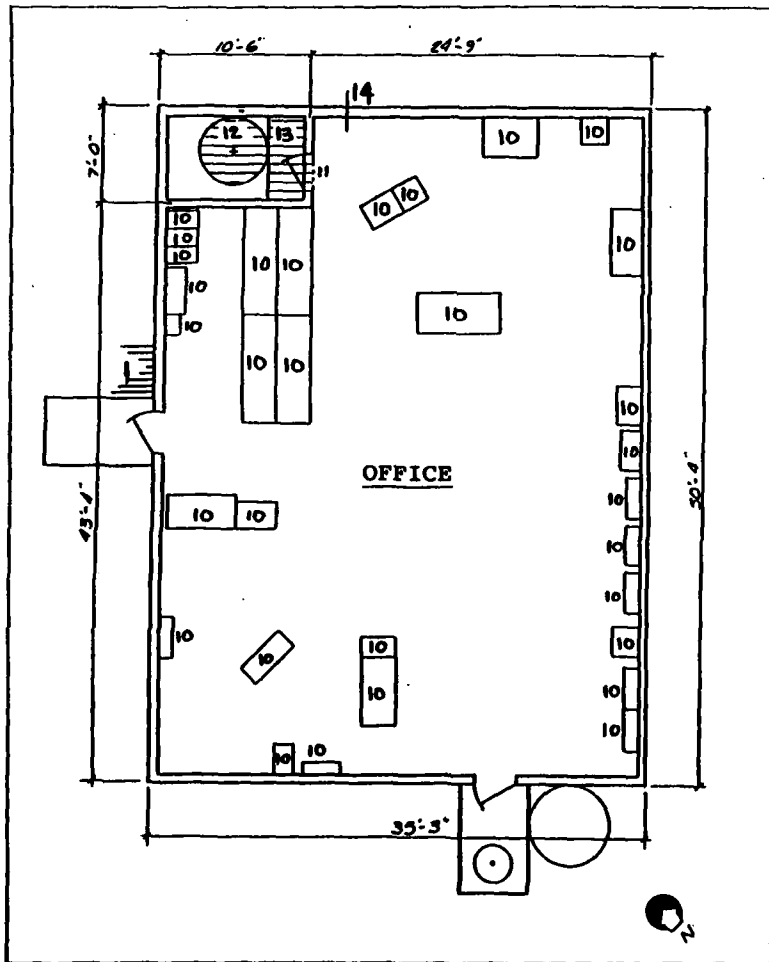
The proposed floor plan for the first floor is shown
in Figure 4-5. The modified second floor is shown in
Figure 4-6 and the enlarged loading platform and up-
graded Hardstand appear in Figure 4-5. The building
will continue to be used as a mechanical, electrical
and electronic repair facility, with engineering and
administrative offices on the second floor. Proposed
changes are for energy conservation, better accessi-
bility for large equipment to be repaired or overhauled
and acquisition of shop equipment for engine and winch
overhaul capability.

Figure 4-5: Proposed layout of building 185, first floor showing proposed diesel/winch repair area, enlarged loading platform and hardstand, indoor stairway and gratings on drain pits.

Modifications proposed to update and improve the habitability, energy efficiency, accessibility and capabilities are given in Table 4-9 and shown in Figures 4-5 and 4-6. In the machine shop, a vent fan is needed to exhaust fumes and welding smoke. A transformer is required for testing and repairing the cable hauler and transporter.

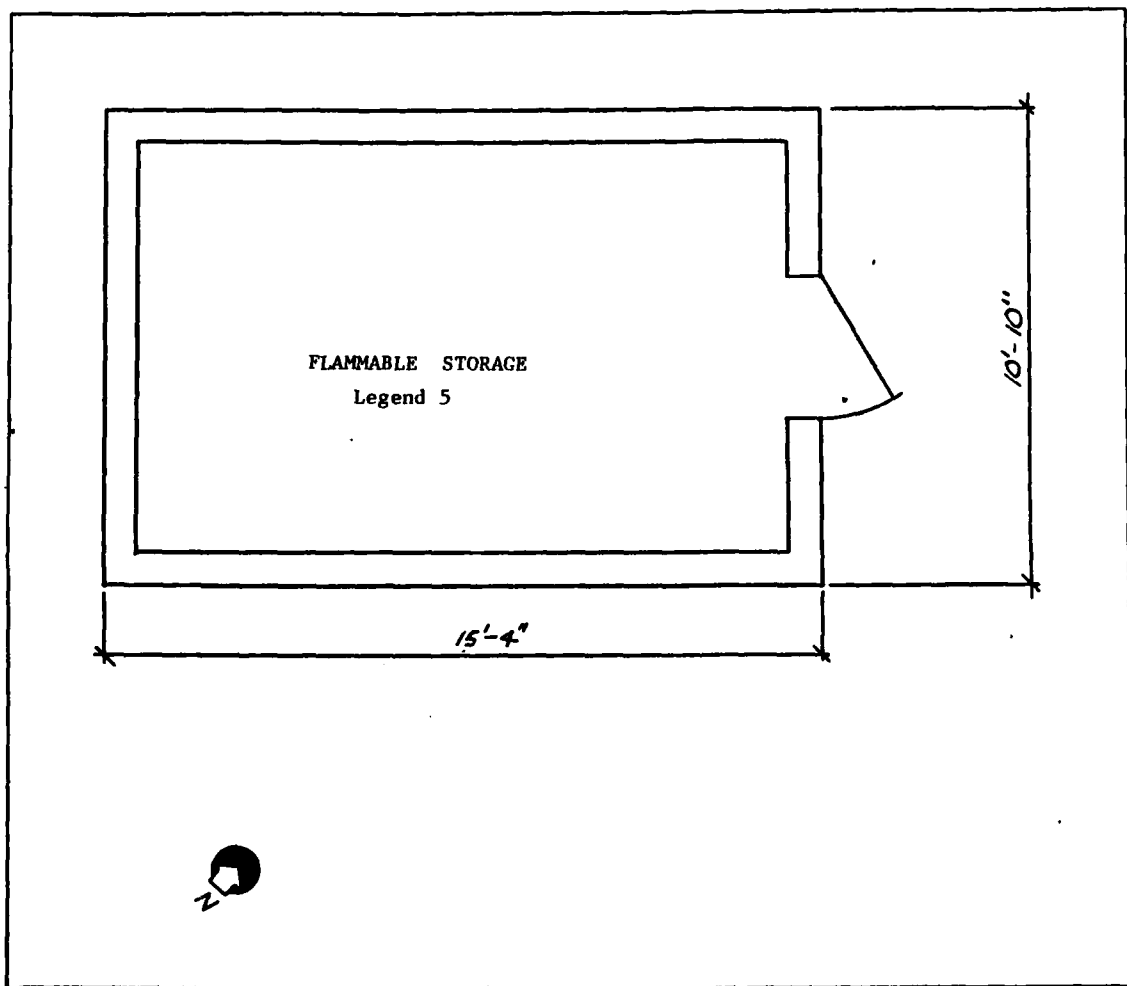
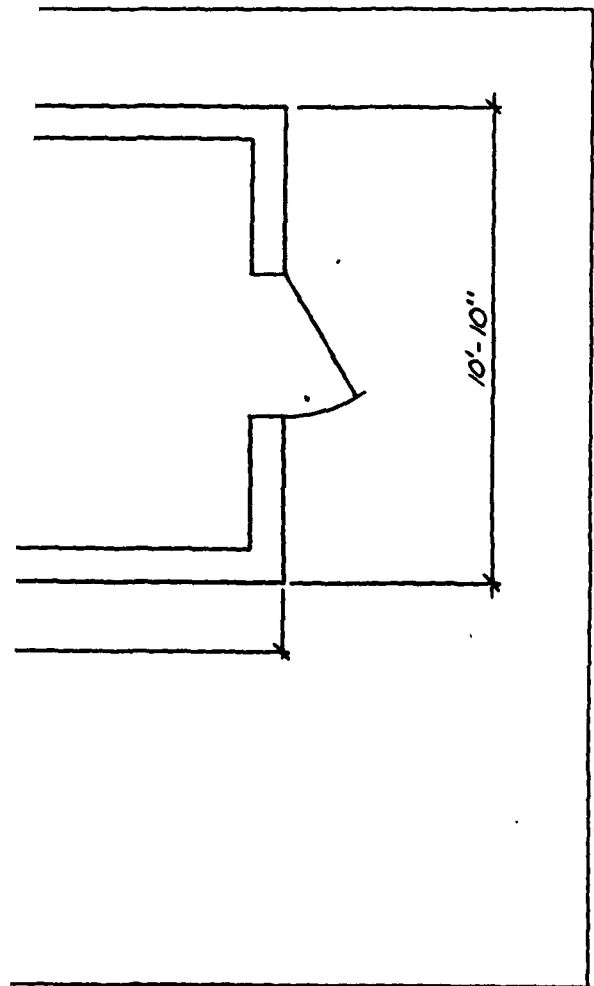
Figure 4-7: Shows the proposed usage of building 209X for flammable storage.

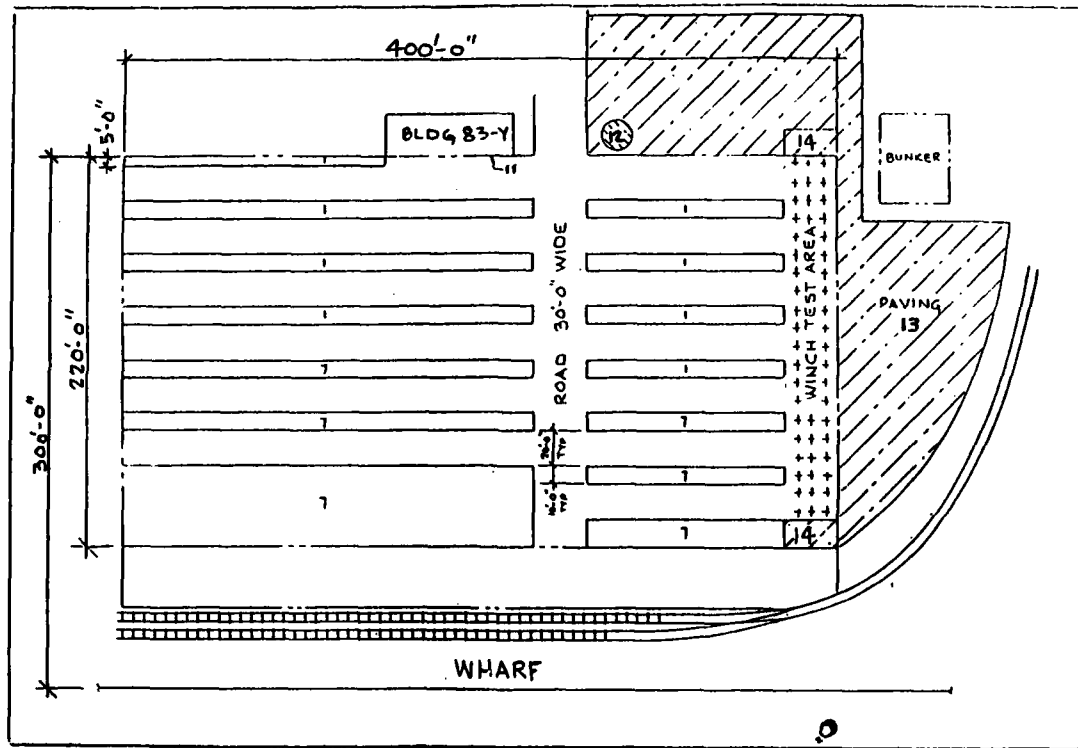
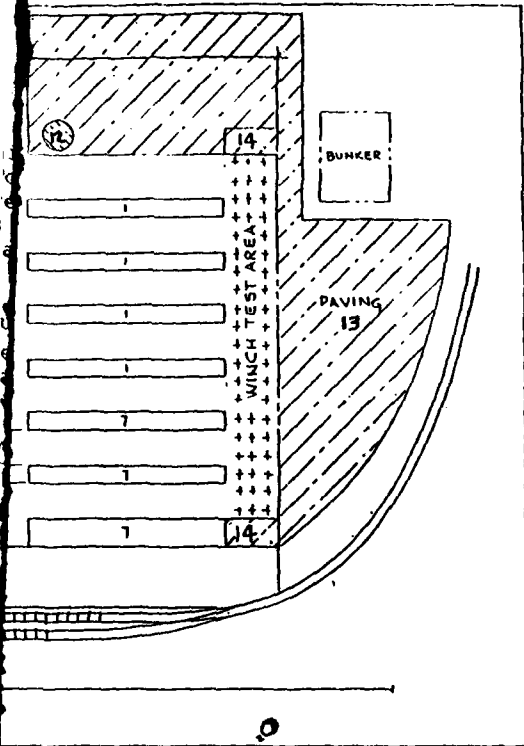
Figure 4-10: Proposed layout of the Hardstand showing re-arrangement of storage and addition of fresh water, security lighting, a winch test area and additional paving.

Smaller pieces of non-OCEI machinery and equipment are to be moved into Building 83-Y, followed by a reorganization of the Hardstand for efficiency of access and protection.
