ENGINEERING INVESTIGATION REPORT
ON
LOSS OF THE SEACON'S CENTER WELL DOORS

C.E. BODEY DIRECTOR, ENGINEERING
AND DESIGN DIVISION
FPO-1

FPO-1-80(2)
DECEMBER 1979

OCEAN ENGINEERING
AND CONSTRUCTION PROJECT OFFICE
CHESAPEAKE DIVISION
NAVAL FACILITIES ENGINEERING COMMAND
WASHINGTON, D.C. 20374

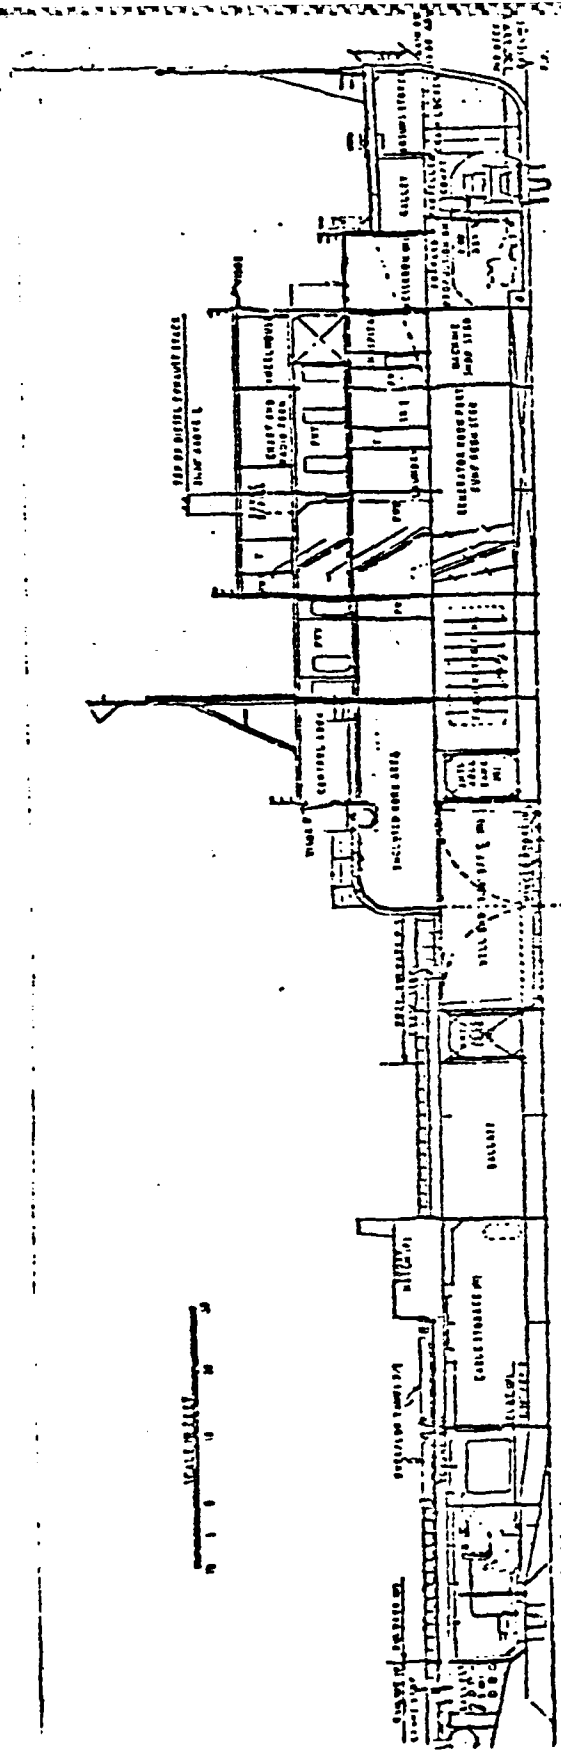
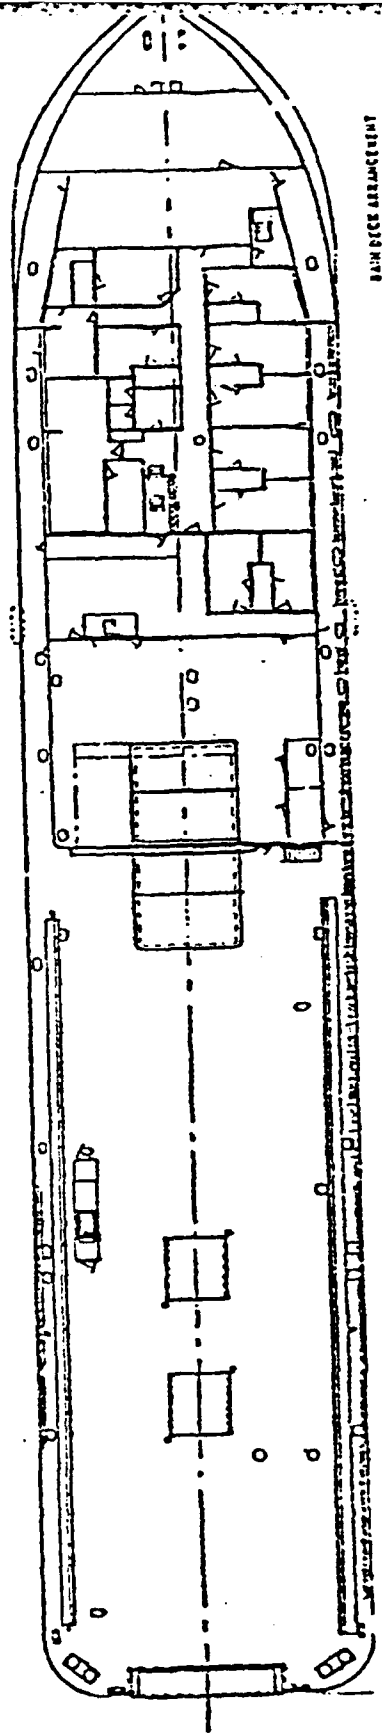
Figure 1. SEACON, GENERAL ARRANGEMENTS

3.1 Initial Service (1976 to May 1979): The SEACON was converted from a NASA YFNB to an ocean engineering and construction work platform by NAVFAC in 1976. Figure 1 shows the general arrangements of the vessel, the center well, the underwater doors and the hatch covers. Since its' launching, the SEACON has been utilized on a variety of Navy ocean engineering and construction projects. Many of these missions have used the launch and recovery capability of the center well feature; and no difficulties were experienced with it either self-powered, or under tow prior to this.
