UNDERWATER FACILITIES
INSPECTIONS
&
ASSESSMENTS

U. S. NAVAL STATION
GUANTANAMO BAY, CUBA

AUGUST 1980

PERFORMED BY:
UNDERWATER CONSTRUCTION TEAM ONE

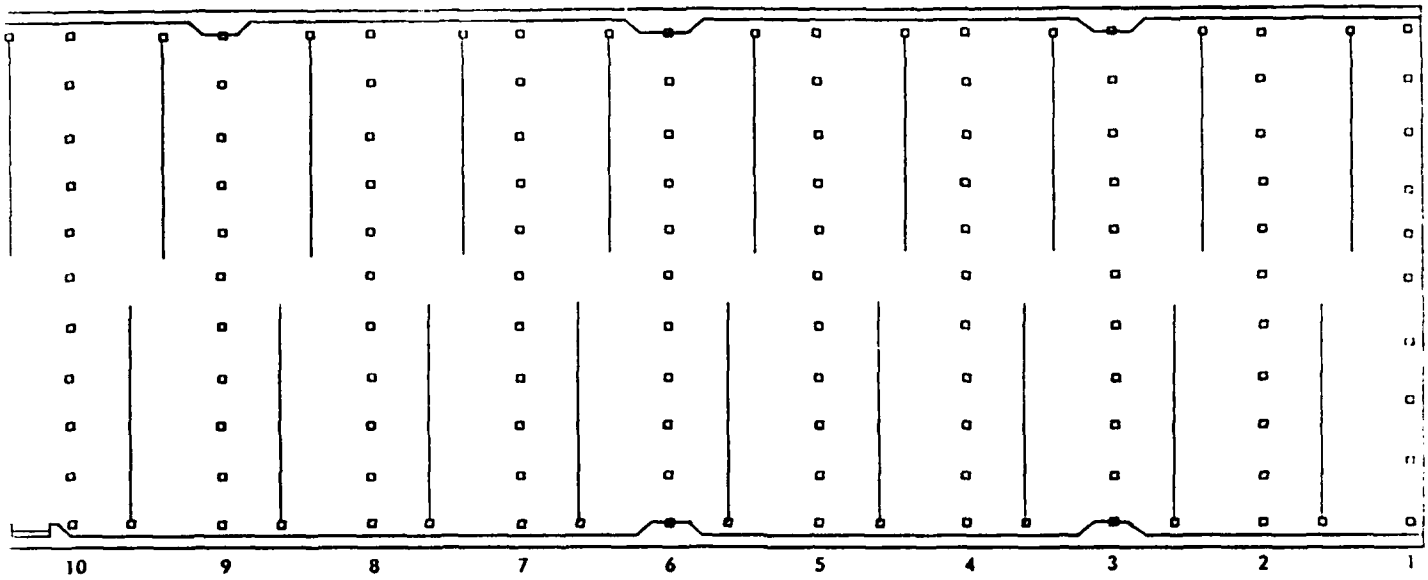
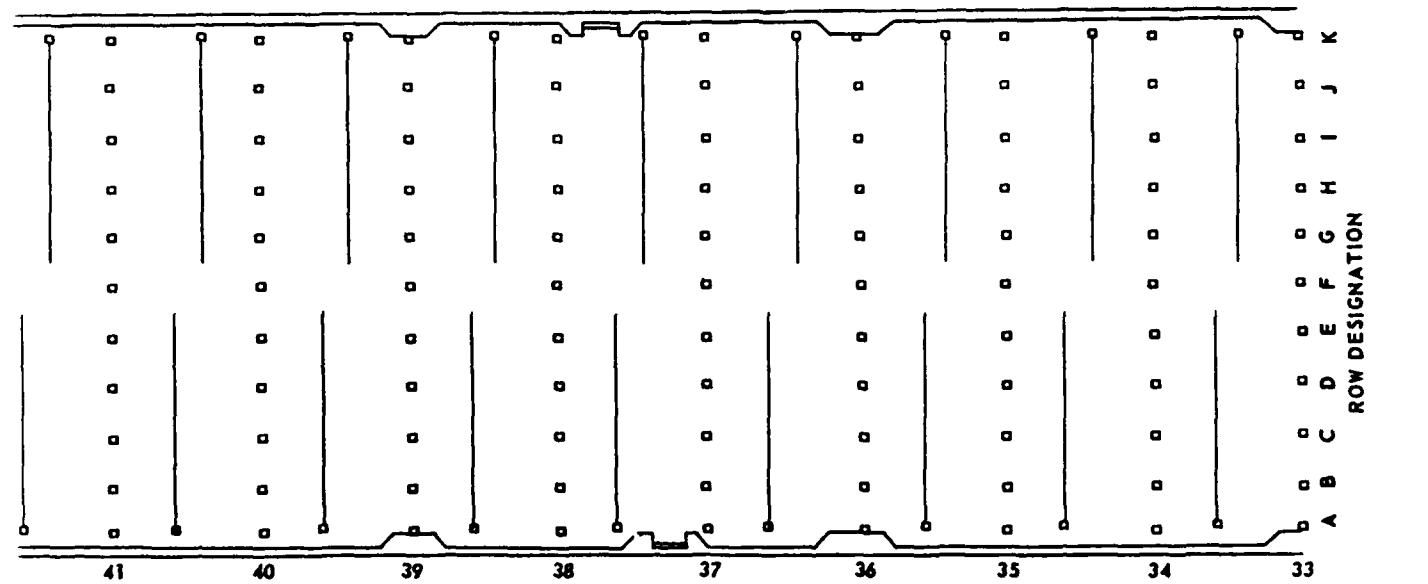
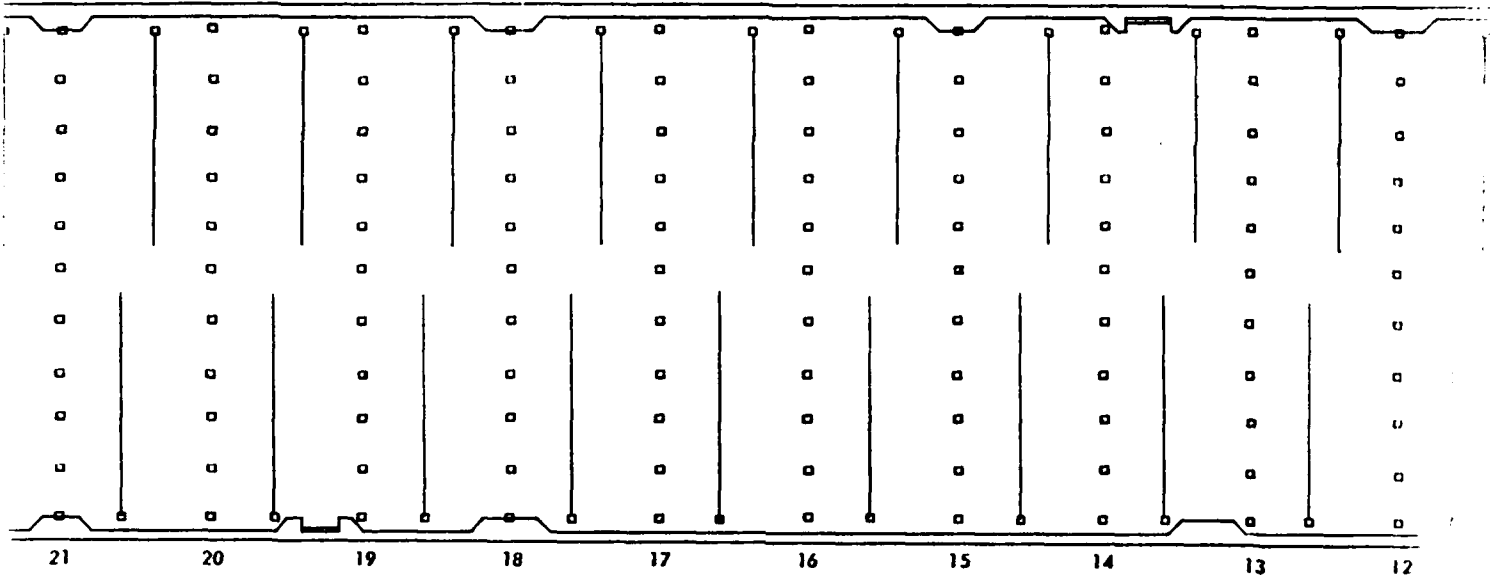
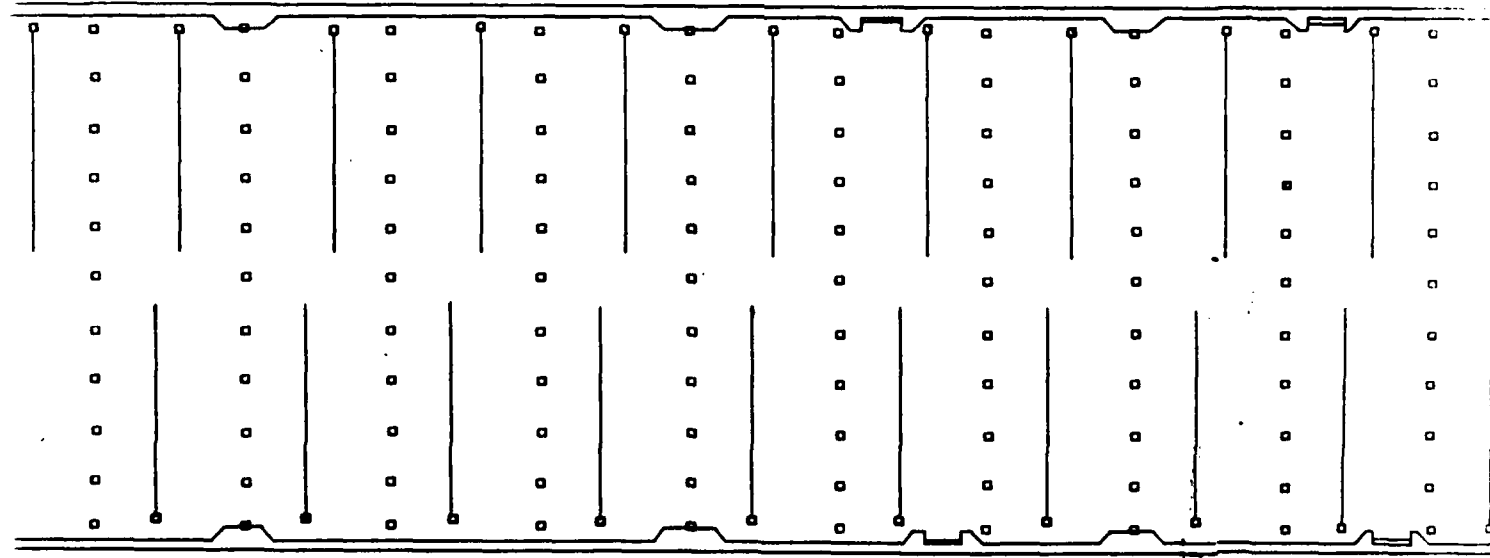
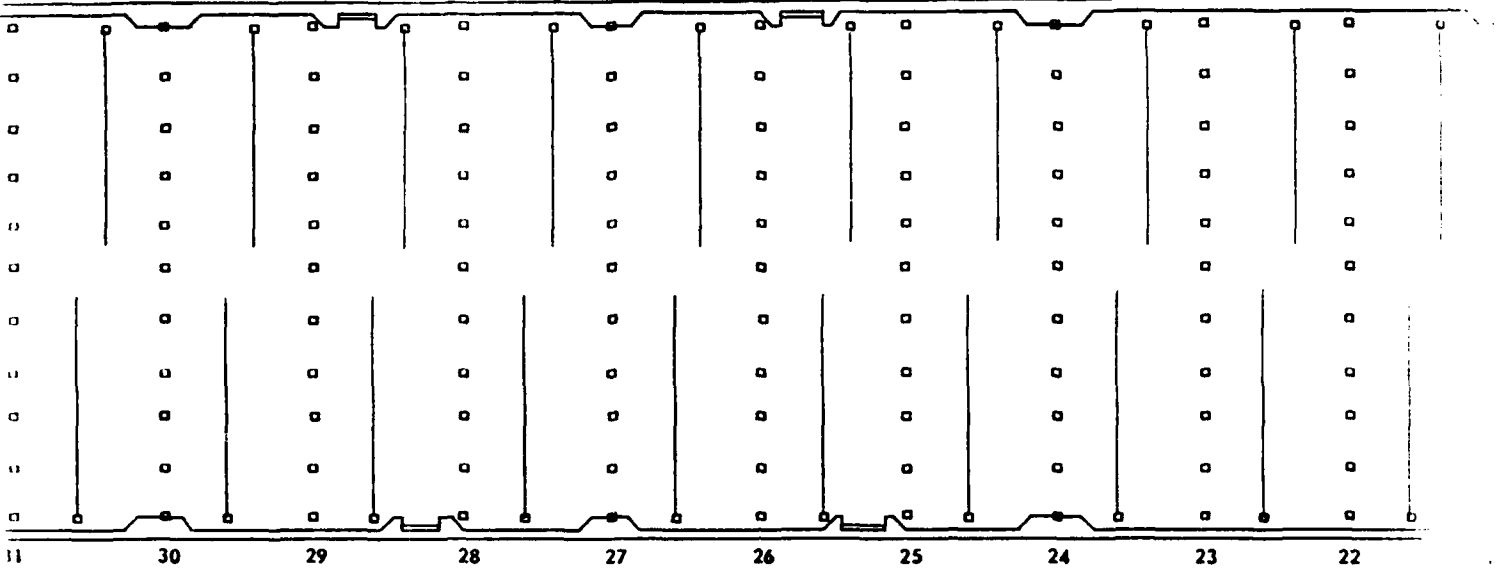
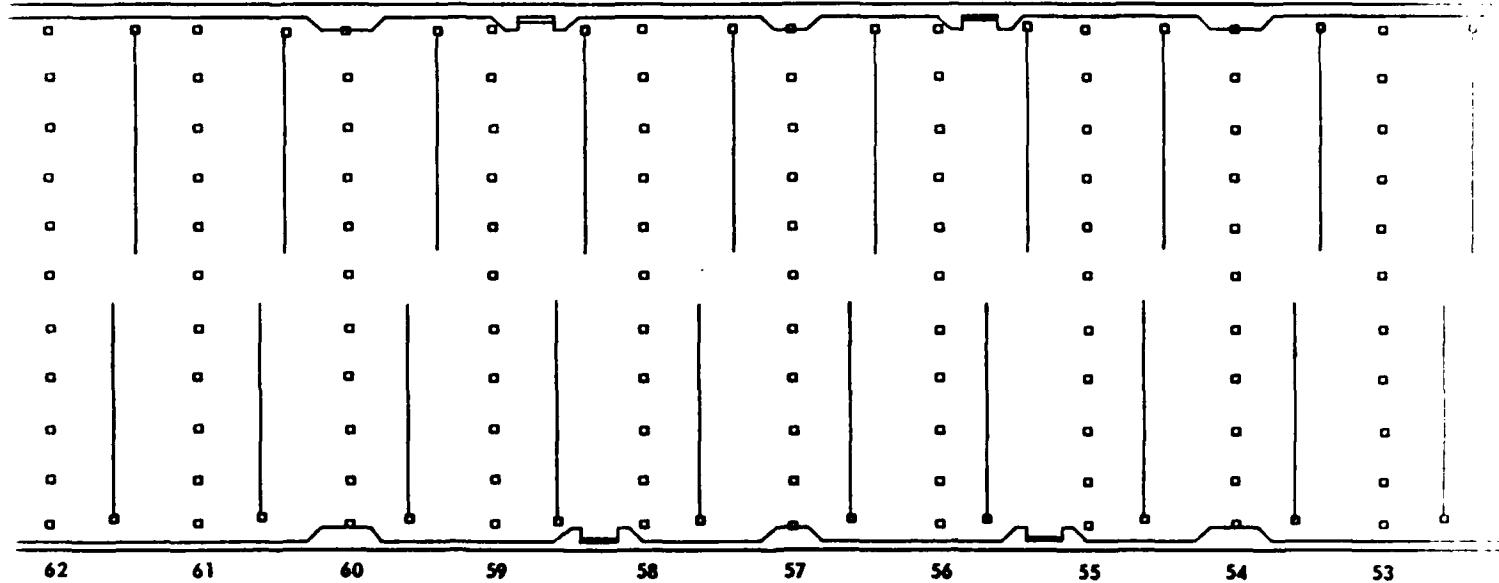
FIGURE 3

Pier V is an open-type reinforced concrete pier that is approximately 1008 feet long and 60 feet wide. The concrete beam and deck structure is supported on precast reinforced concrete piles arranged in sixty-four bents with eleven bearing piles and one batter pile per bent as shown in Figure 3. Also illustrated in Figure 3 is the pile designation system used in the following illustrations and tables.

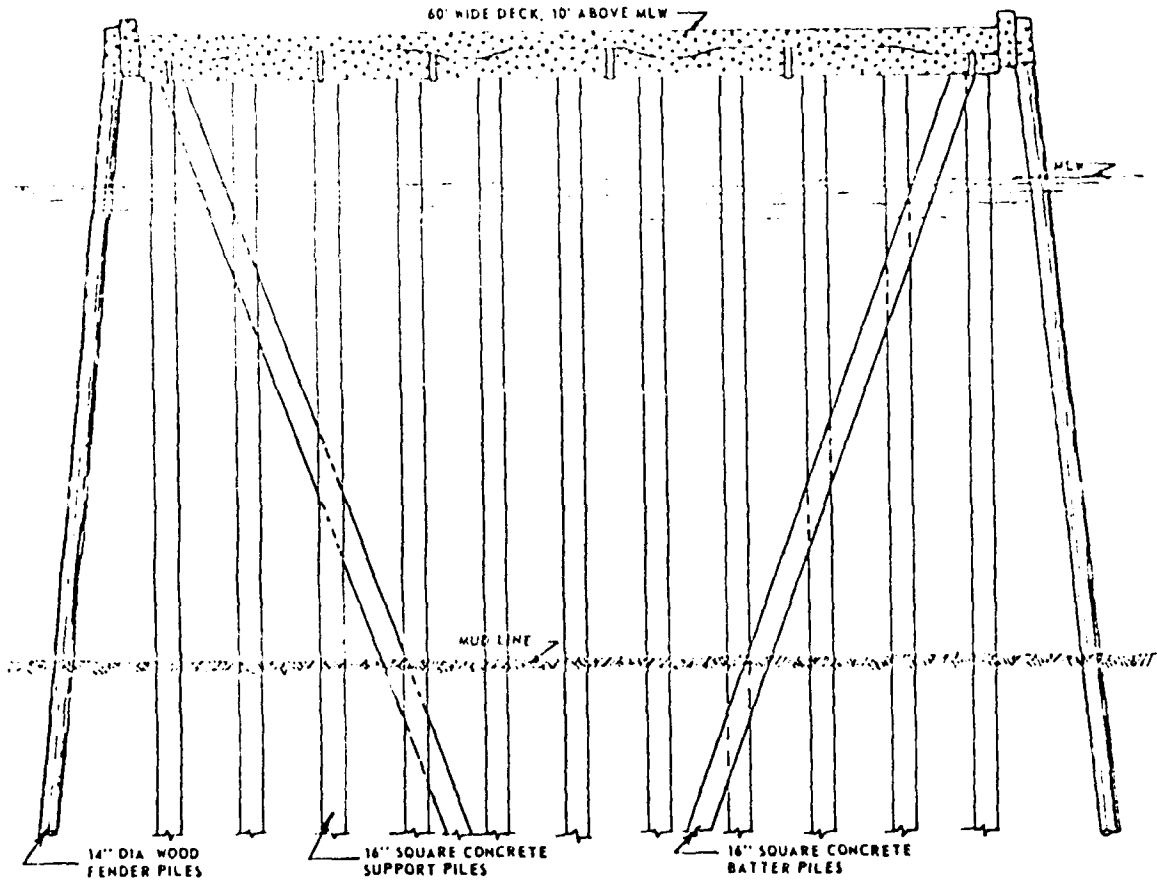
FIGURE 13A

The location of some of these damaged areas can be envisioned by reference to Figure 13A which is a cross section of Pier V.

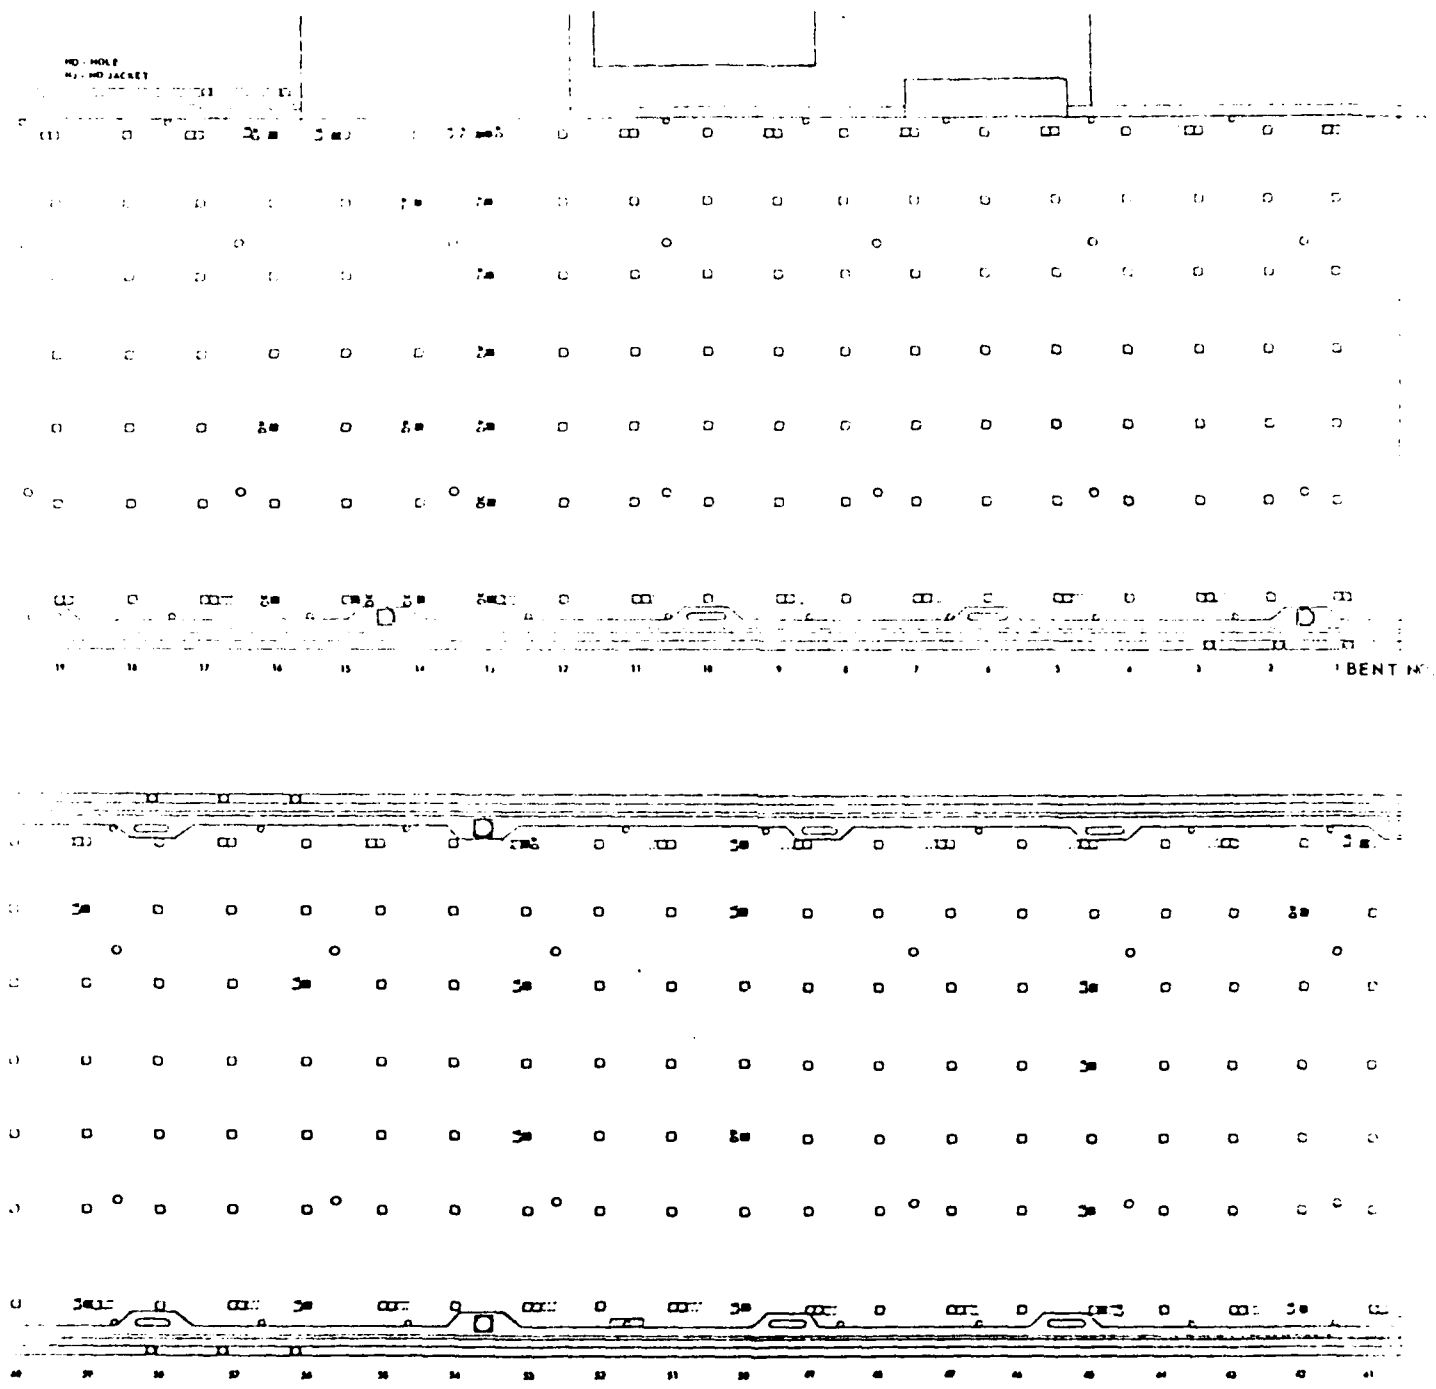
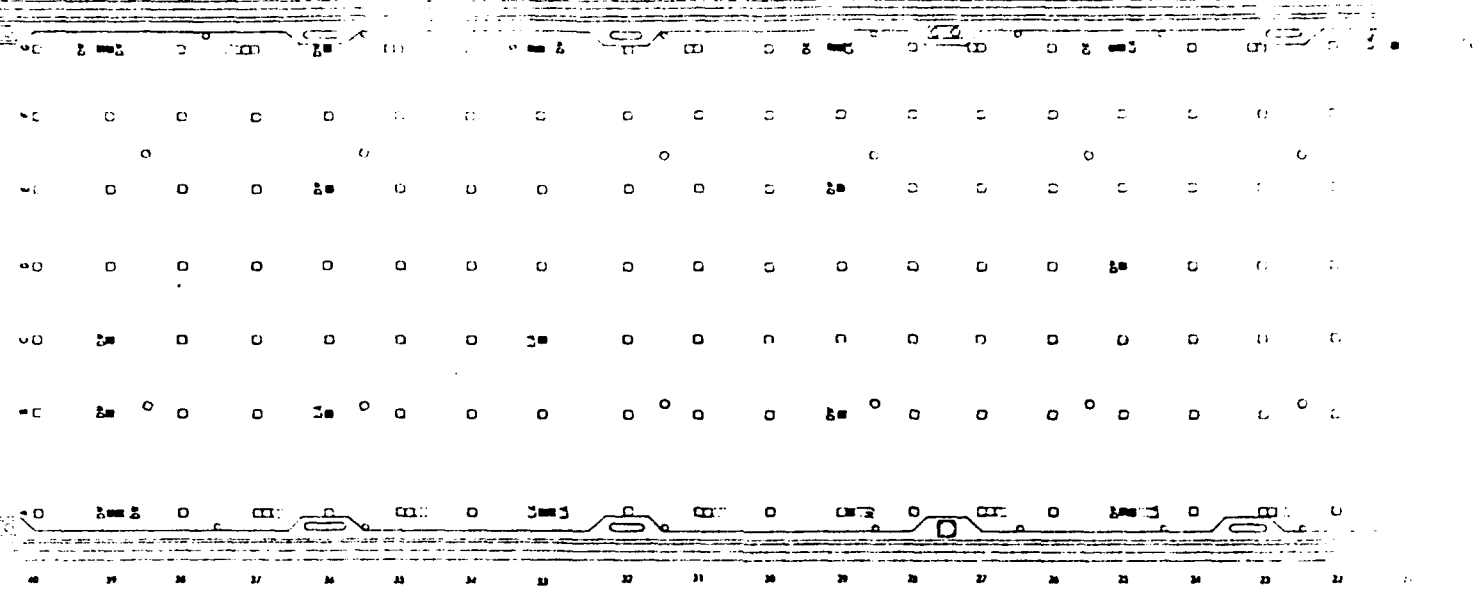
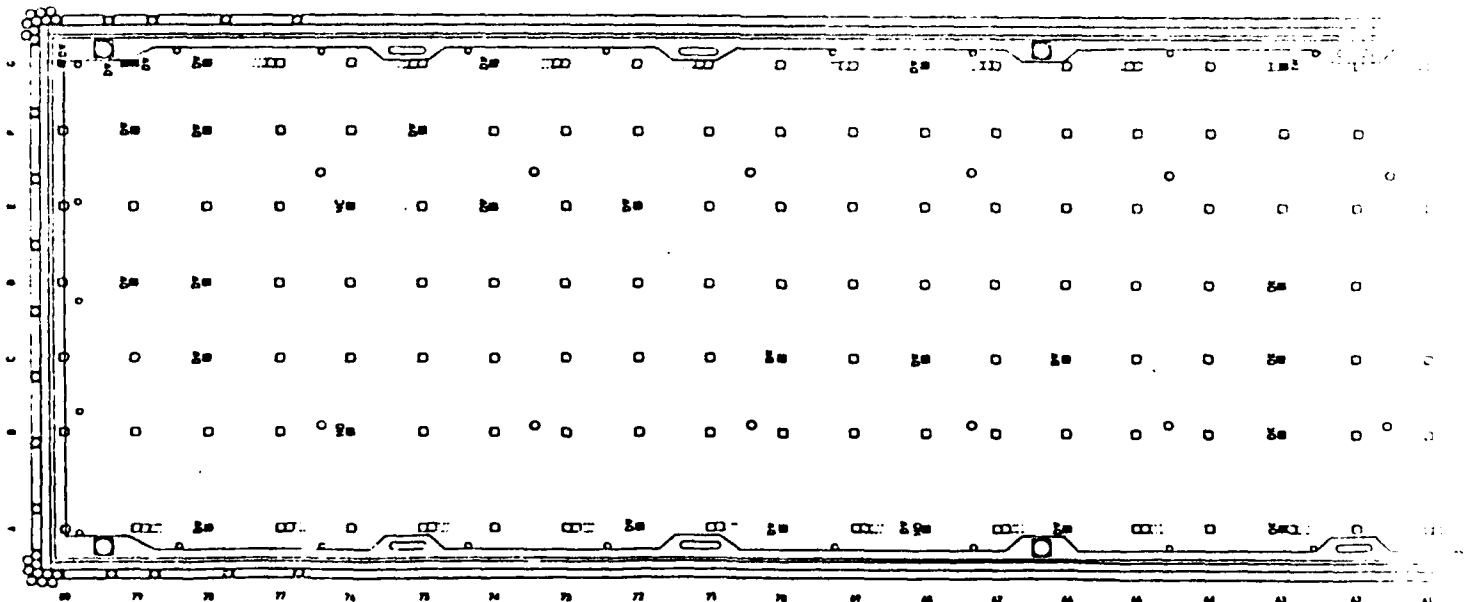
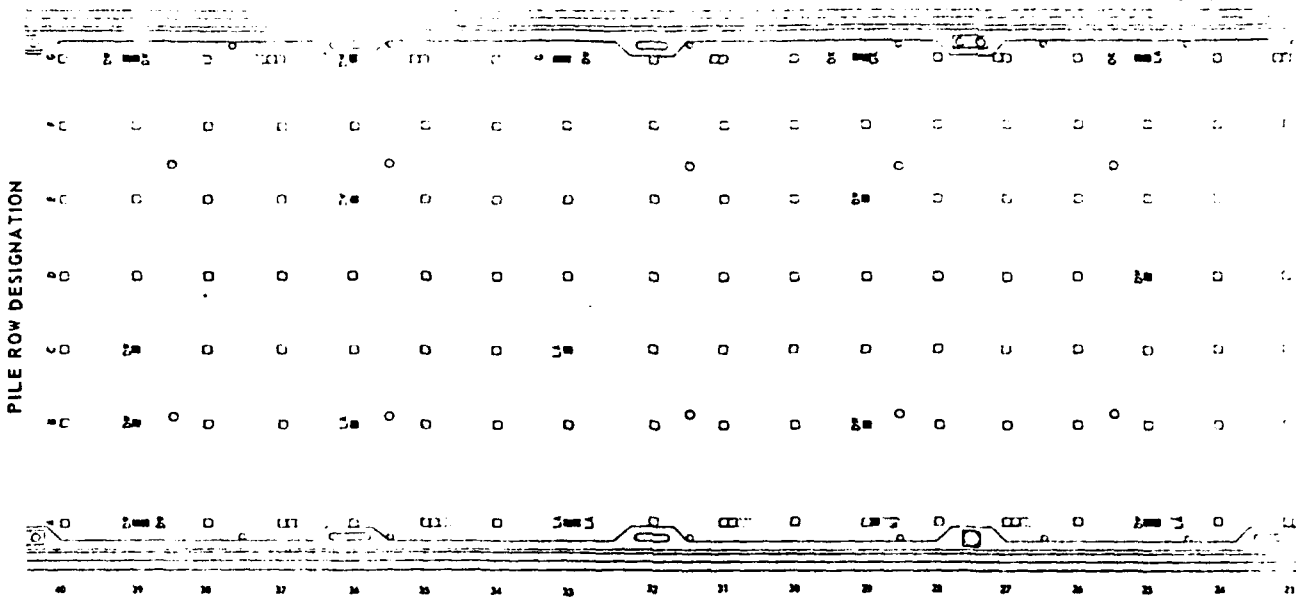
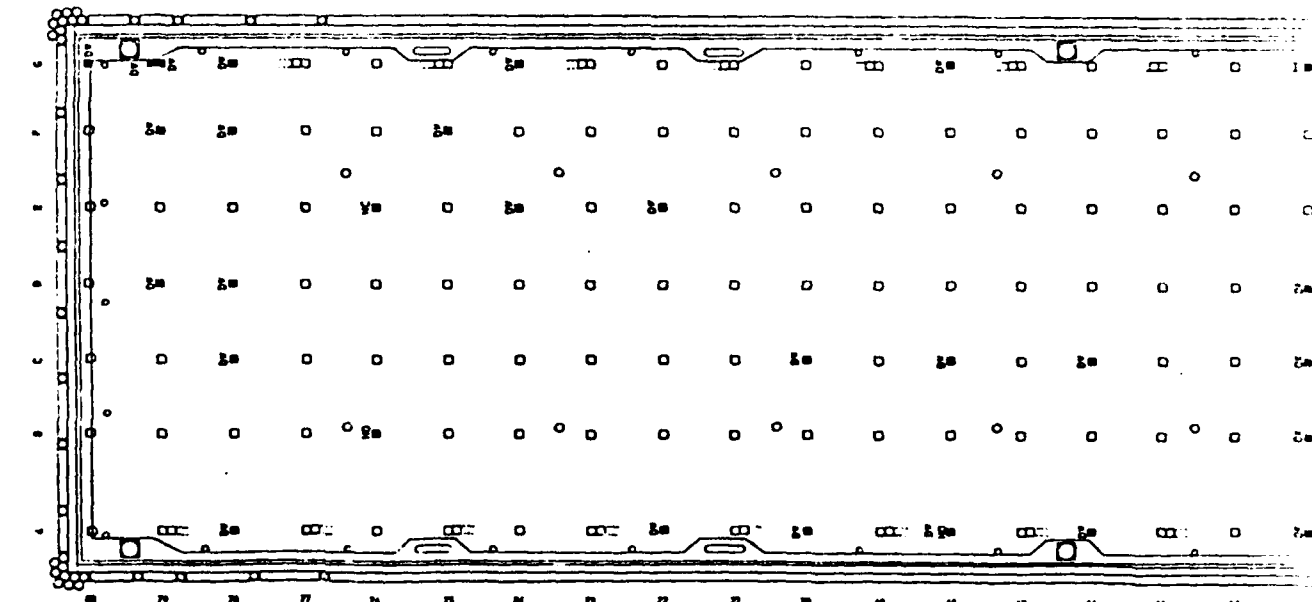
FIGURE 14

Pier L is an open-type reinforced concrete pier approximately 60 feet wide and 644 feet long. The pier is supported by steel H-piles arranged in 81 bents with seven bearing piles and two batter piles per bent. The piles are presently partially protected by a wooden fender system that extends to the vicinity of the mean low water line, where intact, and by concrete collars that extend approximately three to four feet above and to two feet below the mean low water line. The arrangement of support and batter piles is shown in Figure 14 together with the alpha-numeric designation of the various piles discussed below and in Table L1.

Additional designations of damage or deterioration are given both in Figure 14 and in Table L1.

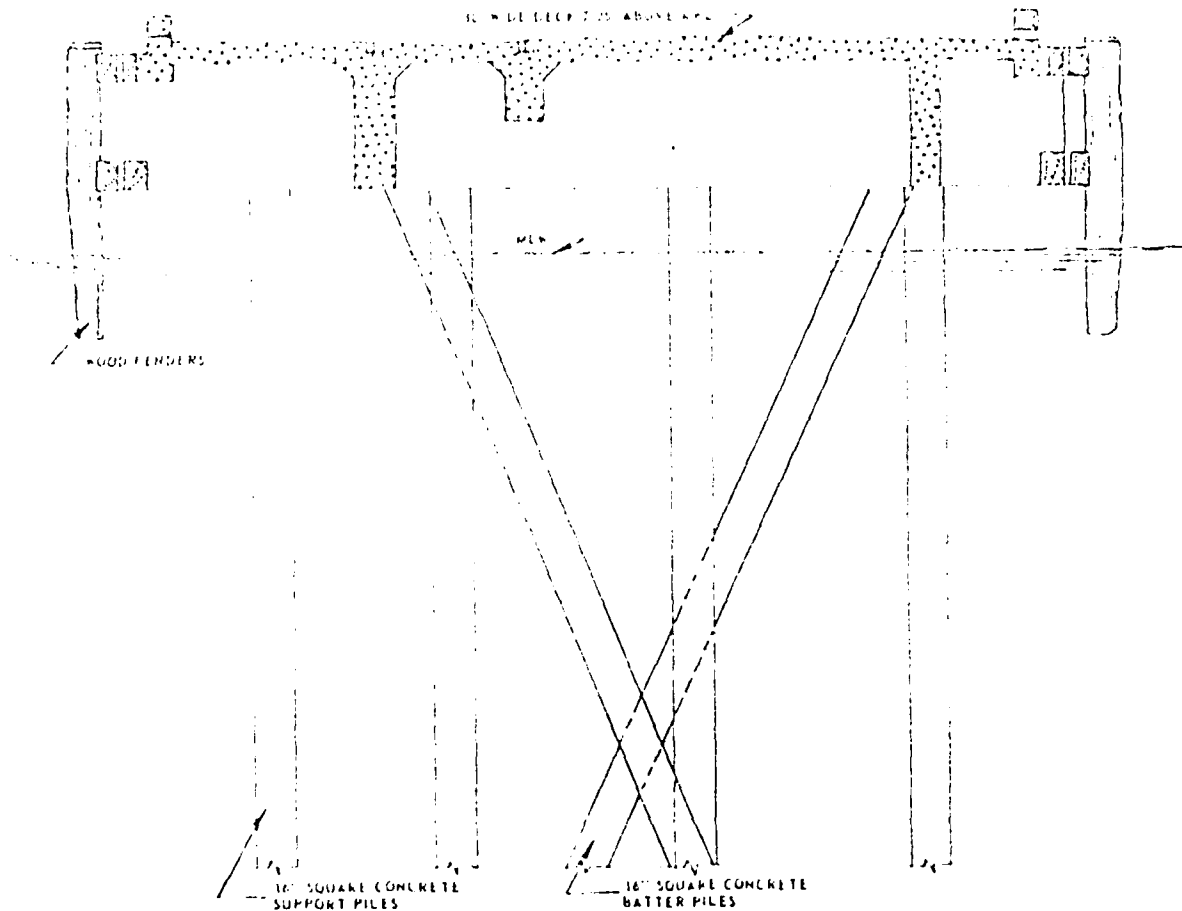
FIGURE 24A

Areas of deterioration can be determined by reference to Figure 24A.

- o Repairs to the deteriorated concrete be initiated, as soon as possible.

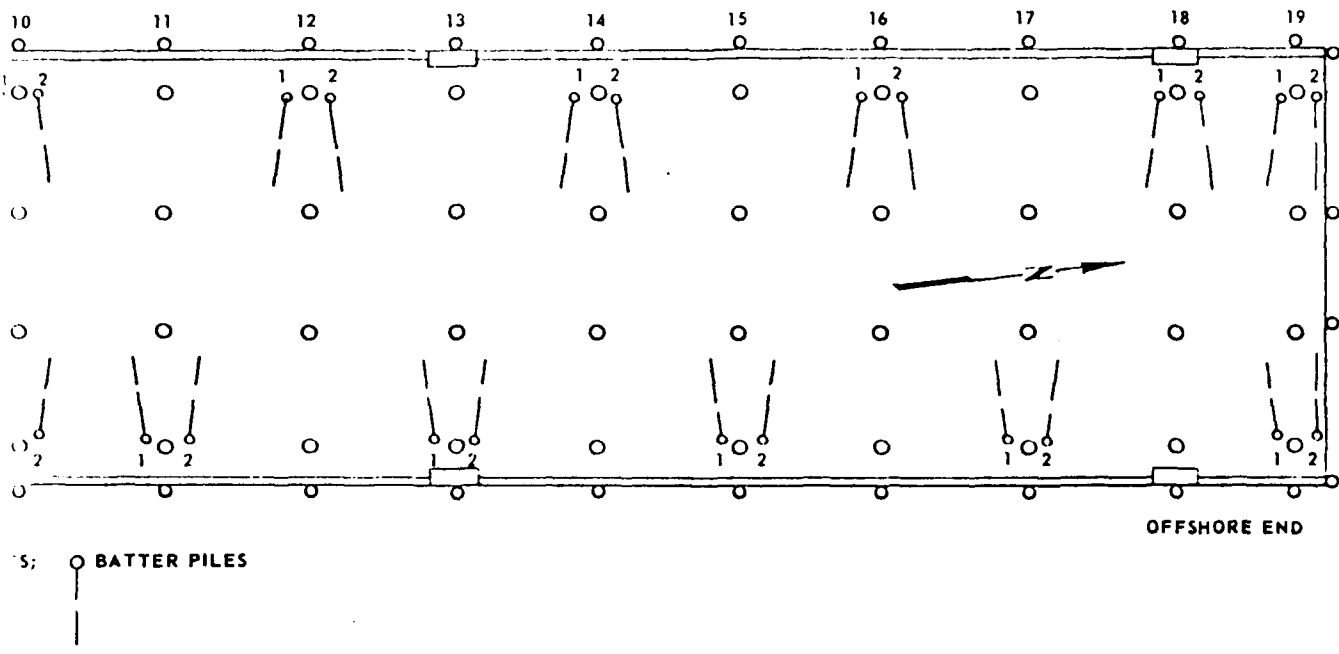
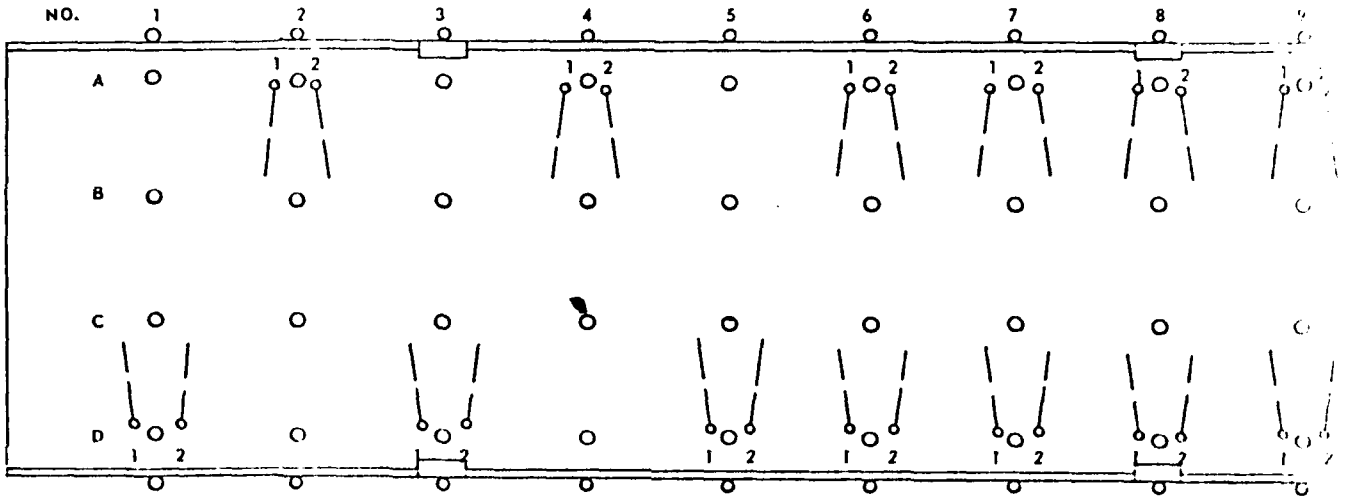
FIGURE 25

Pier Q is an open-type timber pile pier approximately 180 feet in length and 30 feet wide located on the Leeward Side of Guantanamo Bay. The timber deck is supported by timber piles arranged in 19 bents with four bearing piles and two to four batter piles per bent as shown in Figure 25. The pier is protected by four timber and steel dolphins and a timber fender system. Overall views of Pier Q are provided in Figure 26.

- o Repairs to dolphin piles be initiated as soon as possible to prevent damage to the pier structure.
- o Repairs to the underwater portion be initiated to prevent further deterioration of sound piles.
- o Pile tops be coated and capped to prevent fungus rot.

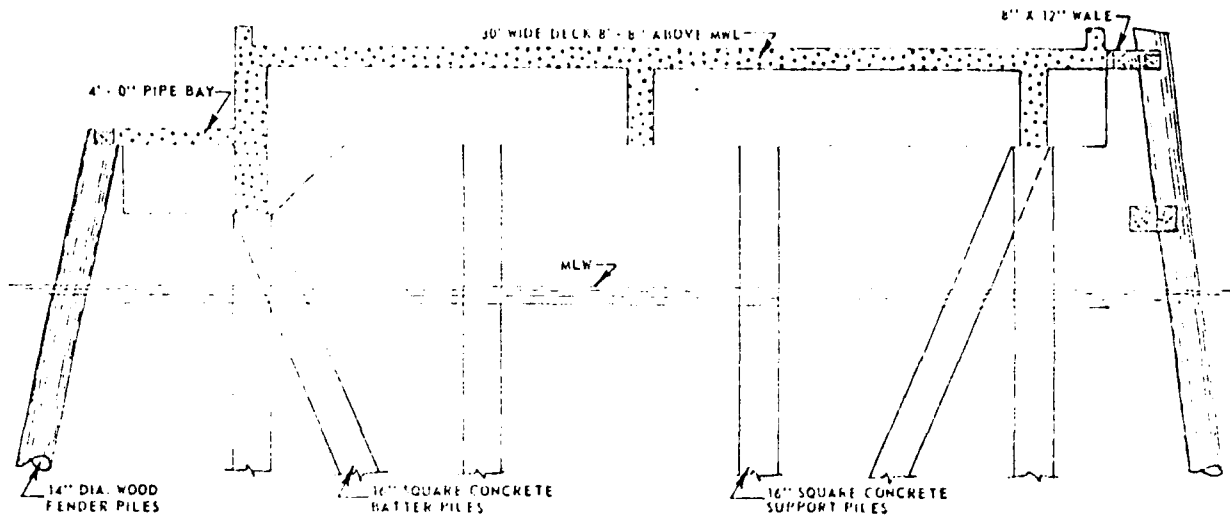
FIGURE 33A

These areas of deterioration may be identified by reference to the pier cross-section shown in Figure 33A.

Future utilization of Pier C will depend on the effective repair of the deteriorated portions of the structural portions of the pier. It is recommended that:

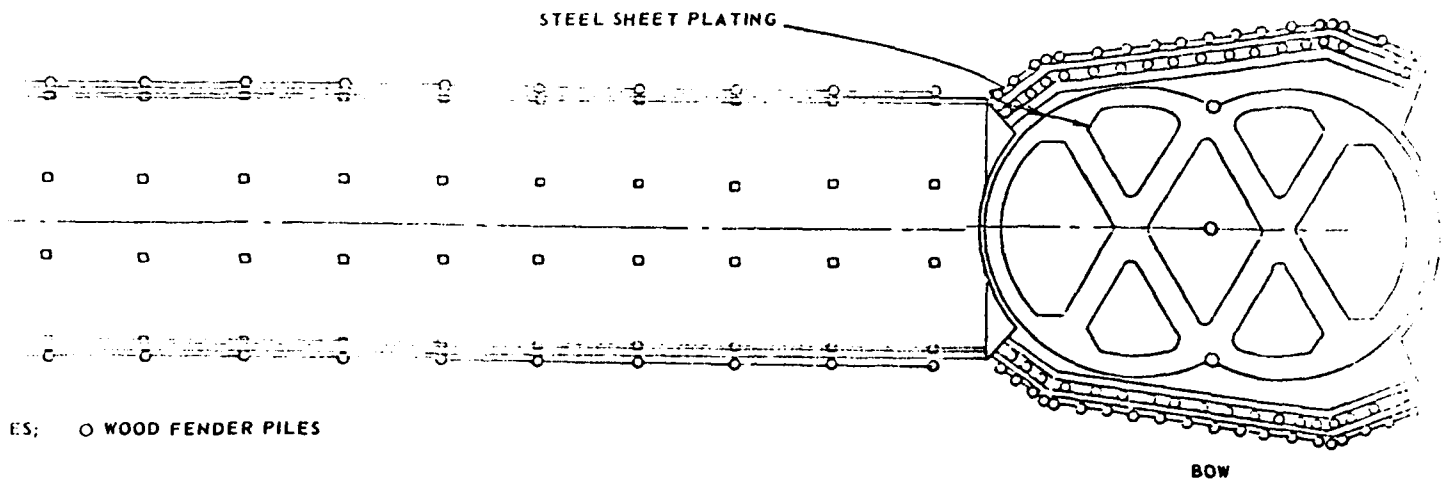
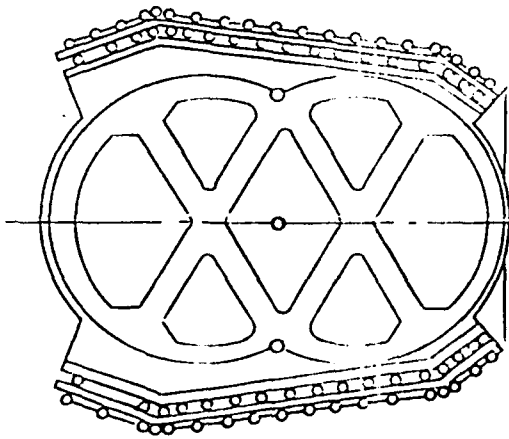
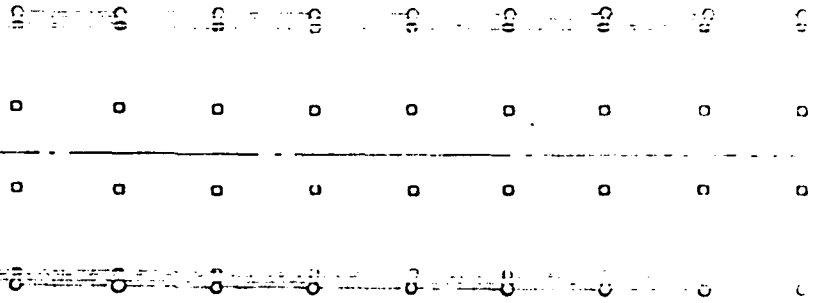
FIGURE 34

Mooring BB-1 consists of two sheet pile caissons located approximately 300 feet apart. Between the two caissons, a concrete deck, 32 feet wide, is supported by approximately 20 bents with four bearing piles and two batter piles per bent. The batter and bearing piles consist of steel H-piles that are protected by a wooden fender pile, wales, and chocks, Figure 34. Deterioration of the H-piles and sheet piles is minimal and limnoria attack is beginning to show on the wooden sections of the mooring.
