UNDERWATER FACILITIES INSPECTIONS & ASSESSMENTS

U.S. NAVAL STATION
KEY WEST, FLORIDA

FPO 1-80(9)

SEPTEMBER 1980

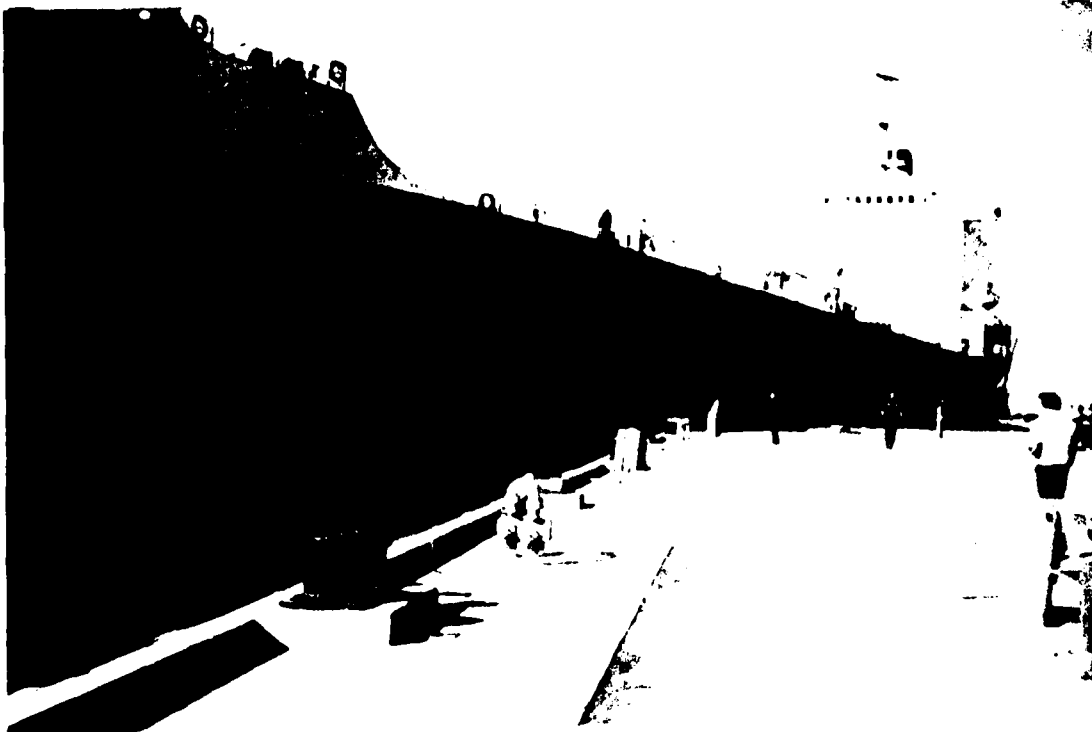
FIGURE 4

23 January -- Planned inspections with an ultrasonic thickness measuring device, underwater voltmeter, and underwater video were delayed due to scheduled departure of the tanker (USNS SEALIFT CHINA SEA) at 0900. The tanker started moving at 0930 and, under the action of a 20 to 25 knot southerly wind, the tanker stern swung and contacted the south side of Pier D-3, Figure 4, and bow contact was made at point 3+50 resulting in damage to the pier, Figure 5, at point 3+50 where the concrete was cracked and broken. Sheet piles

TANKER COLLIDING WITH PIER D-3 DURING DE-BERTHING
FROM PIER D-2 WITH THE TUG JEFFERSON ASSISTING

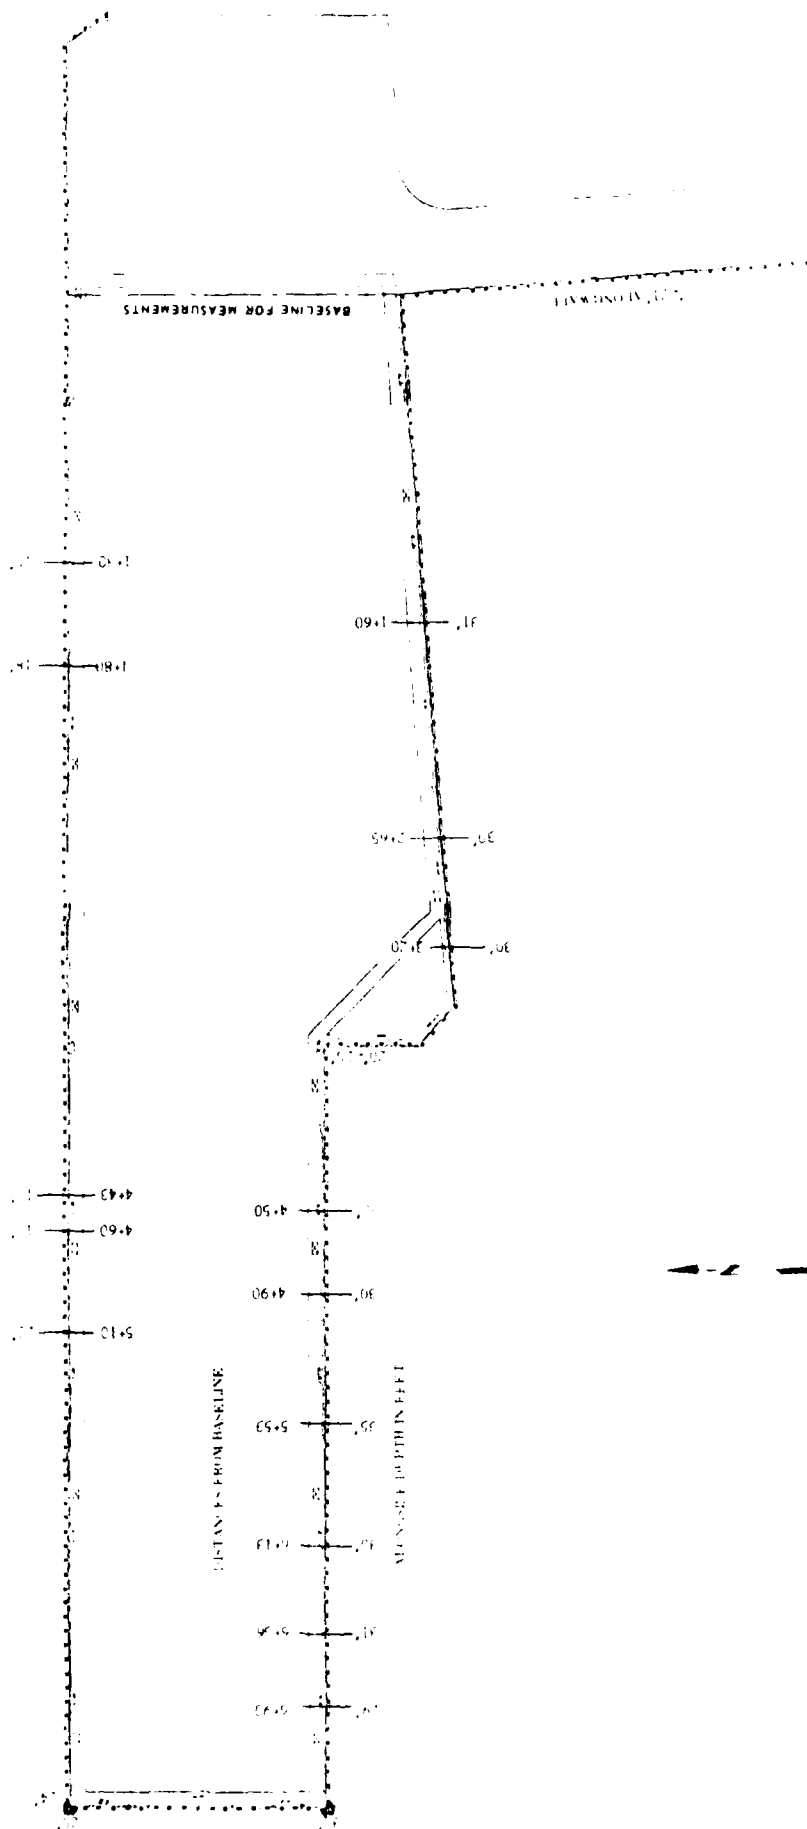
DEPTHS ALONGSIDE PIER D-3
FIGURE 8

Vessels using this pier would primarily be tied up on the south side which is dredged to a depth of more than 30 feet as shown in Figure 8 and was reconfirmed during the current inspection. The bottom is coral covered by a thin layer of sediment. The north side of the pier is dredged to a depth of

only 15 feet to 20 feet and is exposed to a tidal current on the order of 4 to 5 knots; the bottom is coral and there is no sediment due to the current action. This side of the pier is probably not usable.
