This report contains the results of the inspection of the fleet mooring located near Gaeta, Italy. A CHESNAVFACENGCOM-assigned Engineer-in-Charge and divers from Underwater Construction Team One conducted the inspection during the period 15-24 September 1983.

## NAVAL SUPPPORT ACTIVITY NAPLES

## (GAETA) FLEET MOORING UNDERWATER

#### INSPECTION REPORT

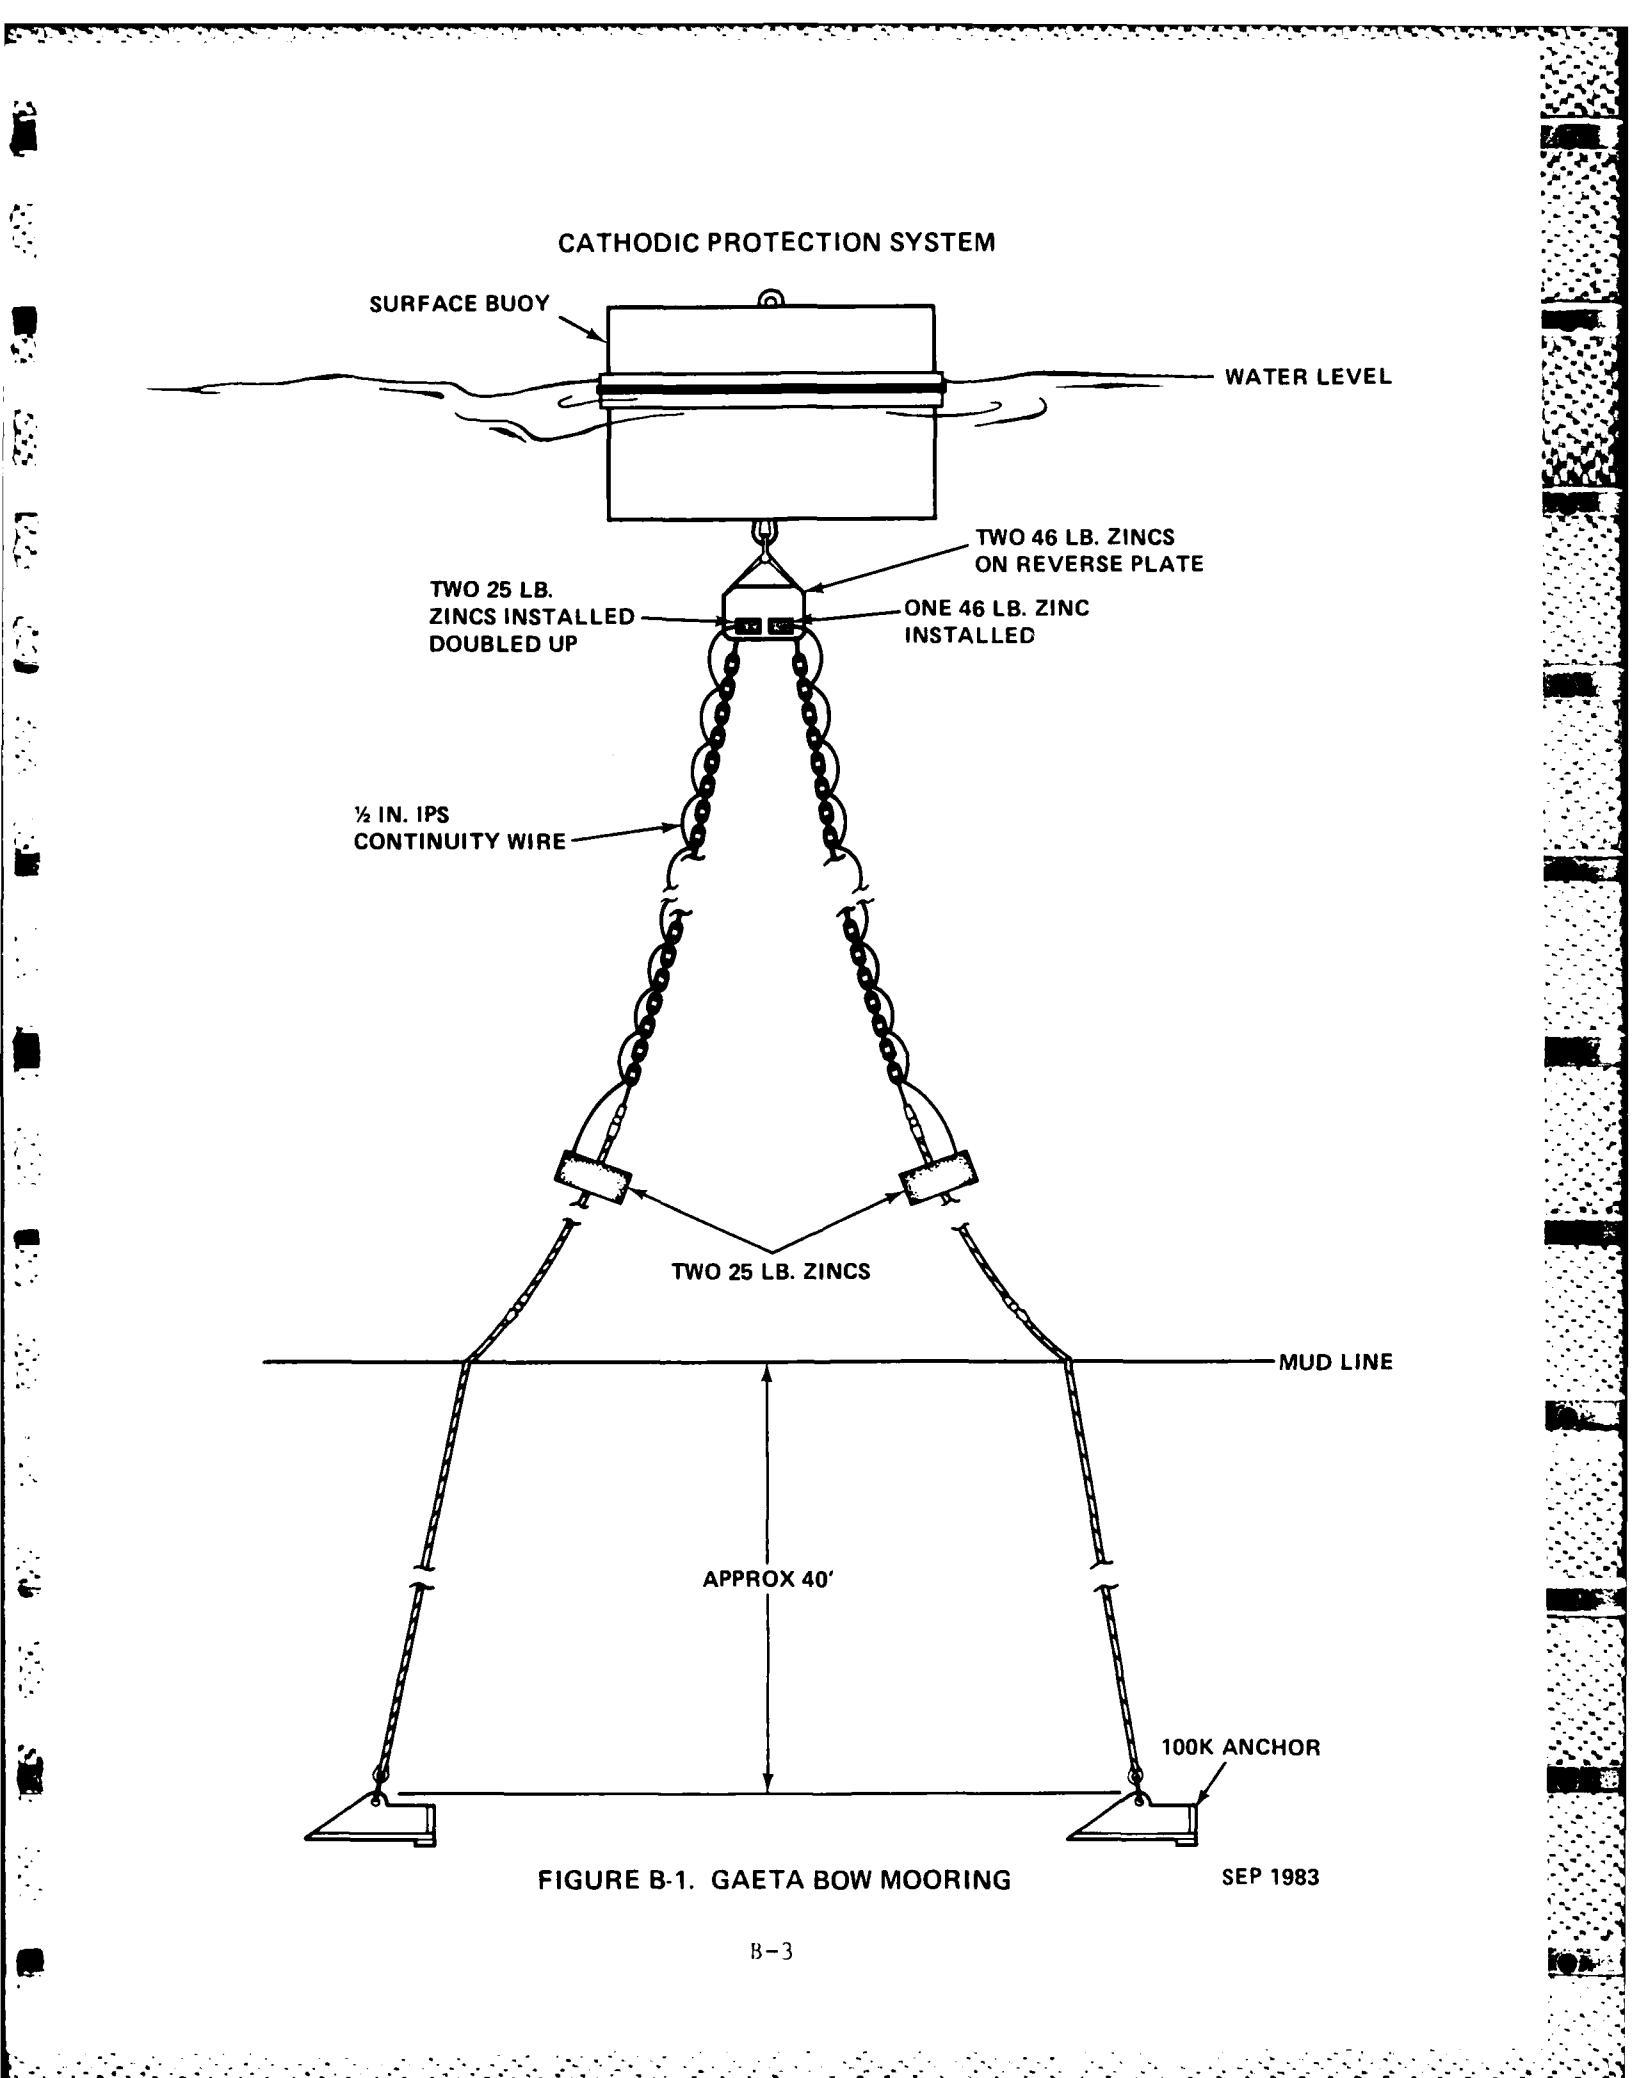
A 25-pound anode was mounted on each of the northern and southern anchor pendants, below the swage fitting which connects the anchor pendant to the equalizer chain. The 1/2-inch continuity wire was continued down from the chain and attached to each zinc anode. A schematic drawing of the cathodic protection system is depicted in Figure B-1.

Underwater voltmeter readings were taken at specific locations in the mooring and at various times during the installation, both with and without USS PUGET SOUND's impressed current system in operation. Table B-1 contains a copy of these readings.
