NAVAL AIR STATION SIGONELLA (AUGUSTA BAY) FLEET MOORING UNDERWATER INSPECTION REPORT

NOVEMBER 1983

OCEAN ENGINEERING
AND CONSTRUCTION PROJECT OFFICE
CHESAPEAKE DIVISION
NAVAL FACILITIES ENGINEERING COMMAND
WASHINGTON, D.C. 20374

FPO-1-83 (45)

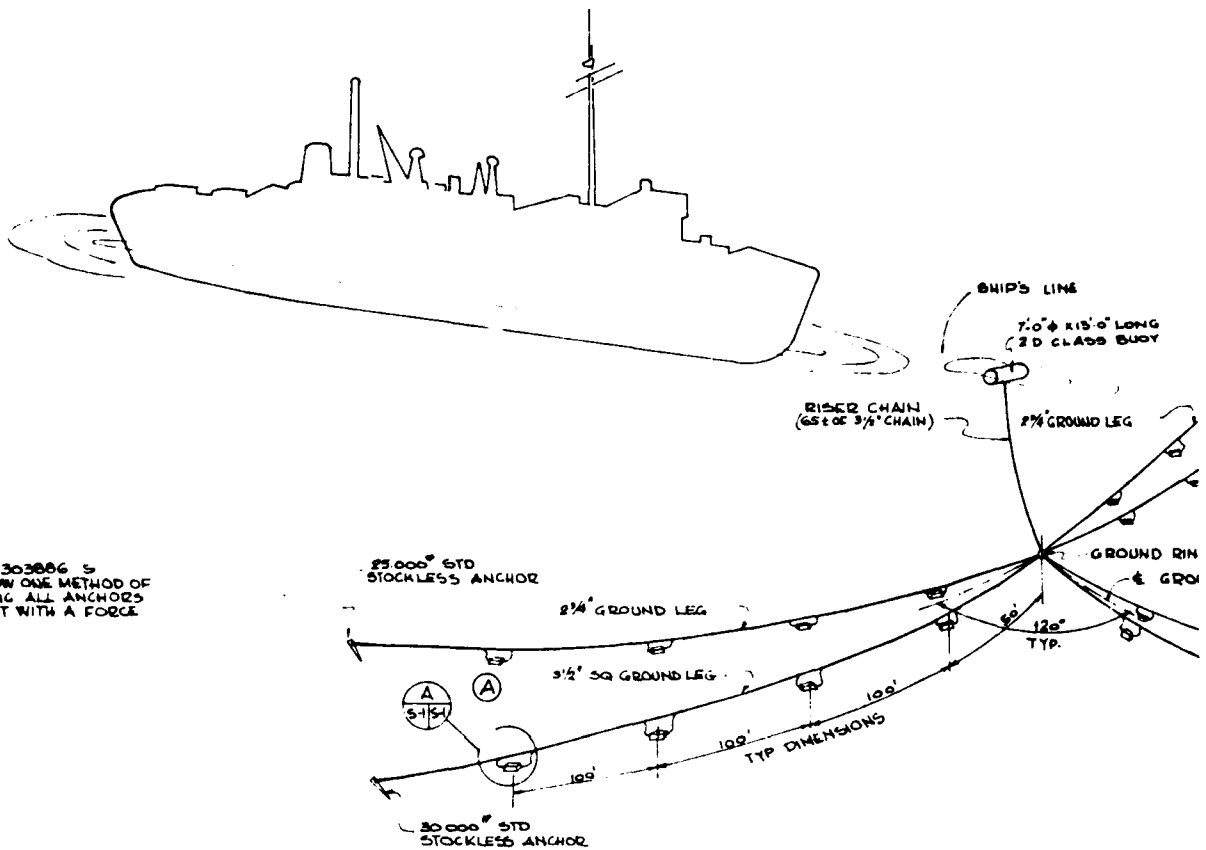
The mooring was installed in about 85 feet of water and was last overhauled in October 1980. Figure 3 is a schematic drawing of the mooring design while Figure 4 depicts the latest known as-built configuration of the mooring. In April of 1981, a Yugoslavian freighter struck the buoy while maneuvering to leave port and damaged it below the water line. Italian Navy personnel repaired the damage. There are no available maintenance records and verbal reports indicate that the mooring has not been used during the past two years. The Italian Navy provided two boats with crews for use by the inspection team as diving platforms. The Italian Navy also placed their recompression chamber on standby in event of a diving casualty.
