**UNDERWATER FACILITIES  
INSPECTIONS  
AND  
ASSESSMENTS  
AT  
NAVAL SHIPYARD  
CHARLESTON, SC**

**FPO-1-81 (8)**

**MAY 1981**

**CHILDS ENGINEERING CORPORATION  
MEDFIELD, MASSACHUSETTS 02052**

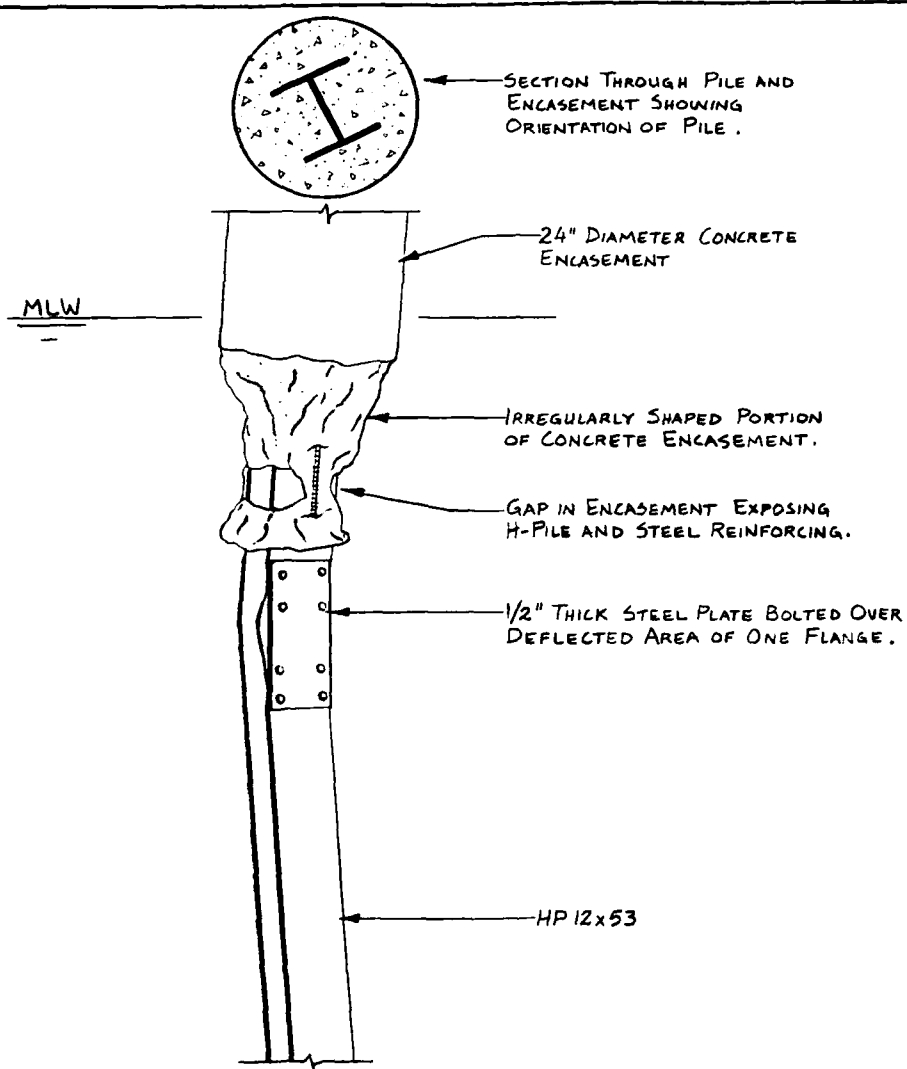
GRAPHIC SCALE	Childs Engineering Corporation Box 1332 Norfolk, VA	CHESAPEAKE DIVISION NAVAL FACILITIES ENGINEERING COMMAND WASHINGTON, D.C.	
NOT TO SCALE		NAVAL SHIPYARD CHARLESTON, SC	P.B. NO. 9

Figure 9 shows a composite of some of the pile conditions found at Pier HOTEL.
