**UNDERWATER FACILITIES
INSPECTIONS
AND
ASSESSMENTS
AT**

**NAVAL STATION
MAYPORT, FLA.**

JULY 1980

**CHILDS ENGINEERING CORPORATION
MEDFIELD, MASSACHUSETTS 02052**

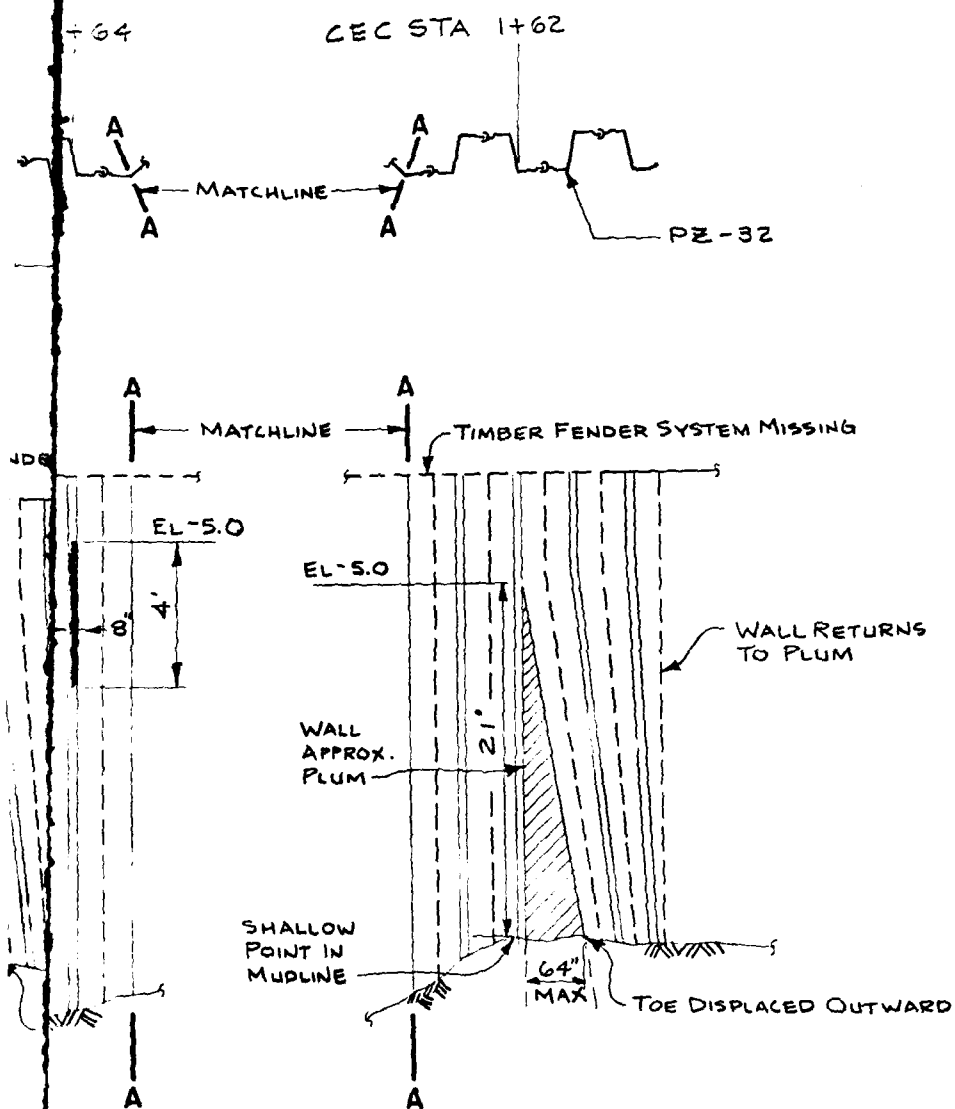
GRAPHIC SCALE	Childs Engineering Corporation Box 353, Needham, MA	CHESAPEAKE DIVISION NAVAL FACILITIES ENGINEERING COMMAND Seaside, N.C.	
NOT TO SCALE		NAVAL STATION BULKHEAD EAST OF CARRIER BERTH C-2	FIG. 15

The following conditions were observed during our inspection of the bulkhead east of carrier berth C-2 (see Figure 15):

2 OBSERVED STRUCTURAL DAMAGE

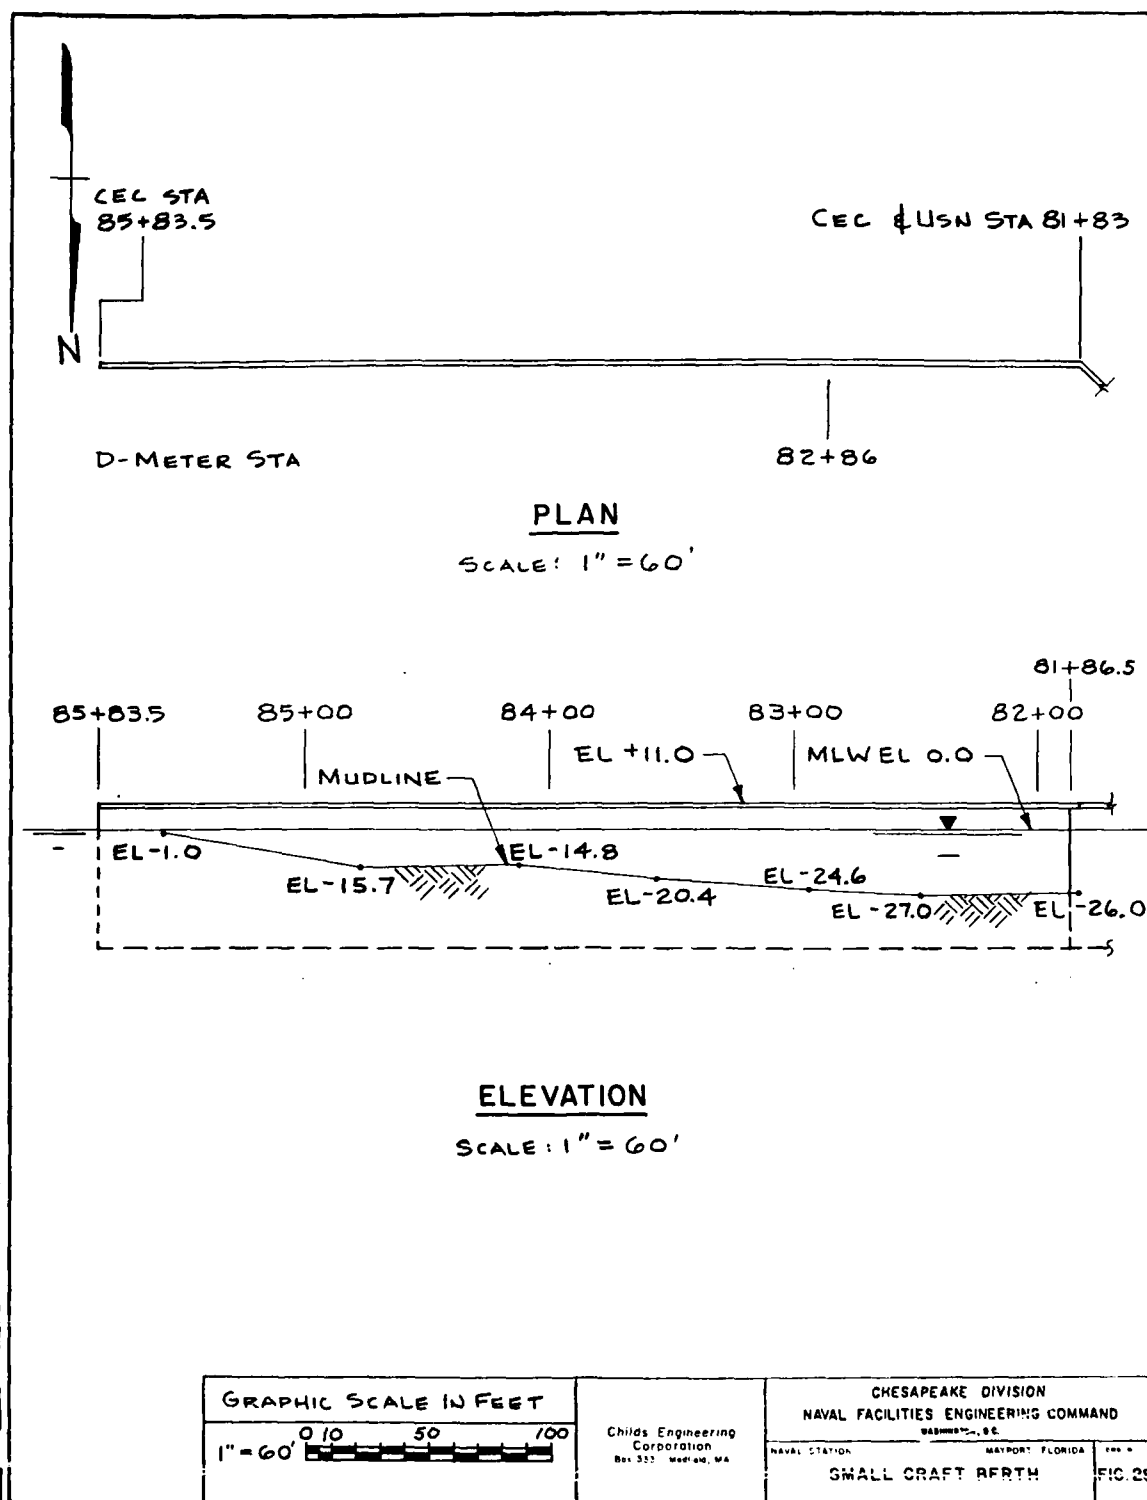
In this berthing area, the only structural damage observed occurred at CEC Sta. 82+65 at elevation -6.5'. Here a 6"Ø hole in the web was found with a piece of timber extruding from the hole. No subsidence in the pavement behind the hole was observed.

In the area where the hole was noted, loss of fill is the most critical problem that could occur since its location is not in an area of maximum stress.

To prevent the continual loss of fill and eventual subsidence of the pavement, the hole at CEC Sta. 82+65 at el. -6.5' should be patched. There are several techniques which could be employed to patch this hole and eliminate the loss of fill. The range in costs for the repairs is estimated between \$450.00 and \$500.00, depending on the repair technique employed.
