**UNDERWATER FACILITIES
INSPECTIONS
AND
ASSESSMENTS
AT

U.S. NAVAL STATION

ROOSEVELT ROADS, P.R.**

FEBRUARY 1982

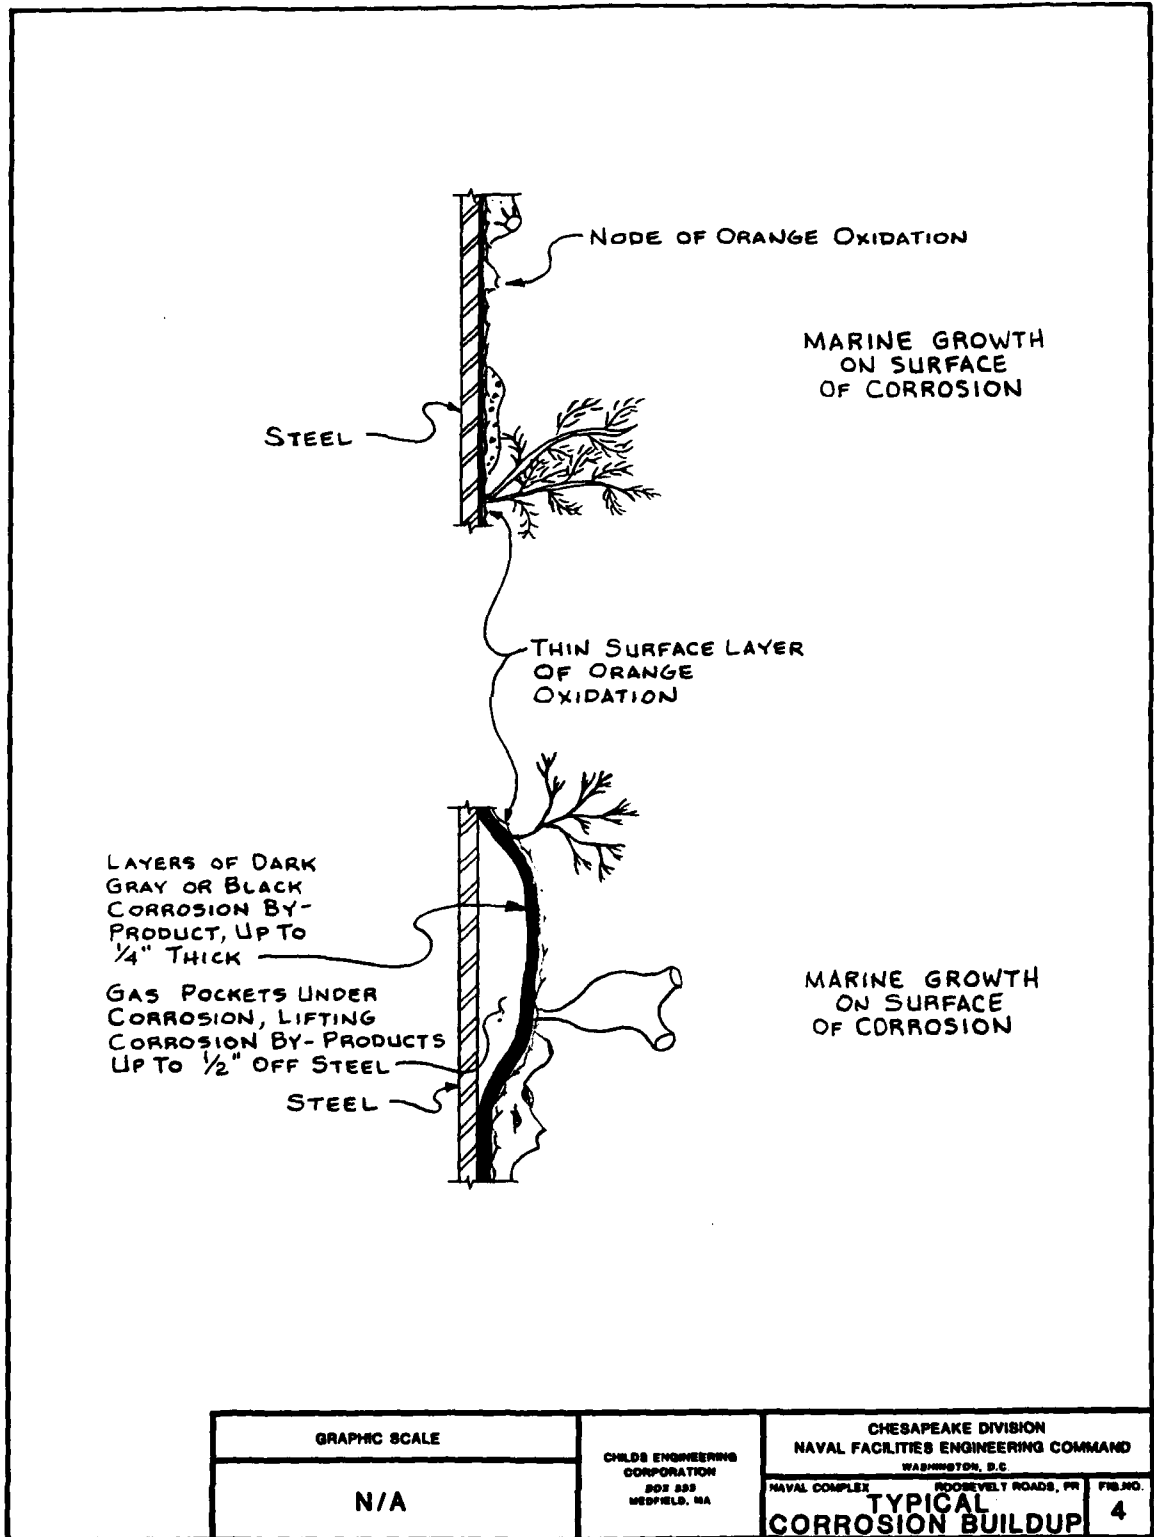
CHESAPEAKE DIVISION NAVAL FACILITIES ENGINEERING COMMAND WASHINGTON, D.C.	
NAVAL COMPLEX ROOSEVELT ROADS, PR	FIG. NO. 4
TYPICAL CORROSION BUILDUP

On the older facilities with steel piles, deposits of black corrosion by-product with gas pockets trapped beneath were not uncommon. This corrosion buildup was not heavy, usually less than 1/4" thick. Patches of orange oxidation were seen on all steel structures, particularly at any interface between concrete and steel. Both types of corrosion are illustrated in Figure 4 .

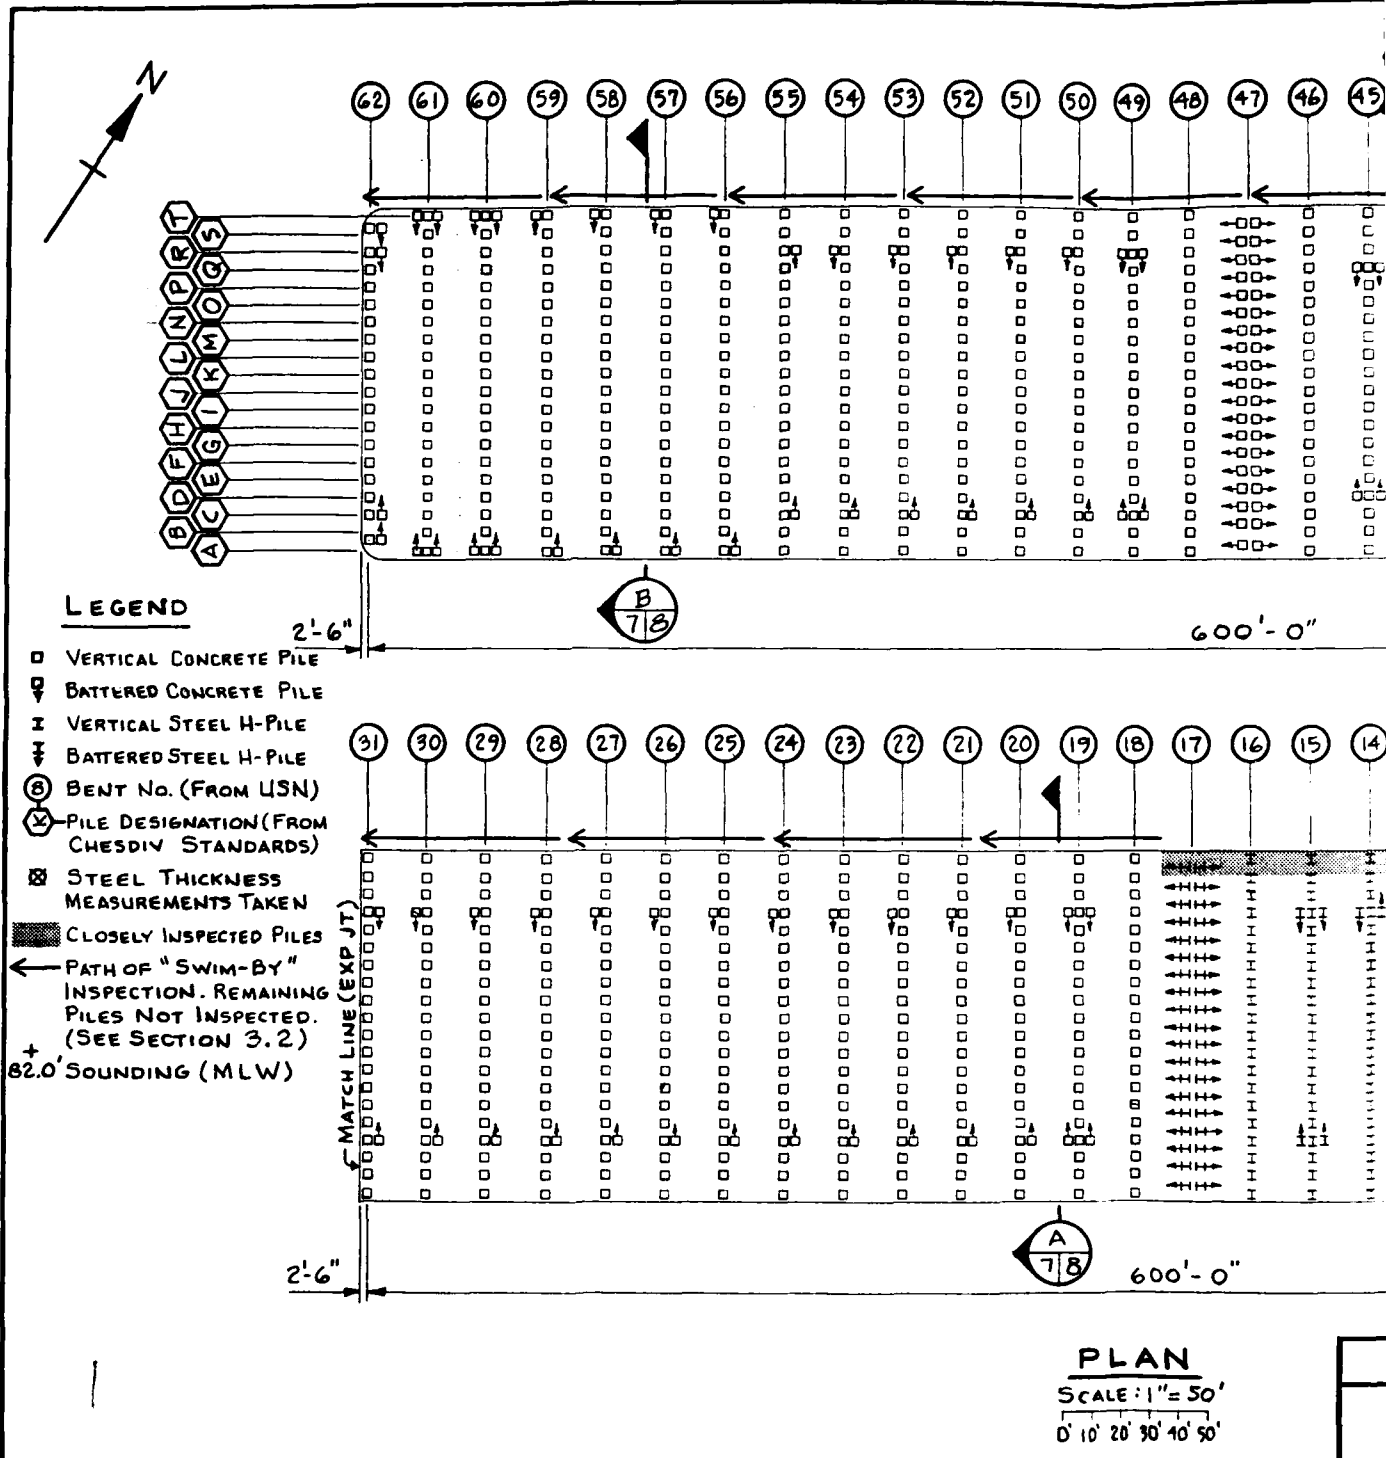
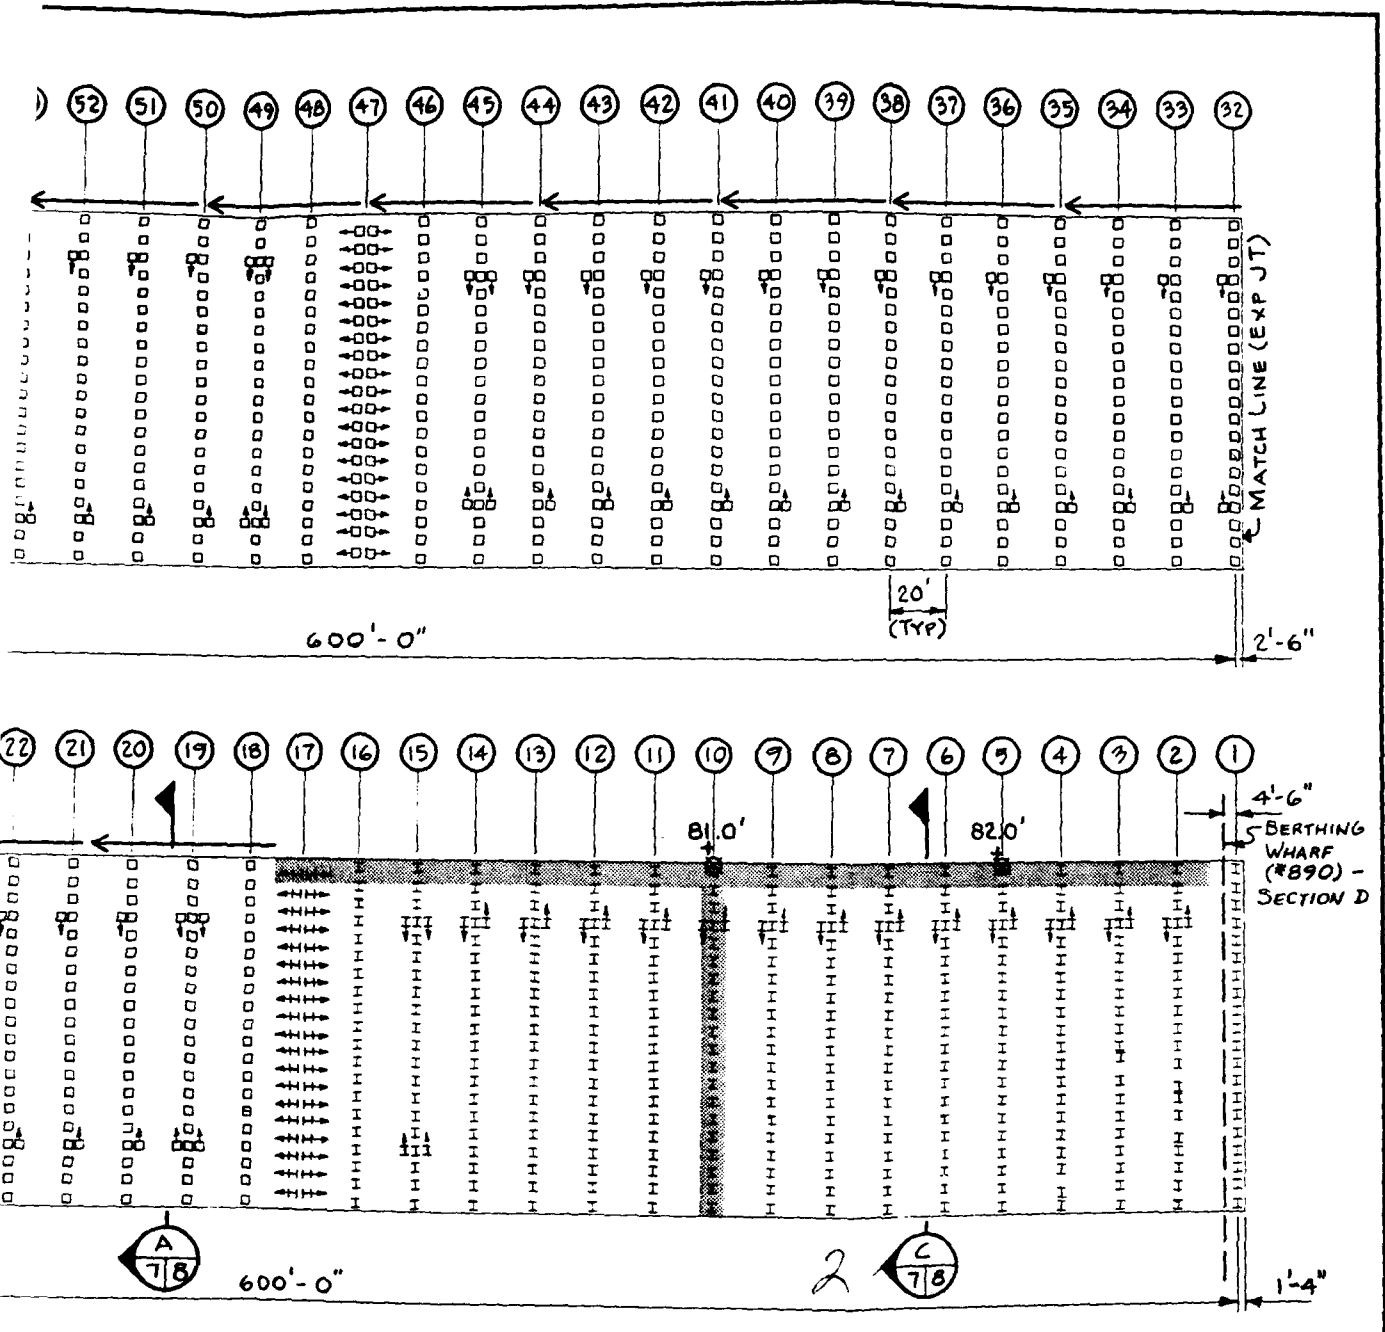
GRAPHIC SCALE	CHESAPEAKE DIVISION	
	NAVAL FACILITIES ENGINEERING COMMAND	
AS SHOWN	CHILD'S ENGINEERING CORPORATION	WASHINGTON, D.C.
	BOX 533 MEDFIELD, MA	NAVAL COMPLEX ROOSEVELT ROAD, PM
	BERTHING PIER (#799)	FIG. NO. 7

One concrete pile exhibited severe structural deterioration, probably due to impact from a berthing vessel (Pile A, specific bent unknown). The pile is completely severed just below the pile cap (see Photo #8). No major spalling, cracking or softness was observed on the remaining concrete piles (see Photo #9).

The jacketed steel piles exhibited some minor cosmetic spalling on the concrete jackets (see Photo #10). The exposed portions of the steel piles had suffered minor corrosion and exhibited some pitting (see Photo #11). Two piles were measured to determine the extent of corrosion. The average metal loss on these piles was between 2% and 4% (see Appendix for readings).

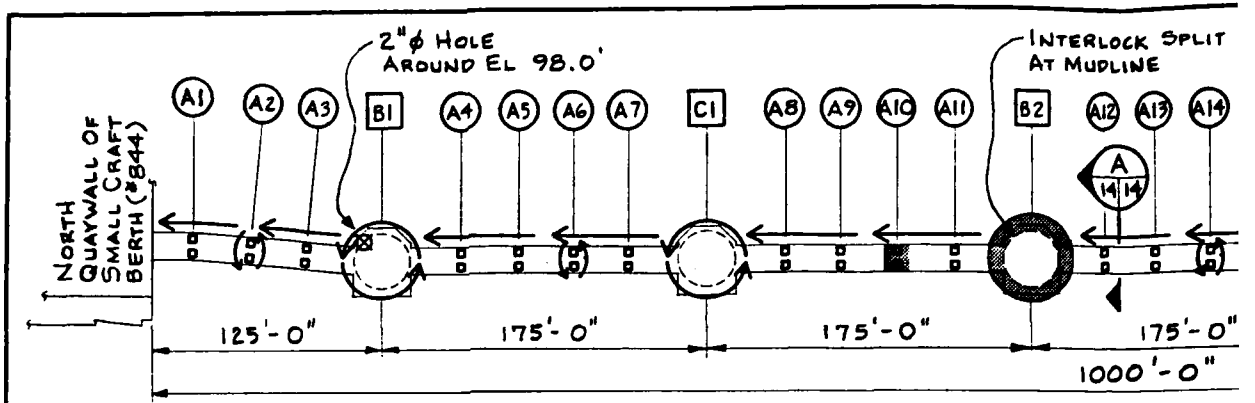
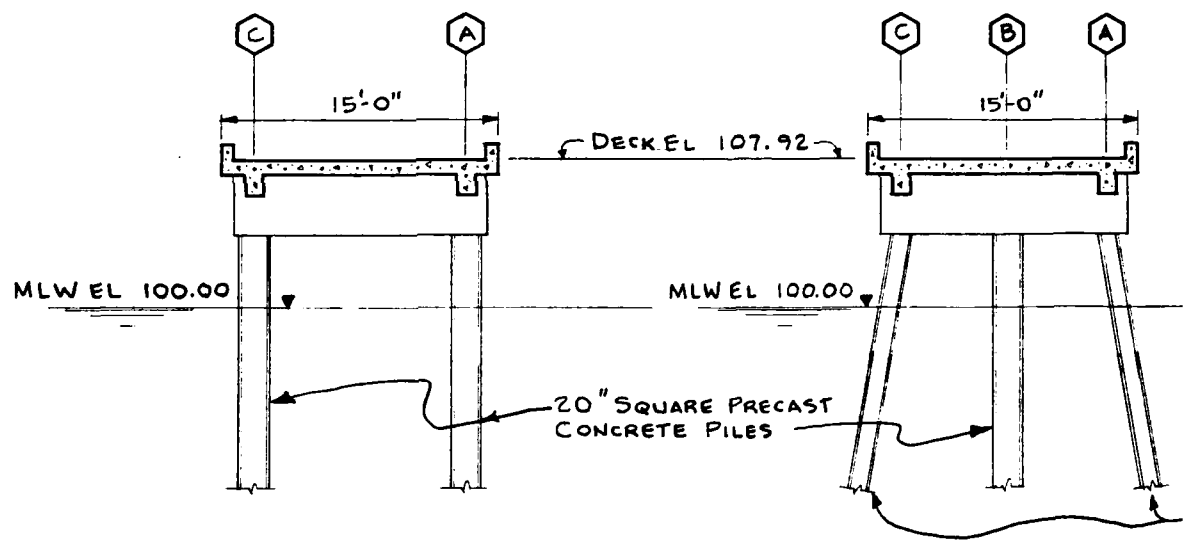
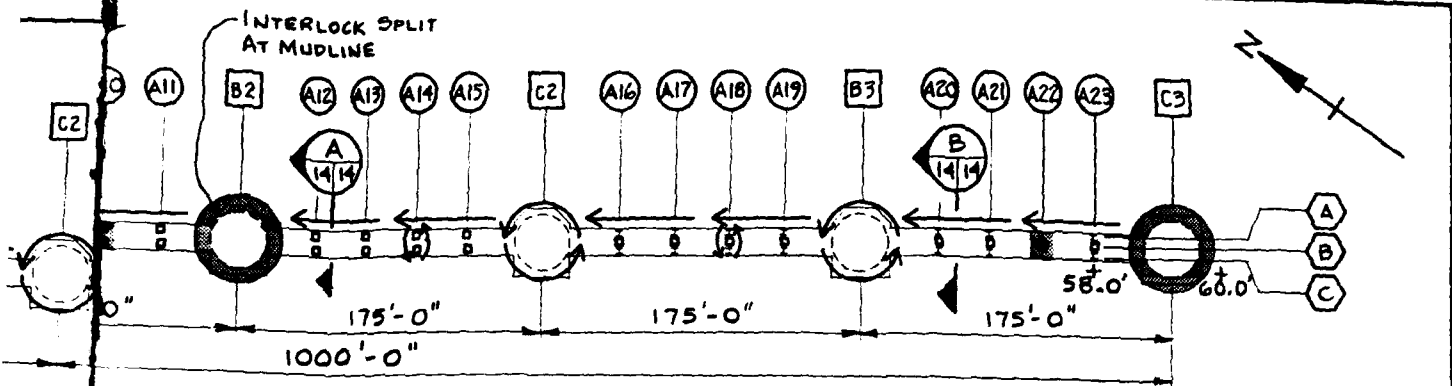
GRAPHIC SCALE	CHILDS ENGINEERING CORPORATION BOX 888 MEDFIELD, MA	CHESAPEAKE DIVISION NAVAL FACILITIES ENGINEERING COMMAND WASHINGTON, D.C.	
AS SHOWN		NAVAL COMPLEX ROOSEVELT ROADS, PR	FIG. NO. 14

The concrete piles which support the reinforced concrete deck between the steel sheet pile cylinders exhibited some softness around mean low water. The steel H-piles at the outshore end of the Approach Pier exhibited minor to moderate corrosion. The steel sheet pile cylinders exhibited severe deterioration around mean low water and in the splash zone (see Photo #19; see Appendix for thickness readings). Holes were evident in the splash zone area and could be created in the area just below mean low water with the aid of a chipping hammer (see Photo #20 and Figure 14). At Cylinder B2, a split interlock was found, extending from the mudline up 4' (see Figure 14). A void was noted through the split indicating that a substantial amount of fill material had been lost from the cylinder.

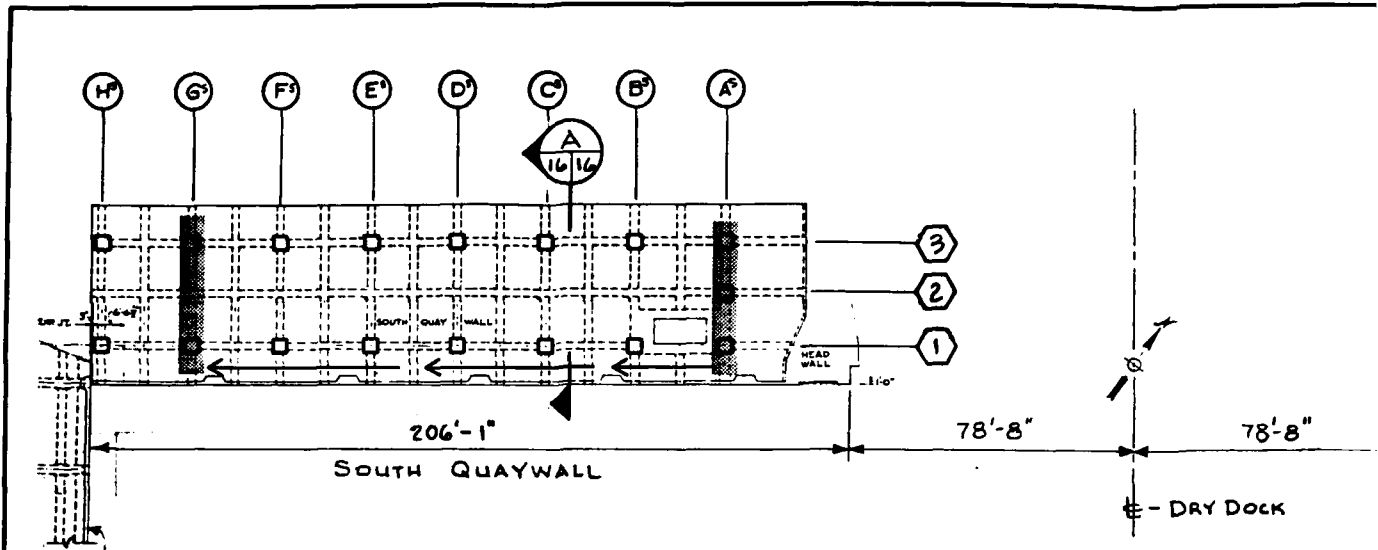
PHOTO #21

The Small Craft Berth is located on Puerca Bay in the Naval Station. It is comprised of two sections, the North and South Quaywalls, which flank the mouth of Dry Dock No. 1. The use of these quaywalls is currently restricted due to the deteriorated condition of the fender system (see Photo #21).

PHOTO #21: View of Face of North Quaywall
of Small Craft Berth (844).

No major structural deficiencies were observed in the reinforced concrete column foundation of the Small Craft Berth. Some softness was noted in the concrete columns around mean low water.

The reinforced concrete superstructure, including column caps, beams and decking, was severely deteriorated. There were large areas of severely spalled concrete in which reinforcing was exposed and rusting.

Government-furnished information indicates that the Small Craft Berth is used only on a restricted basis. Therefore, no repairs are recommended for the column foundation at this time. If full use of this facility is desired, a thorough inspection of the reinforced concrete superstructure will be necessary to determine the extent of the deterioration and the repairs required for adequate rehabilitation.

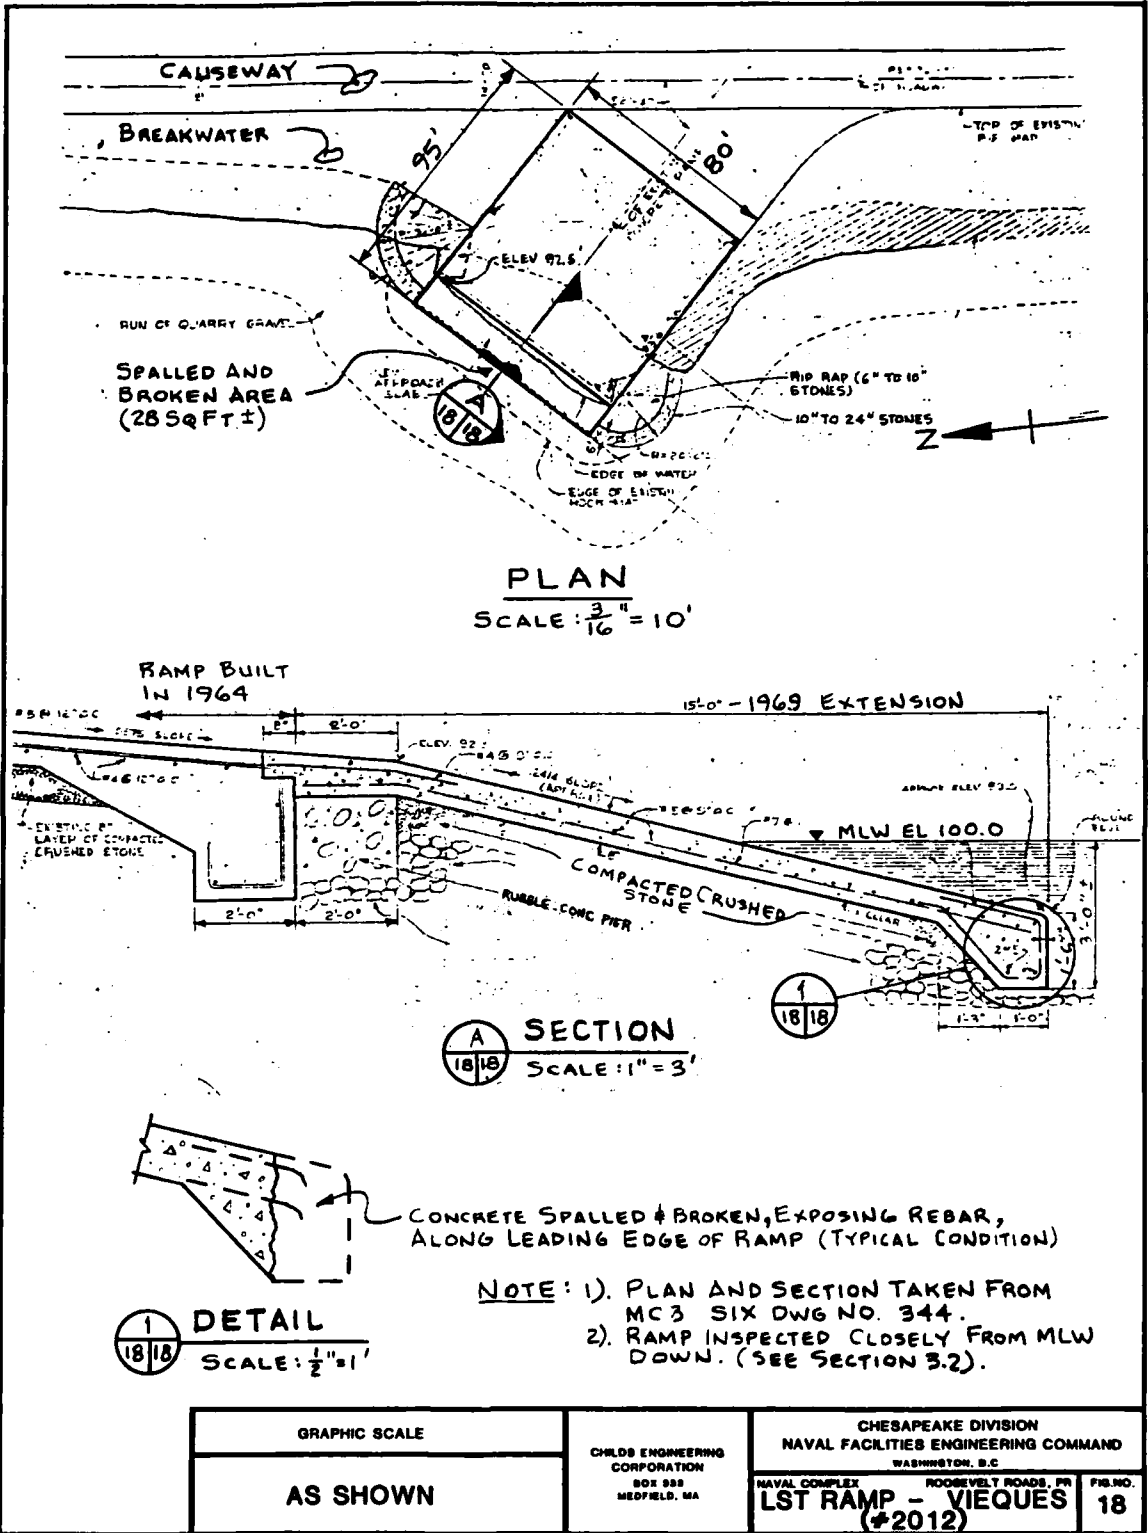
GRAPHIC SCALE	CHILD ENGINEERING CORPORATION BOX 588 MEDFIELD, MA	CHESAPEAKE DIVISION NAVAL FACILITIES ENGINEERING COMMAND WASHINGTON, D.C.	
		NAVAL COMPLEX ROOSEVELT ROAD, PR LST RAMP - VIEQUES (#2012)	FIG. NO. 18
AS SHOWN

CONCRETE SPALLED & BROKEN, EXPOSING REBAR, ALONG LEADING EDGE OF RAMP (TYPICAL CONDITION)

Severe spalling of the concrete was noted along the submerged edge of the LST Ramp on Vieques Island (see Figure 18). Reinforcing was exposed in this area and in a deteriorated condition. In general, the remainder of the concrete ramp appeared sound.

In general, the LST Ramp on Vieques Island is in good condition. The spalling and deterioration along the submerged edge of the ramp should be repaired to prevent further deterioration.

The submerged edge of the LST Ramp on Vieques Island should be repaired by patching with epoxy mortar. Prior to the placement of the new mortar, the existing concrete should be chipped to sound concrete and deteriorated reinforcing should be replaced. The new epoxy mortar should be placed or cast against the existing concrete. The estimated cost for these repairs is \$11,000.
