# UNDERWATER FACILITIES INSPECTIONS & ASSESSMENTS

NORFOLK NAVAL SHIPYARD  
PORTSMOUTH, VIRGINIA

FPO-1-81(19) AUGUST 1981

OCEAN ENGINEERING AND CONSTRUCTION PROJECT OFFICE  
CHESAPEAKE DIVISION  
NAVAL FACILITIES ENGINEERING COMMAND  
WASHINGTON, D.C. 20374

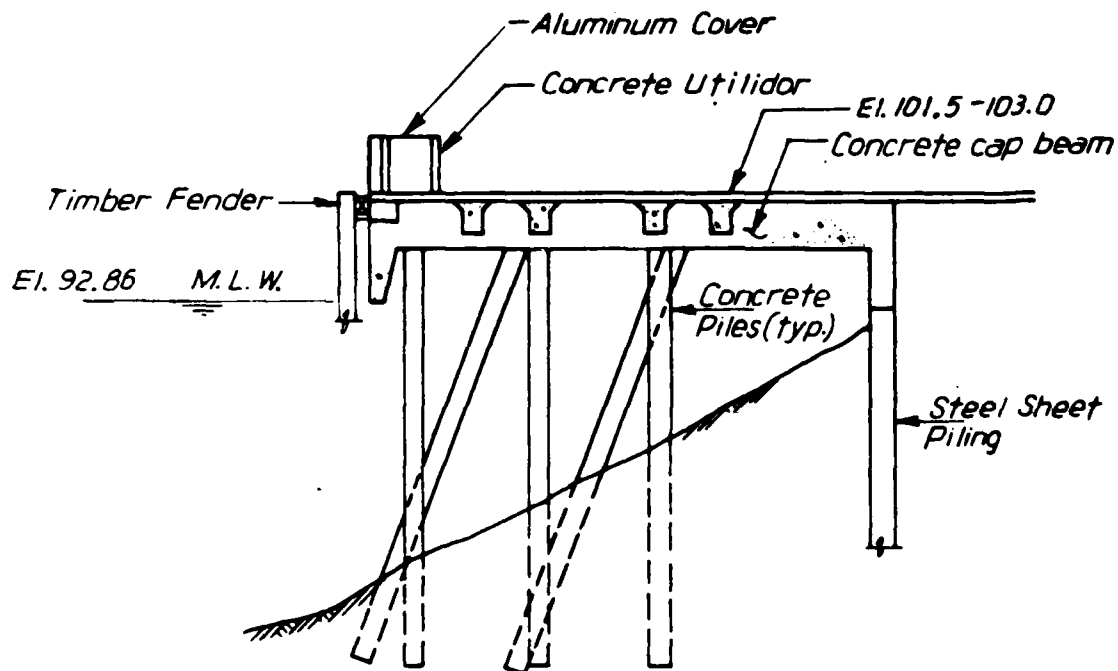
**FIGURE 7 TYPICAL SECTION - BERTHS 3 AND 6**

The steel sheet piling of the quaywalls at Berths 3 and 6 generally are in good condition. Except as described below, there is no visual evidence of significant material deterioration due to corrosion. Refer to Photographs 1 and 2 following this page for typical conditions above and below Mean Low Water.

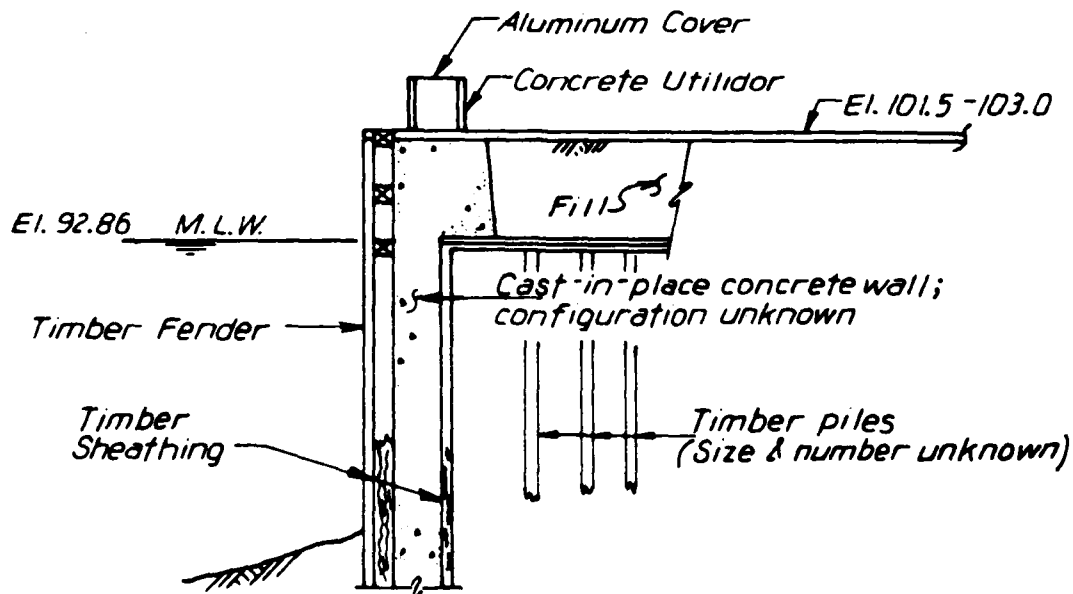
**FIGURE 8 TYPICAL SECTION - BERTHS 4 AND 5**

The concrete wall sections along Berths 4 and 5 and at the west end of the slip are in fair condition. Although there are many surface defects, there is no evidence of actively progressing distress. Near the tidal zone there are many areas of

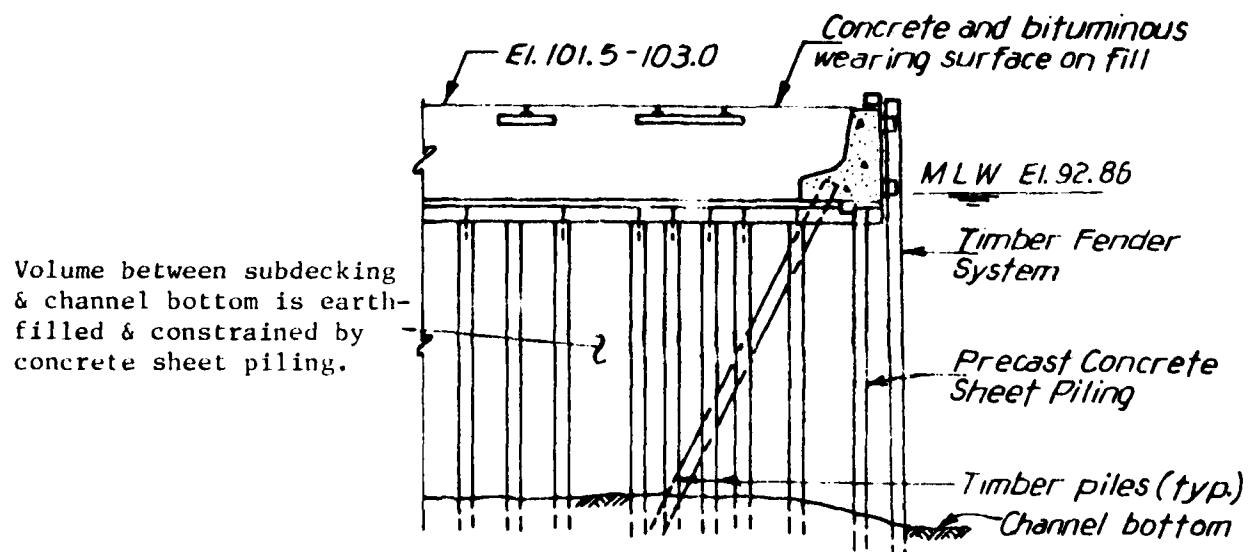
**FIGURE 9 TYPICAL PARTIAL SECTION - PIERS 3, 4, 5., AND 6**

Refer to Figure 6 on Page 14 and Figure 9 below for the configuration of Piers 3, 4, 5 and 6. Since the area under the piers is inaccessible and available pier drawings are poor, the exact nature of the deck load distribution is unclear. These piers were built with timber bearing piles which are enclosed in concrete sheet piling around the perimeter of each pier. The only drawings which could be obtained were very old (as far back as 1917) and appeared to indicate the cross section shown in Figures 6 and 9. Public Works personnel assured the inspection team that the area under each pier and between the concrete sheet piling was completely filled with soil so that all of the timber bearing piles are buried in fill.
