INDIAN ISLAND MOORINGS

PROJECT COMPLETION REPORT

FPO-1-79(9)

OCTOBER 1979

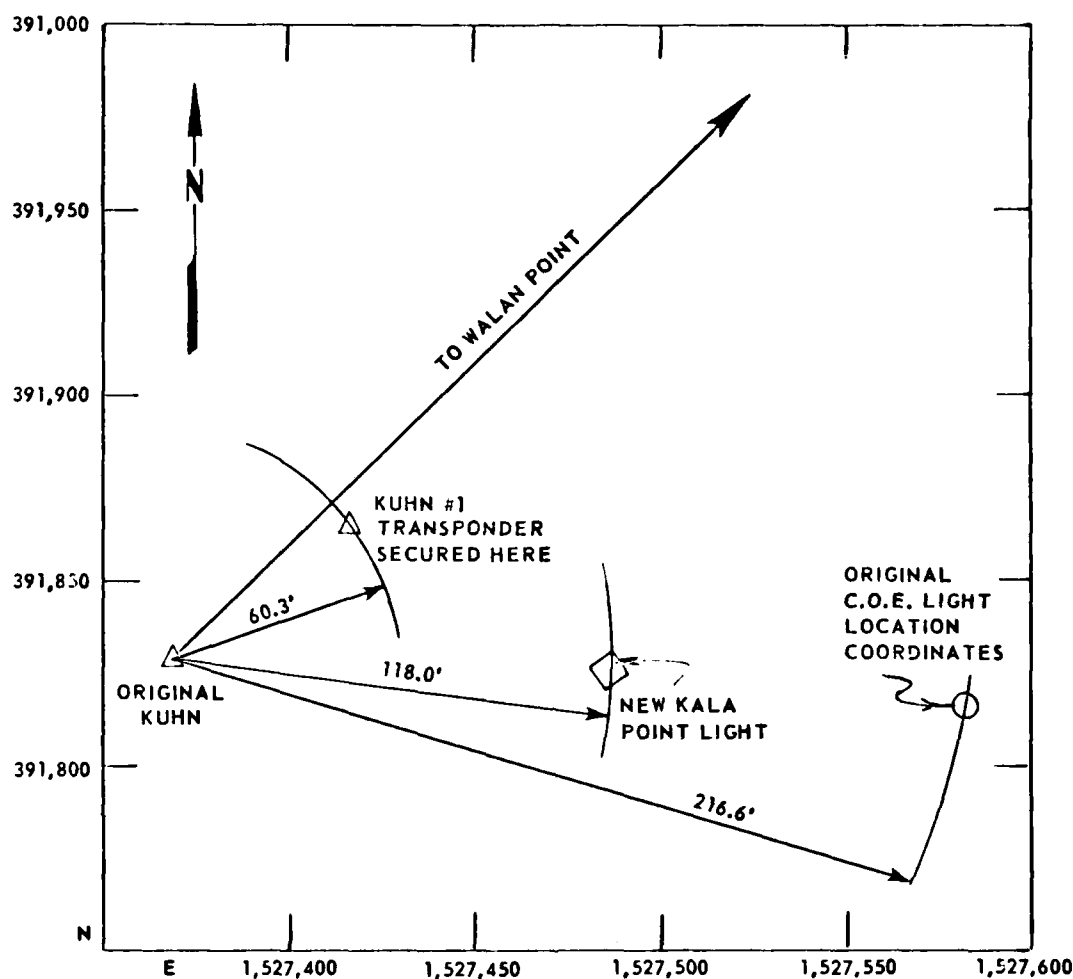
FIGURE A-6

Distances were also measured from Kuhn to the Kala Point transponder site and from Kuhn to the new Kala Point Light. The locations of these various markers on Kala Point are shown in Figure A-6. This completed the on site navigation work for the Indian Island Mooring Project. These various discrepancies in location of markers at Kala Point were analyzed by FPO-1 and are resolved in a memorandum given in Appendix B.

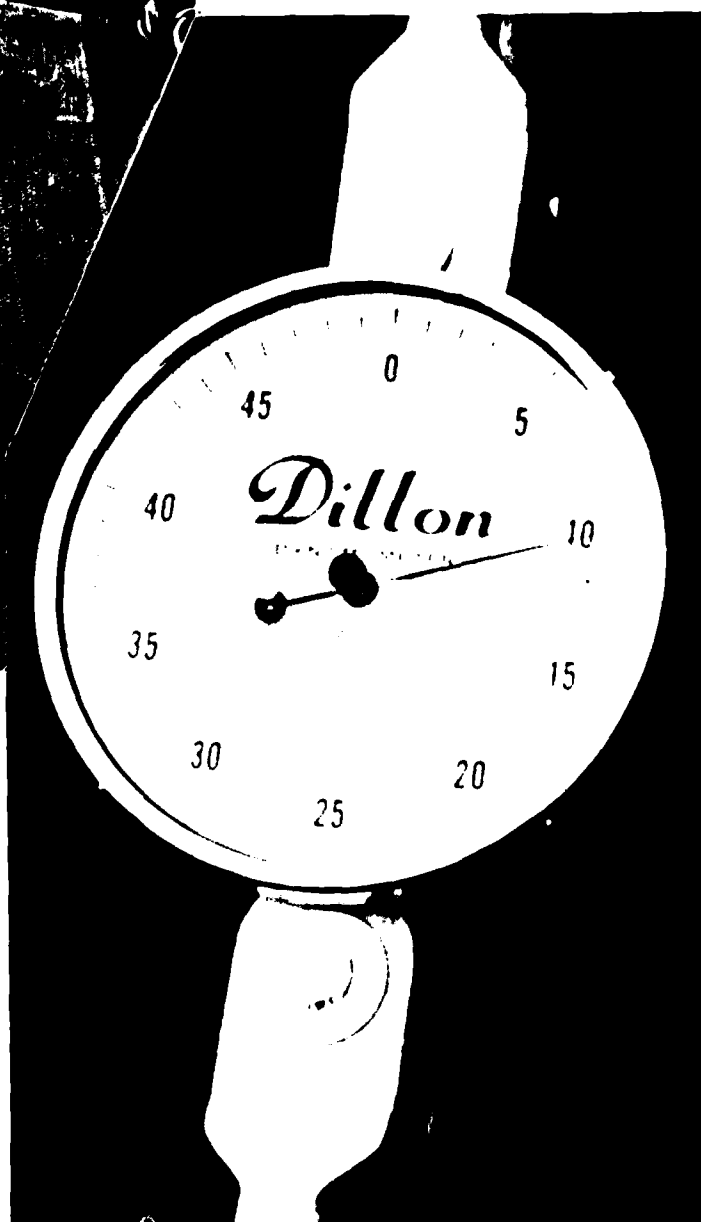
FIGURE A-40: DYNAMOMETER FOR PULL TEST

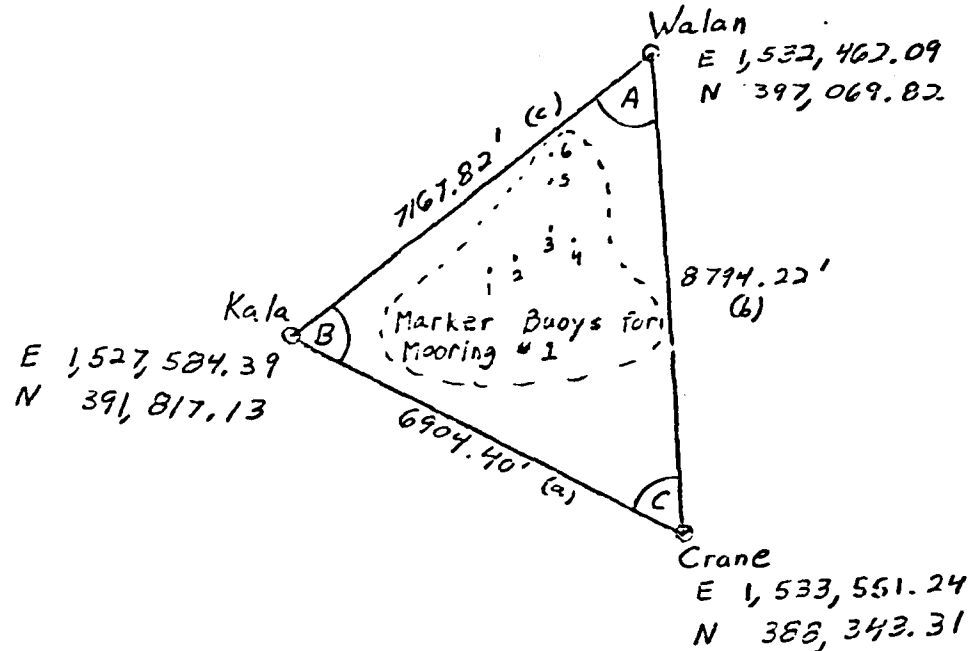
1. Calculate internal angles of triangle Kala-Walan-Crane.

a) $Distance = \sqrt{(E-E)^2 + (N-N)^2}$

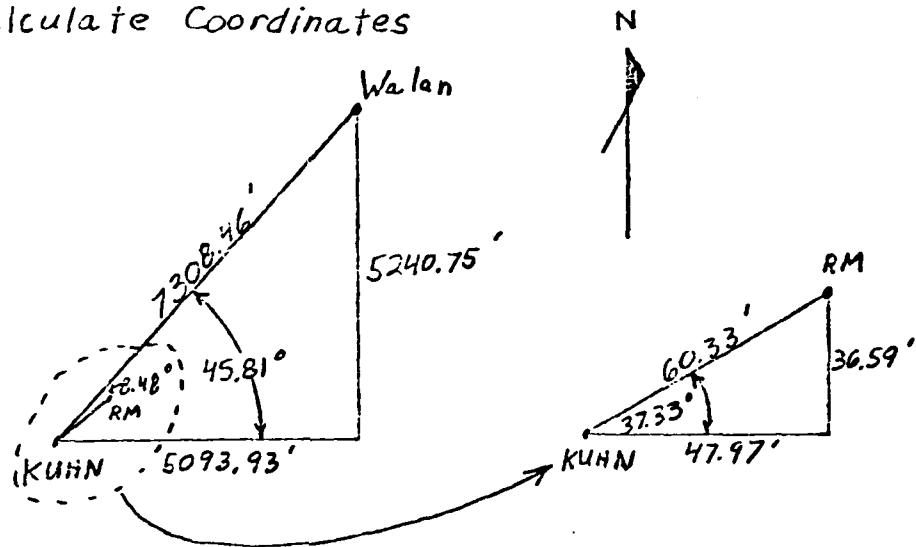
a) Calculate Coordinates

Using the coordinates for KUHN together with the angle and distance to the reference mark, the coordinates for this reference mark were calculated to be, E 1, 527, 416.13 and N 391, 865.66. These coordinates were checked by comparing the calculated internal angles of the triangle Walan-Crane-Reference Mark to those measured.

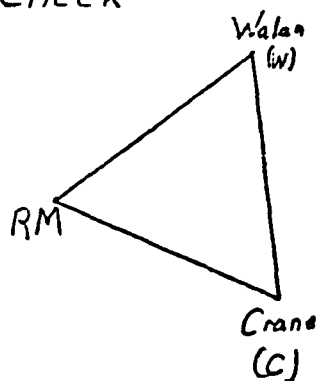
b) Check

| Angle | Calculated | Measured |
| W-RM-C | 75° 41' | 75° 46' |

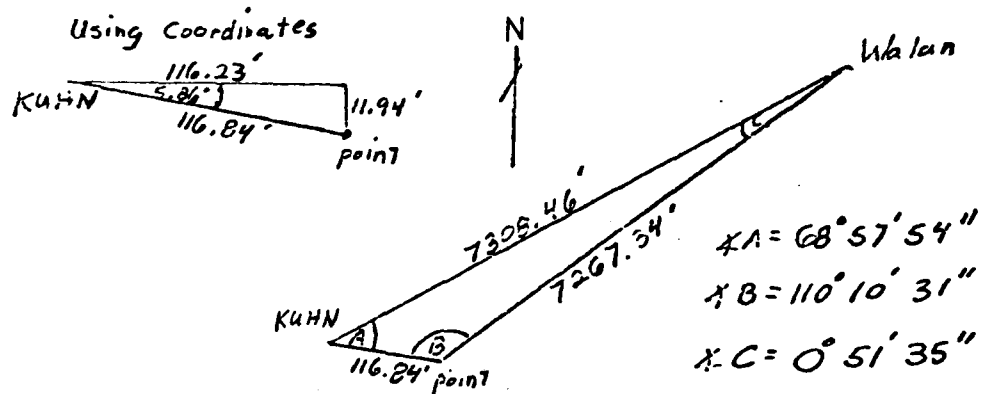
a) Distance from KUHN to Army Corps Coordinates

The angle and distance from KUHN to the new Army Corps coordinates were calculated. This put the point 116.23 feet East and 11.94 feet South of KUHN at an angle of $68^{\circ} 57' 54''$. Which means this point is 43.78 feet South and 2.61 feet East of the Kala Point Light.

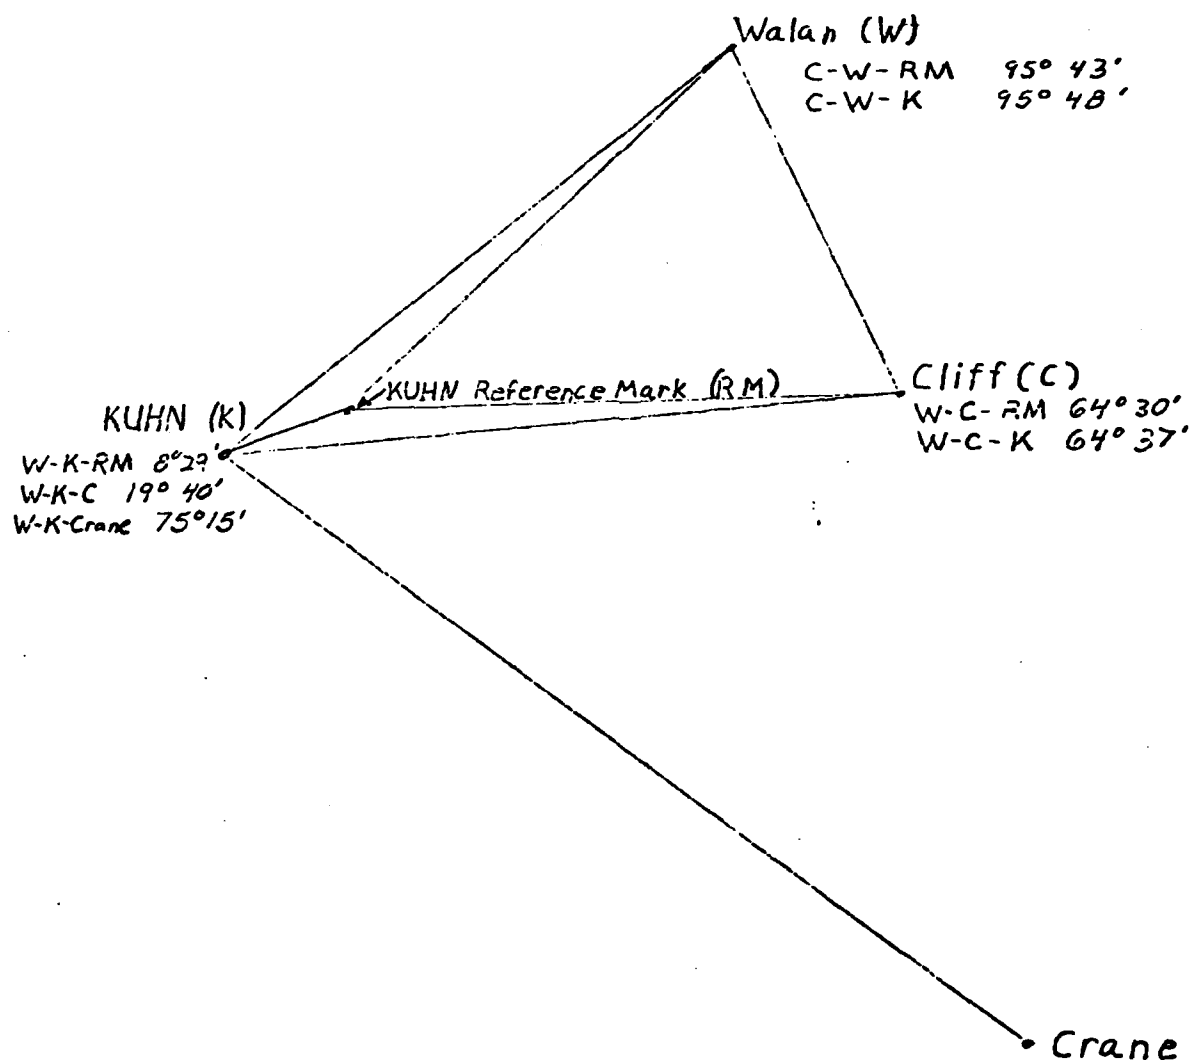
Enclosure (3)

Using two surveyed points identified in NAVFAC Drawing Number 6,045,831, Wala and Cliff, on Indian Island for transit sites, the locations of all the moorings were obtained. Using these same two points and KUHN, the reference mark for KUHN and the light on Kala Point were surveyed in before departing the area.

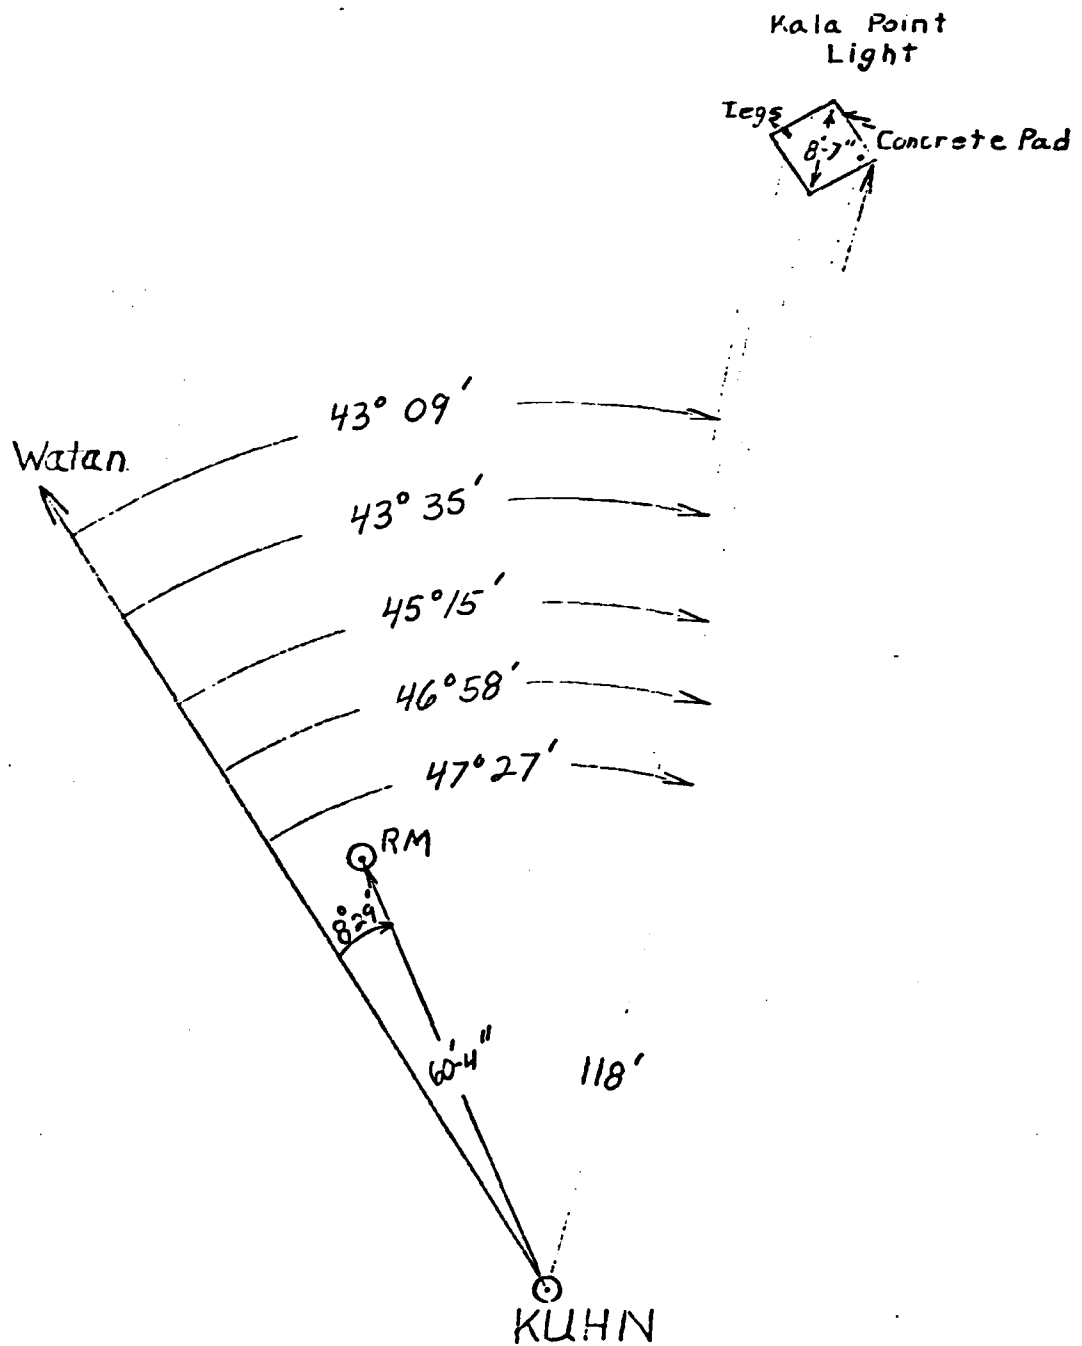
Enclosure (3)

SURVEY OF KALA POINT
