UNDERWATER FACILITIES
INSPECTION AND ASSESSMENT

DEPERMING FACILITY
U.S. NAVAL STATION
NORFOLK, VIRGINIA

FPO-1-81-(16)

July 1981

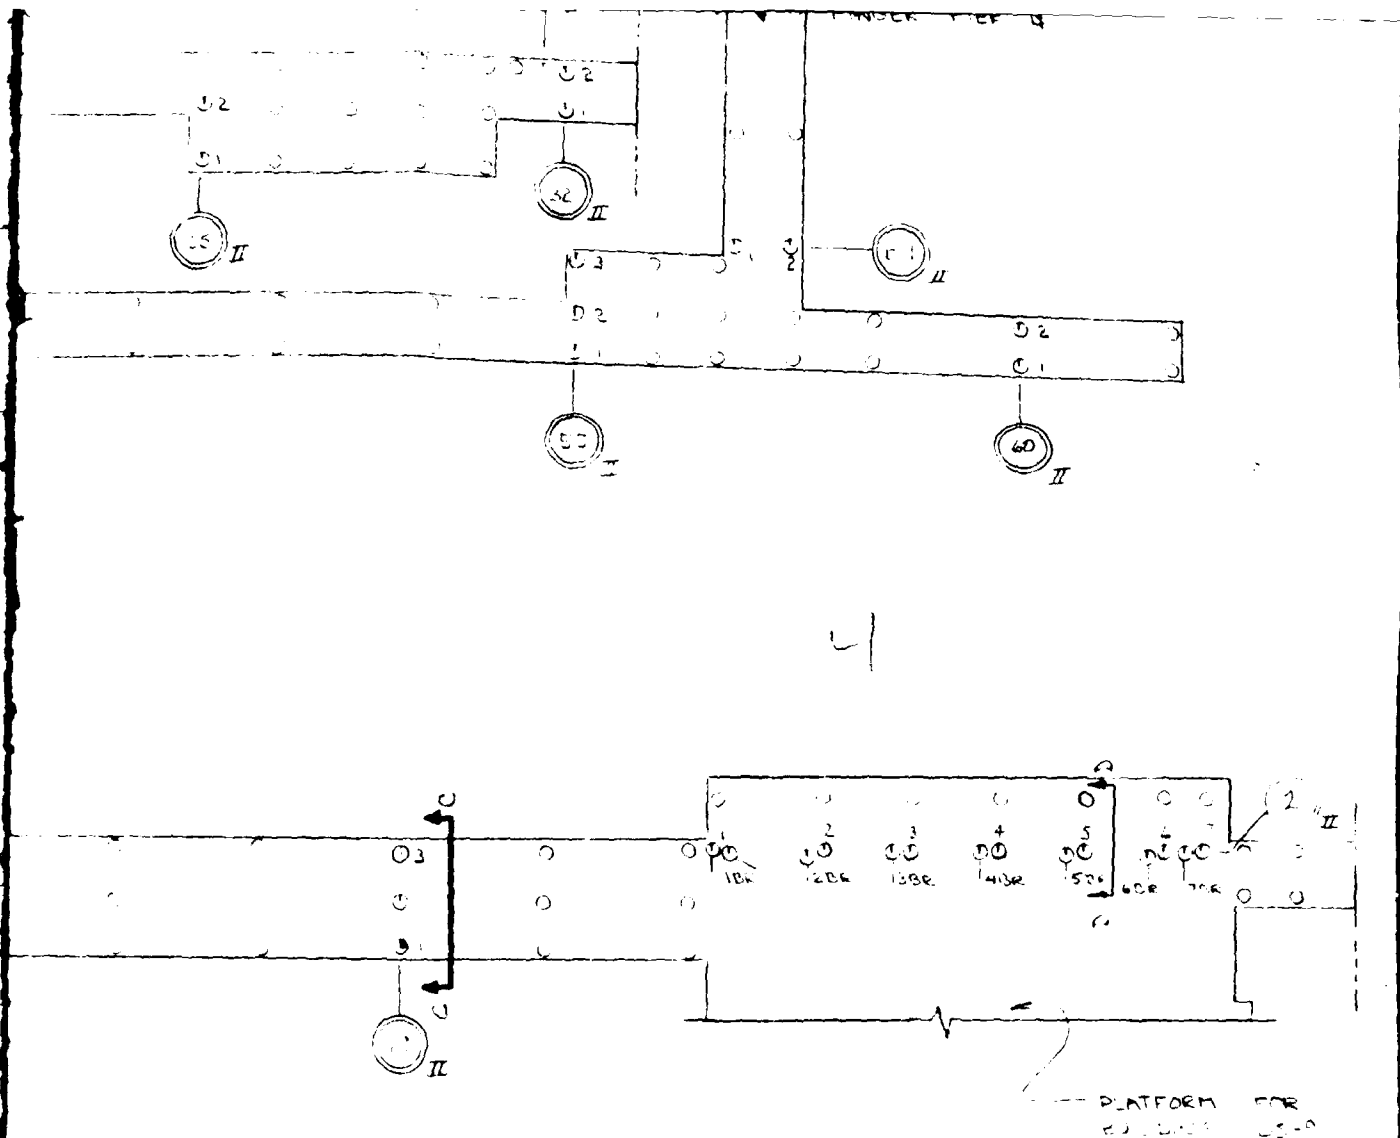
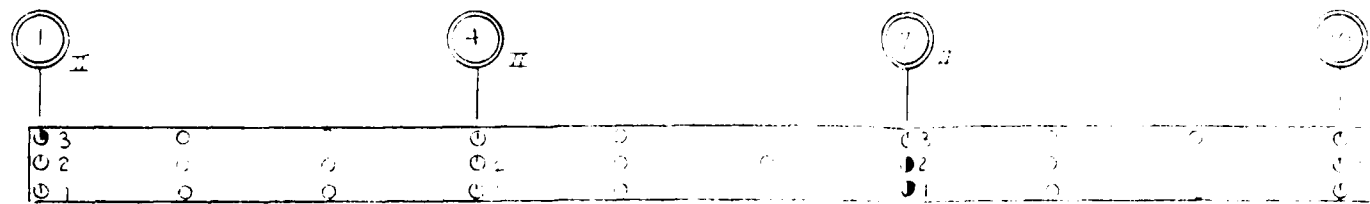
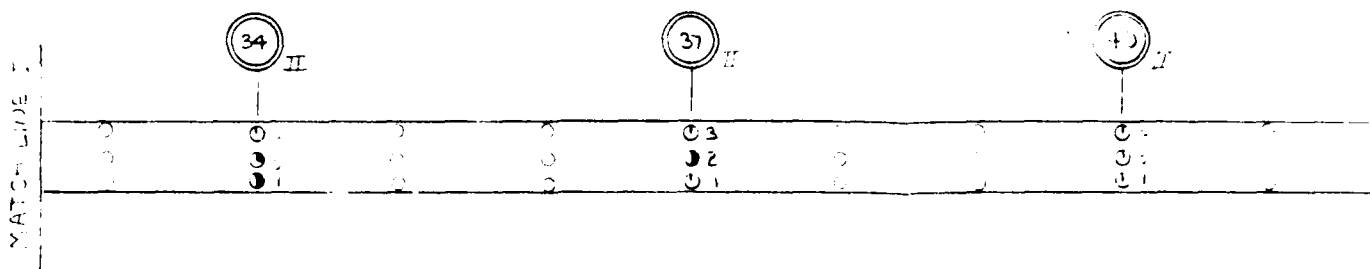
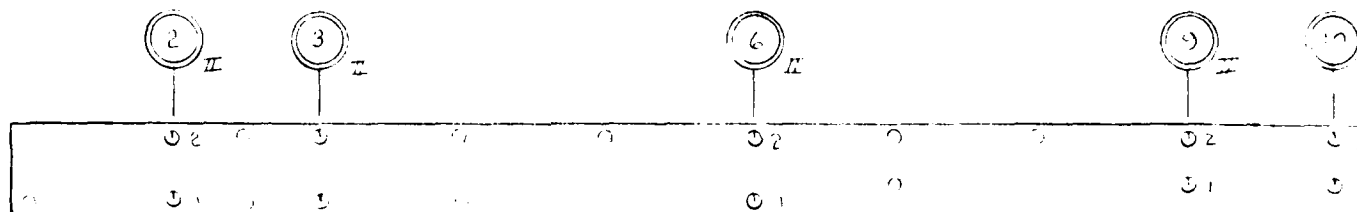
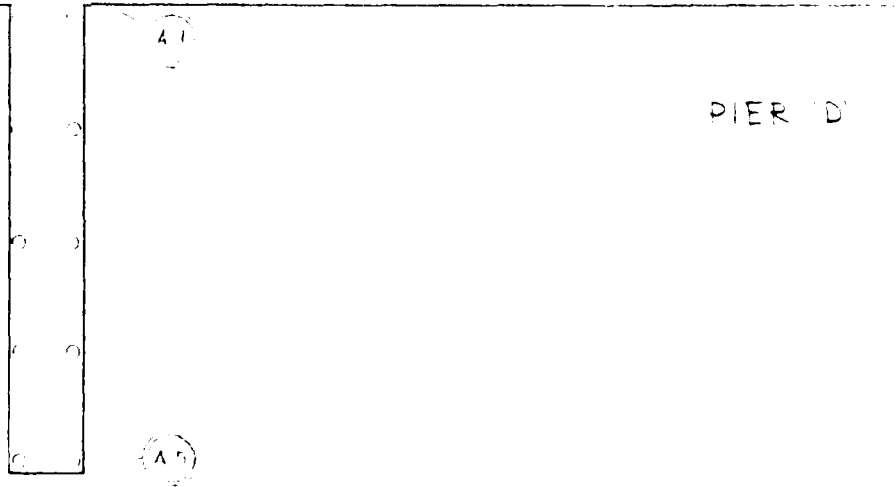
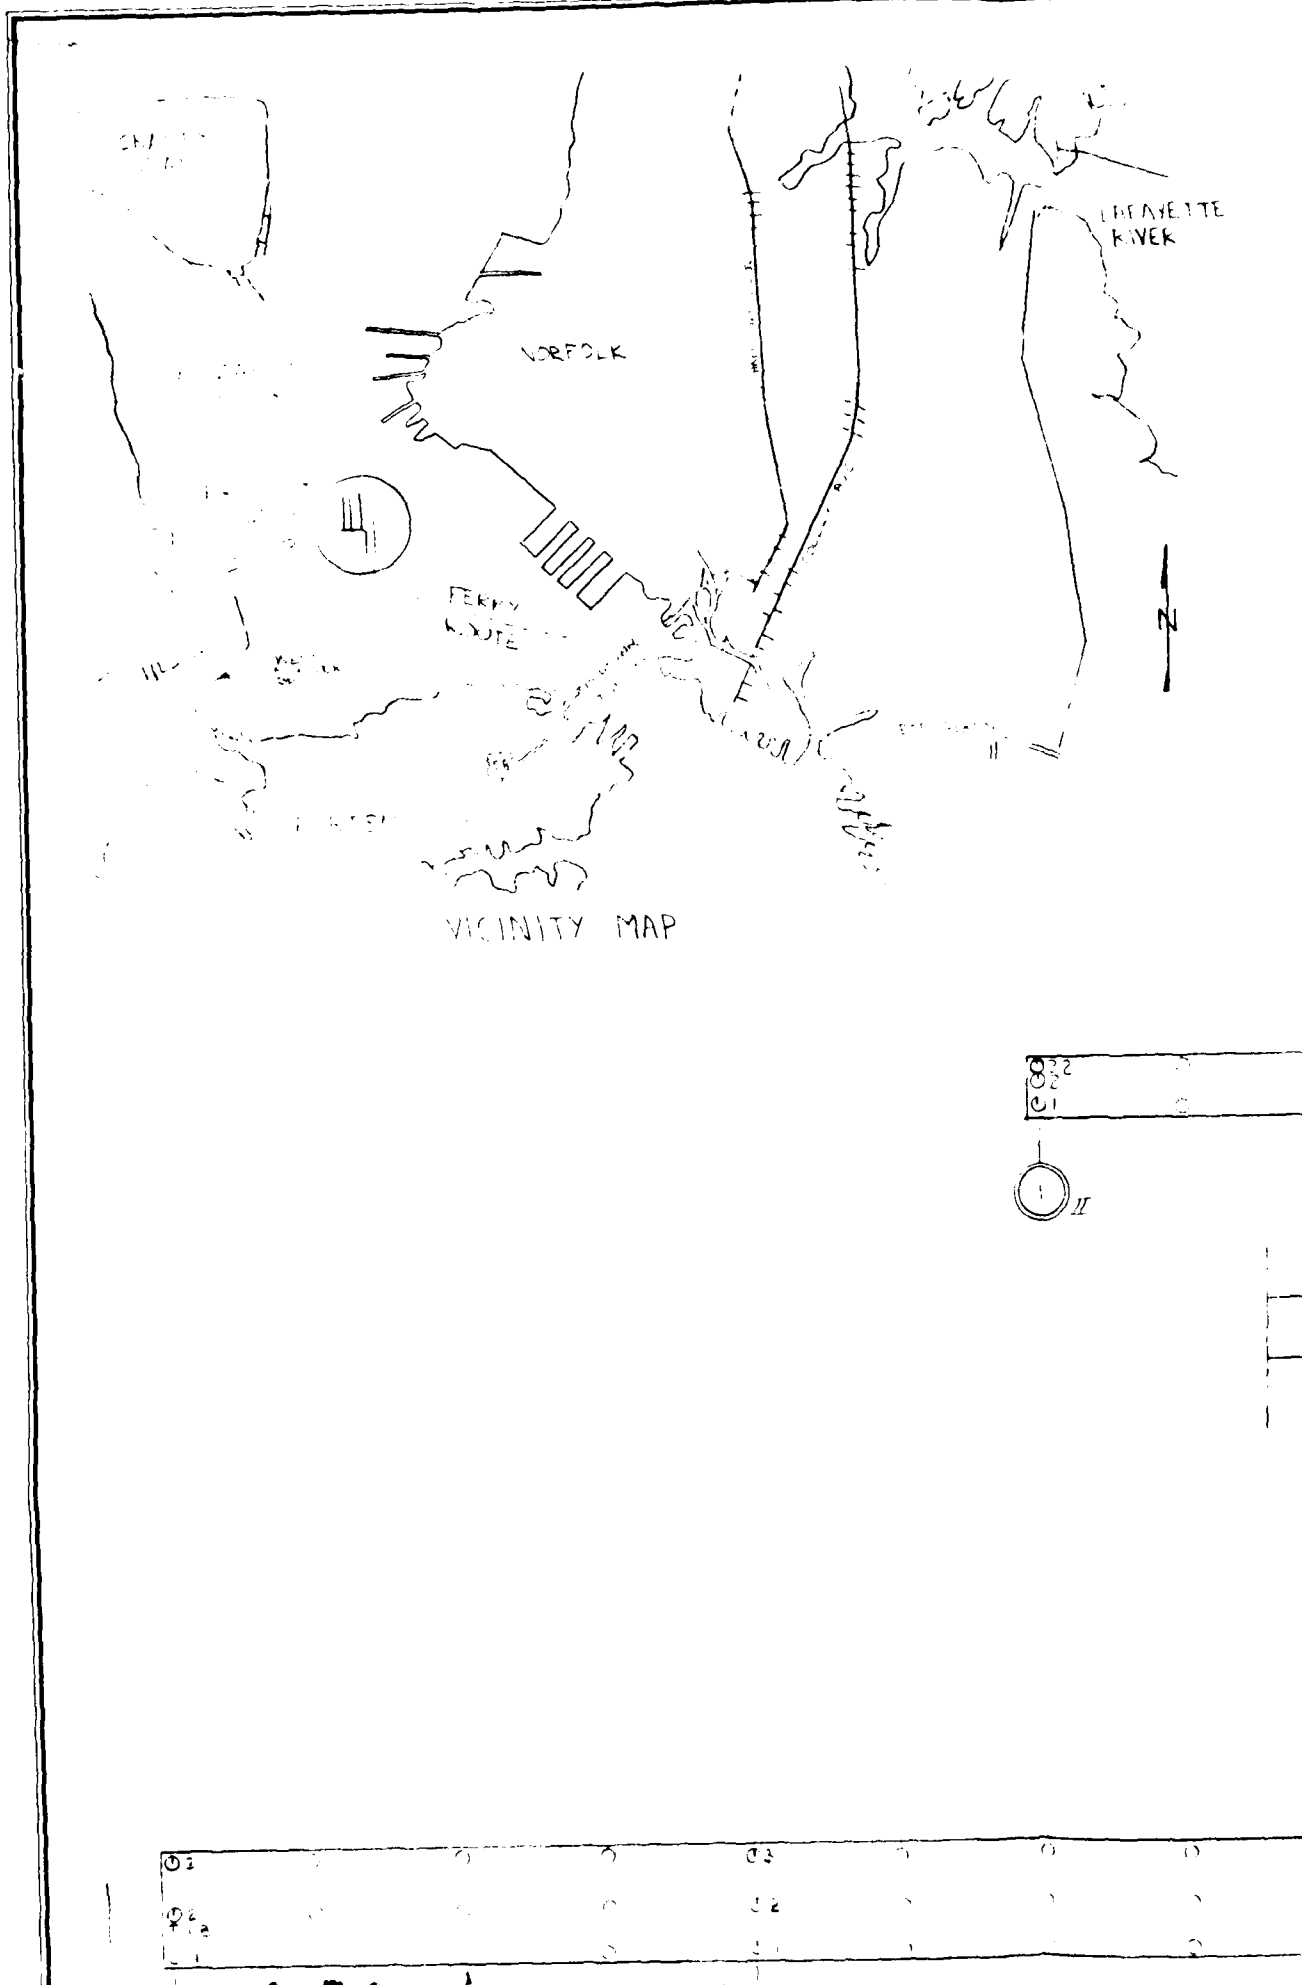
The objective of this inspection was to examine a representative sampling of the structural piles in the facility in order to determine the overall condition of the structures and to provide detailed structural data on the 182 examined piles. To achieve the best possible sampling results, pile bents throughout all structures were selected for testing. This type of sampling would give a representative sample of piles and ambient water conditions across and throughout the length of the piers. See Table 1 and Drawings 1, 2 and 3, pages 3-5, 3-6 and 3-7 for the piles tested.

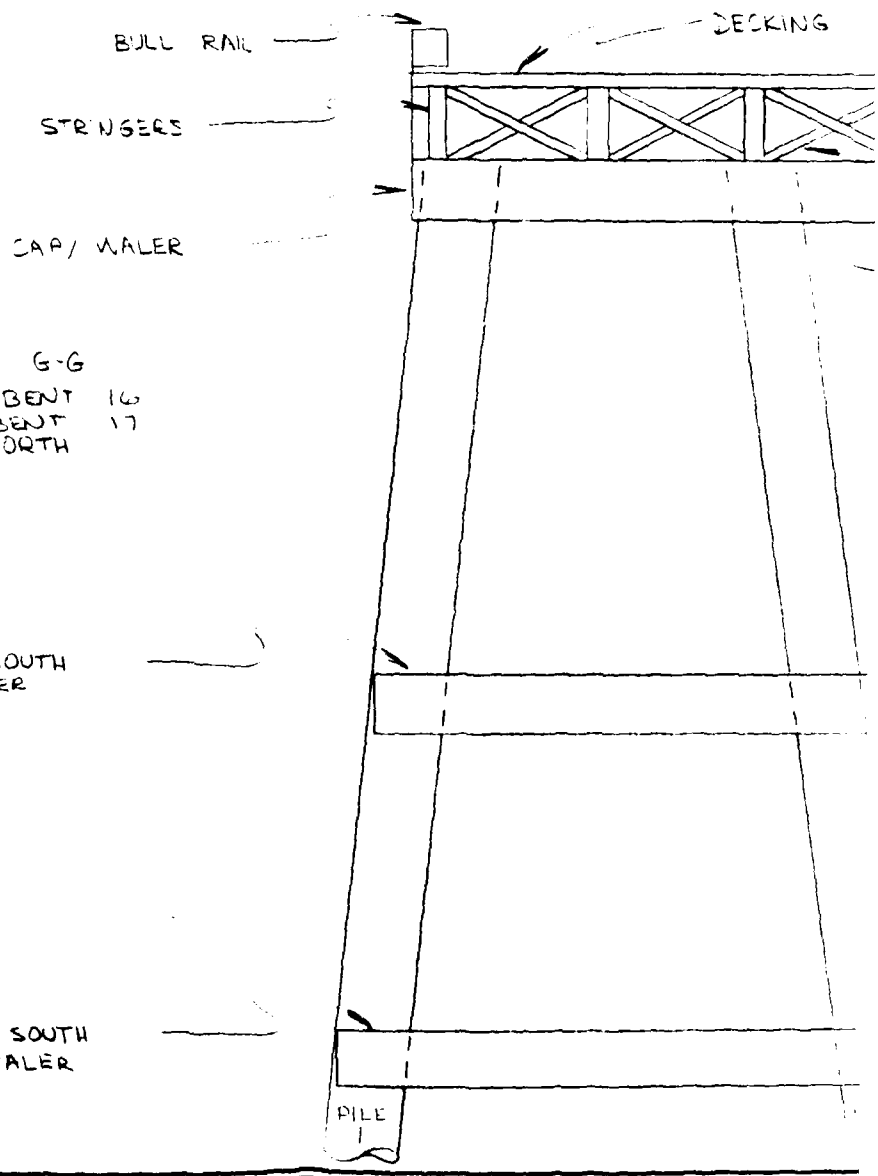
SECTION G-G
PIER C BENT 16
AS SEEN FROM BENT 17
FACING NORTH

The damage on individual piles was found to range from the pile top down through the intertidal zone. The tops of all piling were examined for fungal deterioration by probing (see Photograph 3, on page 3-3). In several instances as detailed in Table 1, the piles have sustained extensive fungal decay resulting in total section loss of the untreated heartwood core of the piles. This damage typically extends down 1-3 feet from the top of the pile. Five of the piles with damage at their tops were found to have undergone restorative maintenance (by concrete jacketing) of their intertidal zones. The fact remains however that because of the damage at the top of the piles, the bearing capacity of these five piles (Pier C, Bent 16-2, Bent 18-2, Pier D, Bent 13-2, Bent 23-2, and Bent 38-2) is severely reduced.

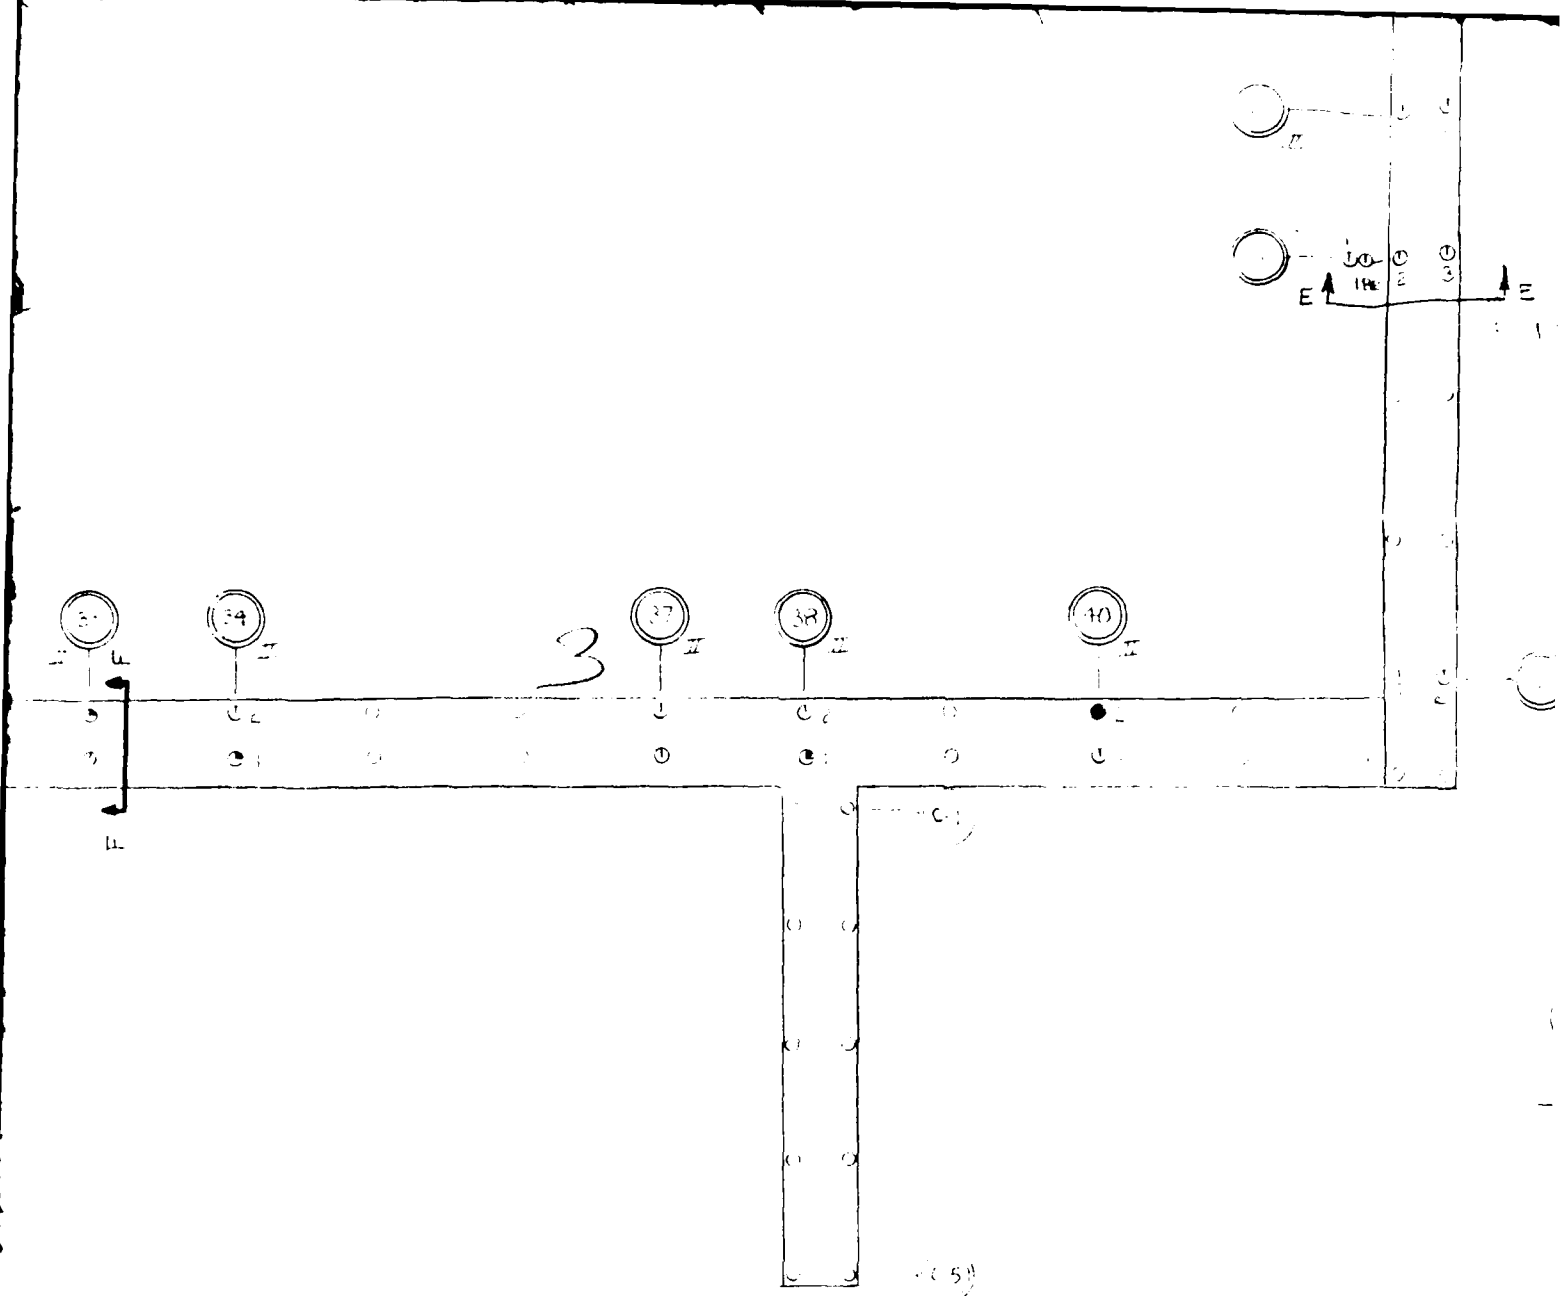
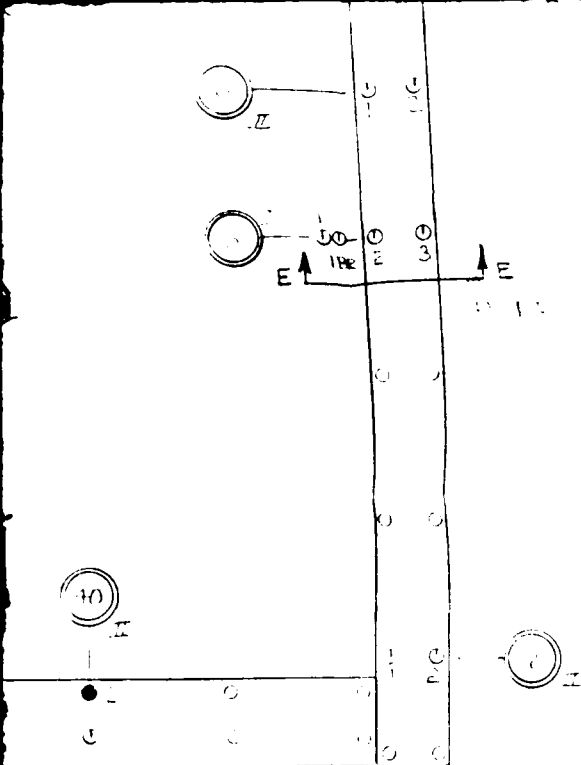
The damaged piles were found in all of the examined structures (excluding Pier E and the Building DS-9 Platform) but were found to be concentrated in Pier C. The following table shows the number of significantly damaged piles found in the detailed ultrasonic inspection. (See Table 3 for additional damaged piling found in the "Rapid Visual Swim By Inspection".)
