# SAN NICOLAS ISLAND BARGE LANDING SITE SURVEY

FPO-1-79(3)  
NOVEMBER 1978

OCEAN ENGINEERING AND CONSTRUCTION PROJECT OFFICE  
CHESAPEAKE DIVISION  
NAVAL FACILITIES ENGINEERING COMMAND  
WASHINGTON, D.C. 20374

Subj: San Nicolas Island Survey

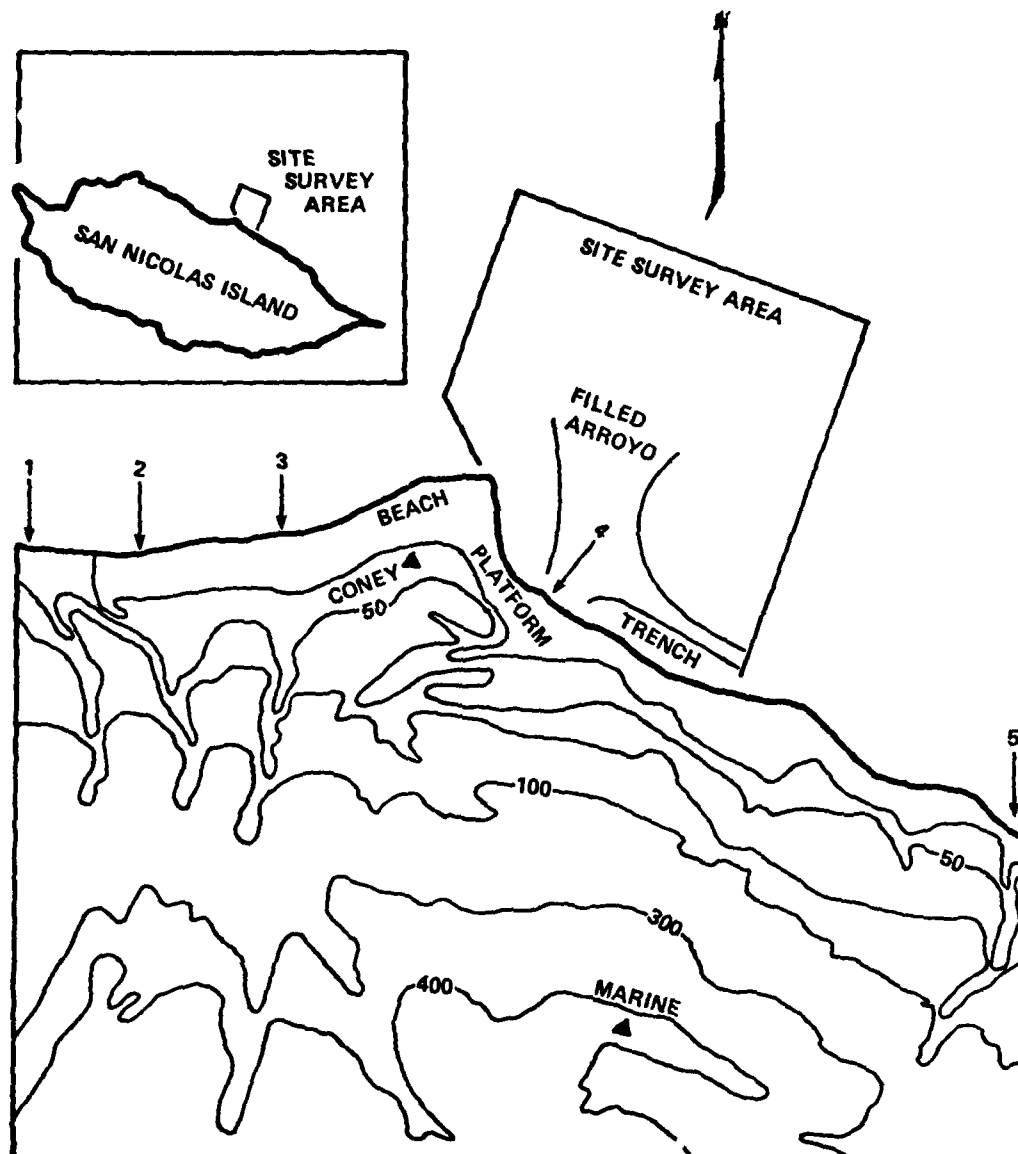
Figure 2. Location Of The Survey Area, San Nicolas Island (Showing Ancient Onshore Arroyos (numbered 1 through 5) and the Later Beach Platform (a late Pleistocene marine terrace))

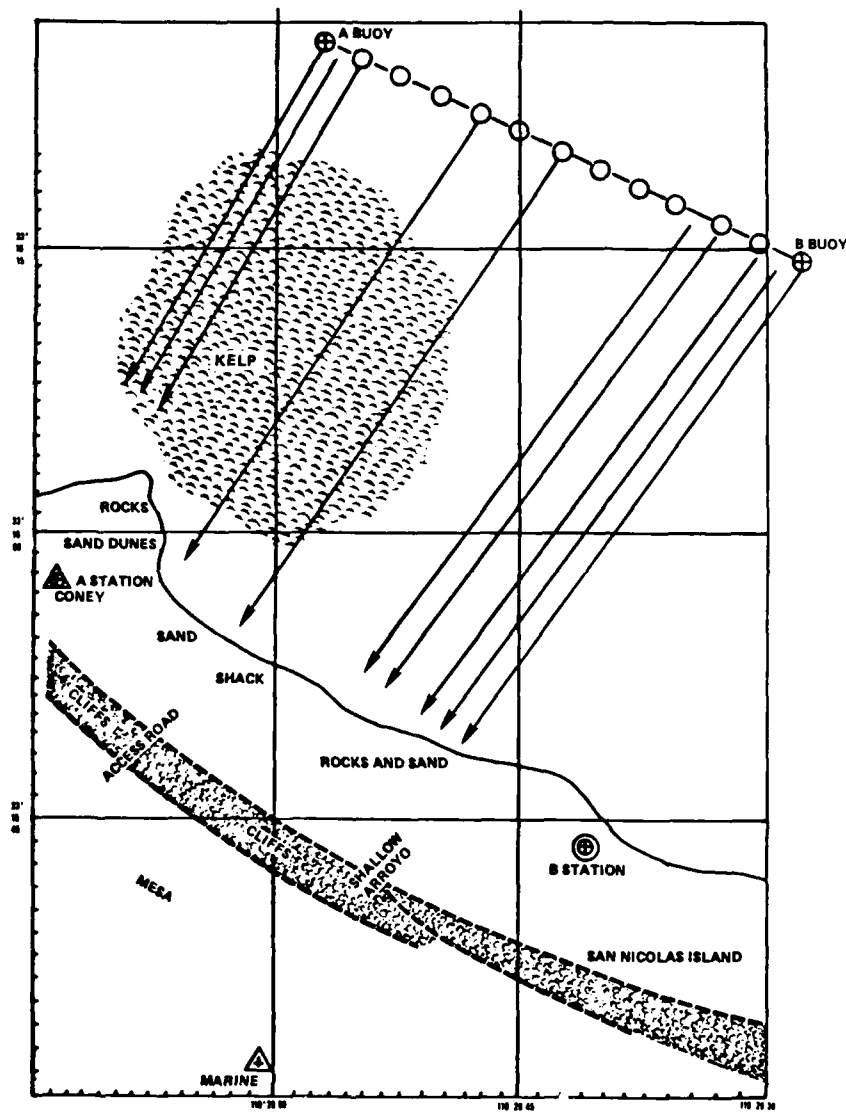
the successive runs. Kelp beds over the western and central portions of the site survey area presented some problems with fouling of the LARC-5 propeller. This required direction reversals and maneuvers of the vessel, which had no effect on the validity of the data, but did introduce some random excursions from the basically intended tracks. In fact, from observation of the sounding sheet, which is presented as the first fold-out of the Appendix, it can be seen that the irregular courses actually enhanced the survey accuracy by providing a more thorough and refined coverage of the survey area. The last half dozen runs, terminating with the run from "B" buoy to "BRAVO" station, were relatively unhindered. The LARC tracks and various features of the beach and the survey area are shown in Figure 7.

Figure 7: Boat Track Chart Showing Benchmark and Buoy Locations, Kelp Beds, and Beach Features.

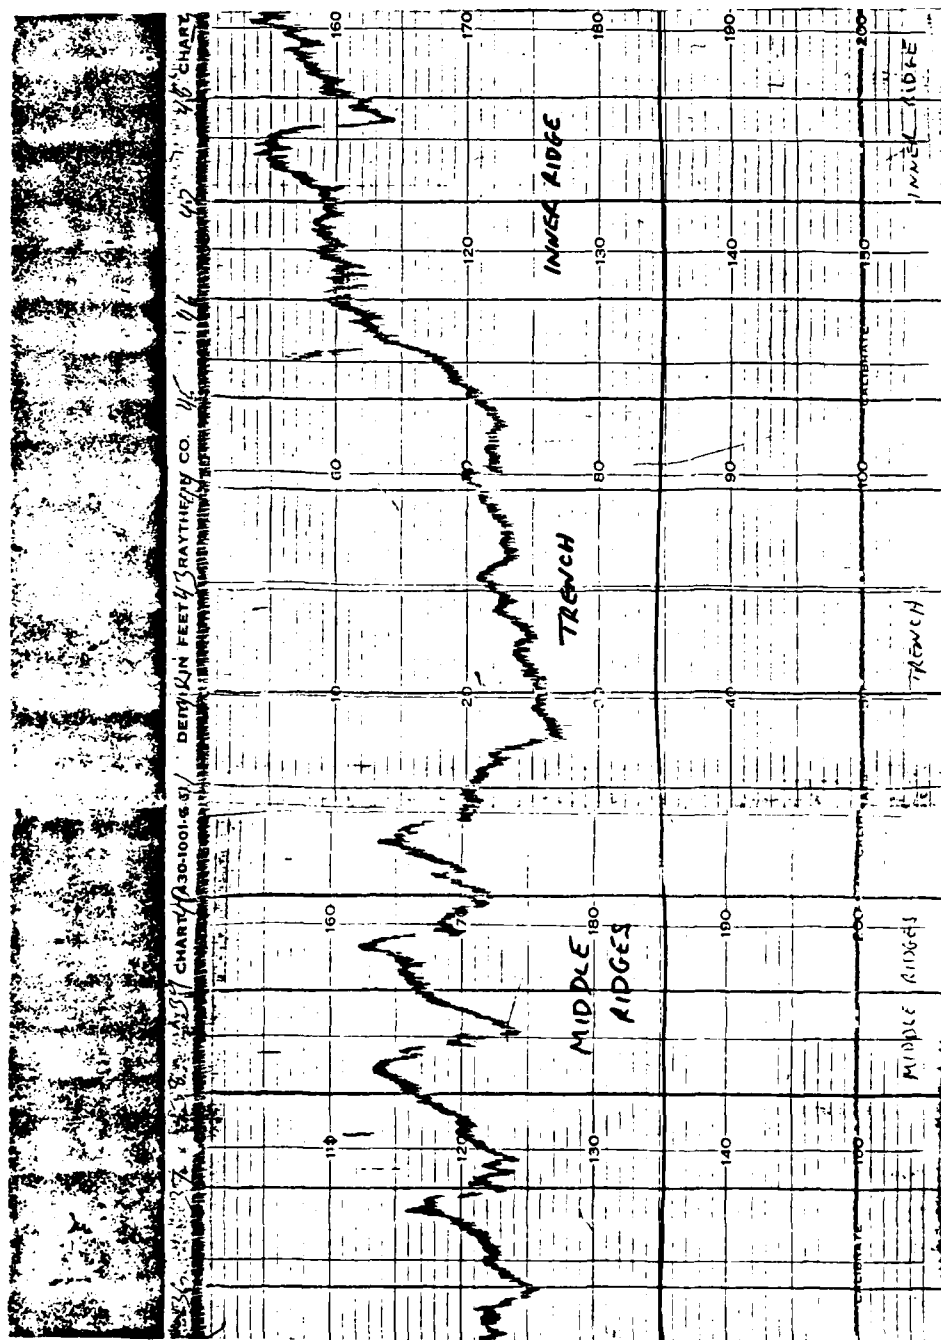
Figure 8: A run across the ridges in the western portion of the site survey area. Note that the ridges are steeper on the landward side than on the seaward side. (The left of the picture is seaward.)

Figure 8. Fathometer Record Sample - Ridge Transect  
(Showing the Middle Ridges, the Trench, and  
the Inner Ridge).

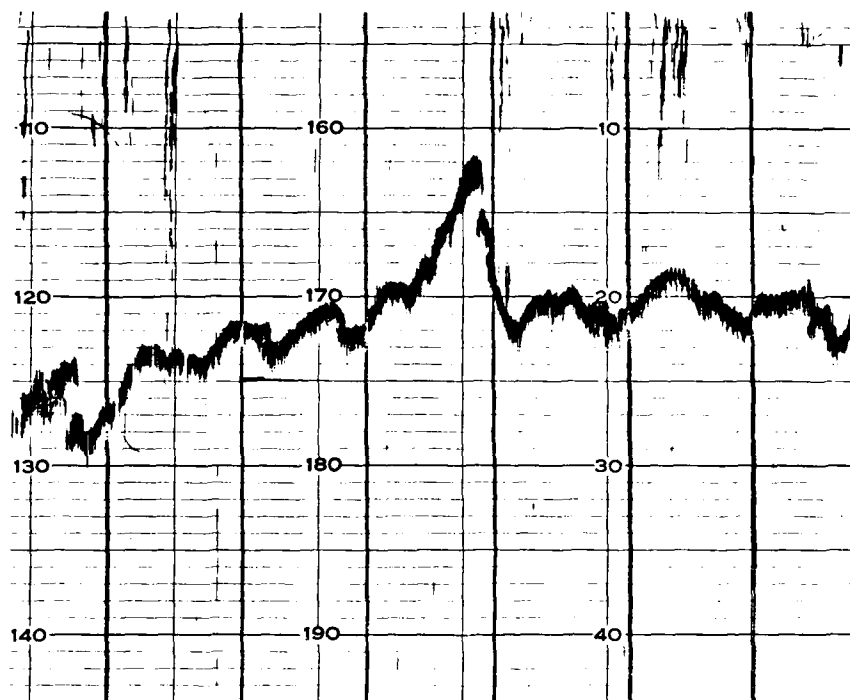
Figure 9: A run across Position 5 indicating the sharp rise of this feature from the bottom on both sides.

Figure 9. Fathometer Record Sample - Isolated Feature Transect  
(Showing the Prominence at Position 5)

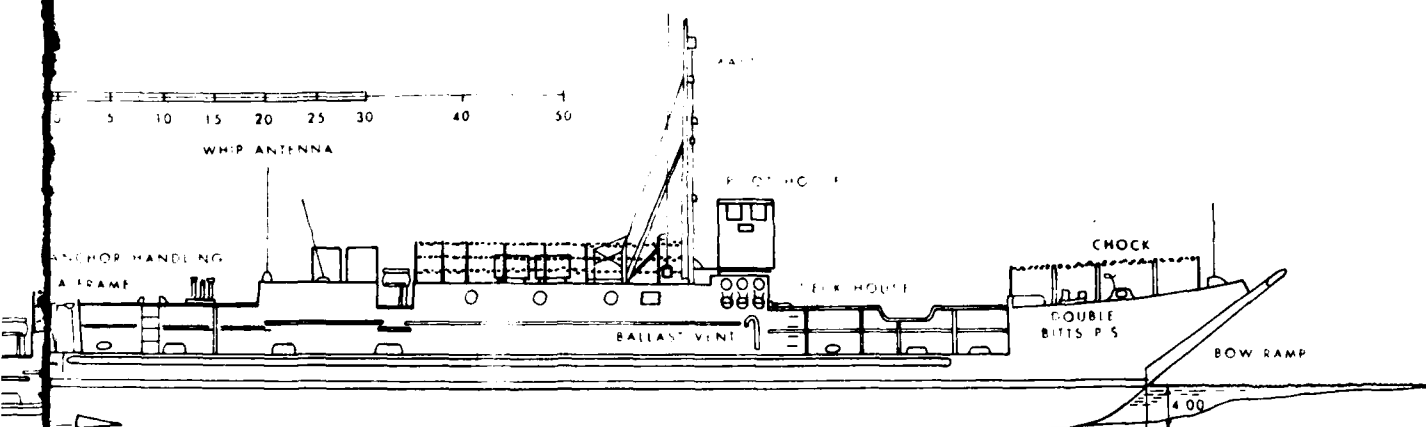
A bottom profile over the A - A' section without vertical exaggeration and with a loaded YFU at the beach is shown in Figure 15. The profile is taken at MLLW (mean lower low water), and will vary somewhat at higher waters. Notable, however, is the fact that the bottom slope is too shallow to permit dry landing of cargo when the bow ramp of the YFU is down. The YFU bow ramp must lie on a 1:10 slope (about 6.5 degrees) to permit dry landing without the redistribution of sand around the ramp. The profile shows 10 feet of the YFU hull aground. The rest of the hull clears the bottom only slightly, reaching a 2 foot clearance at the stern. This is not detrimental to the YFU operation, but may be limiting when the surf is rough. At a distance of approximately 320 feet from shore, the rise to 8 feet minimum depth is evident. The resolution of the bathymetry at this scale is insufficient to indicate the profile with precision. However, the presence of the rise on or near the axis of the channel is restrictive at water levels corresponding to the extremes of low water.

Figure 15. YEU (LCH-1610) Profile,  
Loaded Configuration, on A-A' Section
