Chena River Lakes Project Fairbanks, Alaska

Overview of Tanana River monitoring and research studies near Fairbanks, Alaska

OVERVIEW OF TANANA RIVER MONITORING AND
RESEARCH STUDIES NEAR FAIRBANKS, ALASKA
(with Appendices)

Prepared by
U.S. Army Cold Regions Research and Engineering Laboratory
Hanover, New Hampshire

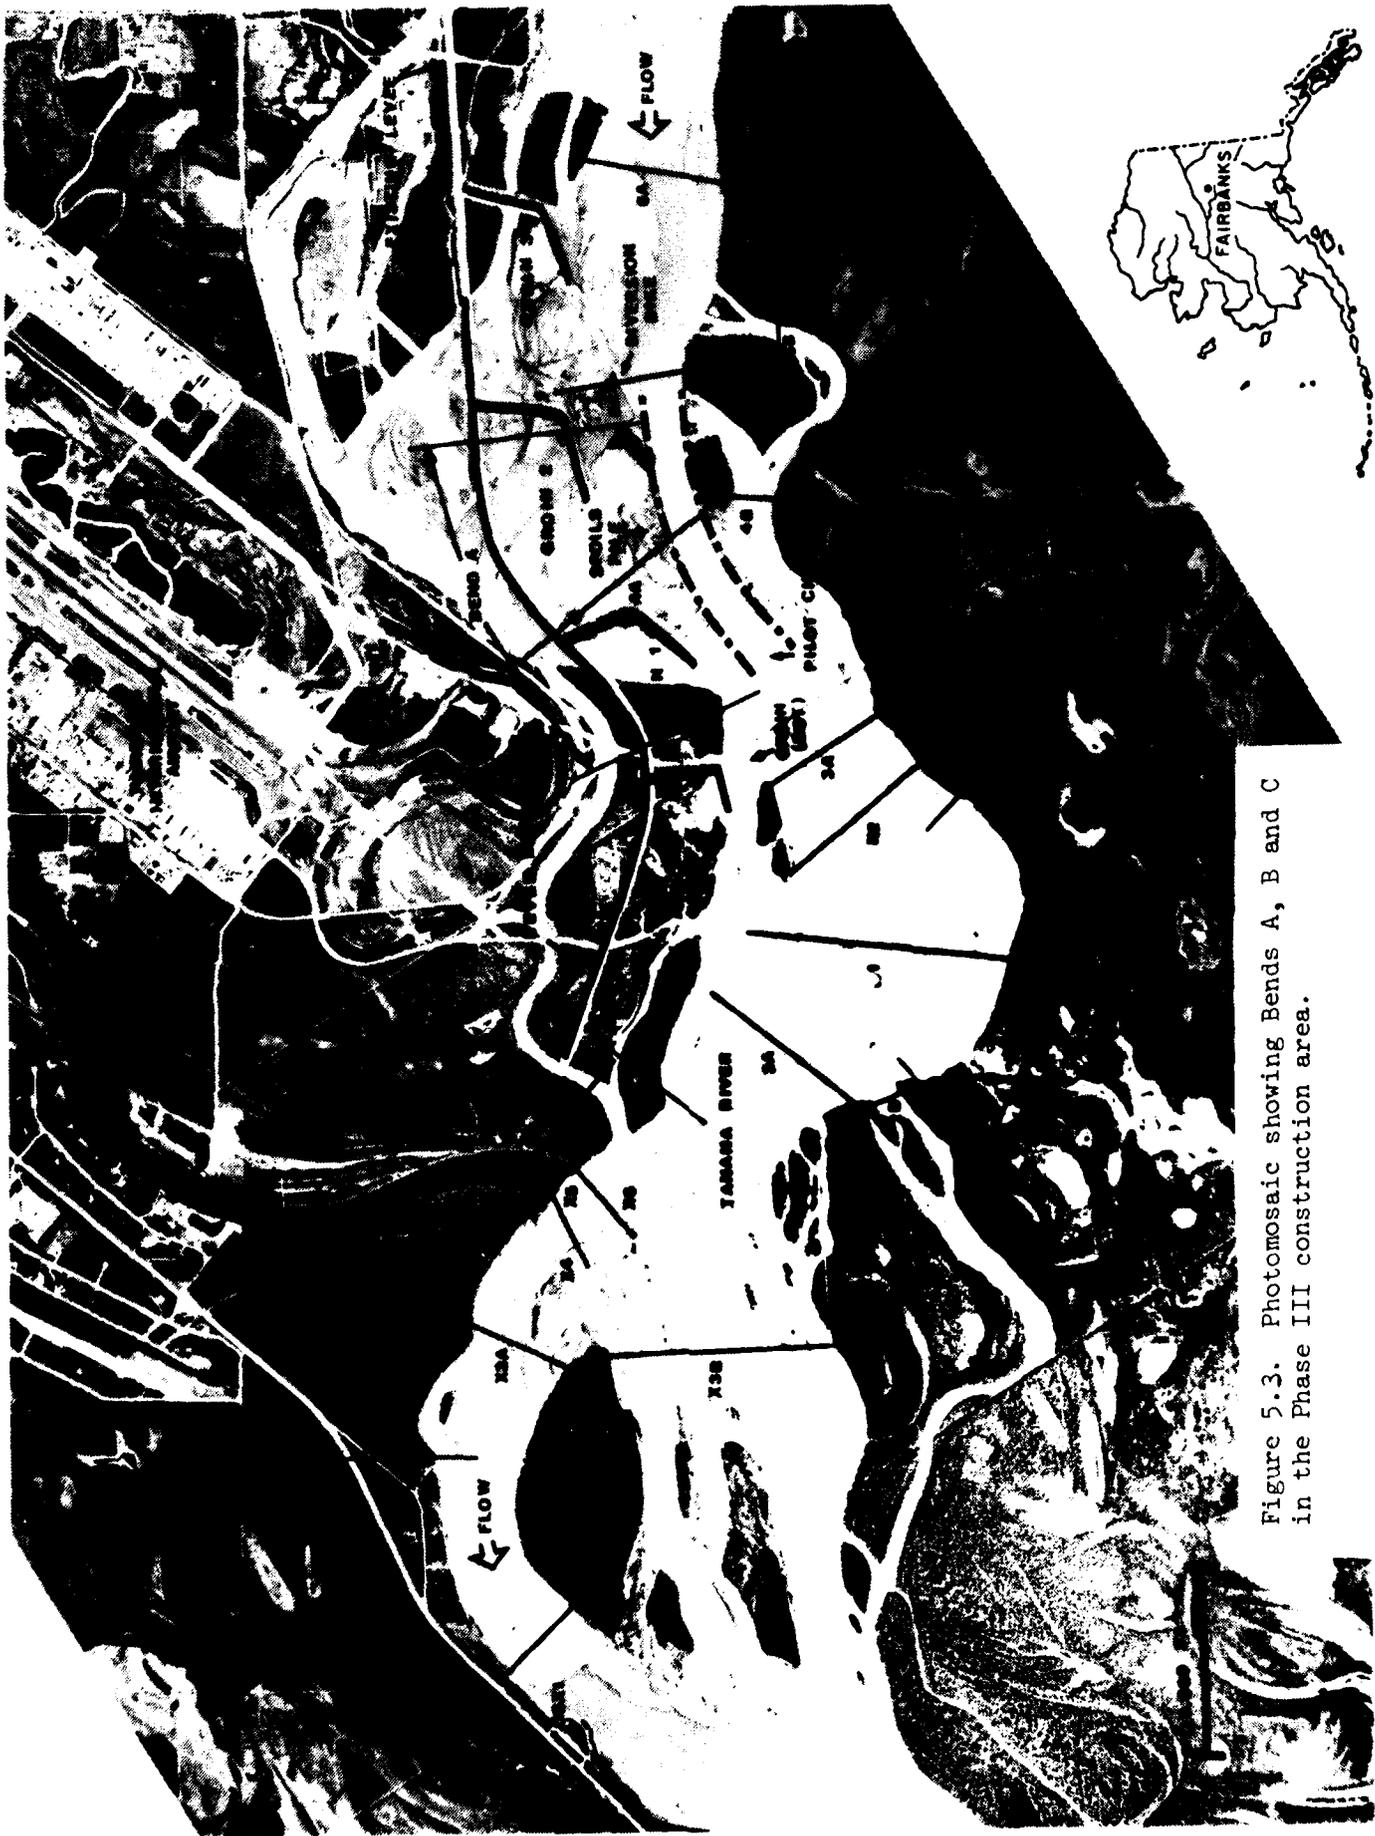
Figure 5.3. Photomosaic showing Bends A, B and C in the Phase III construction area.

The Phase III Construction portion of the Chena River Lakes Projects extended the levee to a point near the mouth of the Chena River just south of the Fairbanks International Airport (Figure 5.3). Four L-head groins (Groins 0 through 3) were placed to protect the levee and to divert the main channel of the Tanana River southward. A pilot channel was excavated to allow for construction of the levee and groin system and to initiate the formation of a new channel along the curved alignment. The four groins were designed to maintain an active channel width after construction of approximately 1,500 ft. The previous minimum natural width in the area was about 1,600 ft, but the actual minimum pre-construction width was about 1,370 ft, between the DOT Groin and the south bank. The bend length through the new pilot channel alignment is 4,000 ft compared to a pre-construction bend length of 7,300 ft. The pilot channel was 300 ft wide at the invert, with 2 to 1 side slopes. Material excavated from the pilot channel was placed in a spoil pile adjacent to its north bank; see Figure 5.3.

Appendix A contains a detailed analysis of pre- and post-construction areal and volumetric erosion for Bends A, B, and C in the Phase II area (Figure 5.3). Table 5.3 consolidates information from Appendix A on areal and volumetric erosion rates for the bends. From 1970 to 1980, prior to Phase III Construction, the areal erosion rate in Bend A was 298,000 ft² per year. Areal erosion rates in Bends B and C were only about 20% of this rate. Erosion rates in Bend A were fairly consistent during the period, but increased during the high discharge year of 1975 and again following construction of the eastern Goose Island Causeway in late 1975; whether there is a causative connection in the latter case is uncertain. As would be expected, the erosion rates decreased when riprap was placed prior to Phase III Construction, although 1979 was a high water year. Areal erosion rates in Bends B and C were highly variable during the

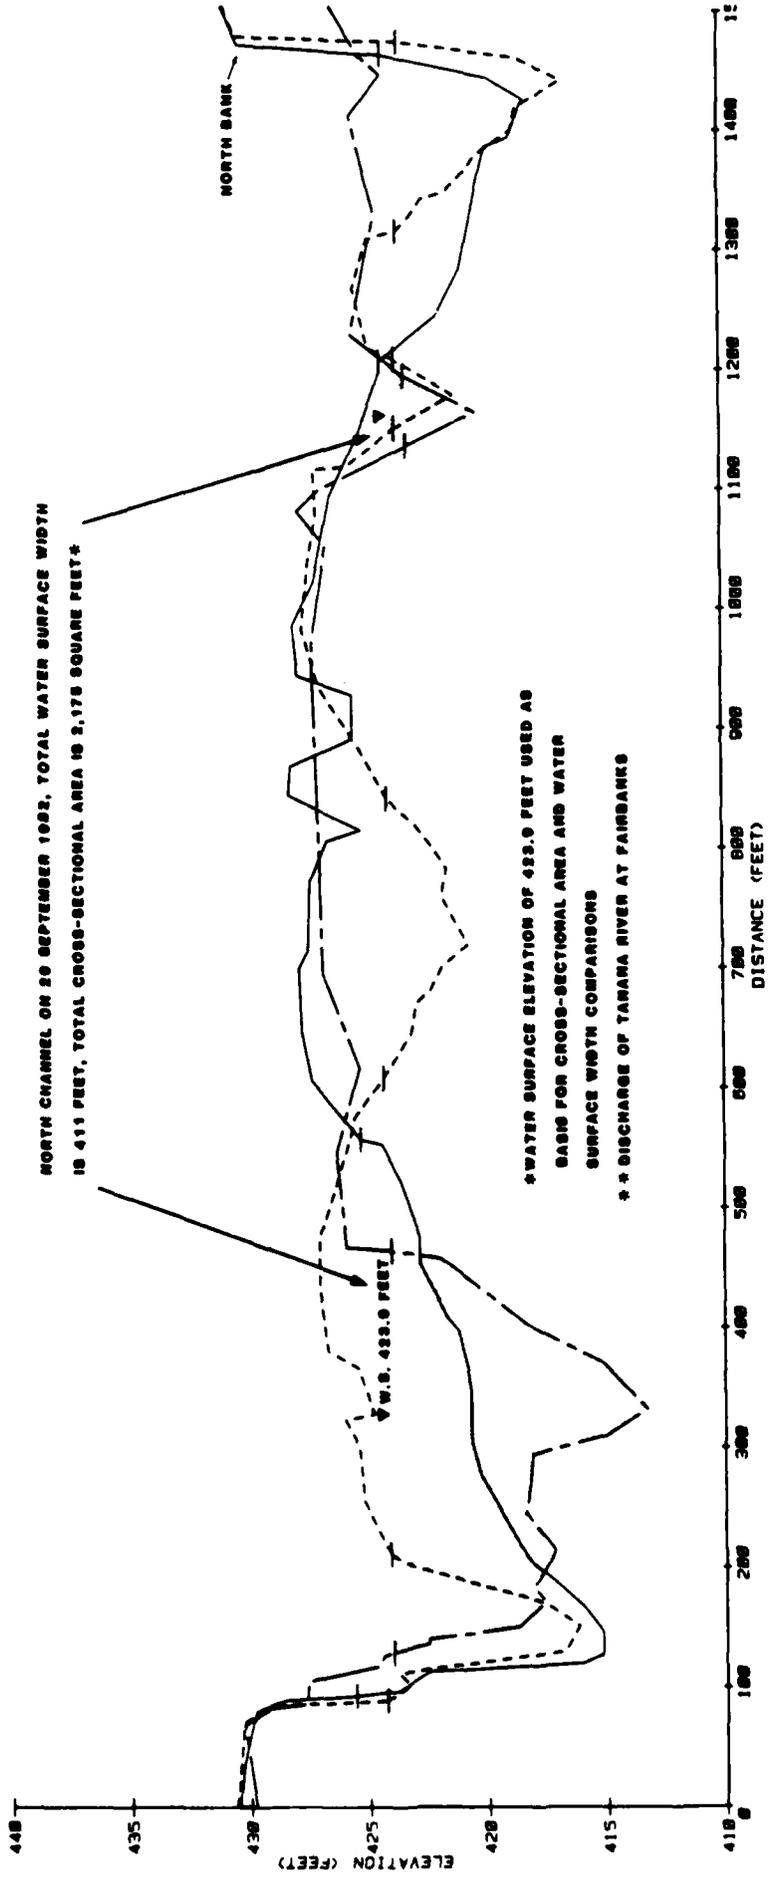
Figure 6.1. Comparison of cross-sectional changes in the north channel downstream of Goose Island, cross section 7A.

Figures 6.1 and 6.2 show cross-sectional changes which reflect the activities at Goose Island. Figure 6.1 shows cross section 7A in the north channel downstream of Goose Island, Figure 6.2 shows cross section 7C in the south channel, and Table 6.2 compares changes at 7A and 7C. A water surface elevation of 423.9 ft was used as a basis for comparison since it was an average of the water surface elevations measured during the surveys; the corresponding discharge was in the vicinity of 20,000 cfs. The distribution of flow area at this condition in 1977 was 56% in the north channel and 44% in the south channel. By 1982 these proportions had changed to 40% in the north channel and 60% in the south channel. Marked changes in cross-sectional shape also occurred within each of the main channels.

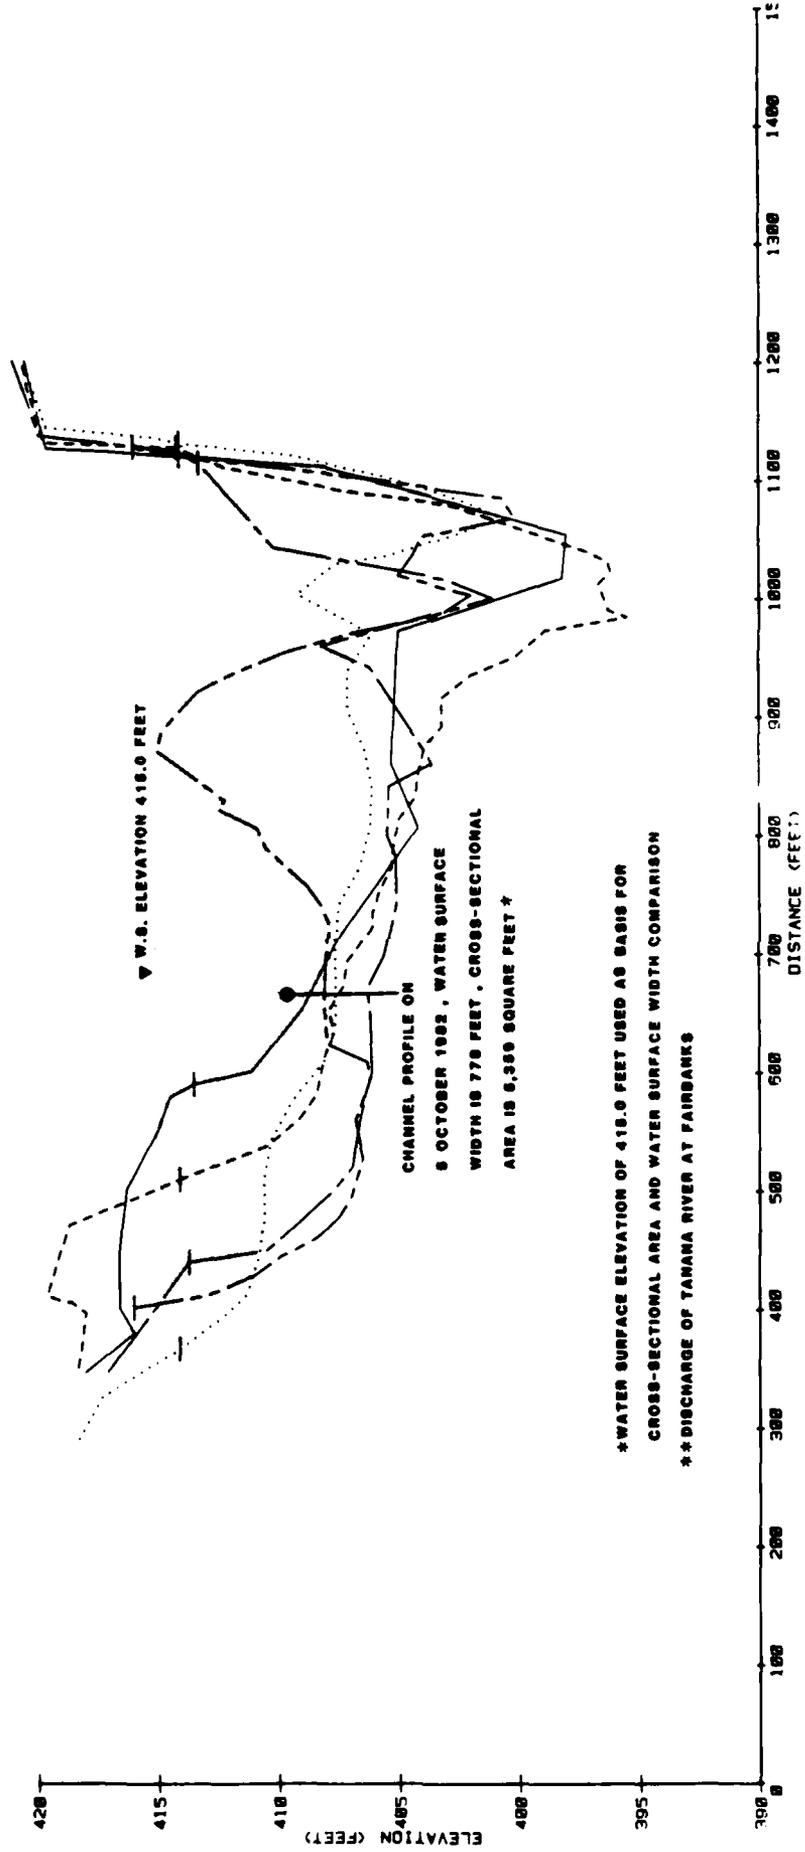
Figure 6.6. Comparison of cross-sectional changes at cross section X4, just downstream of the Chena River confluence.

Figure 6.6 shows cross-sectional changes at section X4, just downstream of the Chena River confluence. Bar development at the mouth of the Chena River is clearly visible in the 15 September 1981 cross section, but is not seen in the 5 October 1982 section*. Changes at this cross section are summarized in Table 6.5 for the last survey of each open-water season since 1978. The north bank of this cross section has remained relatively stable, but increase in width is occurring by erosion of the south bank, which receded about 150 ft in the period 1978-80 and a further 50 ft since Phase III Construction. The cross-sectional area increased during the high discharge years of 1979 and 1982, and decreased during the relatively low years of 1980 and 1981. During the period immediately following Phase III Construction (20 October 1980 to 15 September 1981), the cross-sectional area decreased by 17%, due to deposition of the bar shown in the 15 October 1981 cross section. The bar was closely monitored during the 1982 open-water season. Table 6.6 shows data from surveys conducted during 1981 and 1982 at cross section X4, and gives the location of the bar high point (refer to Figure 6.6) and the minimum water

* Evidence of the nucleus of this bar can be seen in cross sections from 1979, pre-dating Phase III Construction: see Figure 6.6 for example.

depth over the bar. During 1982 the bar reduced in size, to an average height of about 3 ft over a 70-ft width, and moved northward about 130 ft. There appeared to be adequate freeboard for navigation at the time of the latest survey in October 1982. Cross section X6, just upstream of the Chena confluence, is being added to the monitoring program for 1983. Further photographic evidence of the growth of this bar following Phase III Construction is shown in Figures 6.7 and 6.8. At the time of writing it appears difficult to predict the future growth or decay of the bar upstream of the Chena mouth, especially considering the presence of the DOT Groin and associated gravel activities upstream. The DOT Groin is presently under attack by the river and its future is unclear.

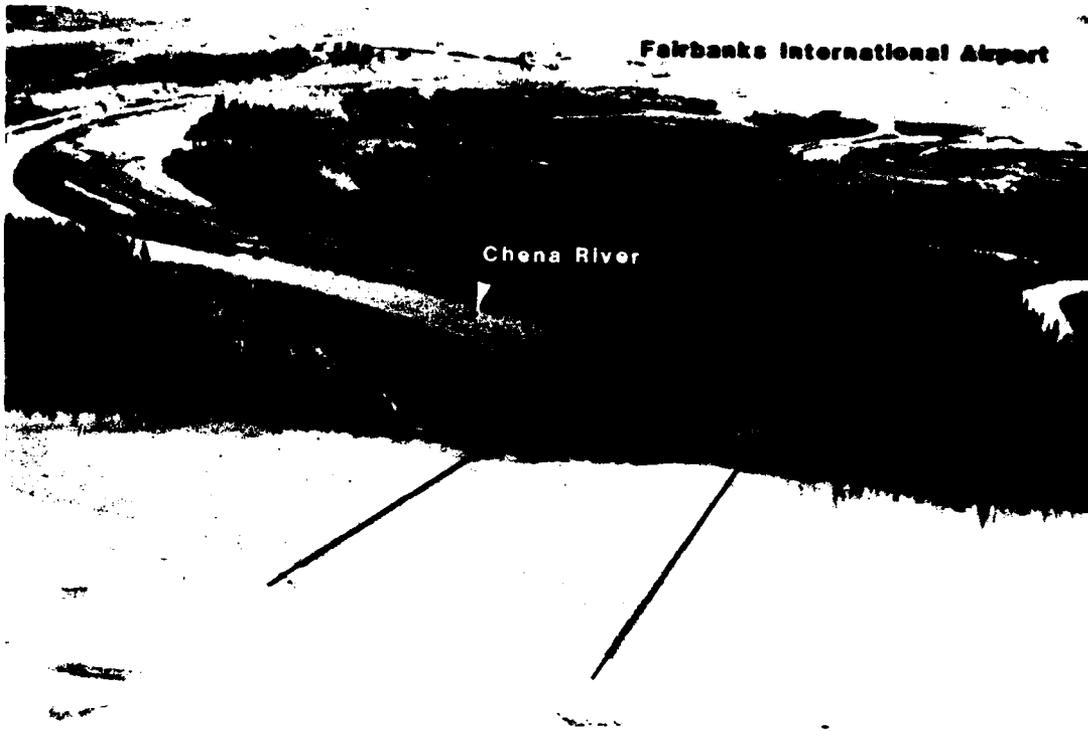
Figure 6.7. Chena-Tanana confluence on 9 May 1980.

5. The Chena River has maintained a navigable opening into the Tanana River even though a bar has accumulated near the confluence. A close watch will be kept on bar development through 1983. In the Phase III Construction area upstream, the channel is approaching an equilibrium cross section. Downstream migration of the meander bend near the Chena mouth, causing

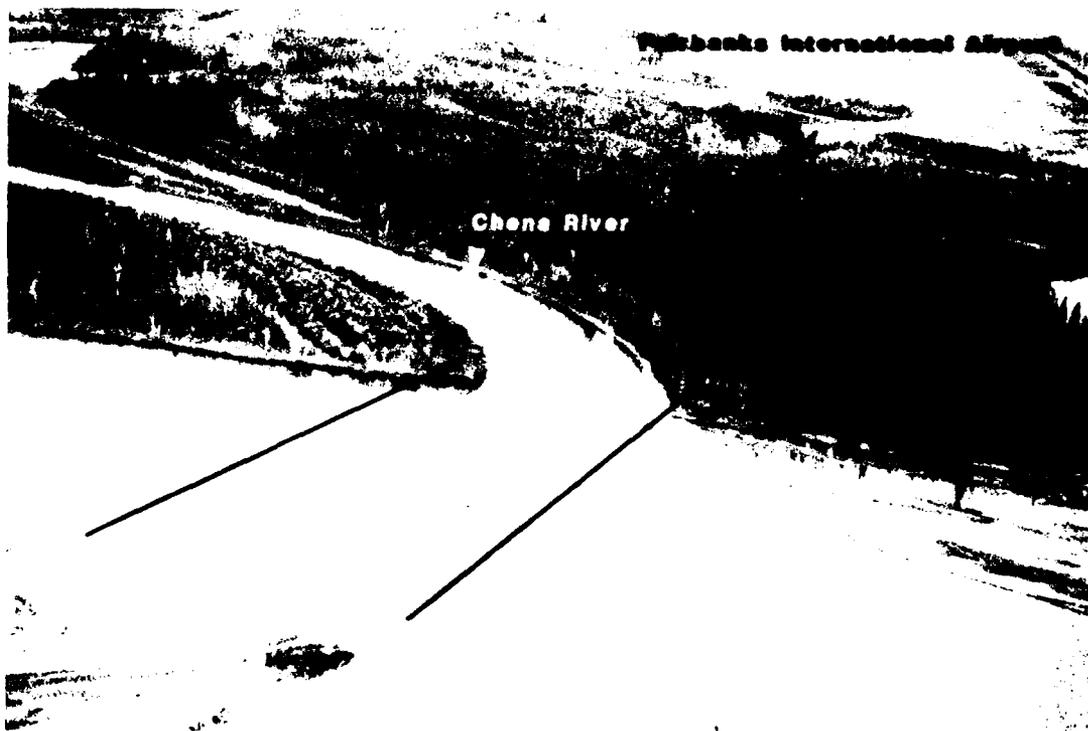
Figure 6.8. Chena-Tanana confluence on 6 October 1982.

erosion of the left bank upstream of Byers Island, may be expected to continue.

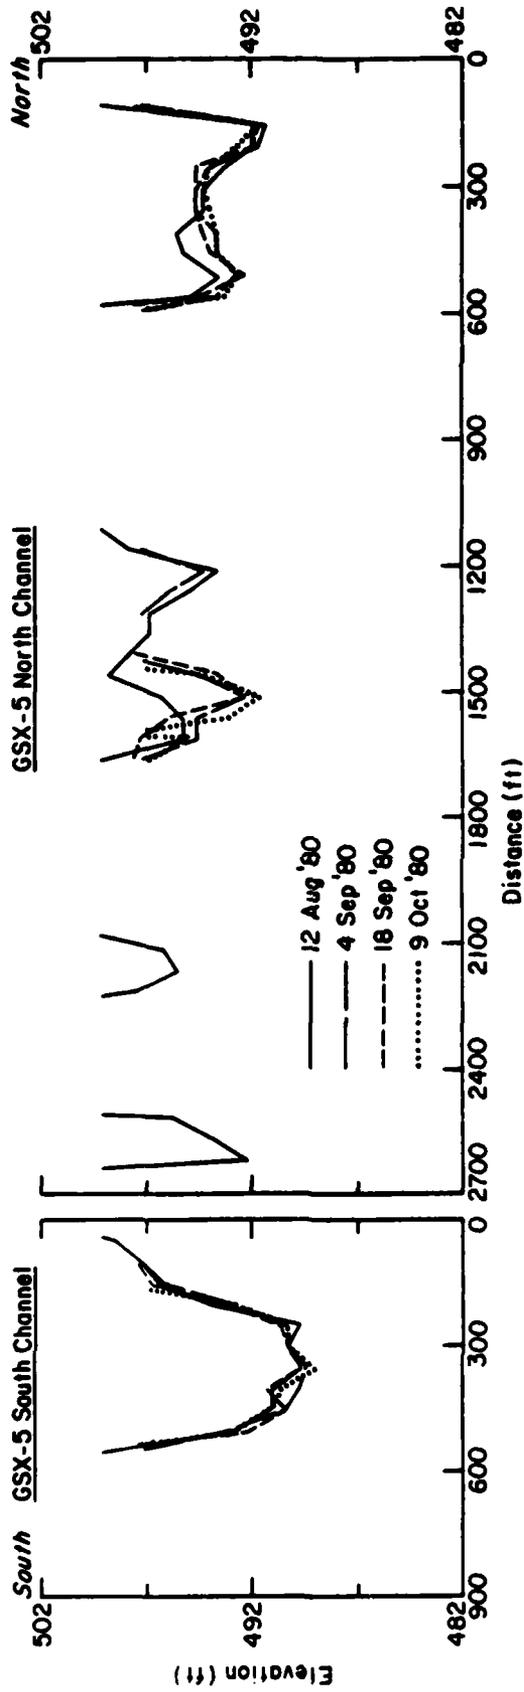
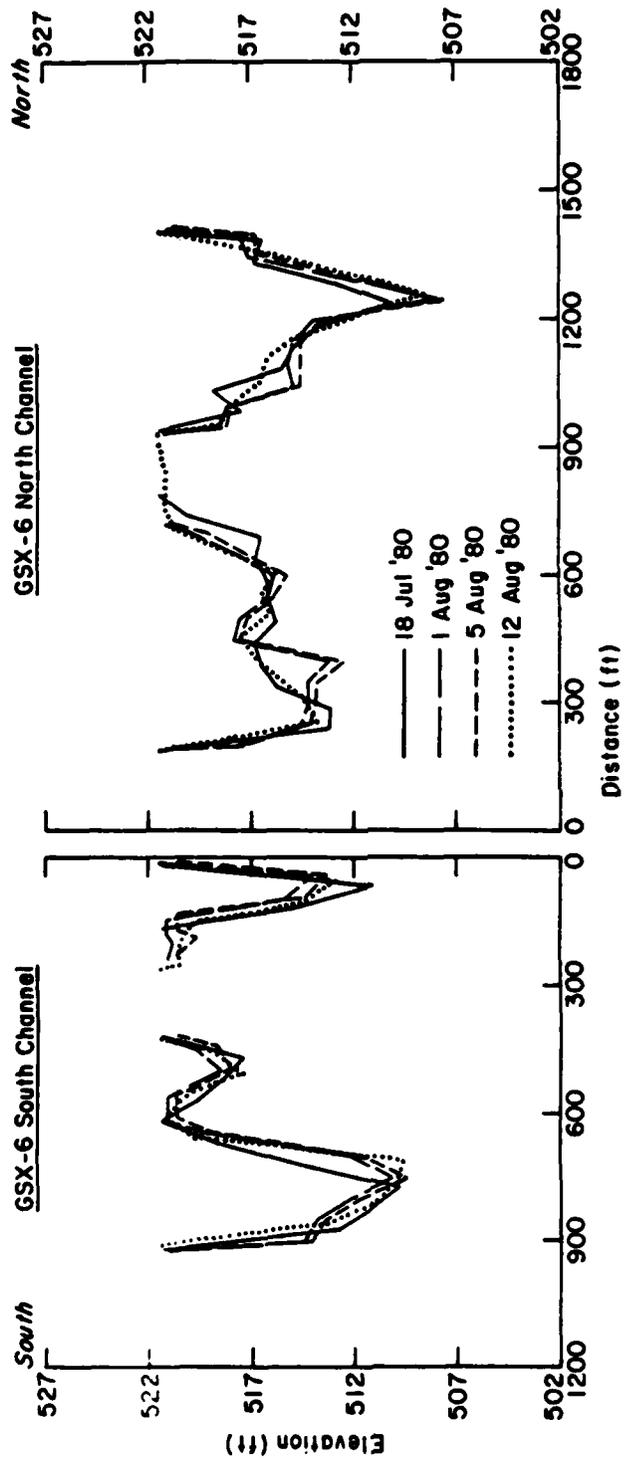
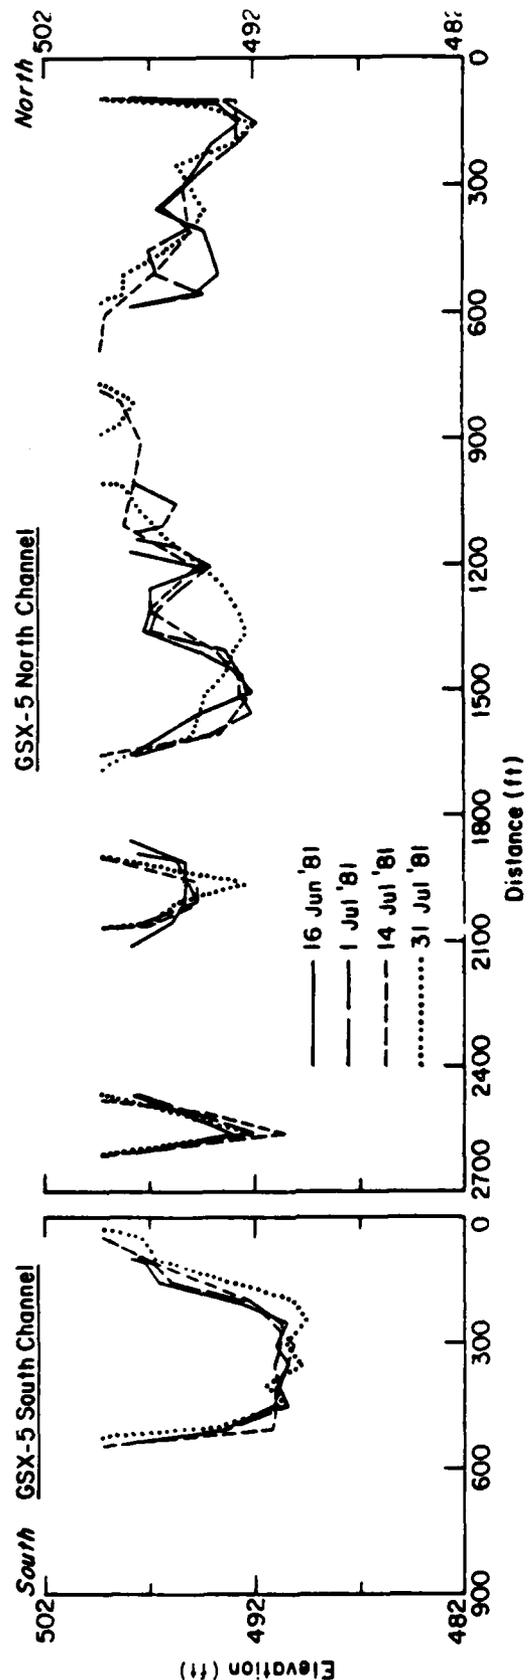
Figure 29. Cross-sections taken in 1979 and 1980 after construction of the floodway sill groin.

The cross-sectional changes that occurred from 1979 to 1980 are as follows (Fig. 29). The south and north channels at GSX-5 were deeper in September 1979 at the end of the high discharge 1979 season. By 24 June 1980 the channels were generally filled-in. During the 1980 season the changes in the south channels were minor while most of the change occurred in the north channel especially during the rising limb of the hydrograph from 24 June to 31 July 1980. Changes at GSX-6 were minor throughout the 1980 season.

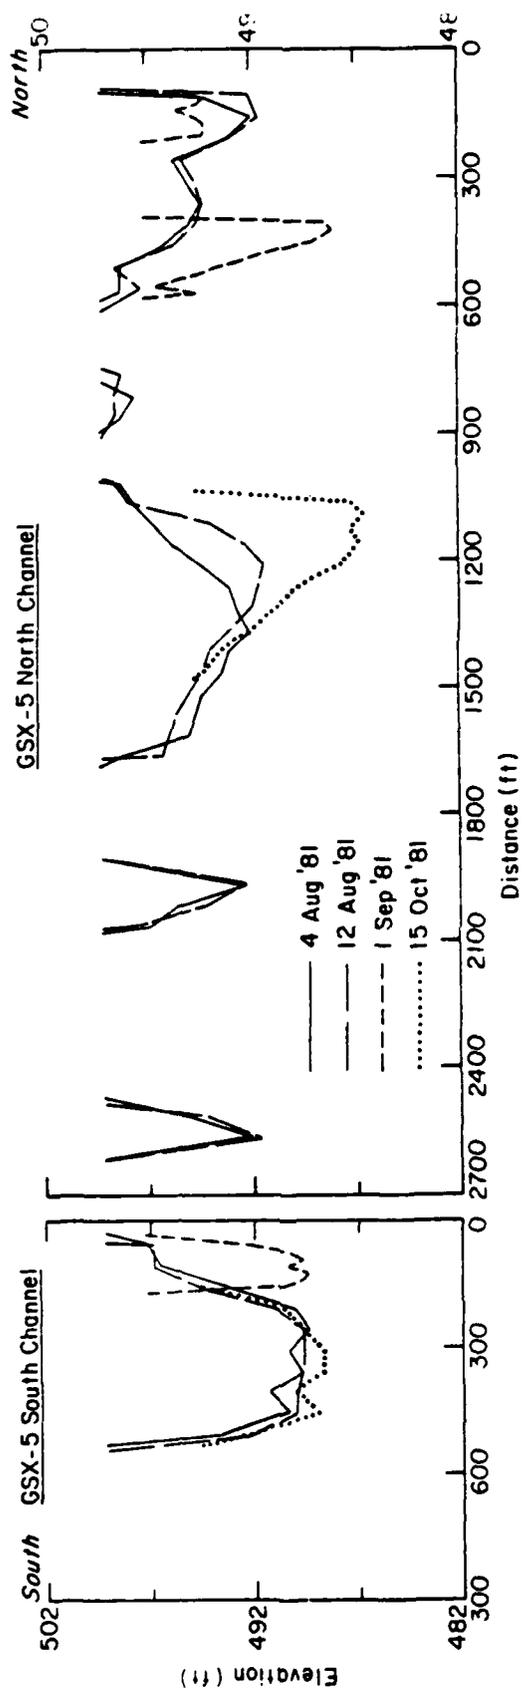
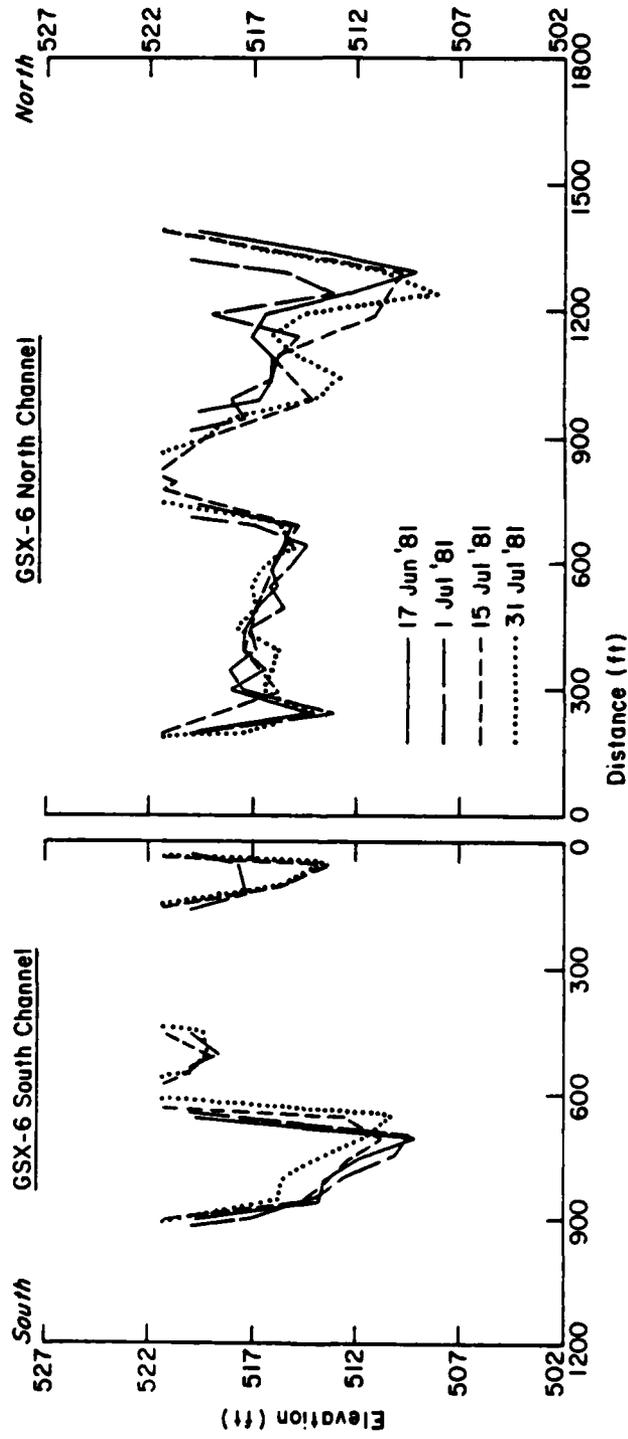
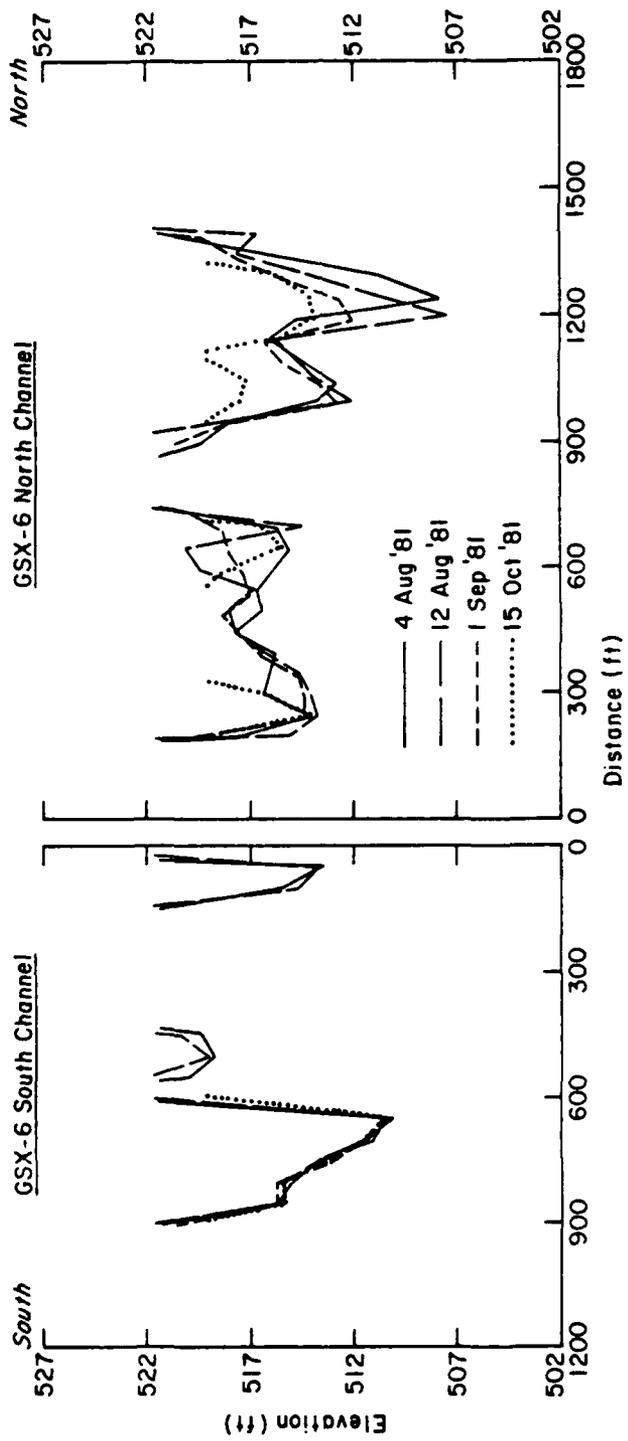
Figure 30. Cross-sections taken in 1981.

The cross-sectional changes that occurred in 1981 are as follows (Fig. 30). The south channel at GSX-5 showed little net change from 16 June 1981 to 15 October 1981. The northern part of the north channel changed considerably during the runoff season. In the middle portion it deepened about six feet and shifted to the north about 300 ft between

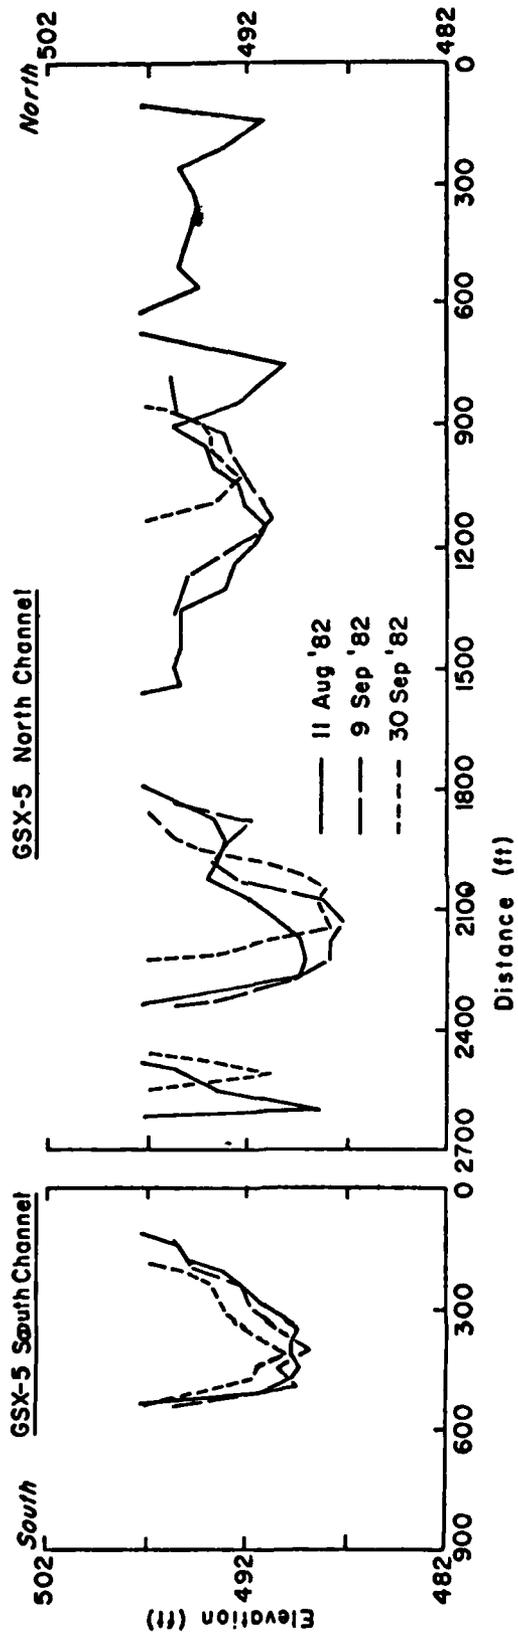
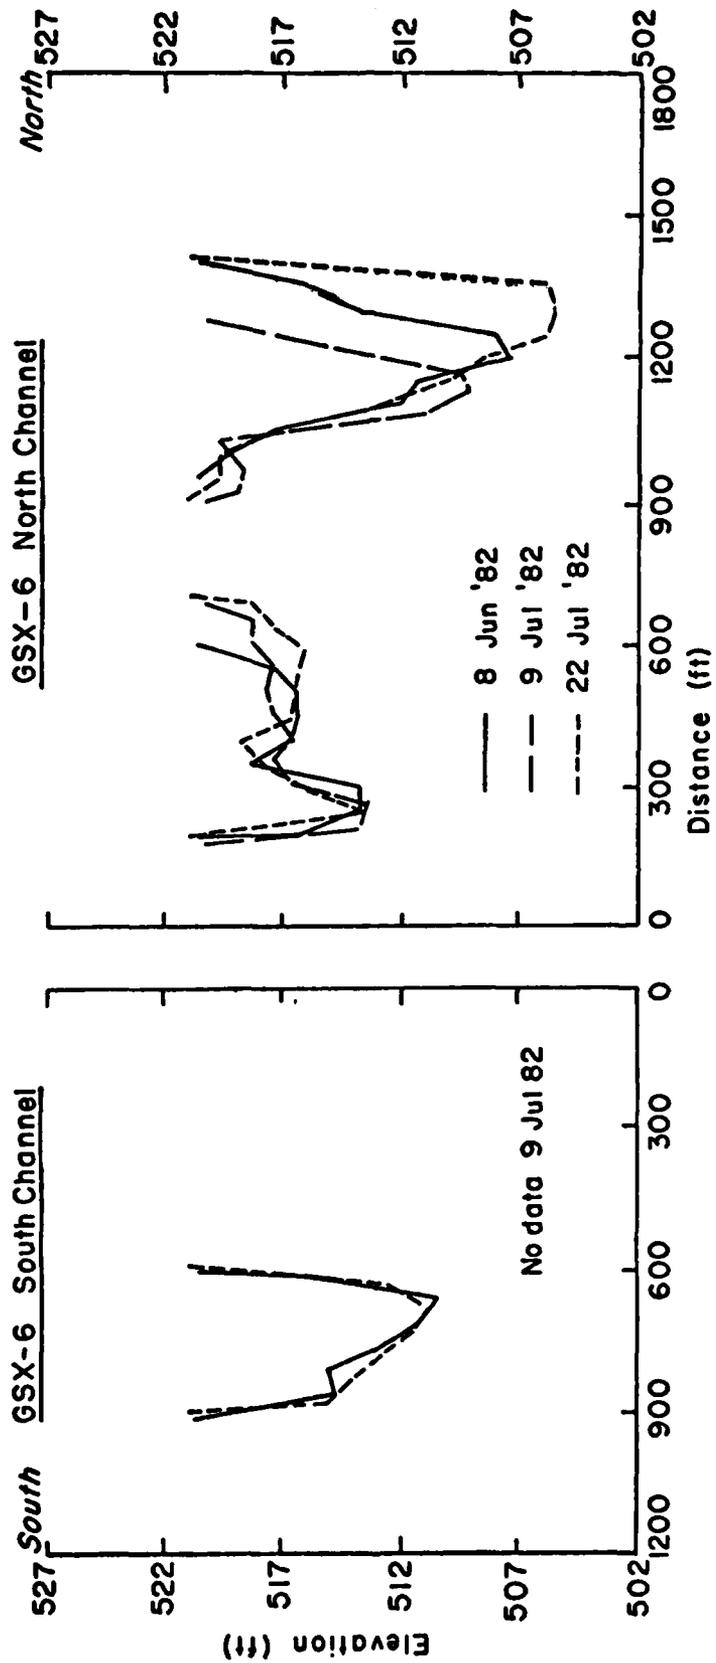
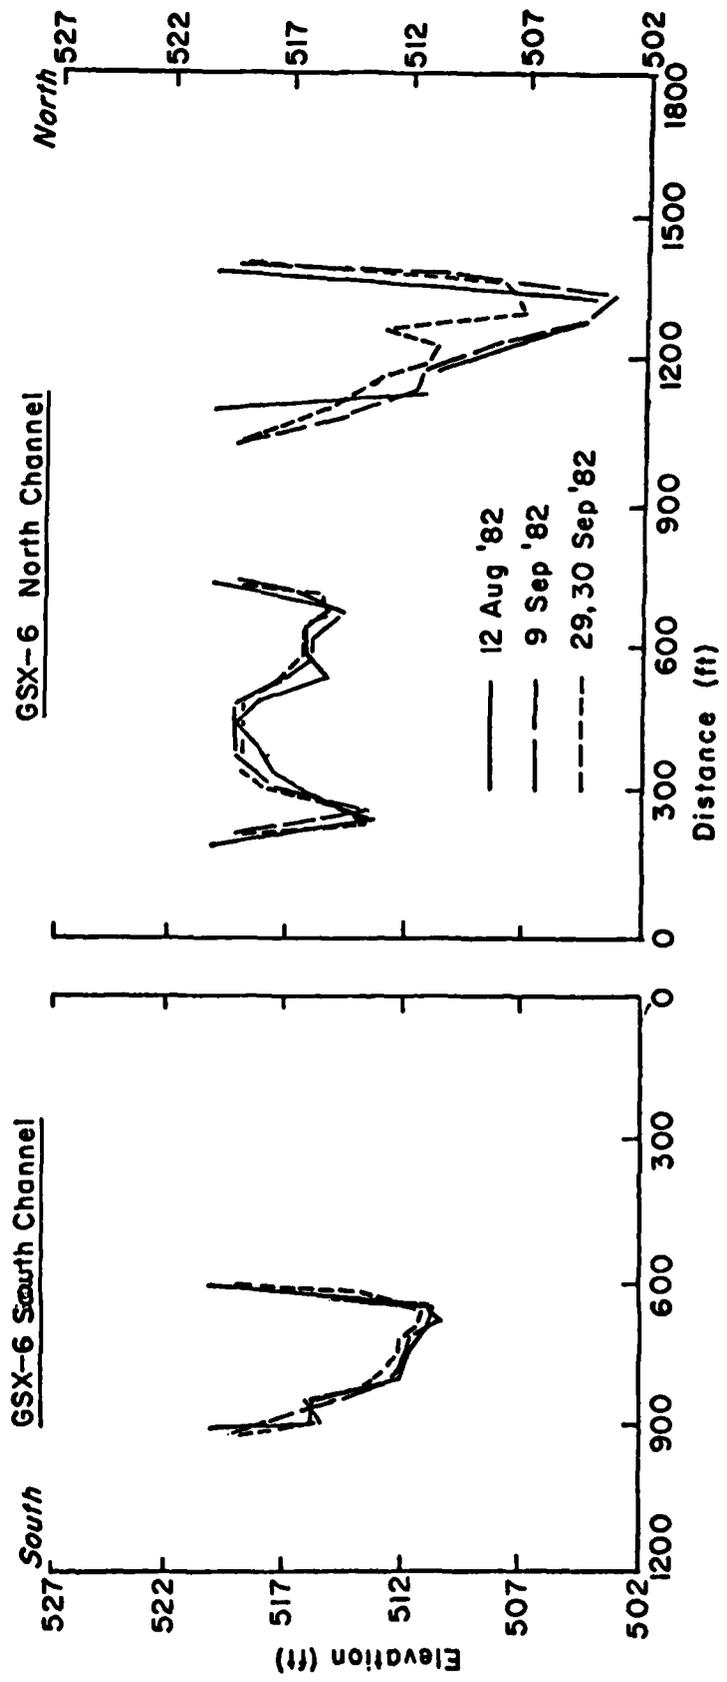
Figure 32. Cross-sections taken in 1982.

The cross-sectional changes that occurred in 1982 are as follows (Fig. 32). The south channel at GSX-5 showed minor changes and deposition occurred during the falling hydrograph. All the north channels showed large changes between surveys and large net changes for the season. Generally, there was a net shift to the north. The GSX-6 south channel showed little change. The north channels changed more during the rising hydrograph and showed a net northerly shift for the season.
