UNDERWATER FACILITIES INSPECTIONS AND ASSESSMENTS AT  
NAVAL STATION NORFOLK (U) STOCK (ARTHUR U) AND  
ASSOCIATES INC DEERFIELD BEACH FL SEP 81

# UNDERWATER FACILITIES INSPECTIONS & ASSESSMENTS

NAVAL STATION

NORFOLK, VA.

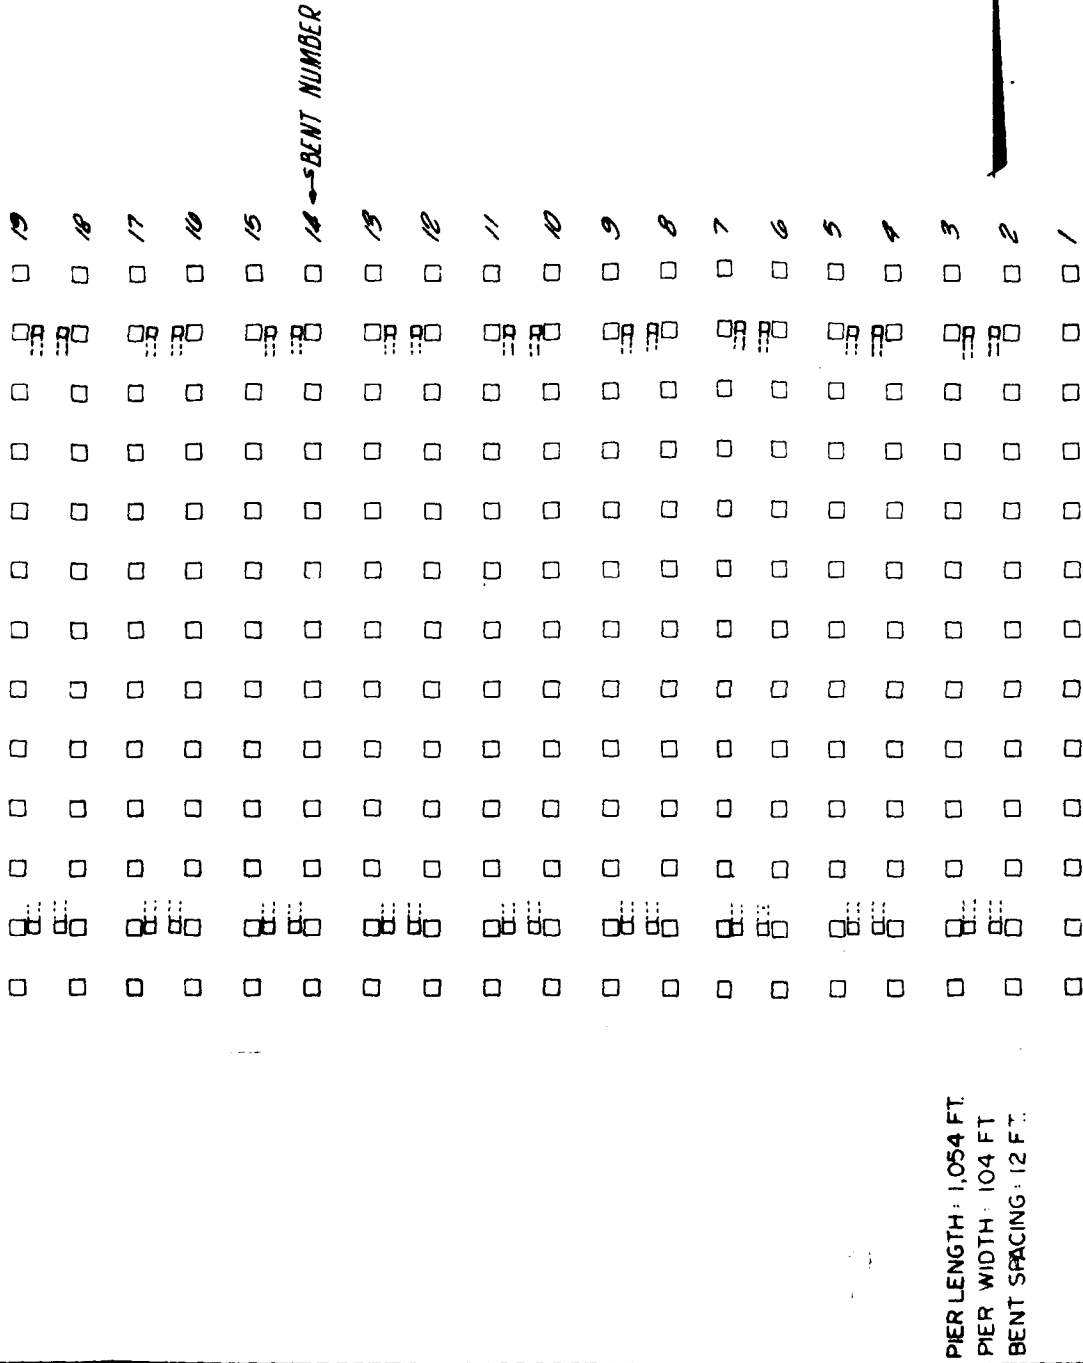
FIGURE  
 12

Of the 1,725 piles inspected, one (1) percent (23 piles) were observed to exhibit damage ranging from hairline cracks to completely failed piles. Only one (1) pile is considered to be in a failed condition offering no bearing to the pier structure. Throughout the length of the pier gunite had been placed on the pile caps. This gunite covered the top of the piles (six (6) to eighteen (18) inches) below the cap. The concrete surface of the piles was generally in good condition. Some pile faces were slightly pitted such that the aggregate is visible. Photographs 1 through 4 show conditions observed at Pier 5. Figures 12, 13, 14 and 15 show the general pier pile plan and observed conditions. A tabulated summary of inspection observations appears in the Appendix (pages A-6, A-18 and A-19).

All piles exhibiting minor damage, such as cracks and light spalling, should be sealed so as to prevent salt water from

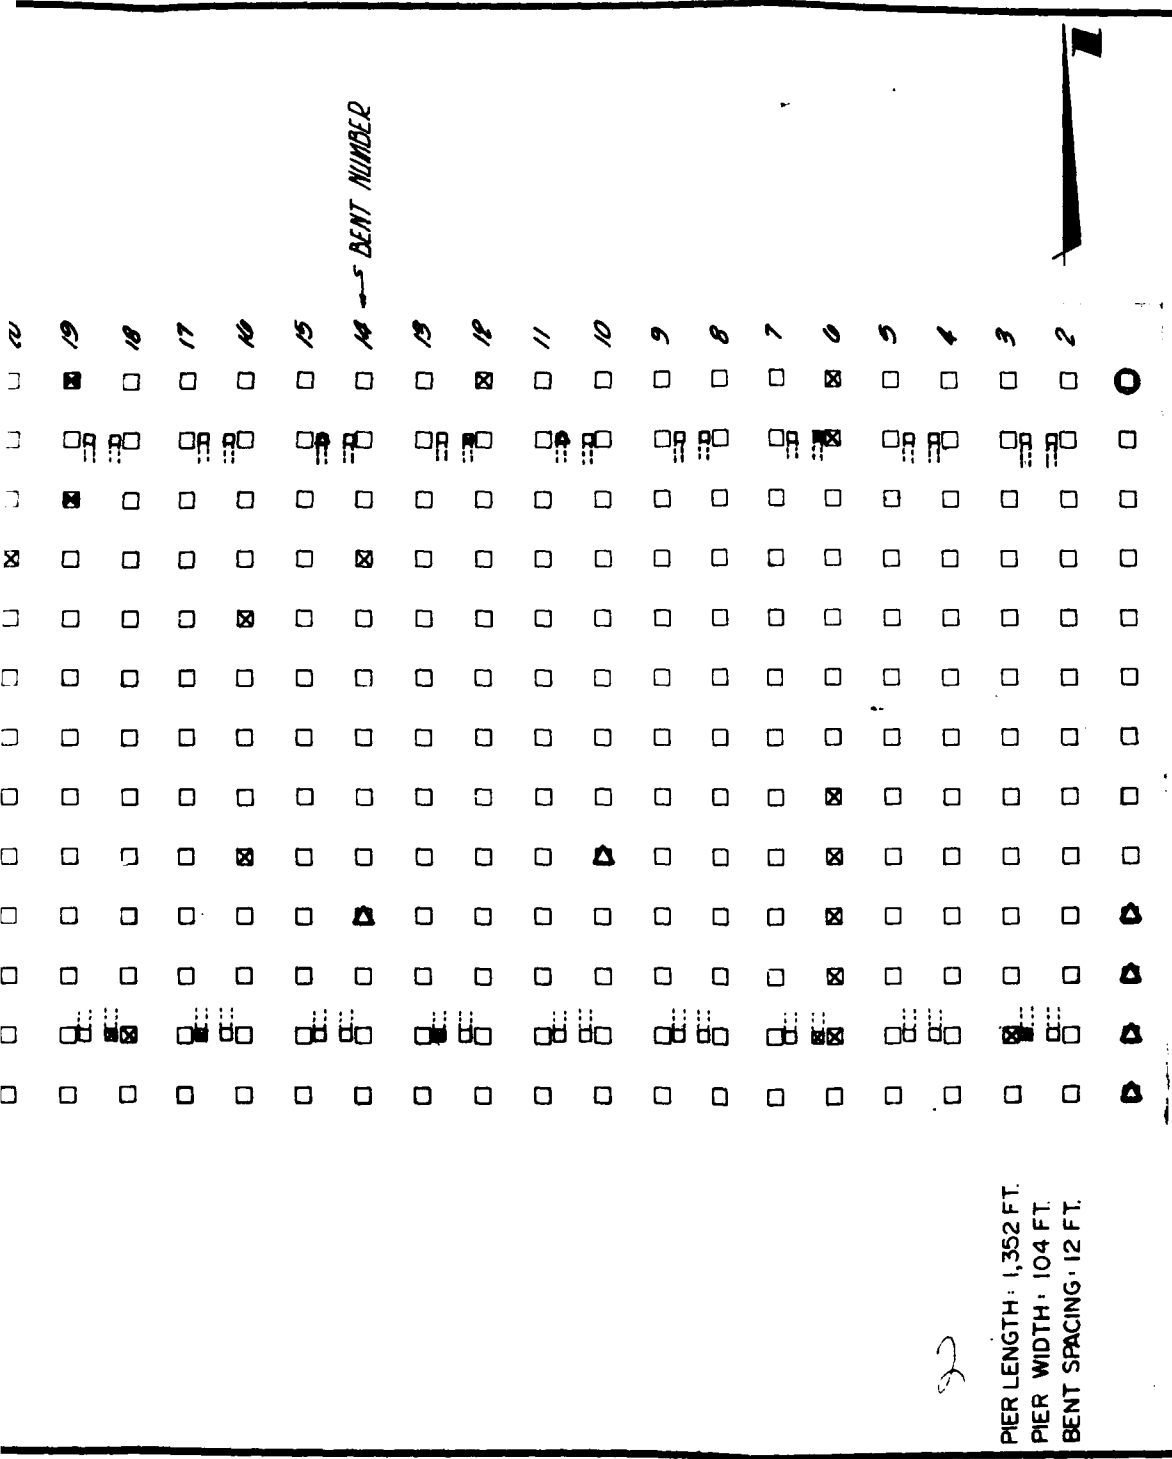
Pier 7 is in overall good condition. A total of six (6) percent of the piles (118 piles) exhibited damage ranging from hairline cracks to completely failed piles. Only two (2) piles were observed to be in a failed condition offering no support to the pier structure. Photographs 1 through 4 of Pier 5 typify conditions observed at Pier 7. A tabulated summary of inspection observations appears in the Appendix (pages A-7 through A-9, A-20 and A-21). Figures 17, 18, 19 and 20 show the general pile plan and inspection observations.

All piles exhibiting minor damage, such as cracks and light spalling, should be sealed so as to prevent salt water from penetrating to the reinforcing steel causing corrosion and accelerated deterioration of the piles. The seal should be made with an epoxy grout which can penetrate and seal the hairline and small failure cracks. Of the piles that have deeply spalled concrete or are failed, the greatest degree of damage is in the area of the pile cap. These piles should be repaired by chipping away concrete exposing the

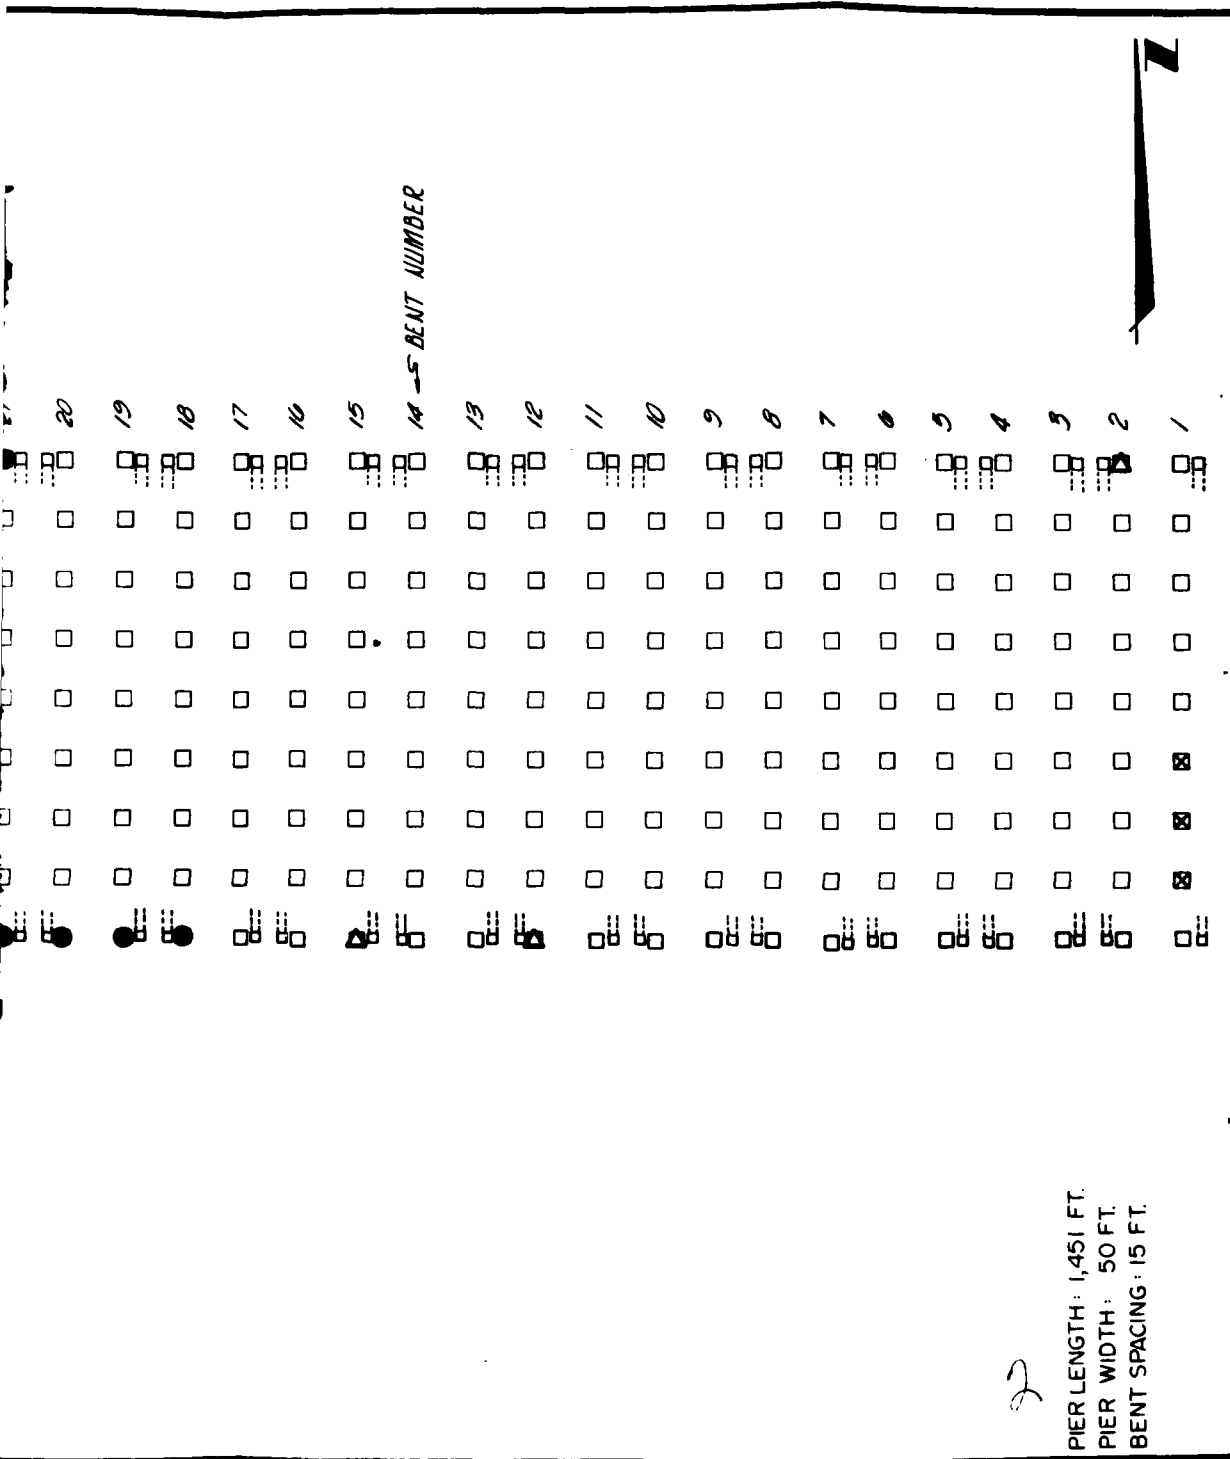
Pier 20 is in overall good condition. This pier was impacted recently by collision of a ship with the pier deck at the outboard end of the pier. The pier shows no signs of critical pile damage that could be associated with this accident. The critically damaged piles appear to have been damaged either by direct impact to the piles or by deterioration due to exposure to the elements.

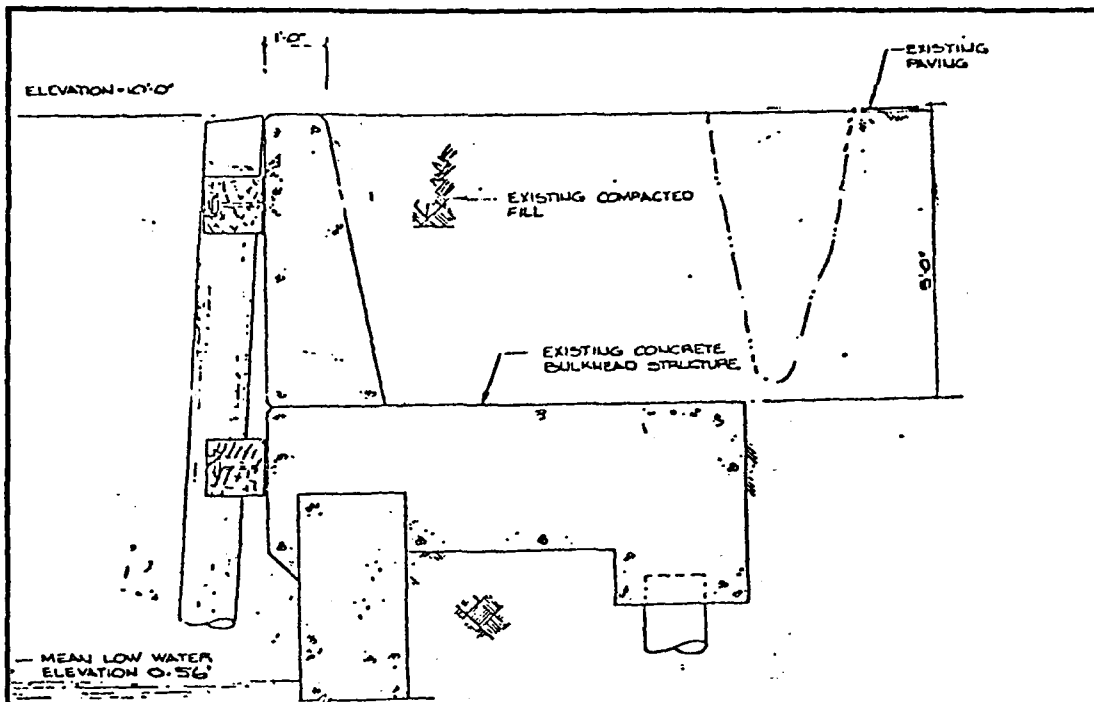
TYPICAL CROSS SECTION THRU QUAYWALL  
CEP-111

The upper portion (cantilever section) of the quaywall has extensive damage in many areas. This appears to be the result of direct impact. Local personnel noted that the wall was recently back-filled where grades subsided following periods of rain.

In general, the bulkhead was found to be in good condition below the water line and fair condition above the water line and along the cap structure. The location of defects in the area of maximum moment indicates that the wall has been overloaded in some regions. The concrete sheet pile joints appear to be leaking.

The damaged sheet pile joints should be sealed and the damaged sections above the water should be repaired. The sheet pile joints should be sealed with a quick setting epoxy grout between stations 5+00 and 10+00. The cantilever section of the bulkhead should be removed and replaced throughout those areas with failed or spalled concrete (350 feet total). The estimated cost for these repairs is \$40,000.

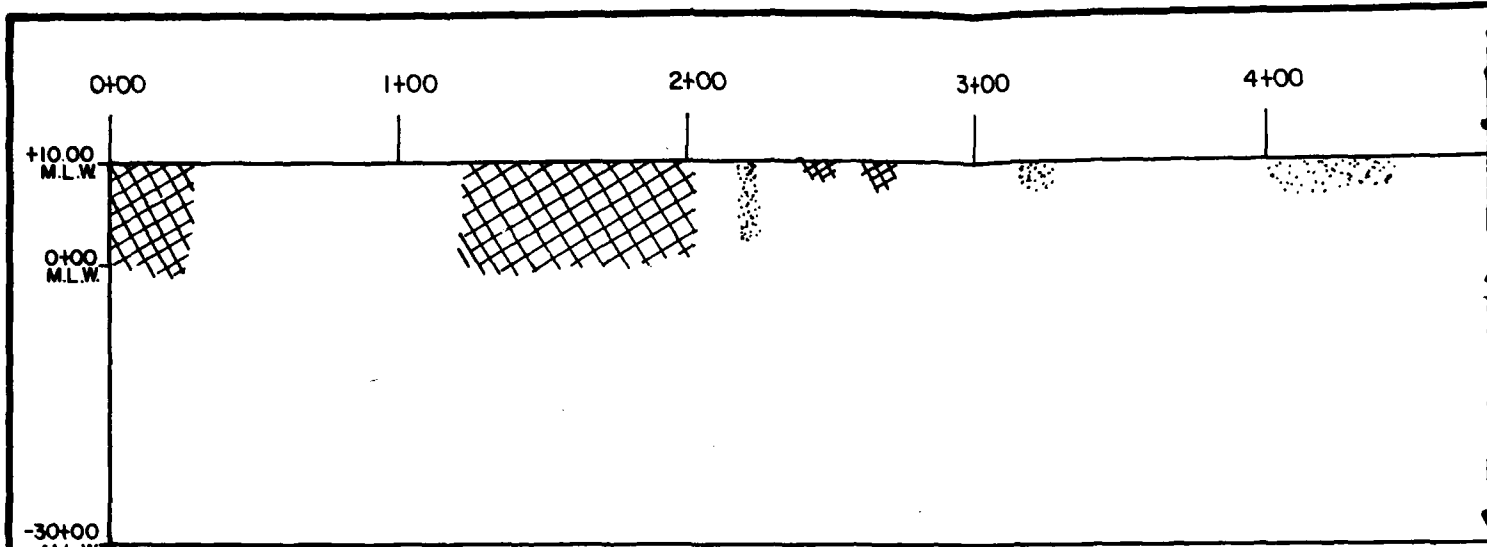
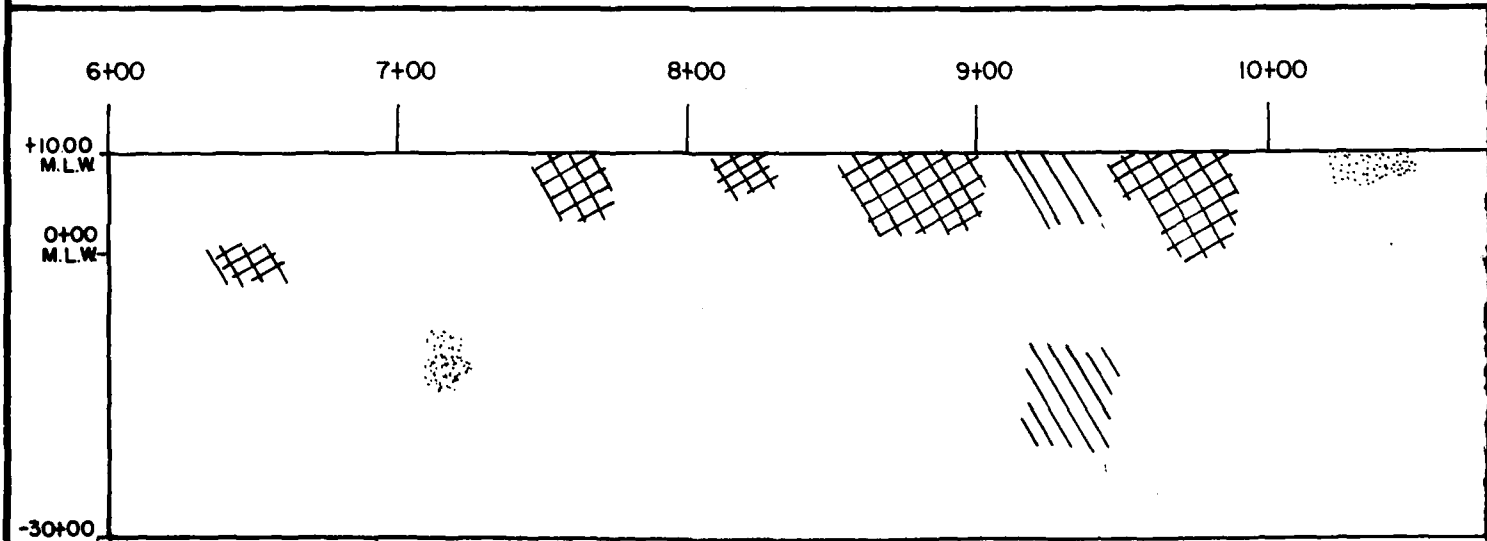
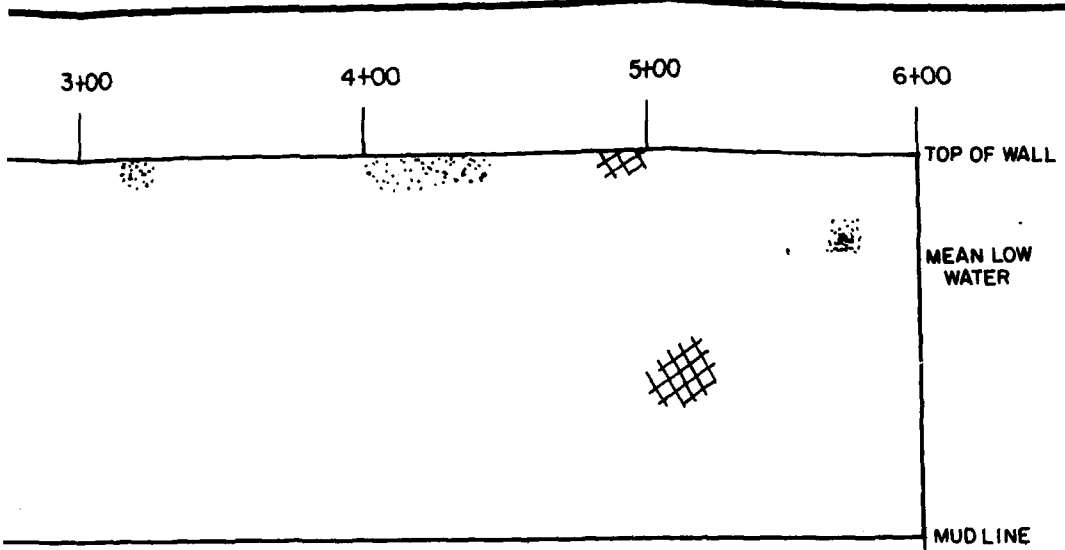
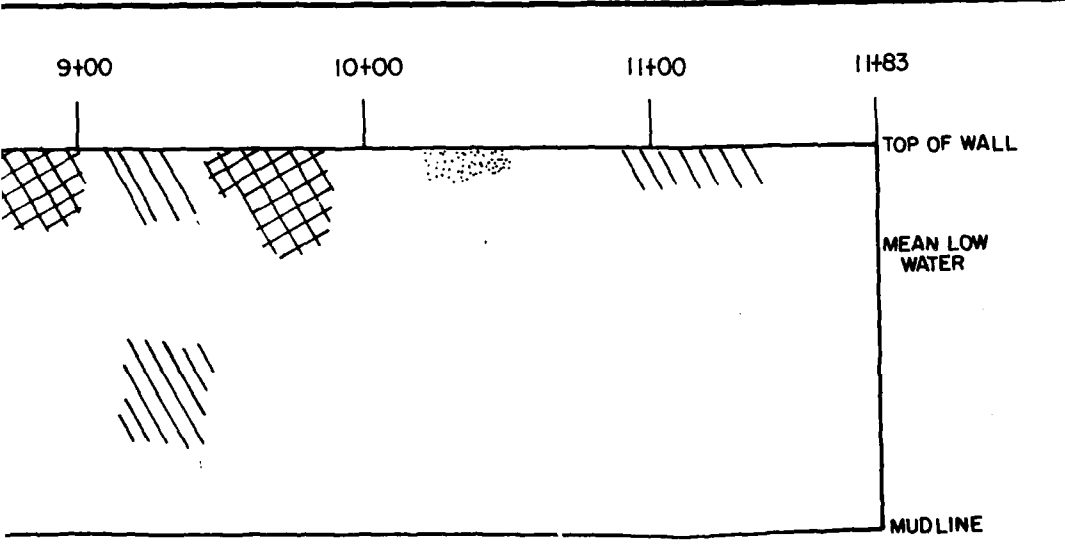
The Level II underwater inspection revealed the only significant defects to occur at stations 5+20 and 9+20 where heavy spalling was observed at 15 to 20 feet below the water line. This spalling occurred along the joints between the concrete sheet piles. At station 7+20, hairline cracks were found mid-depth between the surface and mudline. These defects were found in the area of maximum moment in the sheet piles. Details of inspection observations are shown in Figure 34. The Appendix (pages A26 through A-28) contains a summary of observations. Photographs 17 through 21 document conditions observed.
