NEW RIVER DAM FOUNDATION REPORT GILA RIVER BASIN:
PHOENIX ARIZONA AND VICINITY (INCLUDING NEW RIVER) (U)
ARMY ENGINEER DISTRICT LOS ANGELES CA OCT 85

New River Dam Foundation Report

**NEW RIVER DAM
FOUNDATION REPORT**

**U.S. ARMY CORPS OF ENGINEERS
LOS ANGELES DISTRICT
OCTOBER 1985**

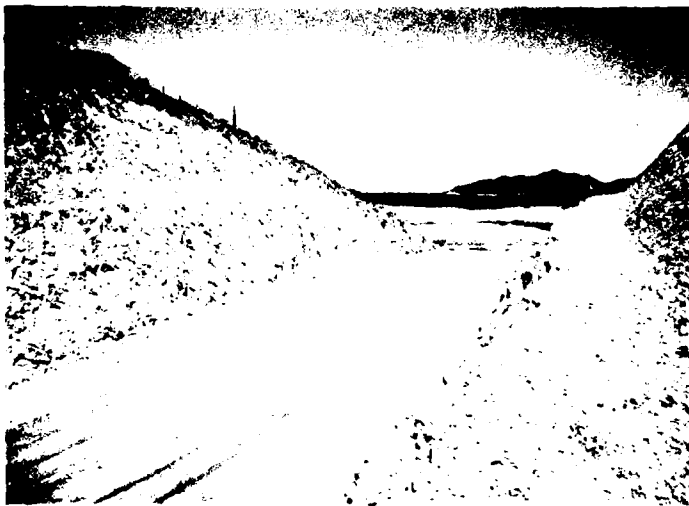
Photo 12. Looking upstream at north wall of completed spillway excavation. Note concrete sill on lower slope. South wall bench at right. 20 March 1985

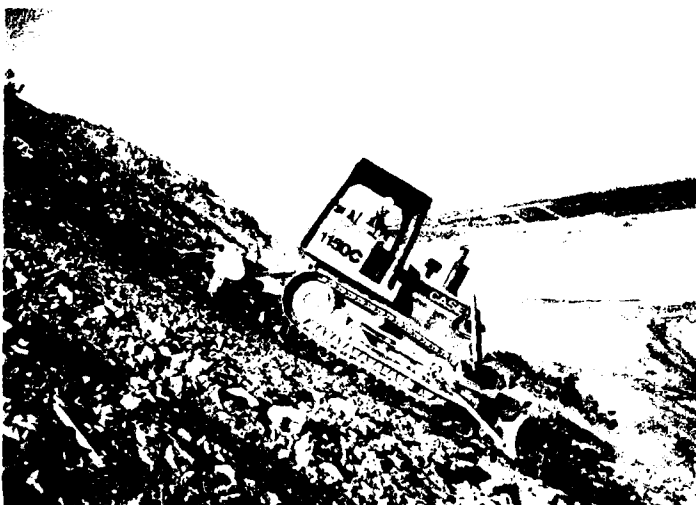
Photo 42. Case 1150C dozer ripping right abutment with
double shank ripper teeth; note double parted winch cable.
6 December 1983

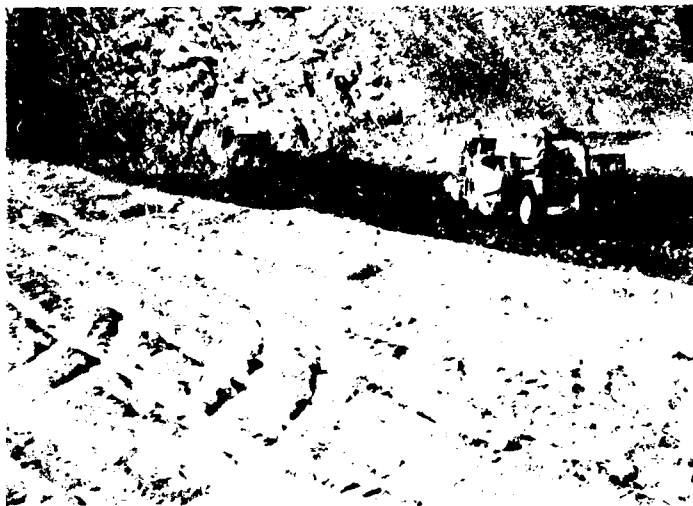
Photo 44. Stage I core trench excavation using push cat and scraper. Note D8 dozer using rippers and blade to excavate base of right abutment. 16 December 1983

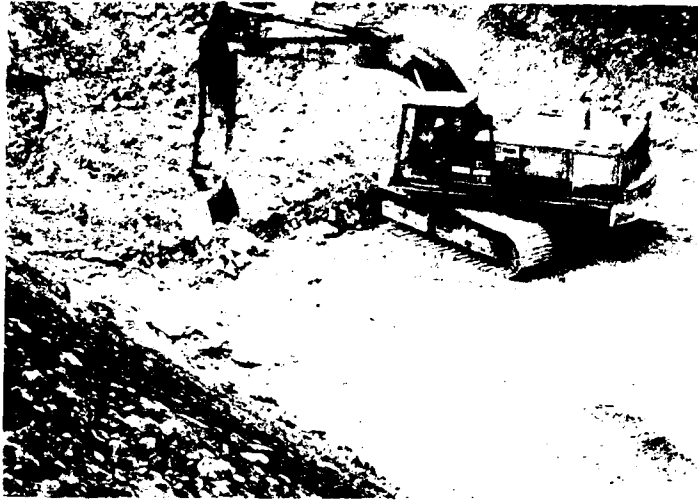
Photo 45. Excavating andesite bedrock in Stage I core trench using Caterpillar 235 excavator, vicinity station 31+10. 22 December 1983

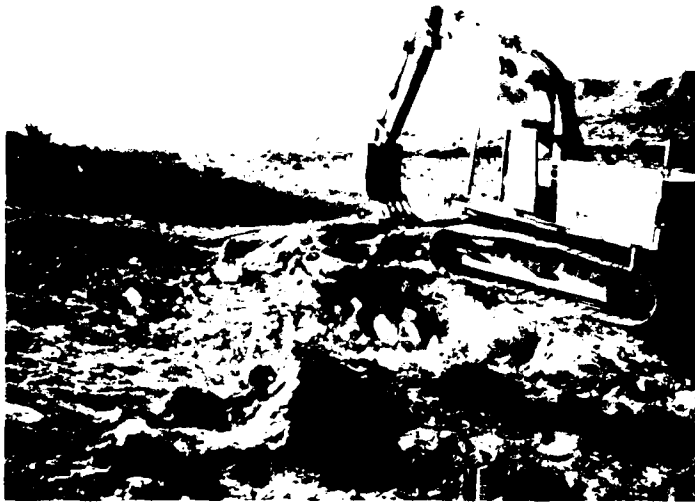
Photo 47. Left abutment excavation using 235 excavator.
January 1984

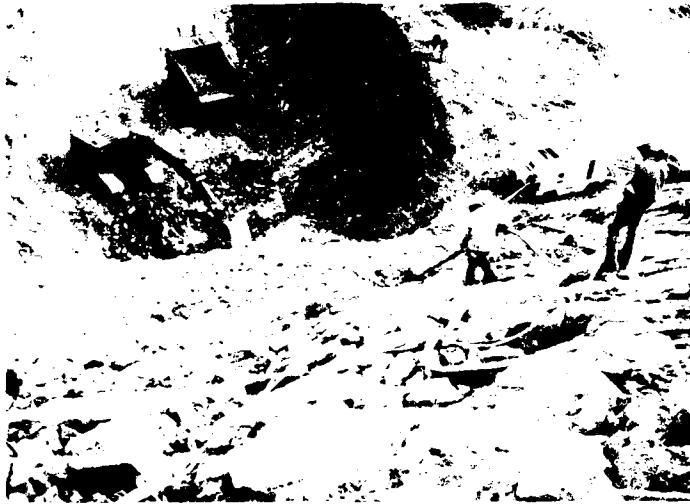
Photo 51. Foundation preparation of right abutment surface using high pressure air blasting. Note excavator working on south side of Stage I core trench. 21 December 1983

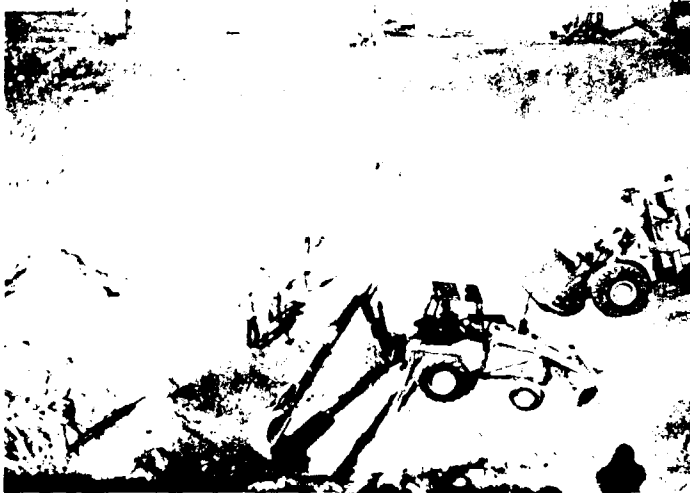
Photo 52. Foundation preparation of Stage I core trench surface using backhoe and hand labor, vicinity station 30+00. Note darker colored rock is agglomerate cap. 6 January 1984

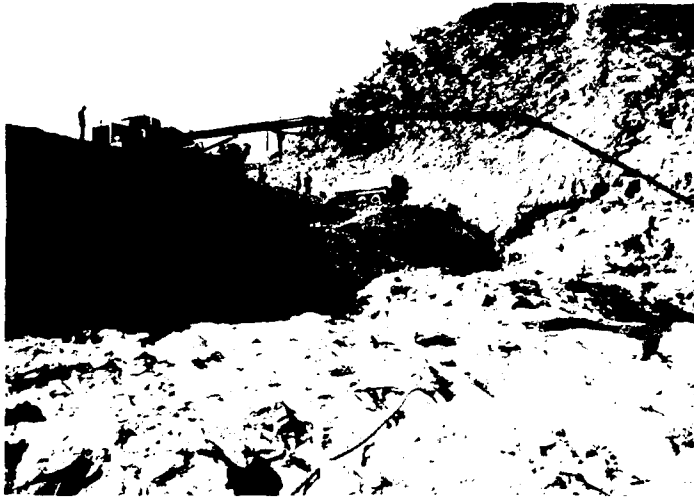
Photo 53. Pump truck with extendable boom and hose used for dental concrete placement in Stage I core trench. 10 February 1984

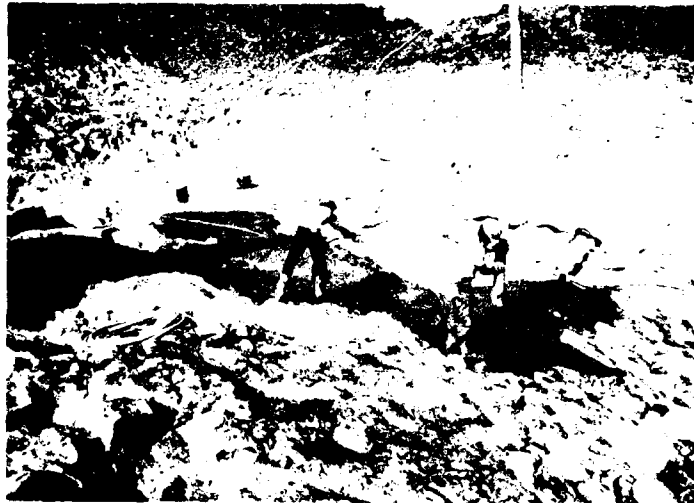
Photo 54. Placing and vibrating dental concrete in Stage I core trench. 10 February 1984

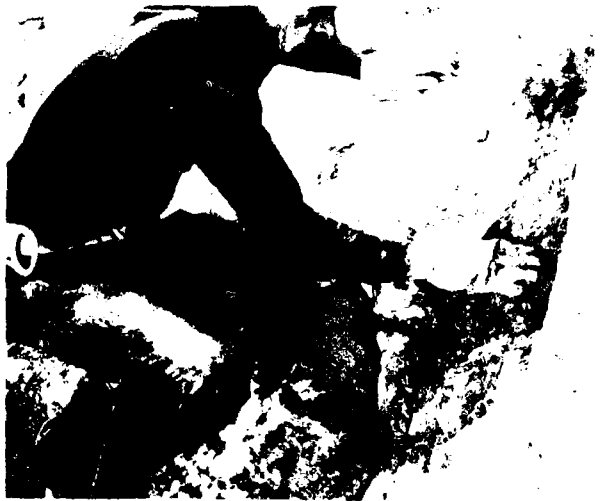
Photo 56. Placing grout slurry mix by hand in prewetted crack between rock blocks, vicinity station 31+80. 10 February 1984

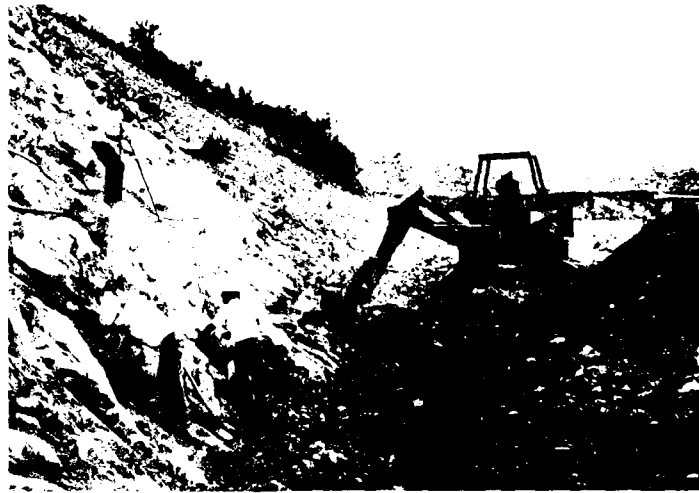
Photo 57. Beginning Stage III right abutment surface preparation. Laborers permitted to work only short reaches without safety lines. Note backhoe removing Stage I protective cover down to elevation 1380 near base of slope. 29 September 1984

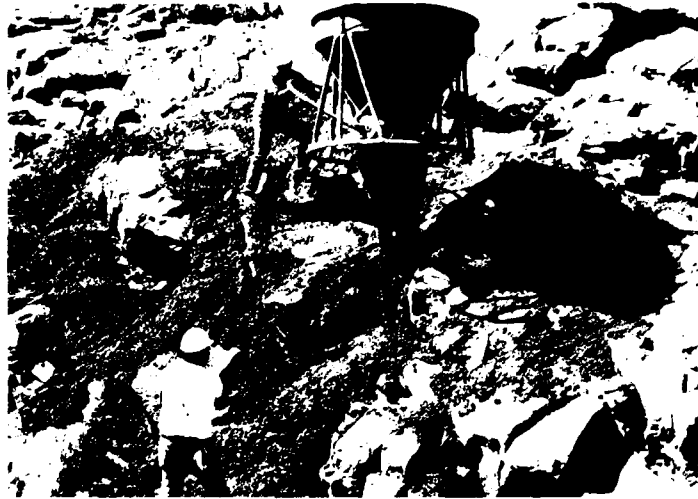
Photo 59. Placing dental concrete on right abutment slope using concrete bucket. 2 October 1984

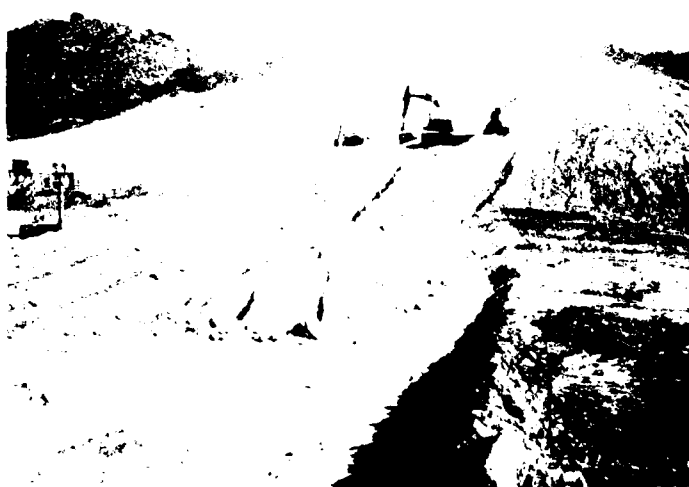
Photo 62. Small Case backhoe assisting excavator during left abutment excavation. Note rock dust generated from air blasting of excavated abutment surface. 10 January 1984

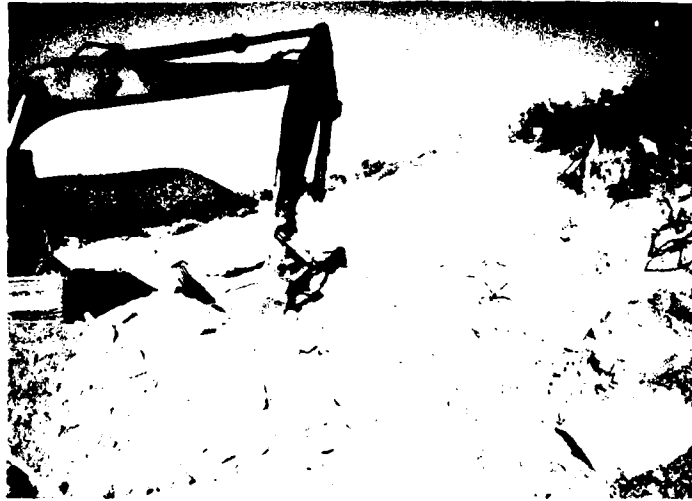
Photo 63. Initial foundation preparation of left abutment surface using low pressure air blasting. Note 235 excavator on left. 6 January 1984

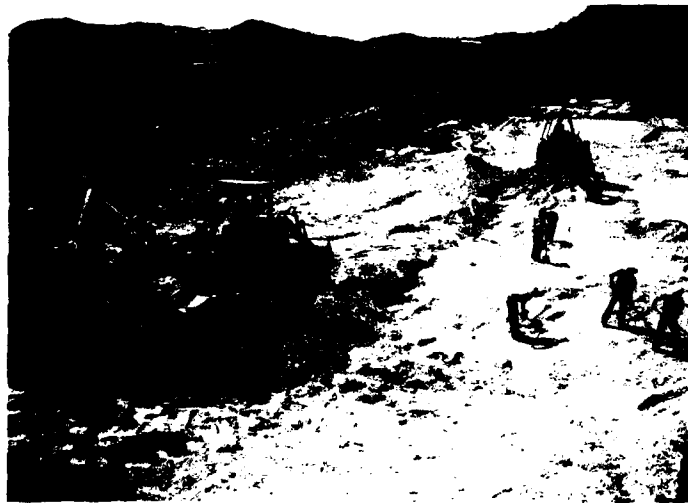
Photo 64. Foundation preparation in Stage II core trench using backhoes and shovels; vicinity station 17+00. 12 March 1984

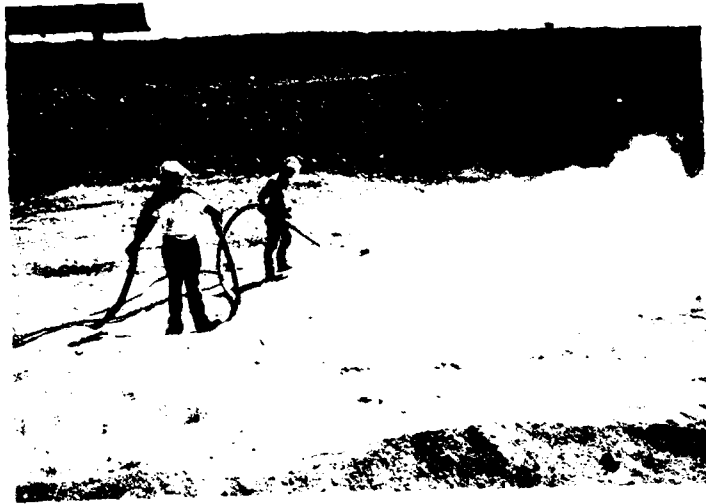
Photo 65. Air cleaning core trench surface at station 20+80 using high pressure bull hose. 16 March 1984

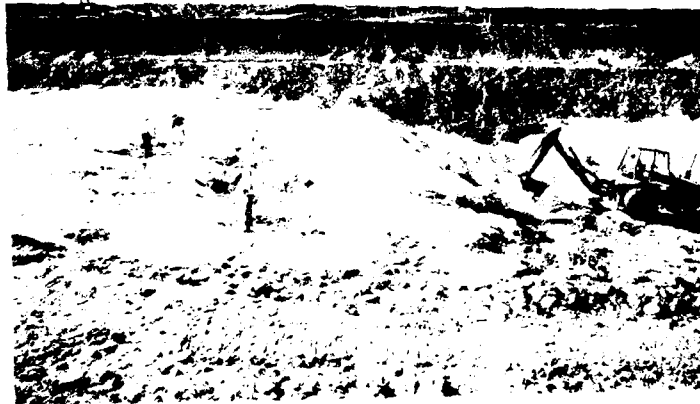
Photo 66. Stage II core trench foundation preparation. Laborers removing alluvial materials loosened by backhoe from bedrock scour channels. 26 March 1984

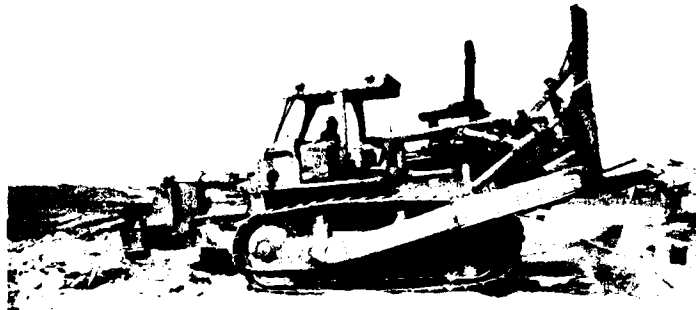
Photo 67. D9H dozer with double shank ripping calichified granite cap at the upstream edge of the core trench, vicinity station 16+30. 12 March 1984

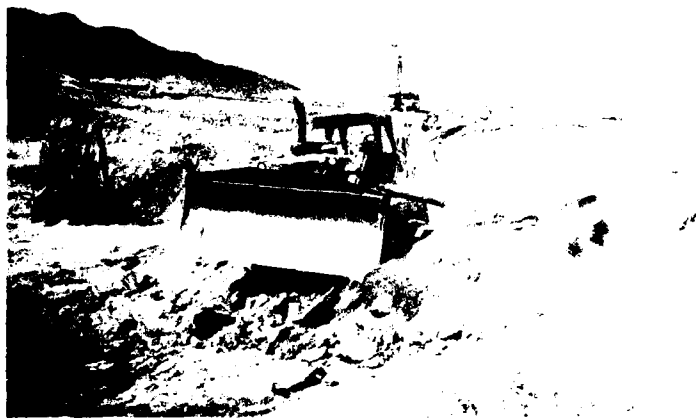
Photo 68. D9H dozer using slopeboard to flatten bedrock slope near station 16+50 to 1:1 and remove soft weathered bedrock from foundation surface. 12 March 1984

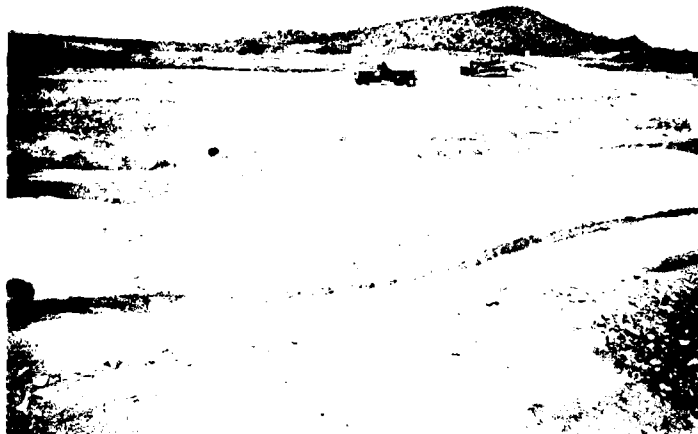
Photo 71. Stage II core trench scour channels between stations 19+10 and 18+10 backfilled with dental concrete. 31 March 1984

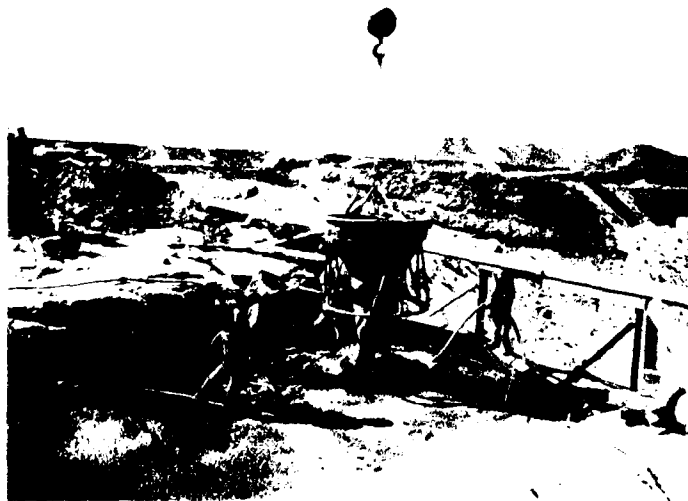
Photo 72. Backfilling preconstruction test trench between stations 16+00 and 16+50, downstream side of core trench, with dental concrete. Note sloping bulkhead constructed across open end of trench to contain concrete. 30 March 1984

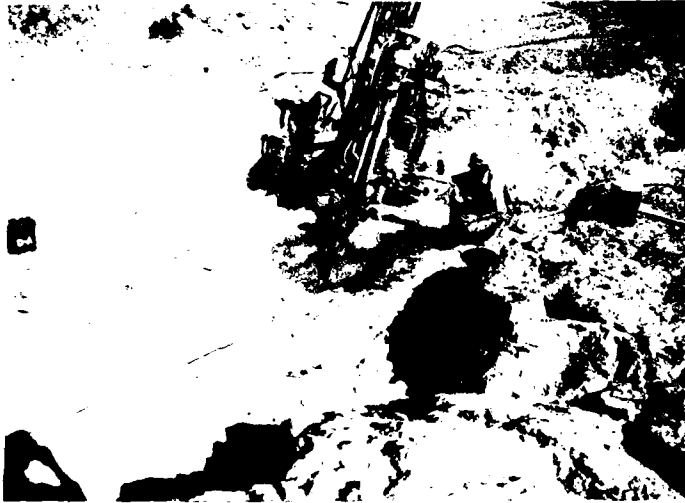
Photo 73. Drilling first zone of primary grout hole 30+00P using air track percussion drill. Air-water mixture used as circulating medium. 10 January 1984

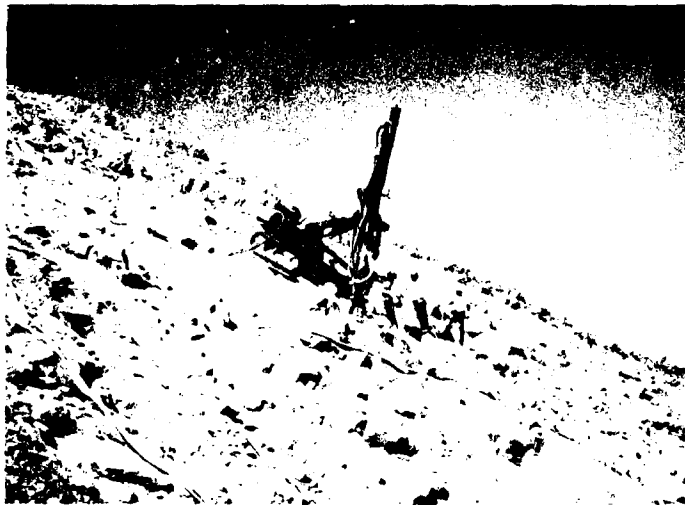
Photo 74. Air track drilling first zone of secondary grout hole 32+34S on right abutment slope. Drill pulled up slope using winch cable system. 6 March 1984

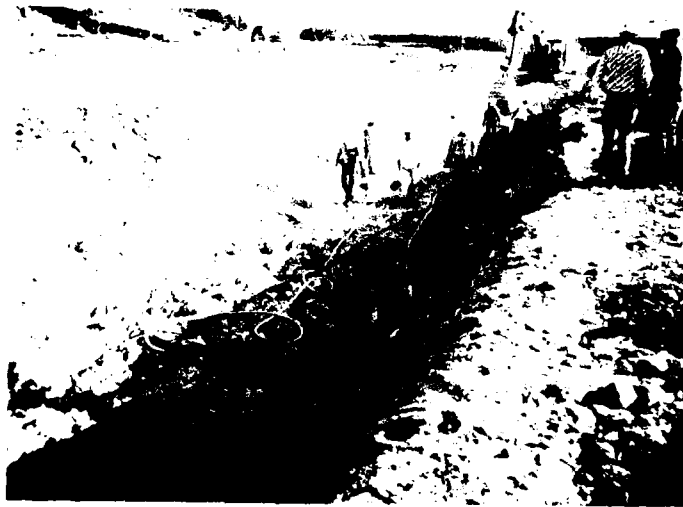
Photo 78. 235 excavator scraping off loosened rock from surface of outlet conduit trench. Note relatively level surface (where laborers are walking). 16 January 1984

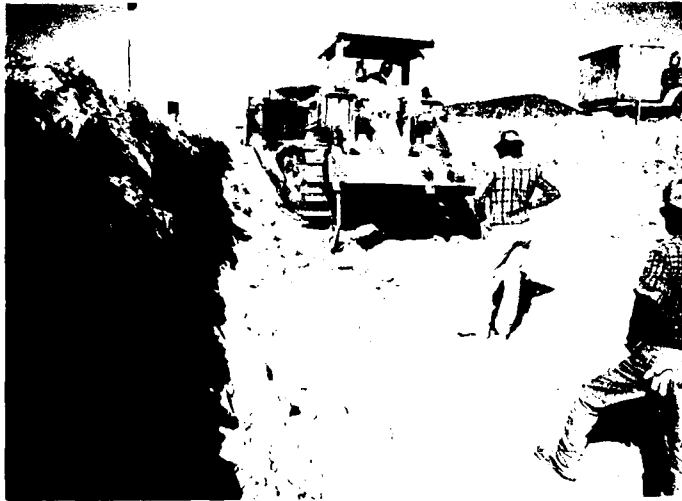
Photo 79. D9 dozer ripping high spot at station 19+70 in outlet conduit trench excavation. 17 January 1984

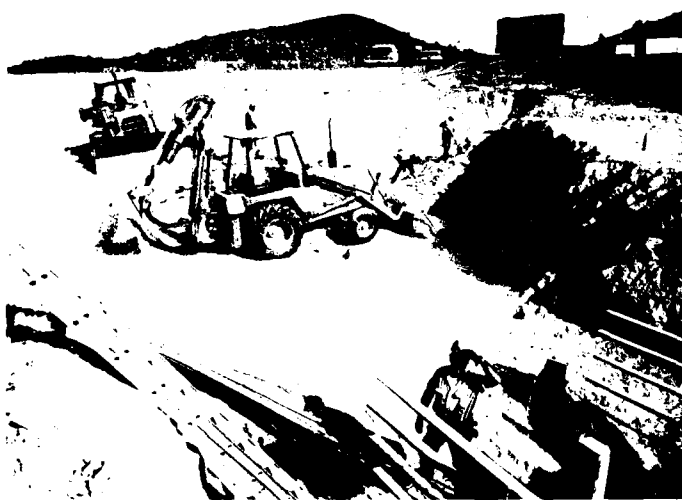
Photo 80. Intake structure foundation preparation. Note laborer jackhammering high spots on left (east) side wing wall steps down to grade. 1 February 1984

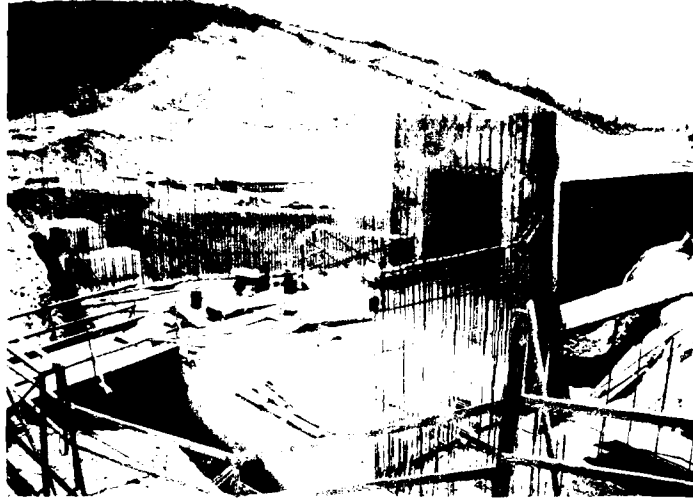
Photo 81. Partially completed outlet works intake structure.
Note overexcavated area upstream of invert concrete slab.
26 March 1984

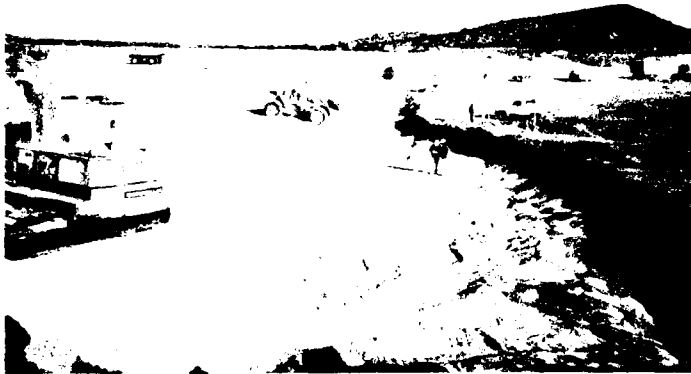
4.115 Since the D9H dozer was having difficulty ripping the hard granite bedrock in the outlet conduit trench, the Contractor decided it would be more cost-effective to blast the similarly hard granite exposed by the excavator in the energy dissipator area (photo 83). The Contractor elected to proceed directly with production blasting without first demonstrating the blasting technique to be utilized as required by the contract specifications. The Government approved their proposal with the understanding that any overexcavation resulting from blasting would be solely the Contractor's responsibility and would be replaced with concrete at no additional cost to the Government. A "step-drilling" plan, similar to the one used effectively in the spillway, was employed to blast the bedrock. Three production blasts (nos. 5, 6 and 7) were required between station 16+36 in the energy dissipator and station 13+64 in the outlet channel. According to the blasting summary in table 6, a total of 5185 cubic yards of rock (approximately 12 percent of the total outlet works excavation) were blasted using 3387 pounds of ANFO explosive. This resulted in an average powder factor of 0.65 pounds of explosive per cubic yard of rock.

Photo 83. View of outlet works excavation looking upstream. Hard granitic bedrock exposed by excavator within energy dissipator in foreground. 18 January 1984

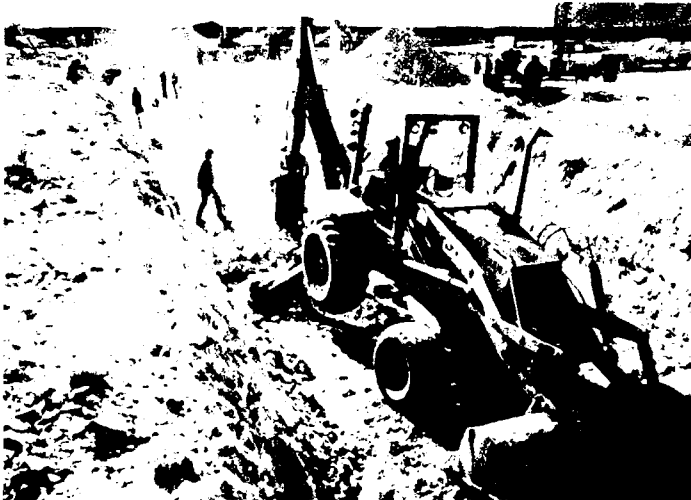
Photo 84. Foundation preparation of outlet conduit excavation using backhoe and hand labor. 18 January 1984

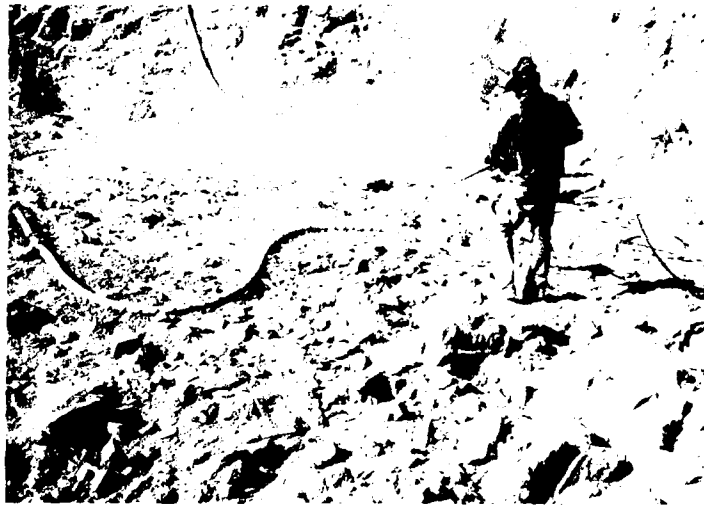
Photo 85. Air cleaning energy dissipator foundation with very low pressure air hose to avoid degradation of granite bedrock surface. Note hard granite blocks in decomposed granite matrix. 15 February 1984

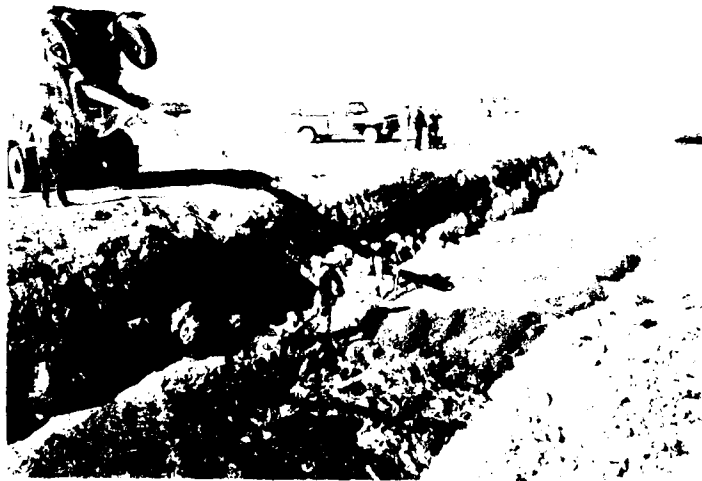
Photo 86. Placing leveling slab of dental concrete in outlet conduit excavation. Wooden screed bar used for leveling surface of slab. 24 January 1984

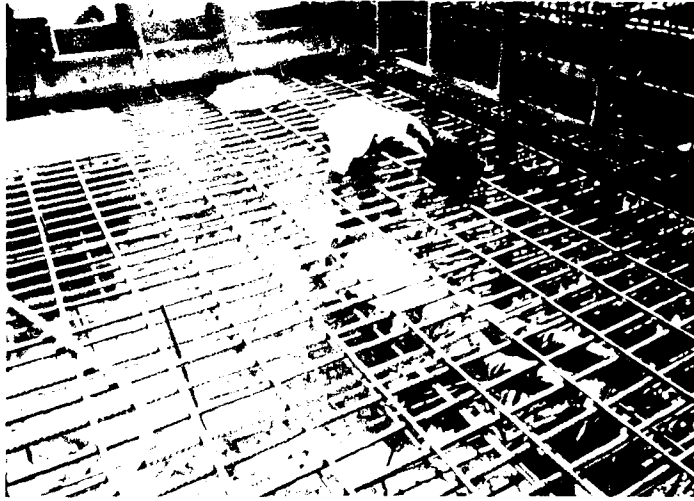
Photo 89. Hand picking loose rock from foundation surface underneath energy dissipator rebar lattice. 20 March 1984

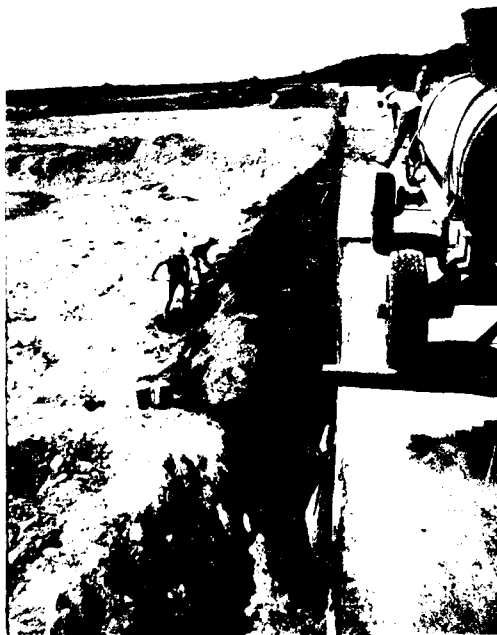
Photo 92. Concrete plug on west side of outlet conduit. Note upper portion of plug is slightly steeper than 1:1 to eliminate "feather" edges against the top of the conduit. 25 April 1984

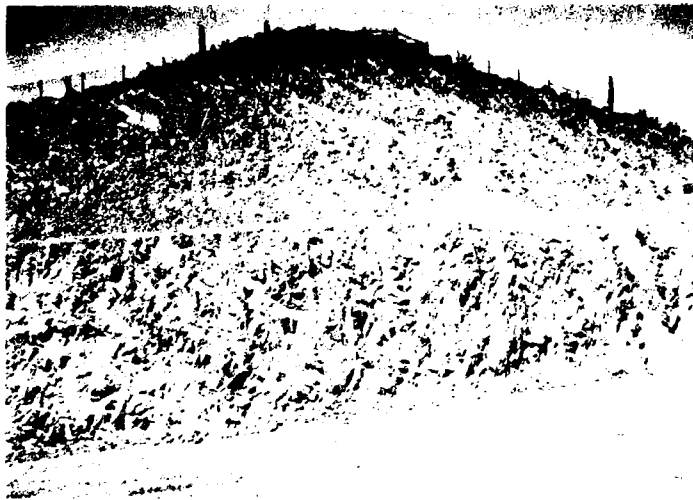
Photo 95. Typical example of strongly jointed andesite flow exposed in north wall of spillway excavation, vicinity station 17+00. Note variable joint patterns and darker colored "zone of weathering" near surface of flow.
20 March 1985

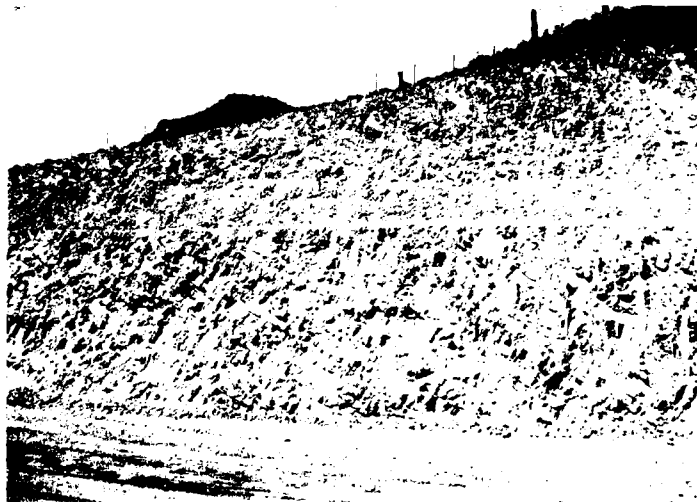
Photo 96. Strong subparallel to wedge shaped joint pattern (striking $N75^{\circ}E$, dipping $45^{\circ}NW$) exposed in north wall of spillway excavation below bench, vicinity station 15+50.
20 March 1985

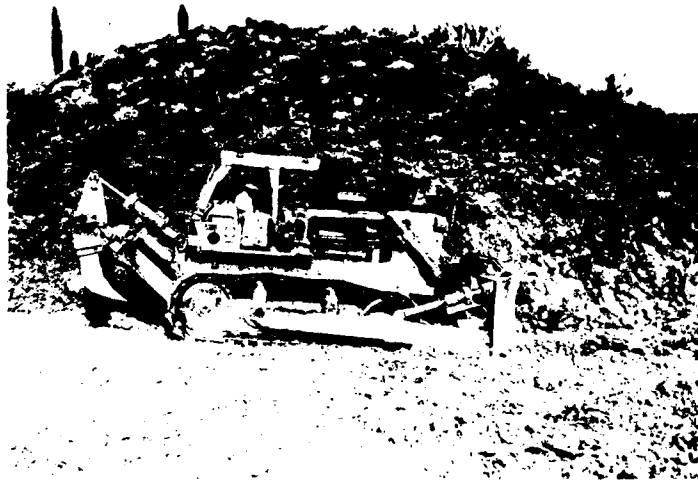
Photo 97. Mechanical excavation in spillway using D9H dozer with double shank. Note slopeboard used for slope trimming. 27 October 1983

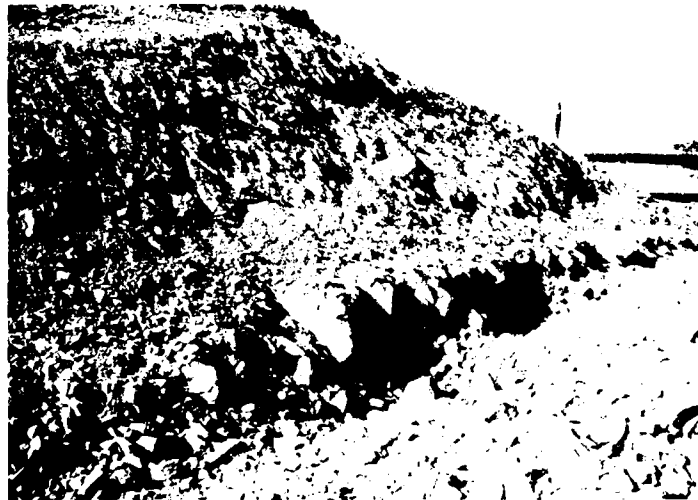
Photo 98. North side of spillway excavation after production shot No. 9 down to bench excavation. Note 1 to 2-foot buffer of rock left by step-drilling blasting technique which was subsequently removed to grade using dozer slopeboard. 9 March 1984

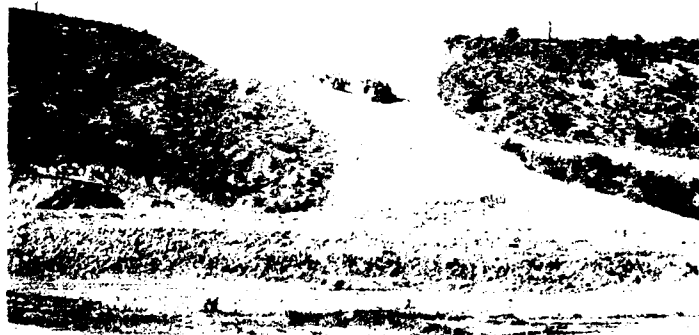
Photo 100. Scraper hauling shot rock from spillway for Stage II diversion levee slope protection. Dozer with slopeboard used for slope trimming. 22 March 1984

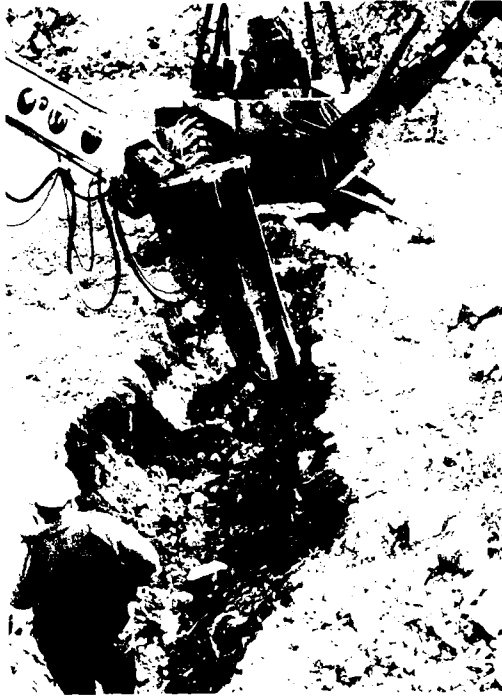
4.158 Work on the sill section did not begin until late November 1984, as the Contractor concentrated on completing the dam embankment closure section. The Contractor did not drill and shoot the sill excavation as shown on plate 59 of the contract drawings. Instead he used a Gradall equipped with a hydraulic ram attachment to break up the rock, and a Case backhoe to excavate the broken rock (photo 103). A grade checker constantly monitored the progress of the excavation to insure that the sill was excavated as closely as possible to the specified lines and grades. Given the diverse geologic conditions, this method of excavation proved fairly successful in limiting severe overbreak in the andesite rock mass (photo 104). Deviations from neat line were unavoidable due to the irregularly spaced, blocky joint structures and, particularly on the side slopes, adversely oriented joint structures. The end result was an overall wider and somewhat deeper excavation which required approximately 2-1/2 times the amount of concrete estimated (photo 105).

Photo 103. Excavating spillway sill at station 17+50 using a Gradall with hydraulic ram attachment to break up the rock, and a Case backhoe to excavate the broken rock.
28 November 1984

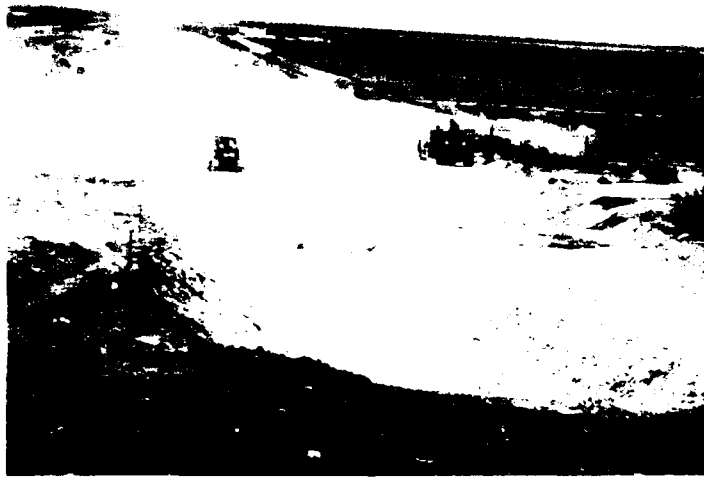
4.170 After stripping was completed, an exploration trench was excavated beneath the core zone (photo 110) to an average depth of 5 feet or sound bedrock as shown on plates 53 through 55. Only about 8 percent of the excavation was in bedrock with the remainder being in caliche (photo 111). The exploration trench was ripped with D9 dozers and then excavated with push dozers and scrapers. Removal of approximately 2 to 9 feet of andesite rock was required to reach a suitable foundation surface. An overall greater depth of excavation was required in the weathered portion of the andesite flow near the downstream end. The caliche or hardpan layer was so well indurated in some reaches that the dozer was unable to reach the designated depth and as a result hard humps were left in the bottom of the trench.

Photo 110. View of dike No. 1 exploration trench excavation
looking north from south abutment. January 1984

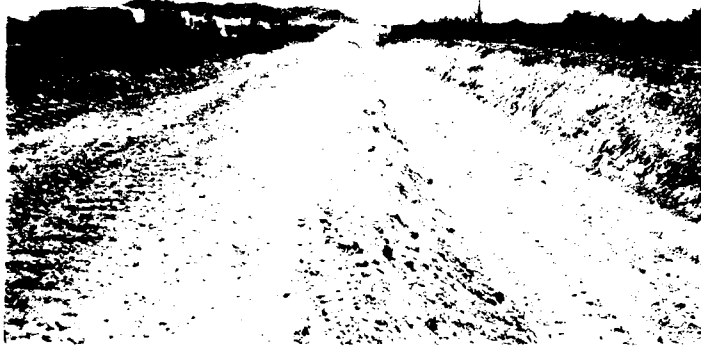
Photo 111. View of dike No. 1 completed exploration trench excavation looking south from station 13+00. Note widespread caliche. 25 February 1984

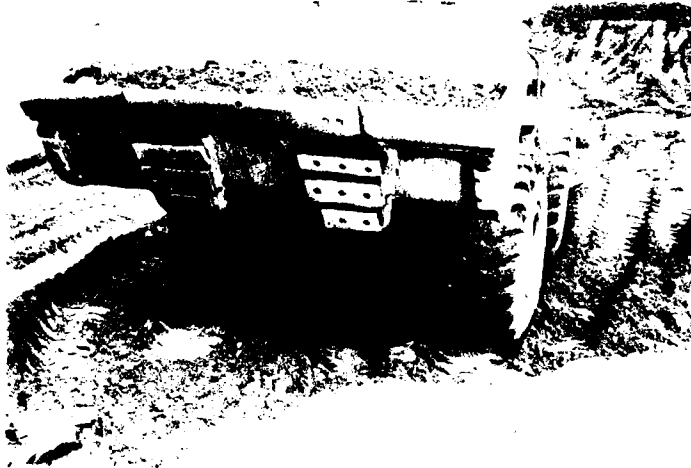
5.02 Special procedures were used in placing and compacting core materials at the rock contacts within the core zones of the dam and dike no. 1 embankments in order to insure a suitable embankment/foundation bond. The initial lifts of wet-of-optimum core material were placed in 6 to 12-inch thicknesses on the cleaned and wetted bedrock surface with a rubber tired front end loader. Placement of wetter core materials was done not only to insure its bonding to the rock but to maximize the filling of voids and cracks in the rock with core materials. Compaction was accomplished by 8-wheel passes of the front end loader with a loaded bucket (photos 113 and 114). Wheel rolling was used to prevent damage to the treated bedrock surface by the tamping roller (photo 115). The compacted surface was scarified by back dragging the bucket teeth prior to placing the next lift. Compaction with a tamping roller was initiated when a sufficient thickness of material covered the bedrock surface. Core materials were placed and compacted on a 4H to 1V slope against each abutment (photo 116). Establishment of these ramps allowed the tamping roller to eventually compact closer to the abutment since the rock surface was protected from the tamping roller by a layer of core material. The same placement and compaction procedures were used against the 1V on 1H slopes of the concrete plug within the dam embankment core zone.

Photo 113. Front end loader with full bucket compacting initial lift of core material against treated bedrock surface in Stage I core trench, vicinity station 30+70. 13 February 1984

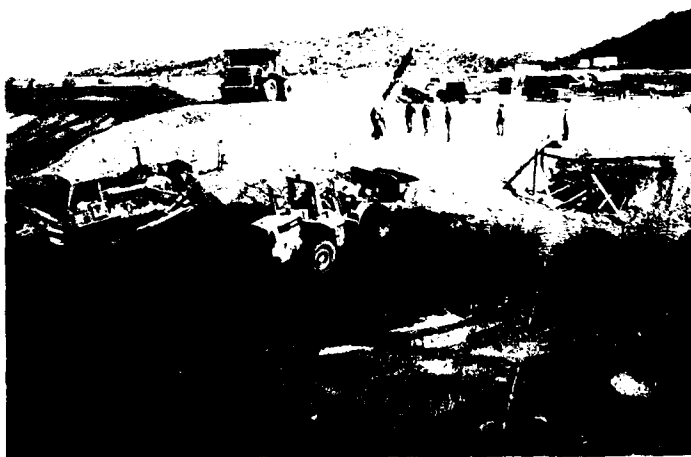
Photo 114. Front end loader compacting core material against bedrock slope in Stage II core trench, vicinity station 16+50. Note dozer using blade to spread core material over foundation surface. 2 April 1984

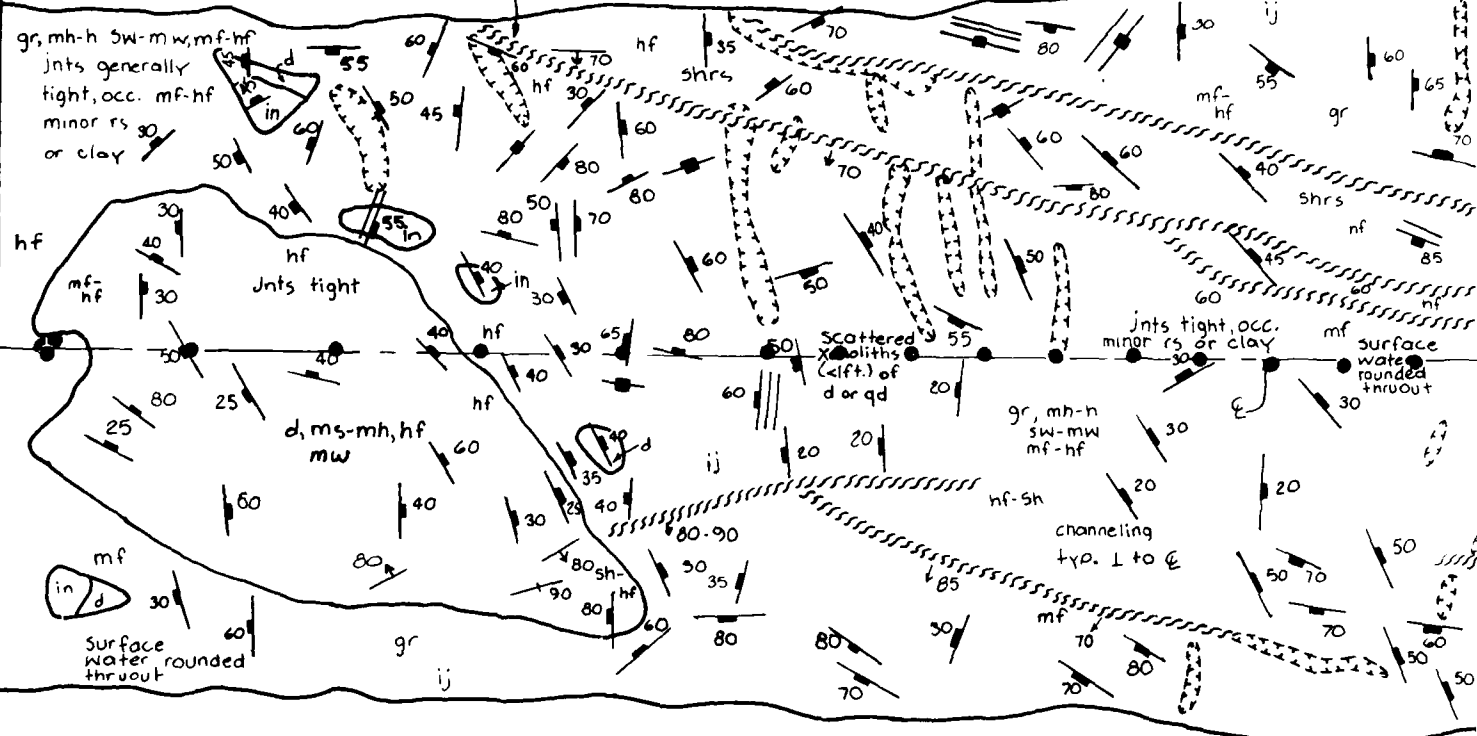
Typ. SZ, y/b, up to 12" wide (avg. 4") with cg (only major shears mapped)

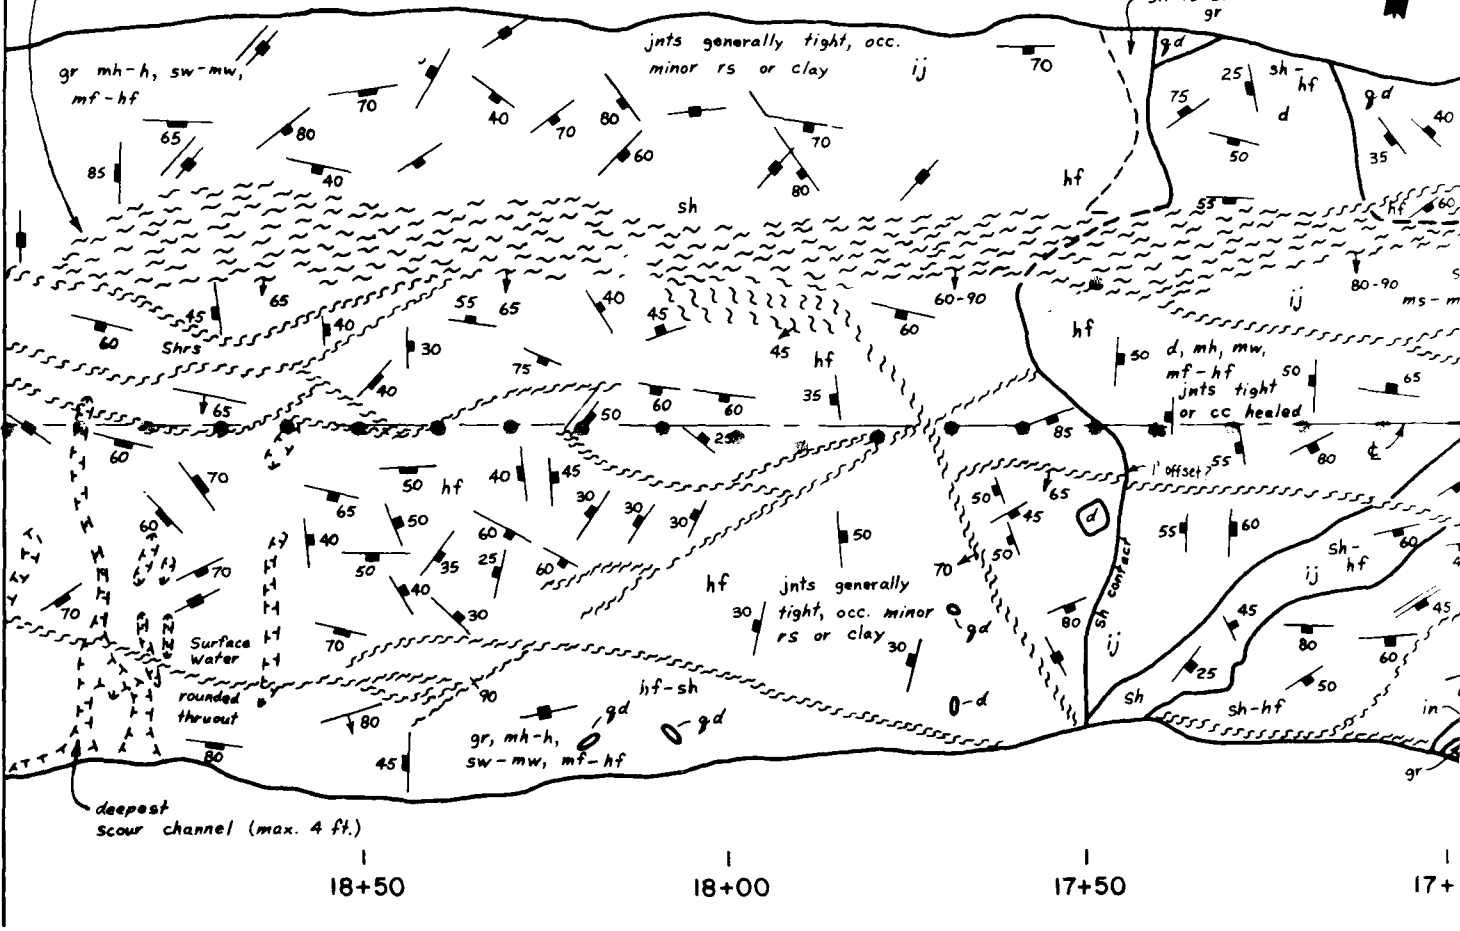
STA. 19+00

deepest scour channel (max. 4 ft.)

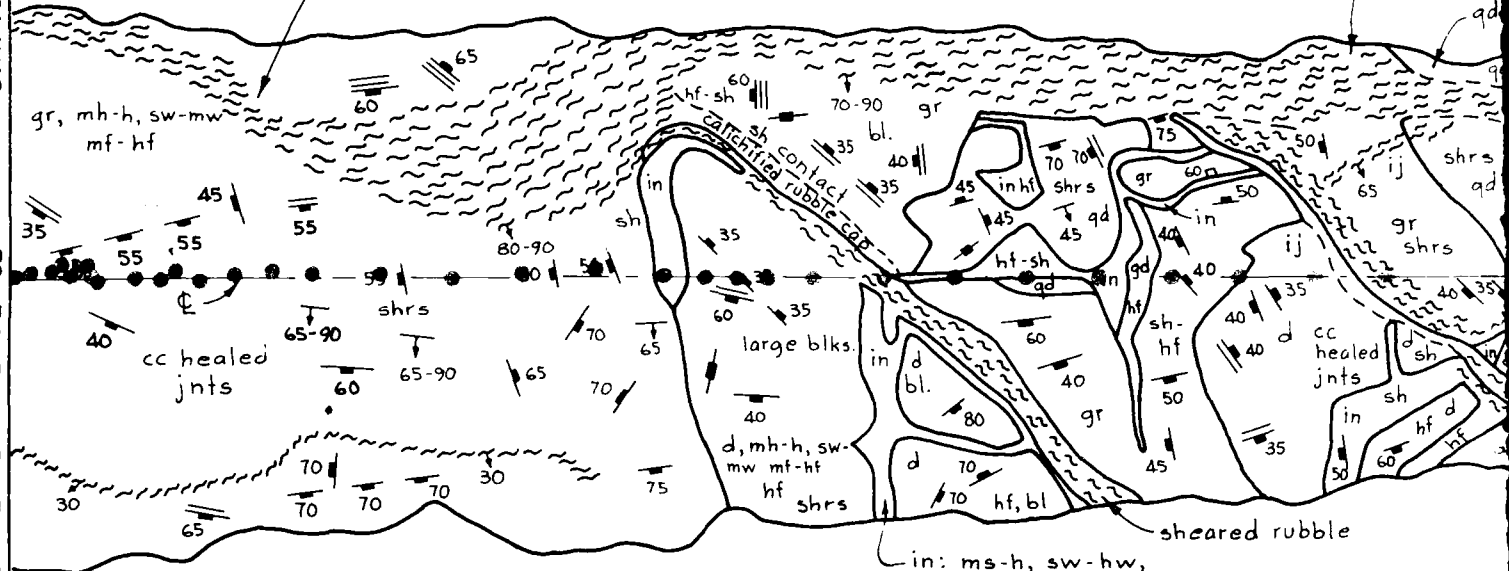
LEFT (EAST)
ABUTMENT

1"-2" wide shears infilled with clay gouge
splay outward from major sz diagonally
across abutment.
