# PRESIDENTIAL COMMISSION

*on the Space Shuttle  
Challenger Accident*

*Report to the President*

June 6th, 1986  
Washington, D.C.

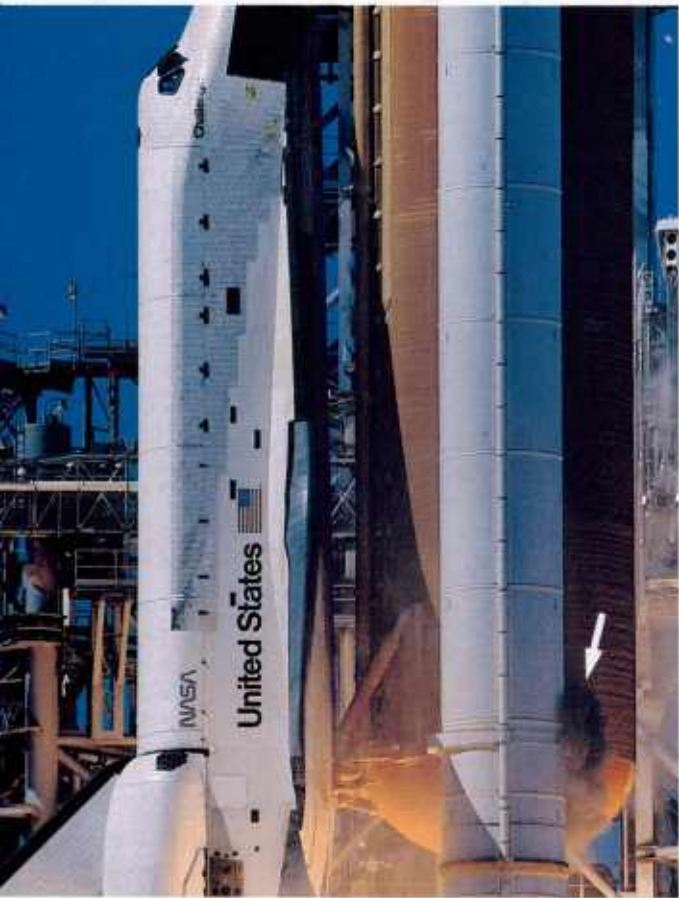
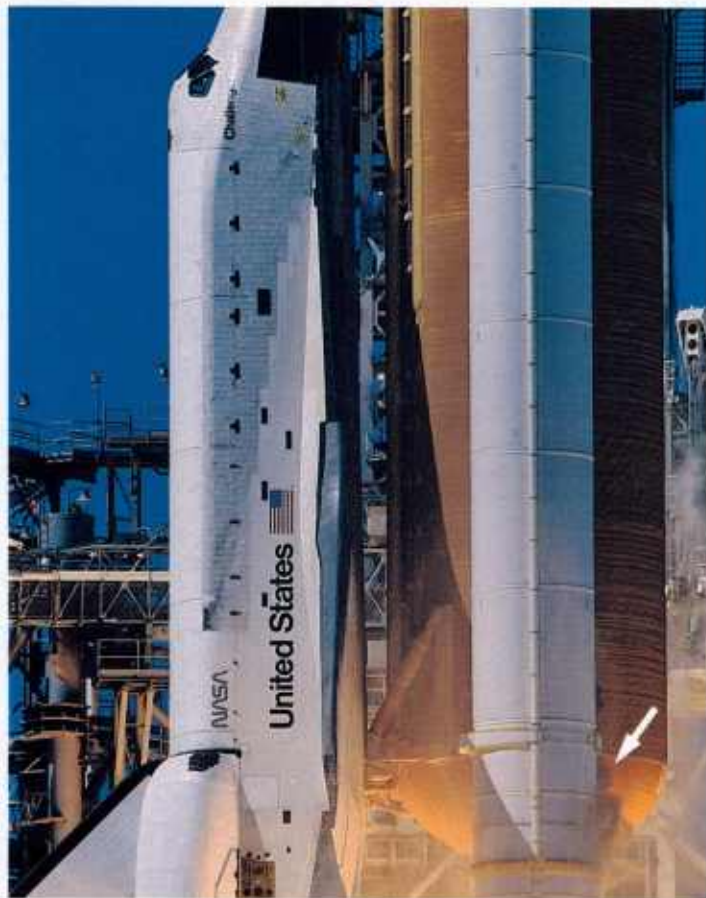
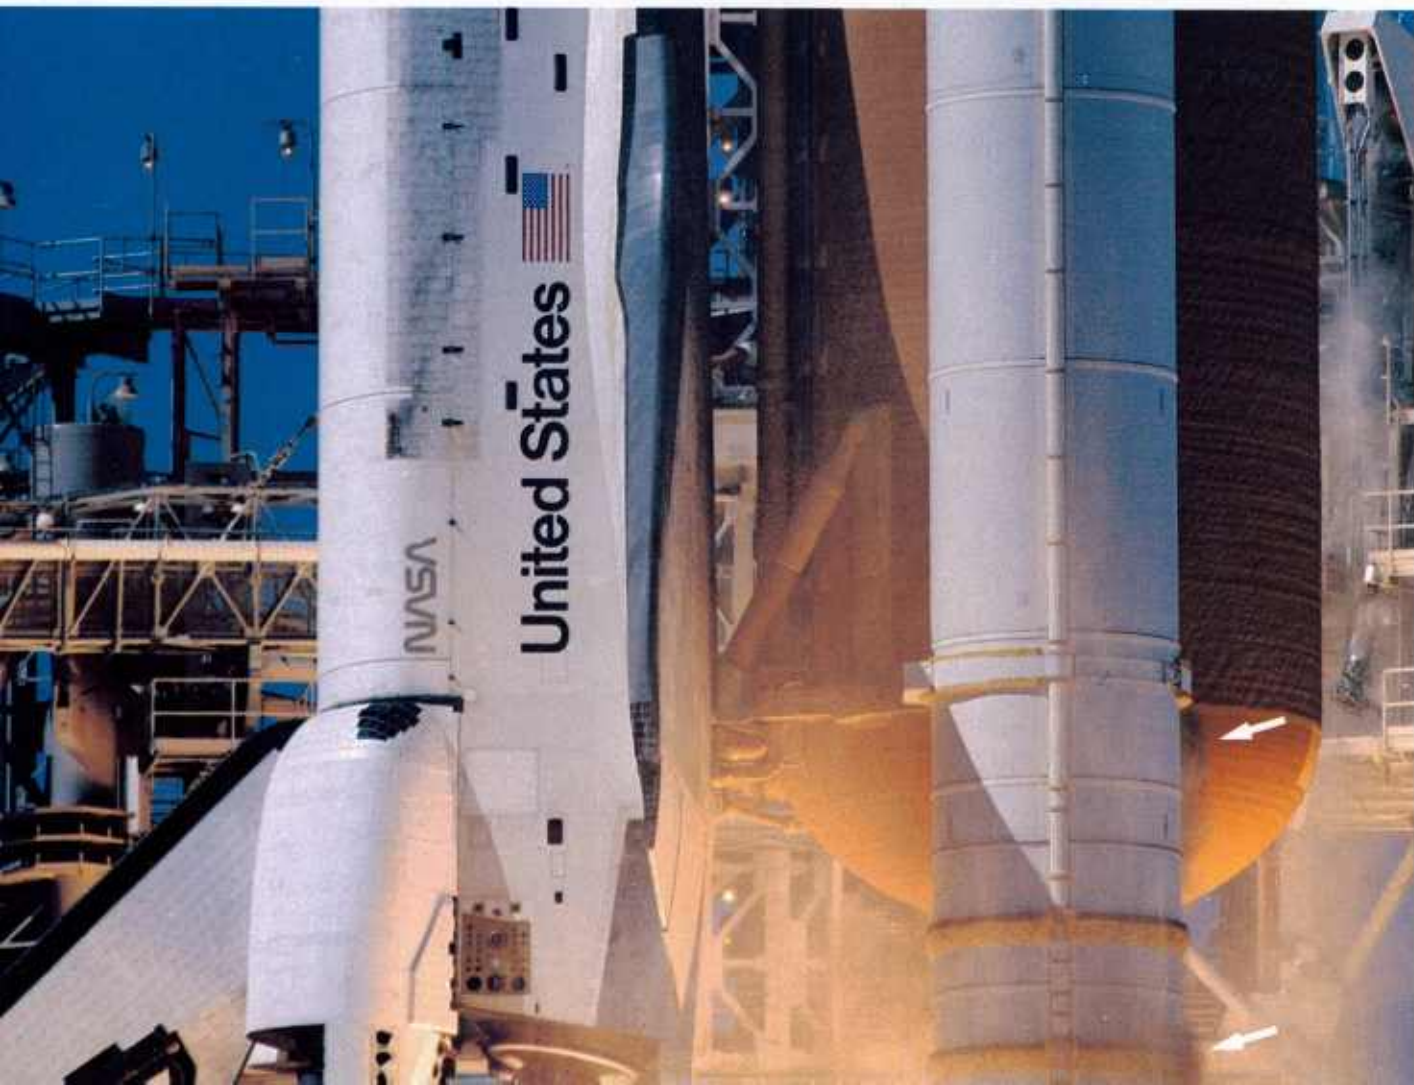
Immediately after solid rocket motor ignition, dark smoke (arrows) swirled out between the right hand booster and the External Tank. The smoke's origin, behavior and duration was approximated by visual analysis and computer enhancement of film from five camera locations. Consensus: smoke was first discernible at .678 seconds Mission Elapsed Time in the vicinity of the right booster's aft field joint.

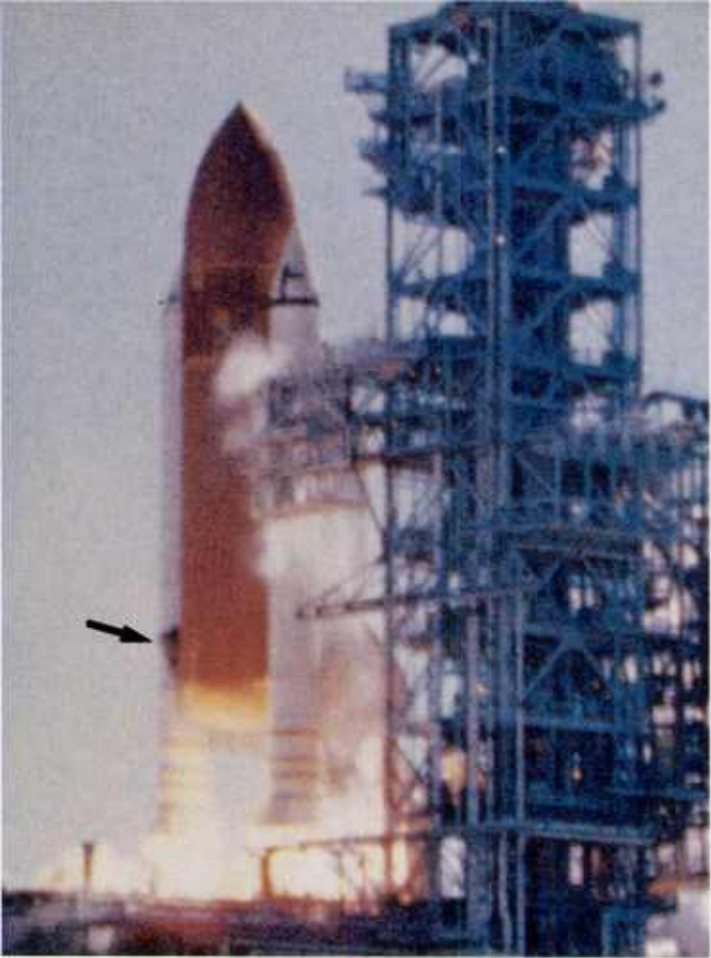
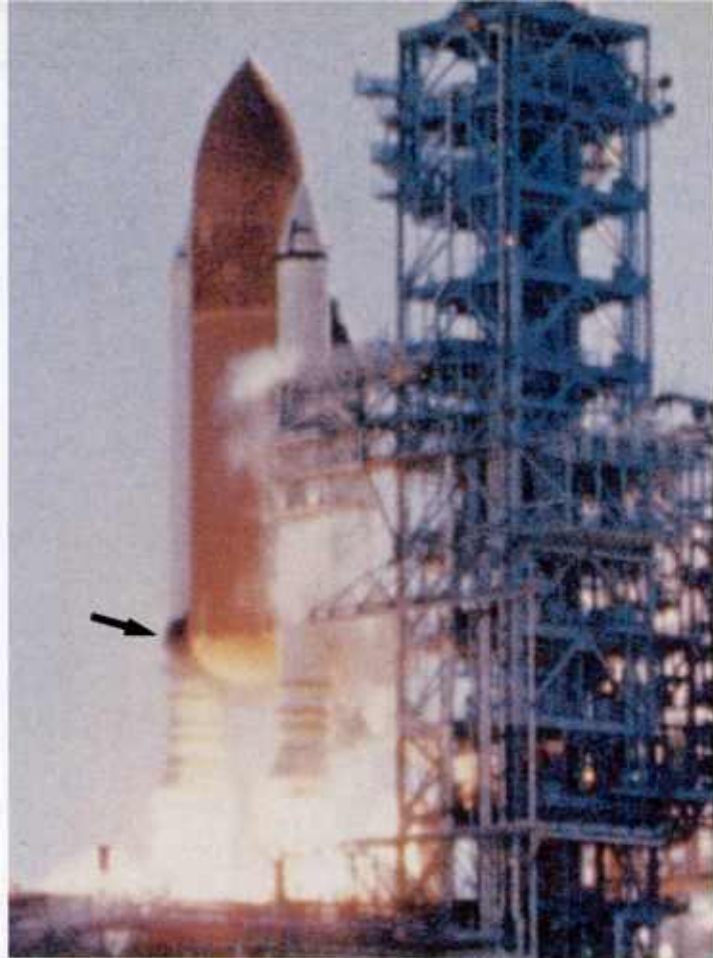
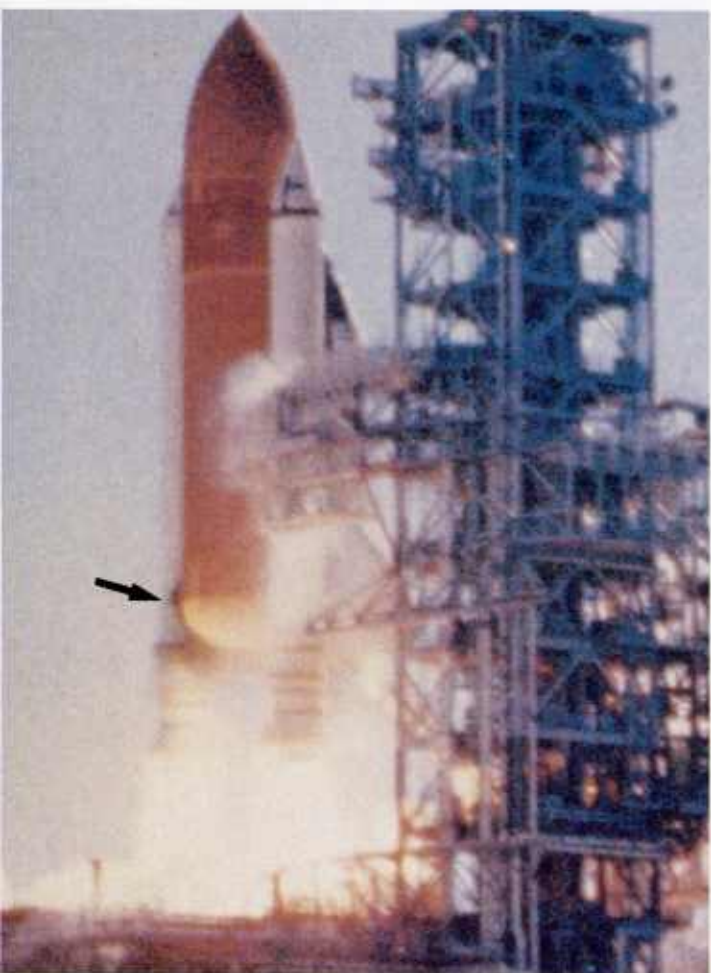
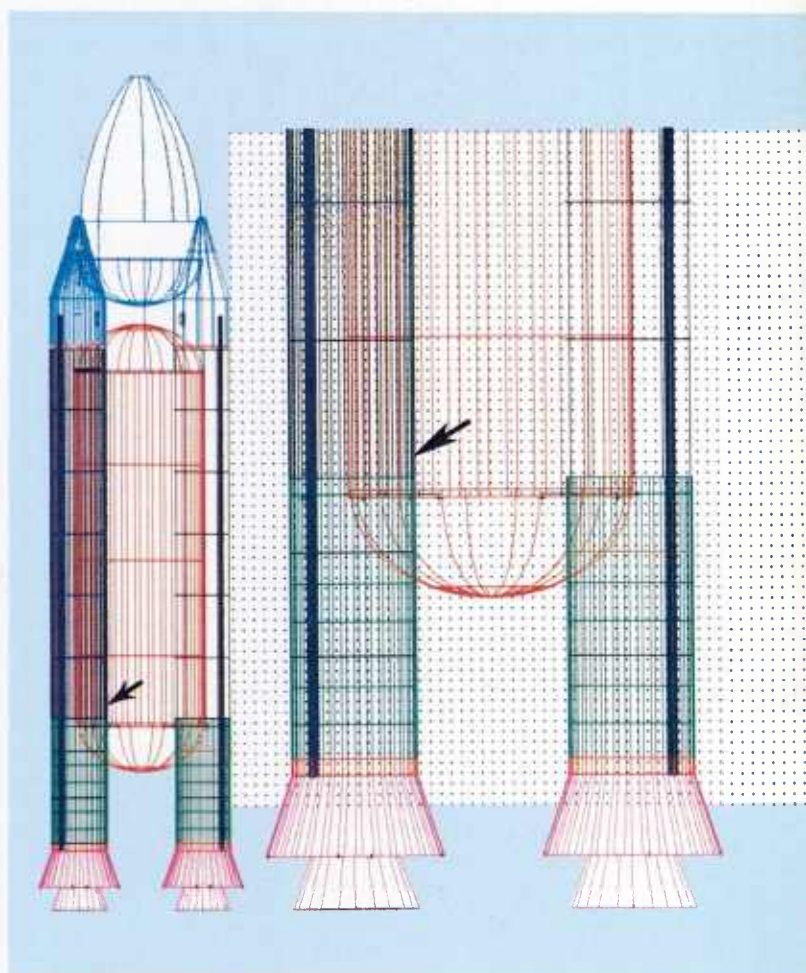
Multiple smoke puffs are visible in the photo above (arrows). They began at .836 seconds and continued through 2.500 seconds, occurring about 4 times a second. Upward motion of the vehicle caused the smoke to drift downward and blur into a single cloud. Smoke source is shown in the computer generated drawing (far right).

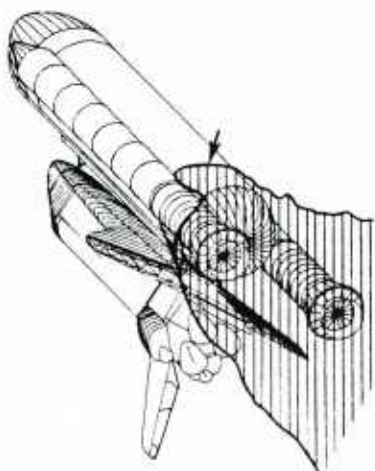
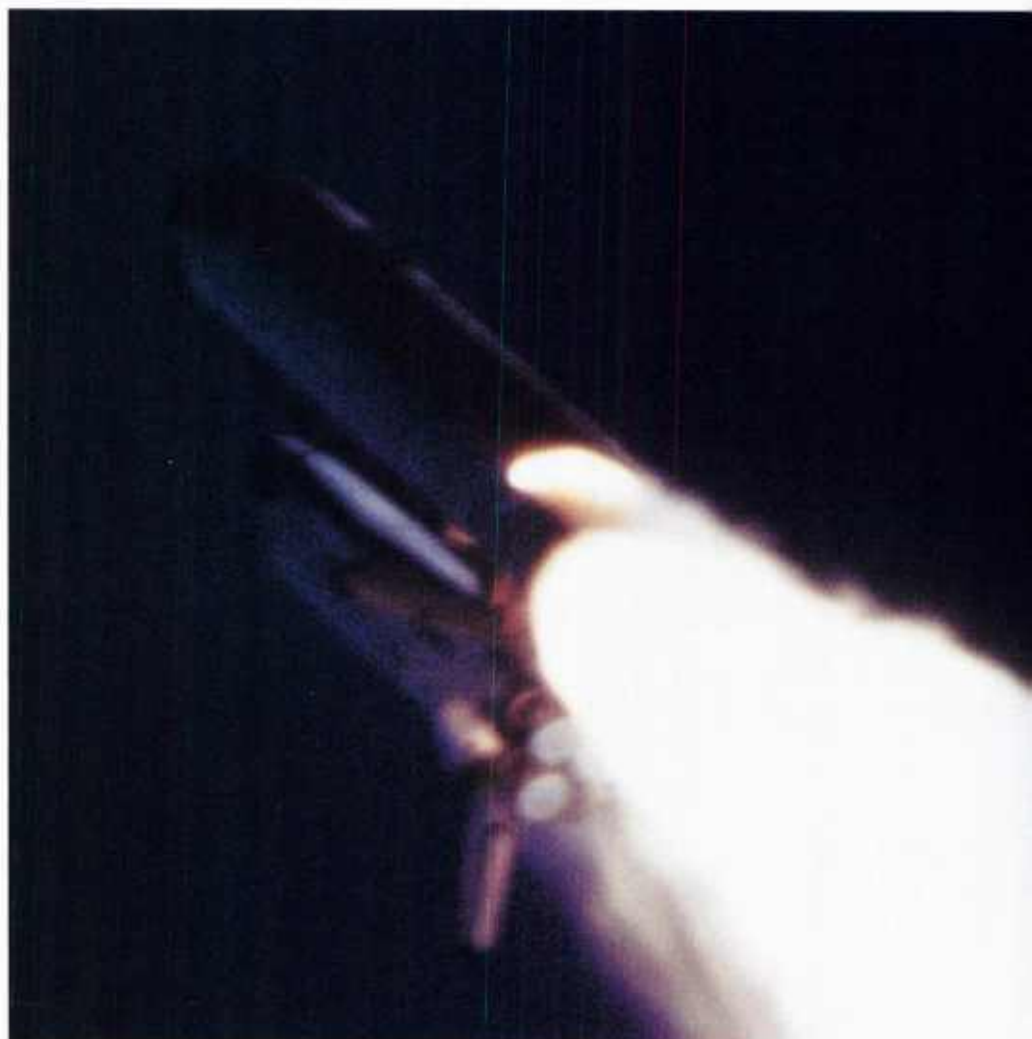
At 58.788 seconds, the first flicker of flame appeared. Barely visible above, it grew into a large plume and began to impinge on the External Tank at about 60 seconds. Flame is pinpointed in the computer drawing between the right booster and the tank, as in the case of earlier smoke puffs. At far right (arrow), vapor is seen escaping from the apparently breached External Tank.

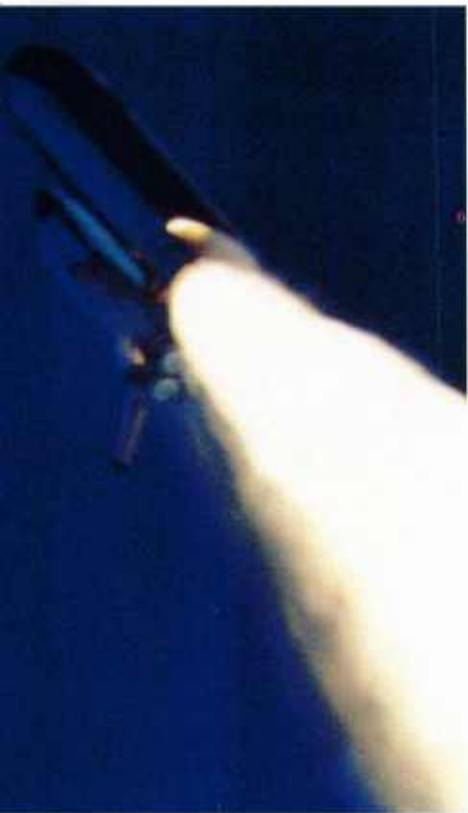
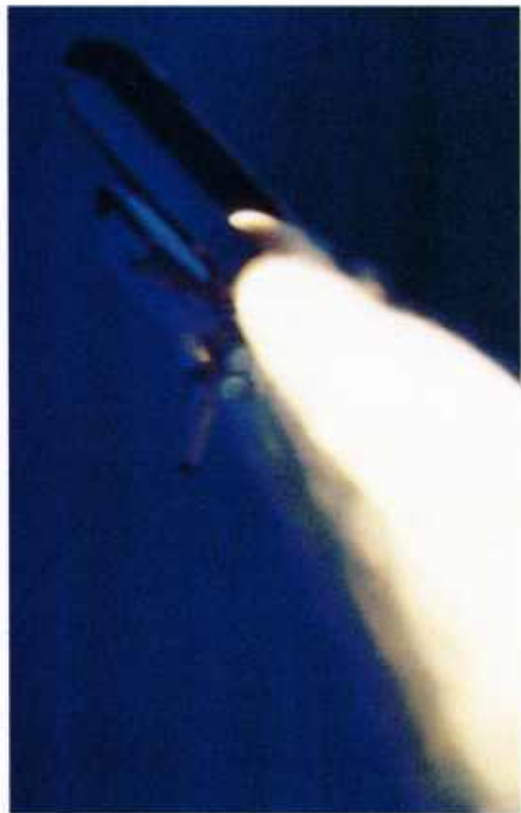
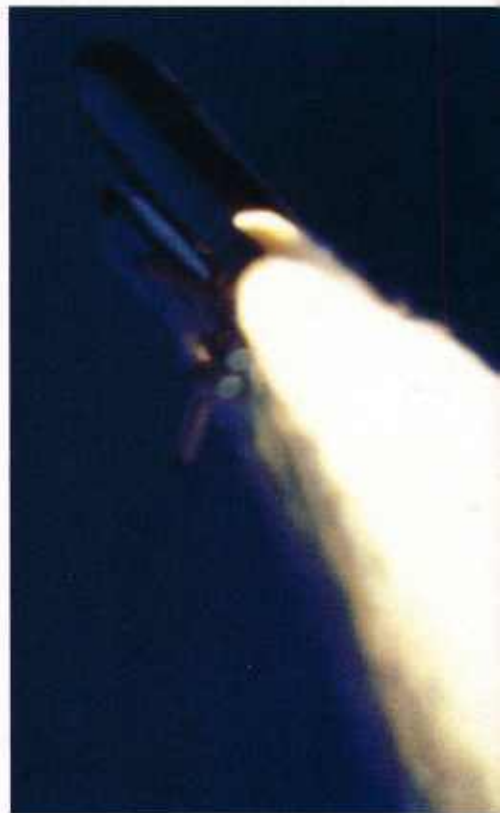
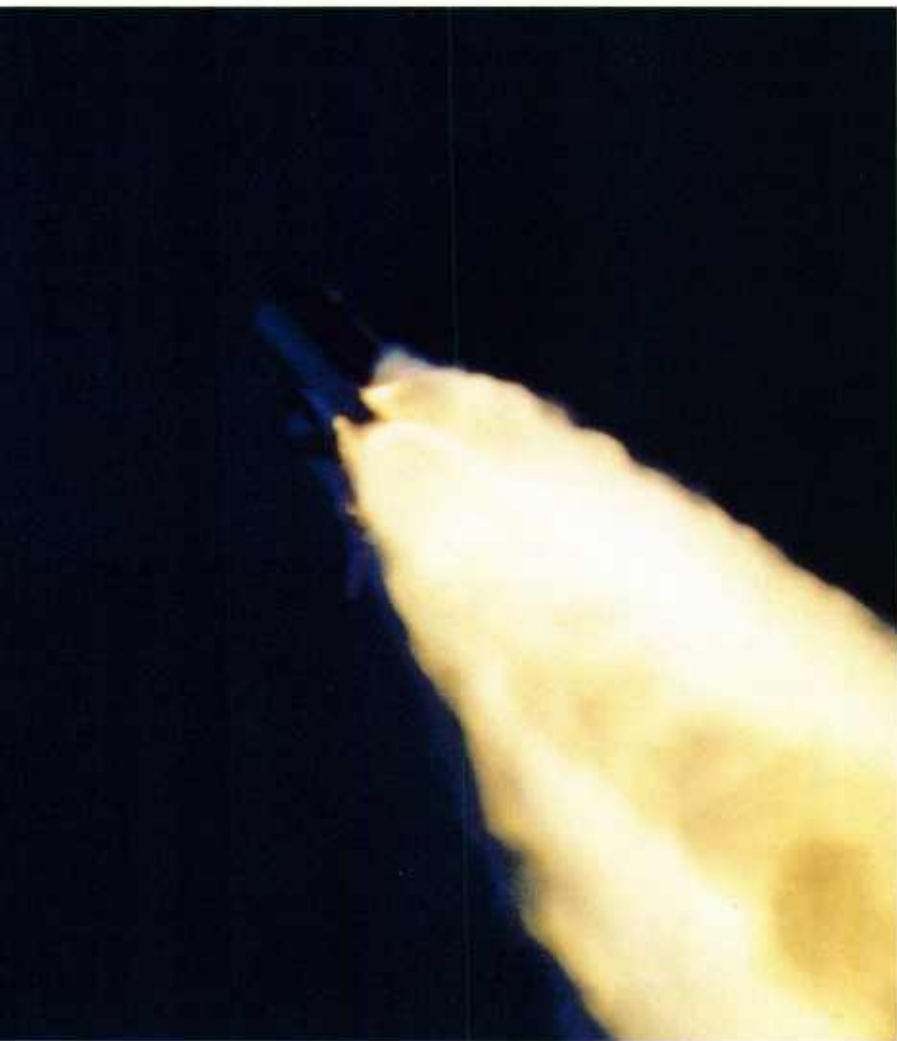
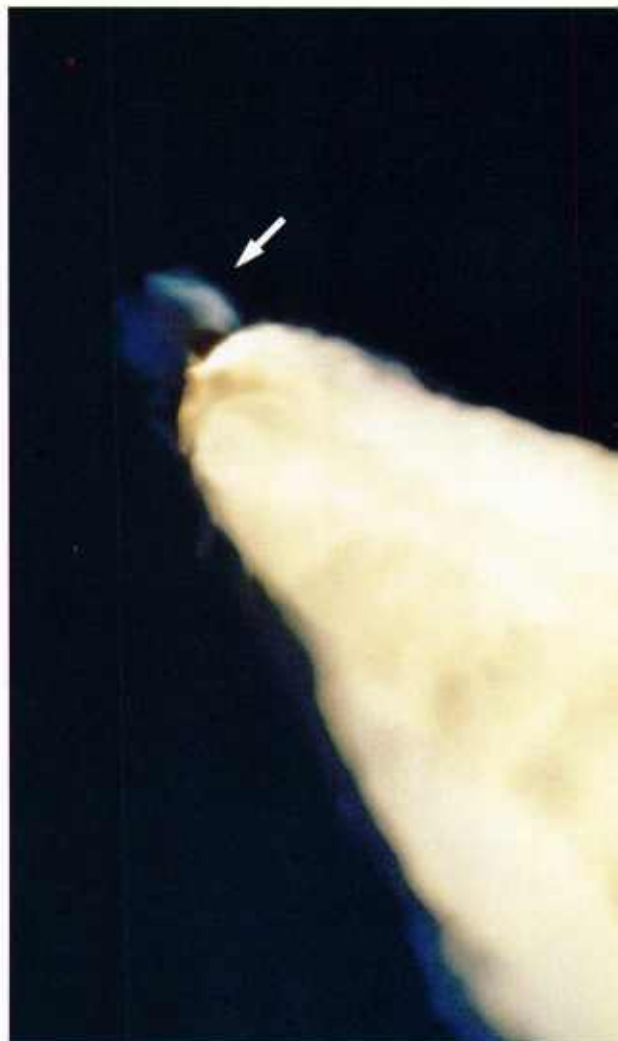
Camera views indicate the beginning of rupture of the liquid hydrogen and liquid oxygen tanks within the External Tank. A small flash (arrows above) intensified rapidly, then diminished. A second flash,

attributed to rupture of the liquid oxygen tank, occurred above the booster/tank forward attachment (below left) and grew in milliseconds to the maximum size indicated in the computer drawing.

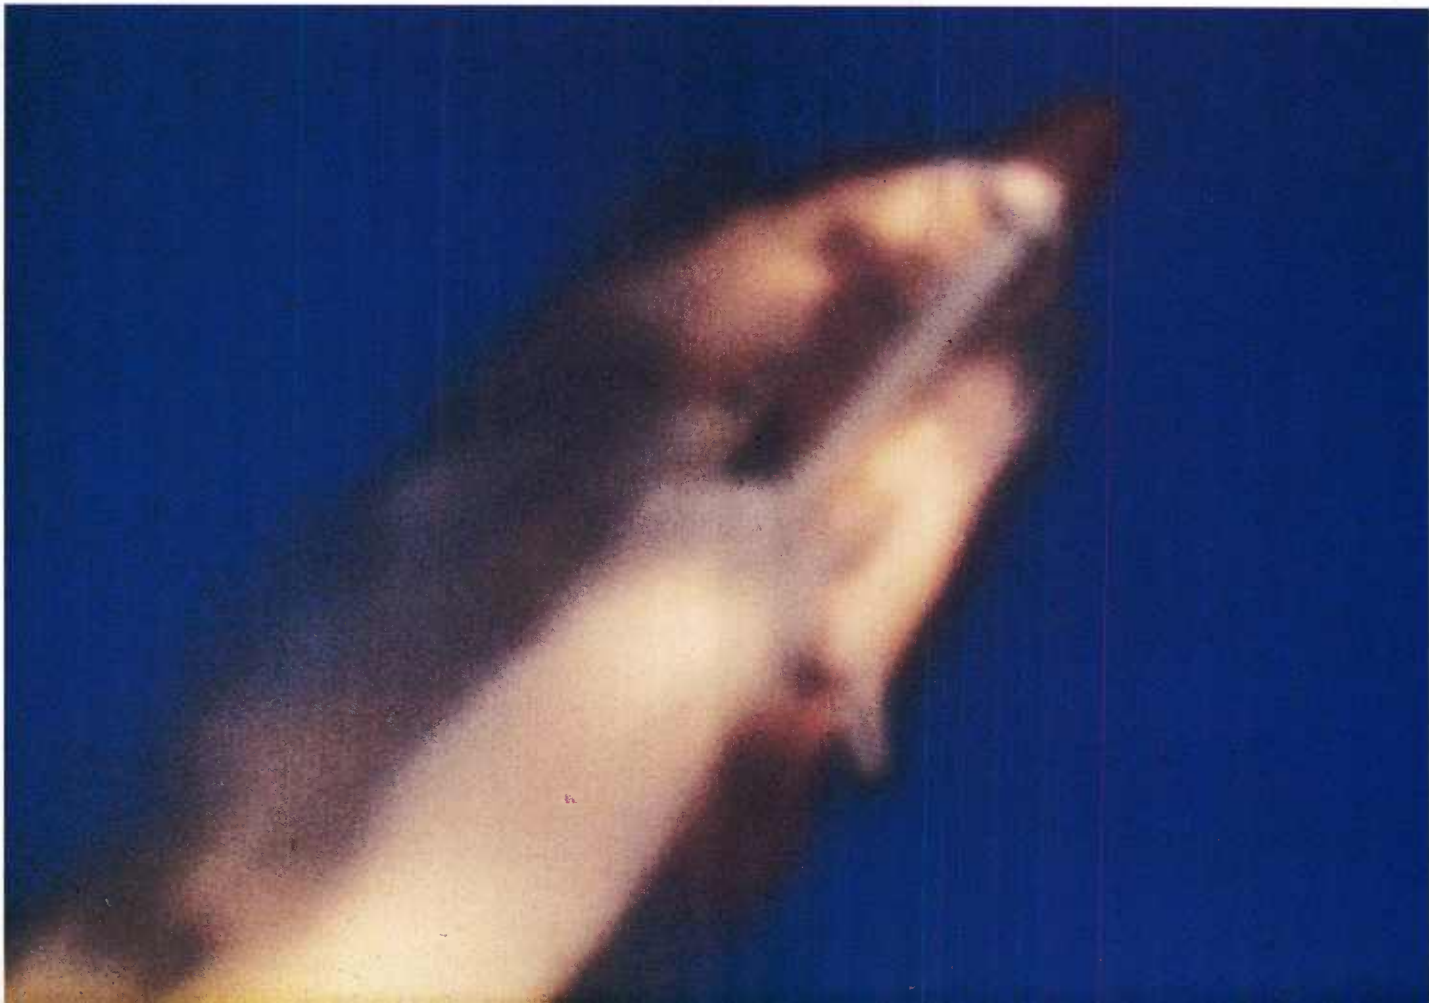
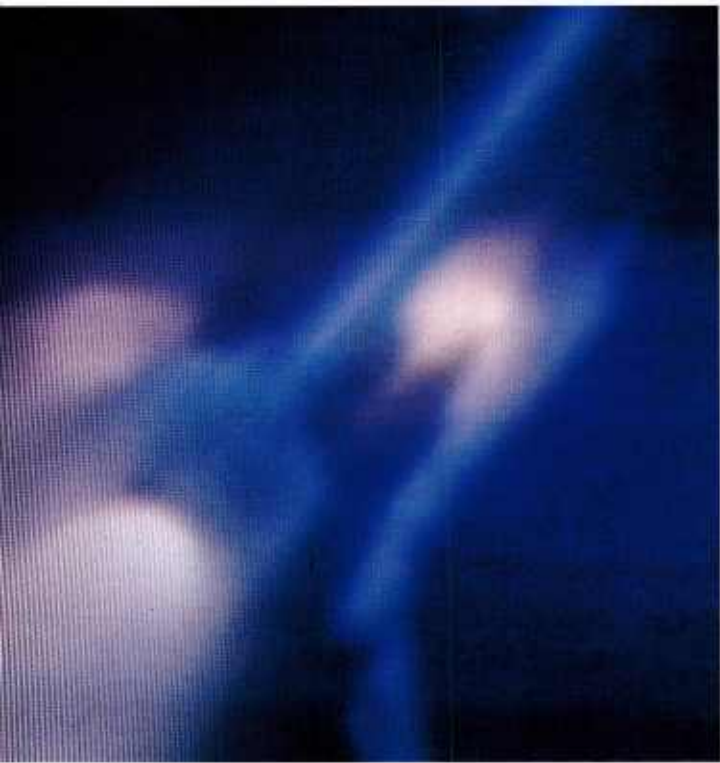
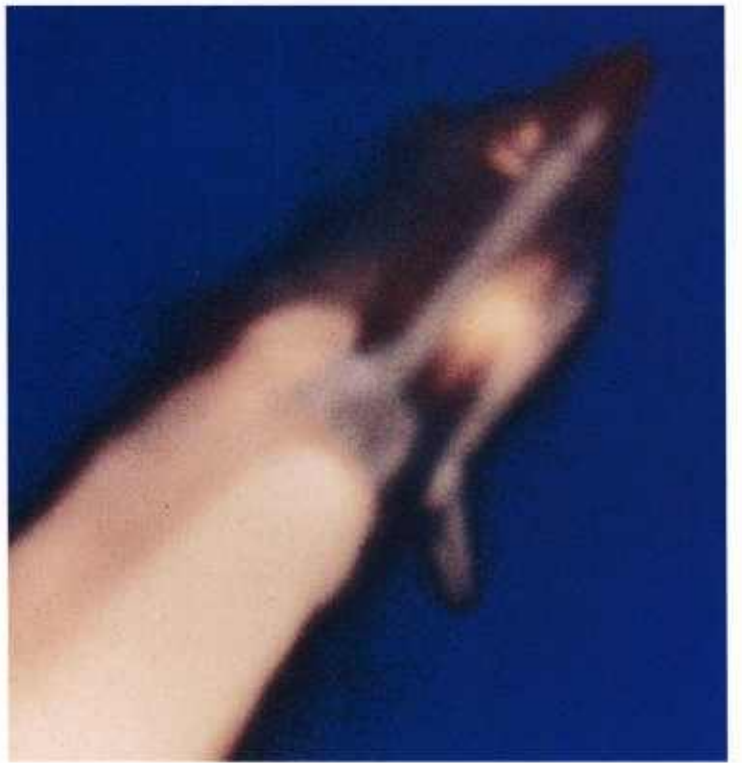
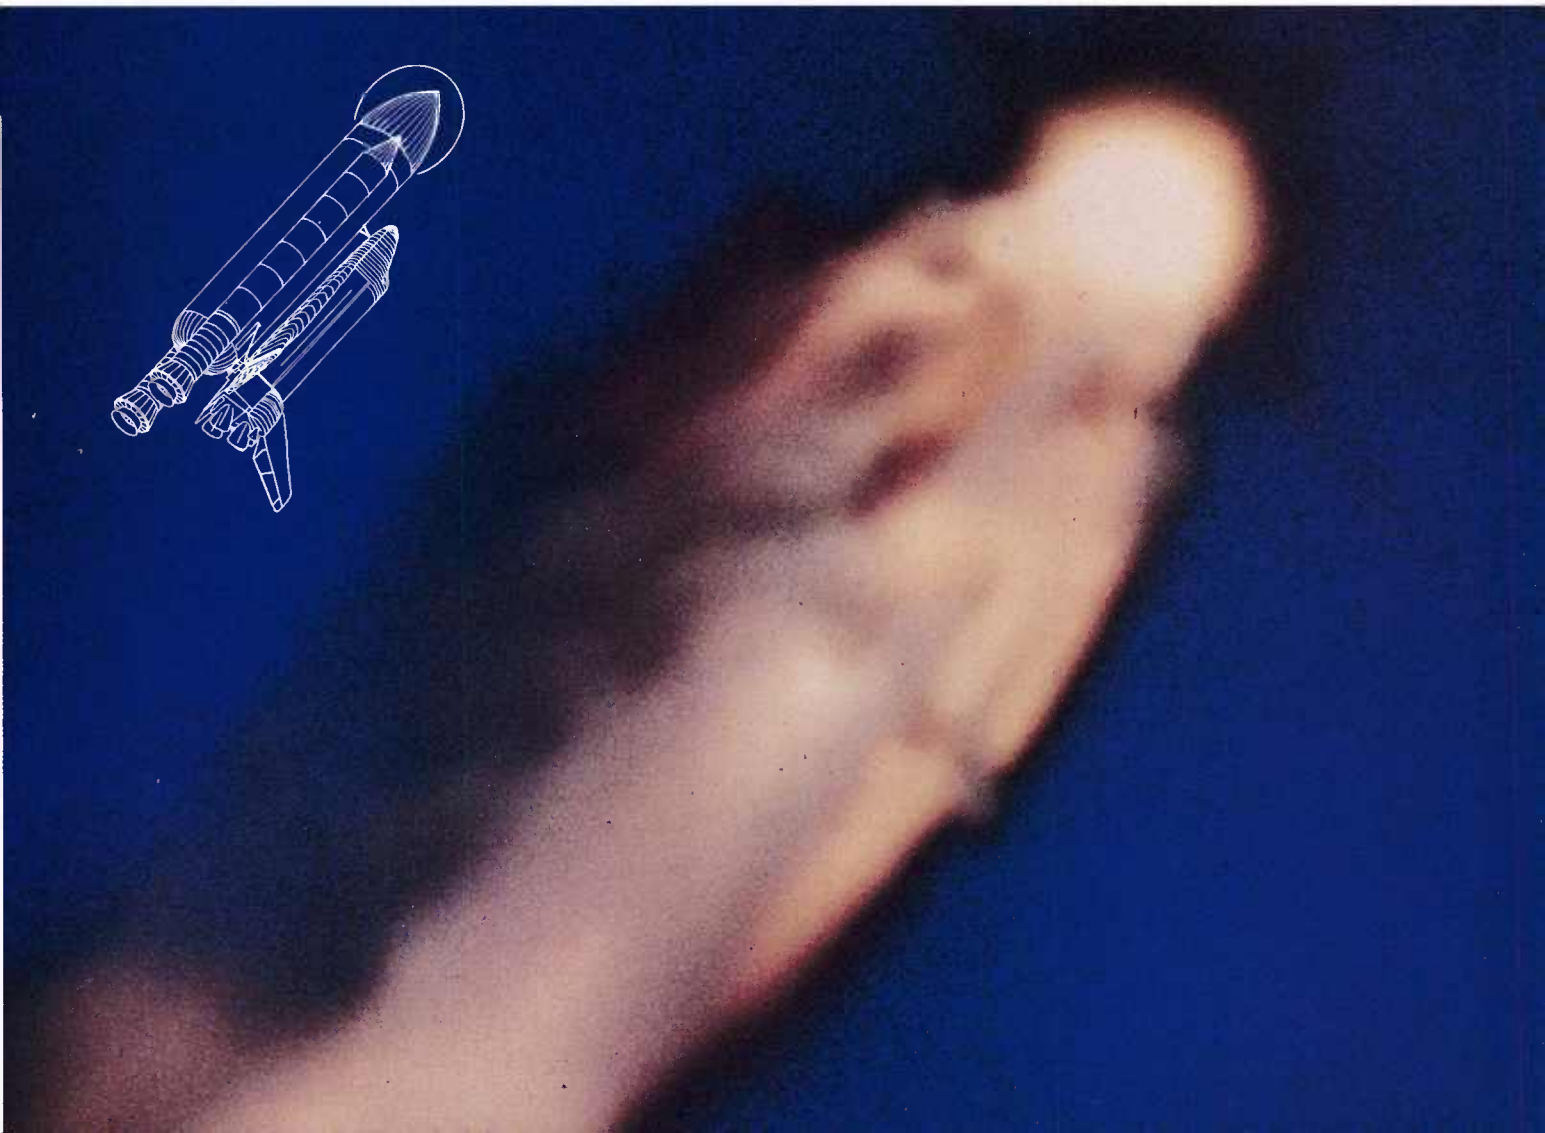
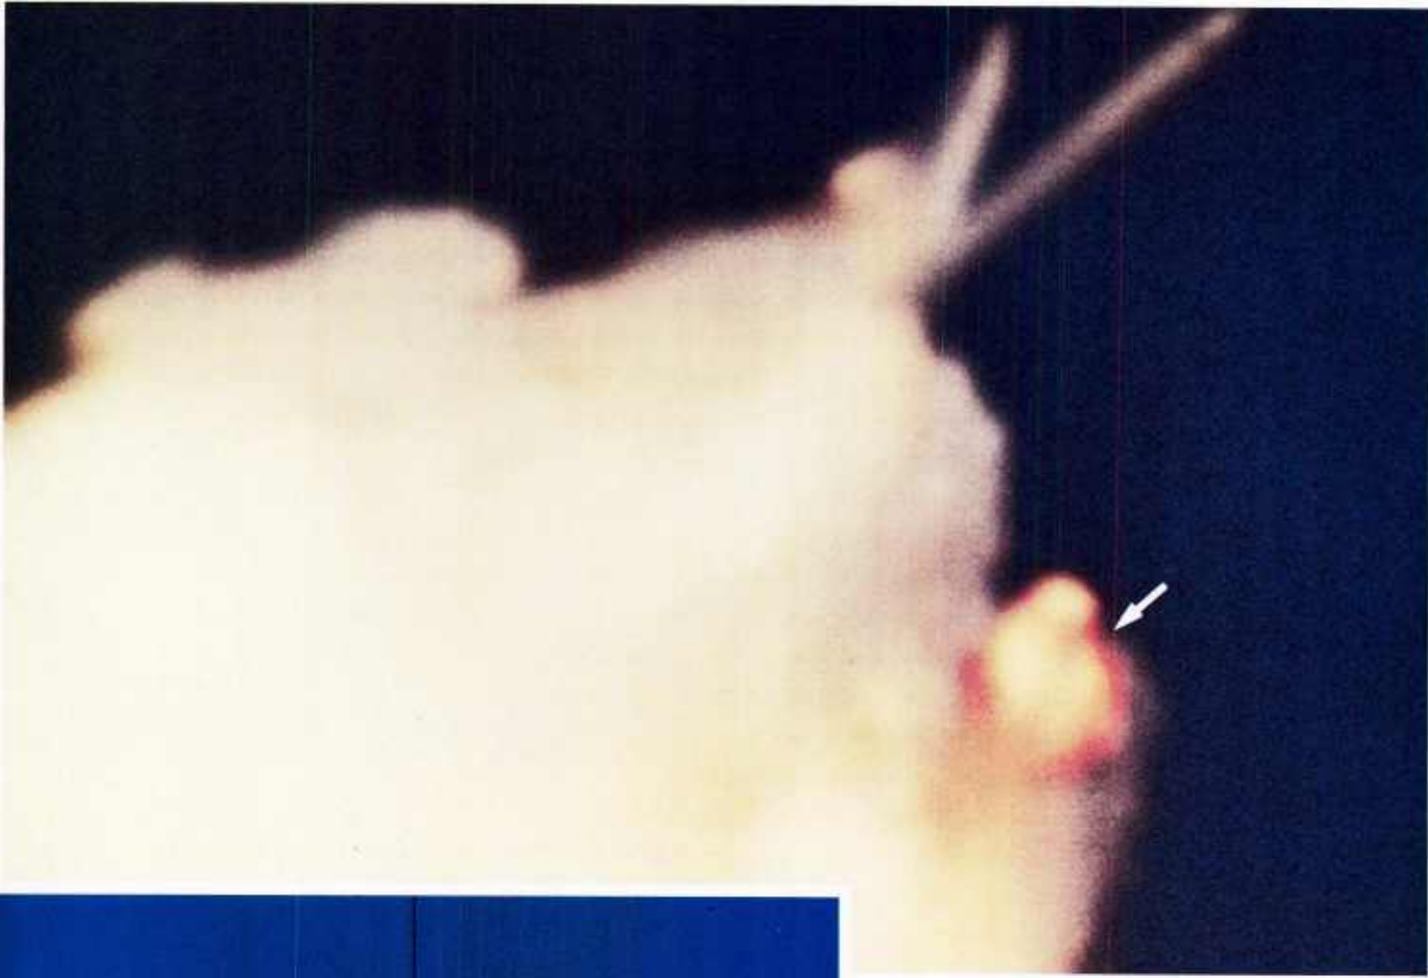
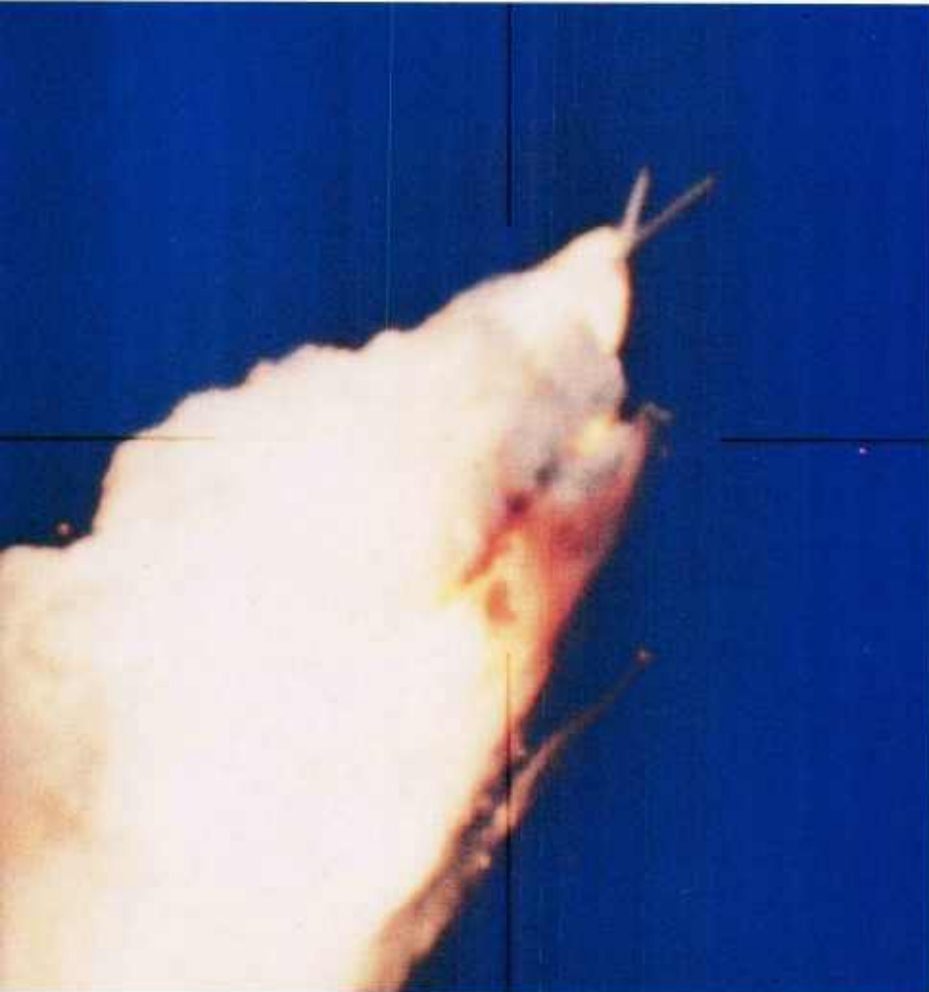
Structural breakup of the vehicle began at approximately 73 seconds. Fire spread very rapidly. Above, a bright flash (arrow) is evident near the nose of the Orbiter, suggesting spillage and ignition of the spacecraft's reaction control system propellants. At left, the two Solid Rocket Boosters thrust away from the fire, crisscrossing to form a "V." The right booster—identifiable by its failure plume—now to the left of its counterpart. At right, the boosters diverge farther; the External Tank wreckage is obscured by smoke and vapor. The Orbiter engines still firing, is visible at bottom center.

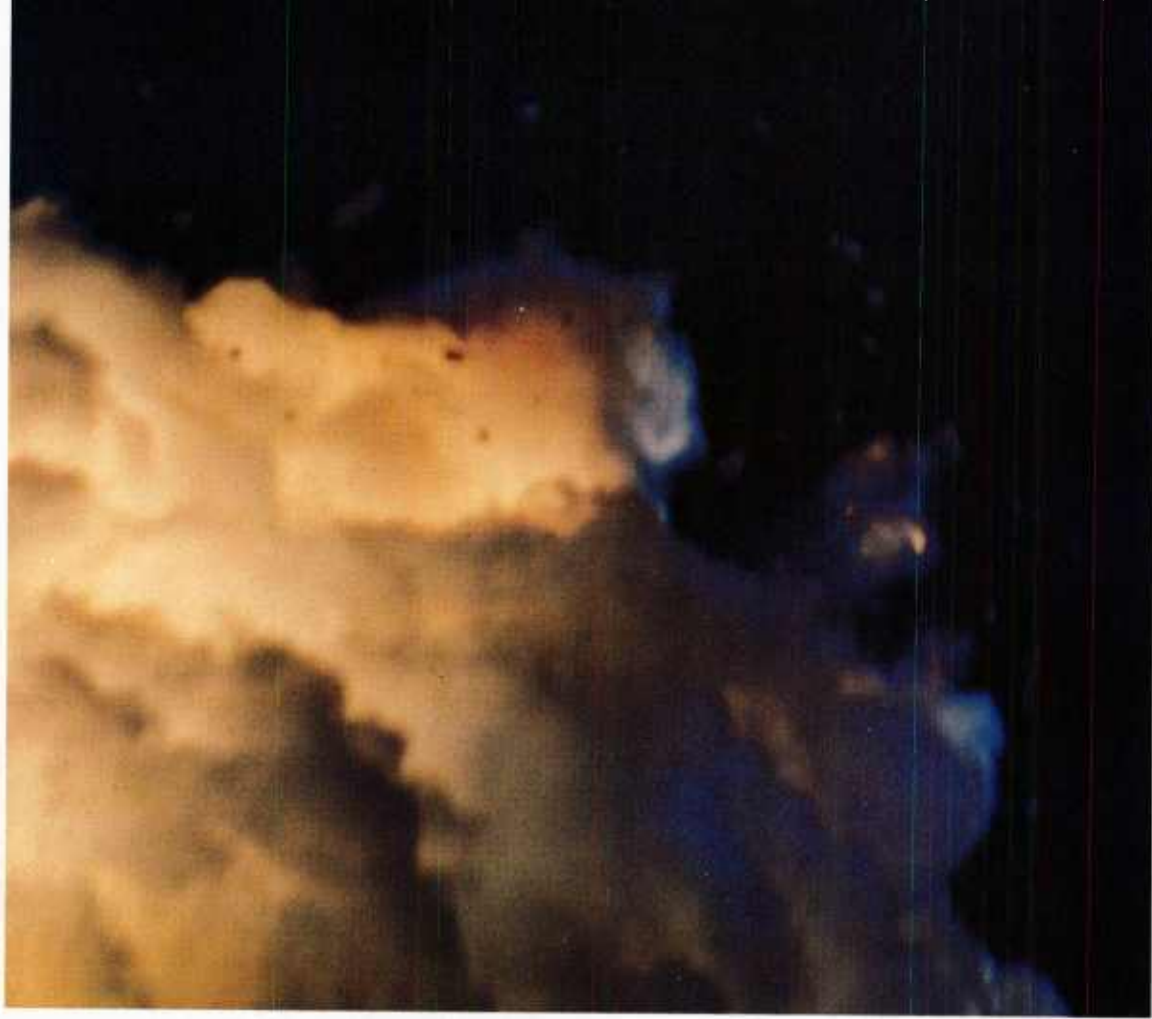
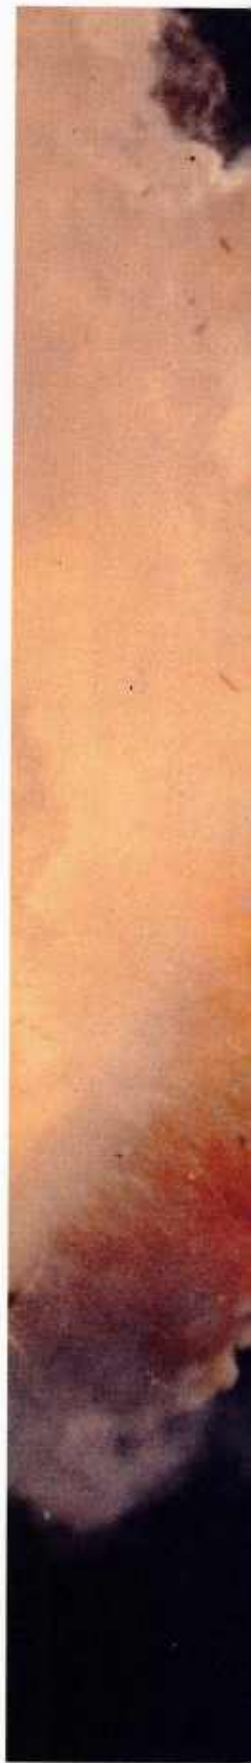
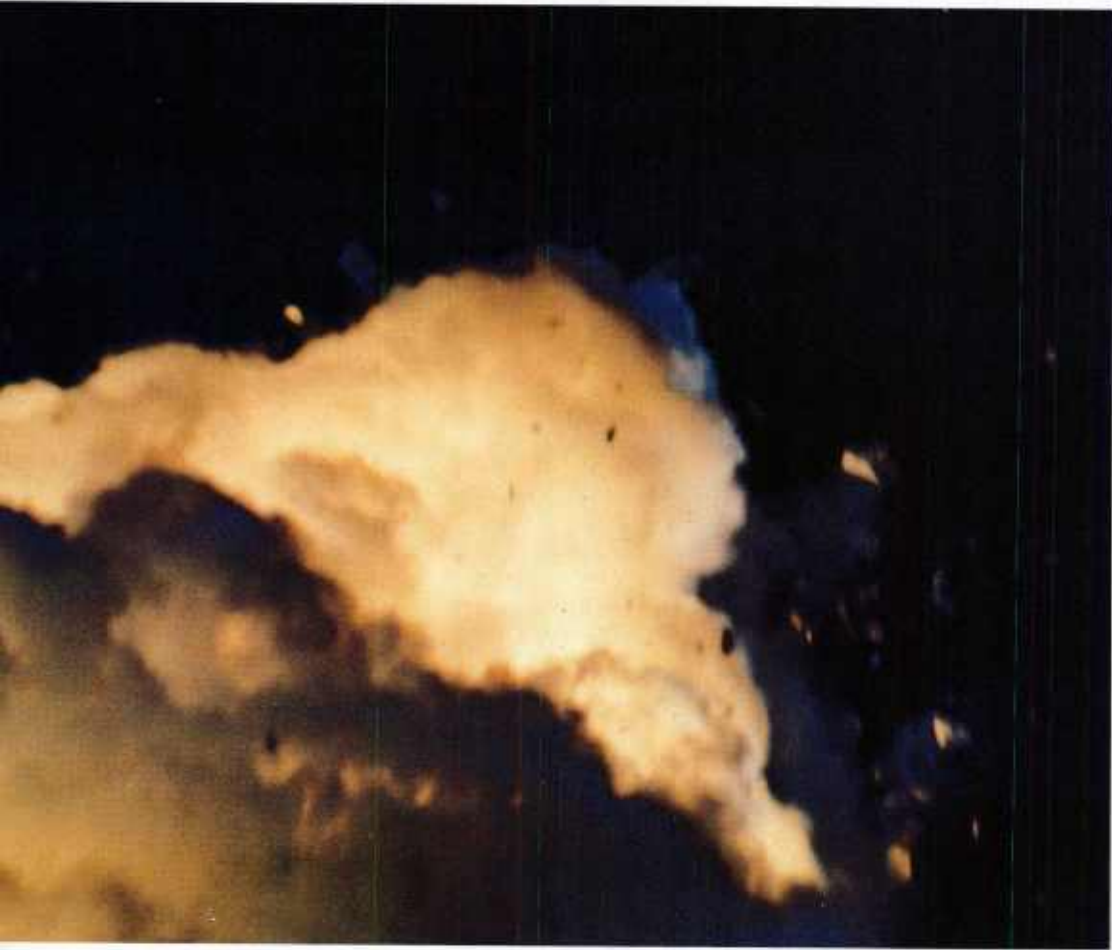
At about 76 seconds, unidentifiable fragments of the Shuttle vehicle can be seen tumbling against a background of fire, smoke and vaporized propellants from the External Tank (left). In the photo at right, the left booster (far right)

soars away, still thrusting. The reddish-brown cloud envelops the disintegrating Orbiter. The color is characteristic of the nitrogen tetroxide oxidizer in the Orbiter Reaction Control System propellant.

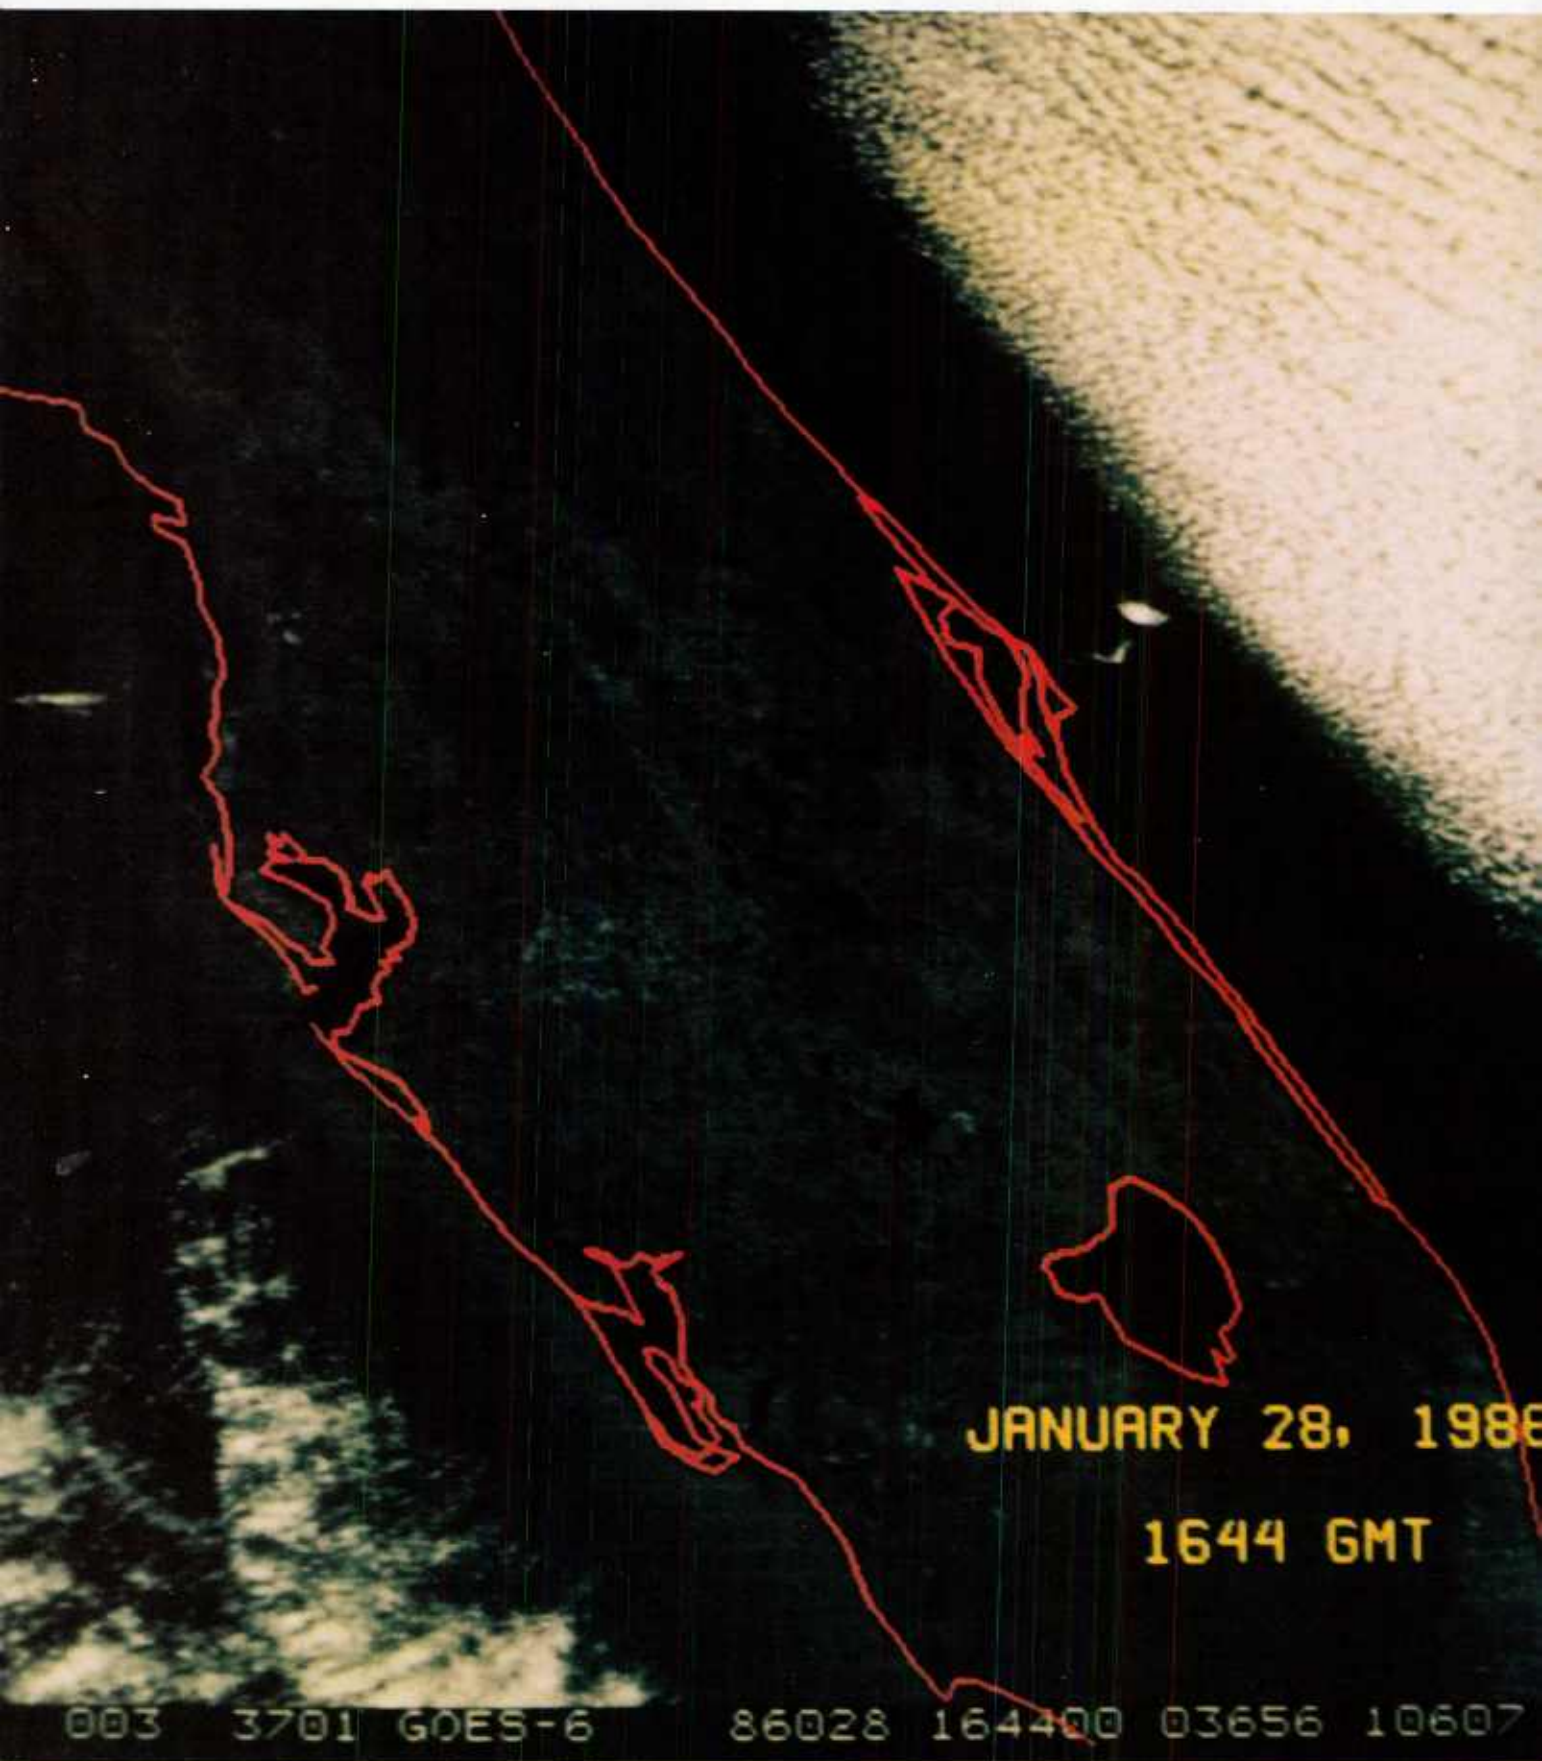
At 11:44 a.m. Eastern Standard Time, a GOES environment-monitoring satellite operated by the National Oceanic and Atmospheric Administration acquired this image of the smoke and vapor cloud from the 51-L accident. The coast of Florida is outlined in red.
