# PRESIDENTIAL COMMISSION

*on the Space Shuttle  
Challenger Accident*

*Report to the President*

June 6th, 1986  
Washington, D.C.

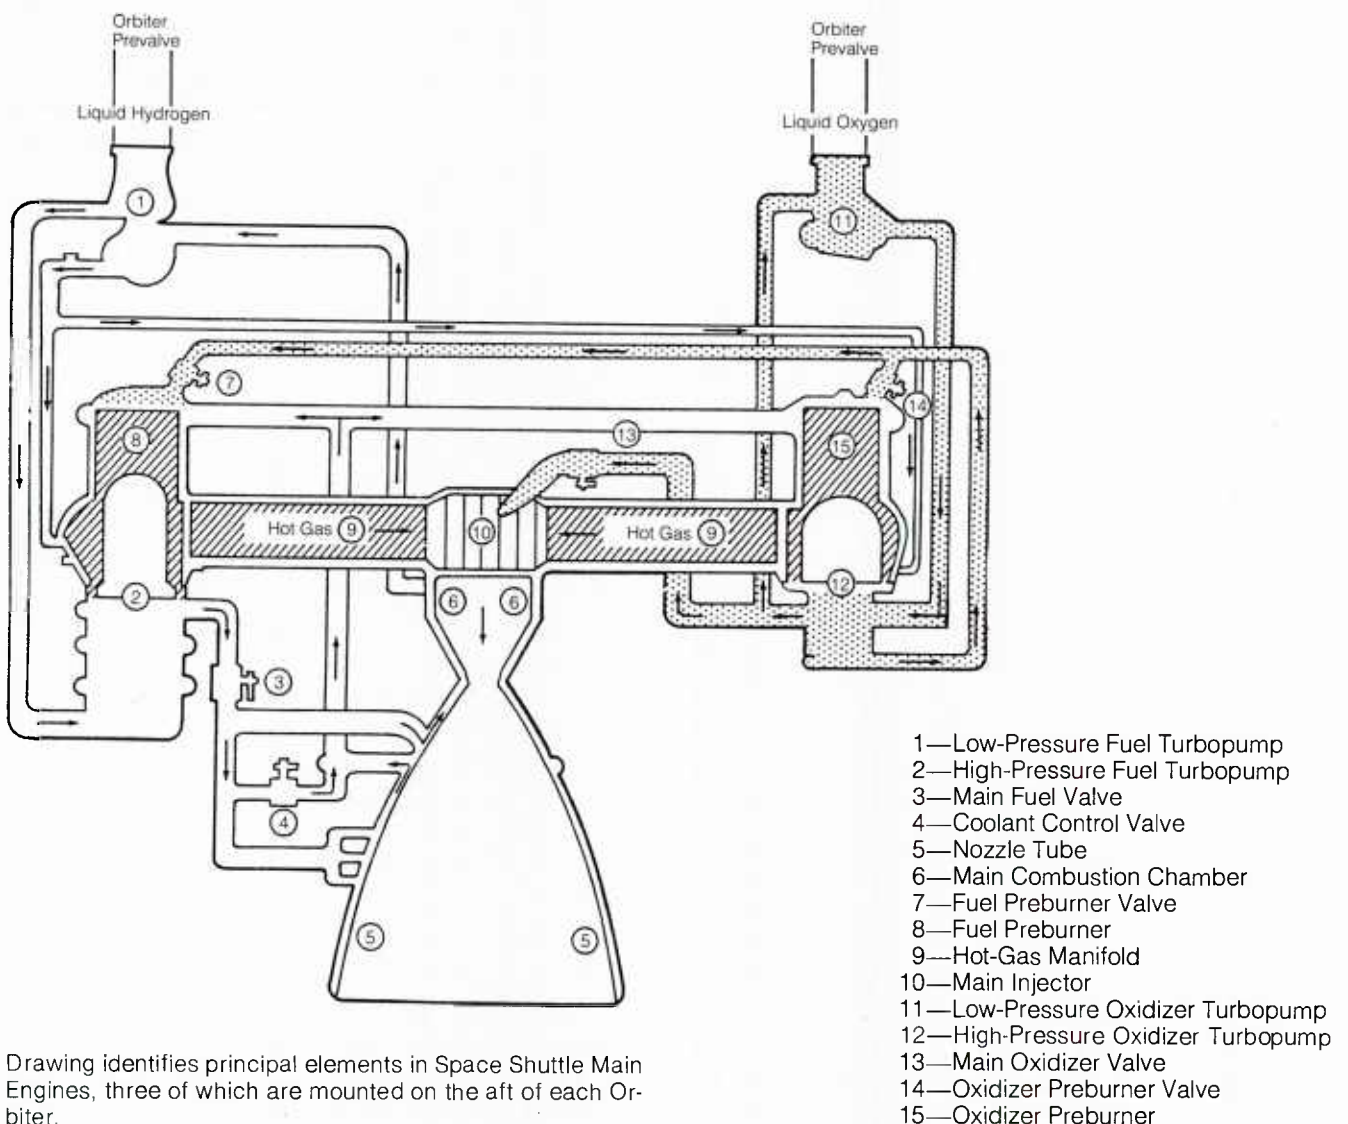
Figure 4

The first abnormal engine indication was a drop in engine fuel tank pressure at 72.564 seconds. As fuel pressure dropped, the control system automatically responded by opening the fuel flowrate valve. The turbine temperatures then increased because of the leaner fuel mixture.

The increased temperature caused an increase in pump speed. This could not, however, increase the fuel pressure because of a decrease in fuel tank top (ullage) pressure resulting from the burned through hydrogen tank leakage. When the fuel pump pressures dropped below 140 pounds per square inch, the programmed control system disqualified the measured data because it was past reasonable limits. This caused the fuel flowrate and high-pressure fuel pump discharge pressure to decrease, while the lack of load allowed the pump's speed to increase. The decreased fuel flow caused a drop in fuel preburner chamber pressure, though the fuel preburner oxygen valve was then advancing toward a more open position. The mixture ratio in the fuel preburner became leaner, which raised high-pressure fuel turbine discharge temperatures above the redline limits. This caused the engine control system to start automatic shutdown of the engine.

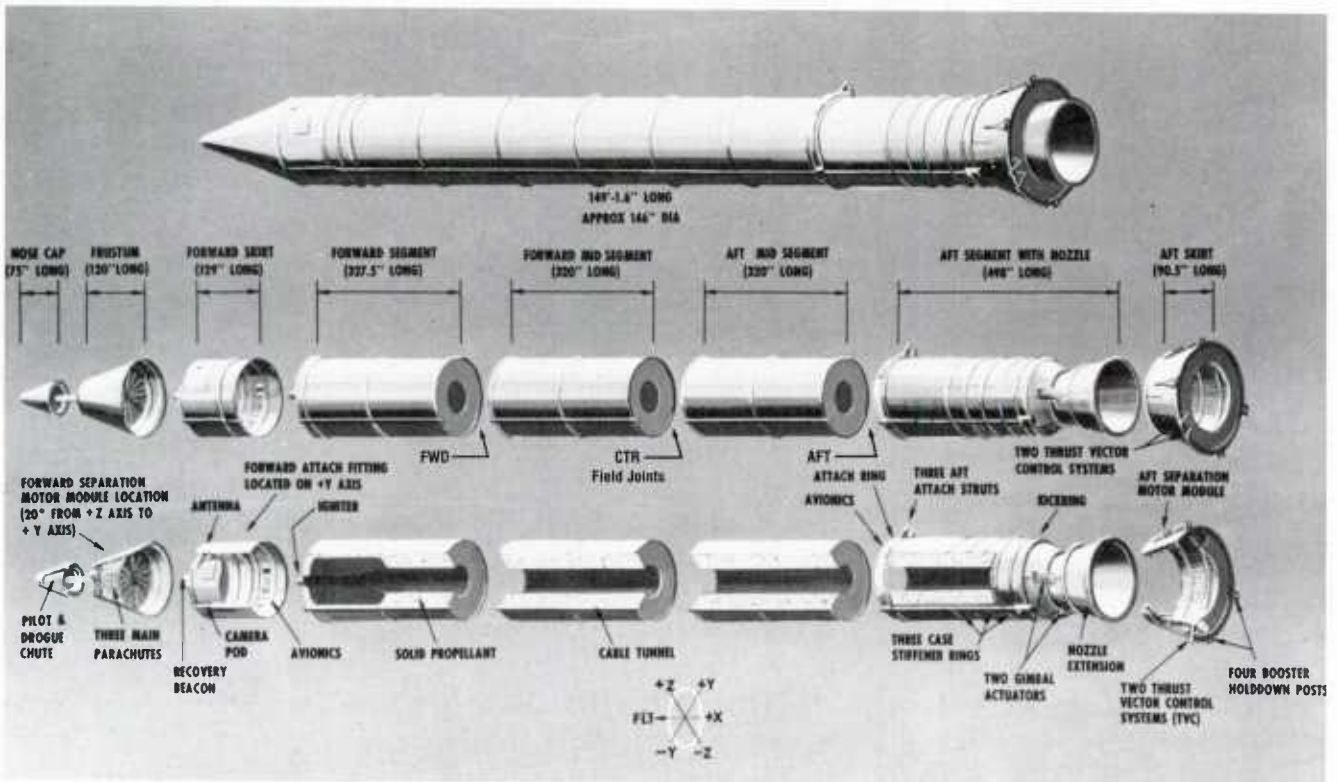
Figure 8  
Solid Rocket Booster drawing at top is exploded in lower drawings to show motor segments and other elements at forward and aft ends of booster.

During stacking operations at the launch site, four segments are assembled to form the Solid Rocket Motor. The resulting joints are referred to as field joints, located as depicted in Figures 8 and 13. Joint sealing is provided by two rubber O-rings with diameters of 0.280 inches (+0.005, -0.003), which are installed, as received from Morton Thiokol, during motor assembly. O-ring static compression during and after assembly is dictated by the width of the gap

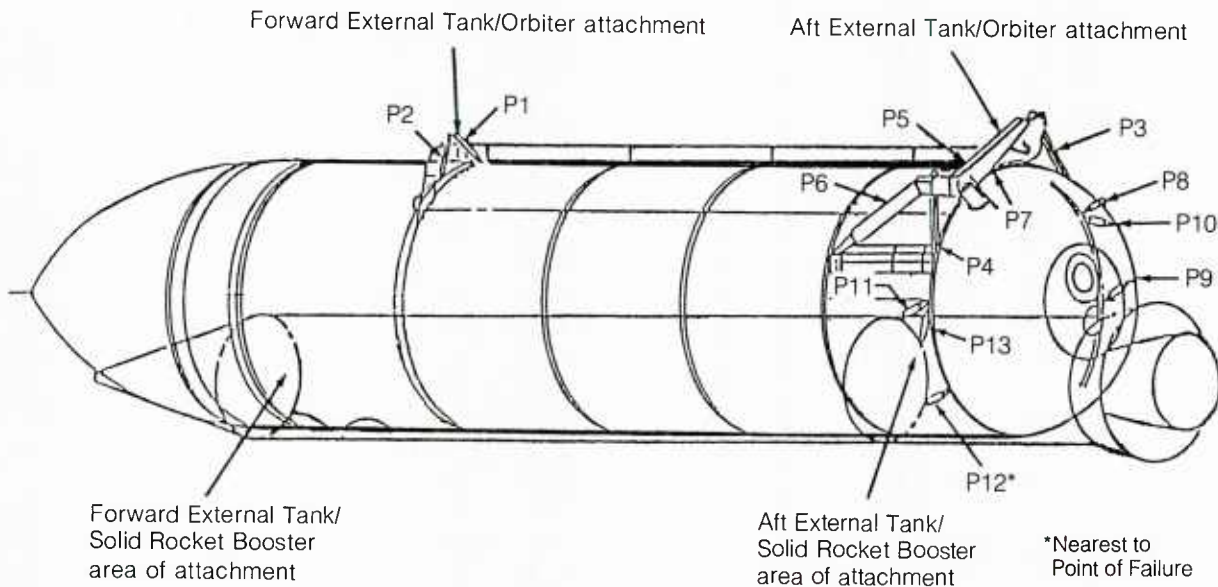
## Shuttle Strut Identification

Figure 10  
Drawing of transparent External Tank, with right Solid Rocket Booster on far side, shows location of struts measured in table of strut loads. (Figure 9)

The STS 51-L lift off loads were compared to design loads and flight measured loads for STS-1 through STS-7 (Figure 9). The Shuttle strut identification is shown in Figure 10. The loads measured on the struts are good indicators of stress since all loads between Shuttle elements are carried through the struts. The STS 51-L lift off loads were within the design limit.

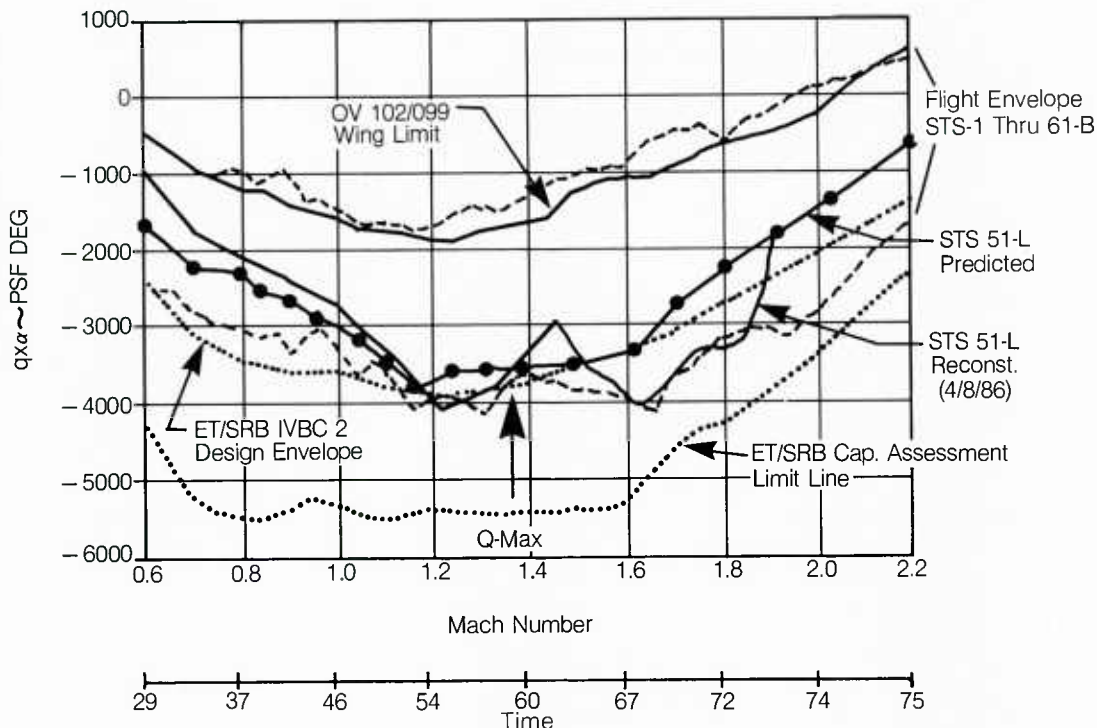
Loads were constructed for all in-flight events, including the roll maneuver and the region of maximum dynamic pressure. A representative measure of these loads is the product of dynamic pressure ( $q$ ) and the angle of attack ( $\alpha$ ). Since the Shuttle is designed to climb out at a negative angle of attack, the product is a negative number. The loads in the  $q \times \alpha$  pitch plane are shown in Figure 11. Although the  $q \times \alpha$  variations in loads due to wind shear were larger than expected, they were well within the design limit loads.

The Solid Rocket Motor field joint axial tension loads were substantially lower at maximum dynamic pressure than at lift off:  $11.6 \times 10^6$  pounds for the forward field joint and  $10.6 \times 10^6$  pounds for the aft field joint. Compared to the internal pressure loads, the dynamic variations due to wind shear were small—about  $\frac{1}{15}$  those of the pressure loads. *These loads were well below the design limit loads and were not considered the cause of the accident.*

Figure 11  
The loads in the pitch plane are shown by the solid line marked "STS 51-L RECONST." The curve "STS 51-L PREDICTED" give the loads expected before the flight. The dashed lines show the limit of experience from STS-1 through 61-B. The present design limits are the two lines marked "OV

102/099 WING LIMIT" above, and "ET/SRB CAP. ASSESSMENT LIMIT LINE" below. (After STS-6, the wing was strengthened. The previous design limits were "ET/SRB IVBC 2 DESIGN ENVELOPE" below, and a curve in the positive region of  $q \times \alpha$  above)

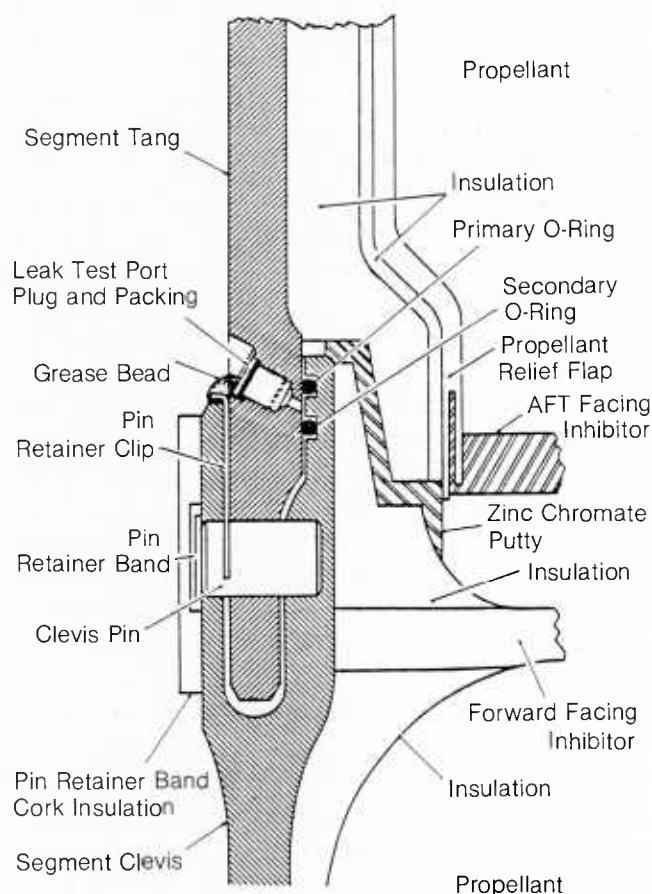
between the tang and the inside leg of the clevis. This gap between the tang and clevis at any location after assembly is influenced by the size and shape (concentricity) of the segments as well as the loads on the segments. Zinc chromate putty is applied to the composition rubber (NBR) insulation face prior to assembly. In the assembled configuration the putty was intended to act as a thermal barrier to prevent direct contact of combustion gas with the O-rings. It was also intended that the O-rings be actuated and sealed by combustion gas pressure displacing the putty in the space between the motor segments (Figure 14). The displacement of the putty would act like a piston and compress the air ahead of the primary O-ring, and force it into the gap between the tang and clevis. This process is known as pressure actuation of the O-ring seal. This pressure actuated sealing is required to occur very early during the Solid Rocket Motor ignition transient, because the gap between the tang and clevis increases as

Figure 14  
Solid Rocket Motor cross section shows positions of tang, clevis and O-rings. Putty lines the joint on the side toward the propellant.

pressure loads are applied to the joint during ignition. Should pressure actuation be delayed to the extent that the gap has opened considerably, the possibility exists that the rocket's combustion gases will blow by the O-ring and damage or destroy the seals. The principal factor influencing the size of the gap opening is motor pressure; but, gap opening is also influenced by external loads and other joint dynamics. The investigation has shown that the joint sealing performance is sensitive to the following factors, either independently or in combination:

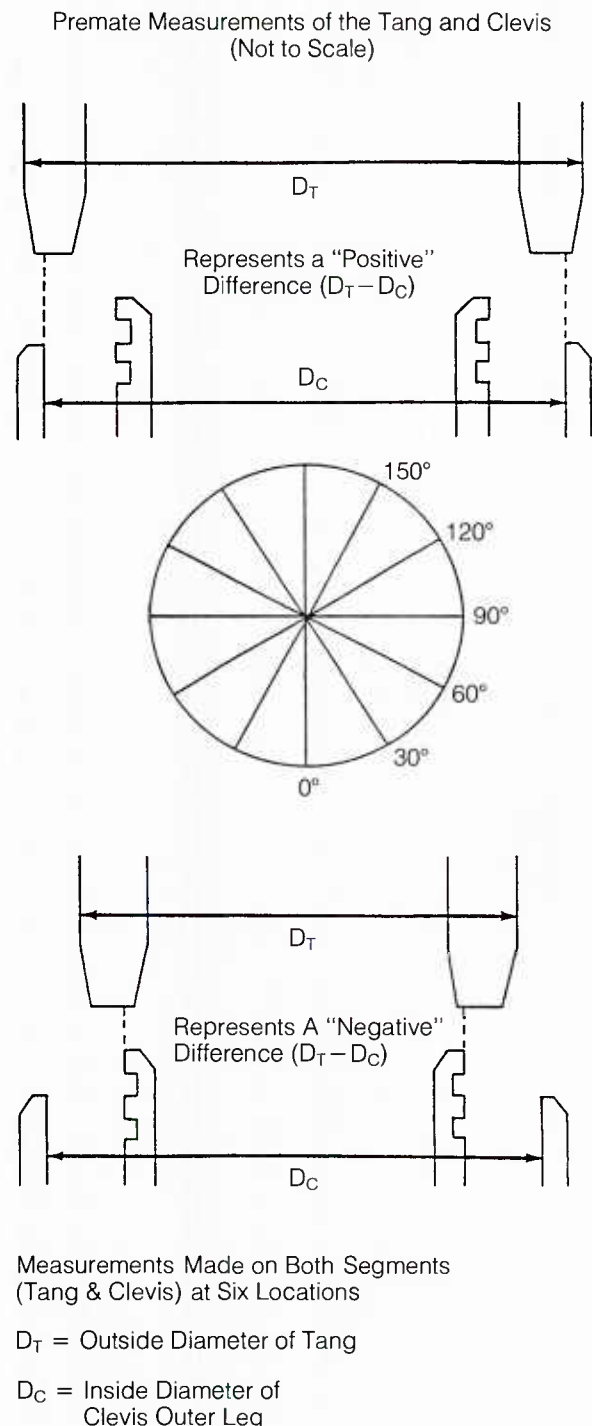
### SRB Joint Tang/Clevis Interference

Figure 15 Sketch shows how diameters of tang and clevis are measured to assure proper fit of two Solid Rocket Motor segments.

from previous use, and the effects of shipping and handling. The most important effect is from the load of propellant, a plastic and rubbery material, which can take a set that relaxes very slowly. For example, since the segments are shipped in a horizontal position on railroad cars, their weight can make them somewhat elliptical—a shape they can maintain for some time. At assembly, after the lower segment (with the clevis on top) is placed vertically, the tang of the next segment is lowered into it. To make the fit easier, the upper segment is purposely reshaped by connecting the lifting crane in an appropriate position and, on occasion (51-L was one of these), directly squeezing the tang section with a special tool. To monitor the fit, the diameters of the clevis,  $D_C$ , and the tang,  $D_T$  (Figure 15) are measured at six positions 30 degrees apart, and difference of these measurements ( $D_T - D_C$ ) are noted. When these differences are such that the tang encroaches somewhat into the outer clevis, slanted edges (chamfers) permit the pieces to slide together. If the difference is too great, flat areas of the tang meet flat areas of the clevis. What really counts, of course, are differences of radii, which diameter measurements alone do not determine, for one does not know during the assembly how far off the centers are. This is a circumstance to be avoided, but one that can be detected during assembly. Experience has shown that a diameter difference of less than +0.25 inches usually permits assembly without a flat-on-flat condition arising. A negative diameter difference means the tang encroaches on the inside of the clevis. The possibility was noted that contaminants from sliding metal and direct O-ring pinching might occur if this overlap is large. If it is too great, a flat-on-flat condition can arise inside the joint where it is very difficult to see. These dimensions shift as the pieces slide together and they change further as the propellant stresses relax during the period between assembly and launch. Therefore, a condition such as that which occurred during assembly of the aft segment for flight 51-L, wherein the maximum interference between tang and clevis at the O-rings was at approximately 300 degrees, may or may not have persisted until launch—seven weeks after assembly.

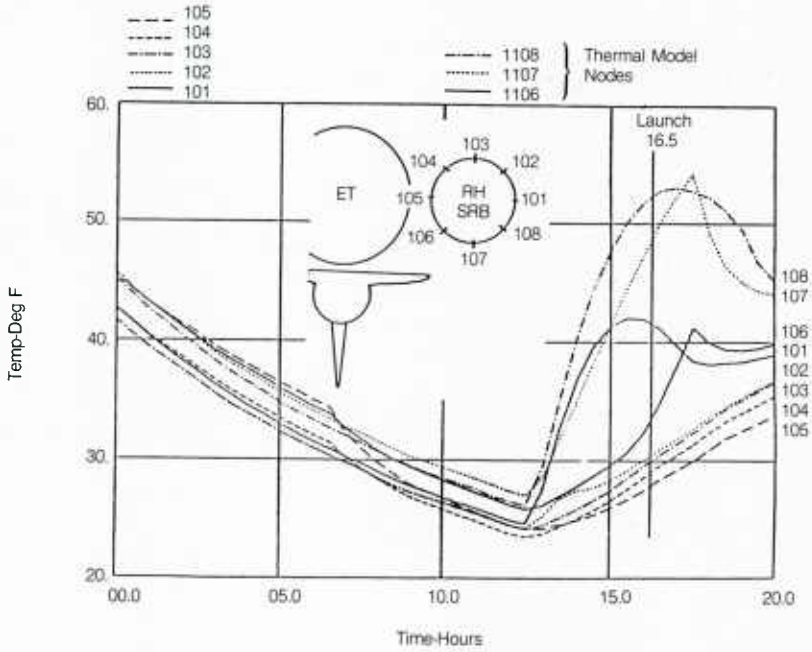
**Aft Right Segment Temperatures for STS 51-L**

joint in Figures 20 and 21. These data are representative of other joints on the respective Solid Rocket Motors.

Figure 20  
Temperature model for 51-L right solid booster aft segment circumferential positions from 16.5 hours prior to launch to 3.5 hours after launch.

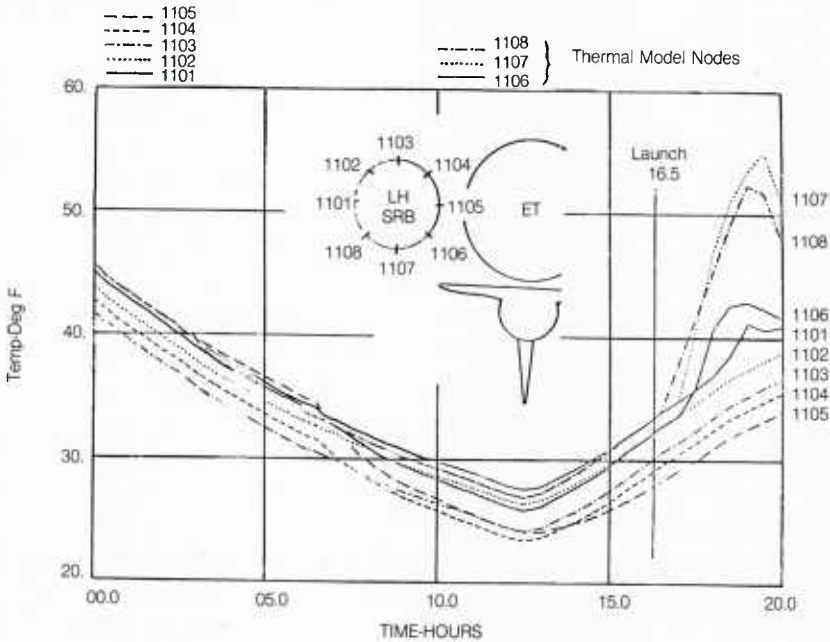
**Aft Left Segment Temperatures for STS 51-L**

Figure 21  
Temperature model for 51-L left solid booster aft segment circumferential positions from 16.5 hours prior to launch until 3.5 hours after launch.

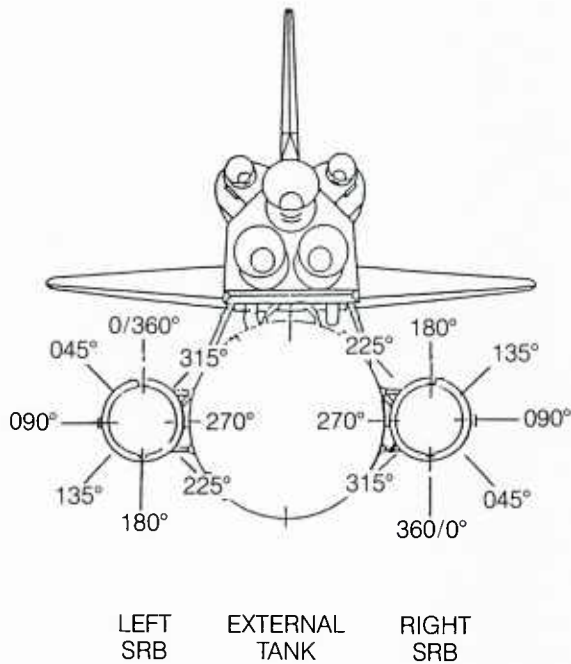
**Angular Coordinate System  
For Solid Rocket Boosters/Motors**  
Figure 26

parts 131, the upper segment tang region, and part 712, the lower clevis region of the joint. This burned area extends roughly from station 1476, in the upper section, to 1517 on the lower region. In a circumferential direction (see figure 26) the lower end of the eroded region extends from roughly 291 degrees to 320 degrees and the upper eroded section extends between 296 and 318 degrees. Note that the region at about 314 degrees includes the attachment region of the strut to the attachment ring on the right Solid Rocket Booster.

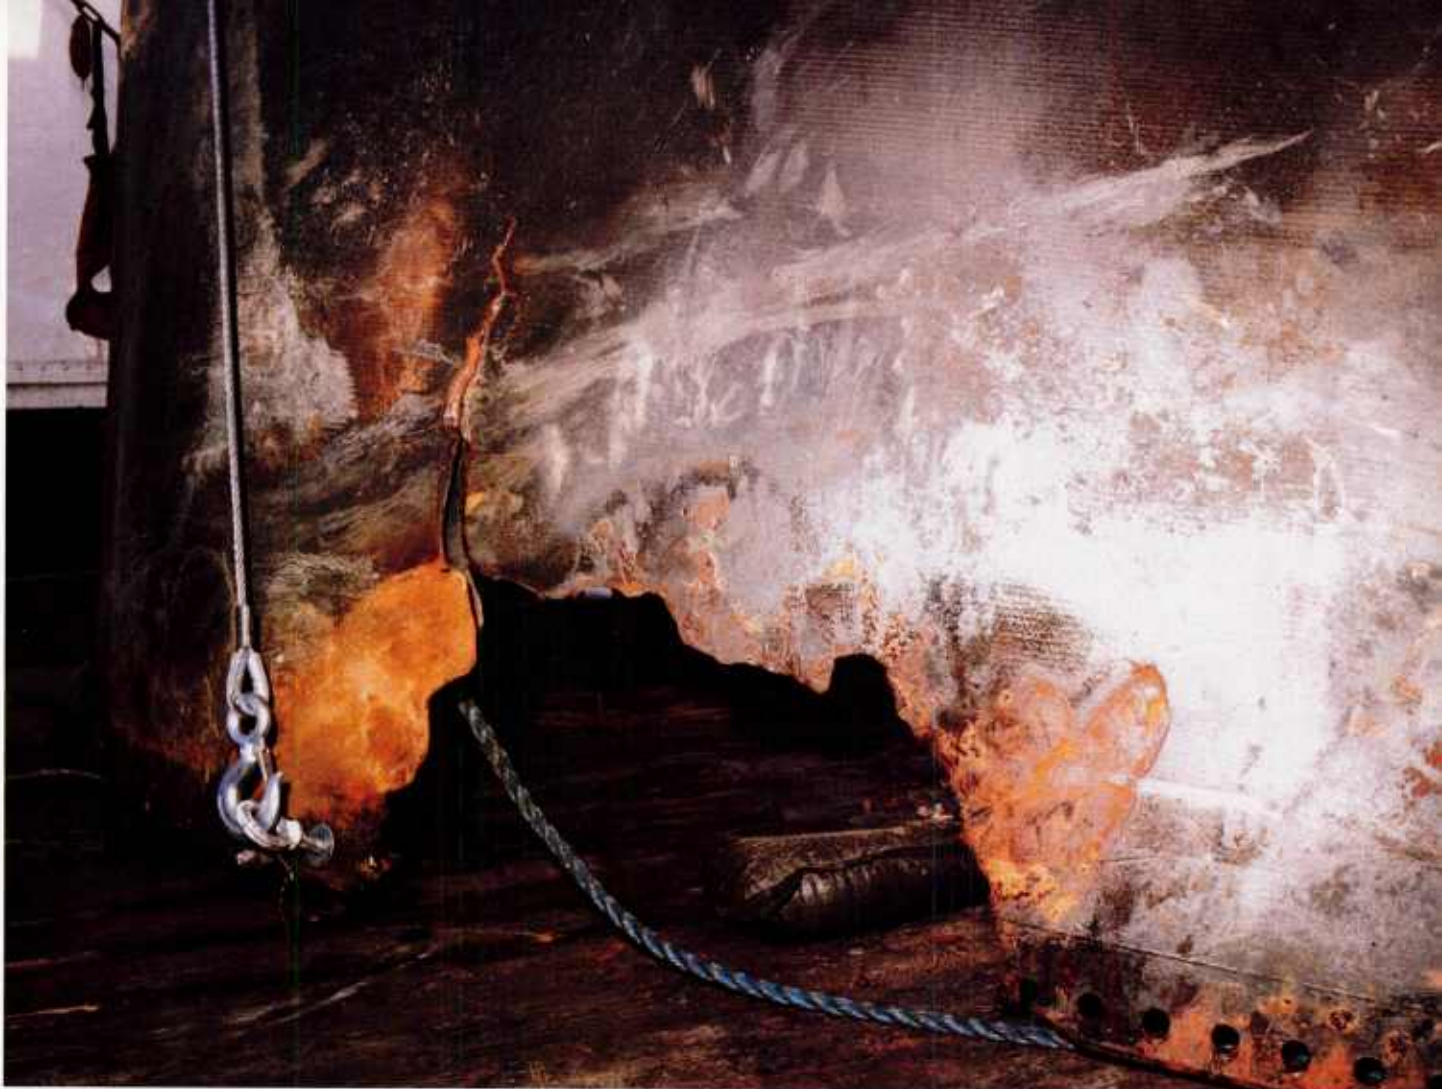
I

Some observations were made from a detailed examination of the aft center section of the joint, contact 131. This piece (photo I) shows a large hole that is approximately centered on the

307-degree circumferential position. Although irregular, the hole is roughly rectangular in shape, extending approximately 27 inches circumferentially along the tang (296 to 318 degrees) with total burnout extension approximately 15 inches forward of the tang. At either side in the interior of the hole (photo K) the insulation and steel case material showed evidence of hot gas erosion that beveled these surfaces (indicative of combustion products flowing through the hole from the interior of the Solid Rocket Motor). The top surface of the hole was hardly beveled at all. The

L  
 Examined at Kennedy Space Center after their recovery from the ocean, these fragments show the extent of burn through the right hand booster's aft field joint. On the left page are sections of the aft center motor segment above the joint. On the right page are sections (inverted) of the aft motor segment showing burn-hole below the joint (bracket). Except for the interior views on lower left, the camera is viewing the parts from outside the casing.

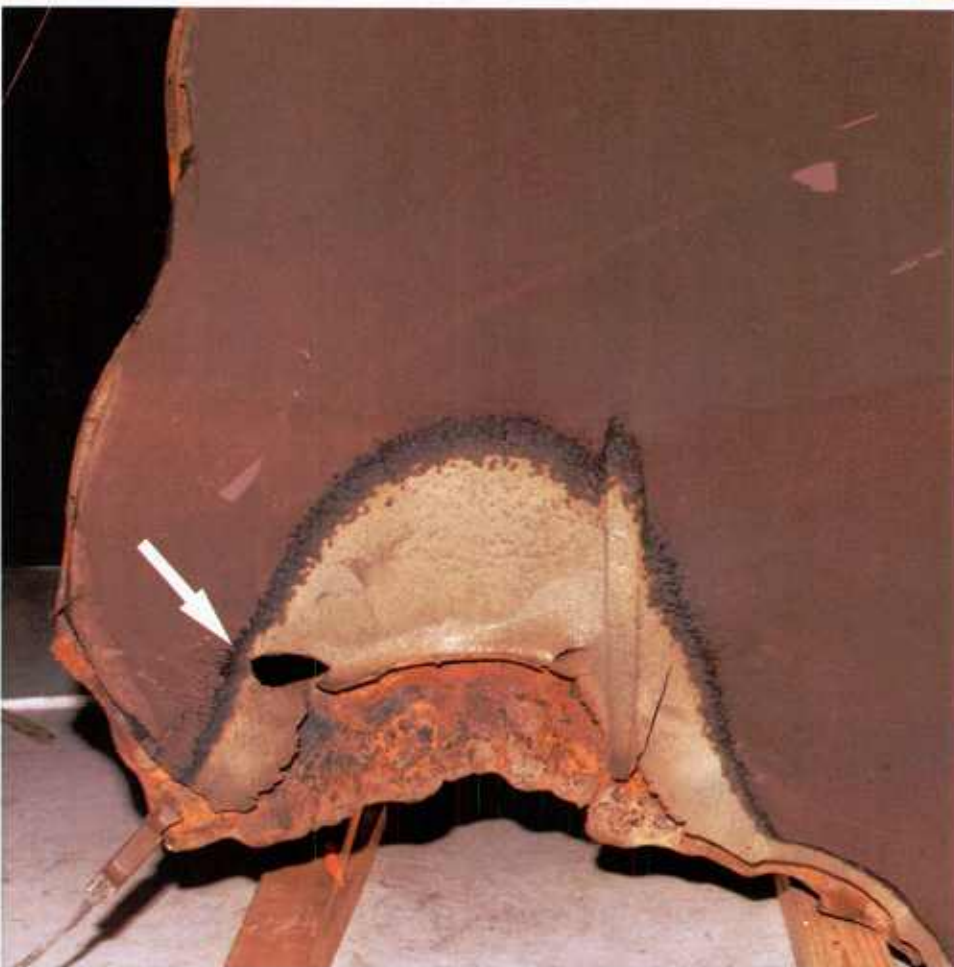
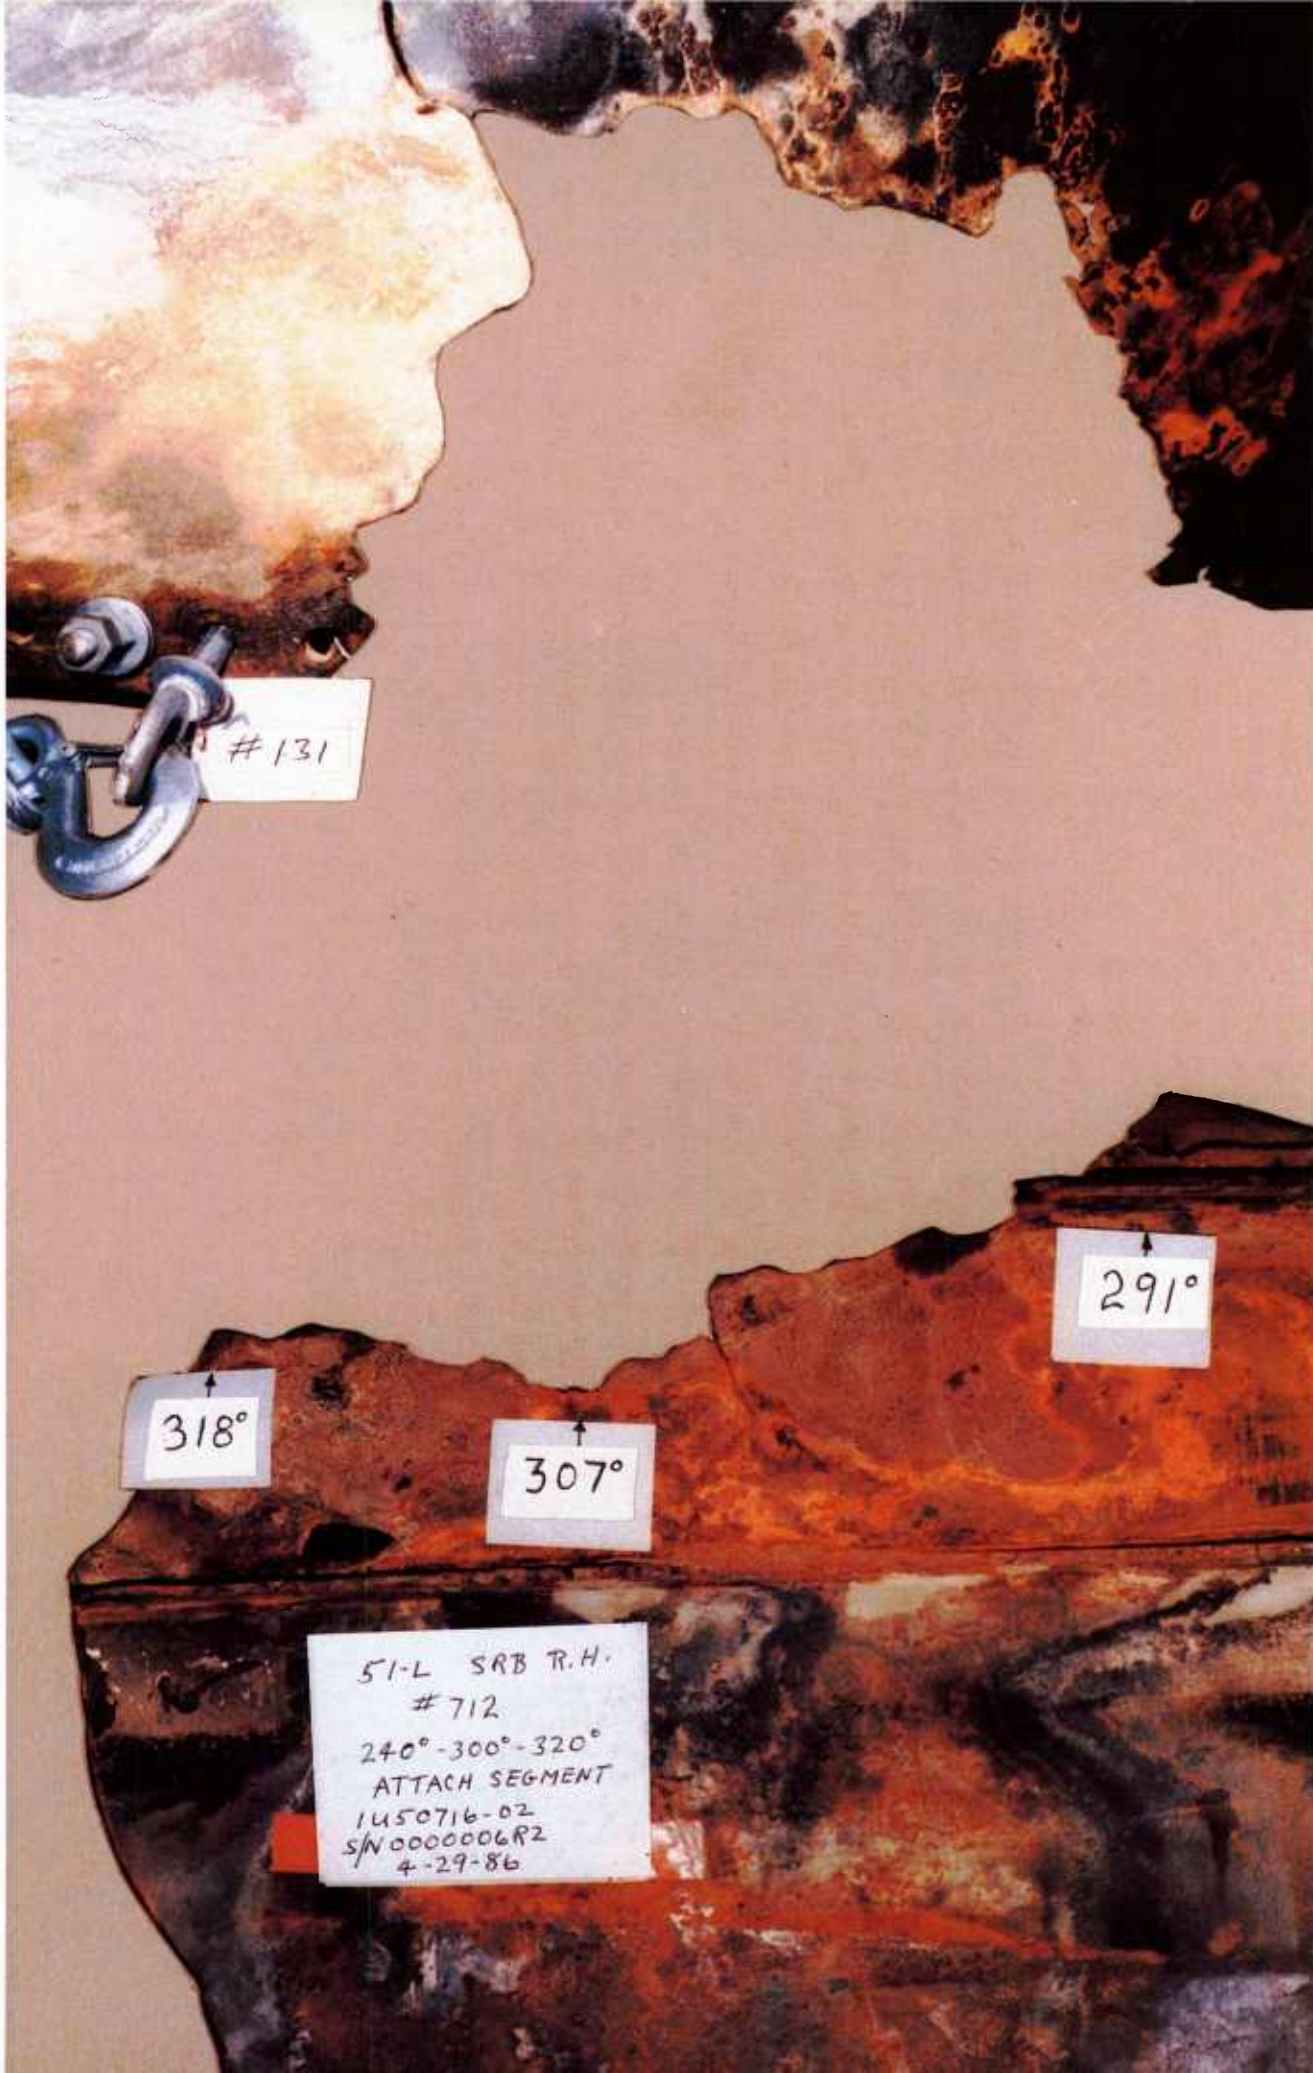
At upper left is the aft segment burn viewed from inside the casing; the lower photo is a closeup of the same section. The latter photo shows a hole (arrow) where the flame plume may have burned through the casing from the outside. At right is a composite view of the burn above and below the aft field joint.

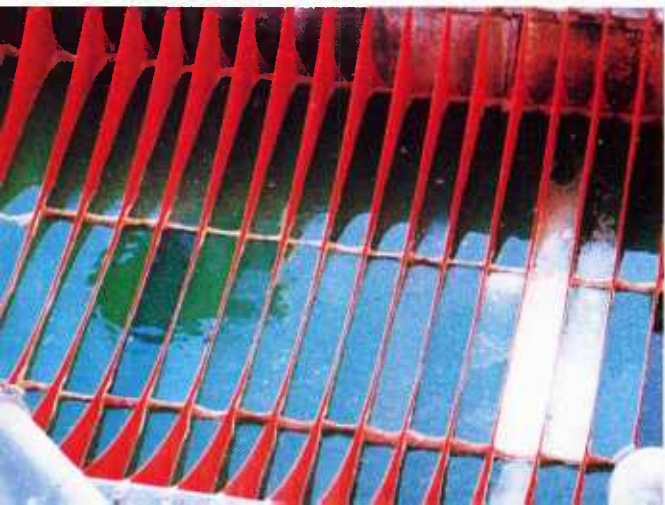
Above, Shuttle 51-L on Kennedy Space Center Pad 39B in the early morning of launch day. Temperatures were well below freezing, as indicated by the lower left photo, which shows thick ice in a water trough despite use of an anti-freeze solution.

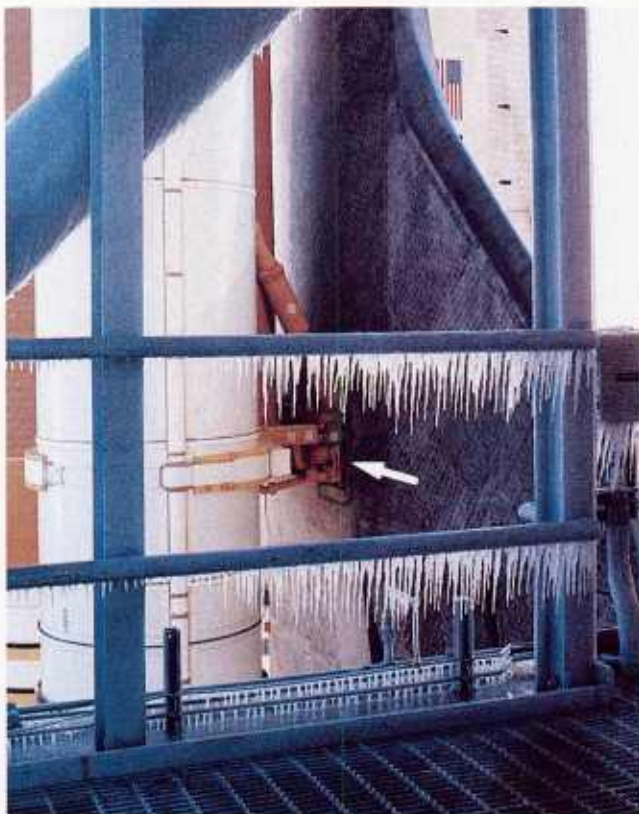
Above, foot long icicles on a lower level of the Fixed Service Structure frame the attachment point where the Orbiter is attached to the external tank (arrow). Icing was even more extensive at upper levels of the service structure (upper right and below). At right below is a ground communications box (not used during launch) rendered inoperable by heavy ice.

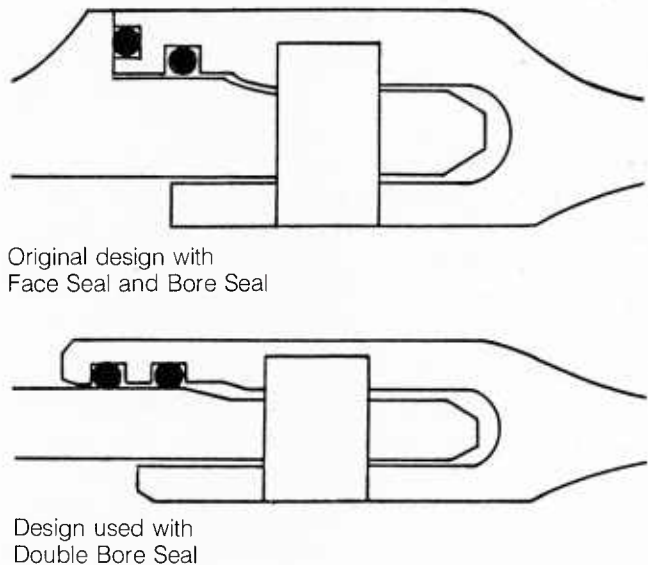
Figure 1

The initial Thiokol design proposal was changed before the production motors were manufactured. Originally, the joint seal design incorporated both a face seal and a bore seal.<sup>16</sup> (Figure 1.) However, the motor that was eventually used had double bore O-rings. The original bore seal/face seal design was chosen because it was anticipated that it “provides [better] redundancy over a double bore ring seal since each is controlled by different manufacturing tolerances, and each responds differently during joint assembly.”<sup>17</sup> Because the early design incorporated tolerances similar to the Titan and it also incorporated a face seal, Thiokol believed it possessed “complete, redundant seal capability.”<sup>18</sup>

Nevertheless, as the Solid Rocket Motor program progressed, Thiokol—with NASA’s concurrence—dropped the face/bore seal design for one using a double bore seal (Figure 1). NASA engineers at Marshall said the original design would have required tapered pins to maintain necessary tolerances and assure enough “squeeze” on the face-sealing O-ring.<sup>19</sup> However, design analysis determined that motor ignition would create tension loads on the joint sufficient to cause the tapered pins to pop out. Solving that would have meant designing some type of pin-retainers. Moreover, the rocket assembly was much easier with the dual bore seals. Because inspections and tests had to be conducted on the Solid Rocket Motor stack, horizontal assembly was required. Thiokol engineer, Howard McIntosh, described this in a Commission interview on April 2, 1986:

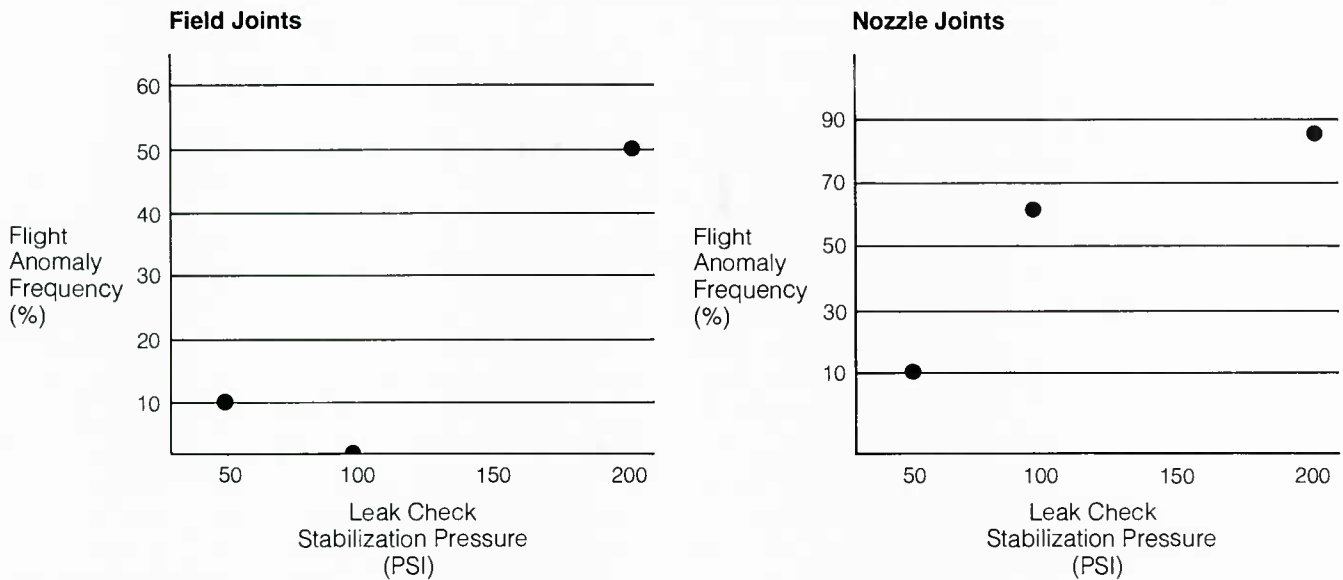
Graphs depict flight anomaly frequency for both field and nozzle joint of solid motors for a variety of leak check pressures. Figure 3

This hypothesis that O-ring erosion is related to putty blow holes is substantiated by the leak check history (Figure 3). Prior to January, 1984, and STS 41-B, when the leak check pressure was

The trends of flight anomalies in relation to leak check stabilization pressure are illustrated for the field joint and the nozzle joint in Figure 3, on page 133. While the data point concerning the 100 pound per square inch field joint leak check is not conclusive since it is based on only two flights, the trend is apparent.

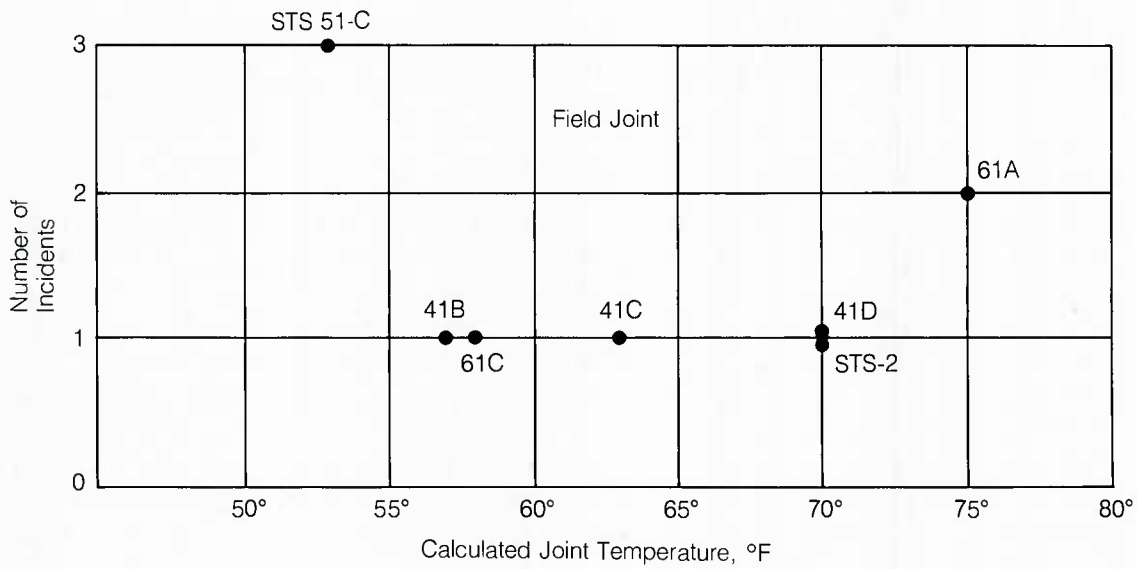
cy of occurrence based on all flights (Figure 6). In such a comparison, there is nothing irregular in the distribution of O-ring “distress” over the spectrum of joint temperatures at launch between 53 degrees Fahrenheit and 75 degrees Fahrenheit. When the entire history of flight experience is considered, including “normal” flights with no erosion or blow-by, the comparison is substantially different (Figure 7).

Figure 6  
Plot of flights with incidents of O-ring thermal distress as function of temperature

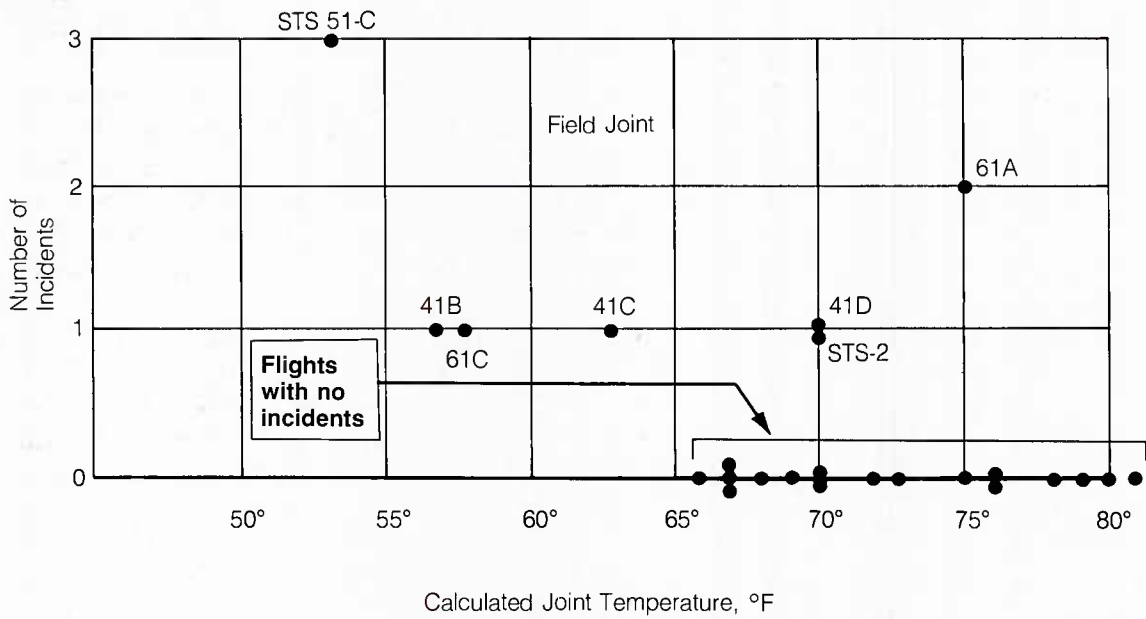
Figure 7  
Plot of flights with and without incidents of O-ring thermal distress

NOTE: Thermal distress defined as O-ring erosion, blow-by, or excessive heating

6. A careful analysis of the flight history of O-ring performance would have revealed the correlation of O-ring damage and low temperature. Neither NASA nor Thiokol carried out such an analysis; consequently, they were unprepared to properly evaluate the risks of launching the 51-L mission in conditions more extreme than they had encountered before. ■

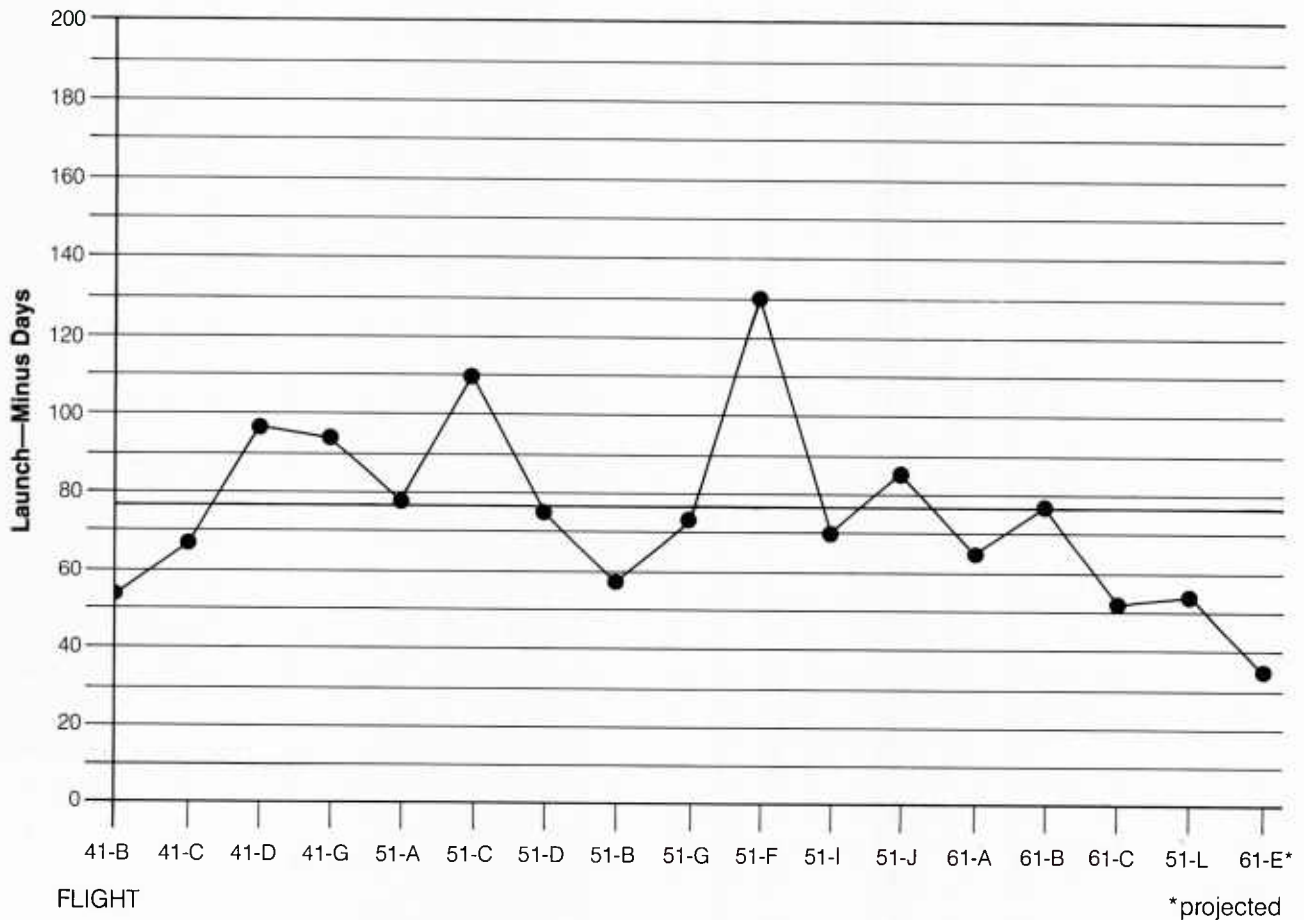
Graph depicts beginning of simulator training for Shuttle crews in days before launch for missions 41-B through 61-E.

behind. An assessment of the system's overall performance is best made by studying the process at the end of the production chain: crew training. Analysis of training schedules for previous flights and projected training schedules for flights in the spring and summer of 1986 reveals a clear trend: less and less time was going to be available for crew members to accomplish their required training. (See the Shuttle mission simulator training chart.)

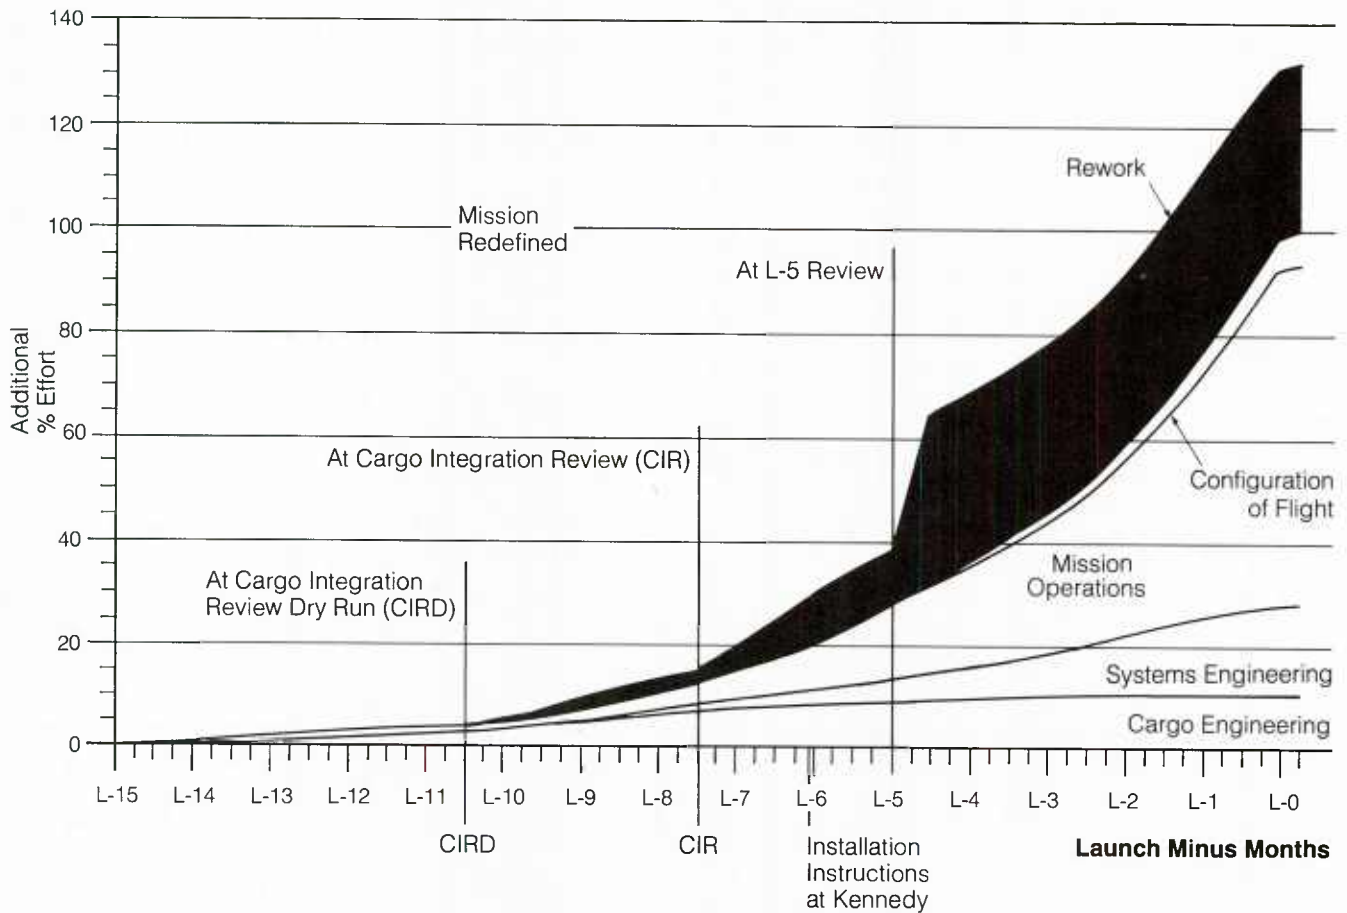
Graph shows that changes to the payload manifest for Shuttle missions can boost Johnson Space Center workload as much as 130 percent.
