# PRESIDENTIAL COMMISSION

*on the Space Shuttle  
Challenger Accident*

*Report to the President*

June 6th, 1986  
Washington, D.C.

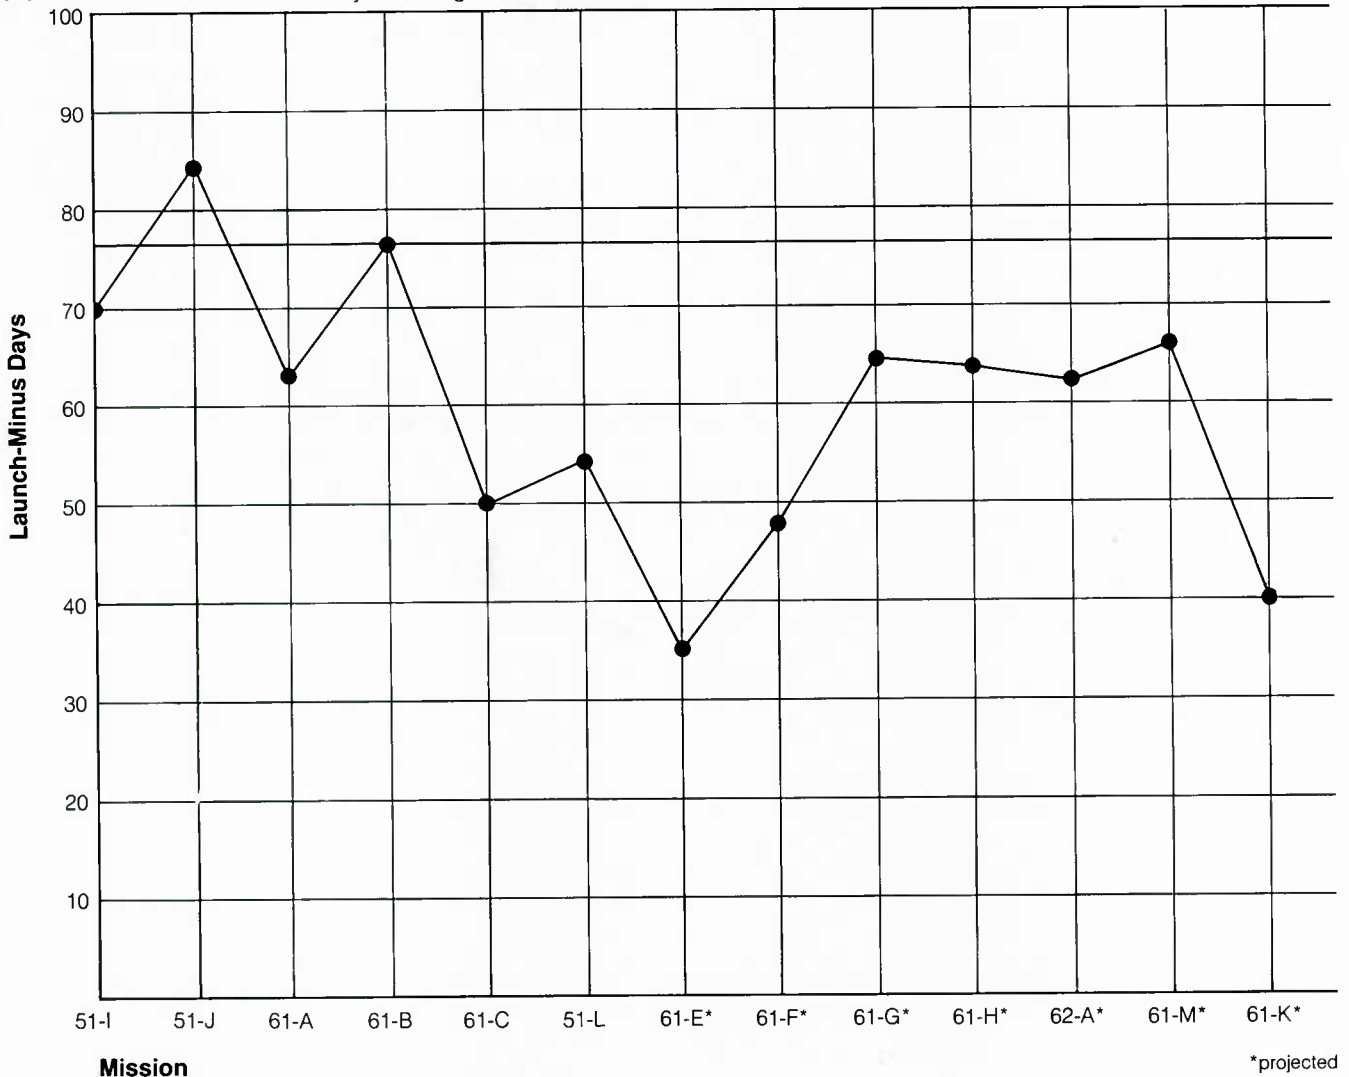
Graph depicts beginning of simulator training for Shuttle crews in days before launch for missions 51-L through 61-K. Launch minus 77 days is normal training date start.

Again, a "single" late change affected at least two flights very late in the planning and preparation cycles.
