TECHNICAL REPORT M-86/17
September 1986
Underground Distribution Systems

Corrosion of Aluminum Jackets on Aboveground Heat Distribution Systems

by
Kirk E. Cooper
Ellen G. Segan

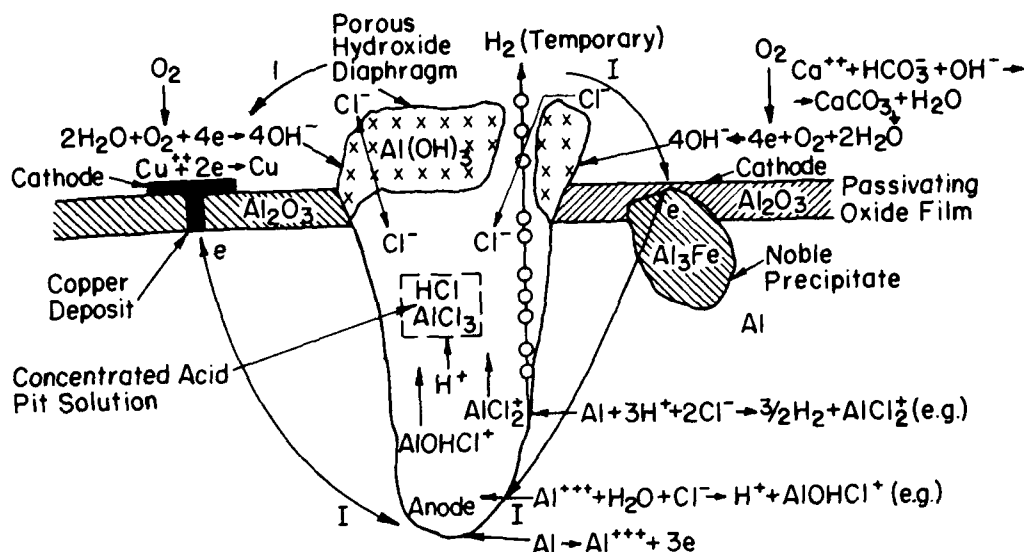
condensate water . . .¹⁰ Several investigations¹¹ have shown that large amounts of chloride ions were present in the corroded systems. It is well known that chlorides in solution are a major cause of pitting corrosion in passive metals such as aluminum;¹² the chloride ions migrate to anodic sites where metal ions hydrolyze and form a protective oxide or hydroxide.¹³ The deleterious effect of dissolved chlorides is enhanced by the presence of local galvanic cells resulting from metal particles or intermetallic phases. Figure 1 shows the mechanism of pitting involving these factors.

Figure 1. Typical reactions within an aluminum pit. (From *Corrosion, Volume 1: Metal/Environment Reactions*, L. L. Shreir, ed., 2nd ed. [Newnes-Butterworths, London, 1976]).

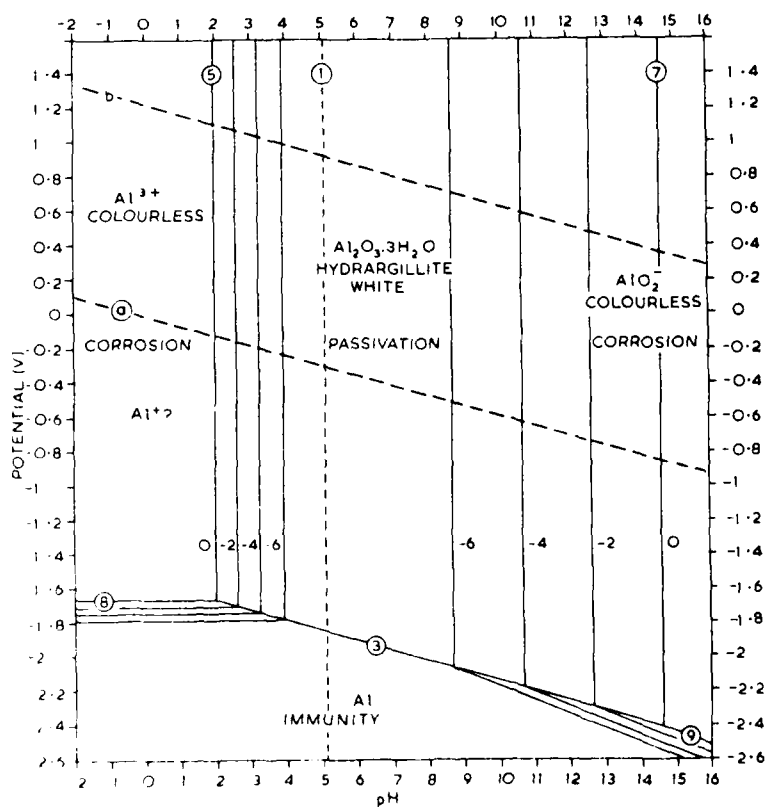
As suggested above, pH also plays a role in aluminum pitting. Mechanical defects in the protective oxide layer may act as sites for pit initiation in alkaline media.¹⁴ Pits behave like occluded cells, in which pronounced decreases in pH and high chloride ion concentrations (often a seven to twelvefold increase over the bulk solution) are observed.¹⁵ In such a case, the potential inside the pit is in the active region (Figure 2), while most of the specimen may be in the passive region.

regions. The aluminum alloys used contained no unusual microstructural features or compositional anomalies that would reduce their resistance to pitting. Alkaline media also enhanced attack of the aluminum in a freely corroding situation (Figure 2).

Figure 2. Potential versus pH diagram for Al/H₂O system at 25°C. (From *Corrosion, Volume 1: Metal/Environment Reactions*, L. L. Shreir, ed., 2nd ed. [Newnes-Butterworths, London, 1976]).
