TECHNICAL REPORT REMR-CO-1

**STABILITY OF RUBBLE-MOUND
BREAKWATER AND JETTY TOES;
SURVEY OF FIELD EXPERIENCE**

Dennis G. Markle

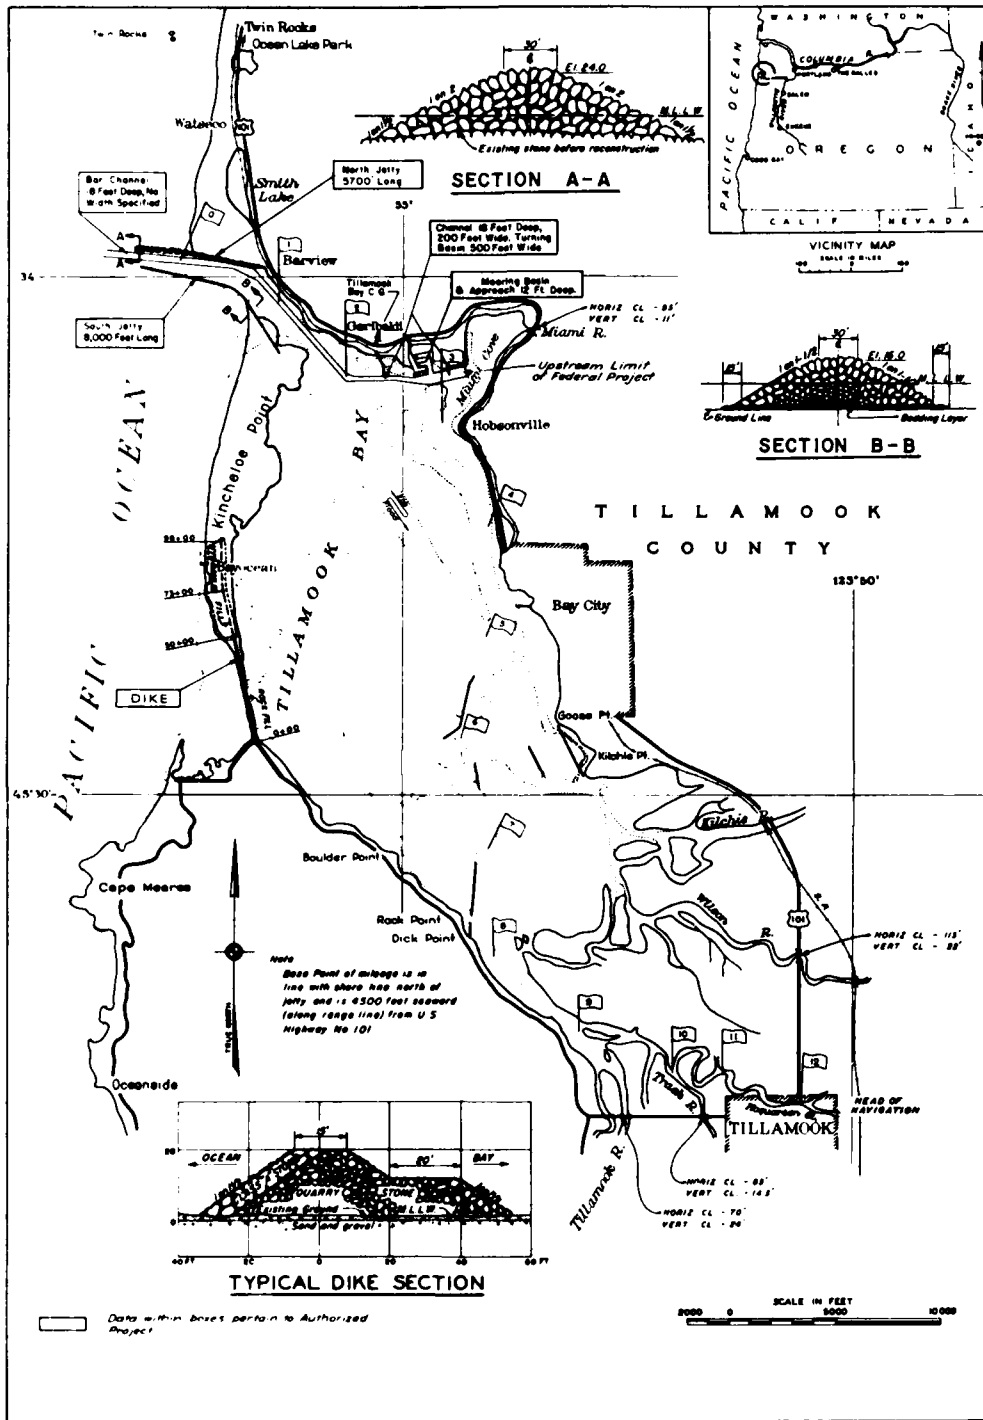
Figure 8. Tillamook Bay Jetties, Oregon

and (c) wave-induced displacement of toe berm stone and/or scour of foundation material which results in undermining of the structure's toe. As a result of this displacement, scour, and/or undermining of the structure's toe, the primary armor stone layers become unstable and lead to structural failure. The Portland District carries out repair in these scour areas by filling the scour holes with small stone, core size or smaller, to form a foundation to rebuild the toe and upper portions of the structure. During the repairs and rehabilitations of the north jetty at Yaquina Bay and Jetty "A" at the mouth of the Columbia River, a sacrificial berm of core-sized material was placed at the structure's toe after the primary armor layers had been placed. It was thought that this material would help stabilize the jetty toes by slowing down the scour rate as well as providing some degree of armoring of the scour hole as the berm stone is displaced into the scour hole. In some instances, scour at the jetty heads has been so severe that it was not economically feasible to try to fill and stabilize the scour holes. The best approach in these cases was to abandon the outer 200 to 300 ft of the jetty heads and rehabilitate the remainder of the structure.

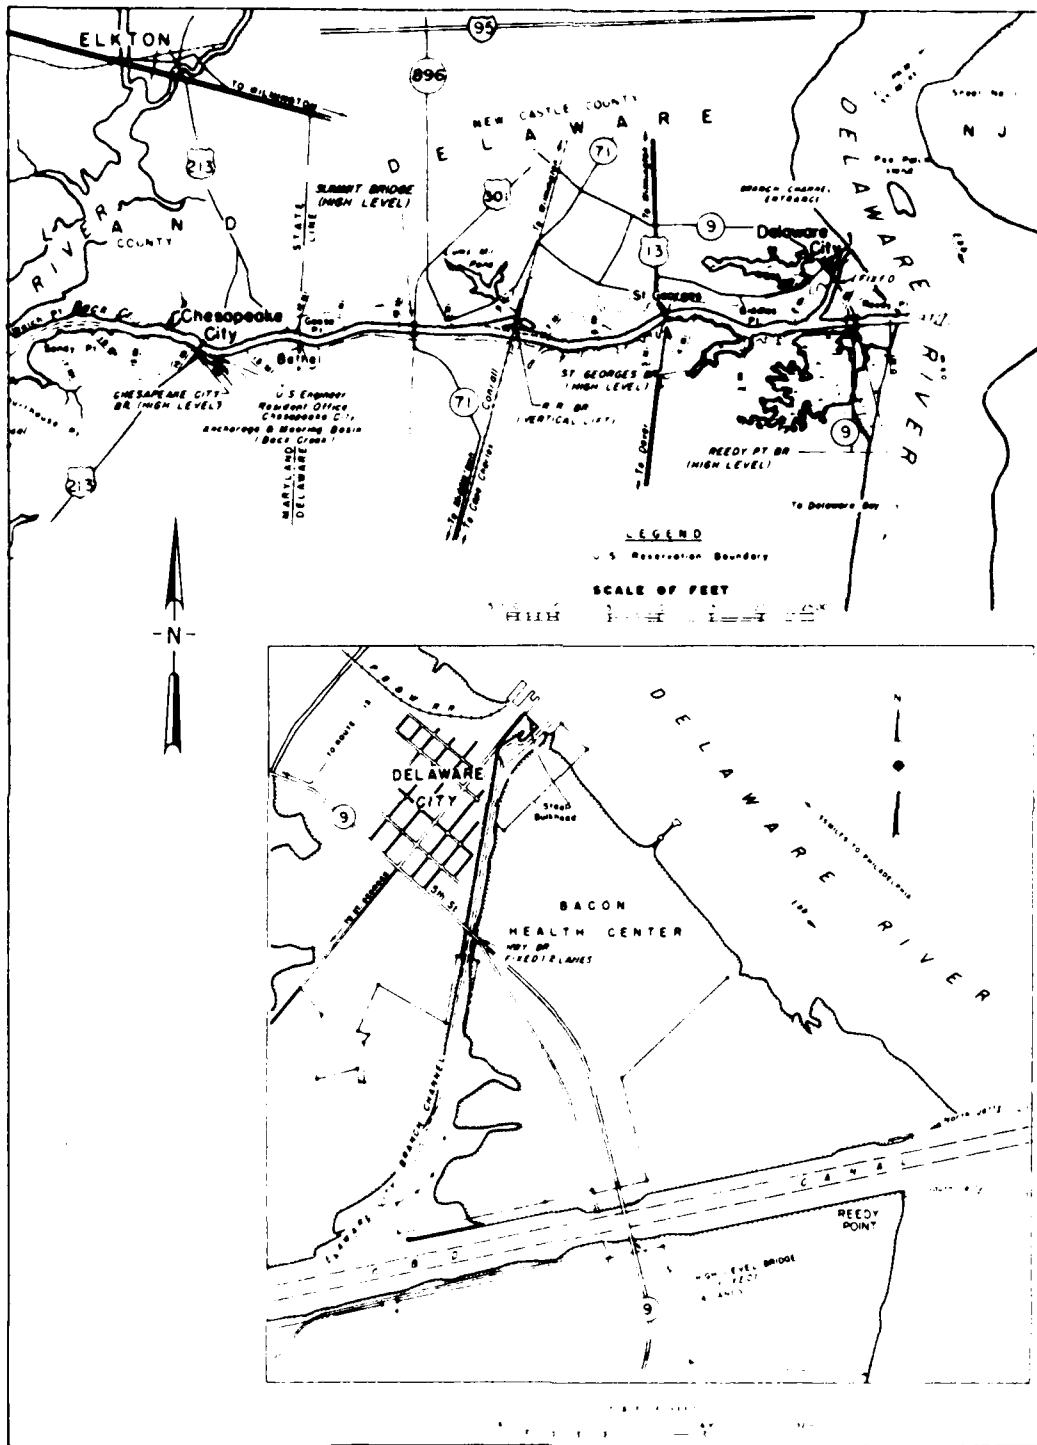
Figure 28. Reedy Point Jetties, Delaware

26. The jetties located at Reedy Point, where the Chesapeake and Delaware Bay Canal intersects the Delaware River, were originally constructed prior to 1938 (Figure 28). Both structures were of rubble-mound construction. In the 1960's the existing south jetty was removed, and a new south jetty was constructed farther south. This was done to increase the entrance size to accommodate larger vessels and improve navigation safety. The present jetties are both 2,095 ft long, and it was reported that the north jetty has problems with toe scour, loss of armor stone, and overall subsidence.

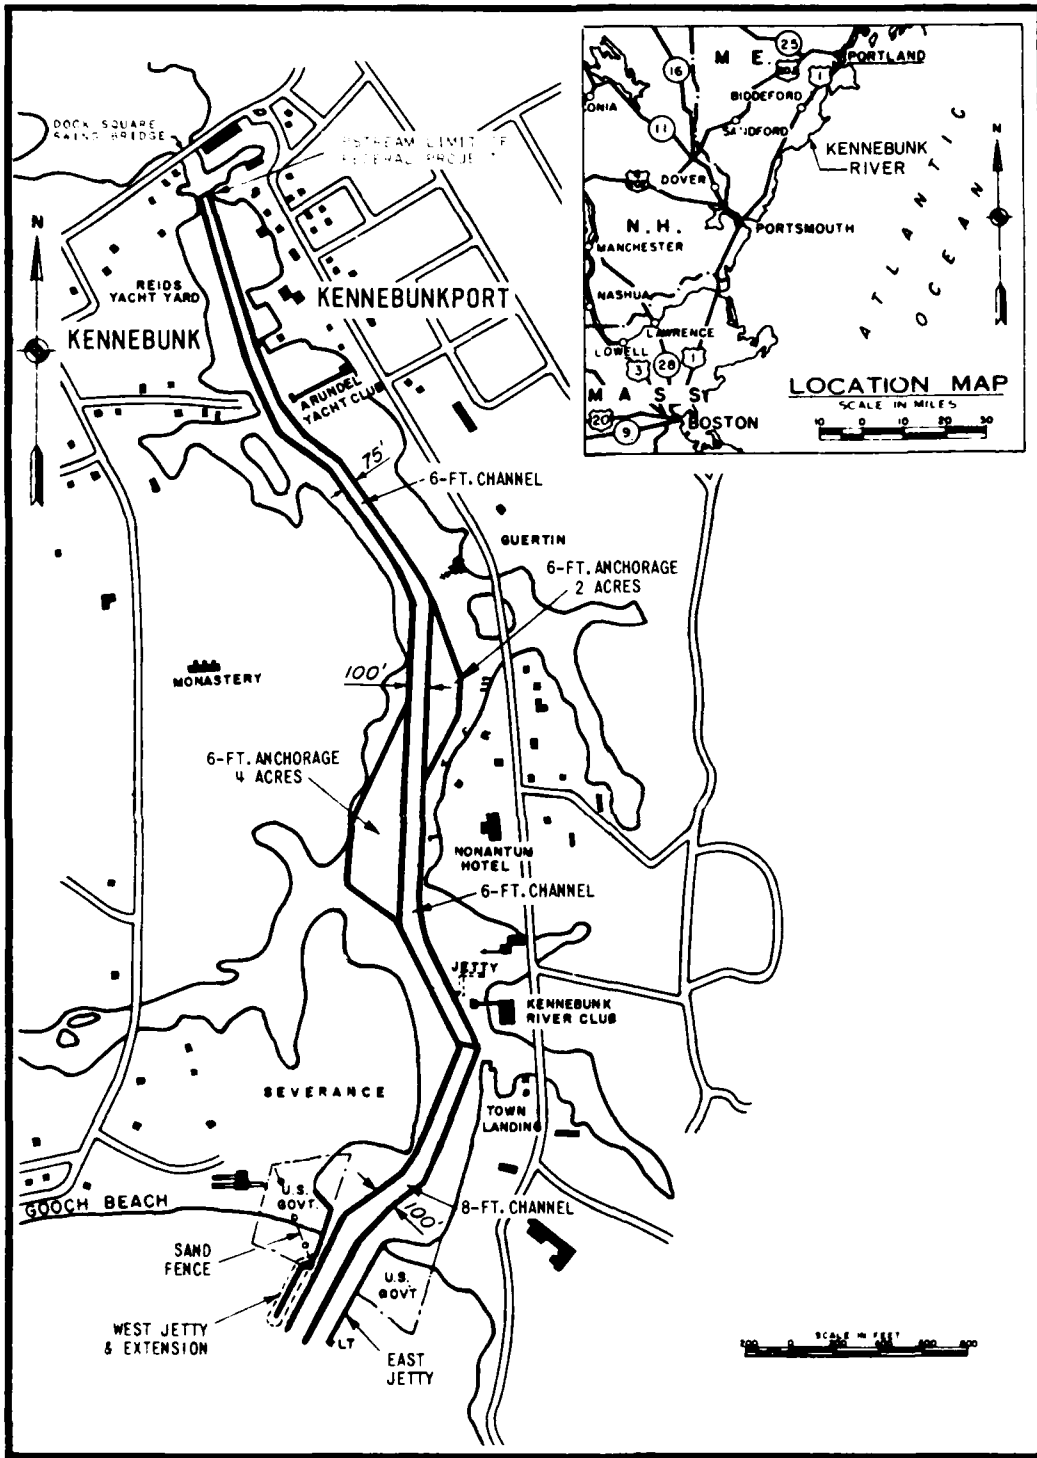
Figure 30. Kennebunk River Jetties, Maine

28. Based on review of historical repair data, it appears that three project sites within the New England Division that contain rubble-mound jetty structures have exhibited stability problems which could be related to instability of the structure toes. Both jetties at the mouth of the Kennebunk River, Maine (Figure 30), have a history of extension and repair. The latest jetty rehabilitation work was completed in 1982. Recent inspections show that both jetty heads are damaged and that 250 ft of the channel side of the east jetty have been undermined. The most recent inspection reports (1973-74), indicate that the north and south jetties at Newburyport Harbor, Massachusetts

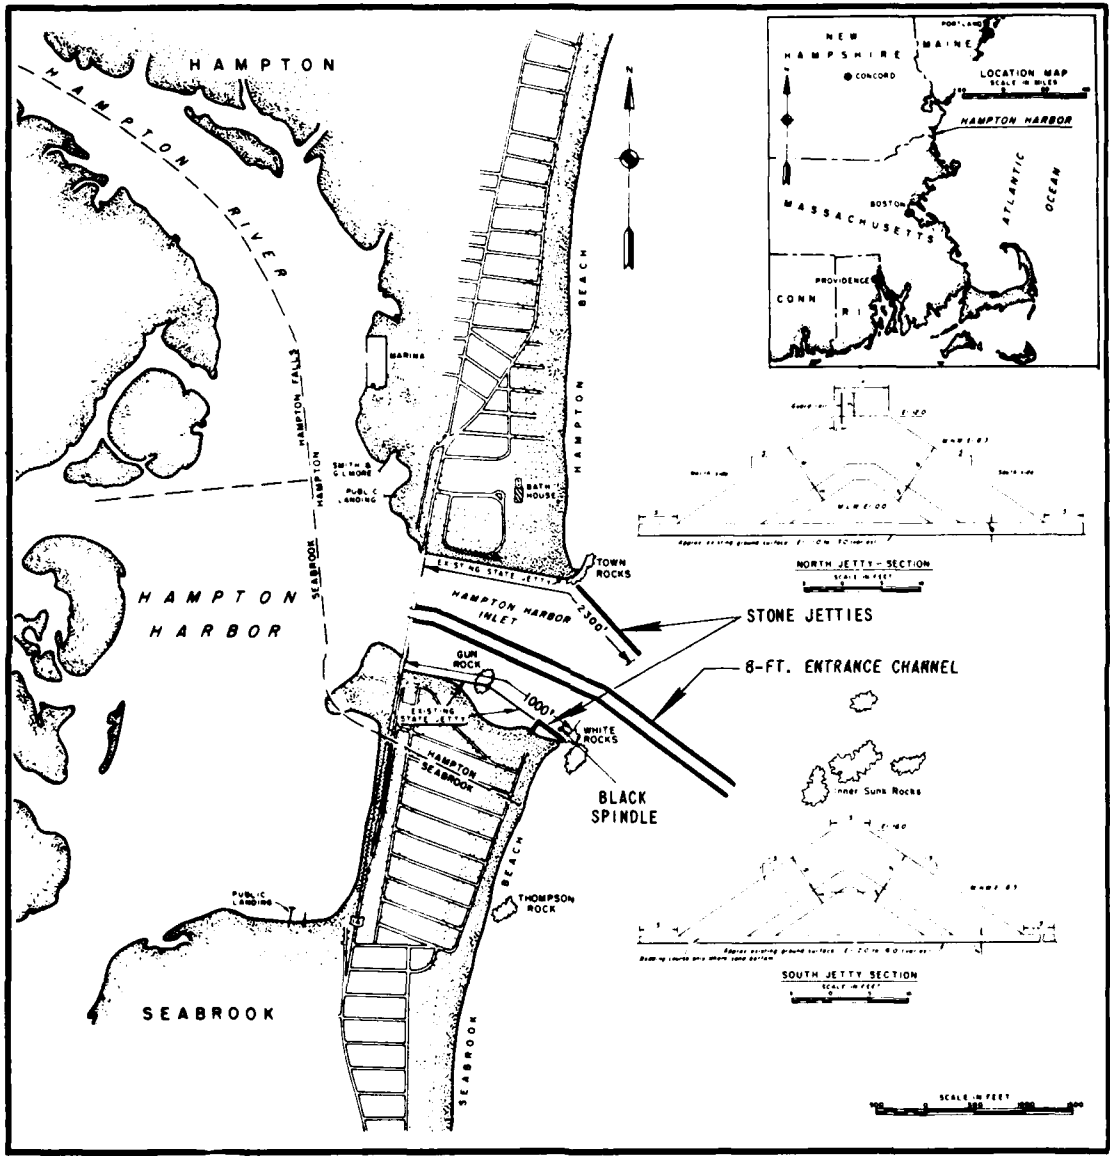
Figure 32. Hampton Harbor Jetties, New Hampshire

(Figure 31), which have an extensive repair and rehabilitation history, are showing considerable damage. This damage appears to result primarily from subsidence. Damage on four areas on the channel side of the south jetty most likely result from undermining of the rubble toe. The jetties at Hampton Harbor, New Hampshire (Figure 32), were originally constructed by the State and were turned over to the Corps in 1964. During 1965 to 1966, considerable work was done on both jetties. Since that time the south jetty has remained in good condition, while the north jetty has required continuous maintenance. Most of the repair and rehabilitation work has been needed on the seaward portions of the north jetty. The last rebuilding of the north jetty was completed in 1980, and it is thought that part of this recurring damage can be attributed to scour and undermining of the jetty toe.

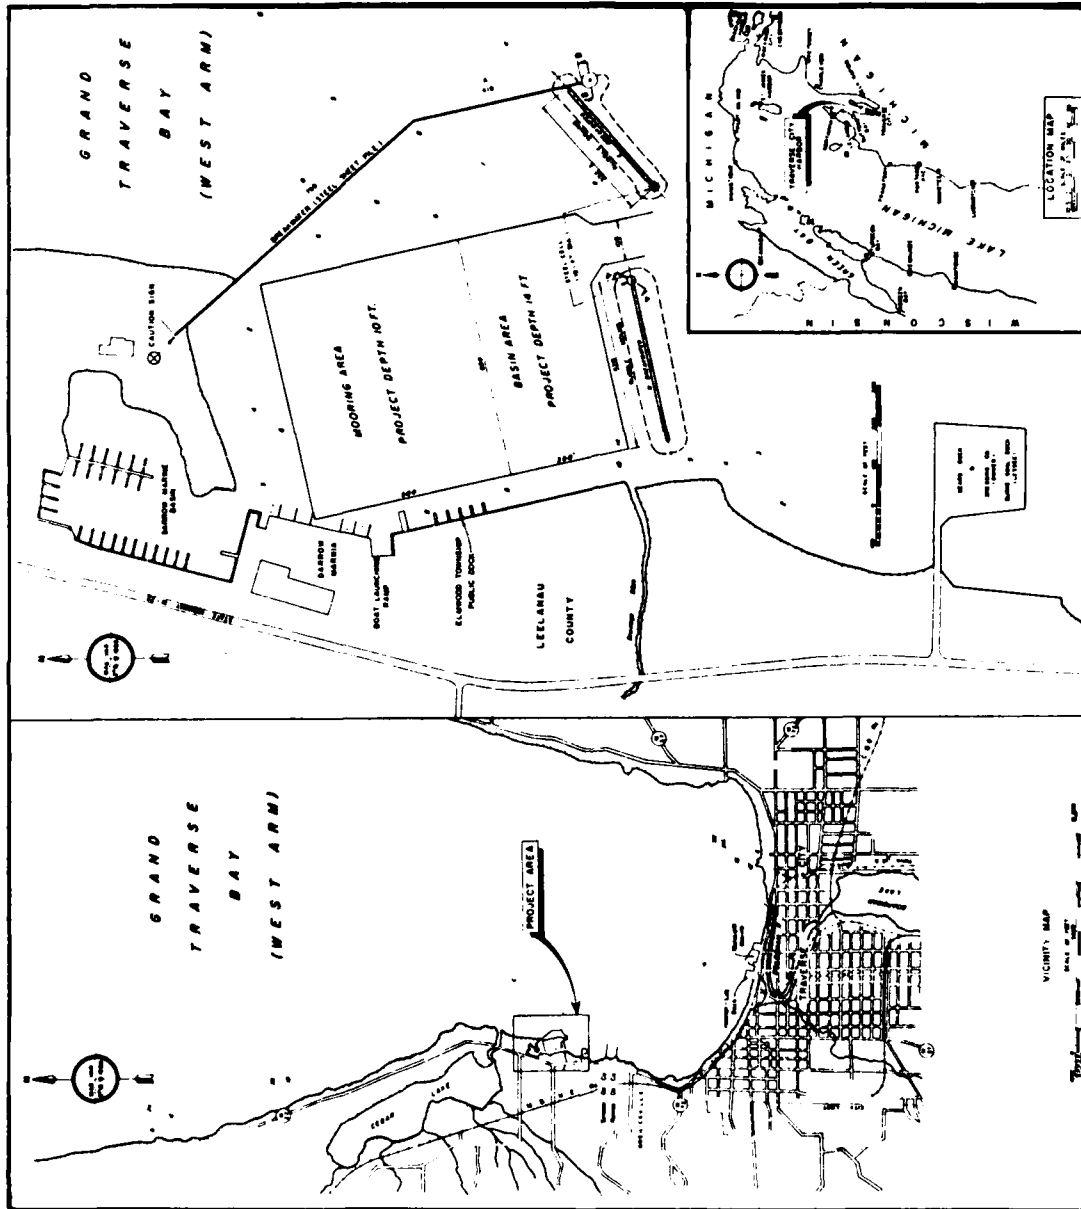
Figure 54. Traverse City Harbor Breakwaters, Michigan

30. Structures at Black River Harbor, Cheboygan Harbor, Hammond Bay Harbor, Harrisville Harbor, New Buffalo Harbor, and Point Lookout Harbor, Michigan, are purely rubble-mound construction (Figures 33-40). Charlevoix Harbor, Michigan; Duluth-Superior Harbor, Minnesota and Wisconsin; and Leland Harbor, Muskegon Harbor, Pentwater Harbor, Port Washington Harbor, and Traverse City Harbor, Michigan (Figures 41-55), have structures that are composed of a combination of rubble mound, timber cribs, timber piles, steel sheet piles, concrete caissons, steel cells, concrete caps, and concrete superstructures. The head of the east jetty on the north end of the Keweenaw Waterway, Michigan (Figures 56 and 57), is an old timber crib which is encased in rubble. For this reason, its response is very similar to that of a purely

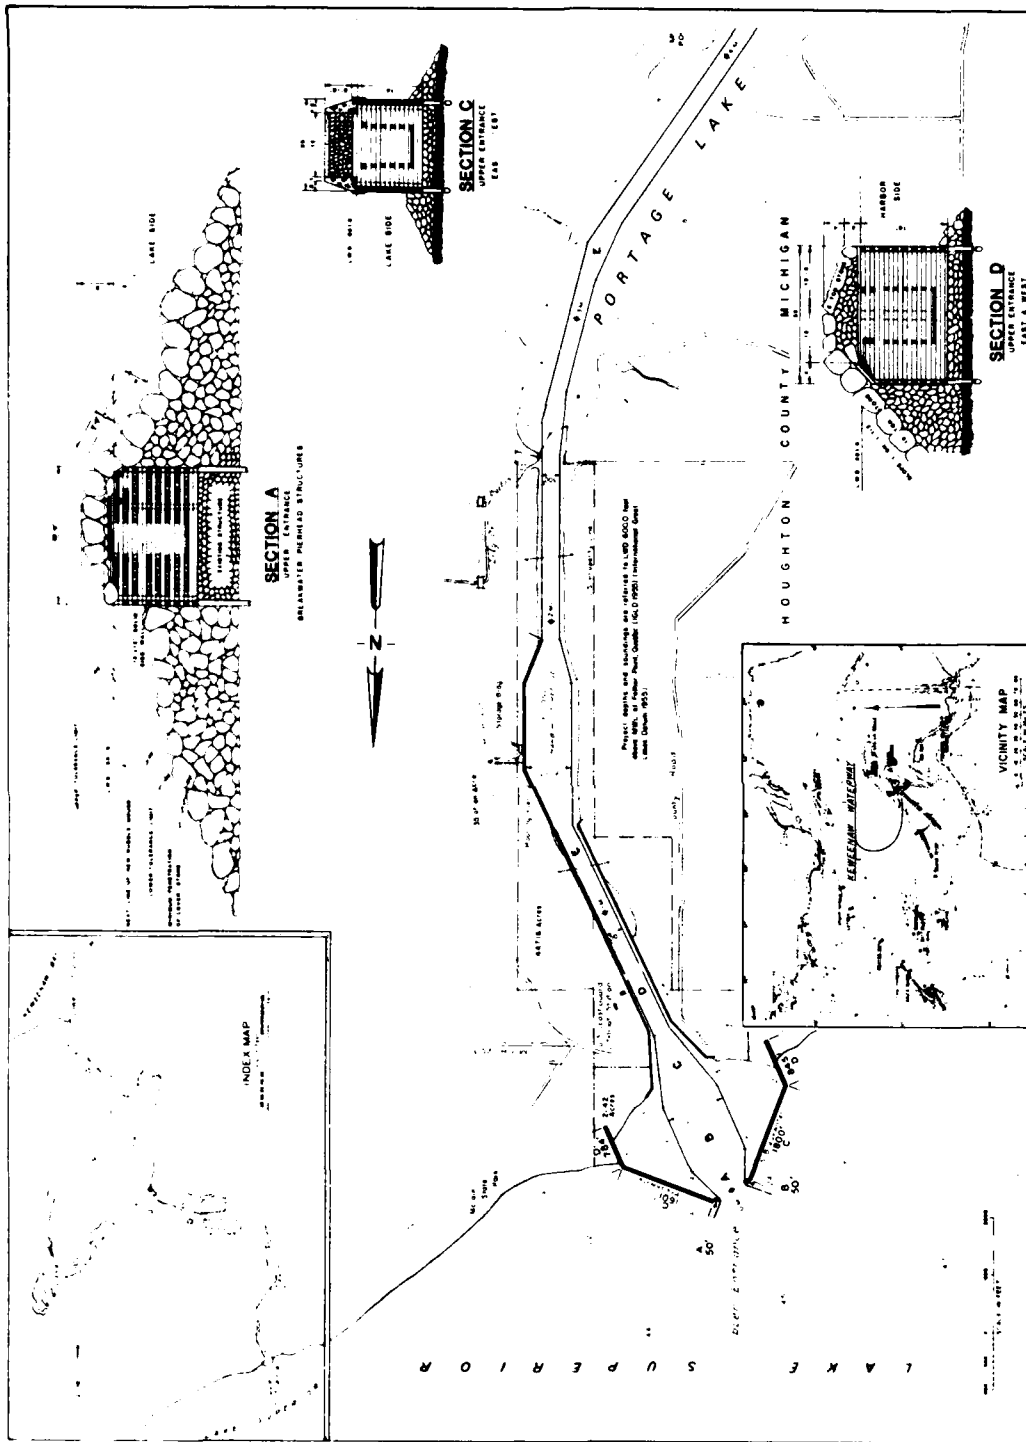
Figure 56. Upper Entrance Breakwaters, Keweenaw Waterway, Michigan

rubble-mound structure. The remainder of the structures at Keweenaw are timber crib with some rubble and steel sheet piles.
