STAGE I AND II PLATFORM STRENGTH EVALUATION OFFSHORE  
PANAMA CITY FLORIDA (U) BARNETT AND CASBARIAN INC  
METAIRIE LA FEB 81 CHES/NAUFAC-FPO-8331A

FPO 8331A

Feb. 81

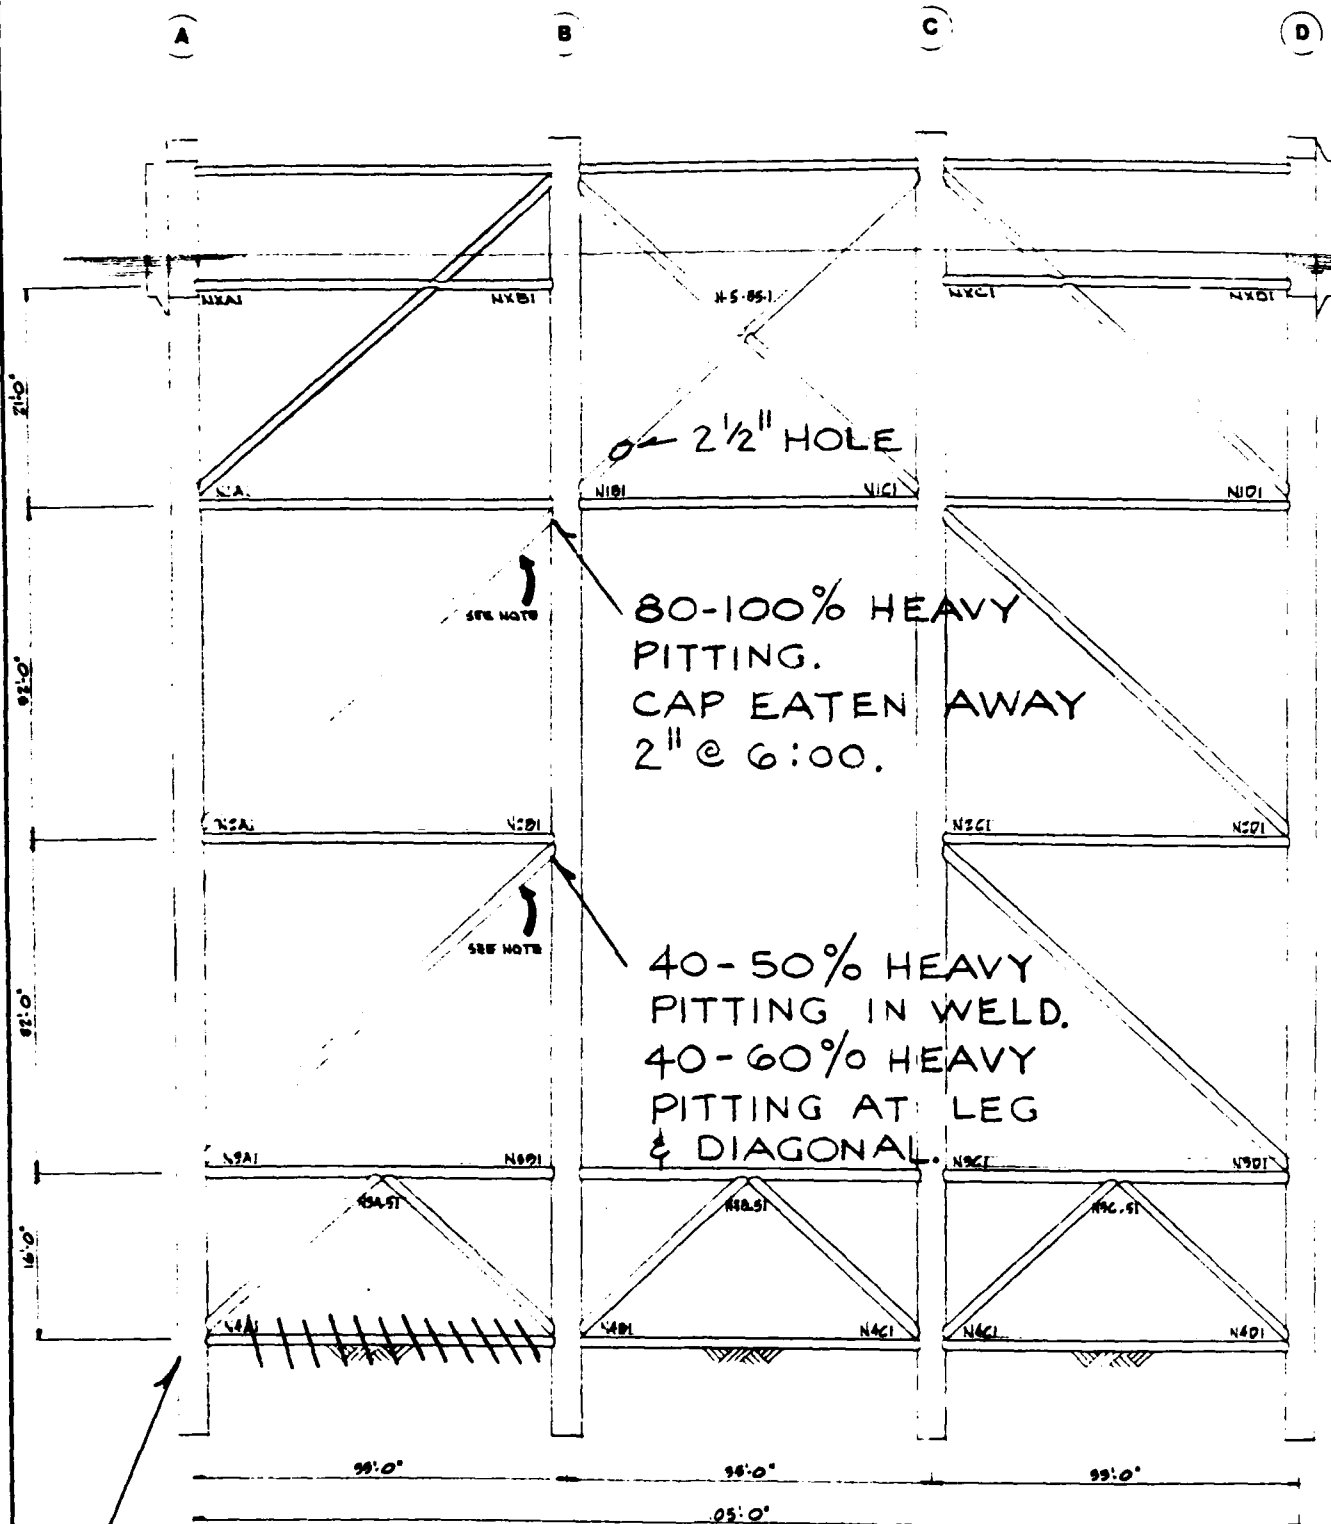
2 ANODES RUBBING ON INNER PART OF LEG. ROW "1"  
 6" TO 1' BARE METAL IS VISIBLE ON LEG.

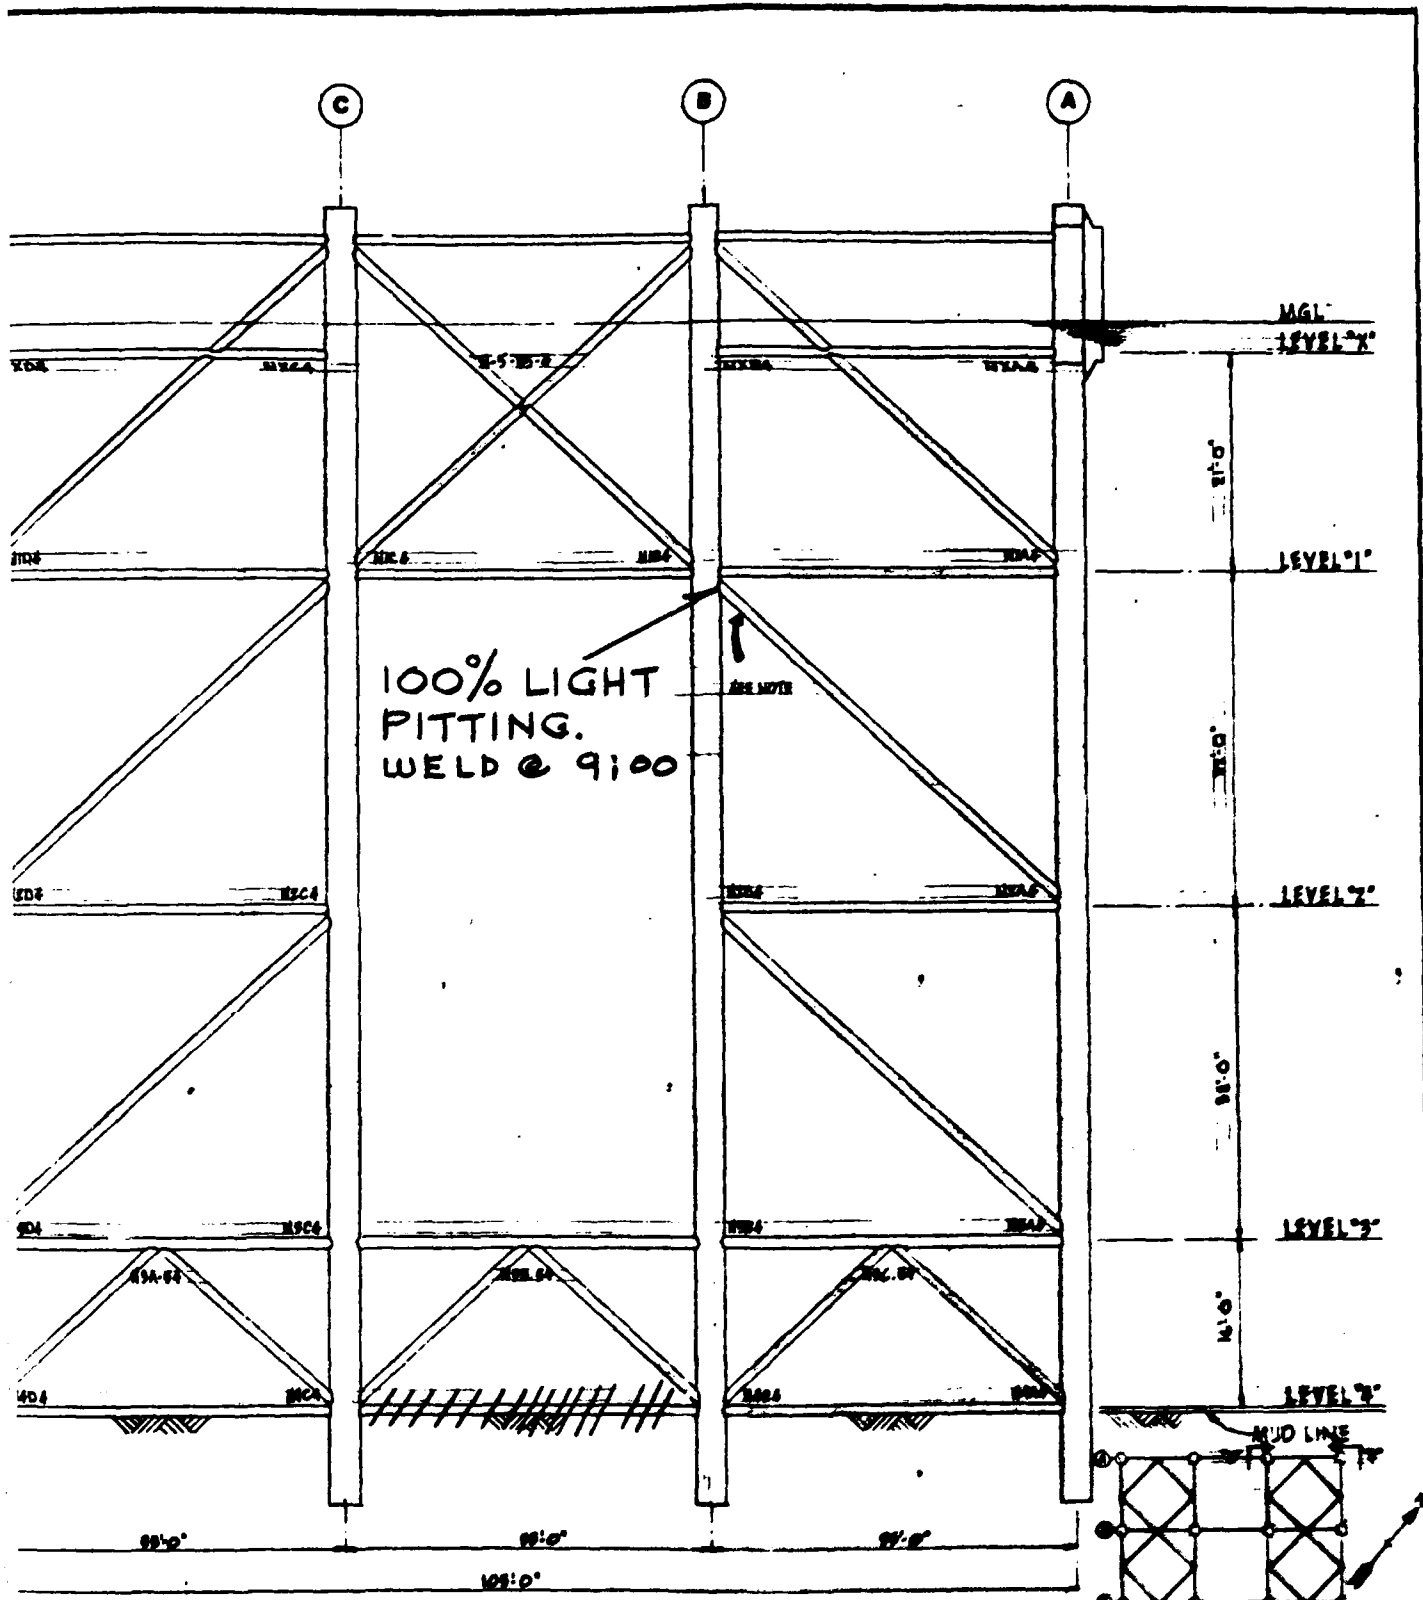
ROW '4'

100% LIGHT FITTING.  
WELD @ 9100

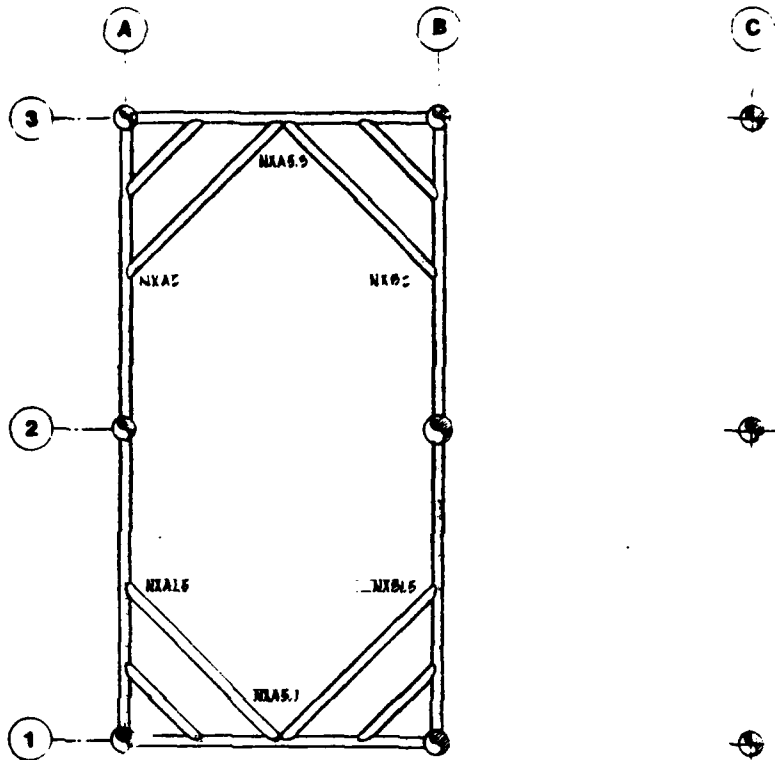
LEVEL 'X'

6' CABLE SCAR

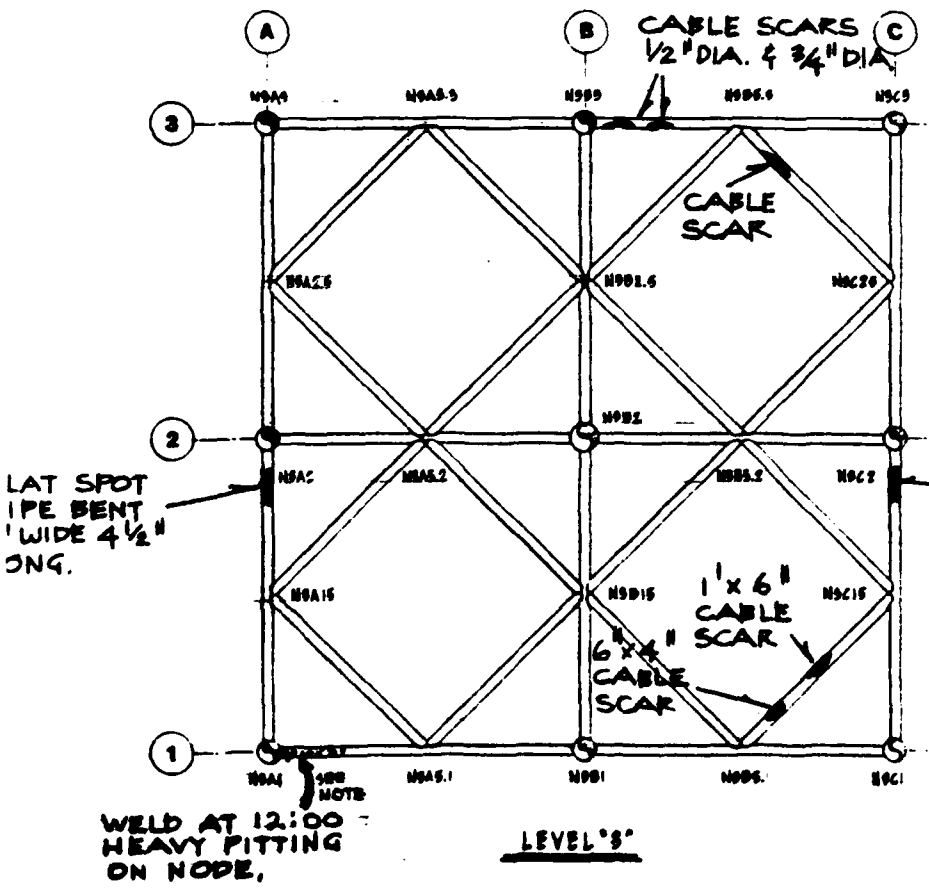
FLAT SPOT 3' LONG

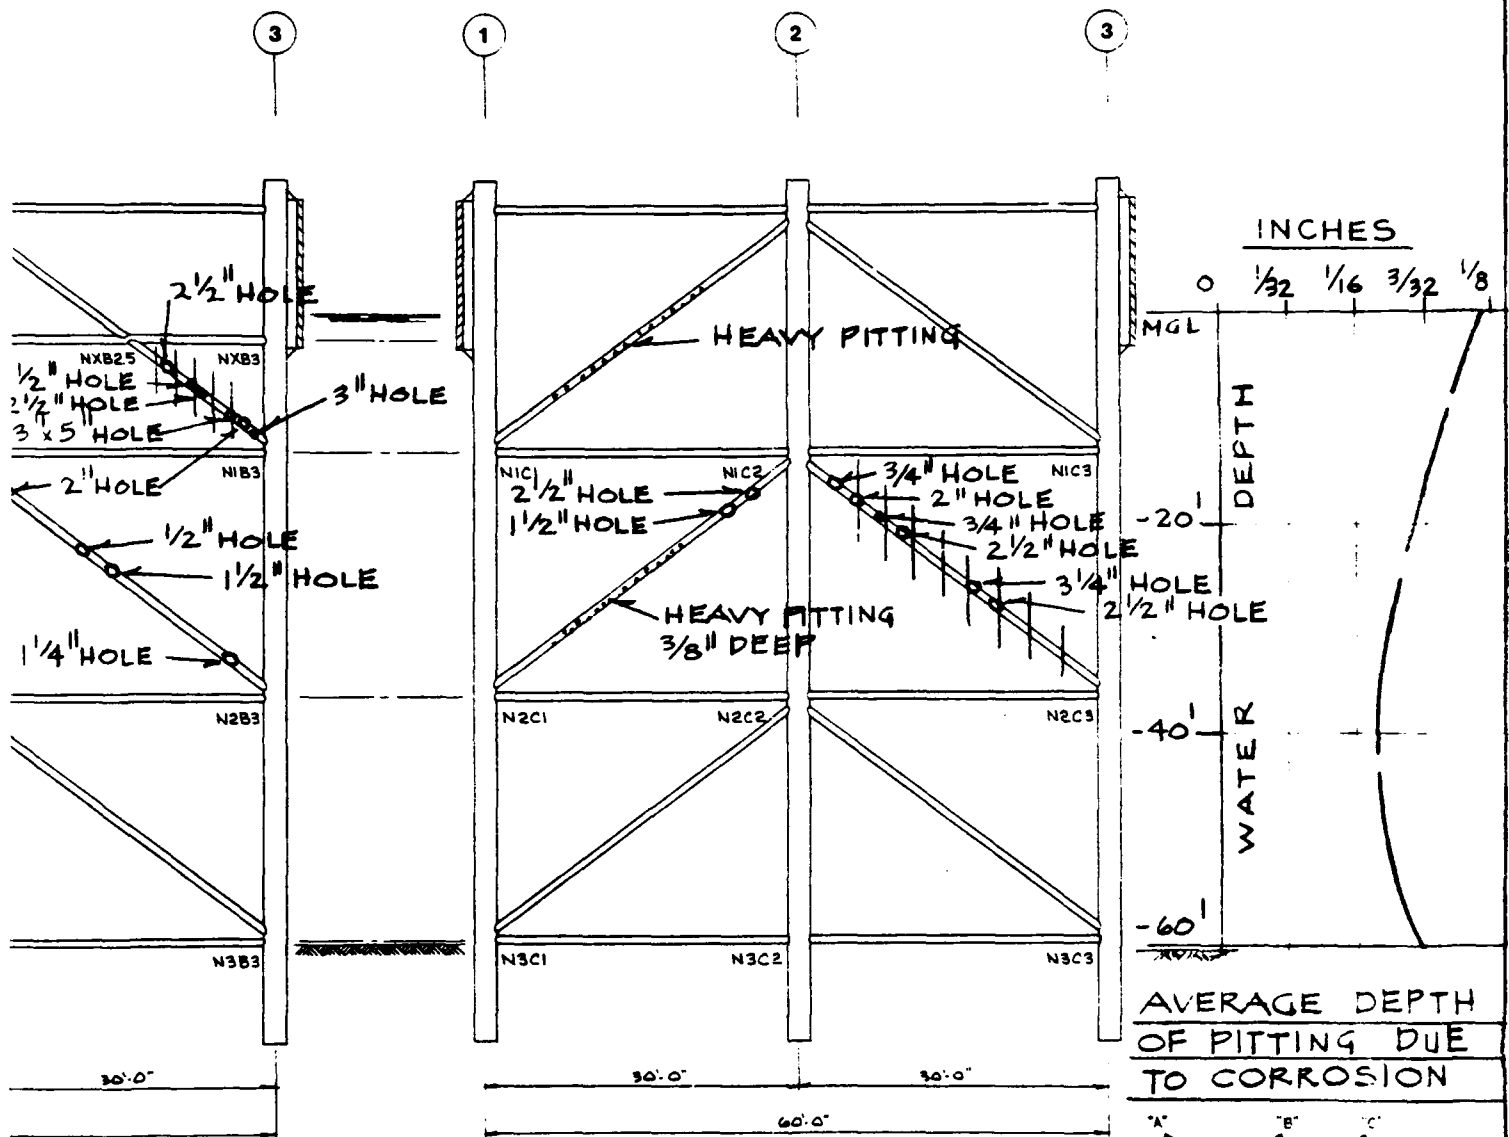
FACE "C"

AVERAGE DEPTH OF PITTING DUE TO CORROSION

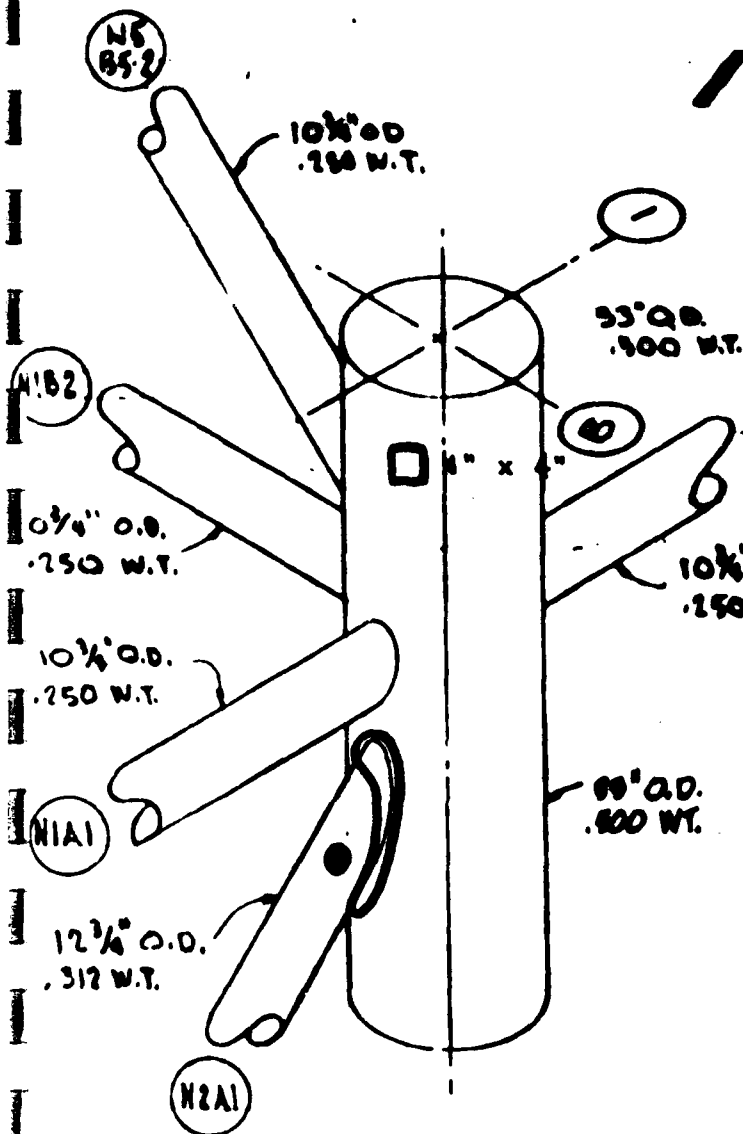
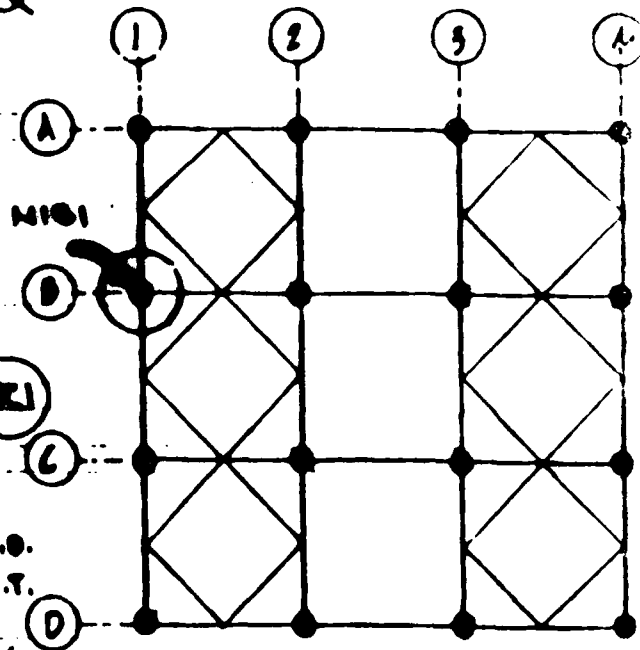
Fig. 2.1.12

WELD NO:	N1B1
DATE CLEANED:	12/5/80
DIVERS NAME:	G. Frost
VISUAL MAP DATE:	12/5/80

The sketch shows in yellow, areas on leg B-1 and at the B-1 junction of the brace down to N2A1, which are illustrated on the following pages. This is the format used for documentation of the seven locations selected for inspection. Clock-face designations are used to describe locations of the junctions of the braces. For example, the 3:00 side of the vertical diagonal junction is indicated by a star.

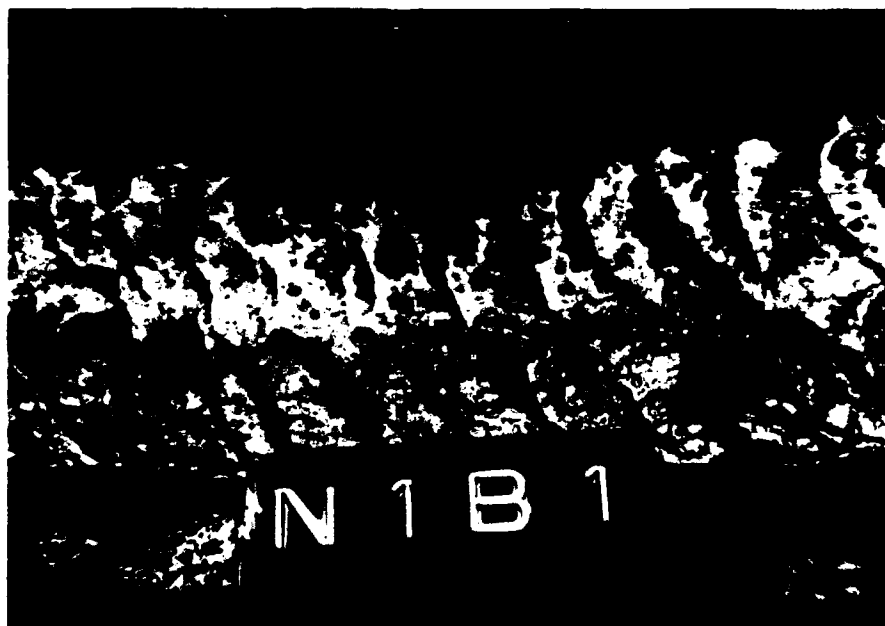
Fig. 2.1.14

Close-ups of same NiB1 weld. Upper photo shows pitting and under-cutting in weld. The photo below is of 4:00 portion of weld where weld is undercut on brace side.

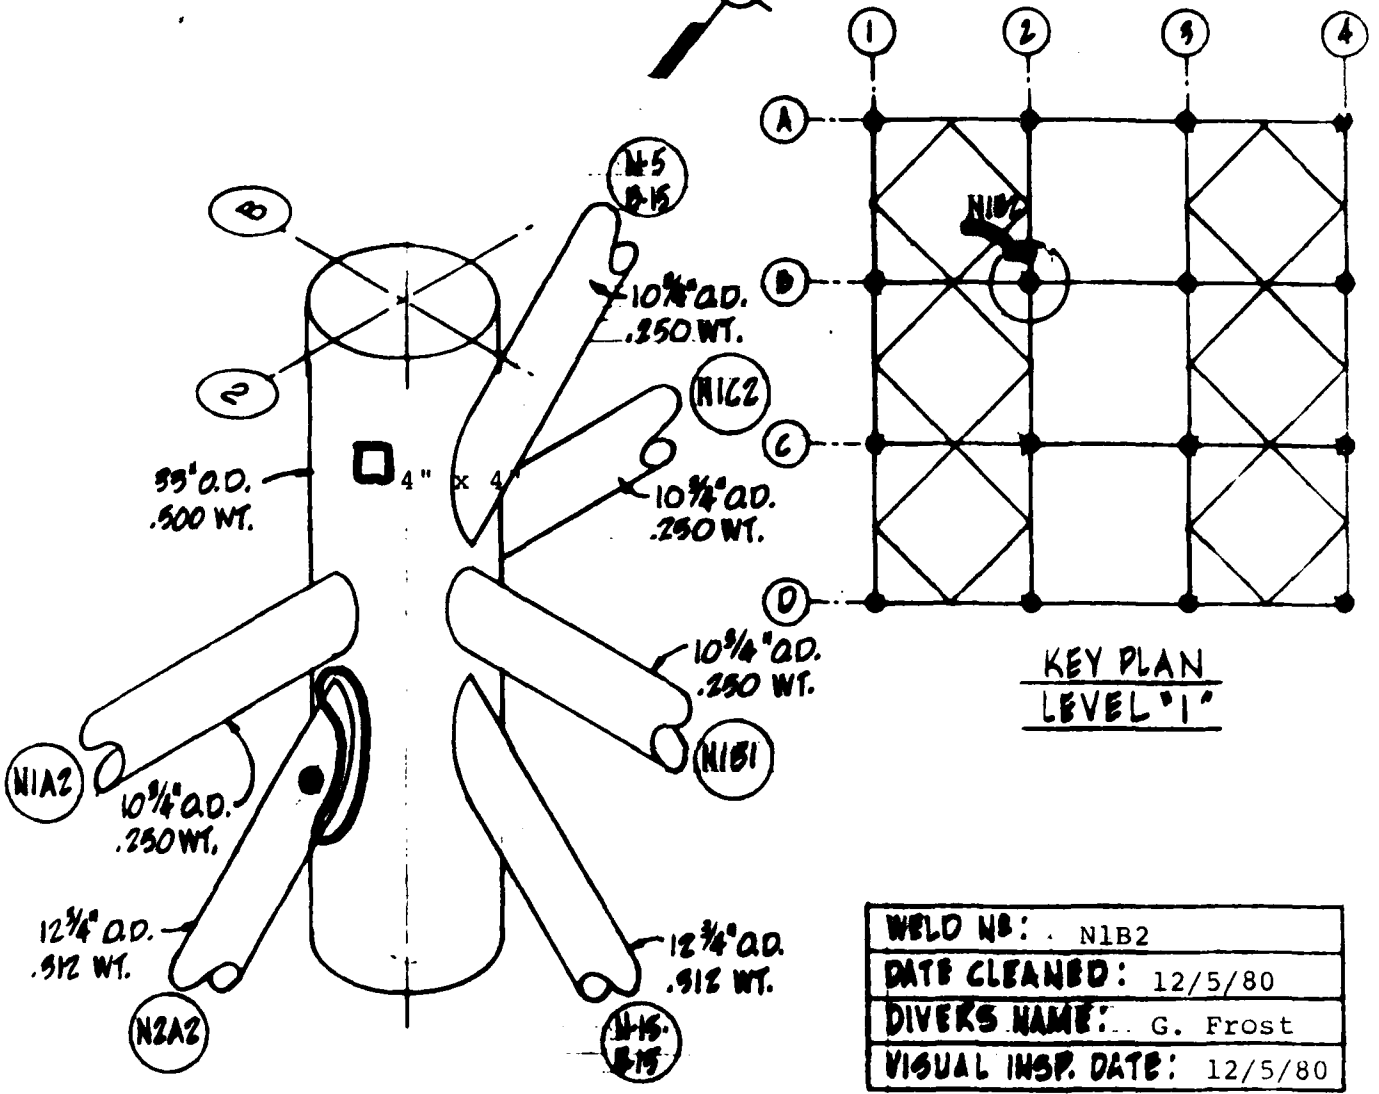
Fig. 2.1.16

WELD NO:	N1B2
DATE CLEANED:	12/5/80
DIVERS NAME:	G. Frost
VISUAL INSP. DATE:	12/5/80

Weld at 8:00  
Numerous pits 1/8" to 3/16" deep

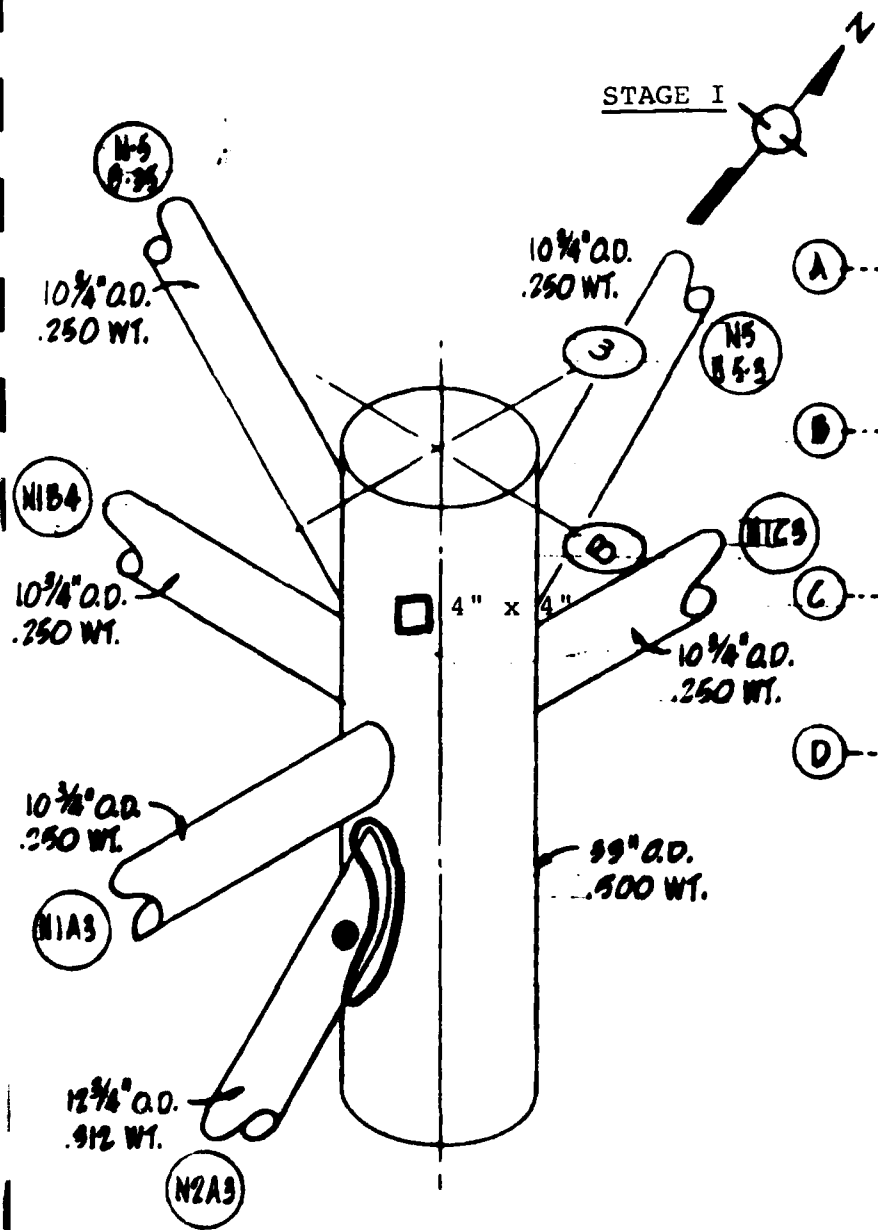
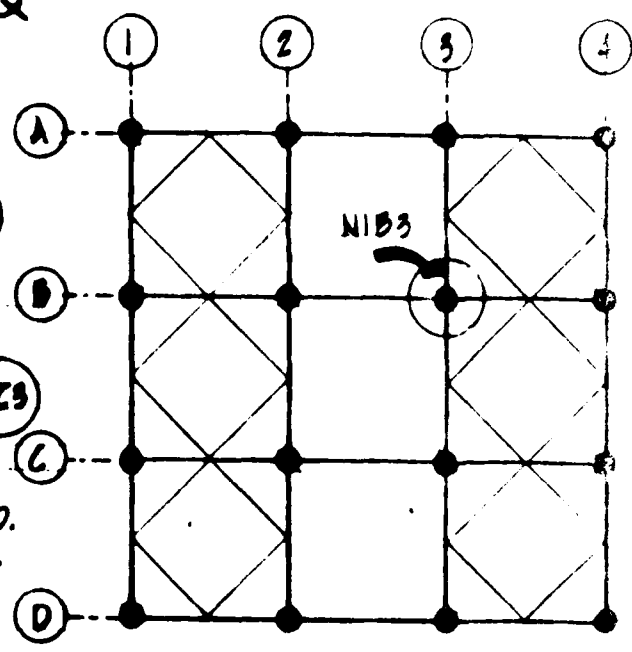
Fig. 2.1.20

WELD NO:	N1B3
DATE CLEANED:	12-8-80
DIVERS NAME:	S. Manlove
VISUAL Insp. DATE:	12-8-80

CP 614, 619  
Bio-Fouling 1-1/2"

Weld at 10:00  
3/8" deep pits in weld

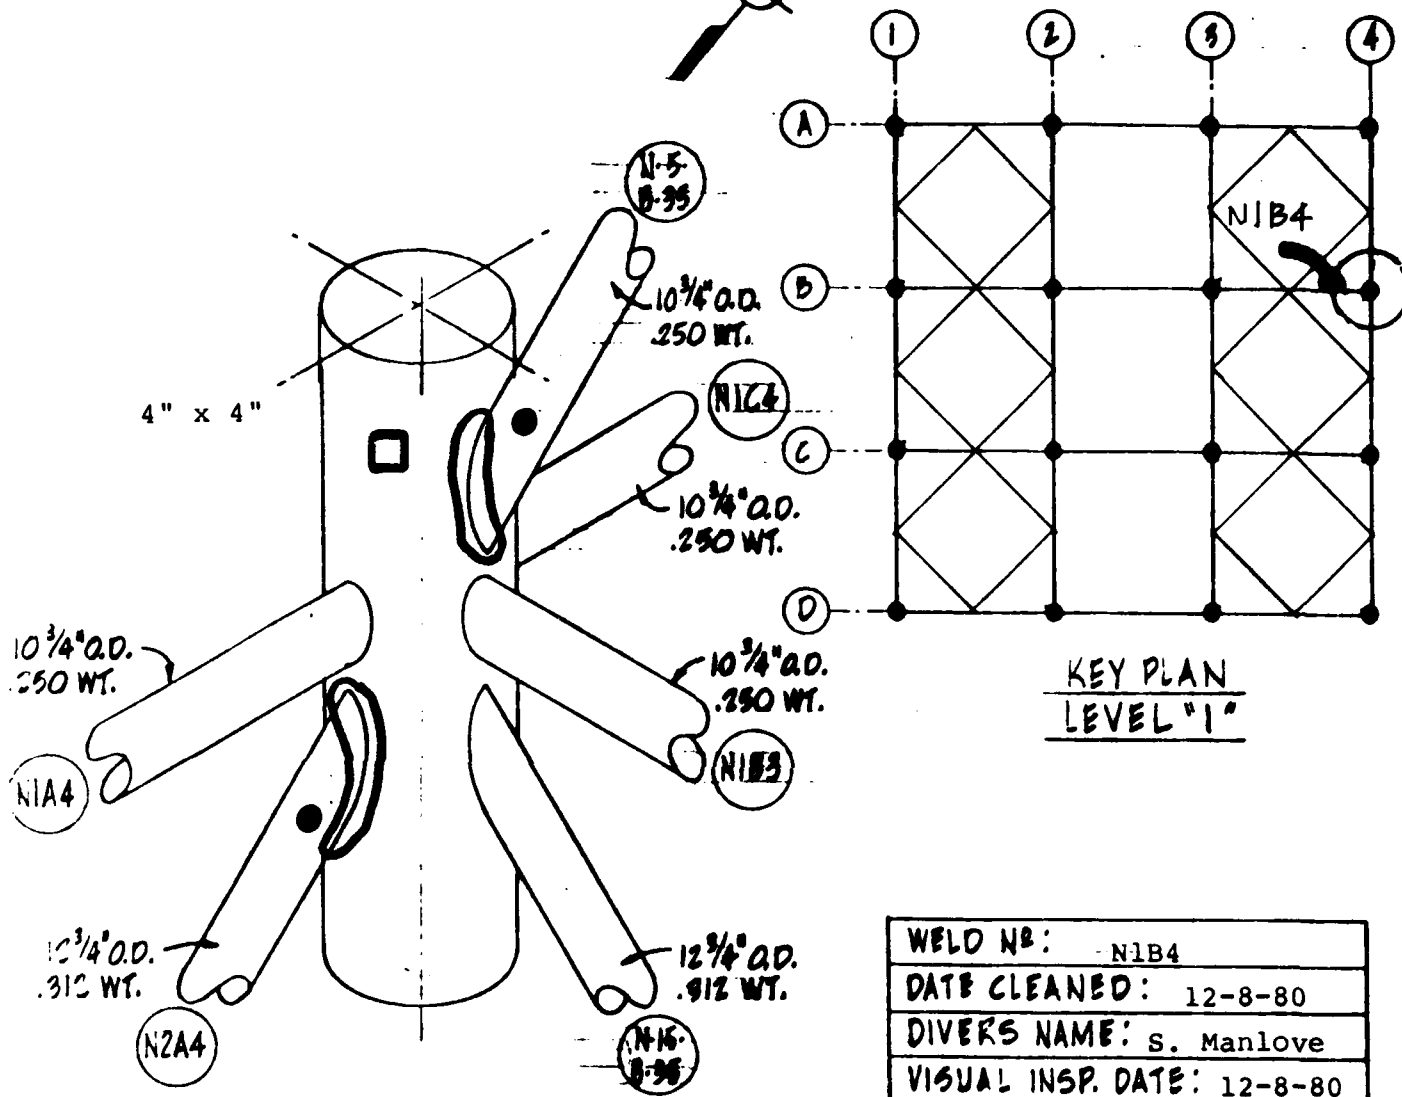
Fig. 2.1.24

WELD NO:	N1B4
DATE CLEANED:	12-8-80
DIVERS NAME:	S. Manlove
VISUAL INSP. DATE:	12-8-80

Weld at 9:00 to N2A4  
100% light pitting

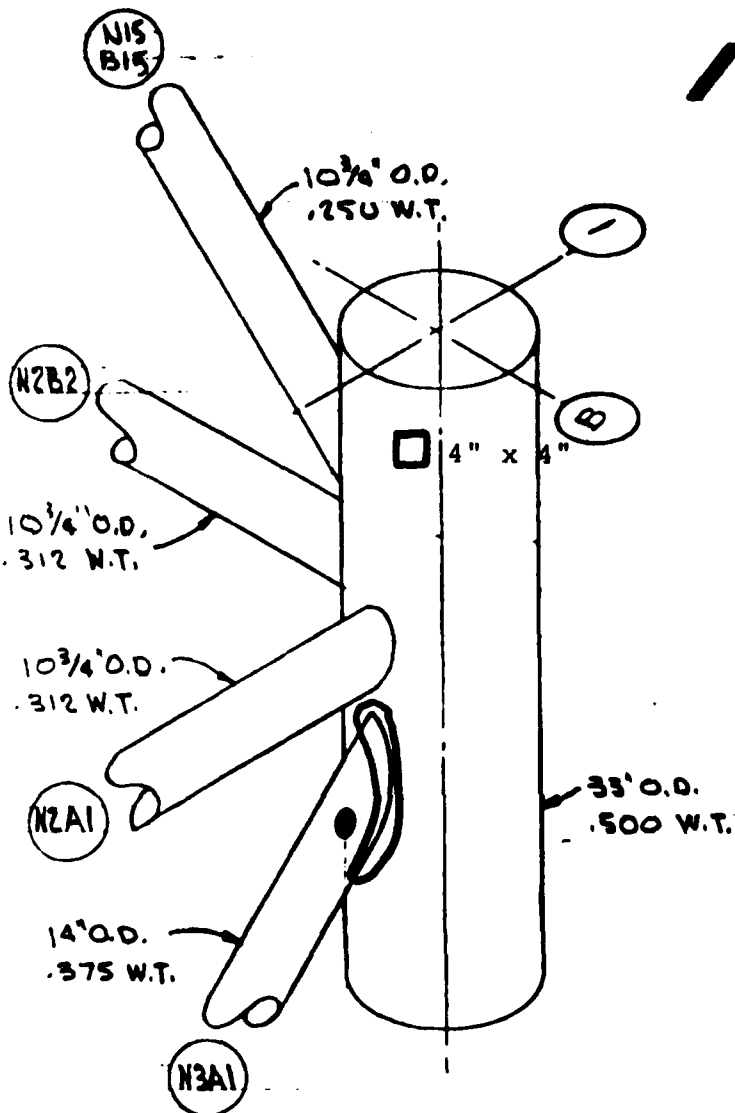
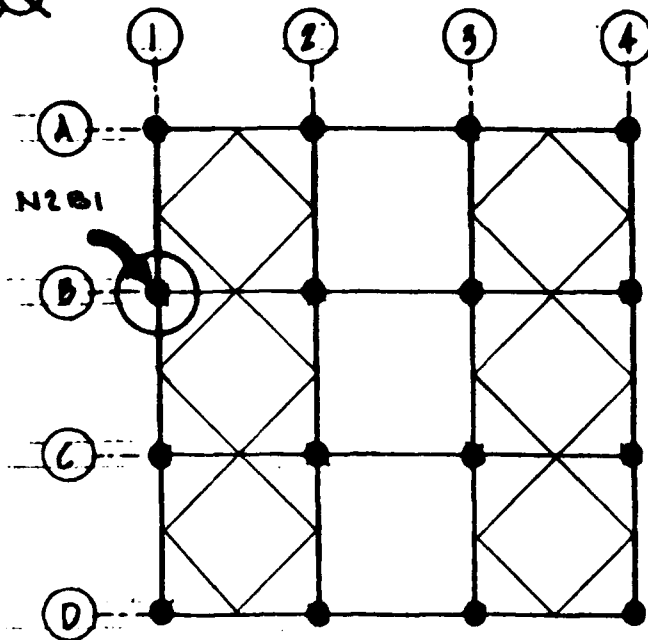
Fig. 2.1.29

WELD NO:	N2B1
DATE CLEANED:	12/5/80
DIVERS NAME:	G. Frost
VISUAL INSP. DATE:	12/5/80

4" x 4" sq.  
 $\frac{1}{8}$ " deep pit,  $\frac{1}{2}$ " wide,  
 $\frac{3}{4}$ " long

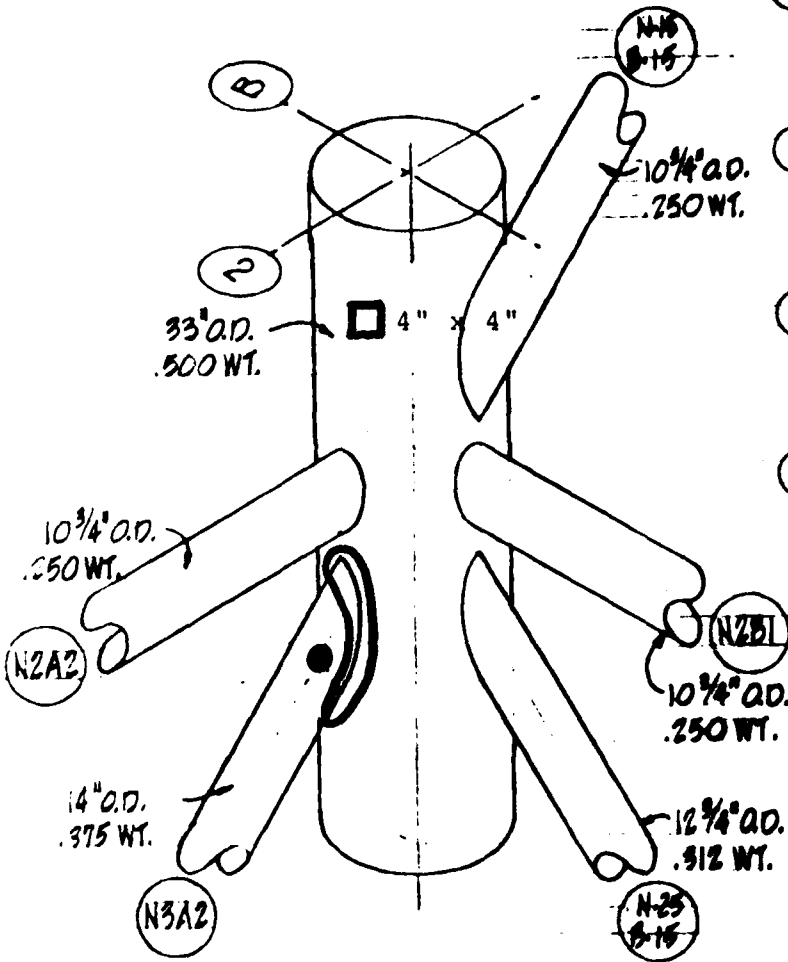
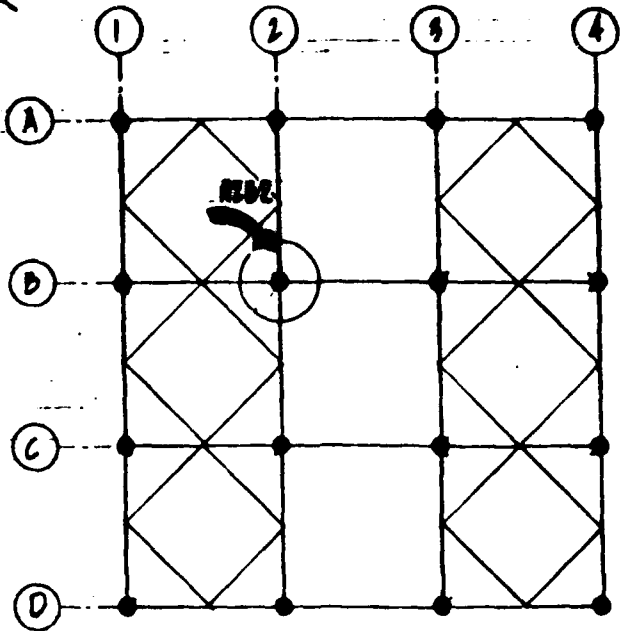
Fig. 2.1.33

WELD NR.: N2B2
DATE CLEANED: 12/5/80
DIVERS NAME: G. Frost
VISUAL INSP. DATE: 12/5/80

4" x 4" sq.  
Numerous pits in jacket leg

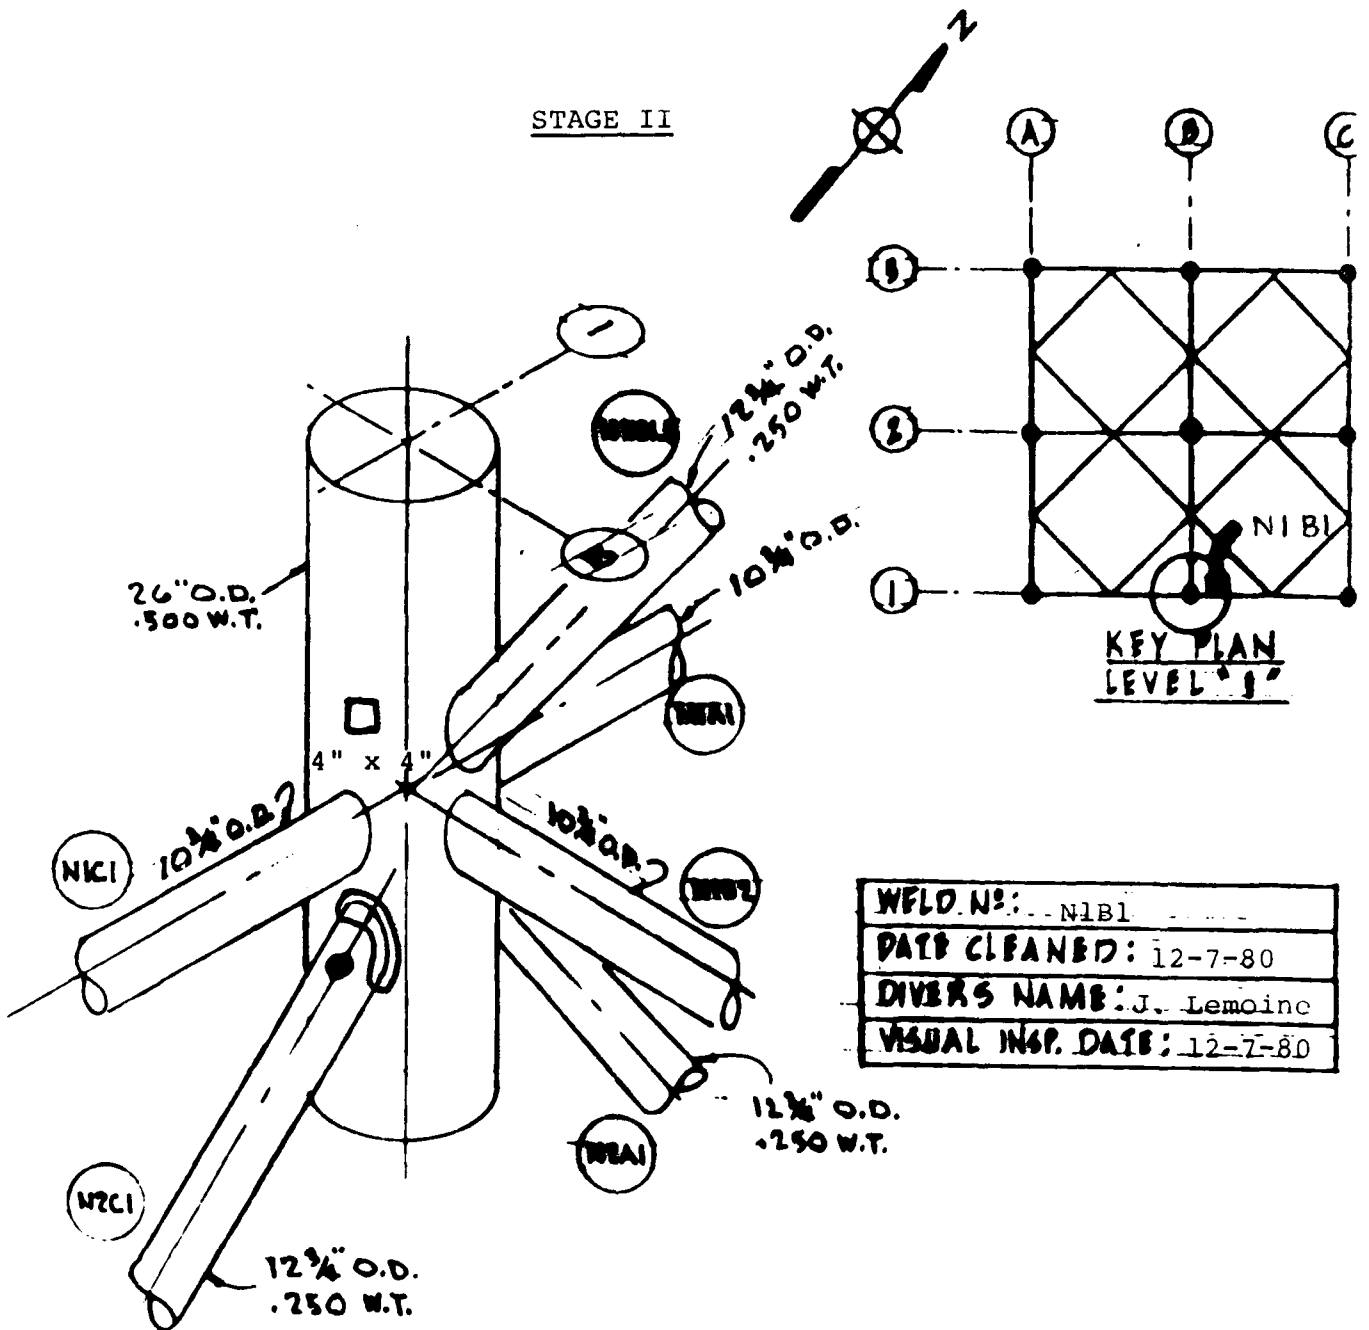
Fig 2.2.11

WELD NO.:	N1B1
DATE CLEANED:	12-7-80
DIVER'S NAME:	J. Lemoine
VISUAL INSP. DATE:	12-7-80

NOTE: At 9:00 - Large pits in weld down to root pass 3/4" in dia.

Diver was unable to detect any of the holes noted prior to water blasting, due to marine growth.

Weld at 5:00 - Hole in brace.

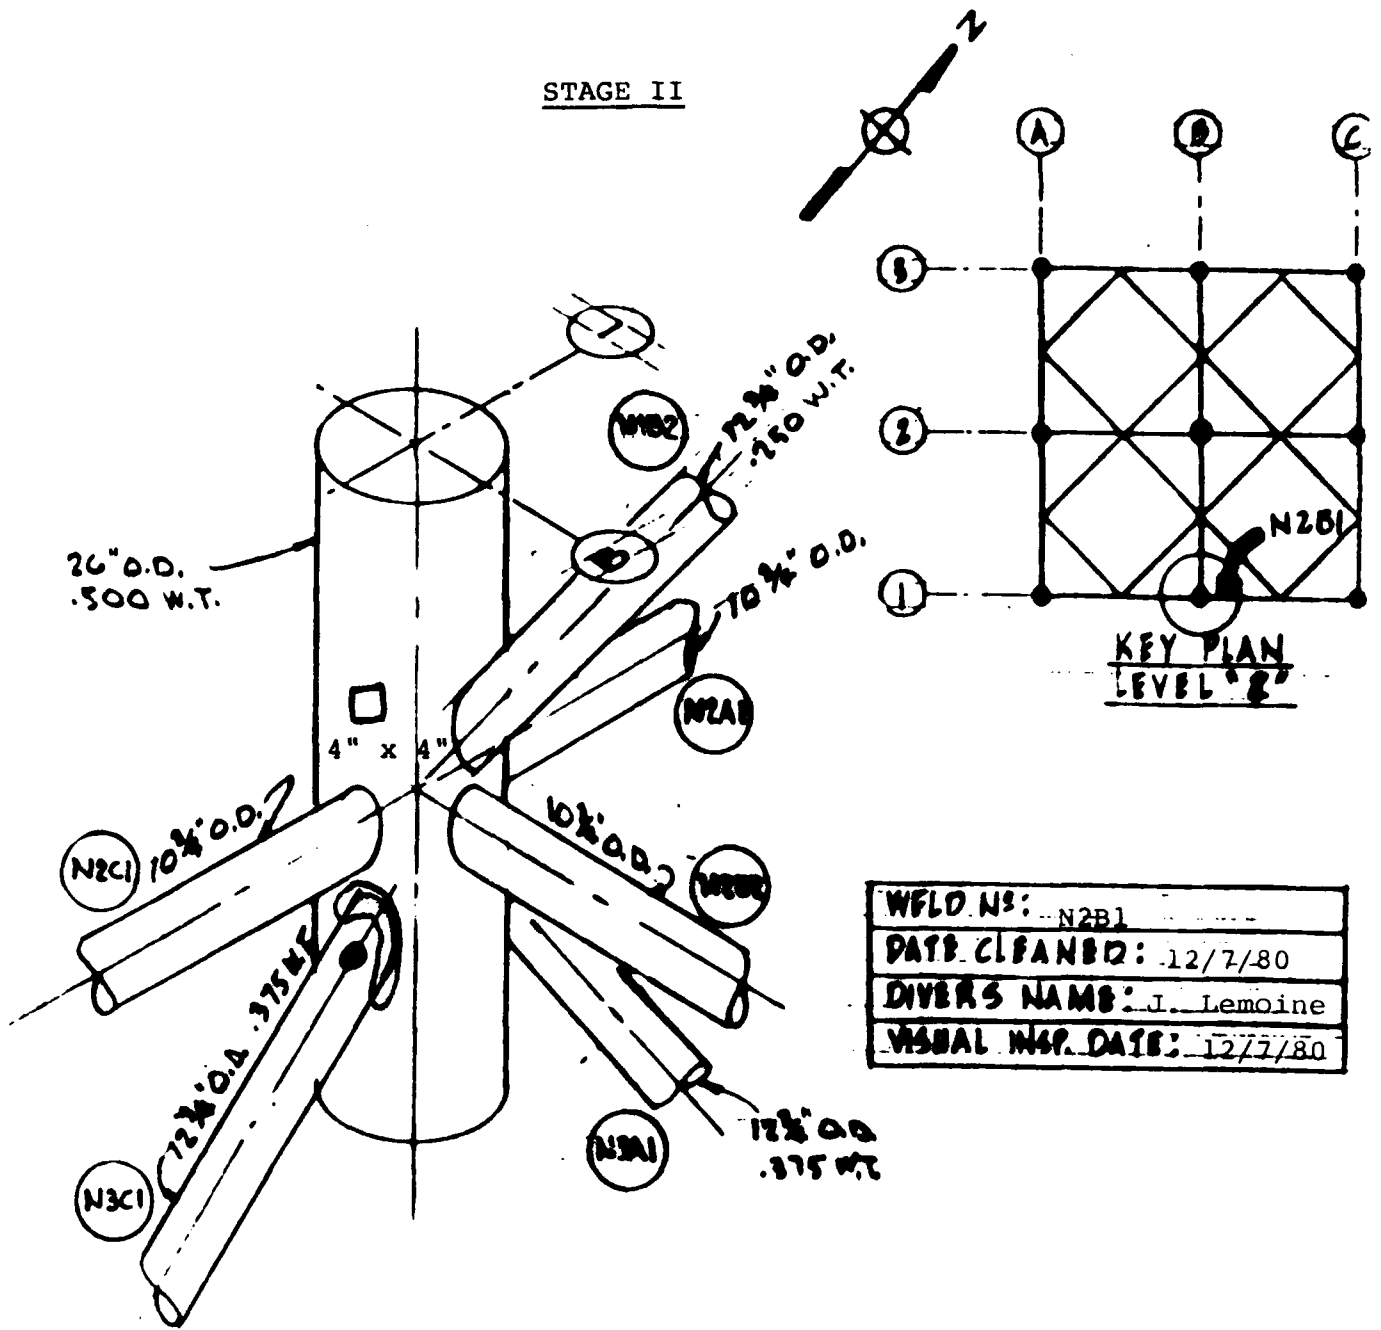
Fig. 2.2.18

WELD NO:	N2B1
DATE CLEANED:	12/7/80
DIVERS NAME:	J. Lemoine
VISUAL Insp. DATE:	12/7/80

CP 672, 697  
Bio-Fouling  $\frac{1}{2}$ "

Weld at 7:00  
 Heavy pitting

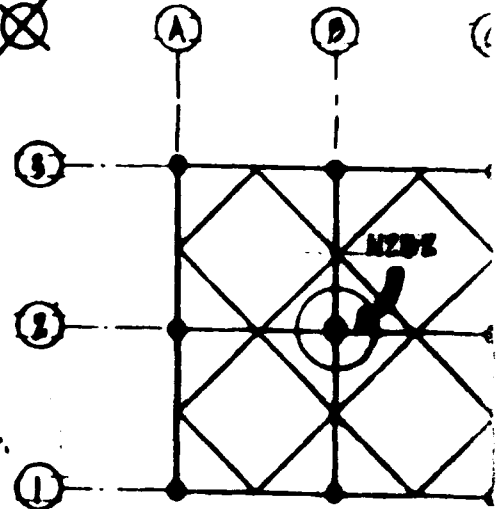
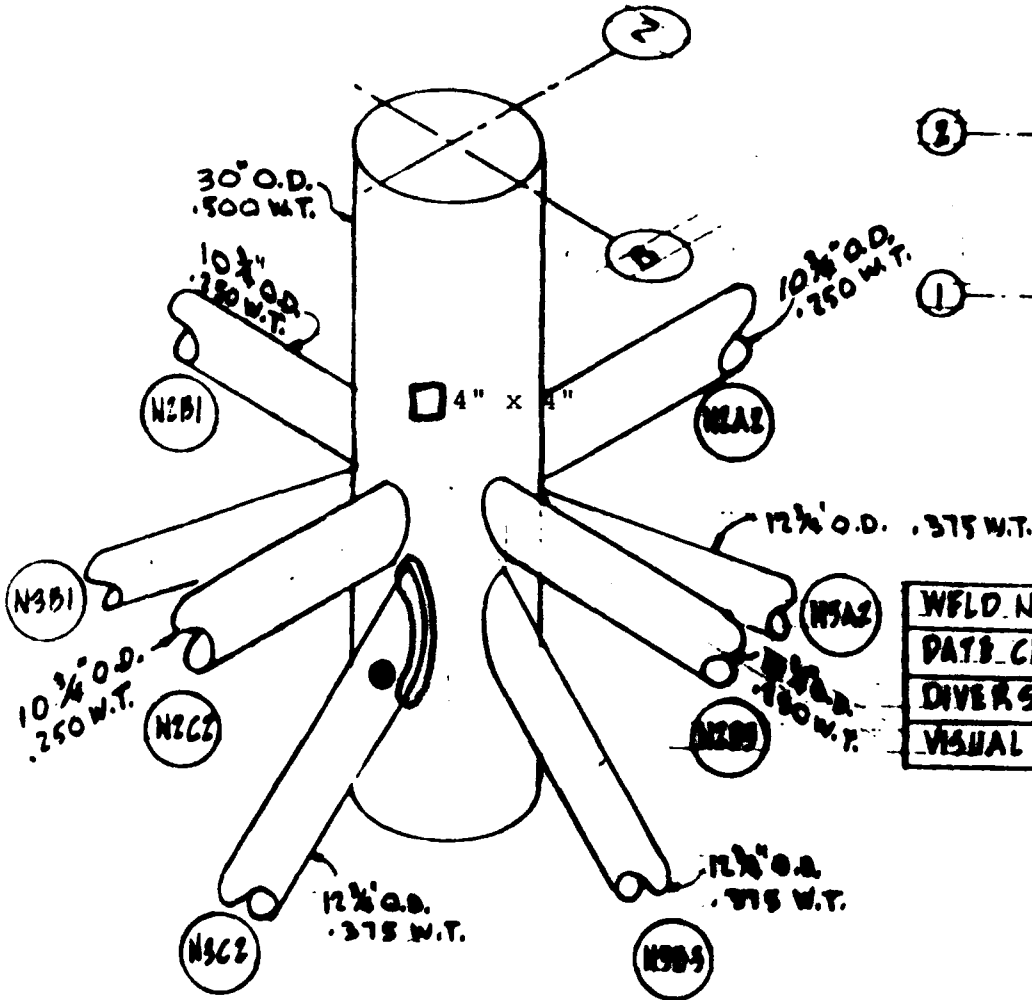
Fig. 2.2.23

WELD NO.:	N2B2
DATE CLEANED:	12/7/80
DIVERS NAME:	S. Manlove
VISUAL INSP. DATE:	12/7/80

NOTE: Diver was unable to detect hole prior to blasting, due to marine growth.

Weld area at 7:00 -  
Hole at 9:00 on brace.  
100% pitting on brace.

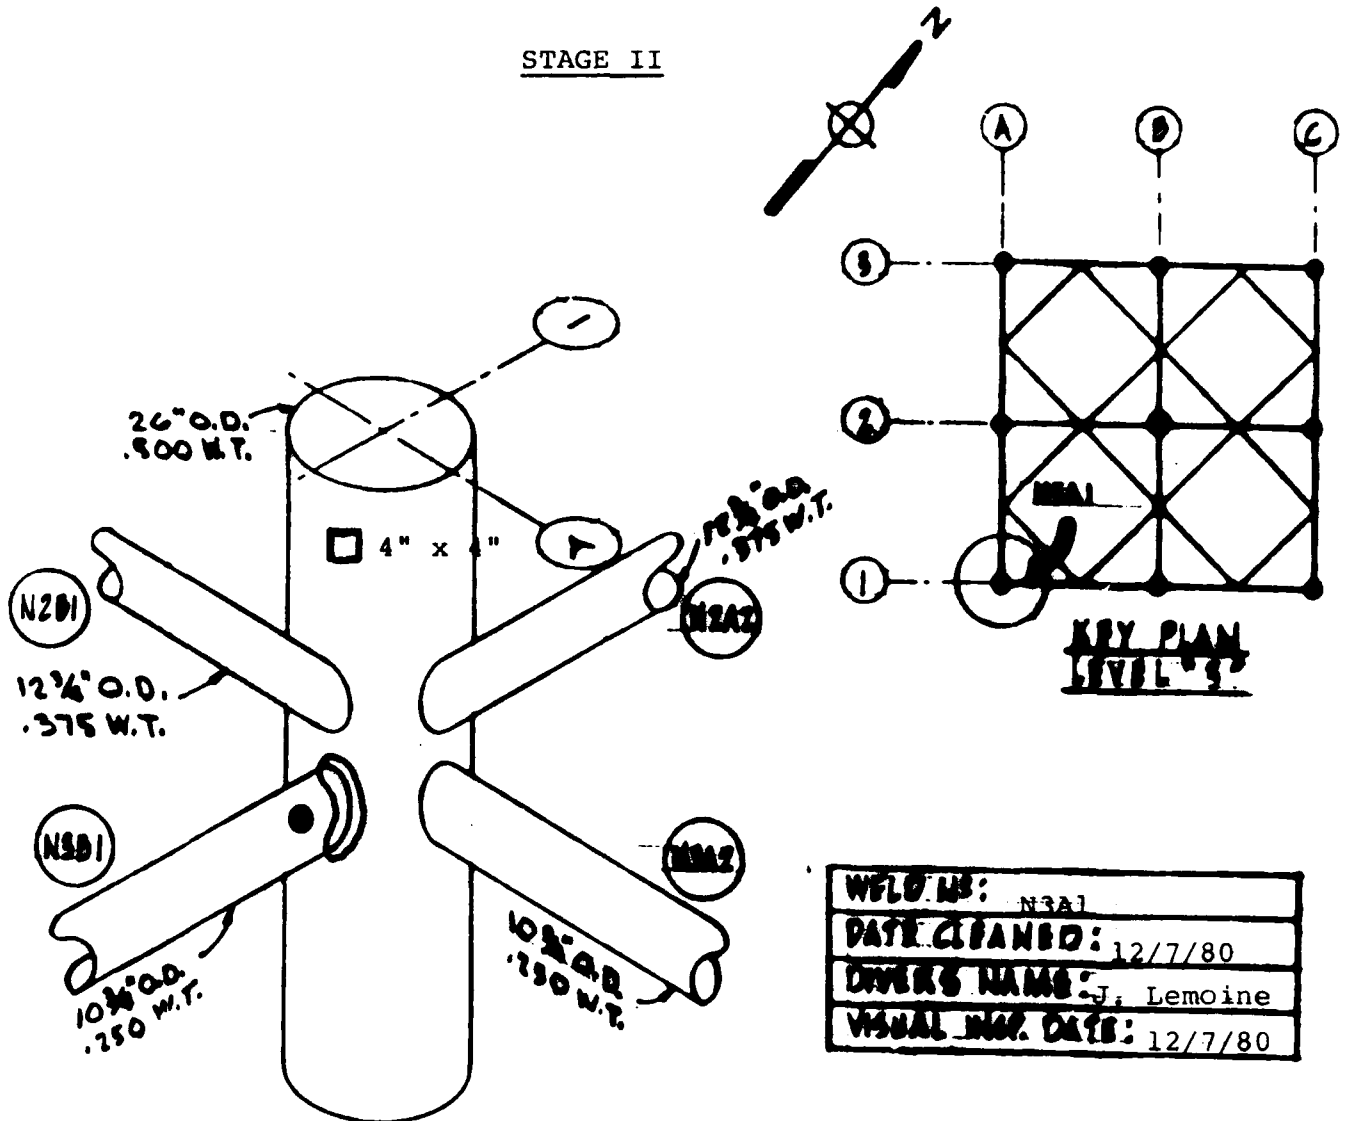
Fig. 2.2.29

WELD ID:	N3A1
DATE CLEANED:	12/7/80
DIVER'S NAME:	J. Lemoine
VISUAL INC. DATE:	12/7/80

CP 660, 698  
Bio-Fouling  $\frac{1}{2}$ "

Weld at 12:00  
 Heavy pitting on node.
