STAGE I AND II PLATFORM STRENGTH EVALUATION OFFSHORE  
PANAMA CITY FLORIDA (U) BARNETT AND CASBARIAN INC  
METAIRIE LA FEB 81 CHES/NAUFAC-FPO-8331A

FPO 8331A

Feb. 81

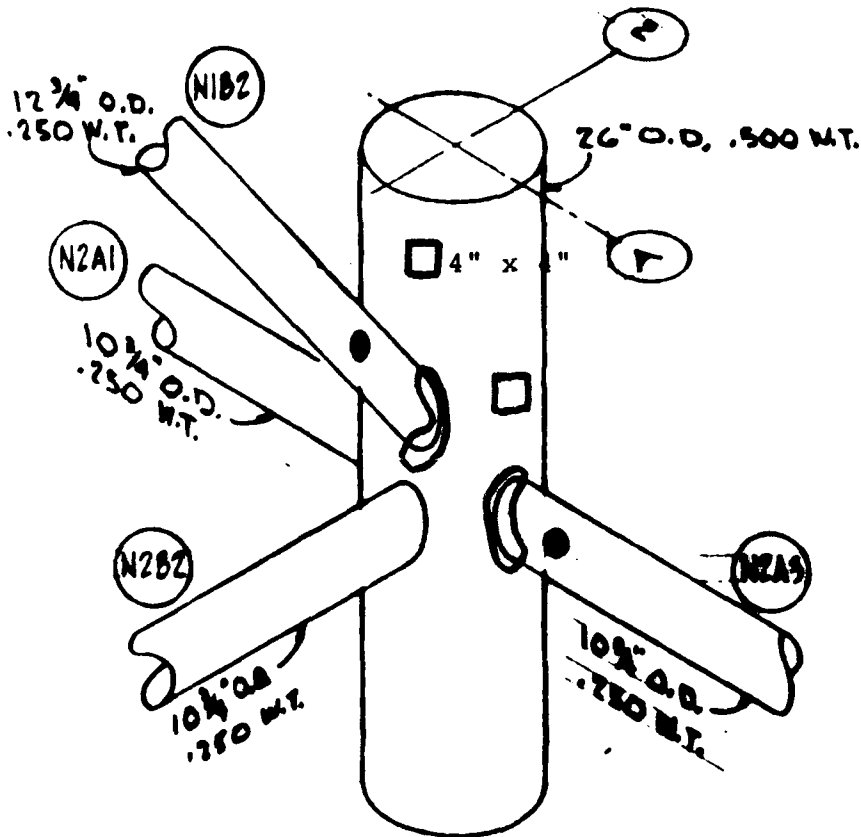
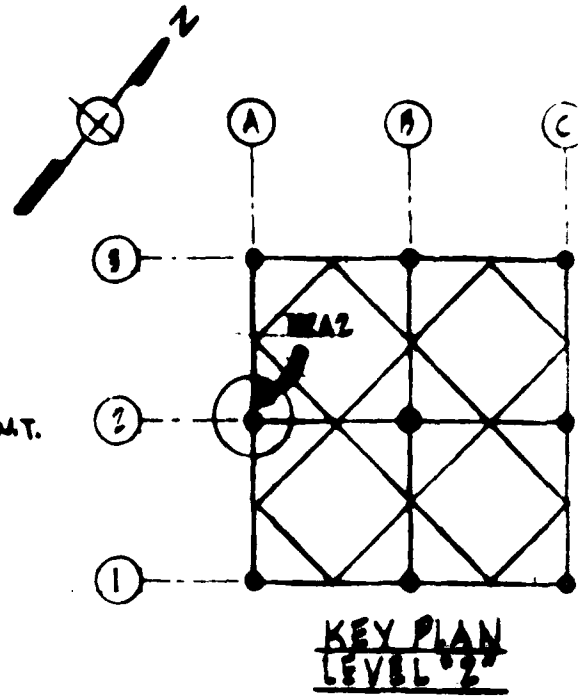
Fig 2.2.34

WELD NO: N2A2
DATE CLEANED: 12-7-80
DIVERS NAME: S. Manlove
VISUAL INSP. DATE: 12-7-80

NOTE: Diver reports that he was unable to detect damage noted above prior to water blasting, due to marine growth.

CP 649, 651  
Bio-Fouling 1/2"  
 N2A2 to N2A3 - Crack in weld  
 at 3:00, 6:00, and 7:00.

CP 657  
Bio-Fouling 1"  
 N2A2 to N1B2 - Large pits on  
 brace at 5:00.  
 Holes in brace at 9:00.
