Research Report 1434

**Human Factors Assessment:  
Light Armored Vehicle,  
Maintenance/Recovery Vehicle (LAVM/RV)**

**December 1986**

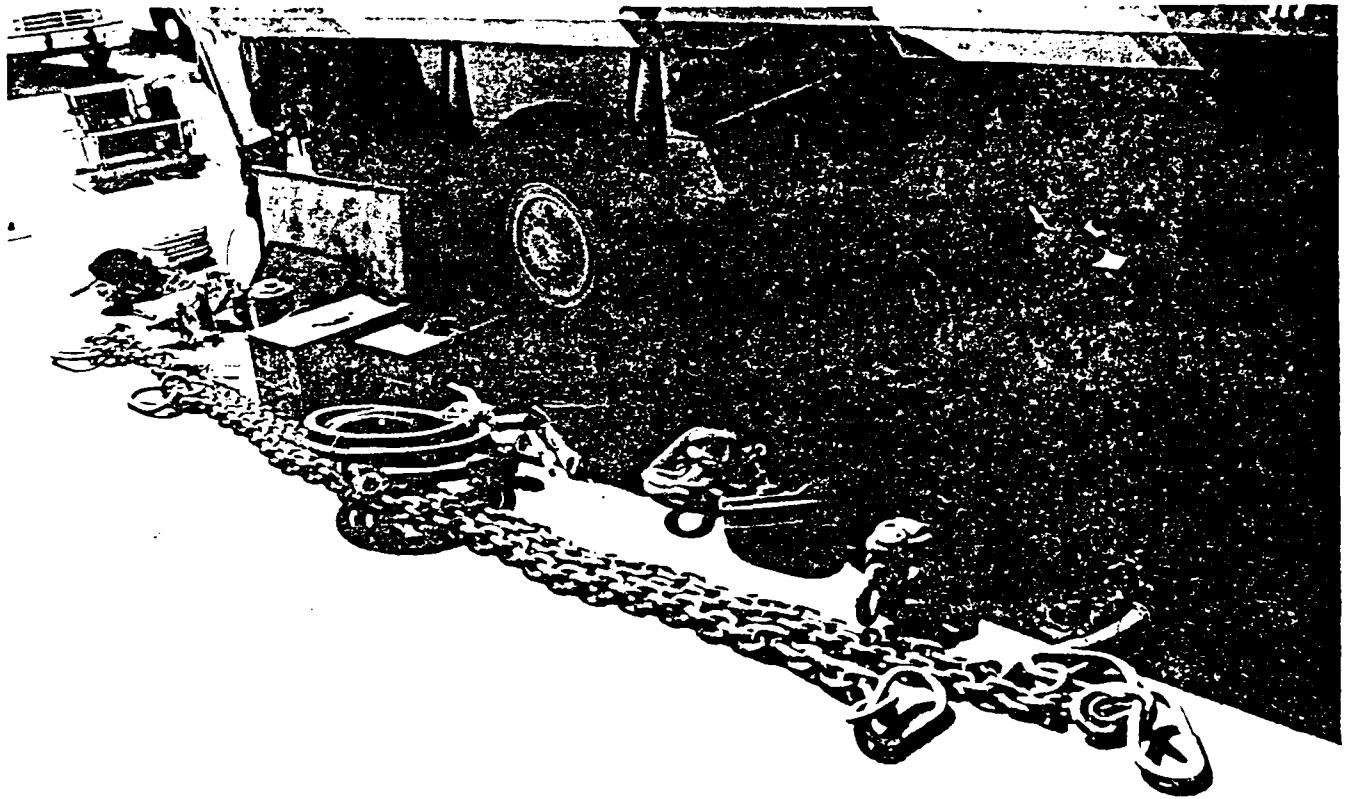
**Tool and accessory storage.** Crews rated the size and location of storage and the protection of equipment in storage as borderline (average mean rating, 3.1, see questionnaire items 43 to 46). Figure 11 shows the equipment carried in internal vehicle storage locations. Figure 11, however, does not show any combat gear which is also stored inside the vehicle. Figure 12 shows the equipment as it is usually stored in the vehicle. Notice that stored equipment is blocking the passageways. Figure 13 shows two of the three secure storage spaces allocated for all the equipment shown in Figure 11. Secure storage consists of two equipment trays (measuring 26 x 7 x 7 in (66 x 18 x 18 cm)) and one tool box (measuring 19.50 x 13.25 x 10 in (50 x 34 x 25 cm)). The lack of secure storage locations results in the stacking of equipment in any available space. The crew also reported that they stored equipment in their seated legroom and carried equipment in their laps when the vehicle was combat loaded. The lack of secure storage results in several problems, including:

Figure 11. The equipment carried inside the vehicle. Additional combat gear is not shown.

Design changes might include repositioning the APU to allow more of the crew to participate in lifting the device. However, even if all five crew members lift the APU, the lifted weight per person is 75 lb (34 kg) and violates the MIL standard. A better solution might be to add a sliding carriage rack to the APU storage rack that slides out and locks in place beyond the rear door opening. It would then be possible to load the
