AEFA PROJECT NO. 84-23

ARTIFICIAL AND NATURAL ICING TESTS OF AH-64 (PHASE II)

MARCH 1987

FINAL REPORT

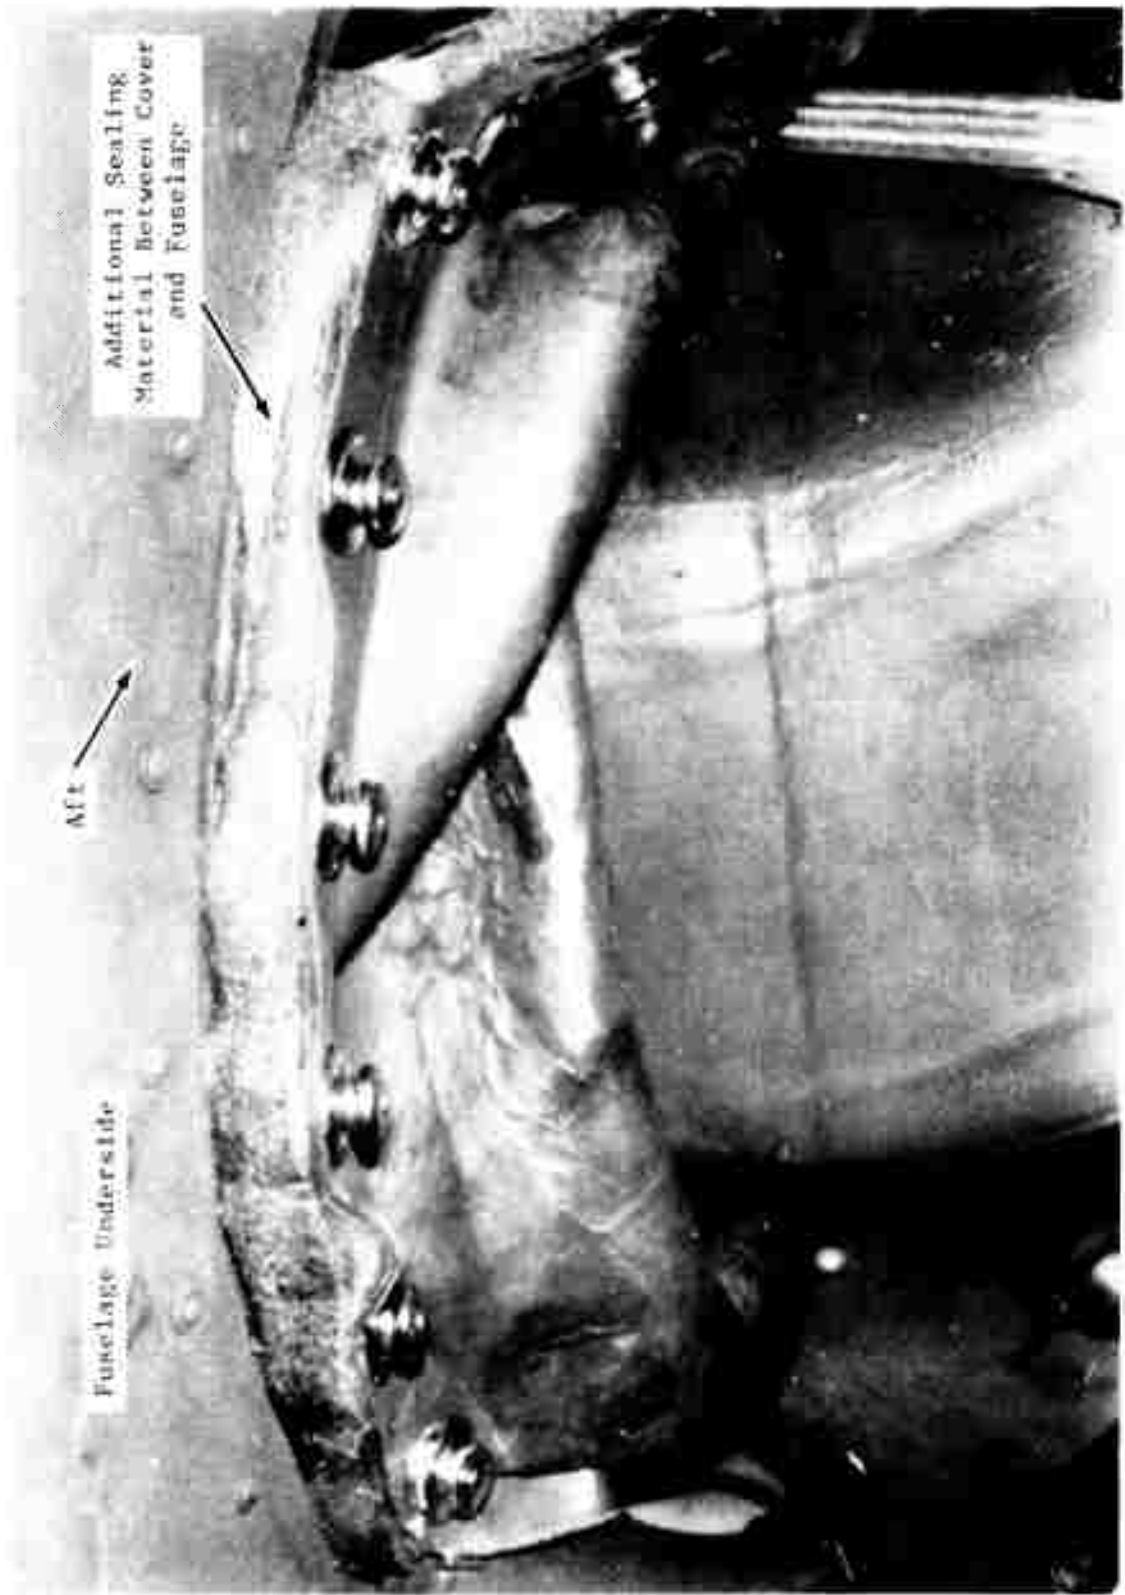
Photo 8. 30mm Ammunition Chute Cover - Upper Portion

38. The ice accretion and shedding characteristics of the 30mm chain gun area weapon system were evaluated in natural icing conditions. Weapons firing was not attempted following flight in icing conditions. Although live fire operations were not performed, the accreted ice did not hamper the traversing operation of the weapon. The gun was traversed in-flight through its full range in azimuth and elevation to verify unrestricted motion. A muzzle protector made of cloth prevented ice build-ups inside the barrel. An environmental cover (photo 7) was installed on the ammunition chute and turret assembly. This dual purpose cover prevented both ice accumulation inside the chute which would jam ammunition feed and cold air from entering the aft cockpit through the turret assembly. An additional seal was installed to improve the seal between the cover and the lower fuselage (photo 8). The ice accretion and shedding characteristics of the area weapon system are satisfactory. The production configuration of the area weapon environmental cover should incorporate a seal between the cover and fuselage similar to the one used on the test aircraft.

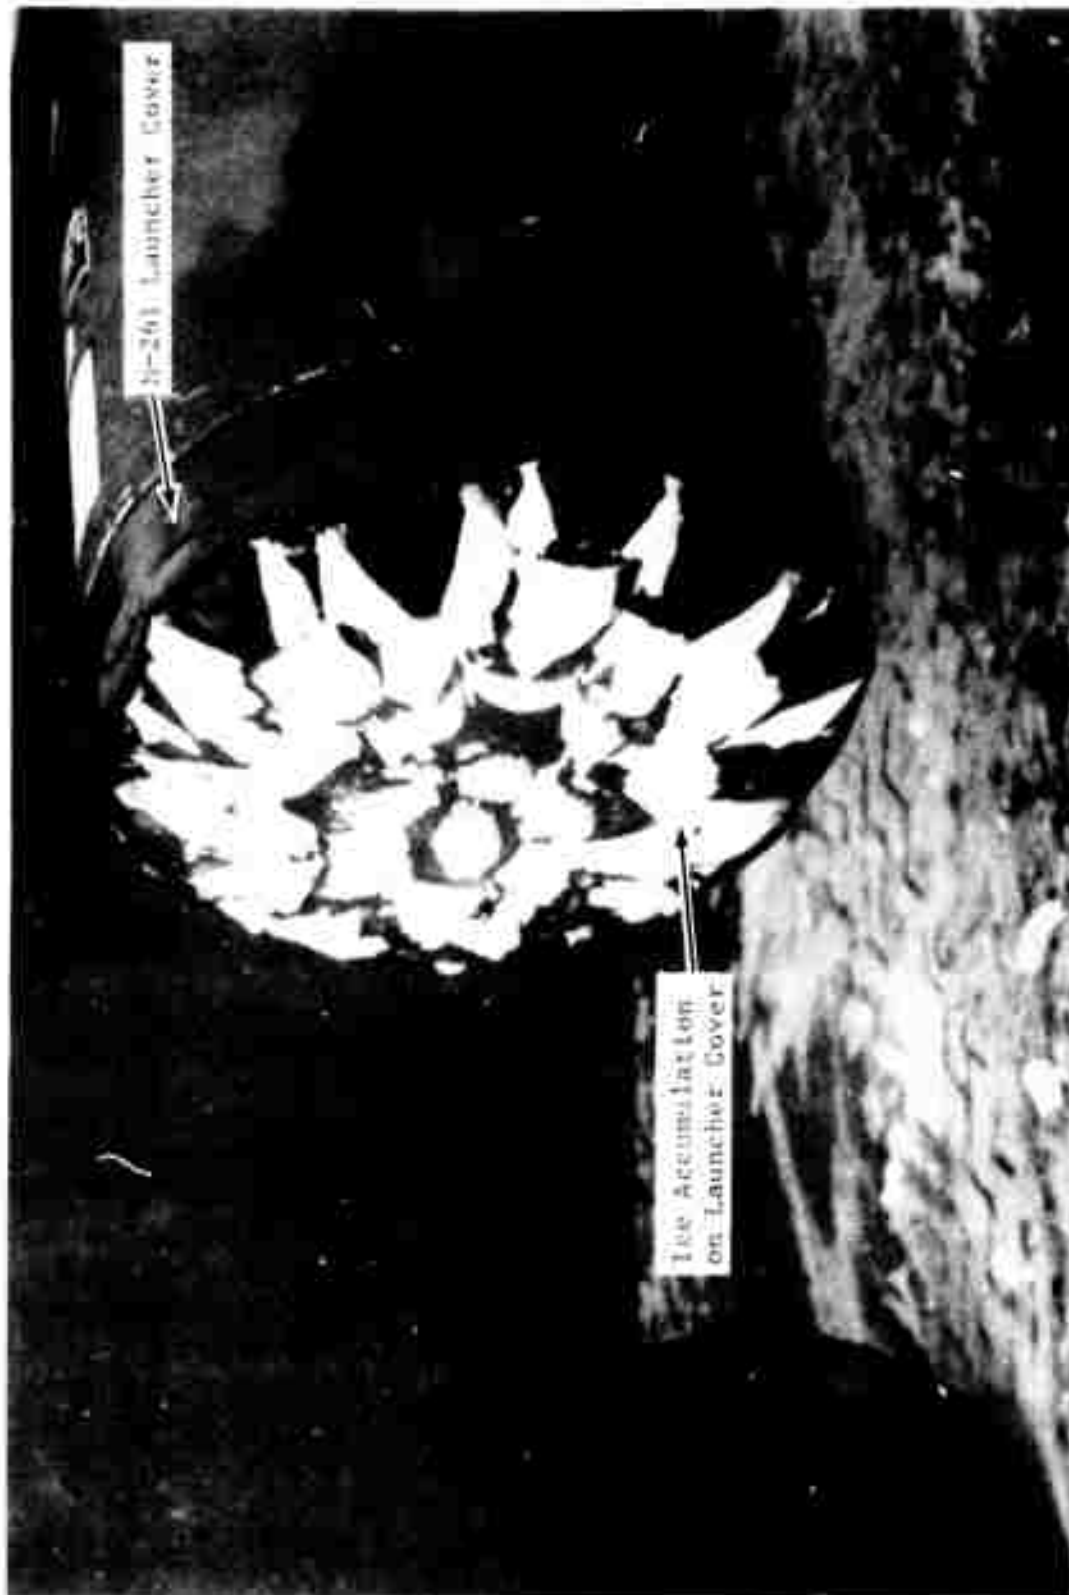
Photo 9. Left Wing Store - N-261 Lightweight Rocket Launcher

39. The ice accretion and shedding characteristics of the M-261 lightweight rocket launchers were evaluated during this test. Protection covers identical to those previously described and tested (app F) were installed on the launchers. Ice accreted on the protective covers as shown in photo 9. Rocket firing was not attempted following an icing encounter. The ice accretion and shedding characteristics of the M-261 lightweight rocket launcher are satisfactory. A test should be conducted to determine the consequences of the M-261 protective covers departing the launcher, with and without accumulated ice.

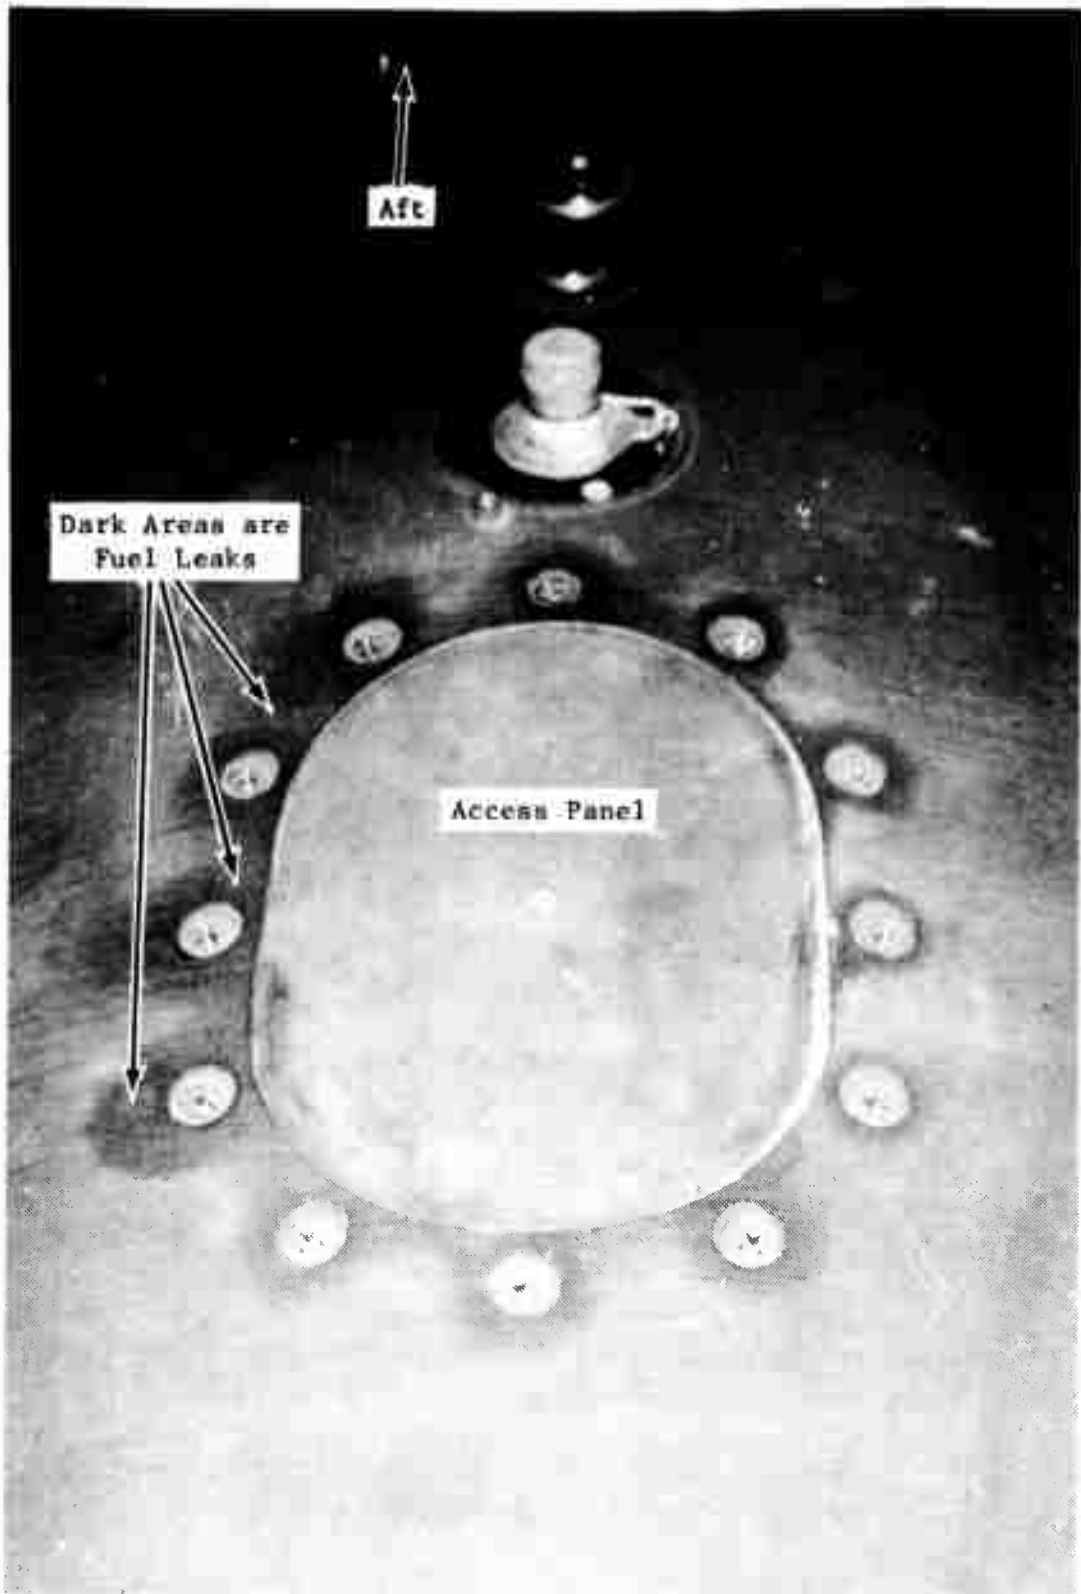
Photo 13. Auxiliary Fuel Tank - Top View

leak when the aircraft is stored after normal shutdown is a shortcoming.

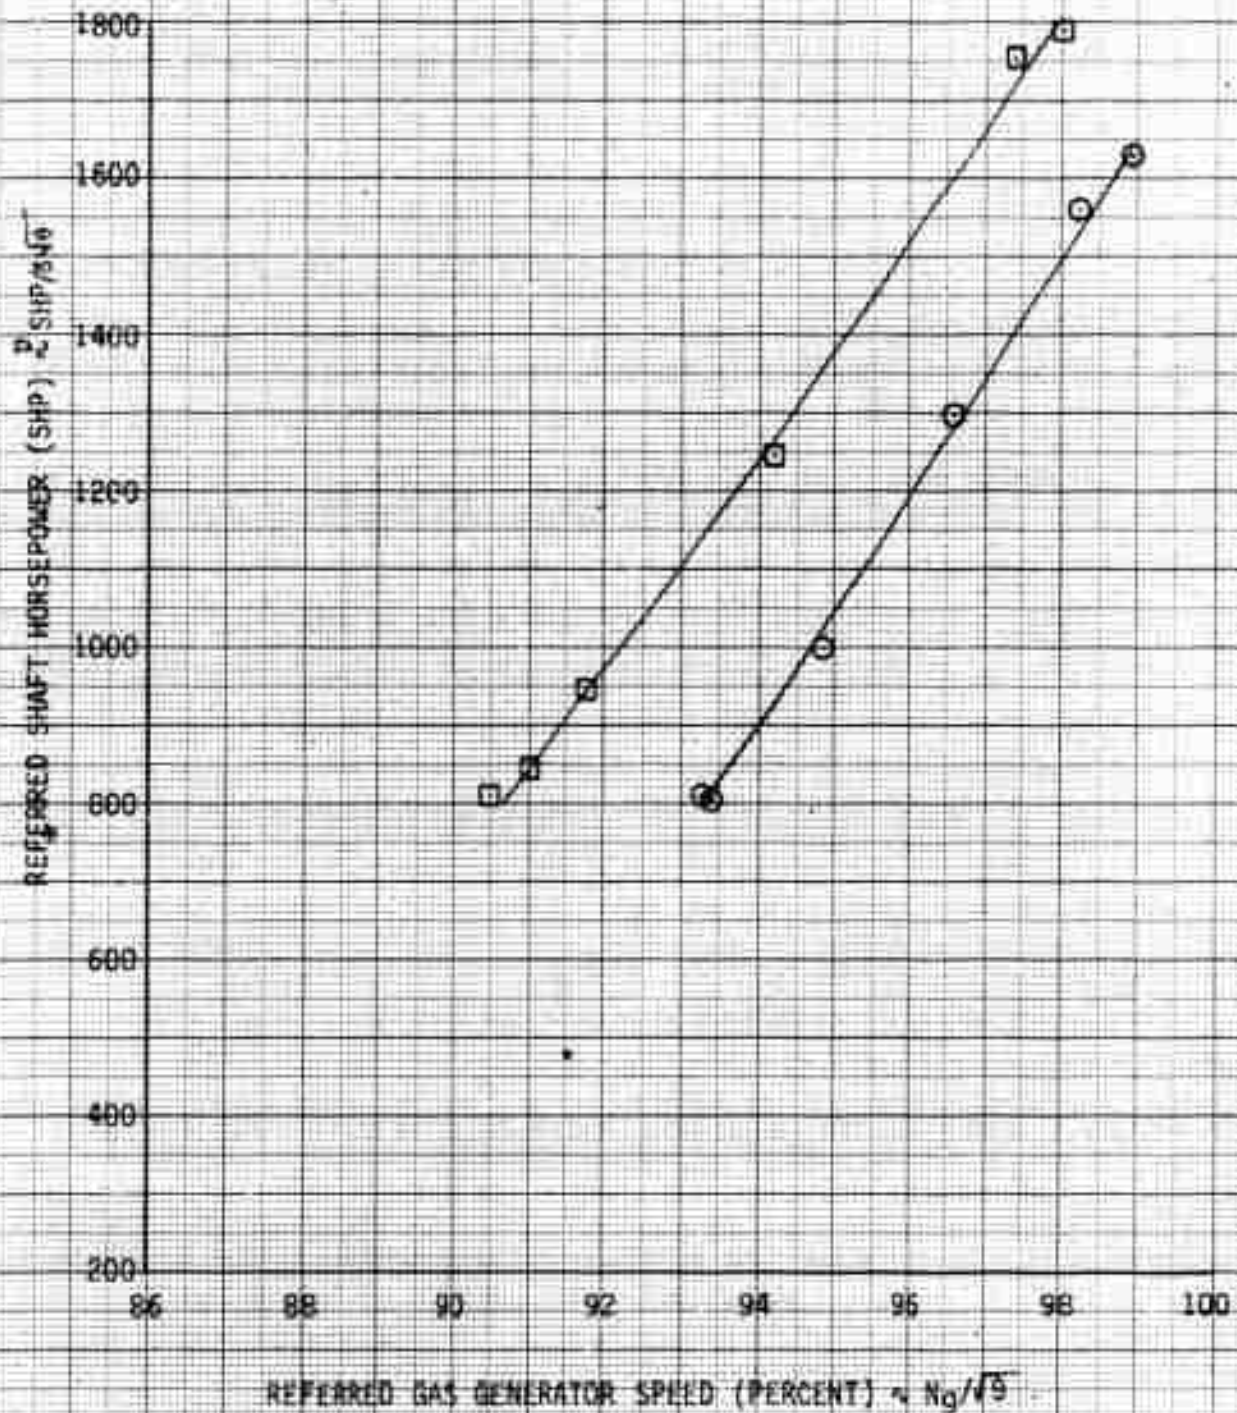
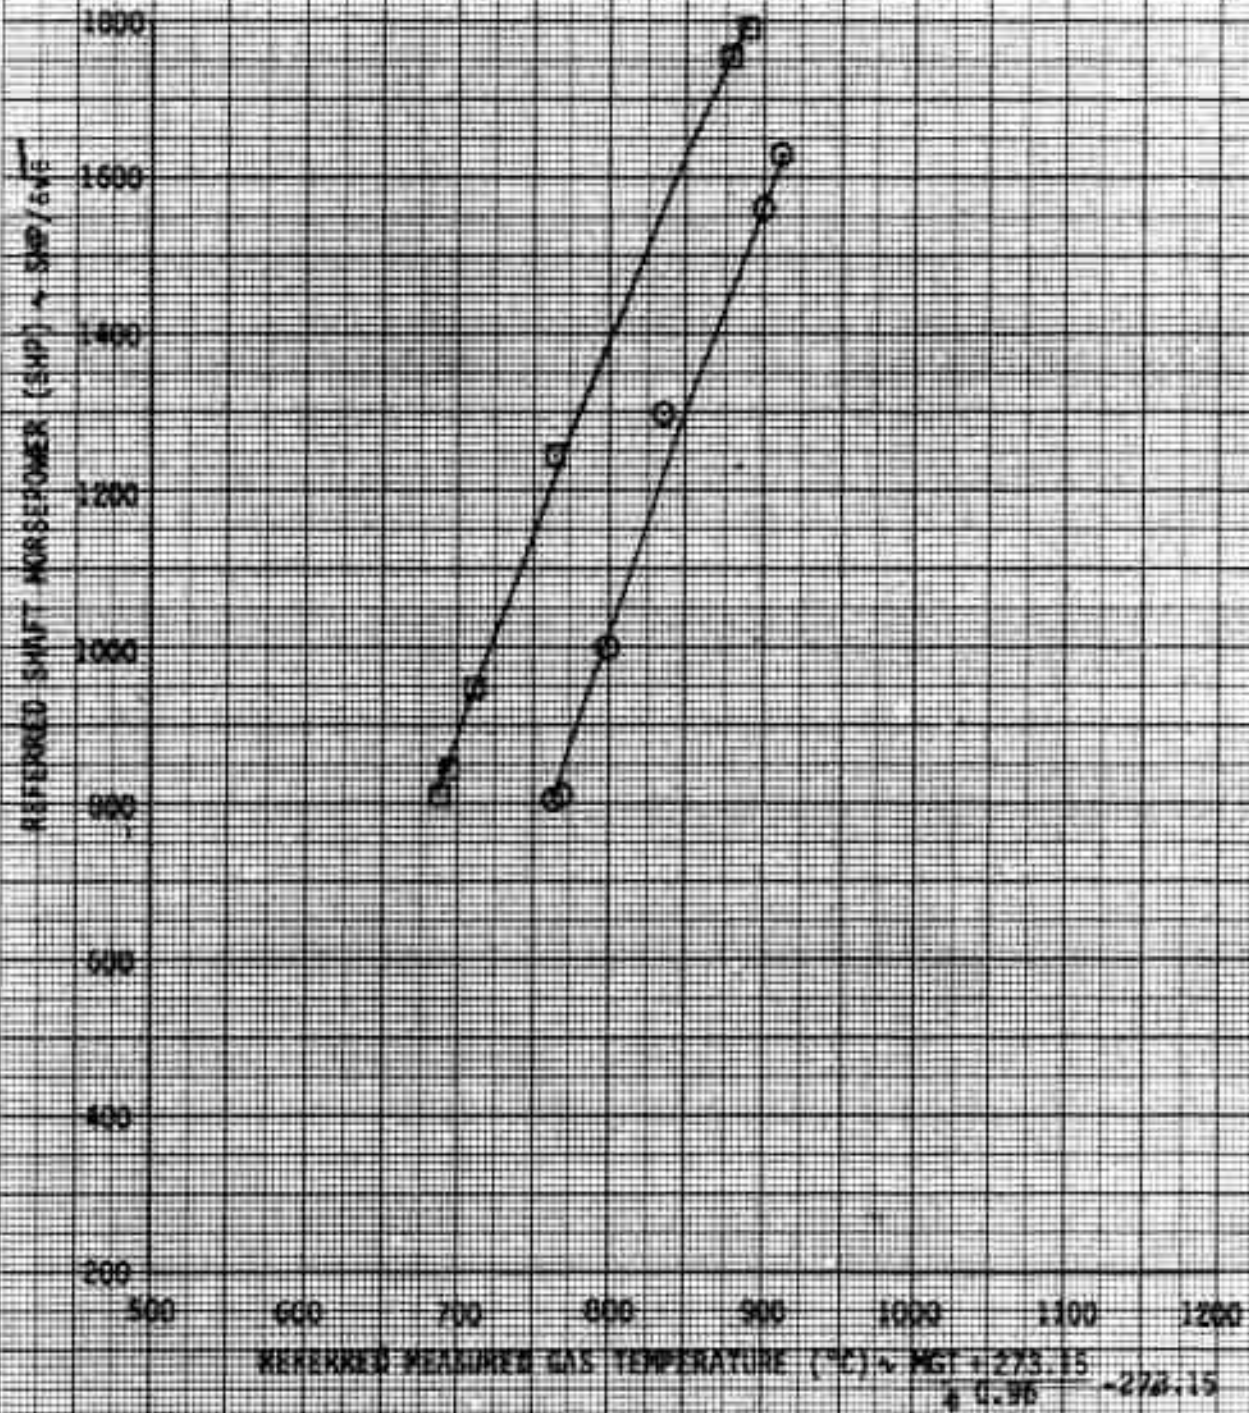
(2) Power Loss with Operation of Anti-Ice Systems. The engine performance characteristics were recorded with the bleed air anti-ice systems OFF and ON for comparison. The comparison is shown in figures 7 and 8, enclosure 4. An approximate 50°C increase in measured gas temperature was observed with anti-ice system use. The power available losses with activation of the anti-ice systems observed during these tests are significant. Performance information incorporating these losses should be published in the operator's manual for the pilot to use in preflight planning.

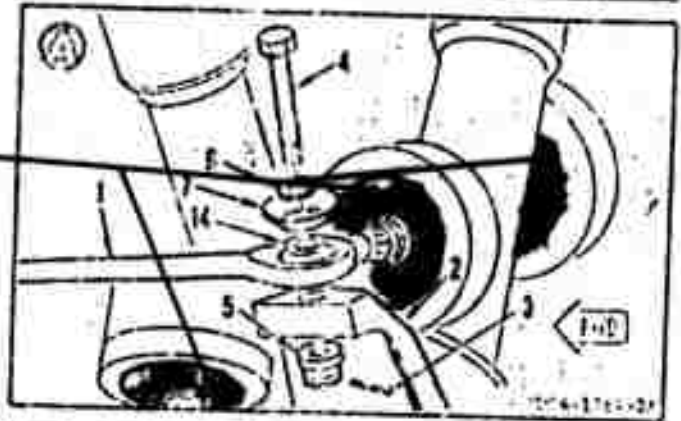
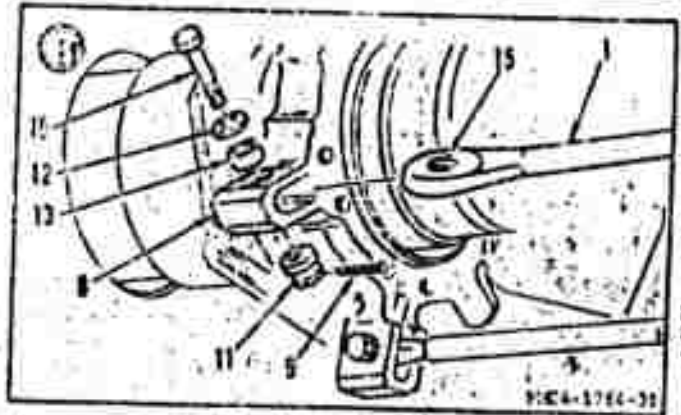
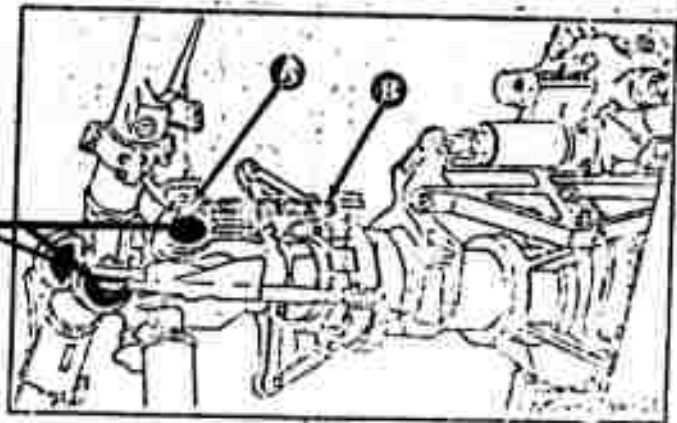
RESILIENT MOUNT, T/R
P/N: 7-211421025

26. DESCRIBE INCIDENT FULLY (INCLUDE IMPACT OF INCIDENT ON MAC CODE IDENTIFIED IN BLOCK 22): During ground inspection, after No. 2 flight, resilient mount was found to have debonded from forked housing on tail rotor yoke housing. Further inspection revealed only one of the four mounts had debonded. Maintenance crews removed the outboard T/R to remove debonded mount. Clean up on fork assembly and old mount was required before rebonding and cure time. Proceeded through bonding procedures titled: Bonding Procedures for the 7-211421008 Tail Rotor Fork Assembly. Time cured before testing bond on ground was approximately 20 hours. Ground run was accomplished approximately 22 hours after bonding. Ground inspection after run revealed no debonding. Balancing of T/R was required after rebonding of mount. Reference: TM 55-1520-238-23 and 23P; Fig. 127, Item 20		
INCIDENT CLASSIFICATION IS SUBJECT TO RECLASSIFICATION

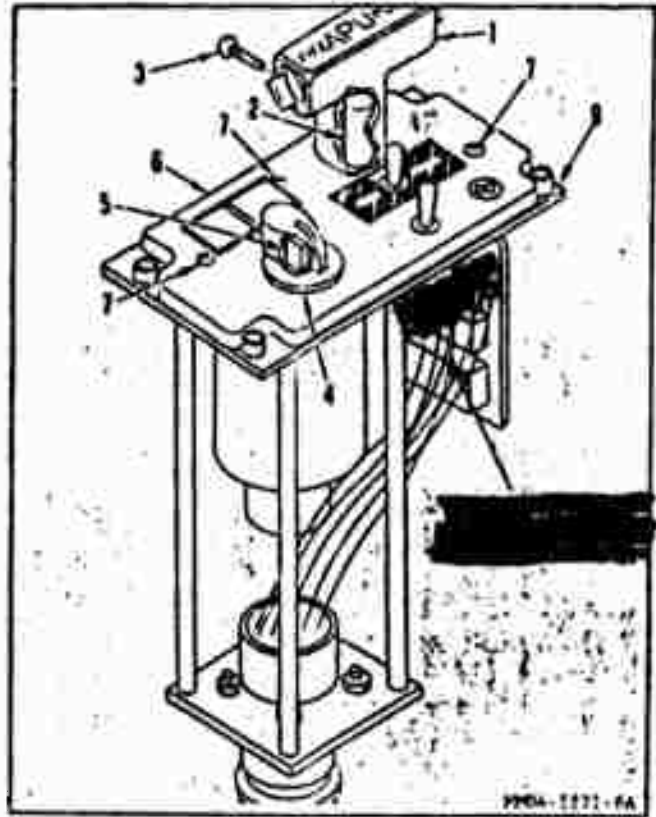
LOCATION OF APU PANEL
ON PILOT'S RT. CONSOLE

26. DESCRIBE INCIDENT FULLY (INCLUDE IMPACT OF INCIDENT ON MAC CODE IDENTIFIED IN BLOCK 22): On APU start, pilot observed traces of smoke from his right console. Pilot terminated APU run. Electricians removed APU panel from right console and discovered an apparent burnt diode. Damaged panel was removed and a new APU panel was installed. Further trouble-shooting of damaged panel reaffirmed the one apparently burned diode, and another one was damaged due to the one that burned. No apparent cause for failure was discovered. Reference: TM 55-1520-238-23 See attached drawing for diodes location and APU panel.		
INCIDENT CLASSIFICATION IS SUBJECT TO RECLASSIFICATION

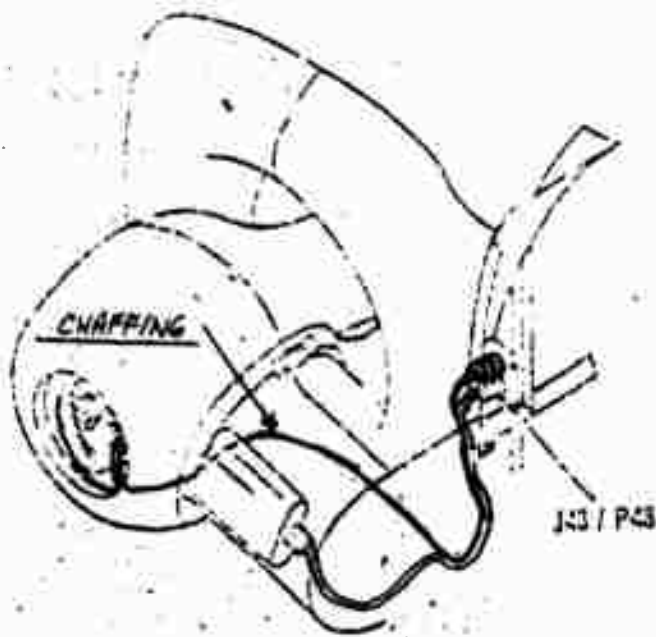
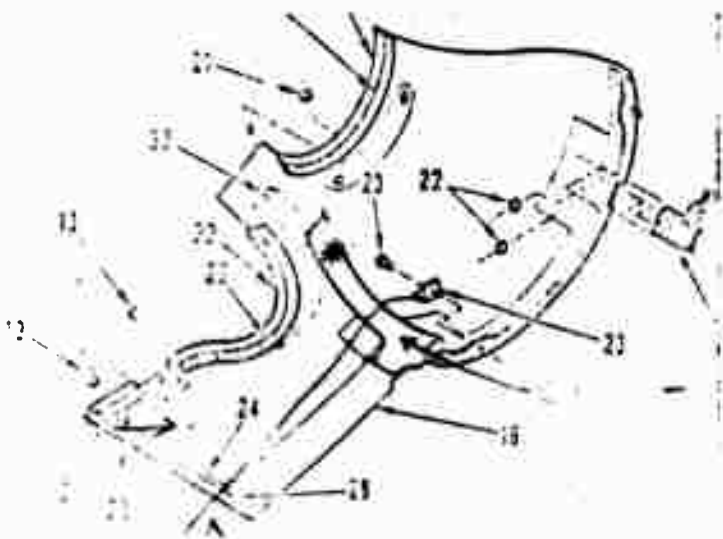
ENGINE 2 NOSE GEARBOX FAIRING

c. INSPECTION		a. CRITICAL
d. OTHER		b. MAJOR
		X c. MINOR
		c. ADJUSTED
		d. DISCONNECTED
		e. REMOVED
		f. NONE
IV INCIDENT DESCRIPTION		
26. DESCRIBE INCIDENT FULLY (INCLUDE IMPACT OF INCIDENT ON MAC CODE IDENTIFIED IN BLOCK 22):		
<p>When installing nose gearbox fairing, lower half, P/N: 7-311140174-2, the wire bundle to the nose gearbox was found to be pinched between the fairing and fan (D/S Covering) P/N: 7-31132001. There was no definite indication to the desired routing or anywhere to secure the wires from being left to dangle. Further inspection revealed the wires had been chaffing in that area due to no way to secure them to fairing. Velcro had been tried but it appeared that it doesn't hold. An alternate routing was tried behind a fairing support (see * on drawing), but connector at J48/P48 location was short from routing and won't connect.</p> <p>See Attached Drawings.</p>		
INCIDENT CLASSIFICATION IS SUBJECT TO RECLASSIFICATION

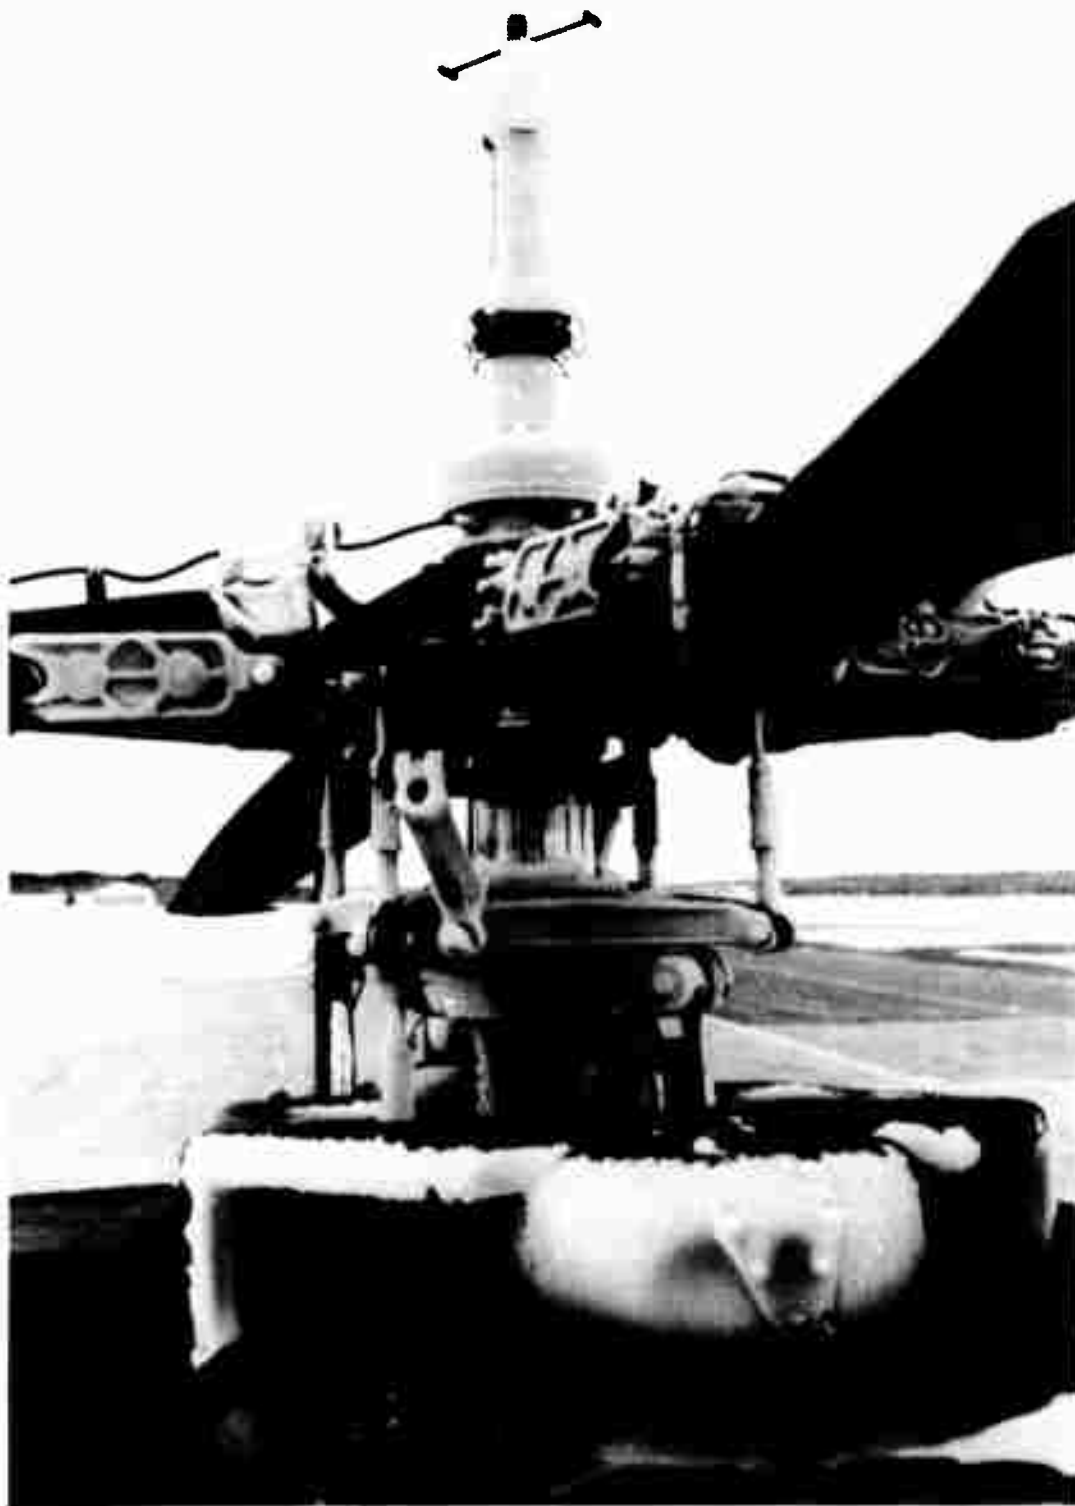
Photo 2. Residual Ice Accumulation on Unprotected Main Rotor Head Components

Conditions: Environment - Artificial
Configuration - Hellfire and Rockets
Flight - 2

Avg OAT - -9°C
Avg LWC - 1.19 gm/m^3
Time in Cloud - 30 minutes

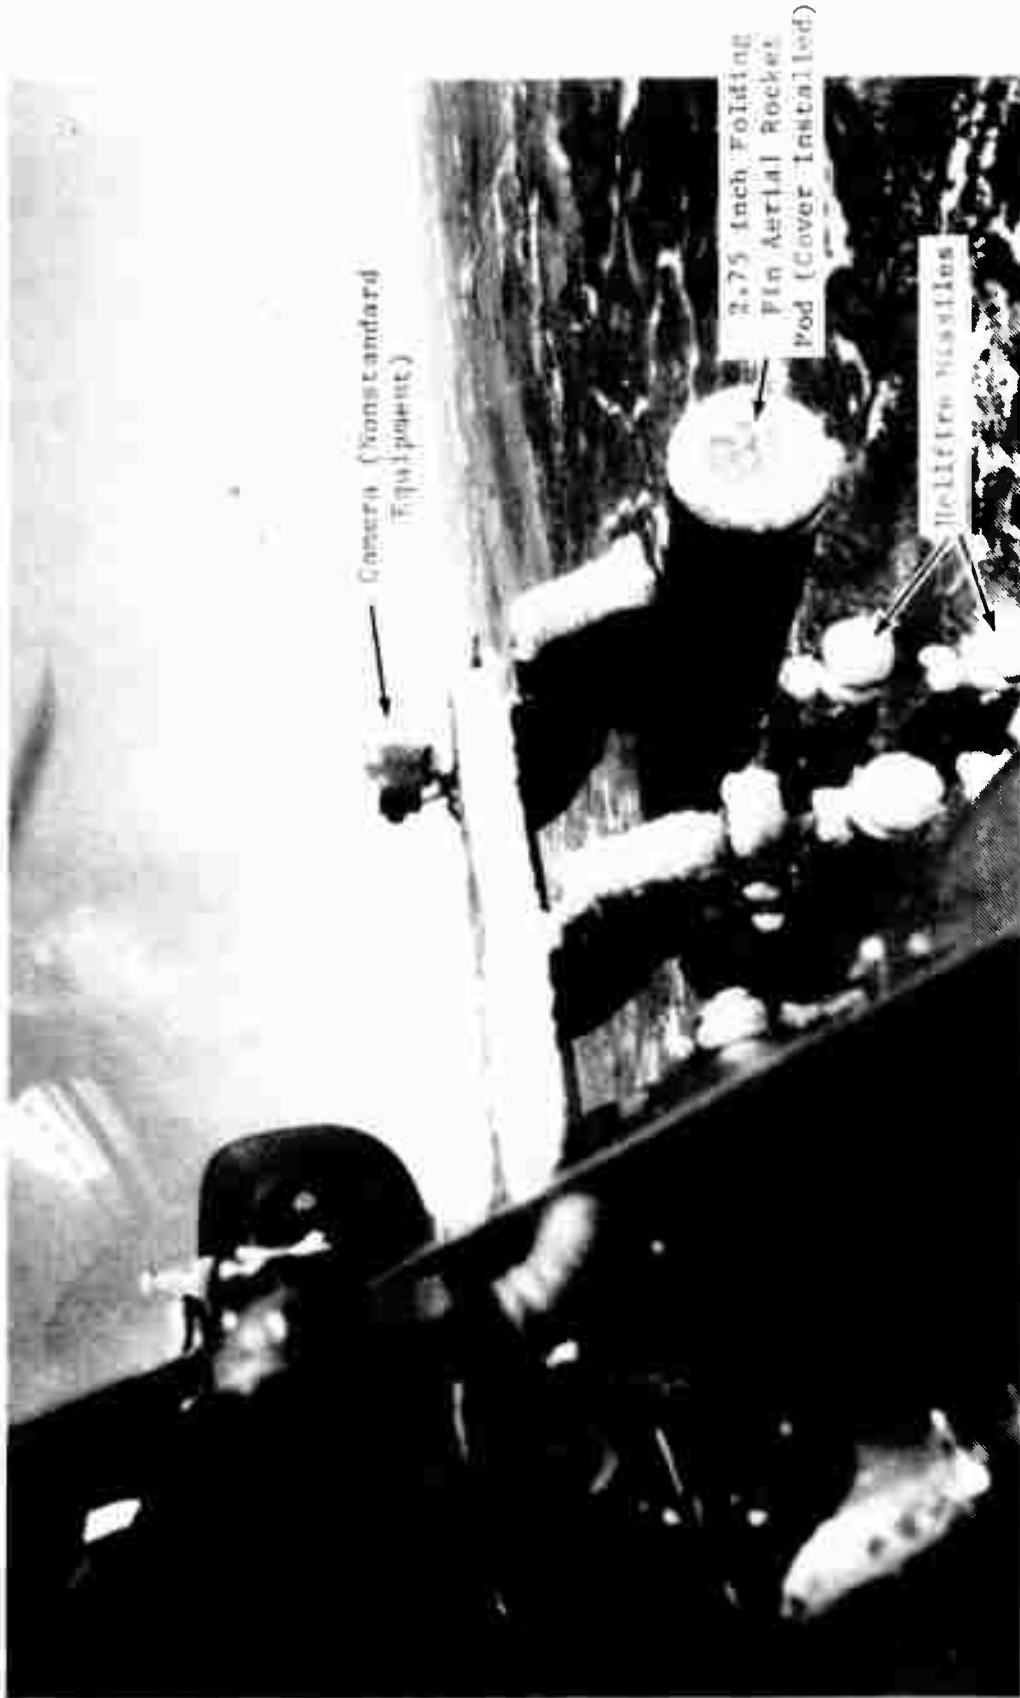
Photo 7. Ice Accumulation on Left Side Wing Stores - Pilot's Station Looking Aft

Conditions: Environment - Artificial
 Configuration - Hellfire and Rockets
 Flight - 4

Avg OAT - -9.5°C
 Avg LWC - 1.21 gm/m^3
 Time in Cloud - 60 minutes

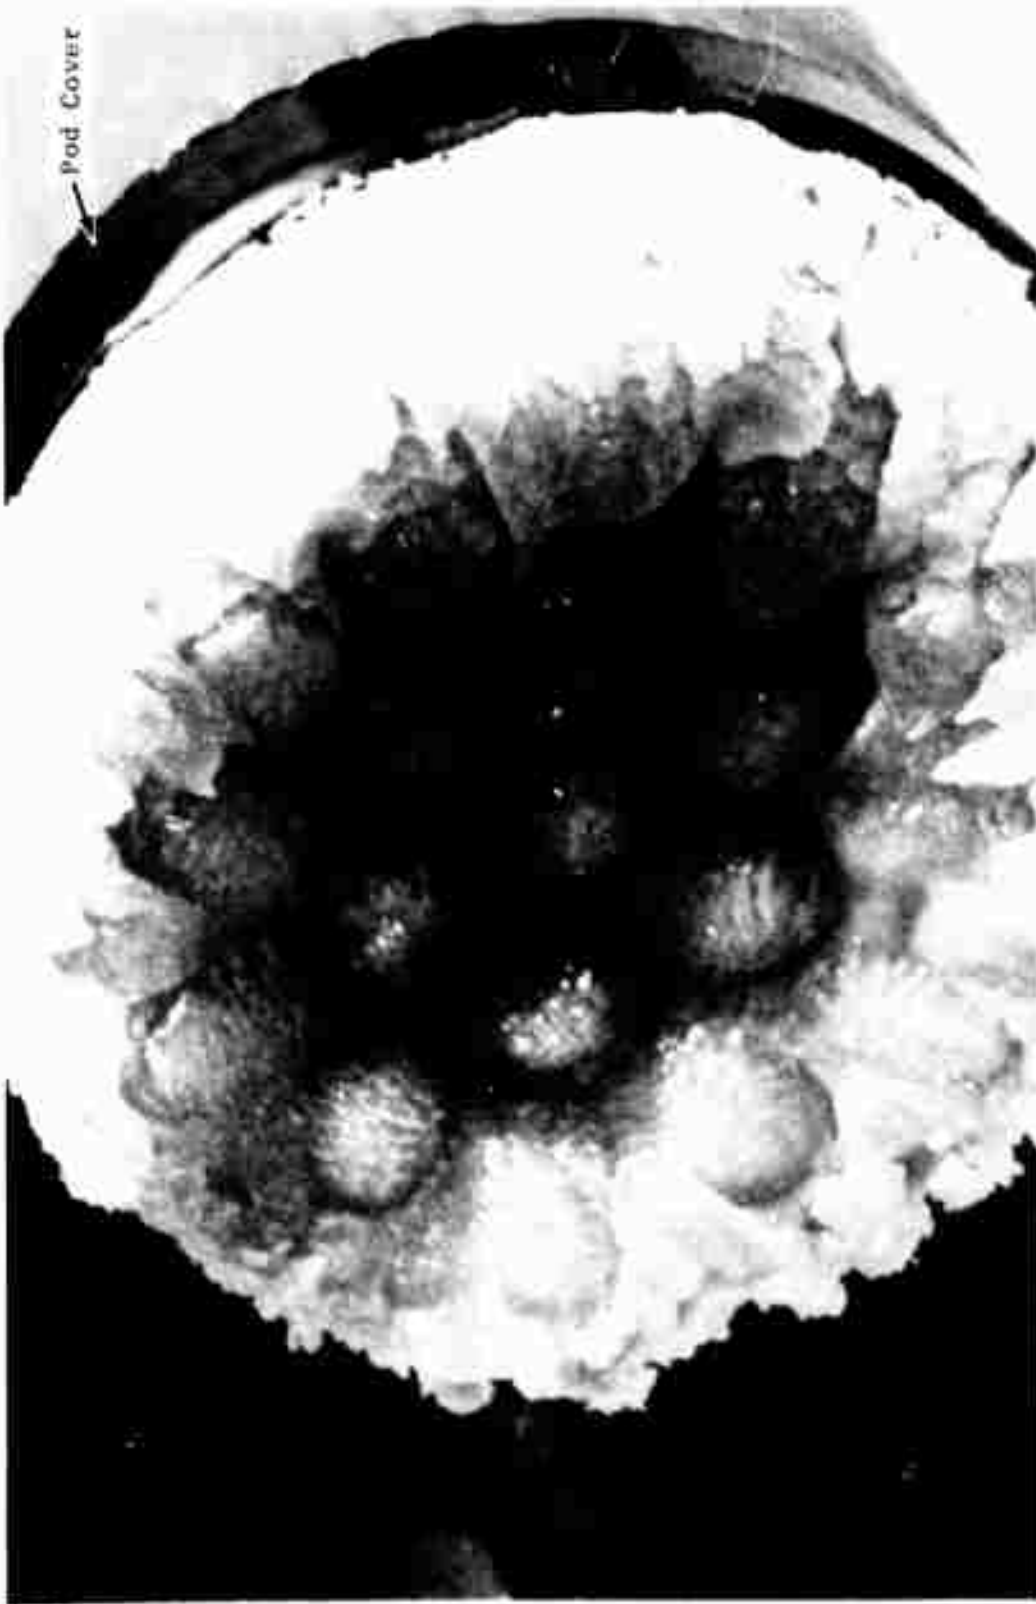
Photo 9. Residual Ice Accumulation on 2.75 inch Folding Fin Aerial Rocket Pod
With Cover Installed

Conditions: Environment - Artificial Avg OAT - -9.5°C
Configuration - Hellfire and Rockets Avg LWC - 1.21 gm/m^3
Flight - 4 Time in Cloud - 60 minutes

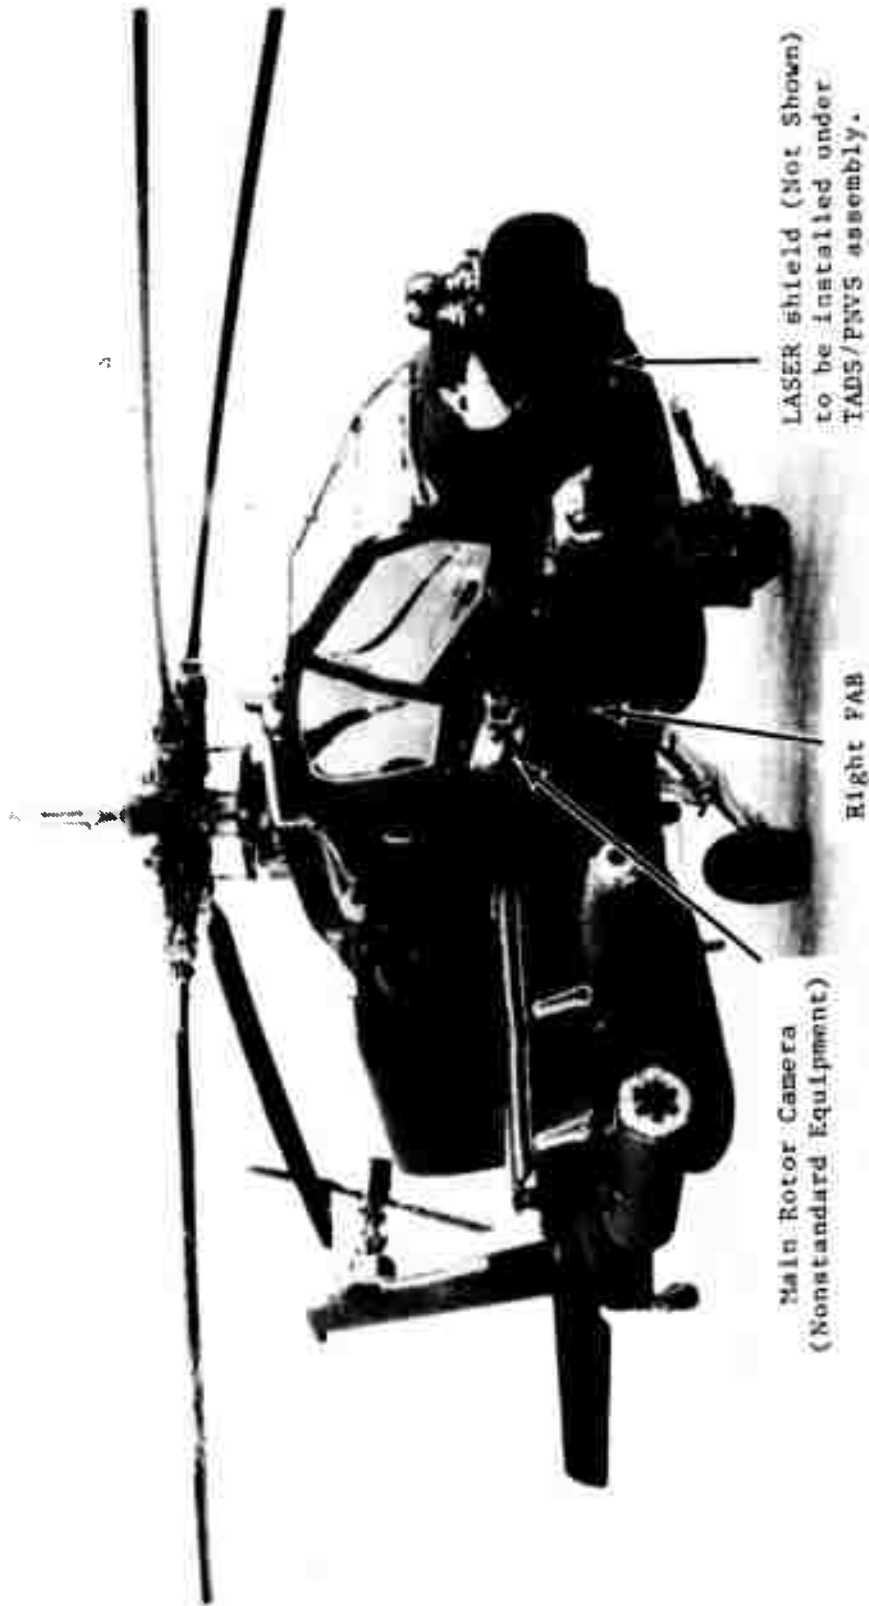
Photo 5. AH-64 - Right Front View

3. Four video cameras were located on the test aircraft to document ice accretion characteristics. One camera was mounted on the right forward avionics bay to photograph the main rotor advancing blade leading edge and lower surface (photo 5, encl 5). Another camera located on the top of the left wing tip photographed the tail rotor and horizontal stabilator (photo 7, encl 5). The third camera photographed the left engine inlet (photo 7, encl 5). A fourth camera was mounted on the transmission access panel for three flights to document ice accretion on the right engine aft nose gearbox cross shaft fairing (photo 15, encl 5).

Main Rotor Camera
(Nonstandard Equipment)

Right FAB

LASER shield (Not Shown)
to be installed under
TADS/PNVS assembly.

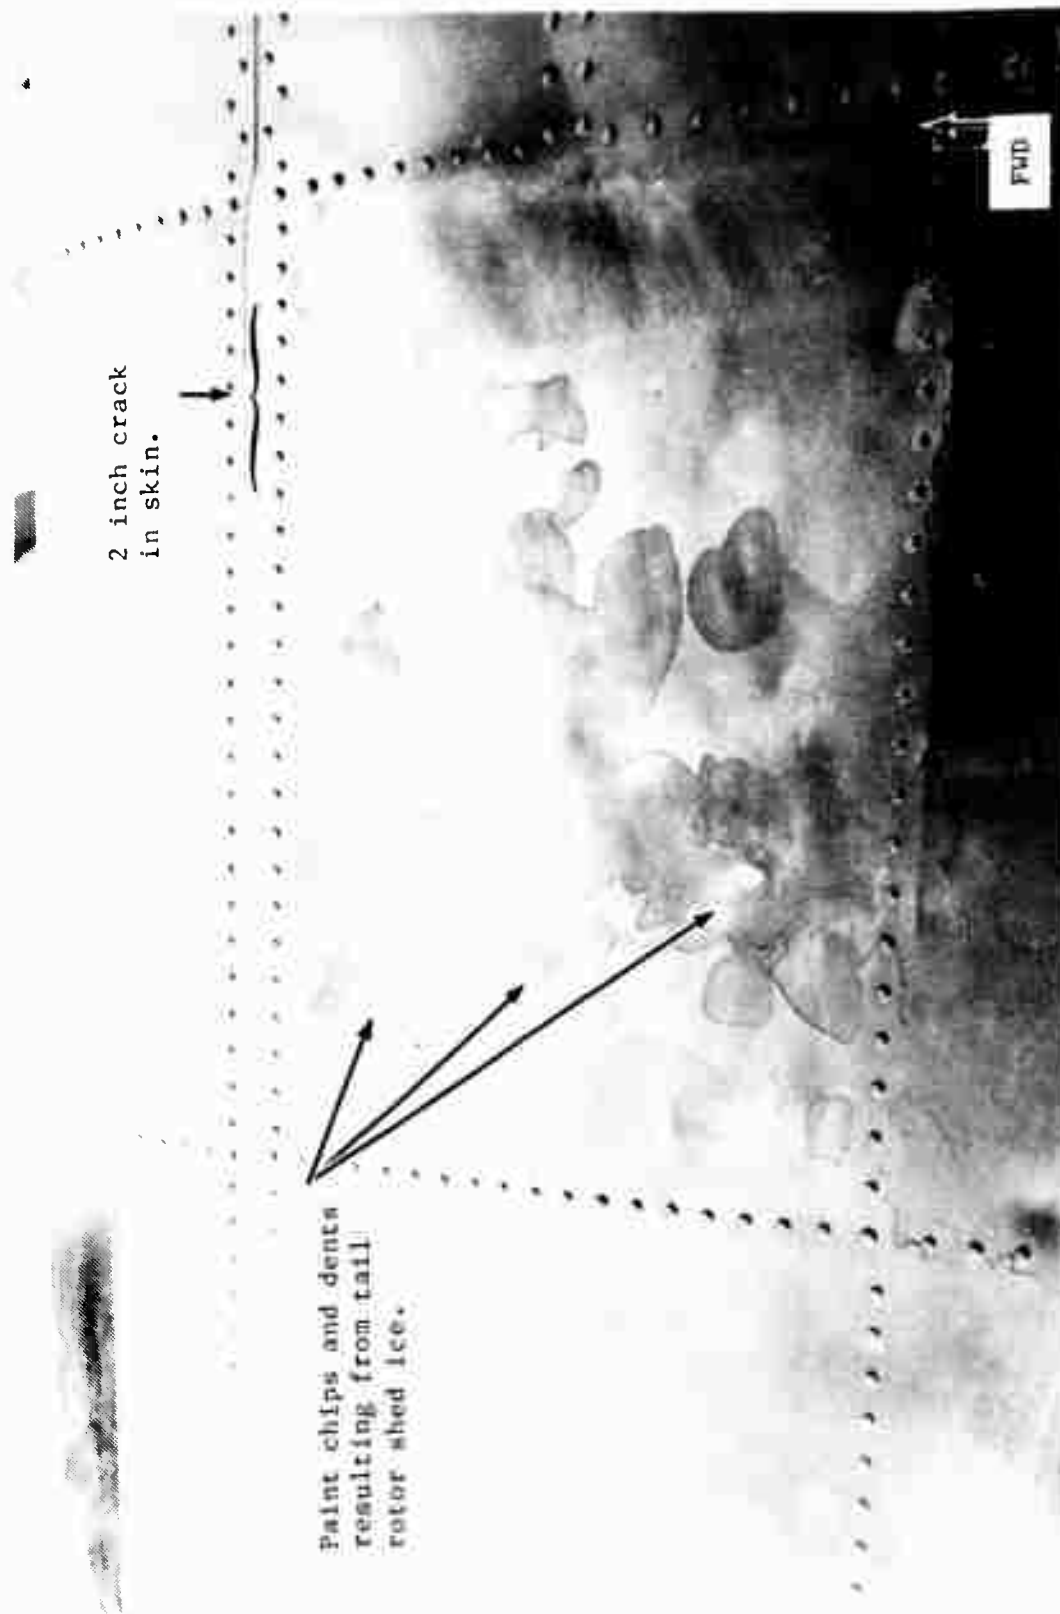
Photo 6. AH-64 Left Stabilator

2 inch crack
in skin.

Paint chips and dents
resulting from tail
rotor shed ice.

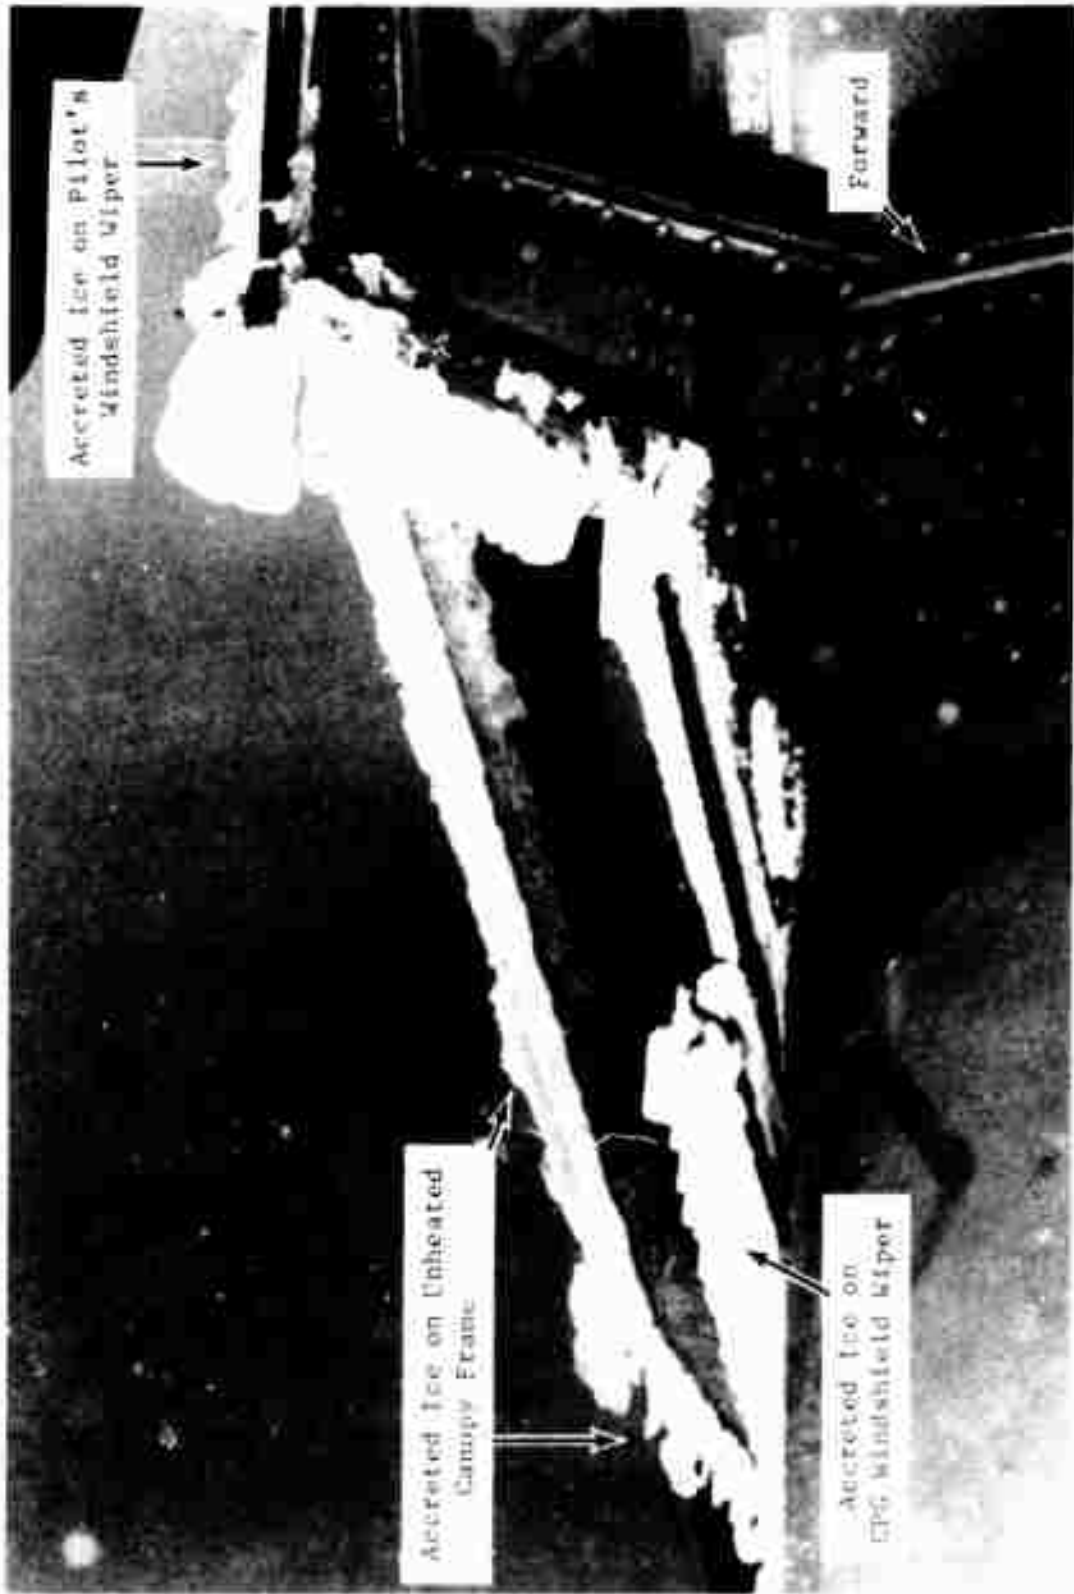
Photo 9. Ah-64 Forward Canopy

(6) Canopy Frames. The framework supporting the essentially flat plate canopy was not anti-iced. The forward canopy frames accreted large quantities of ice (photo 9, encl 5). The CPG windshield wiper was used for removal of water which pooled on the heated glass window. This water and the accreted ice (particularly around the CPG window) combined to form significant ice accumulations on the canopy frames and windshield wiper arms. These ice formations became large enough to break away during flight and could impinge on the nose gearbox or be ingested by an engine. Ice accretion and shedding from the canopy frames should be further evaluated in a more severe natural icing environment.
