AEFA PROJECT NO. 84-23

ARTIFICIAL AND NATURAL ICING TESTS OF AH-64 (PHASE II)

MARCH 1987

FINAL REPORT

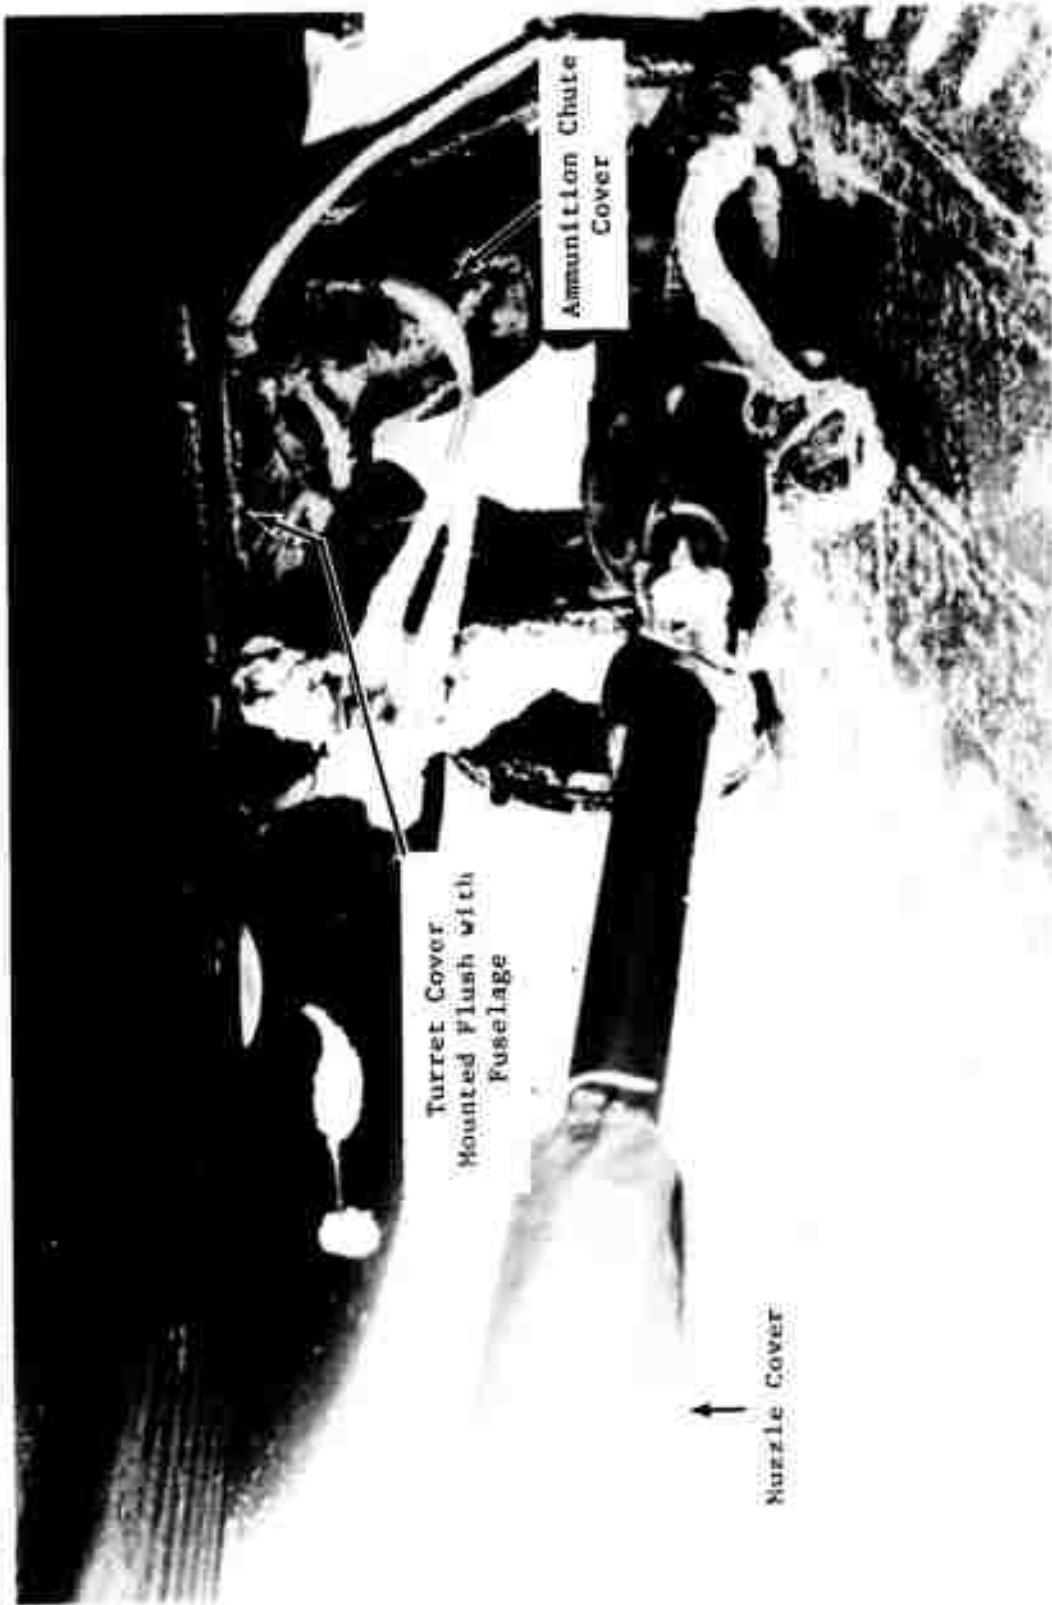
Photo 13. AH-64 30mm Area Weapon on Fuselage Underside

(14) Area Weapon System. The ice accretion and shedding characteristics of the 30mm chain gun area weapon system were evaluated in natural icing conditions. Ice accreted on all stagnation points and sharp edges (photo 13, encl 5). Weapons firing was not attempted following flight in icing conditions. Although live fire operations were not performed, the accreted ice did not hamper the traversing operation of the weapon. The gun was traversed inflight through its full range in azimuth and elevation to verify unrestricted motion. For these flights, a temporary muzzle protector made of cloth prevented ice buildups inside the gun barrel. A nonproduction cover was also fitted over the ammunition chute. This cover was modified from previous tests (ref 1f) and incorporated

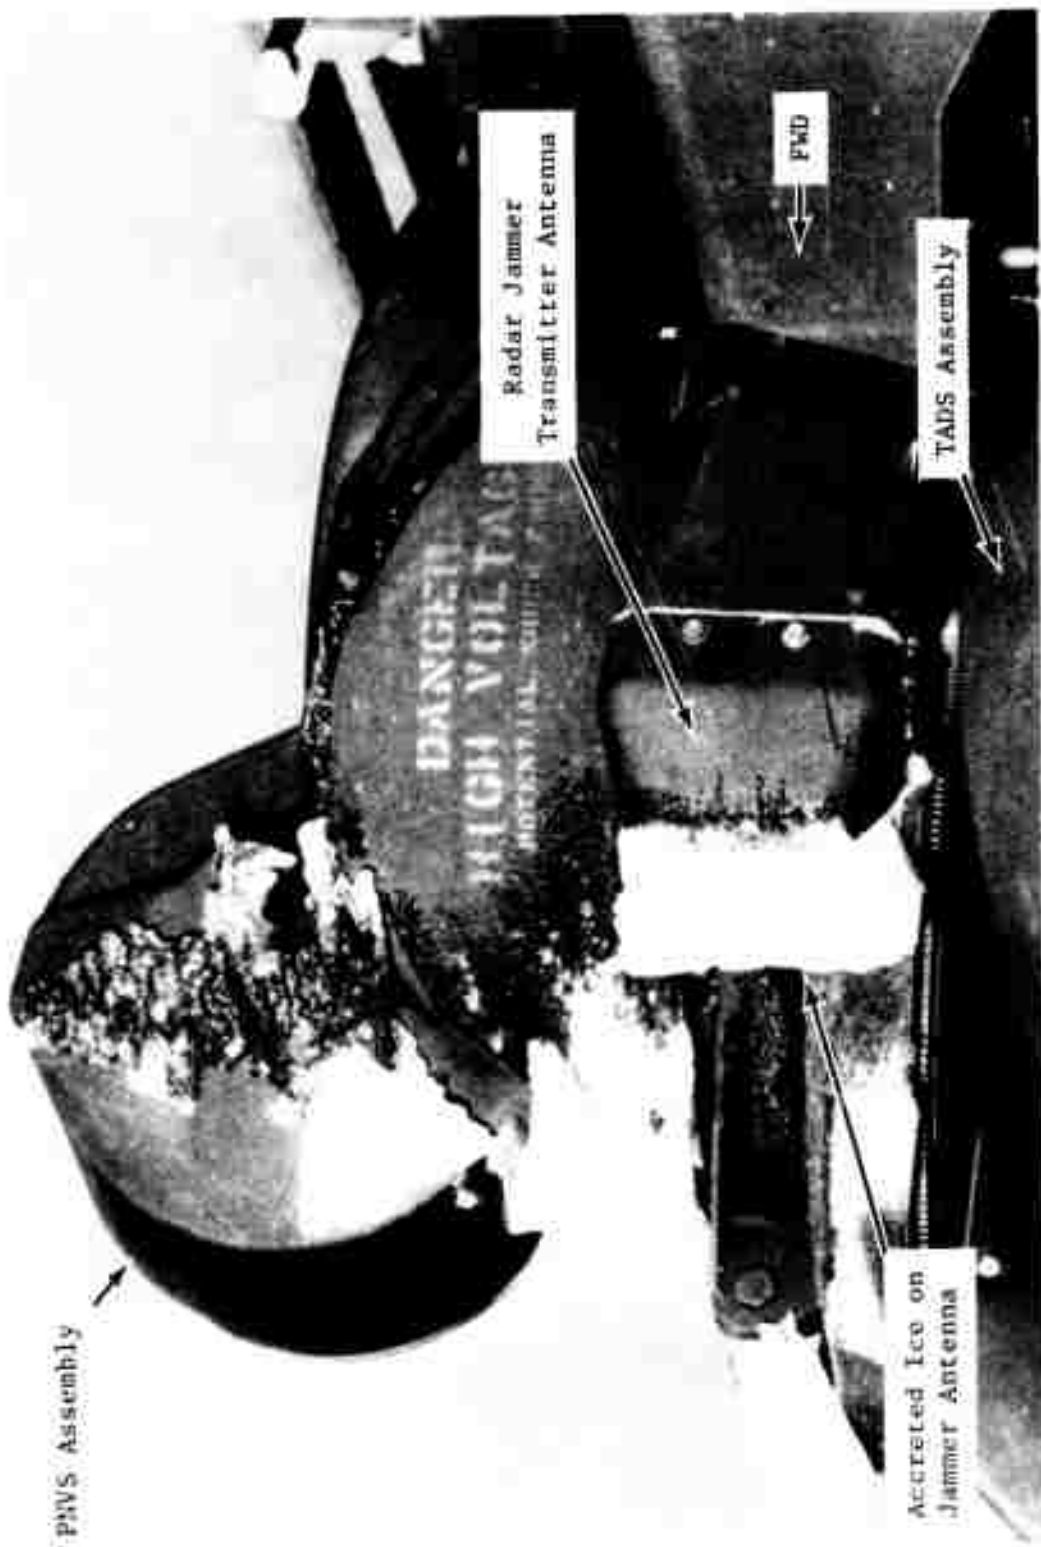
Photo 14. AH-64 TADS/PNVS - Left Front View

(16) Radar Jammer Antennas. A radar jammer transmitter antenna was mounted on the TADS/PNVS capsule (photo 14, encl 5) and a radar jammer receiver antenna was mounted on the upper fuselage (photo 1, encl 5). Operation of these antennas were not evaluated during the artificial icing tests (ref 1f). The 20 natural icing flights with these antennas installed included only two flights with LWC $> 0.3 \text{ gm/m}^3$. Large ice accretions on the unprotected radar jammer transmitter antenna could possibly restrict PNVS capsule motion. The potential for restriction of PNVS capsule range of movement by large ice accretions on the unprotected radar jammer transmitter antenna should be further evaluated in more severe natural icing conditions.

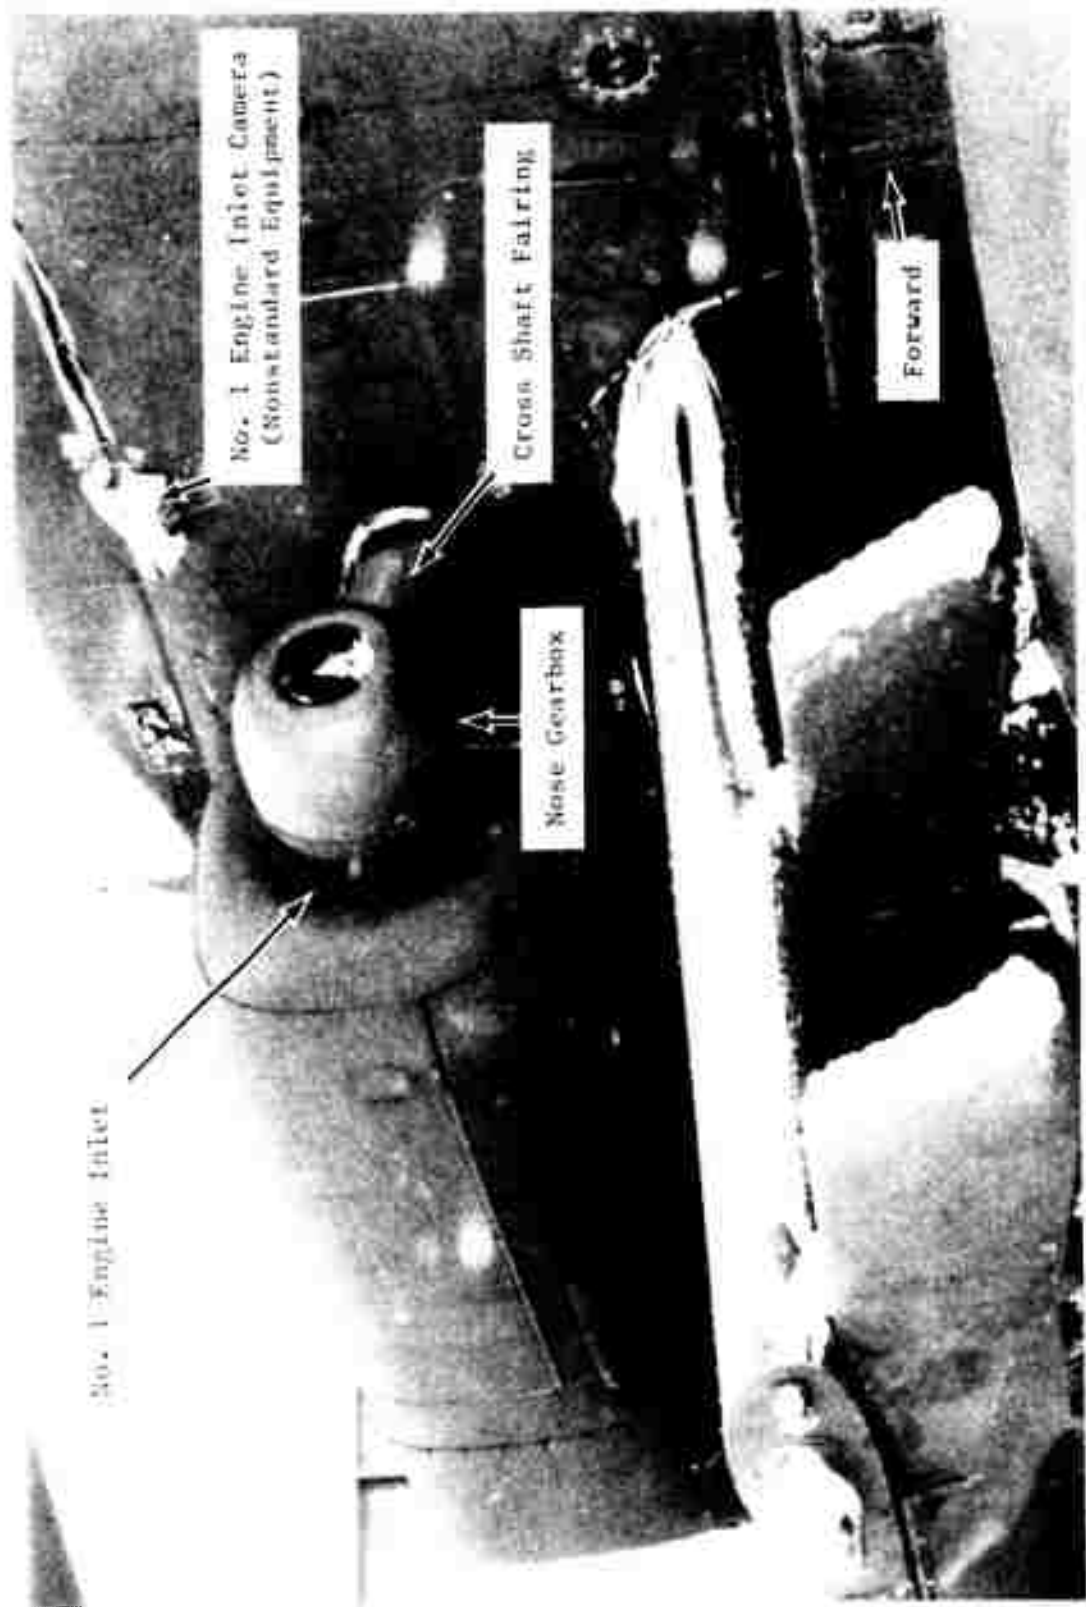
Photo 15. AH-64 Fuselage - Right Side View

3. Four video cameras were located on the test aircraft to document ice accretion characteristics. One camera was mounted on the right forward avionics bay to photograph the main rotor advancing blade leading edge and lower surface (photo 5, encl 5). Another camera located on the top of the left wing tip photographed the tail rotor and horizontal stabilator (photo 7, encl 5). The third camera photographed the left engine inlet (photo 7, encl 5). A fourth camera was mounted on the transmission access panel for three flights to document ice accretion on the right engine aft nose gearbox cross shaft fairing (photo 15, encl 5).
