**REPAIR, EVALUATION, MAINTENANCE, AND
REHABILITATION RESEARCH PROGRAM**

TECHNICAL REPORT REMR-CO-3

**CASE HISTORIES OF CORPS BREAKWATER
AND JETTY STRUCTURES**

Report 1
SOUTH PACIFIC DIVISION

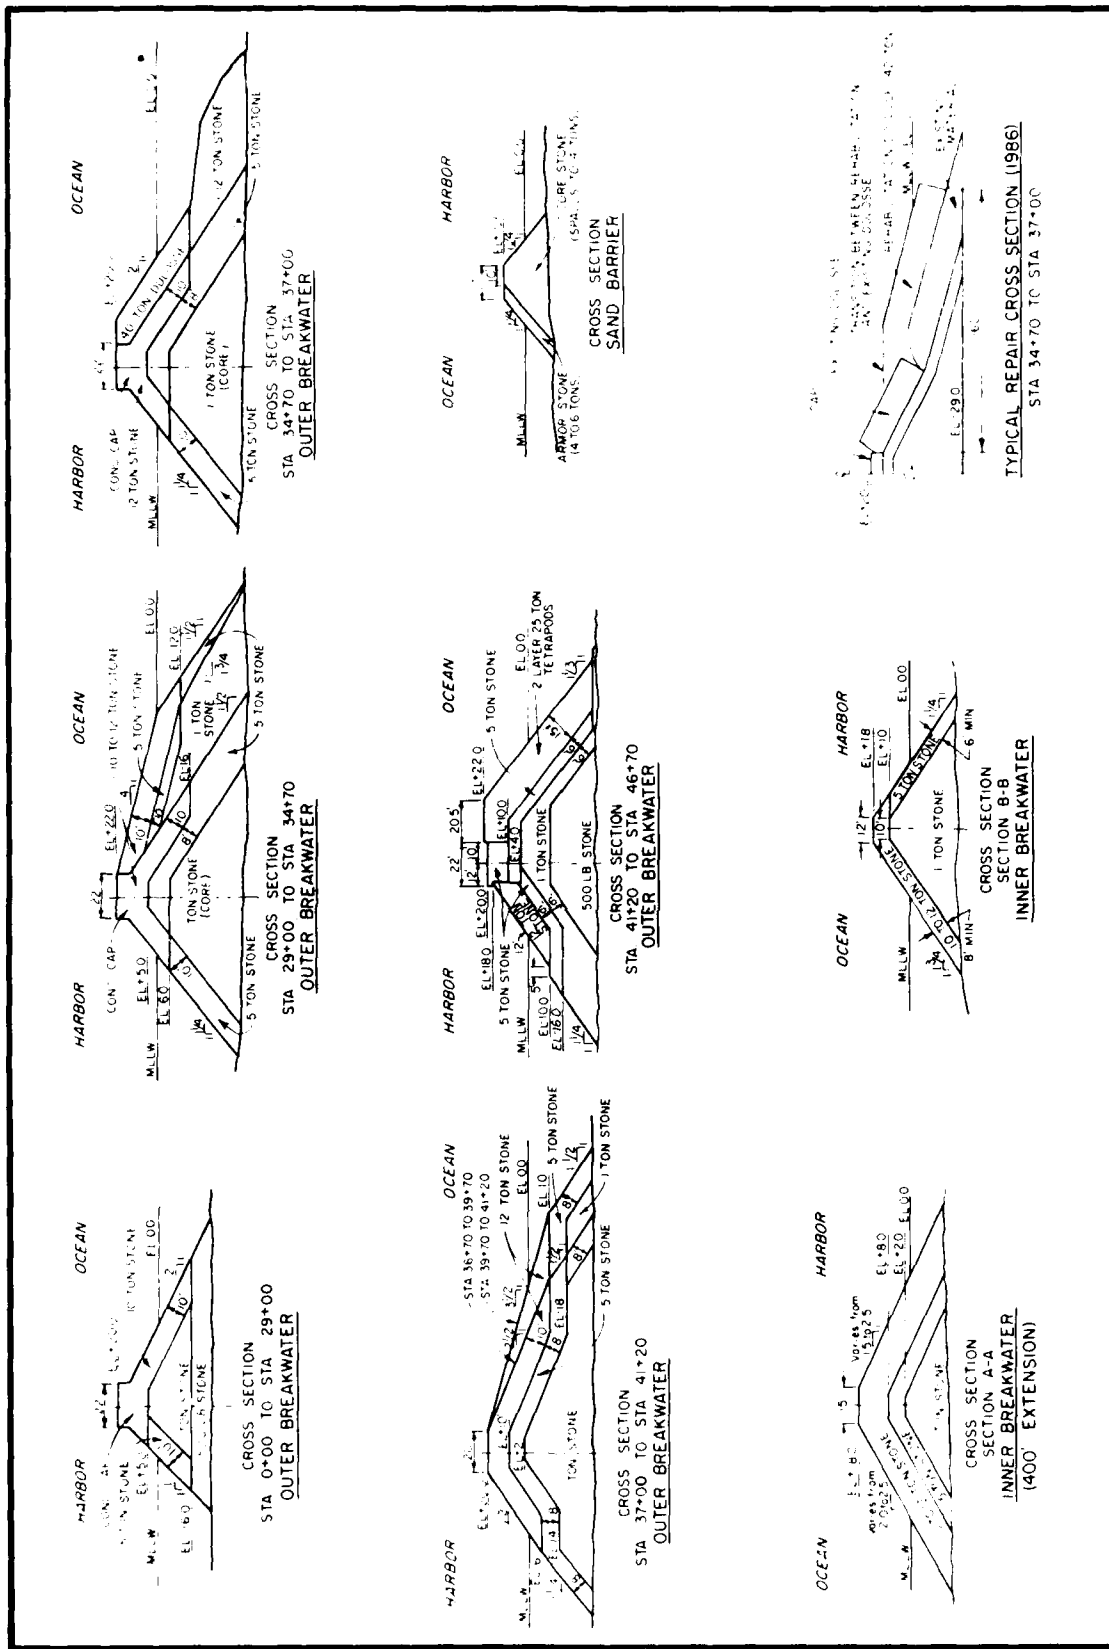
Figure 4. Typical structure cross sections, Crescent City Harbor, California

Date(s)	Construction and Rehabilitation History
1920- 1926	The initial work at the project (Figure 3) provided for a 3,000-ft-long rubble-mound breakwater, 6 to 11 ft above mean lower low water (mllw) with a 20-ft crest width. The first 2,245-ft length of breakwater was completed in 1926. Ten-ton armor stones were used for slope protection (Figure 4).
1928- 1930	A 14-ft-wide concrete cap was added to the original 2,245 ft of structure raising the crest elevation to 14 ft mllw.
1931	An additional 755 ft of breakwater construction was completed resulting in a 3,000-ft-long structure.
1939	Construction of a rubble-mound sand barrier connecting Whaler Island to the shore (Figure 3) was completed to prevent shoaling. The barrier structure was 17 ft wide at its crest with an elevation* of +10 ft mllw (Figure 4). An armor layer of 4- to 6-ton stones protected the ocean side of the sand barrier.
1946	Construction of a 1,200-ft-long inner breakwater was completed to provide protection to a small-craft basin. The inner breakwater extended from Whaler Island northwest (Figure 3). The crest el of the structure was +18 ft mllw (Figure 4) and 10- to 12-ton armor stones were utilized during construction.

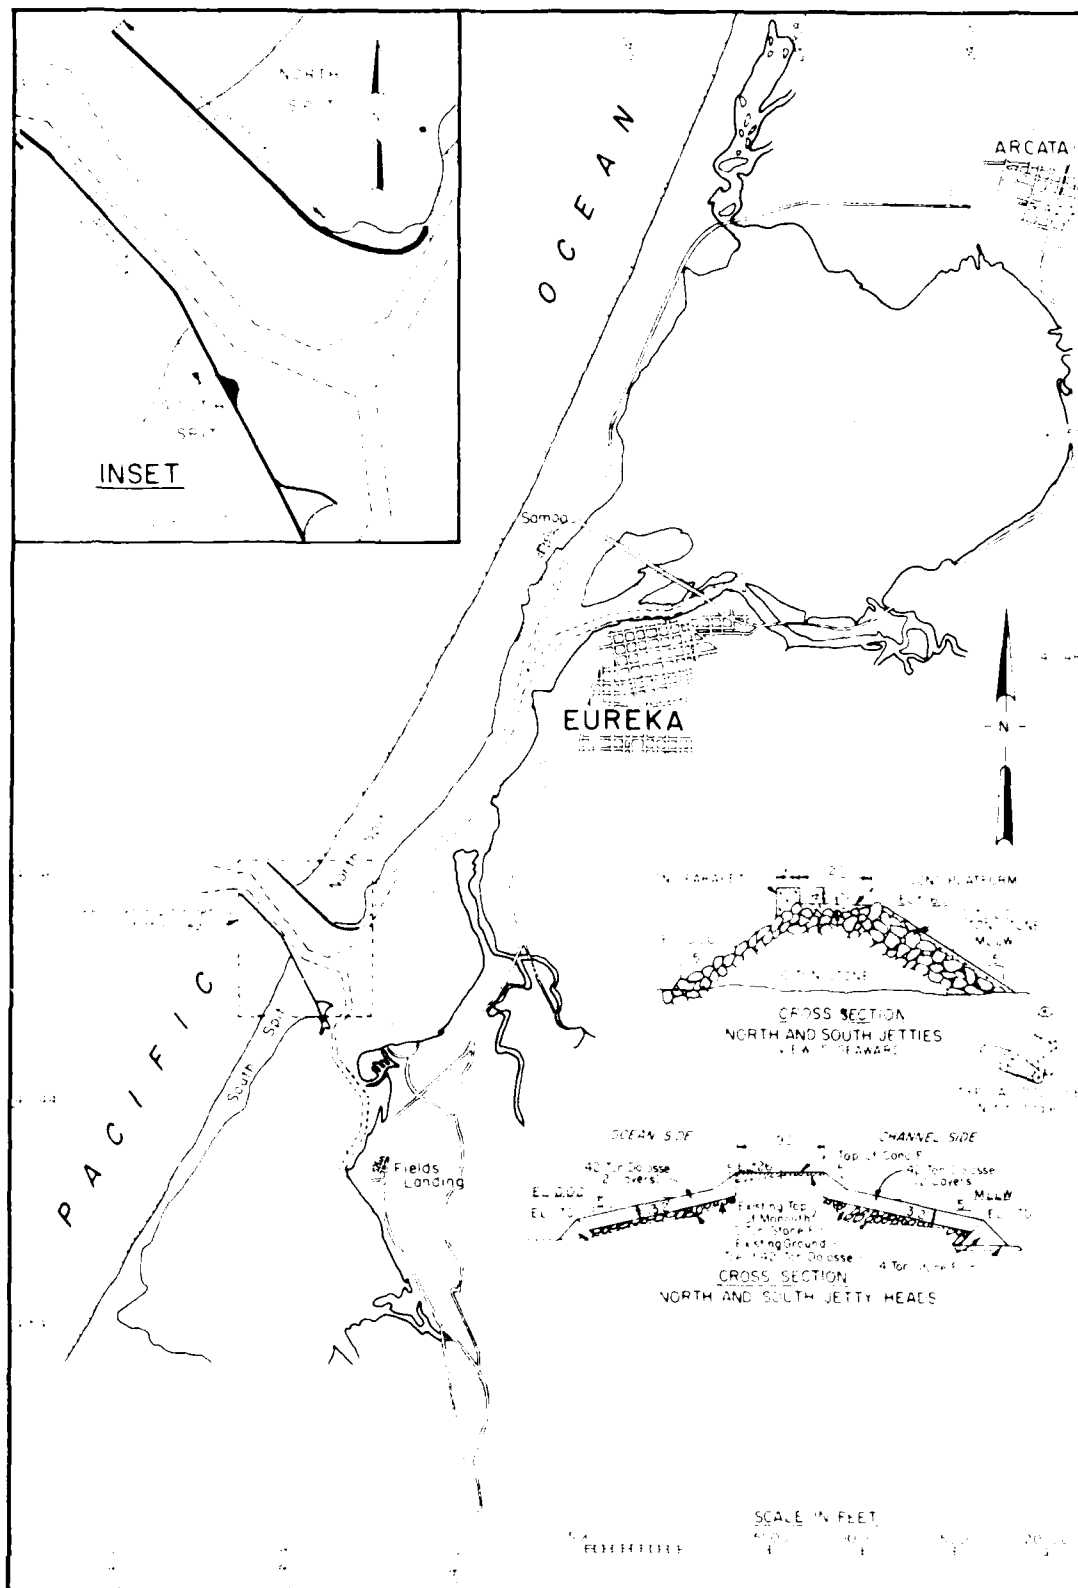
Figure 6. Humboldt Harbor and Bay, California

Date(s)	Construction and Rehabilitation History
1889- 1899	The initial construction of the north and south jetties was completed at the site (Figure 6) during this time frame. The south jetty was 4,000 ft long with a +10-ft mllw crest el. The ocean-side slope was 1V: 2.65H, and the channel-side slope was 1V:2.25H. The north jetty was constructed to a length of 1,500 ft with a crest el of +12 ft mllw. The ocean-side slope was 1V:2.42H, and the channel-side slope was 1V:1.85H. Stones used in the jetties were composed of rock up to 8 tons in weight. The jetties terminated at approximately the 18-ft contour.
1900- 1907	During this period the jetties deteriorated from lack of maintenance. The channel shoaled, and by 1907 the outer ends of the jetties were completely buried in the sand of the uncontrolled bar.
1911- 1915	Reconstruction of the south jetty was in progress. Structure design consisted of 1V:2H side slopes with crest el ranging from +14.8 ft to +19 ft mllw. Class I stones (10 to 20 tons) were used for facing the sea-side slope of the outer 2,400 ft of the jetty; Class II stones (1 to 10 tons) made up the main part of the jetty; and Class III stones (3 to 500 lb) were used to level off the top and fill in the voids between the larger stones. A 2-ft-thick, 20-ft-wide concrete slab was placed on the crown.

<u>Date(s)</u>	<u>Construction and Rehabilitation History</u>
1978	An inspection revealed that the north jetty slope was eroded at several locations, and 12 blowout holes were apparent in the concrete cap. Also, at the north jetty head, waves had broken away a 20-ton concrete block from the concrete monolith which washed across the monolith and was resting against a tip of a dolos. The slope of the south jetty had eroded in numerous locations, and the parapet wall had broken at four stations. Nineteen blowout holes were observed in the south jetty concrete cap. Also a 7-ft stone had broken out of the parapet wall and was deposited on the concrete cap.
1983	Major storms resulted in an estimated \$2,000,000 in damages to the jetties.
1984	Repair of the south jetty consisting of 4,900 tons of 15- to 25-ton stones and replacement of 20-ton concrete blocks at the jetty head was completed. Also 16,665 tons of 15- to 25-ton stones and 16,665 tons of 18- to 31-ton stones were stockpiled on the harbor side of the jetty.

1985	Repair of the jetty heads was completed using a total of approximately 1,000 42-ton dolosse in various areas and the construction of toe berms.

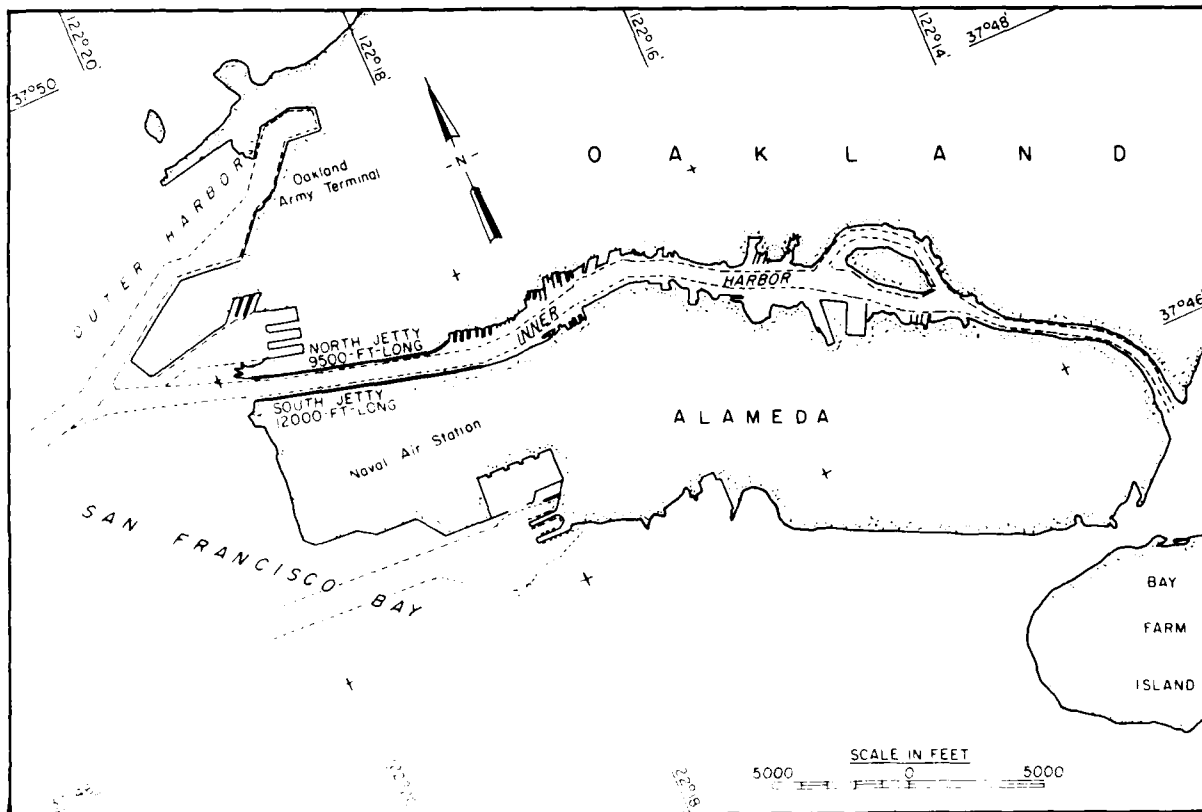
Figure 12. Oakland Harbor, San Francisco Bay, California

Date(s)	Construction and Rehabilitation History
1921-1927	Construction of a 9,500-ft-long north jetty and a 12,000-ft-long south jetty was completed (Figure 12) during this period of time. The jetties were constructed of stone.
1962	Maintenance of the structures along with maintenance dredging was adopted by the Corps of Engineers as authorized by the River and Harbor Act of 1962.
1986	Over the years the shore has been extended bayward on the outside of both jetties, and they function similar to revetments or absorbers. There are no records of maintenance to the jetties, and they are assumed to be in fair condition.

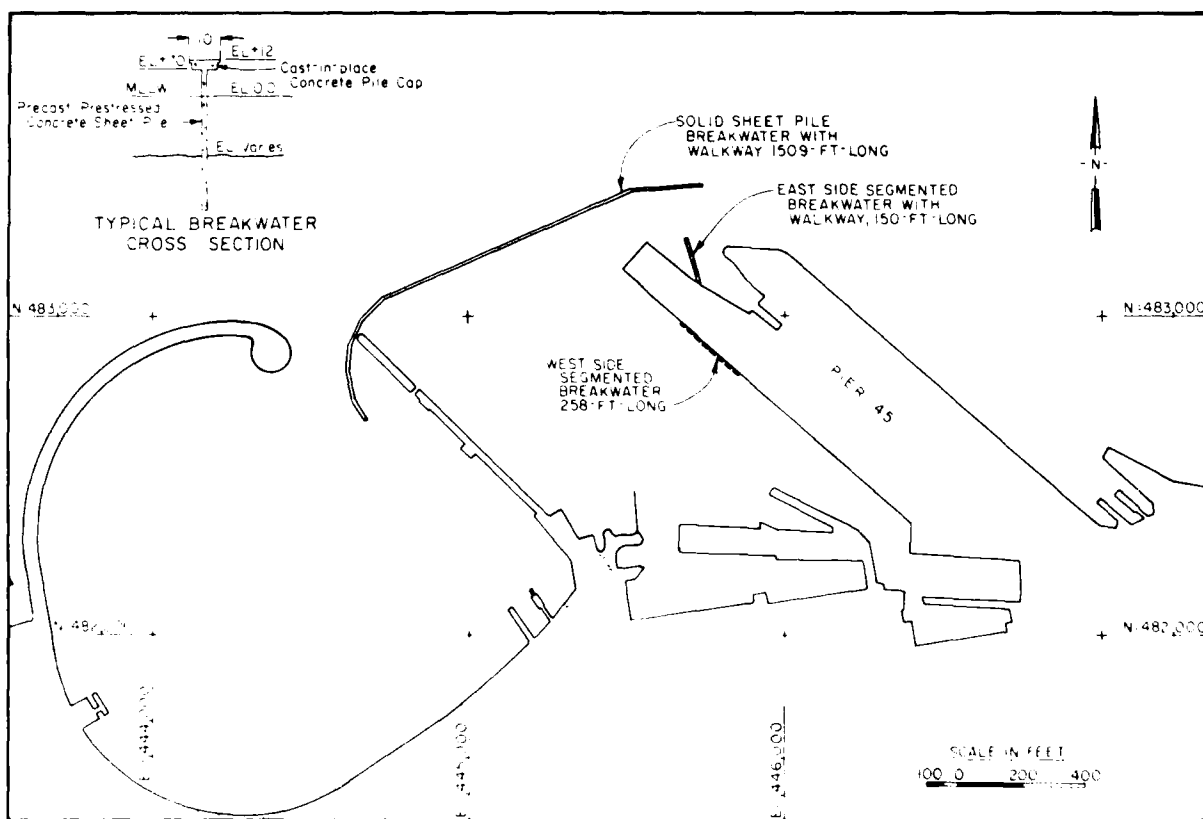
Figure 14. Fisherman's Wharf Harbor, San Francisco Bay, California

Date(s)	Construction and Rehabilitation History
1985-1986	<p>Construction of a 1,509-ft-long solid, concrete-pile breakwater (Figure 14) was completed. In addition, two segmented breakwaters (28-ft solid walls with 6-ft openings) were constructed. These structures were 150 and 258 ft long and were built along Pier 45 (Figure 14). The solid sections of the segmented breakwaters also were constructed with precast concrete piles. The crest el of all three breakwaters was +12 ft mllw. The segmented structures were constructed to provide wave protection against storm waves from northeast and east-northeast and yet permit tidal currents to pass through for flushing of the harbor. The structures were model tested (Bottin, Sargent, Mize 1985) prior to construction.</p>

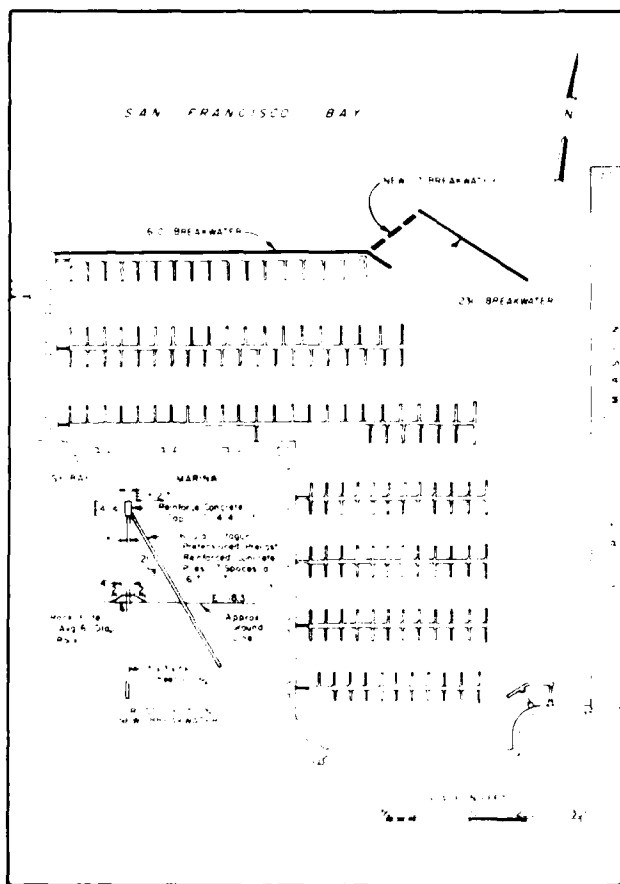
Figure 15. Gas House Cove, San Francisco Bay, California

Date(s)	Construction and Rehabilitation History
1965	Construction of the harbor was completed by the City of San Francisco. Two concrete sheet-pile breakwaters (Figure 15), totaling 840 ft in length, initially were constructed by the City. Boat owners immediately complained of excessive wave action and damage to boats and marine facilities resulting from waves entering the basin from the west through the gap in the existing breakwaters and reflecting within the harbor off the vertical walls of Mason Pier.
1975	The CE completed construction of a 117-ft-long concrete sheet-pile breakwater between and joining the two existing breakwaters. The crest el of the structure was +12.7 ft mllw, and the cost of the project was \$334,090.
1986	There is no record of maintenance or repairs since construction of the breakwater. The structure is in good condition.

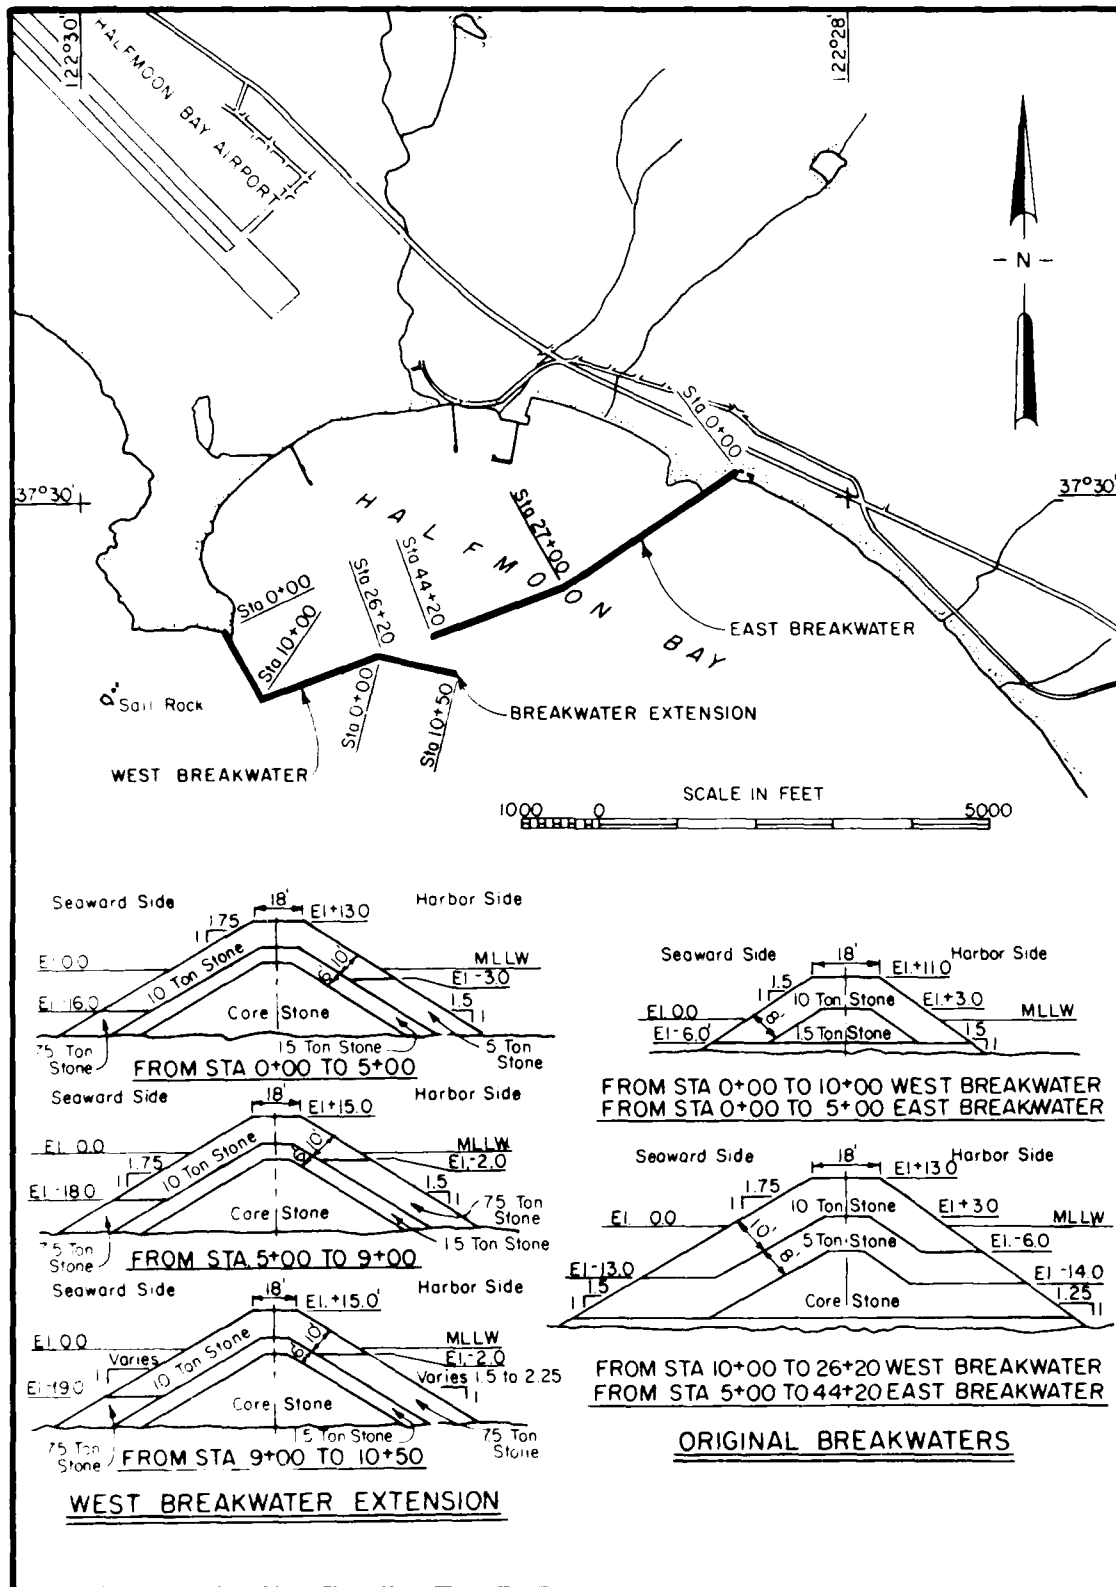
Figure 16. Halfmoon Bay, California

Date(s)	Construction and Rehabilitation History
1961	The CE completed construction of two rubble-mound, shore-connected breakwaters to protect the harbor during severe storms (Figure 16). The west breakwater was 2,620 ft long, and the east breakwater 4,420 ft long. The crest of each structure varied from +11 to +13 ft mllw with side slopes of 1V:1.5H and 1V:1.75H (Figure 13). The cost of the project was \$4,840,000.
1961- 1964	Storms experienced subsequent to breakwater construction indicated they did not provide adequate protection during periods of heavy seas and swell. Between 1961 and 1964, 58 moored vessels were lost or damaged, various marina facilities suffered damages, and two lives were lost during storm conditions.
1967	A 1,050-ft-long extension of the west breakwater in an easterly direction (Figure 16) was completed to alleviate undesirable wave conditions in the harbor (Wilson 1965). The breakwater extension was constructed with a crest el varying from +13 to +15 ft mllw. The side slopes on the harbor side of the structure were 1V:1.5H with 1V:1.75H side slopes on the sea side for the first 900 ft. The side slopes on the head varied from 1V:1.5H to 1V:2.25H. The cost of the extension was approximately \$1,957,400.

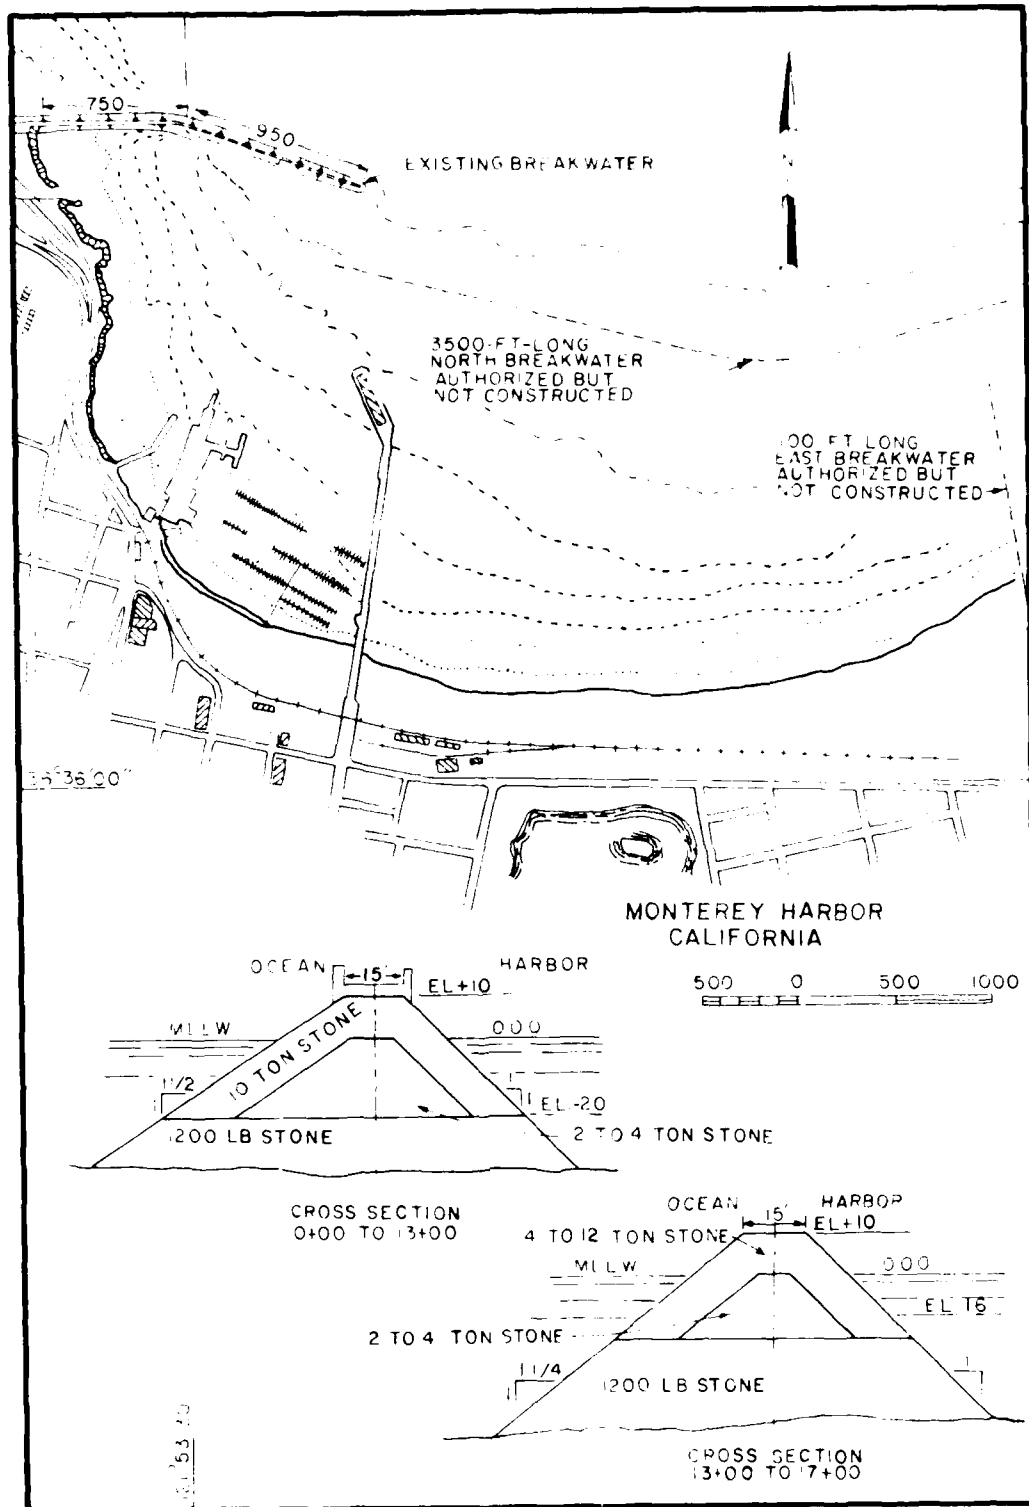
Figure 20. Monterey Harbor, California

Date(s)	Construction and Rehabilitation History
1932	The construction of a 1,300-ft-long rubble-mound breakwater was completed (Figure 20). The crest el of the structure was +10 ft mllw, and the side slopes were 1V:1H on the harbor side and 1V:1.5H on the ocean side. The armor stones used weighed 10 tons each.
1934	A 400-ft rubble-mound extension to the breakwater was built under the Public Works Administration Program (Figure 20). The extension was constructed with a crest el of +10 ft and with 1V:1H side slopes on the harbor side. Side slopes on the ocean side were 1V:1.25H from the existing ground to el -16 ft mllw and 1V:1.5H from el -16 to +10 ft mllw. Armor stones used ranged from 4 to 12 tons. Total cost of the breakwater through 1934 was \$652,951.
1960	Improvements consisting of a 3,300-ft-long north breakwater and a 1,100-ft-long east breakwater (Figure 20) were authorized. These structures were never constructed; however, model tests were conducted to optimize the improvements (Chatham 1968).

1969	Model tests for a proposed tribar breakwater section were conducted (Davidson 1969).
1974	The project authorized in 1960 was reclassified as inactive due to lack of local support.
1986	There is no history of maintenance of the breakwater, and it is in satisfactory condition.

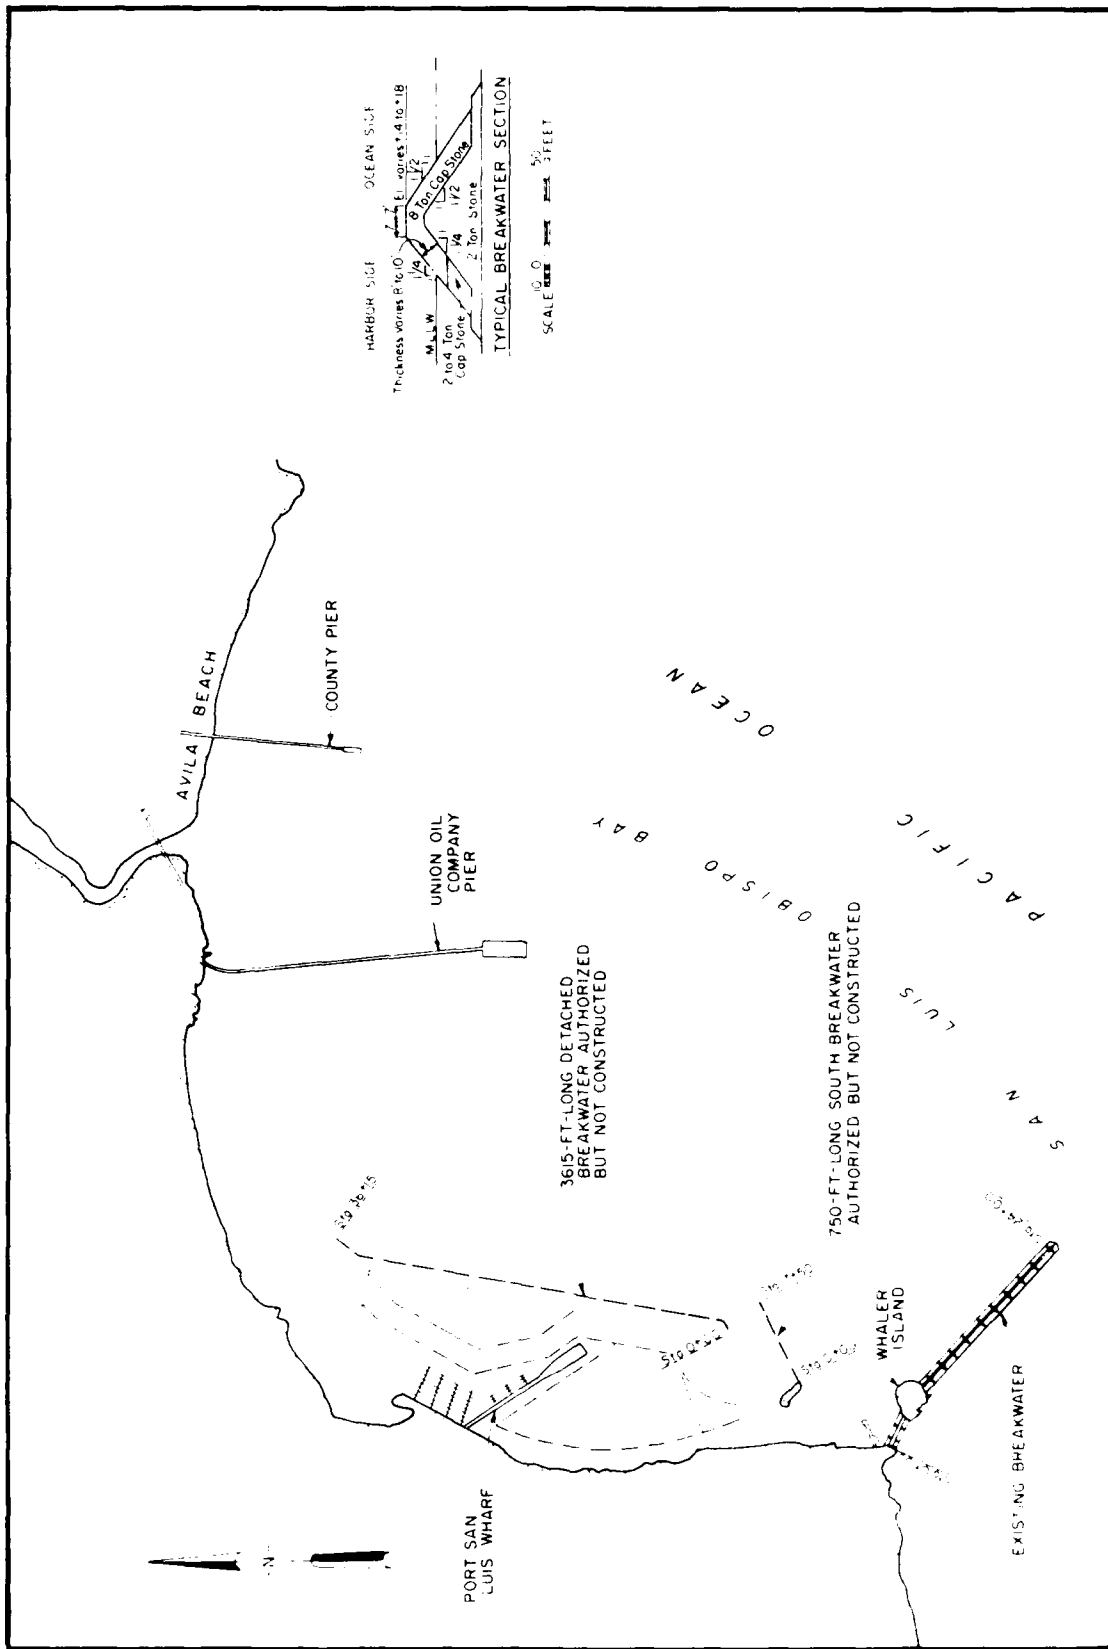
Figure 22. Port San Luis, California

<u>Date(s)</u>	<u>Construction and Rehabilitation History</u>
1888- 1913	Construction of a rubble-mound breakwater, approximately 2,400 ft long, was completed at the site (Figure 22) during this time frame. The crest el of the structure varies from +14 ft to +18 ft mllw with a 14-ft width. The side slopes are 1V:1.5H on the ocean side and 1V:1.25H on the harbor side.
1924	The structure was breached in a zone about 300 ft seaward of Whalers Island (Figure 22) by storm waves.
1927	The breach formed in 1924 was filled with a concrete cap.
1931	The concrete cap placed in 1927 was washed away because of storm wave activity. Also, the head of the breakwater was damaged.
1935	Repairs were made to damaged areas of the structure. The slopes in the damaged zones were covered with 14-ton stones to els of -10 to -15 ft mllw.
1976	Modification of the existing project was authorized. Included were a 750-ft-long south breakwater, a 3,615-ft-long detached breakwater, and dredging of associated channels and anchorage areas (Figure 22). These structures have not been constructed.

1983	Major storms resulted in approximately \$578,000 in damages to the breakwater.
1984	Maintenance repair of the existing breakwater was completed which consisted of approximately 8,700 tons of capstone placement and resetting of 40 existing capstone. The crest width of the structure was increased to 20 ft. Plans and specifications for construction of the modified project (authorized in 1976) were about 80 percent complete.
1986	The breakwater currently is in satisfactory condition.

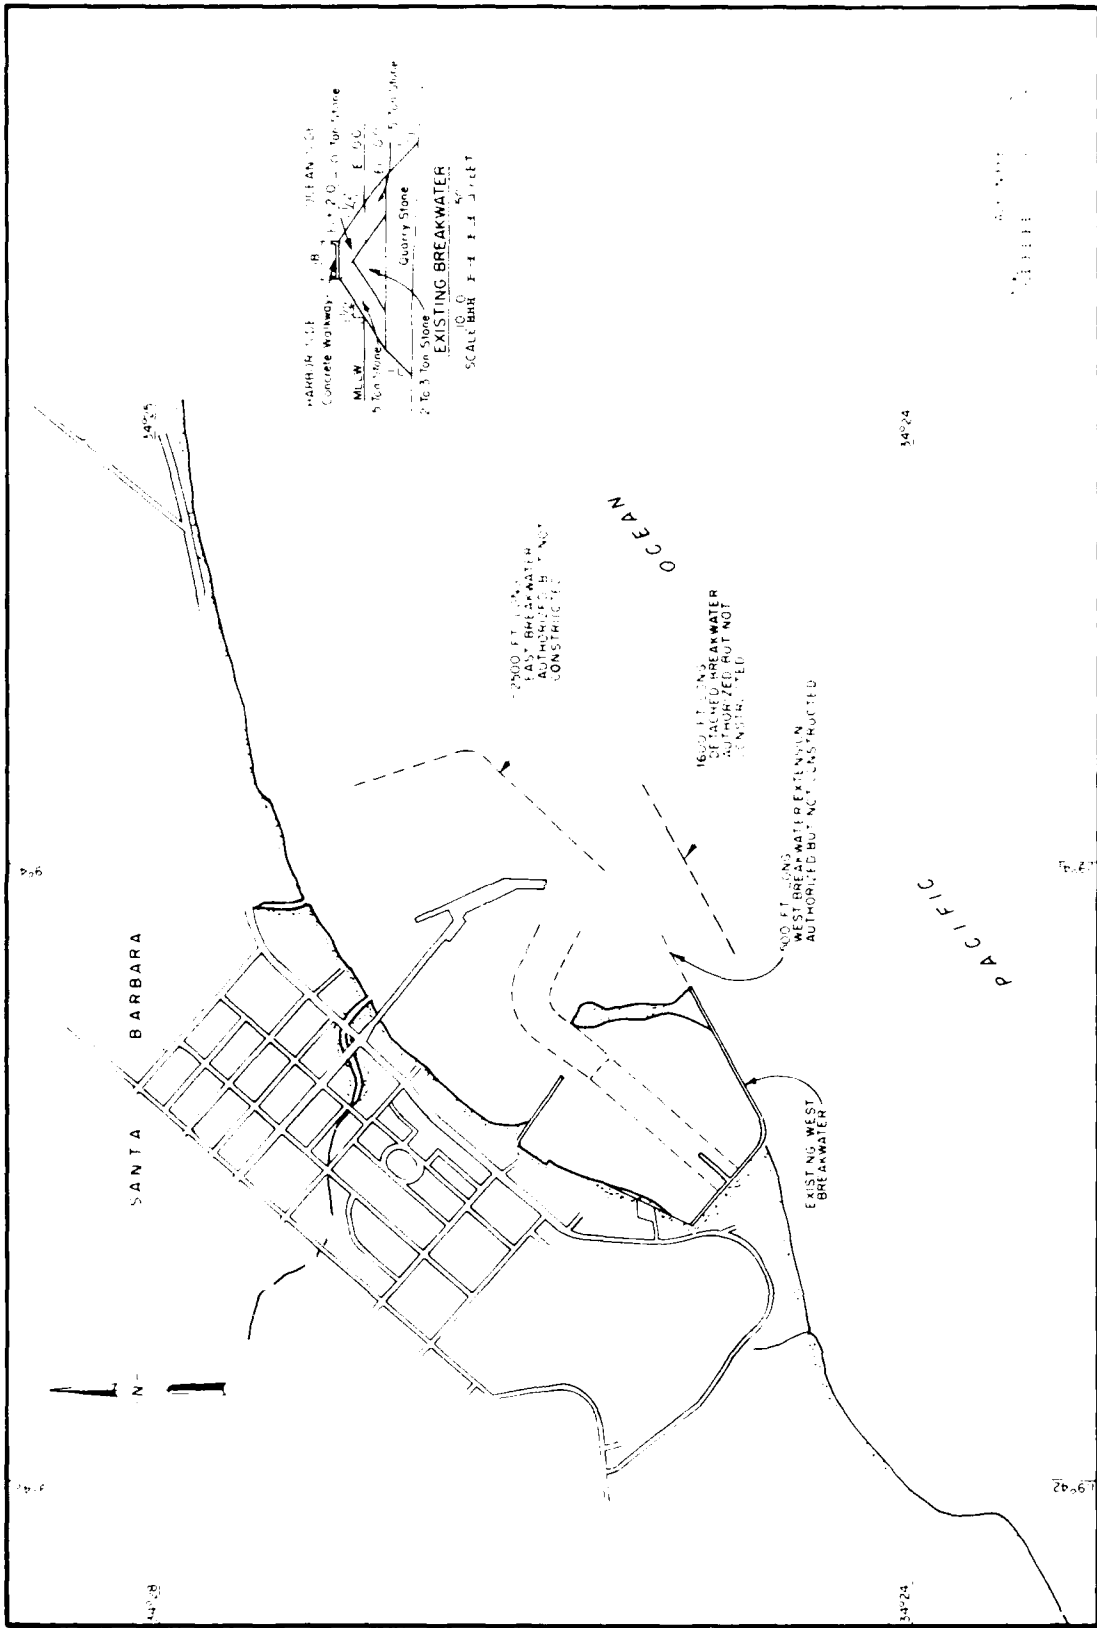
Figure 23. Santa Barbara, California

1962	Modification of the existing project was authorized and included a 500-ft-long west breakwater extension, a 1,600-ft-long detached breakwater, a 2,500-ft-long east breakwater, and dredging of associated channels, basins, etc. (Figure 23). Construction of the modification has not been initiated, although it has been model tested (Brasfeild and Ball 1967).
1969	Modification of the existing project was reclassified to an inactive category.
1986	The structure presently is in satisfactory condition.

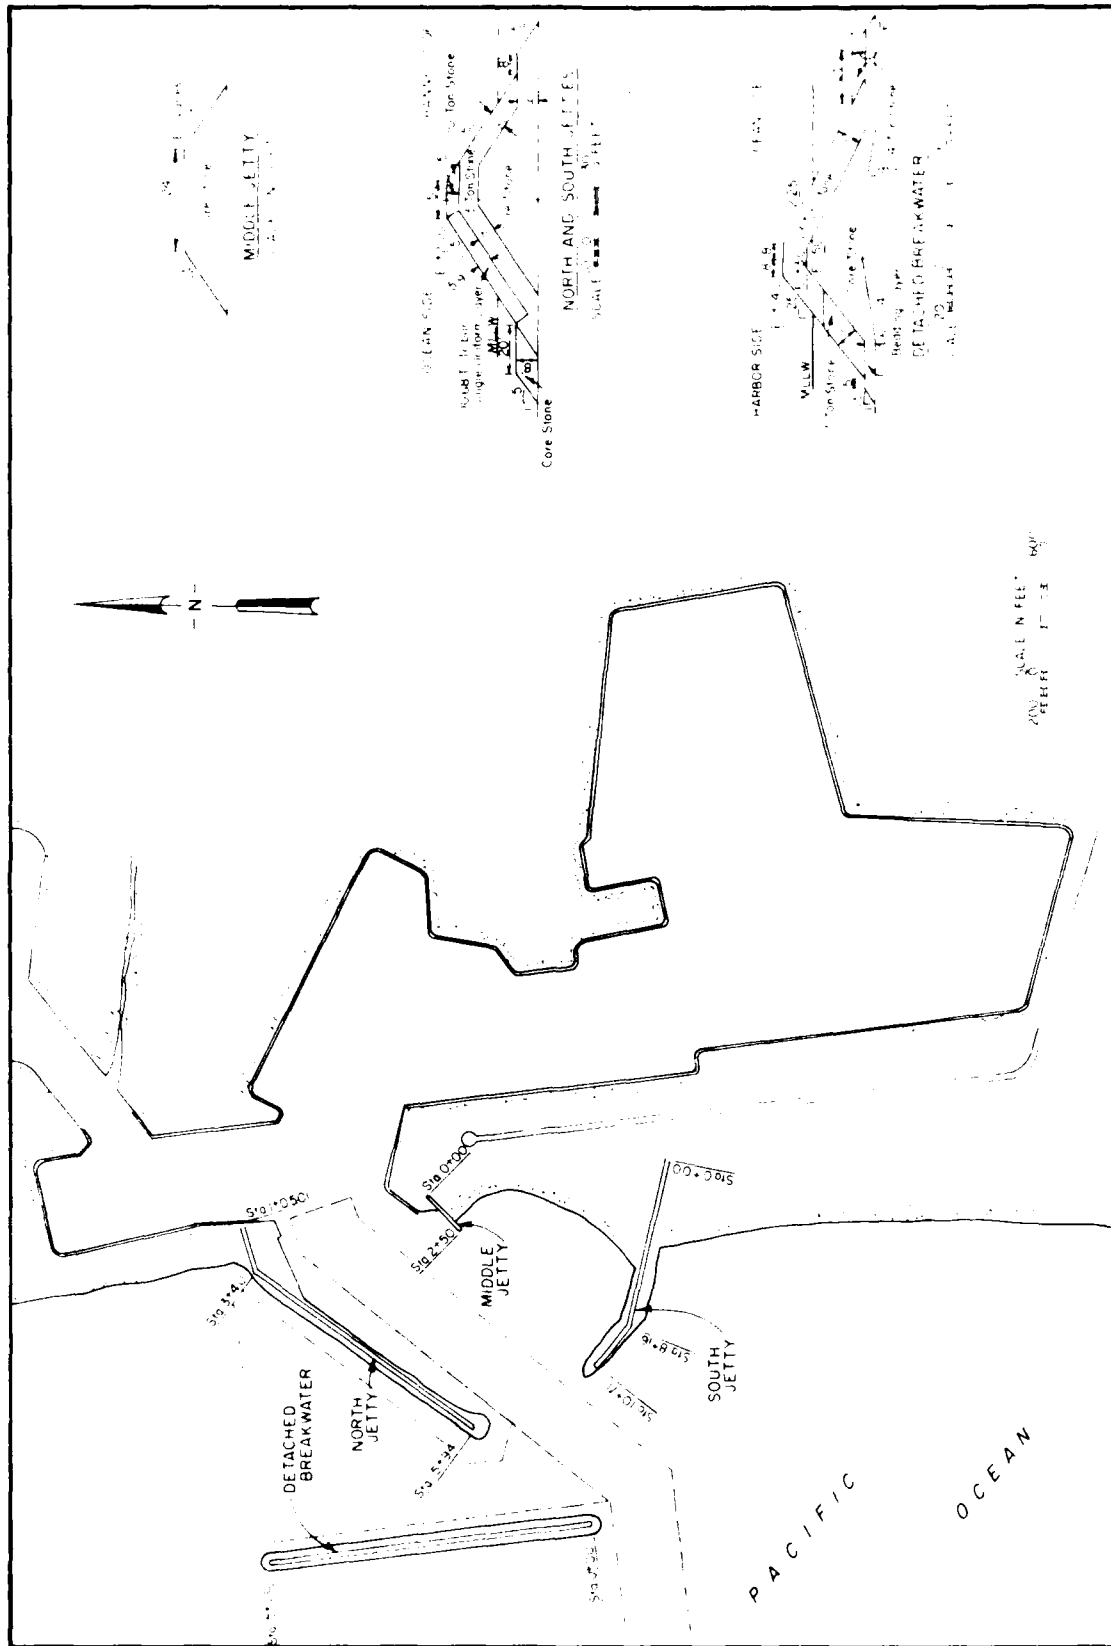
Figure 24. Ventura Marina, California

Date(s)	Construction and Rehabilitation History
1963	Construction of the marina was completed by local interests. Structures included a 1,254-ft-long north jetty, a 1,071-ft-long south jetty, and a 250-ft-long middle jetty (Figure 24). The north and south jetties were constructed with a crest el of +20 ft mllw and a crest width of 15 ft with 1V:1.5H side slopes. The ocean side of these jetties was armored with a single, uniform layer of 10.68-ton tribars. The middle jetty had a crest width of 24 ft with varying els and 1V:1.5H side slopes.
1968	A 1,500-ft-long detached rubble-mound breakwater and dredging of a sand trap were authorized. Also, the authorization plan provided for the US to maintain the existing jetties and channels previously constructed by local interests.
1971	Minor repairs were completed at the head of the north jetty. The repairs consisted of resetting displaced and broken tribars on the seaward end of the jetty and reshaping the jetty head with 3-ton stone.

1972	Construction of the 1,500-ft-long offshore rubble-mound breakwater authorized in 1968 was completed (Figure 24). The structure had a 16-ft-wide crest with an el of +20 ft mllw. Side slopes were 1V:1.25H on the harbor side and 1V:2.25H on the ocean side.
1986	The structures currently are in good condition.

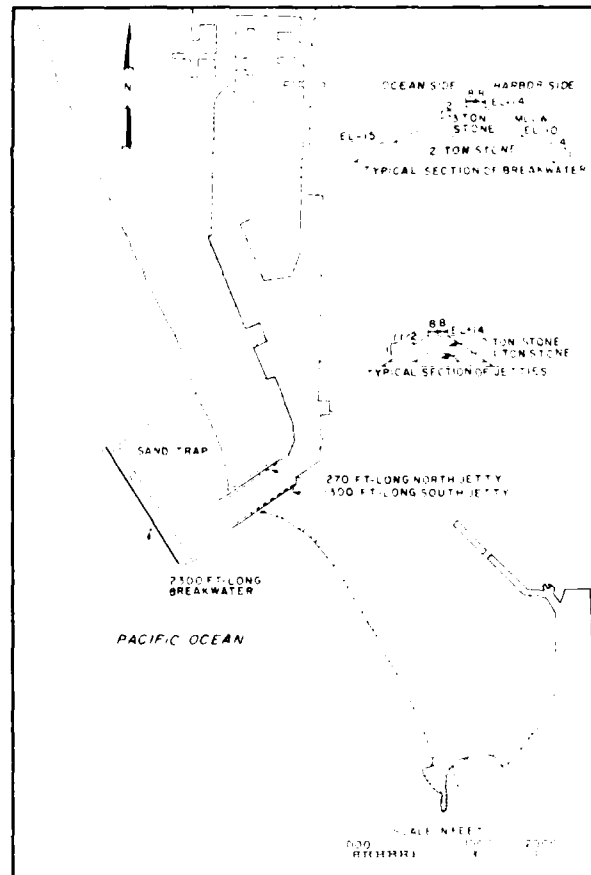
Figure 25. Channel Islands Harbor, California

Date(s)	Construction and Rehabilitation History
1959	Construction of two rubble-mound jetties was completed at the harbor entrance (Figure 25). The north jetty was 1,270 ft long, and the south jetty was 1,300 ft long. Crest els of the jetties were +14 ft mllw with 16-ft crest widths. Side slopes were 1V:1.5H. Cost of jetty construction was \$817,000.
1960	Construction of a 2,300-ft-long detached rubble-mound breakwater was completed for a cost of \$2,619,000. The crest el of the breakwater was +14 ft mllw, and it had a 16-ft width. Side slopes were 1V:1.25H on the harbor side and 1V:2H on the ocean side. This structure was constructed to form a sand trap in conjunction with the existing jetties. Initially, 1,600,000 cu yd of material was dredged in the lee of the breakwater and then biennially for deposit south of the harbor entrance for use in restoring and maintaining the downcoast shoreline.

1986	The structures are in good condition.

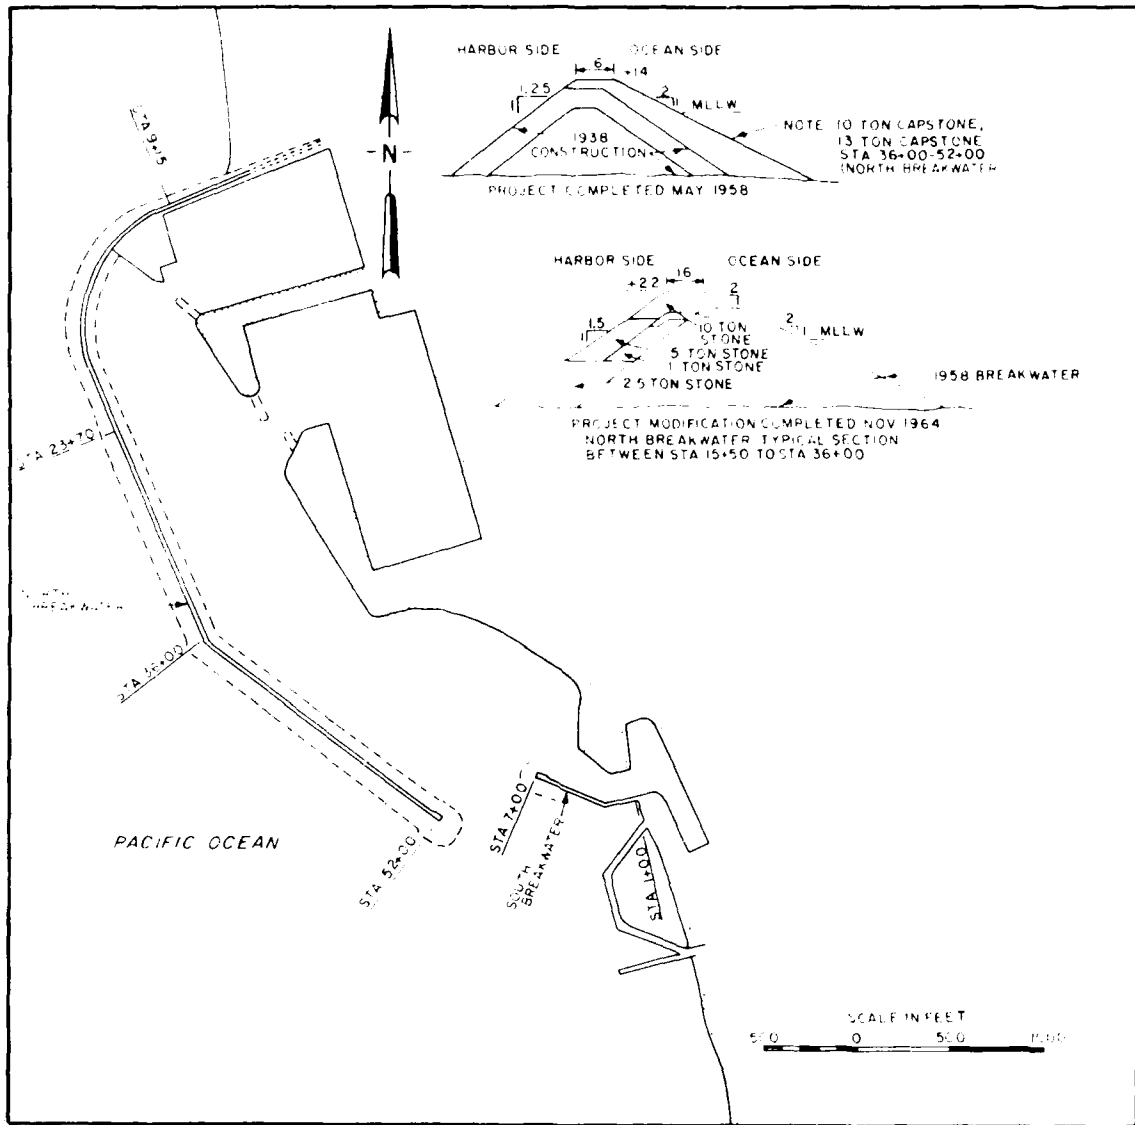
Figure 28. Redondo Beach King Harbor, California

<u>Date(s)</u>	<u>Construction and Rehabilitation History</u>
1938	Construction of a 4,285-ft-long permeable, rubble-mound breakwater (Figure 28) was completed.
1950	The breakwater became a Federal project, and improvements were authorized.
1958	Ten-ton capstones were placed on the ocean side of the breakwater on a 1V:2H slope, and the crest was raised to +14 ft mllw and increased to 16 ft in width. Thirteen-ton capstones were used on the breakwater between sta 36+00 and 52+00. A 600-ft-long south breakwater with a crest el of +14 ft was constructed. The structure has a 16-ft crest width, and side slopes were 1V:2H on the sea side and 1V:1.5H on the harbor side.
1960	Minor repairs to the north breakwater (from a storm in 1959) were completed.
1963	Storms demonstrated the inadequacy of the north breakwater for protecting small craft within the Harbor. While doing only minor damage to the breakwater, damage to small boats and Harbor facilities amounted to \$431,000.

1964	The north breakwater (between sta 15+50 and 36+00) was modified. The structure crest el was raised to +22 ft mllw at this location. Stones, ranging from 2.5 to 10 tons, were placed on the harbor side of the breakwater on a slope of 1V:1.5H (Figure 28).
1978- 1980	Storms of 1978 and 1980 resulted in damage to the north breakwater in nine areas with major voids occurring at sta 16+00 and 22+00.
1982	As a result of the damages in 1978 and 1980, the north breakwater was repaired at a cost of \$304,000.
1983	Storms resulted in significant damage at several locations along the north breakwater. The most significant was a breach 70 ft long, just south of the curved portion. Repair work was completed, and approximately 5,300 tons of new capstone and 1,700 tons of corestone were utilized. At seven additional locations, about 4,000 tons of capstone were replaced. The repair work cost approximately \$400,000.

1986	The breakwaters presently are in satisfactory condition.

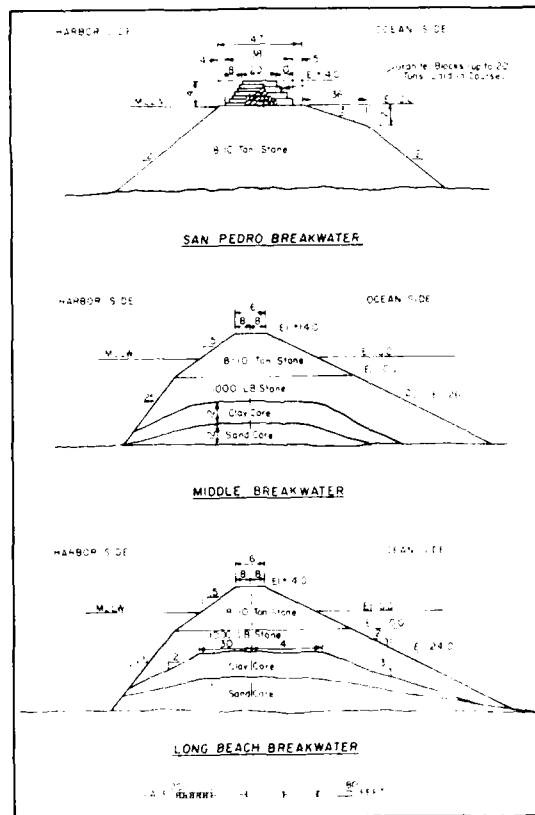
Figure 30. Breakwater cross sections, Los Angeles and Long Beach Harbors, California

Date(s)	Construction and Rehabilitation History
1898- 1910	Construction of the 11,152-ft-long San Pedro Breakwater occurred at the site (Figure 29). The harbor side of the structure was built with 1V:1.2H side slopes, while the ocean side consisted of 1V:1.2H slopes from the bottom up to an el of -12 ft mllw. At this point the slope changed to 1V:3H to an el of 0.0 ft mllw. The rubble-mound portion of the structure (Figure 30) was 47 ft wide at el 0.0 ft mllw. Granite blocks (up to 20 ton) were laid in courses to an el of +14 ft with a crest width of 20 ft. The rubble-mound portion of the structure was constructed with 8- to 10-ton stone and was permeable. Other structures, which are now incorporated into the inner harbor works, were constructed as early as 1871.
1930- 1938	Construction of the 18,500-ft-long rubble-mound middle breakwater (Figure 29) was in progress. The breakwater had a 16-ft crest width at el +14 ft mllw. Side slopes on the ocean side were 1V:2H and on the harbor side ranged from 1V:1.25H to 1V:1.5H (Figure 30). An impermeable core was installed from the bottom (approximately -50 ft mllw) to el -26 ft mllw.

1942- 1960	Construction of the 13,350-ft-long rubble-mound Long Beach Breakwater (Figure 29) occurred during this period. With the exception of the breakwater core el (Figure 30) the cross section of this structure was similar to that of the middle breakwater.
1947	Repairs to the middle breakwater were accomplished for a cost of \$786,700.
1983	Winter storms resulted in extensive damage to the San Pedro Breakwater. The structure was breached in an area immediately seaward of the curved portion of the breakwater. Model tests were conducted after the damage (Carver 1984, Baumgartner, et al. 1986), and restoration of the San Pedro Breakwater was subsequently completed. Work consisted of the placement of approximately 25,000 tons of salvage stone and new angular stones ranging from 15 to 25 tons each. Where voids occurred on the crest after this stone placement, concrete was pumped into flexible temporary forms to complete the repair.
