**REPAIR, EVALUATION, MAINTENANCE, AND
REHABILITATION RESEARCH PROGRAM**

TECHNICAL REPORT REMR-CO-3

**CASE HISTORIES OF CORPS BREAKWATER
AND JETTY STRUCTURES**

Report 1
SOUTH PACIFIC DIVISION

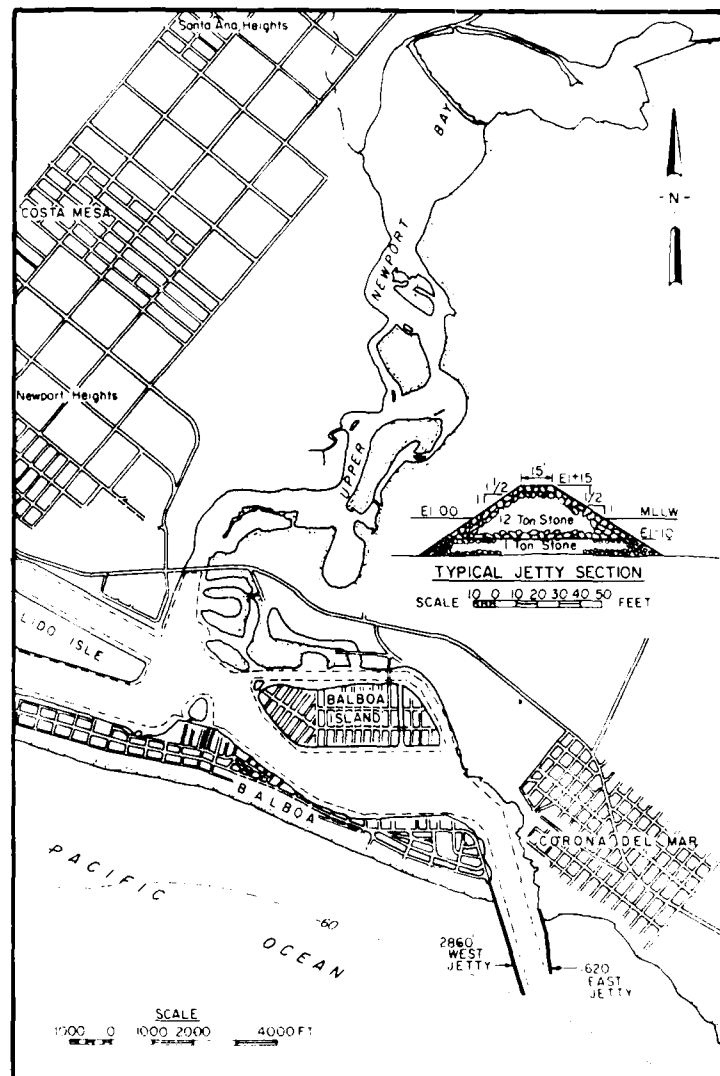
Figure 31. Newport Bay Harbor, California

Date(s)	Construction and Rehabilitation History
1934	Construction of two rubble-mound jetties at the site (Figure 31) was completed. The west and east jetties were 2,860 ft long and 1,620 ft long, respectively. The el of the structures was +15 ft mllw, and the crest width was 15 ft. Side slopes of 1V:1.5H on both ocean and harbor sides were used.
1986	Throughout the years, local interests have provided minor maintenance to the jetties, the extent of which is unknown. The jetties presently are in satisfactory condition.

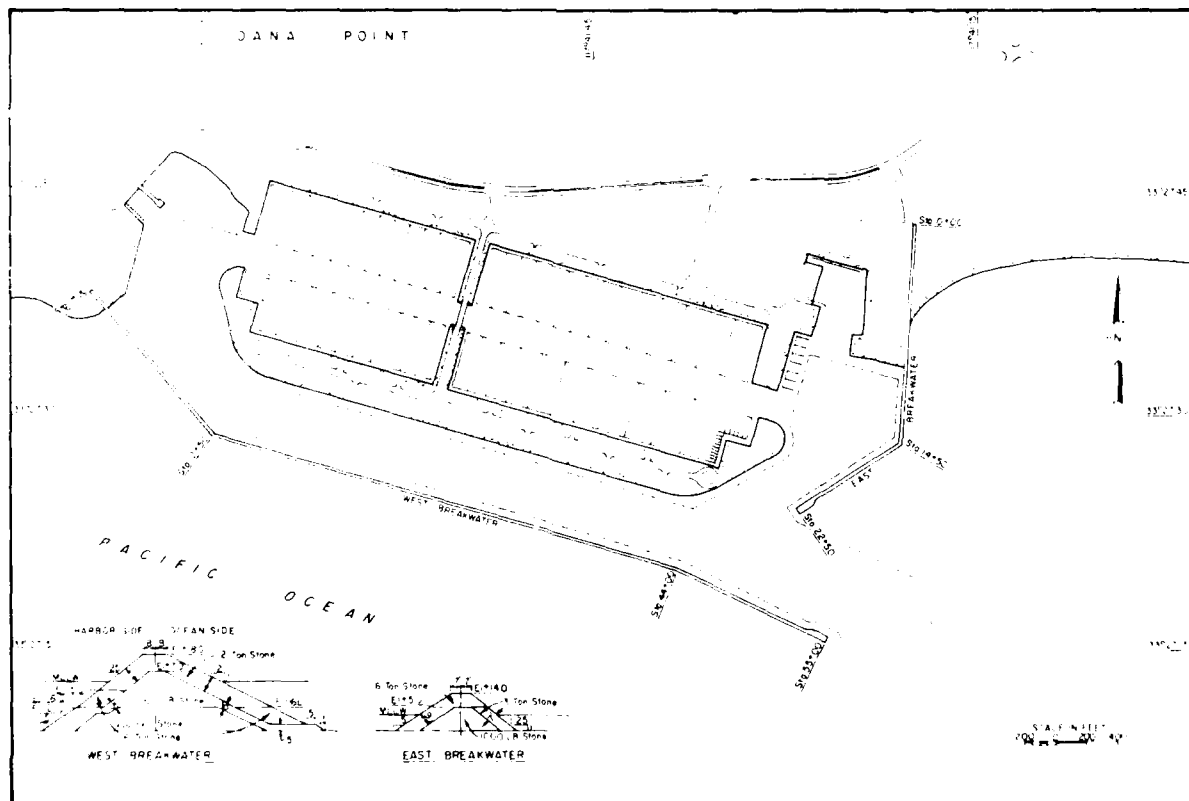
Figure 32. Dana Point Harbor, California

Date(s)	Construction and Rehabilitation History
1968	Construction of two rubble-mound breakwaters at the site (Figure 32) was completed. The west breakwater was 5,500 ft long with a 16-ft-wide crest at el of +18 ft mllw. The ocean side slope of the structure was 1V:2H, and the harbor side was 1V:1.25H. The east breakwater was 2,250 ft long with a 14-ft-wide crest width and a +14-ft el mllw. The ocean-side slope was 1V:1.5H, and the harbor-side slope was 1V:1.25H. Model tests were conducted for the project (Dai and Jackson 1966, Wilson 1966).
1983	Major storms resulted in approximately \$610,000 in damages to the breakwater.
1984	Restoration of the west breakwater in nine locations was completed. About 5,800 tons of capstone were used for this maintenance repair.
1986	The breakwaters are in satisfactory condition.

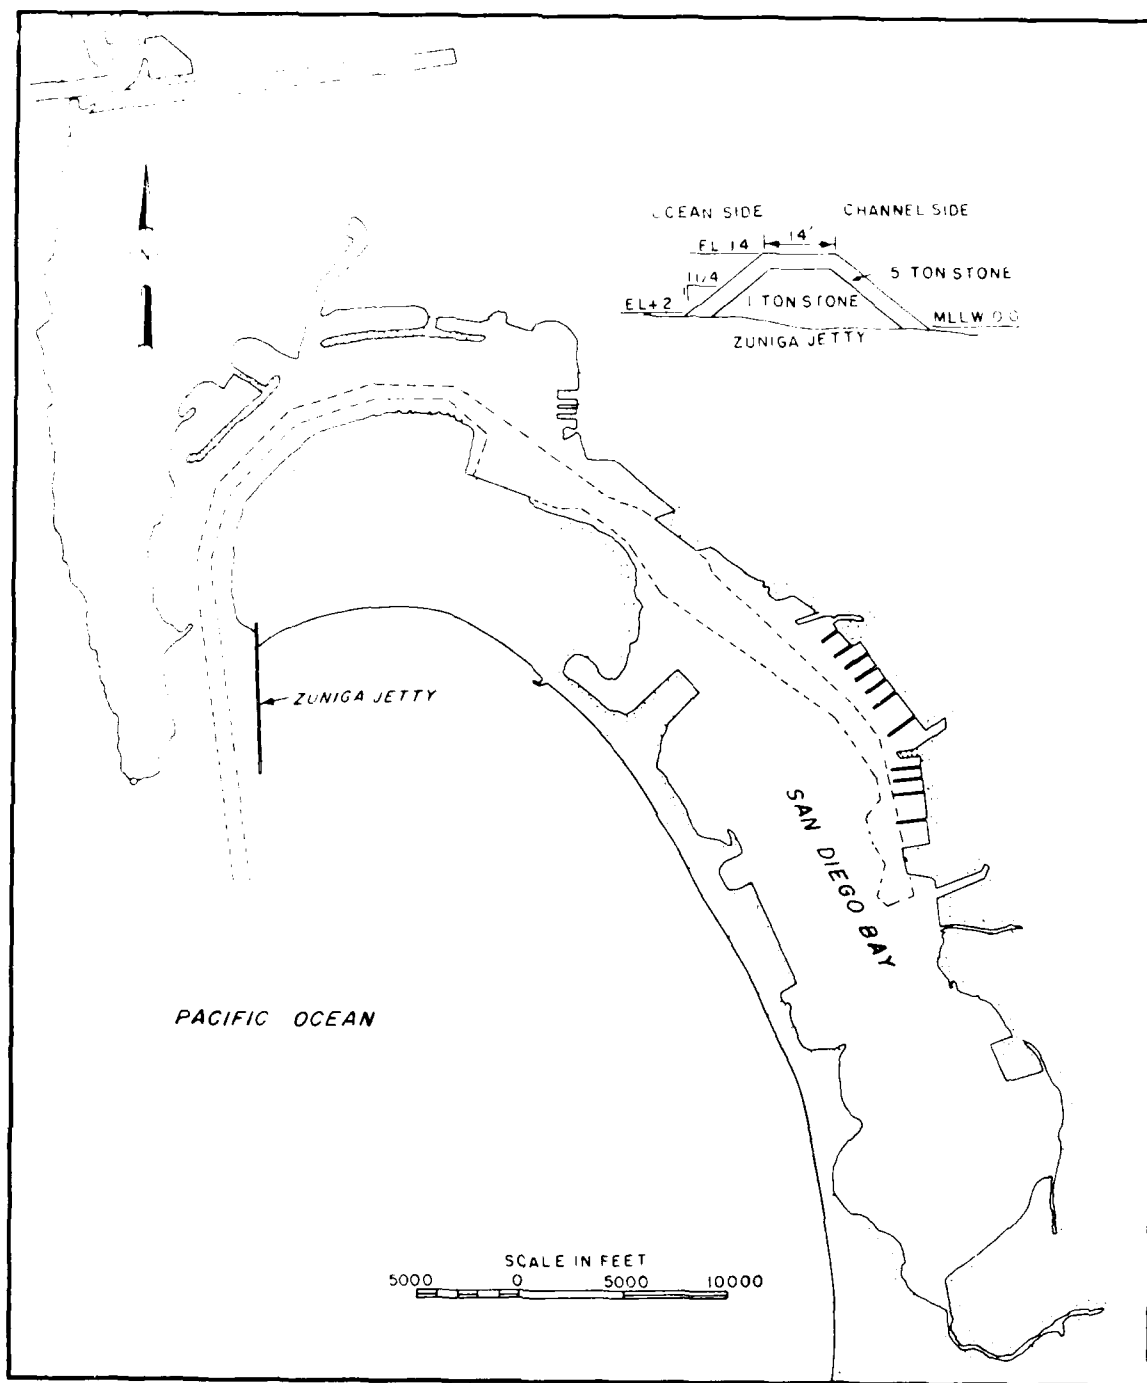
Figure 35. San Diego Harbor, California

Date(s)	Construction and Rehabilitation History
1894- 1902	Construction of a 7,500-ft-long rubble-mound jetty (Zuniga Jetty) was completed (Figure 35) during this time frame. The design height of the jetty was +14 ft mllw with a 14-ft-wide crest. Side slopes were 1V:1.25H. It is indicated, however, that the jetty was not constructed to the full design height.
1942	Rehabilitation work was performed by the US Navy from the shoreward end to a point about 1,400 ft seaward.
1943- 1969	Settlement and flattening of the slopes occurred, particularly in the outermost third of the jetty. As a result, parts of the jetty were awash or submerged at most tide stages, creating hazards to navigation.
1970	Maintenance repair of the jetty was accomplished for a cost of approximately \$127,000. This work consisted of the construction of platforms on the jetty for navigation lights which were installed by the US Coast Guard to alleviate hazards to navigation.

1984	Maintenance repair of the jetty was completed, the extent of which is unknown.
1986	Even though the jetty was not constructed to full design height, it functions satisfactorily as a training wall which concentrates tidal flows and keeps the entrance channel scoured to project depth.
