NDE OF BLACK HAWK HELICOPTER ROTARY WING-HEAD SPINDLE
THREADS USING ELECTRIC CURRENT PERTURBATION

Final Report
SwRI Project 15-7958-818

U. S. Army Aviation Research and
Development Command
St. Louis, Missouri

November 1985

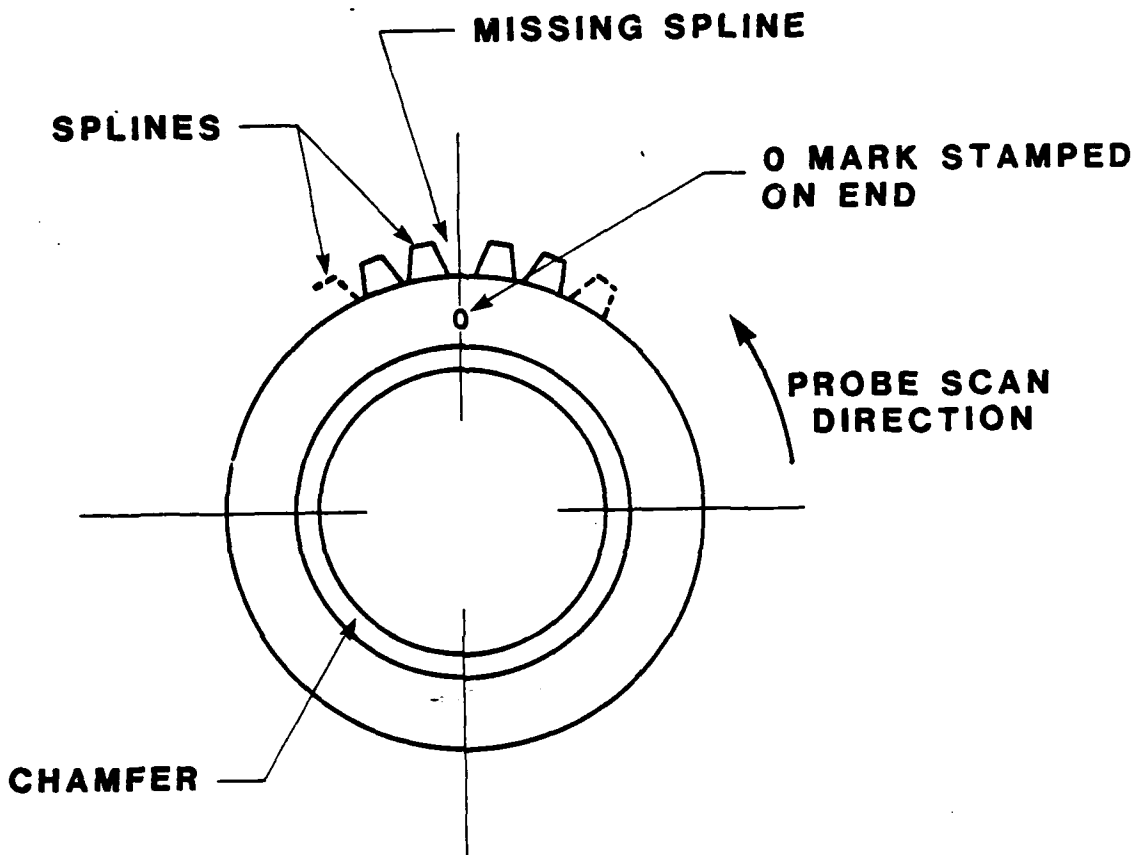
A laboratory setup was established which allowed the spindles to be simultaneously rotated and translated axially by means of a motor drive and lead screw arrangement. The ECP probe remained stationary and the relative motion between the probe and spindle provided a helical scan so that the probe maintained a fixed relationship with respect to the threads. This arrangement minimized influence of the thread geometry on the overall signal response. The probe rode on an air bearing to eliminate contact with the thread surface. Two air bearing blocks were matched to the respective -102 and -103 spindle threads. The probe scan direction with respect to the spindle is shown in Figure 1. The "missing spline" as shown in the figure is typically used as a reference position. Rotational speed was 5.26 rpm.

FIGURE 1. ECP PROBE SCAN DIRECTION LOOKING INTO
THREADED END OF SPINDLE
