**BOAT HULL BLISTERS: REPAIR TECHNIQUES
AND LONG TERM EFFECTS ON
HULL DEGRADATION**

FINAL REPORT

**The American Boat Builders and Repairers Association
Boston, MA**

**Department of Chemical Engineering
The University of Rhode Island
Kingston, RI 02881**

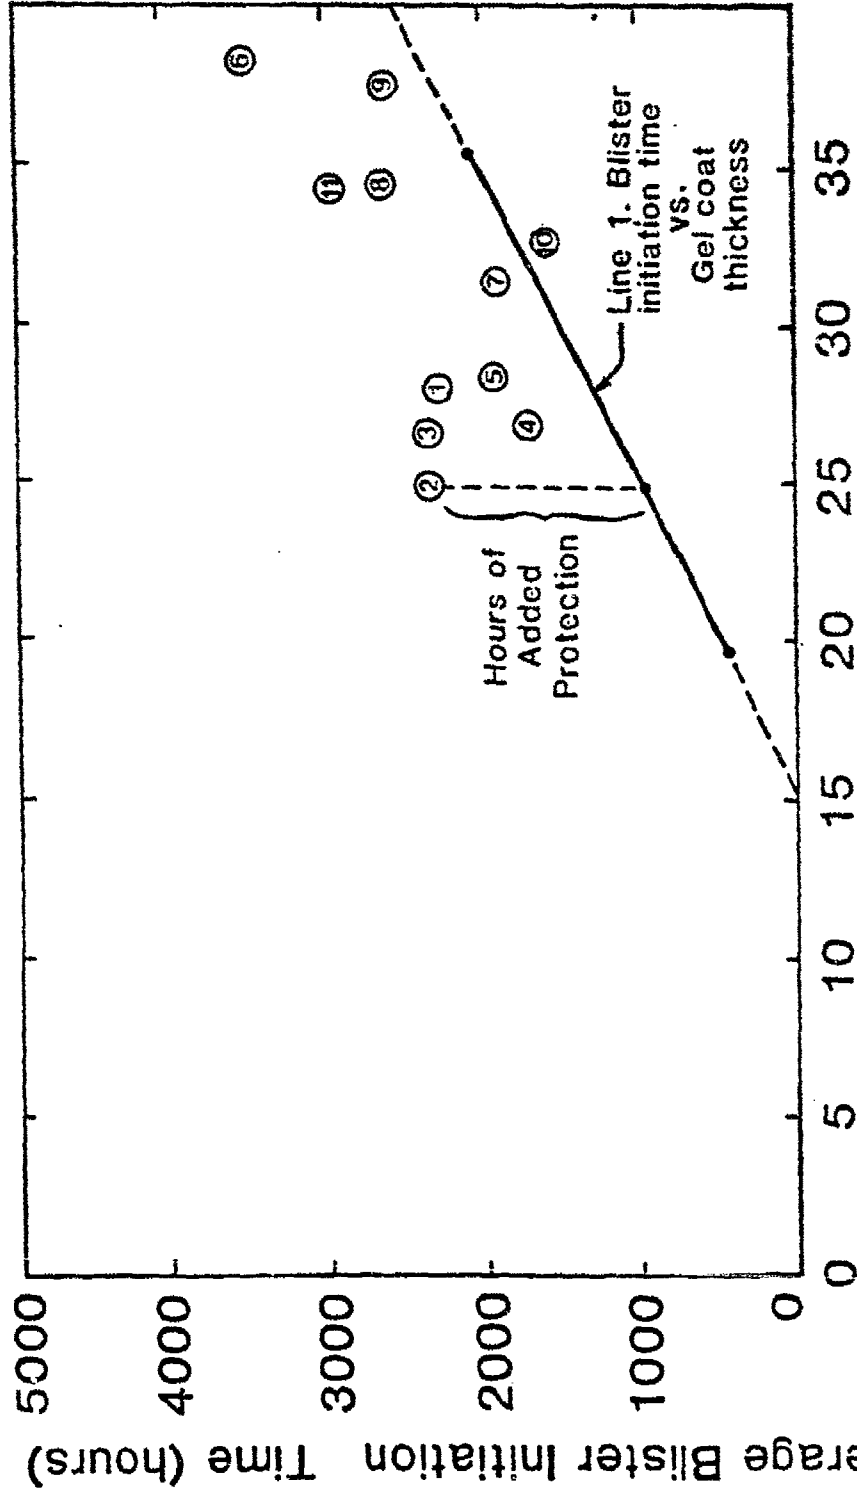
Figure 39. Average Blister Initiation Time vs. Average Total Coating Thickness (Coating Gelcoat), for Series 201 at 65°C.

Fig. 39 shows, for samples a-c of each coating, the average blister initiation time vs the average combined gel coat and coating thicknesses (Line one). It can be seen that there is a general trend of increasing blister initiation time with increased total coating thickness. Line two represents blister initiation time vs gel coat thickness for samples taken from the large

Most importantly, figure 39 shows that if the combined coating and gel coat thickness had all been gel coat, the blister initiation time would have been sooner. Only samples with coating 10 do not show this. The added protection a coating gives must therefore be the difference between the point the coating represents on Line 2 in Figure 39, and the point of equivalent gel coat thickness on Line 1.

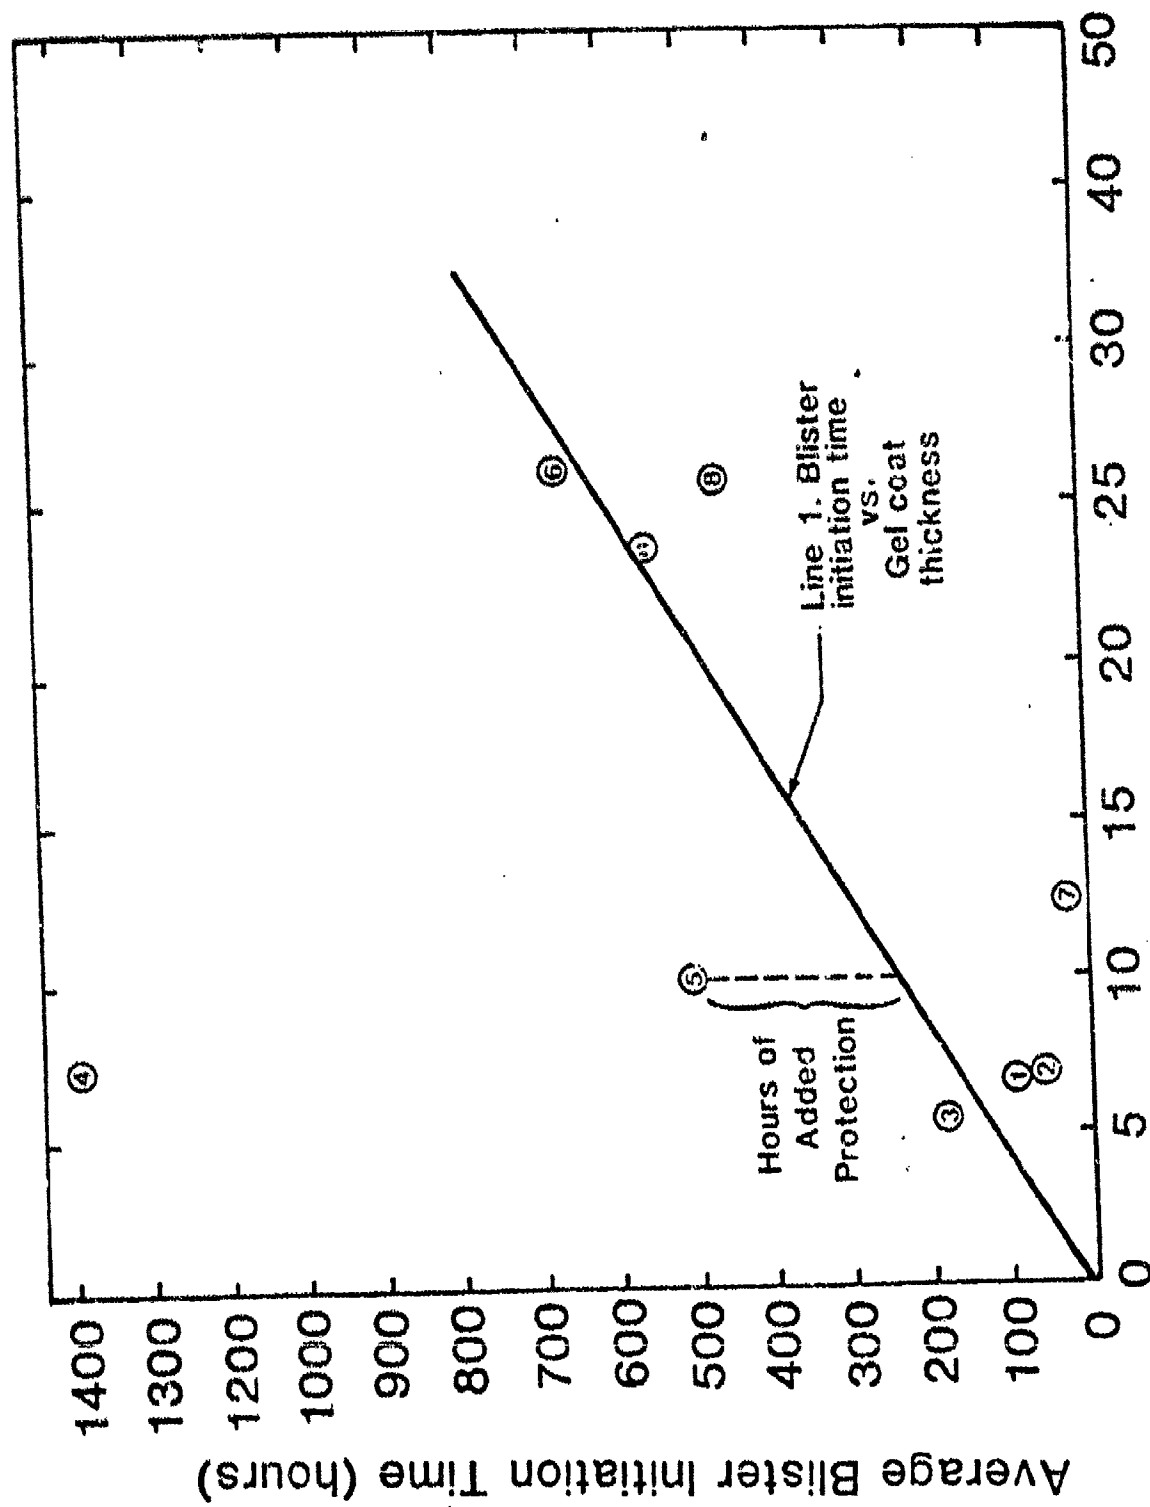
Figure 41. Average Blister Initiation Time vs. Average Coating Thickness

The average blister initiation time vs the average coating thickness, for each of the coatings, is shown in Figure 41. The average was taken for the three samples used to test each coating.

Blister initiation time = $24.3 \times$ gel coat thickness (14.1). This is plotted as line 1 on Figure 41.
