STRAIN ANALYSIS OF HMMWV FRONT LIFT PROVISION

March 1989

US ARMY
LABORATORY COMMAND
MATERIALS TECHNOLOGY LABORATORY

REPORT DOCUMENTATION PAGE		READ INSTRUCTIONS BEFORE COMPLETING FORM
1. REPORT NUMBER MTL TR 89-24	2. GOVT ACCESSION NO.	3. RECIPIENT'S CATALOG NUMBER
4. TITLE (and Subtitle) STRAIN ANALYSIS OF HMMWV FRONT LIFT PROVISION		5. TYPE OF REPORT & PERIOD COVERED Final Report

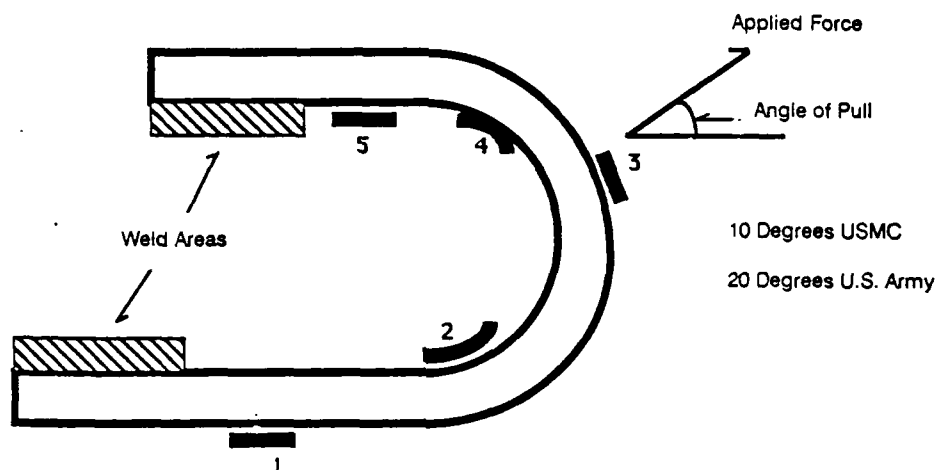
Figure 1. HMMWV provision schematic showing strain gage locations (not to scale).

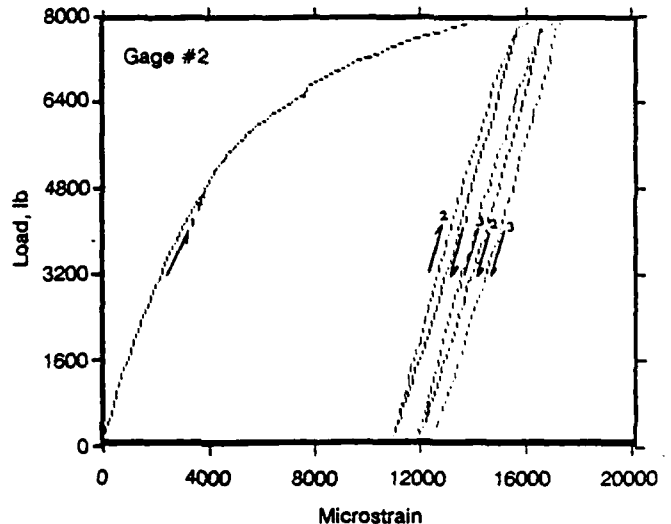
The second and third pulls on these provisions causes only small increases in the total (accumulated) plastic strain because of work hardening. For example, the plastic strain at gage number 2 of the 8,000-lb/10-degree specimen increased from 1.09 percent to 1.27 percent after the third pull. This small increase in accumulated strain was not visually noticeable. Hysteresis was seen in the load-strain data. Figure 7 shows the load-strain response for gage number 2 in the 8000-lb/10-degree test for all three loadings.

Figure 7. Load versus strain data for gage number 2 for loadings 1, 2, and 3. Provision was loaded to 8000 lb at 10 degrees.

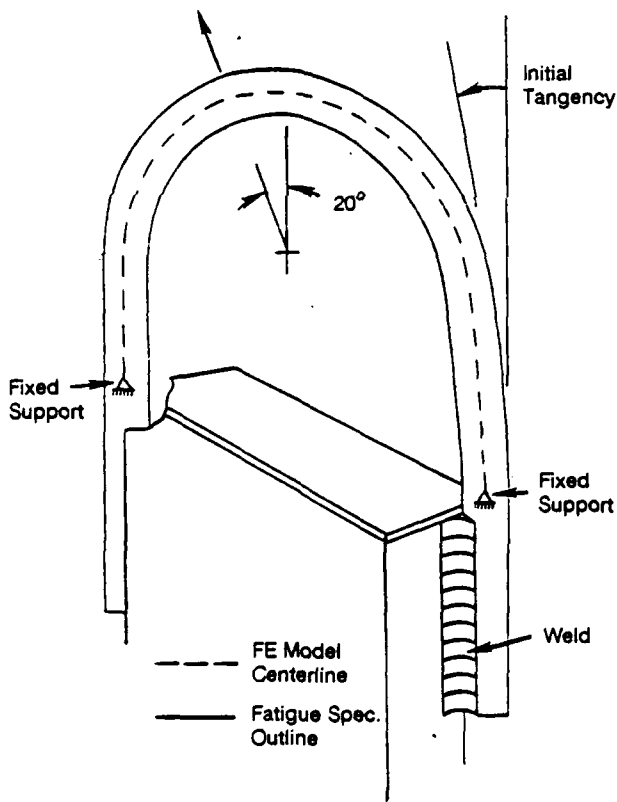
loads specified in Table 2, the model was unloaded to zero load to give permanent displacements and plastic strains. The amount of permanent displacement predicted by the FE model was compared to actual deformation by superimposing the zero load displacement fields of the case number 2 model against the actual deformation of the fatigue specimen as measured by projecting a photo of the deformed specimen. The case number 2 model and the fatigue specimen were both loaded to 8650 lb/20 degrees. Figure 14 shows the superimposed displacements of the FE model and the actual provision. Near-perfect correlation of the displacements is observed. The good agreement is directly related to the use of accurate material parameters, which were derived experimentally. The handbook value of yield strength for a 1020 cold-drawn steel is 30 percent less than the value observed in the tensile tests. The maximum residual plastic strain predicted by the FE model was approximately 5 percent for the case number 1 loading, near the point of concentrated loading.

Figure 14. Permanent set comparison between FE analysis and the fatigue specimen.

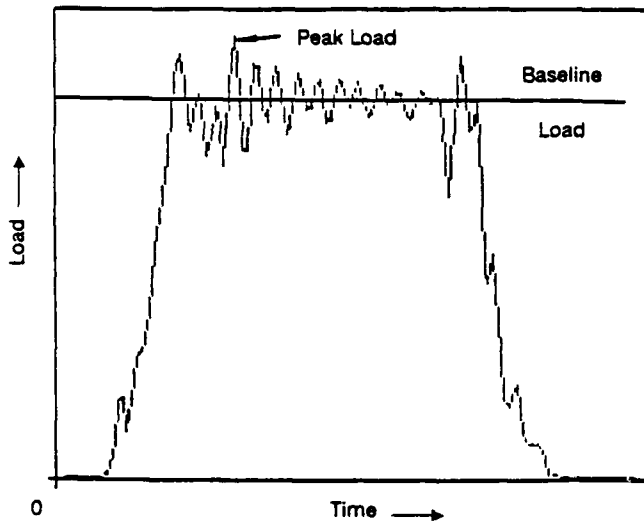
Testing of the provisions was performed by triggering the data acquisition system and then lifting the vehicle. The HMMVW was lifted completely off of the ground in 2 seconds, suspended for 8 seconds, and lowered back to the ground in 2 seconds. A load-time response curve for the left provision is seen in Figure 16. Peak loads for the right and left provisions were 3668 lb and 3251 lb, respectively. No plastic deformation was observed in either of the provisions at these load levels. Peak in-plane strains occurred at the expected locations. Maximum elastic strain values were 0.36 percent and 0.28 percent for the right and left provisions, respectively. The out-of-plane loading angle for the Army configuration is 5 degrees, as shown in Figure 17. This produced a maximum out-of-plane strain on the right provision of just 0.04 percent, which occurred just above the lower weld.

Figure 16. Load-time response curve for simulated air lift test.

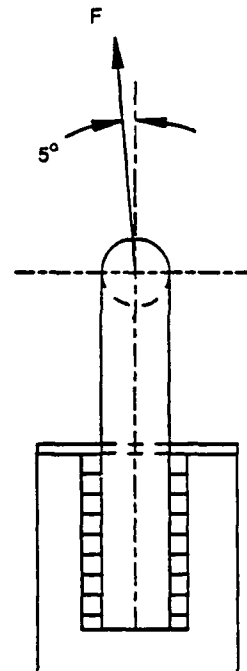
The in-plane loading assumption used throughout all of the testing and modeling was verified for the Army loading configuration. Out-of-plane forces were only 8.7 percent of the total loads. Comparisons of in-plane strains for the simulated airlift test with the finite element analysis demonstrated excellent agreement.

Figure 17. Out-of-plane loading.
