# USAF PRAM PROGRAM FINAL REPORT

28 FEBRUARY 1987

## PRAM PROJECT

FLASHLAMP DEPAINTING SYSTEM

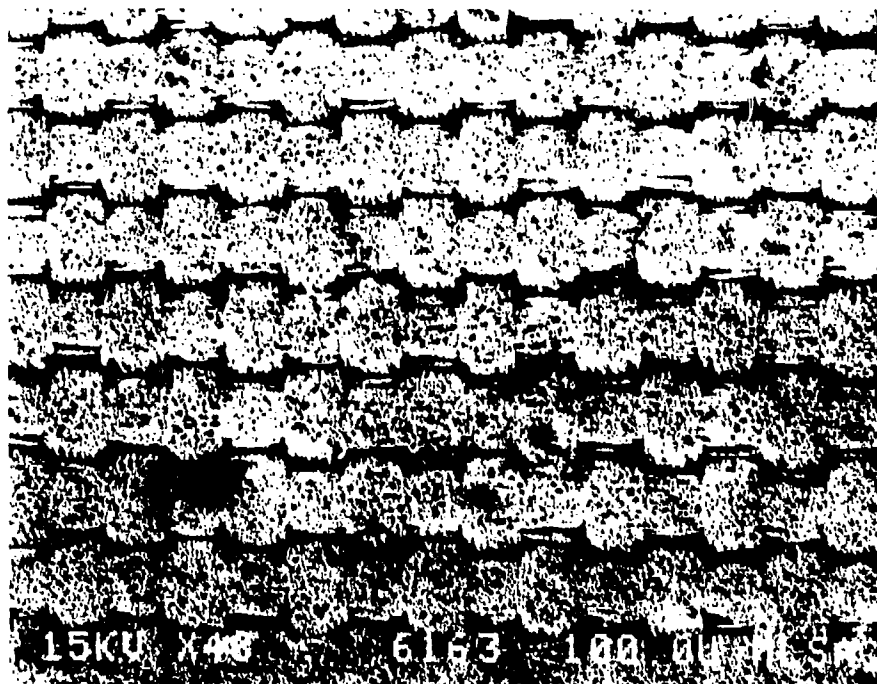
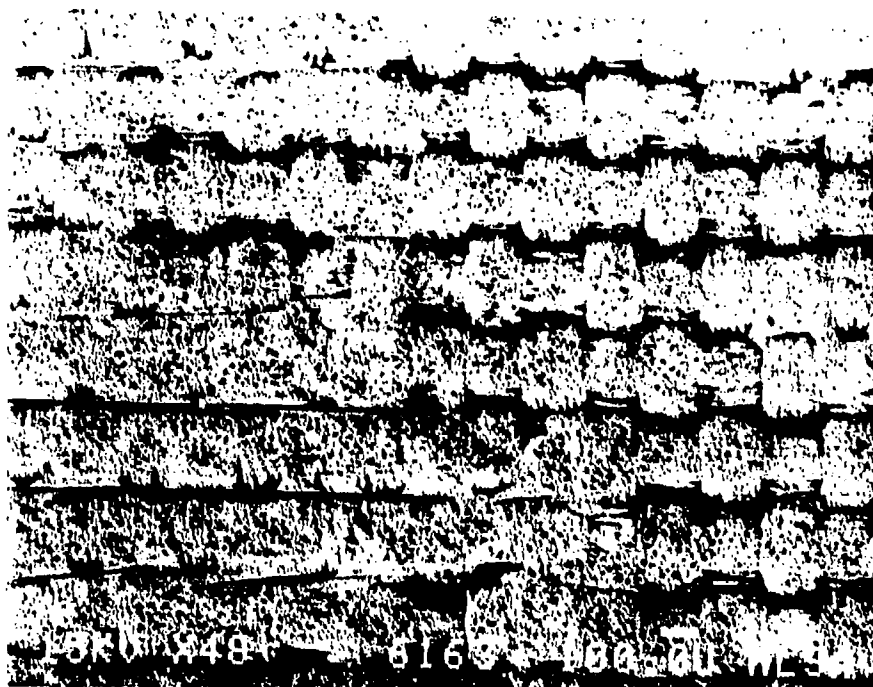
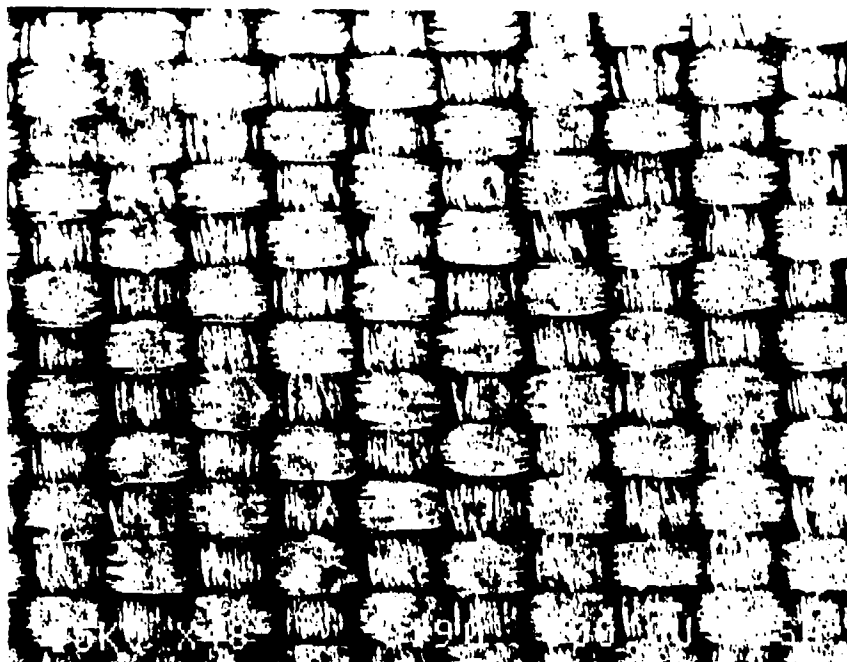
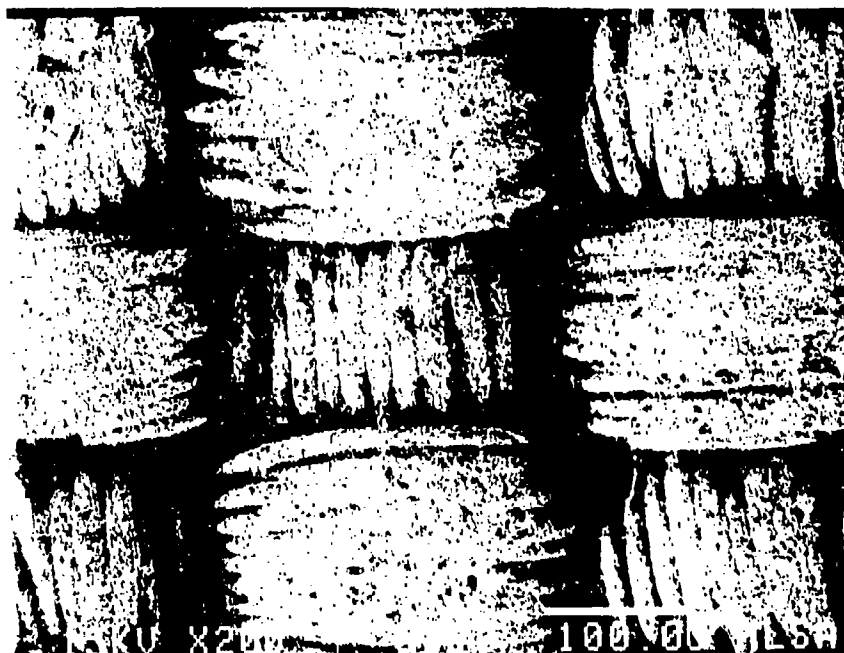
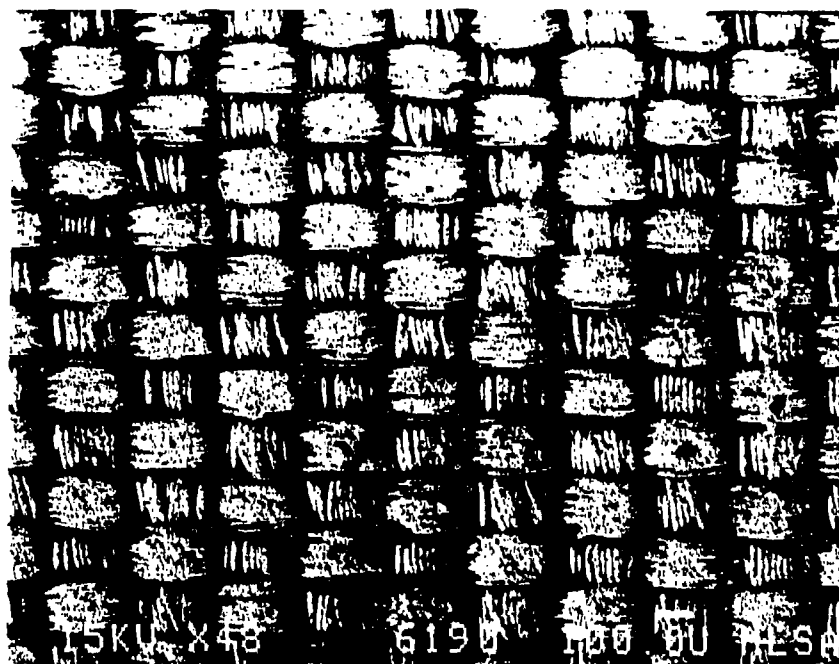
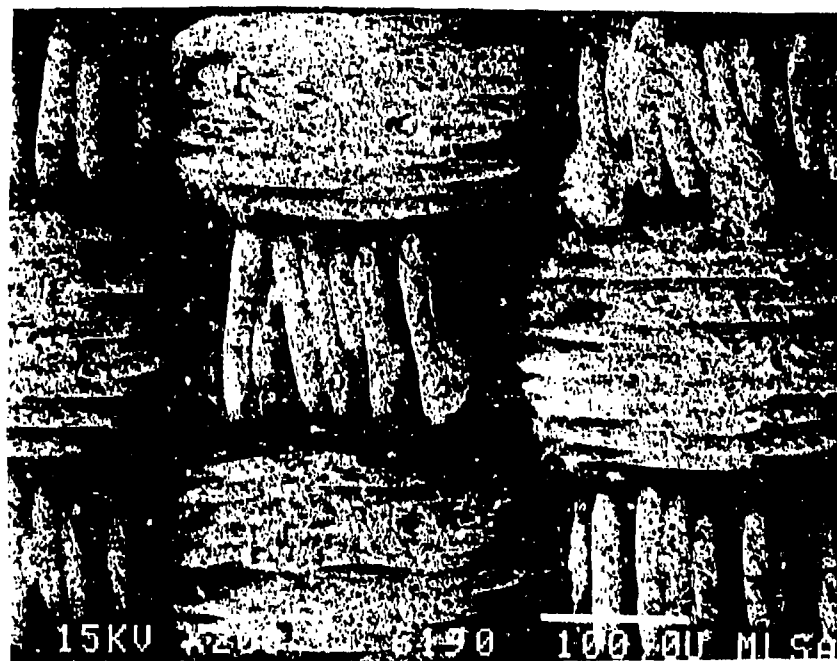
On these specimens a thin layer of the paint/primer system still covered most of the composite surface and no composite material was visible. However, the coating was relatively thin and found mainly in the crevices of the matrix rich layer formed by the peel ply. See Figures 5, 6, 7, 8, 9, 10, 11, 12, 13, and 14.

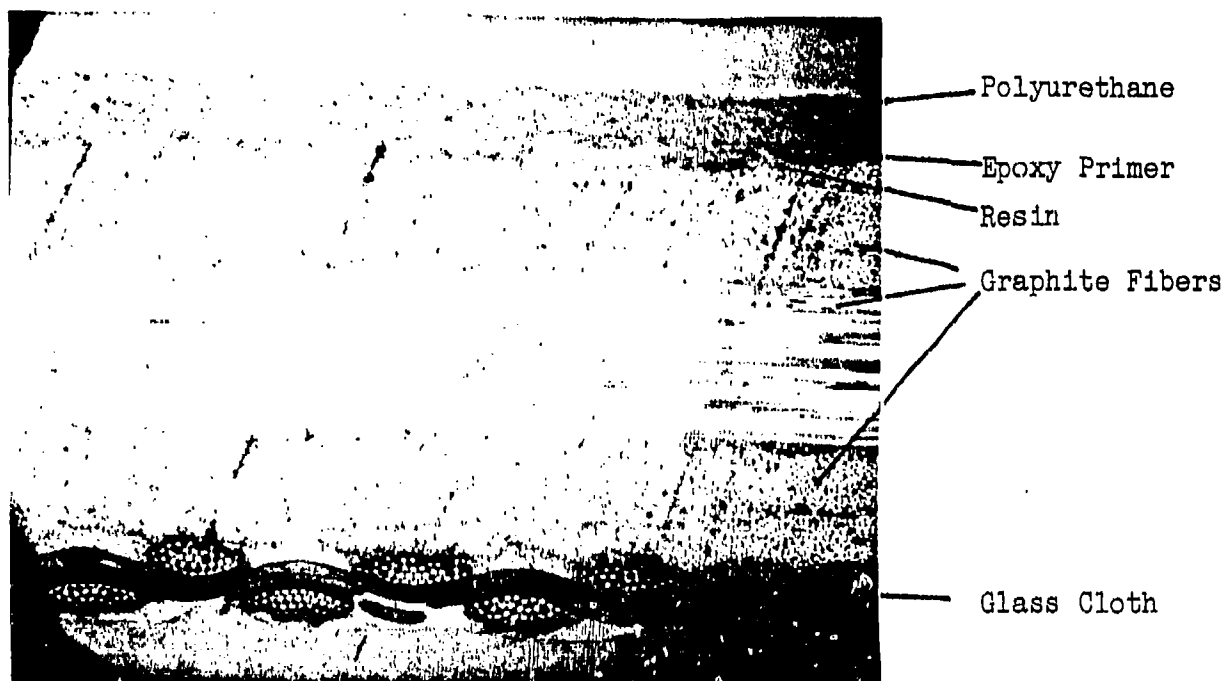
Figure 1. Laminate before paint removal. MAG. 100X  
Chemical Analysis: Si\*, S, Fe\*, Cl, Ba\*

Figure 1 is a photo cross section view of an epoxy/graphite laminate before any paint is removed. The polyurethane top coat and epoxy primer (MIL-P-23377) subcoat are 2.0 mils and 0.7 mils respectively. Between the primer and resin layer is an impression of a peel ply cloth. The other side of the laminate is covered with a glass cloth.

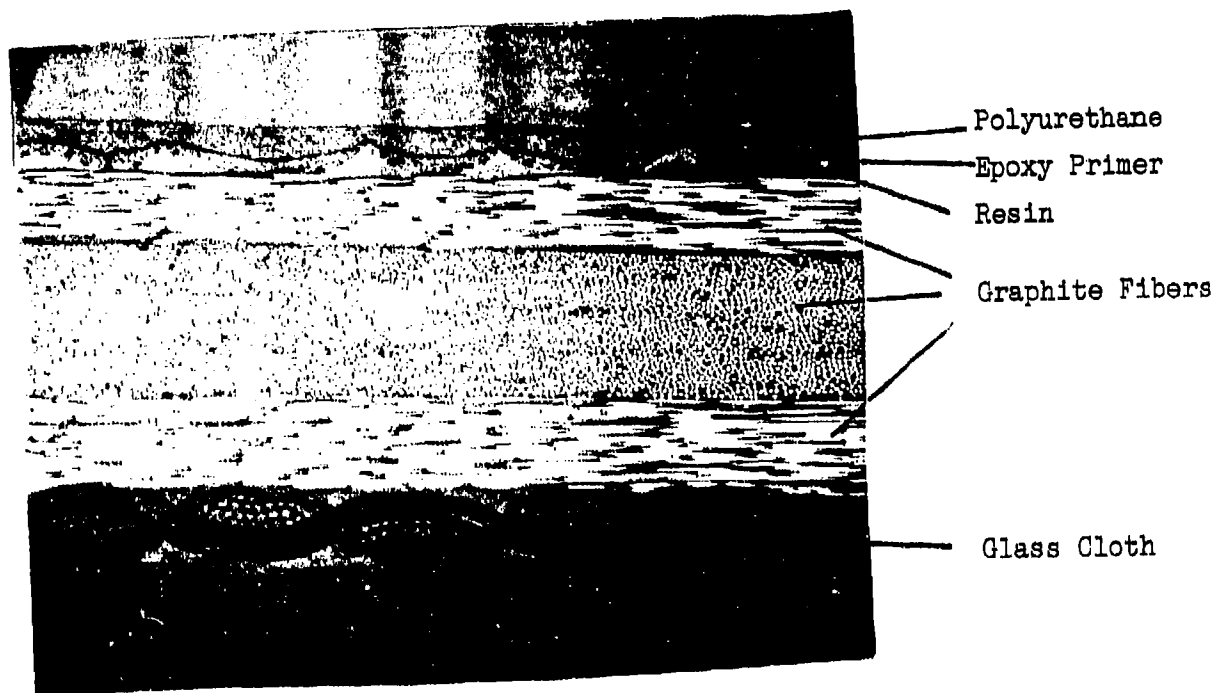
Figure 3. Laminate after paint removal. MAG. 100X  
Chemical Analysis: Si<sup>+</sup>, S, Fe<sup>+</sup>, Cl, Ba

Figure 3 is a different side view of the laminate shown in Figure 2.  
Note how the primer contours the impression left by the peel ply.
