FLOOD PROOFING TESTS

Tests of Materials and
Systems for Flood
Proofing Structures

August 1988

Prepared by
Structures Laboratory
US Army Engineer Waterways Experiment Station
for
Corps of Engineers
National Flood Proofing Committee

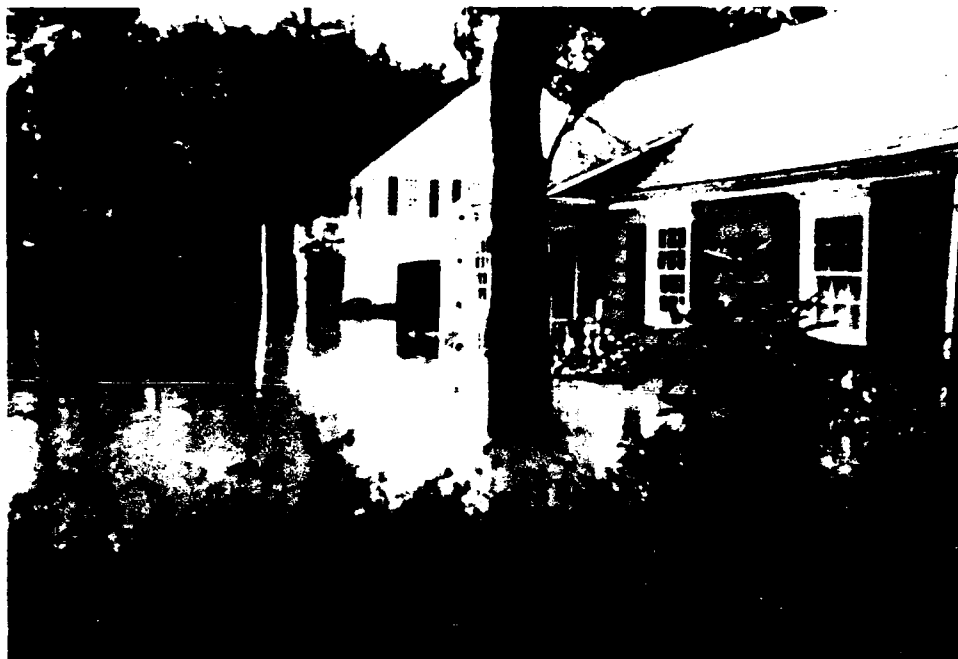
Despite the construction of flood control projects and the development of public programs to reduce flood losses, flood damage to homes and other buildings in the United States has increased dramatically (Figure 1 is an example of a flooded home). The growing exposure of structures to flooding is largely due to rising land costs and a reduction in the quantity of available land for building, thus resulting in an encroachment on flood plains.

Figure 1. Example of a flooded home

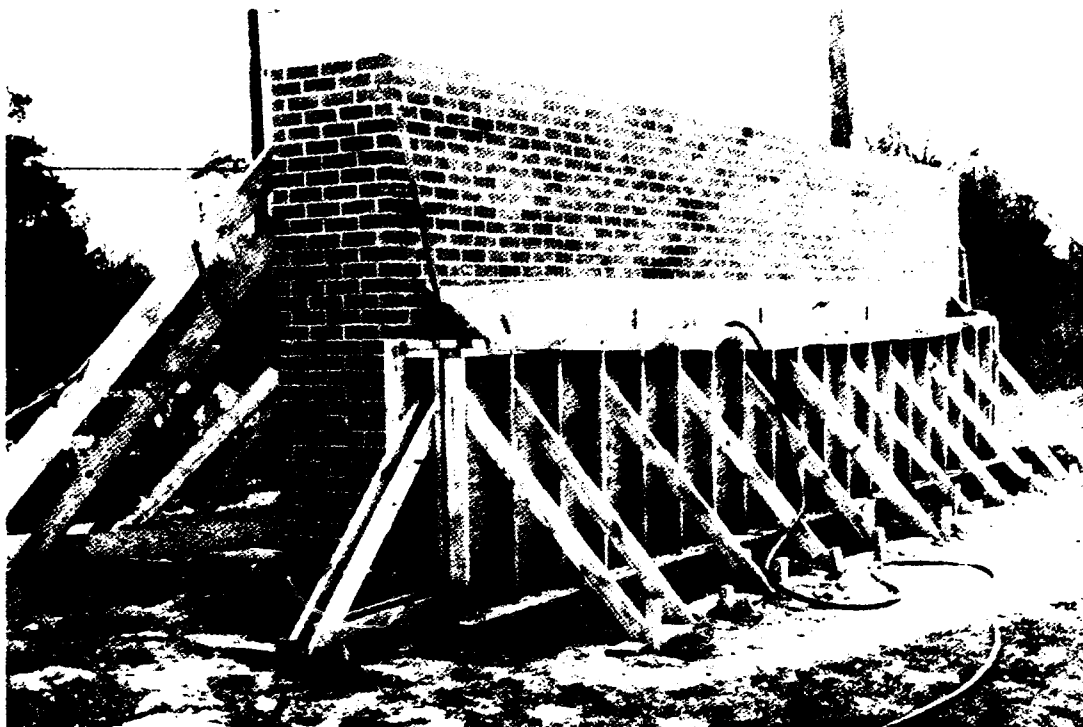
Of the three brick-veneer walls built for testing, Wall 1 (Figure 3) was a typical end wall of a home. In supporting loads, this wall is most critical because the top plate has no roof rafter and ceiling joist restraints to transfer resistance through the wall ties to the brick-veneer wall. Wall 2 and Wall 3 differed from Wall 1 as follows:

Figure 3. Overall view of Wall 1

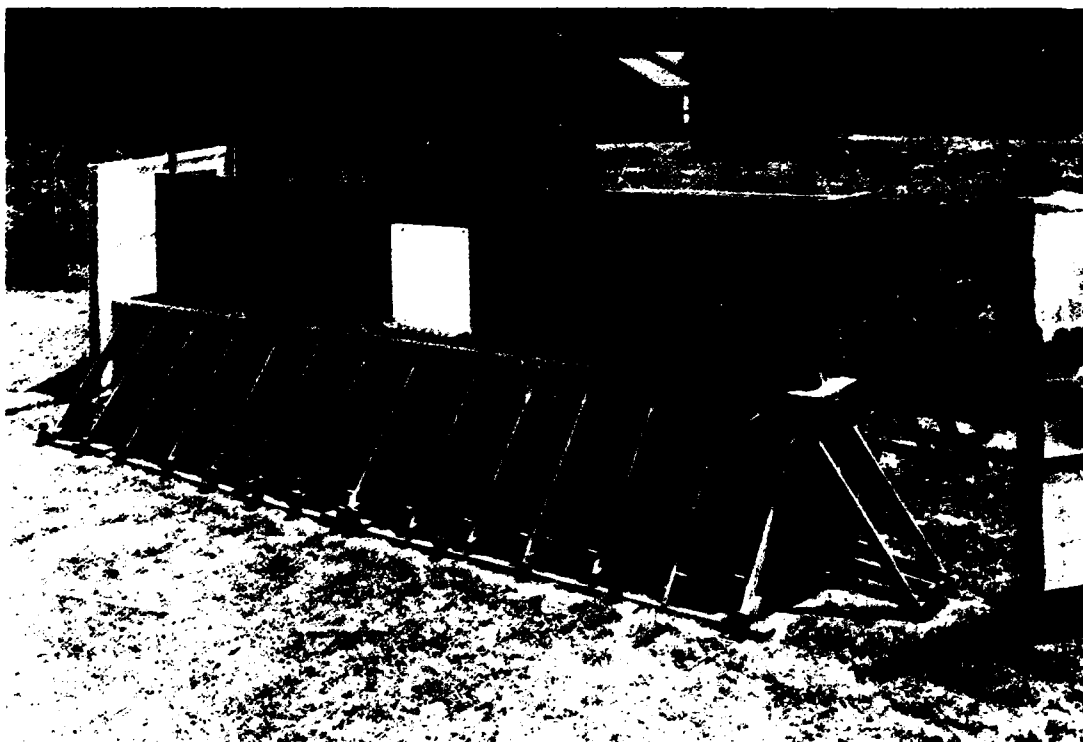
- Wall 2 had a 3-ft* door in its center (Figure 4).
- Wall 3 had roof rafter and ceiling joist restraints (Figure 5).

Figure 4. Overall view of Wall 2

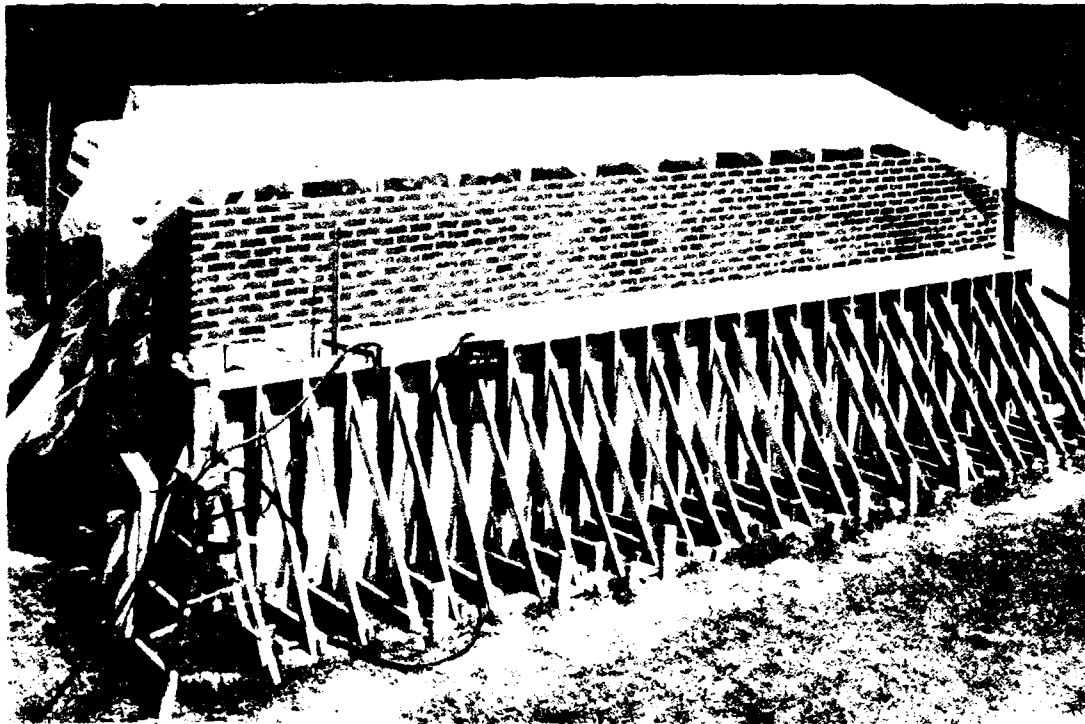
Figure 5. Overall view of Wall 3

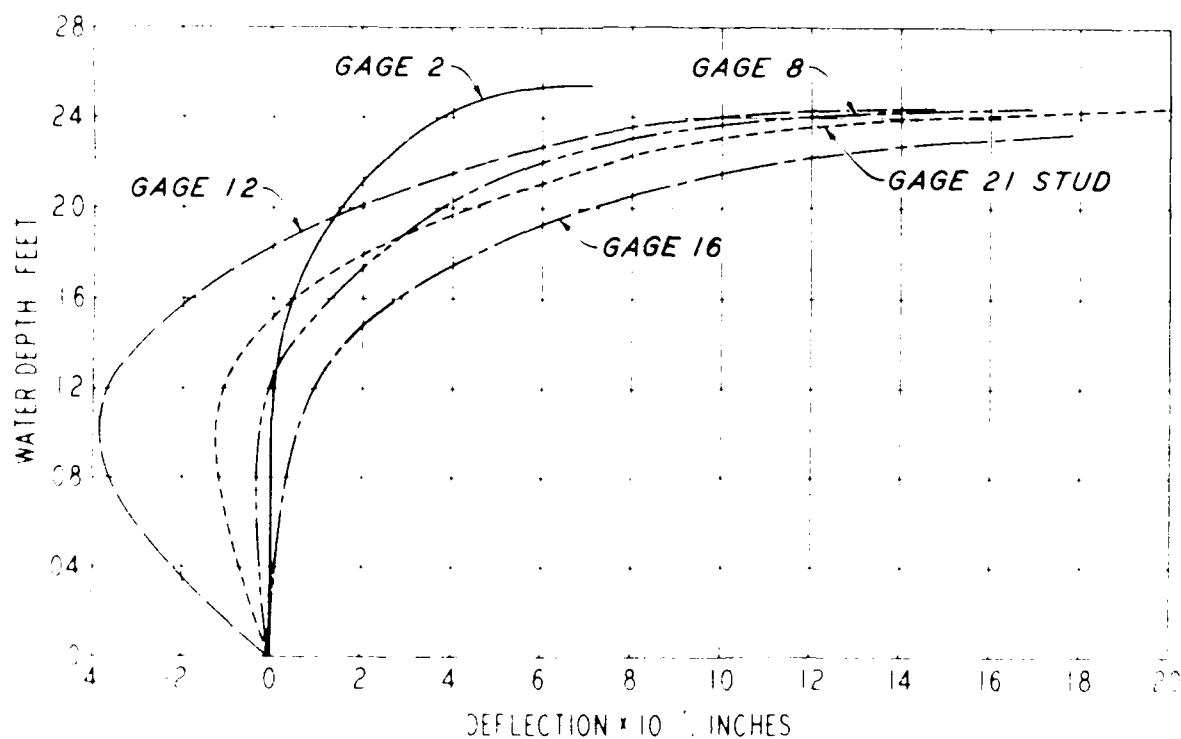
A severe loss of integrity began at 2 ft of water with complete loss occurring at 2.4 ft (Figure 8). The failure at 2.4 ft of water is presented in Figures 10 and 11.

Figure 8. Wall 1. Brick-veneer wall and stud deflections, vertical gage line

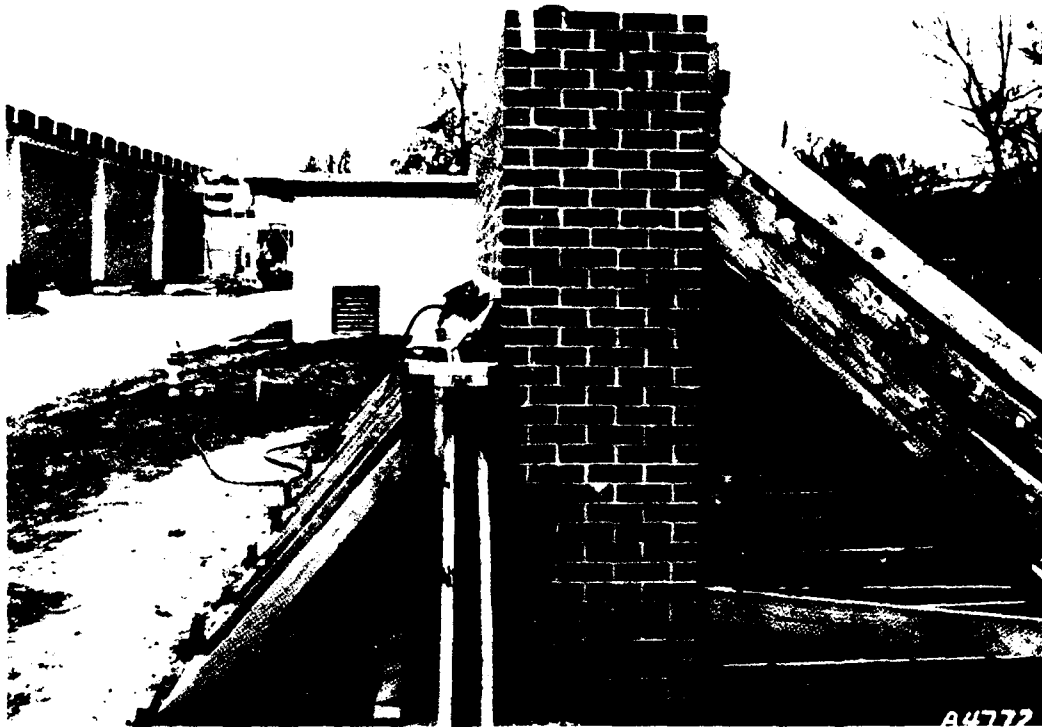
Figure 9. Wall 1. Wall deflection

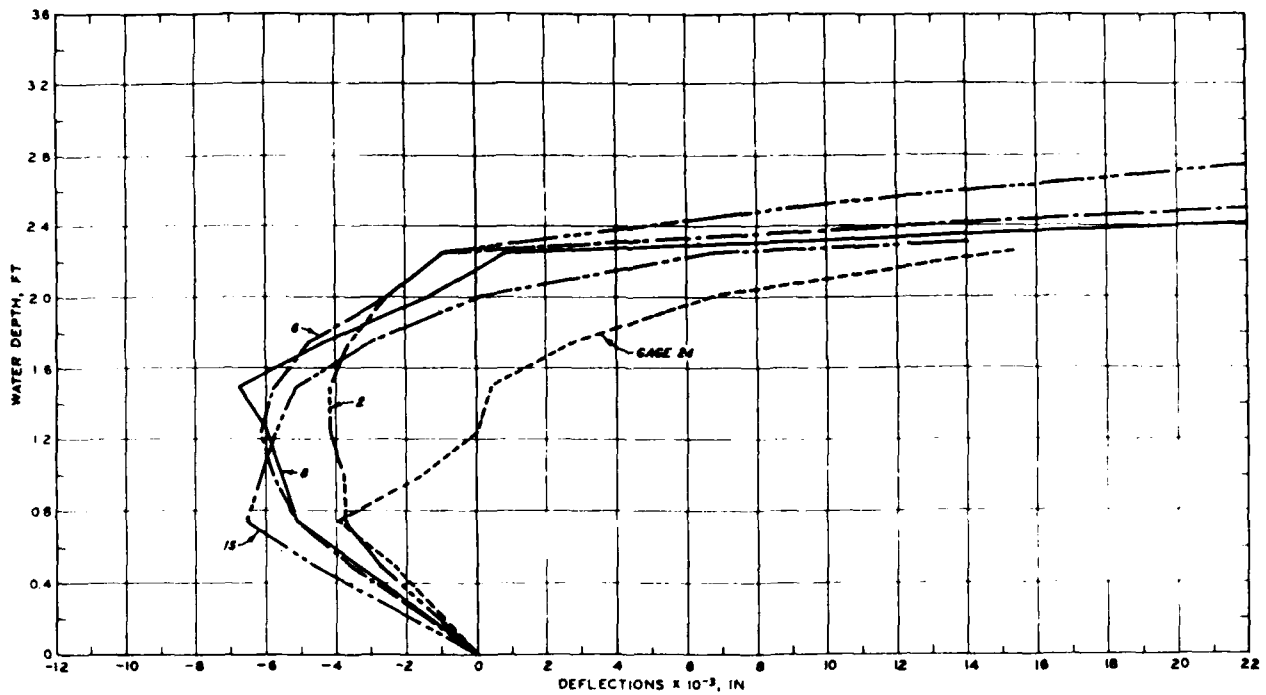
Figure 12. Wall 2. Brick-veneer wall deflections, vertical gage line, initial loading

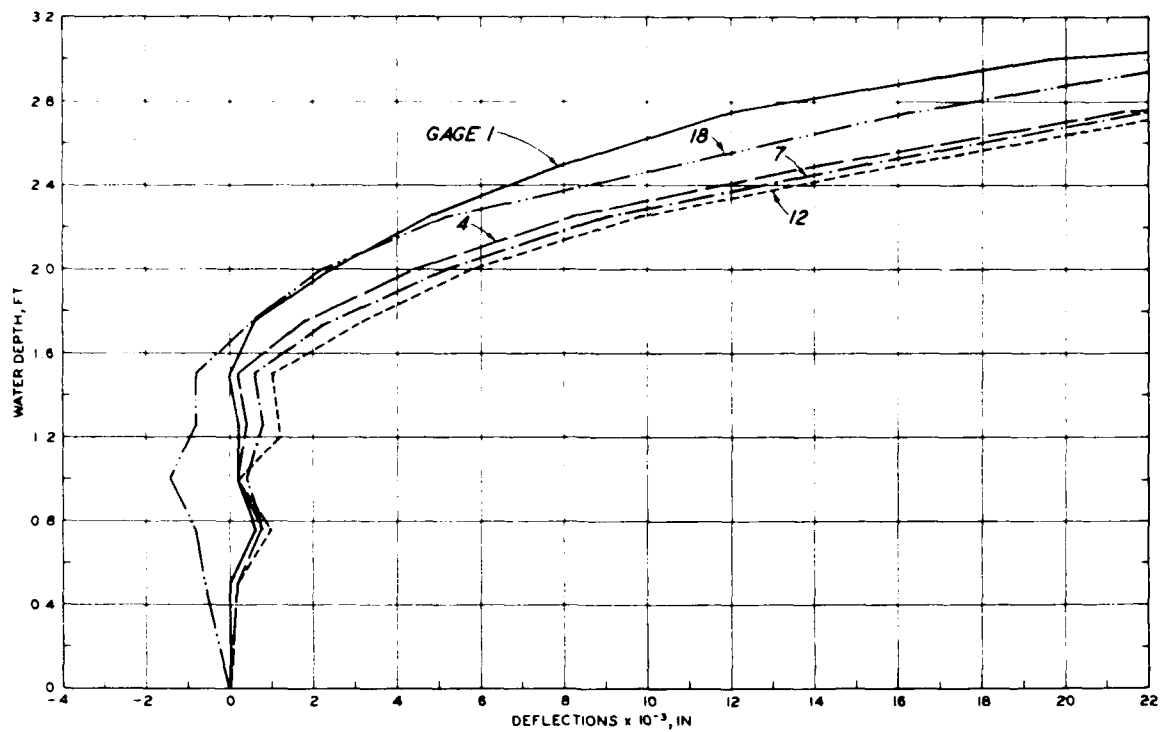
Figure 15. Wall 3. Brick-veneer wall deflection, vertical gage line

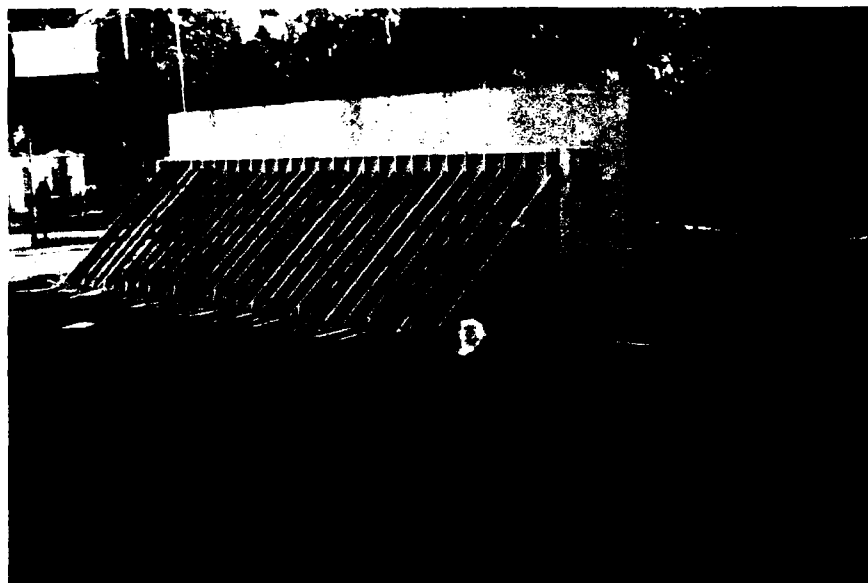
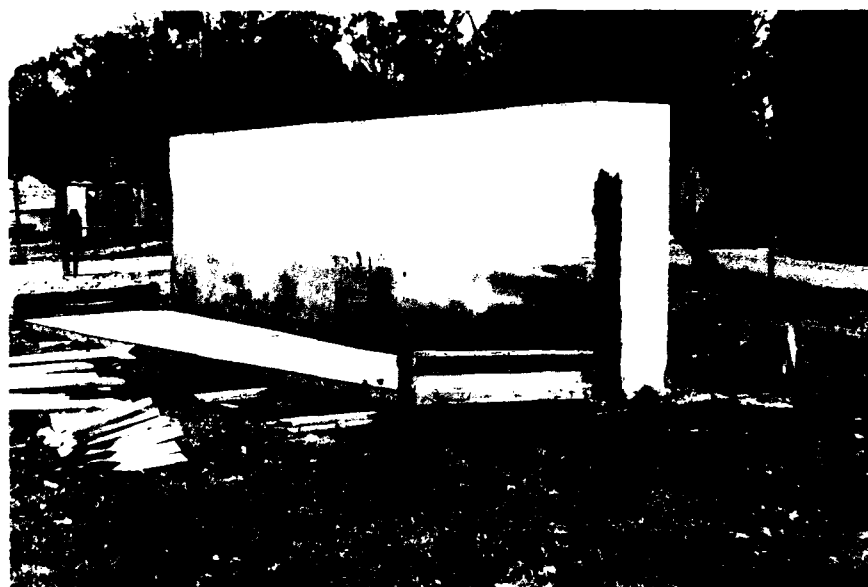
Figure 18. Block Wall 1

a. Before testing

b. After testing

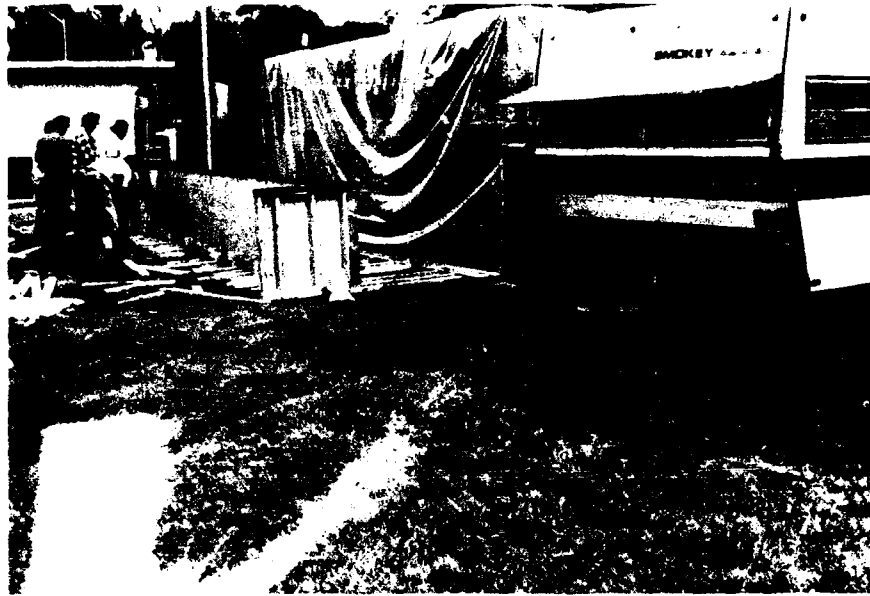
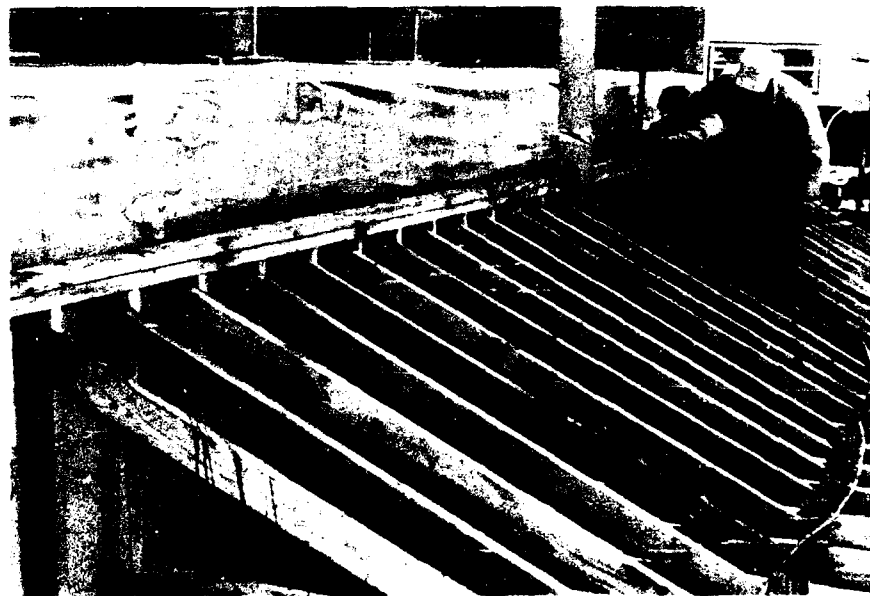
Figure 19. Block Wall 2

a. Preparing for testing

b. During testing

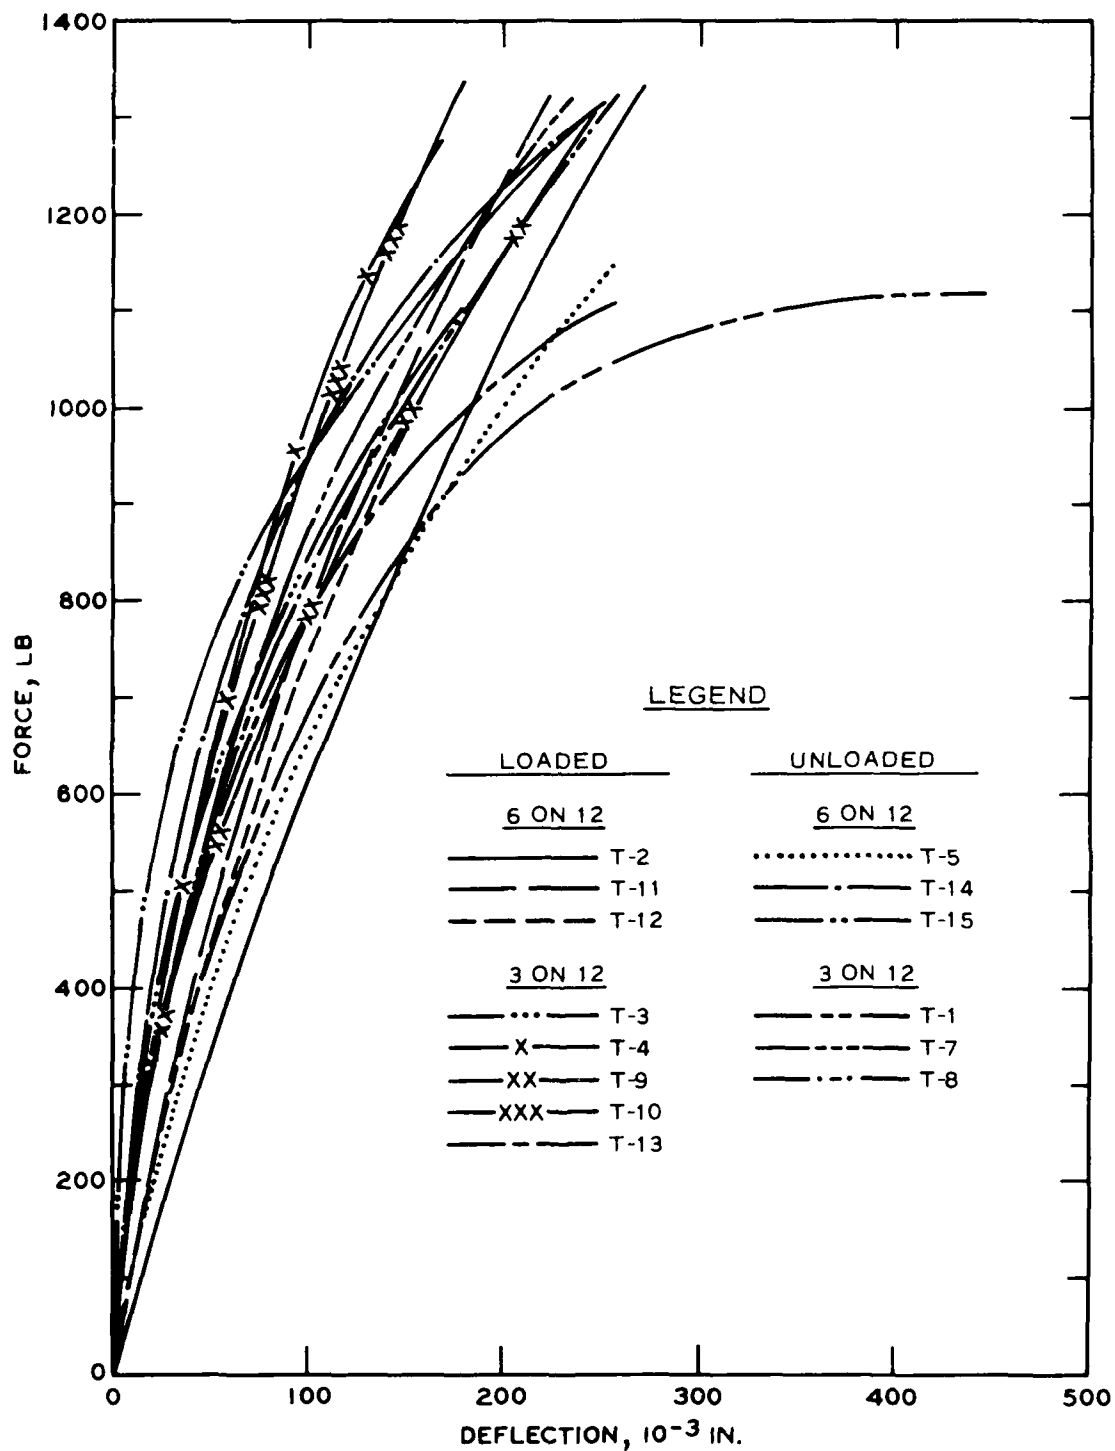
The roof rafter slope and dead load made no noticeable difference in the strength of the roof rafter and ceiling joist restraint. The connection was nailed in the standard manner with reasonable positioning of nails into the member. Later, tests were conducted with nails driven for maximum penetration into the top plate as well as going through enough of the roof rafter and ceiling joist. Connections with nails placed for maximum penetration were slightly stronger, but as long as the nails were placed in a reasonable manner the difference in the strength of the restraint was slight. The pine lumber caused an increase in the slope of the load deflection curves (Figure 23). The maximum restraint of this connection using spruce was about 1,200 to 1,500 lb (Figure 24).

Figure 24. Roof rafter and ceiling joist load deflection curves - spruce (from Pace and Campbell 1978, op. cit. p 6)

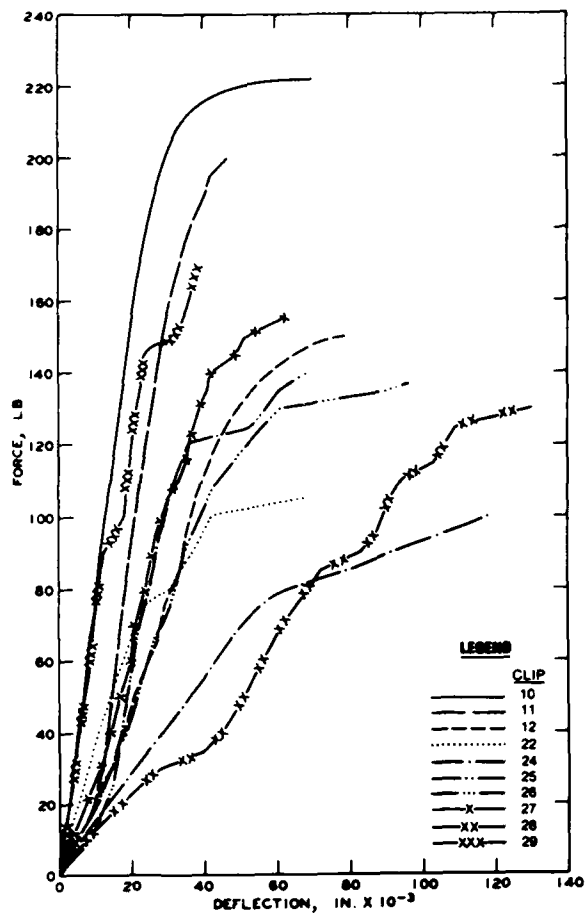
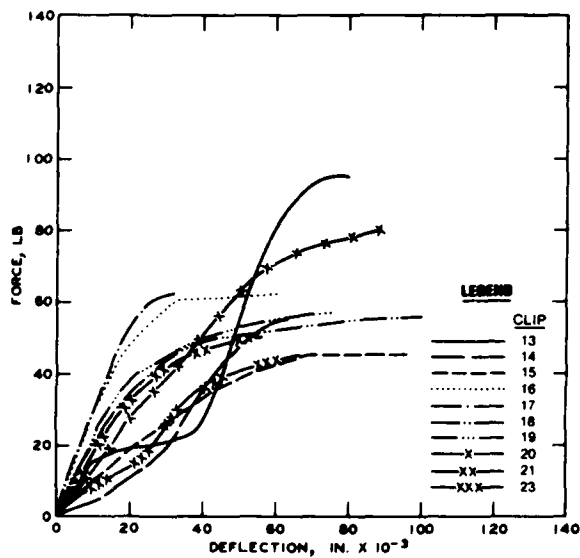
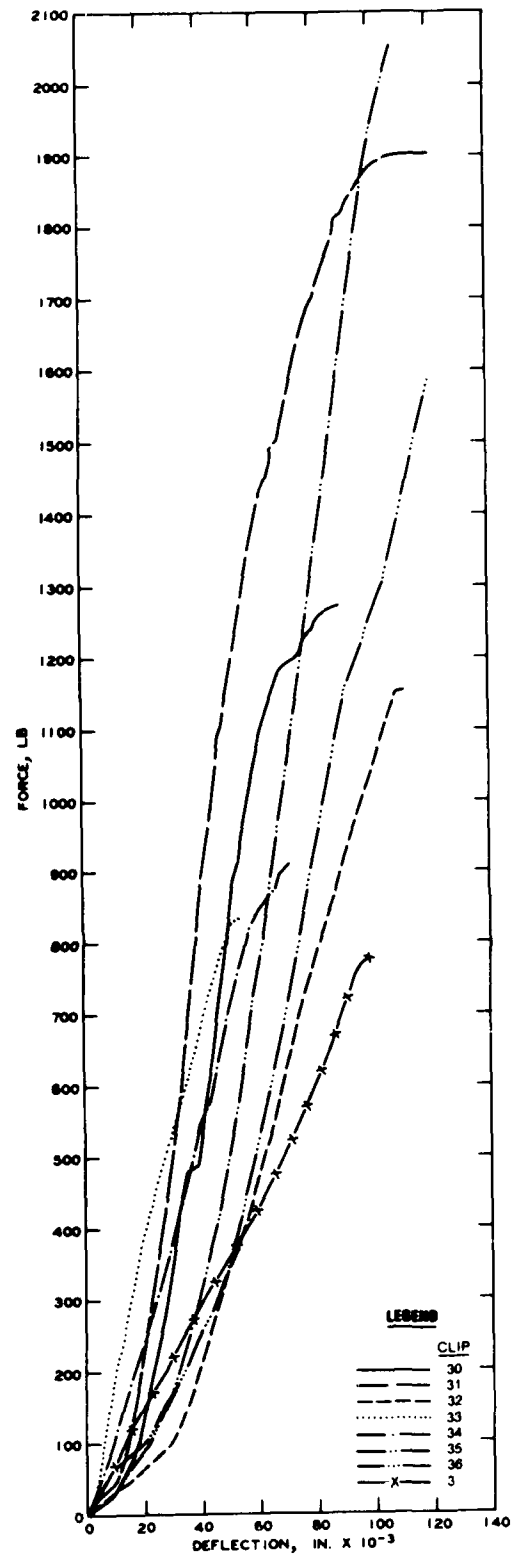
Figure 27. Load deflection curves for wall ties

The restraint due to wall ties was determined. There are several types and thicknesses of wall ties (Figure 25) but the two most commonly used (22 and 28 gage) were tested. The test setup is presented in Figure 26. The clips have a wide variation in load deflection characteristics. In general, the 22-gage clips have a maximum strength of 100 to 200 lb (Figure 27a). The 28-gage clips have a maximum strength of about 40 to 60 lb (Figure 27b). The variation of the strength of the 28-gage clips is greater than that of the

22-gage clips. Mortar that collects on the wall tie is the main factor that affects the load transfer capacity. Figure 27c shows that the load transfer increases drastically if mortar has caught on the wall clip between the studs and the brick wall. The load transfer, because of mortar, may be at least as high as 750 lb. The amount of mortar on a clip varies from none to a considerable amount. At first, it seems that the individual load deflection curves must be known for a wide variation in wall clip and mortar restraint. Fortunately, this is not the case because, for reasonable water loads, the required load transfer is much lower than the maximum. In fact, it is within a range where the slope of all curves is very similar and one relationship will reasonably represent the load transfer relation.

a. 22-gage wall ties

b. 28-gage wall ties

c. 22-gage wall ties
with varying thicknesses
of mortar

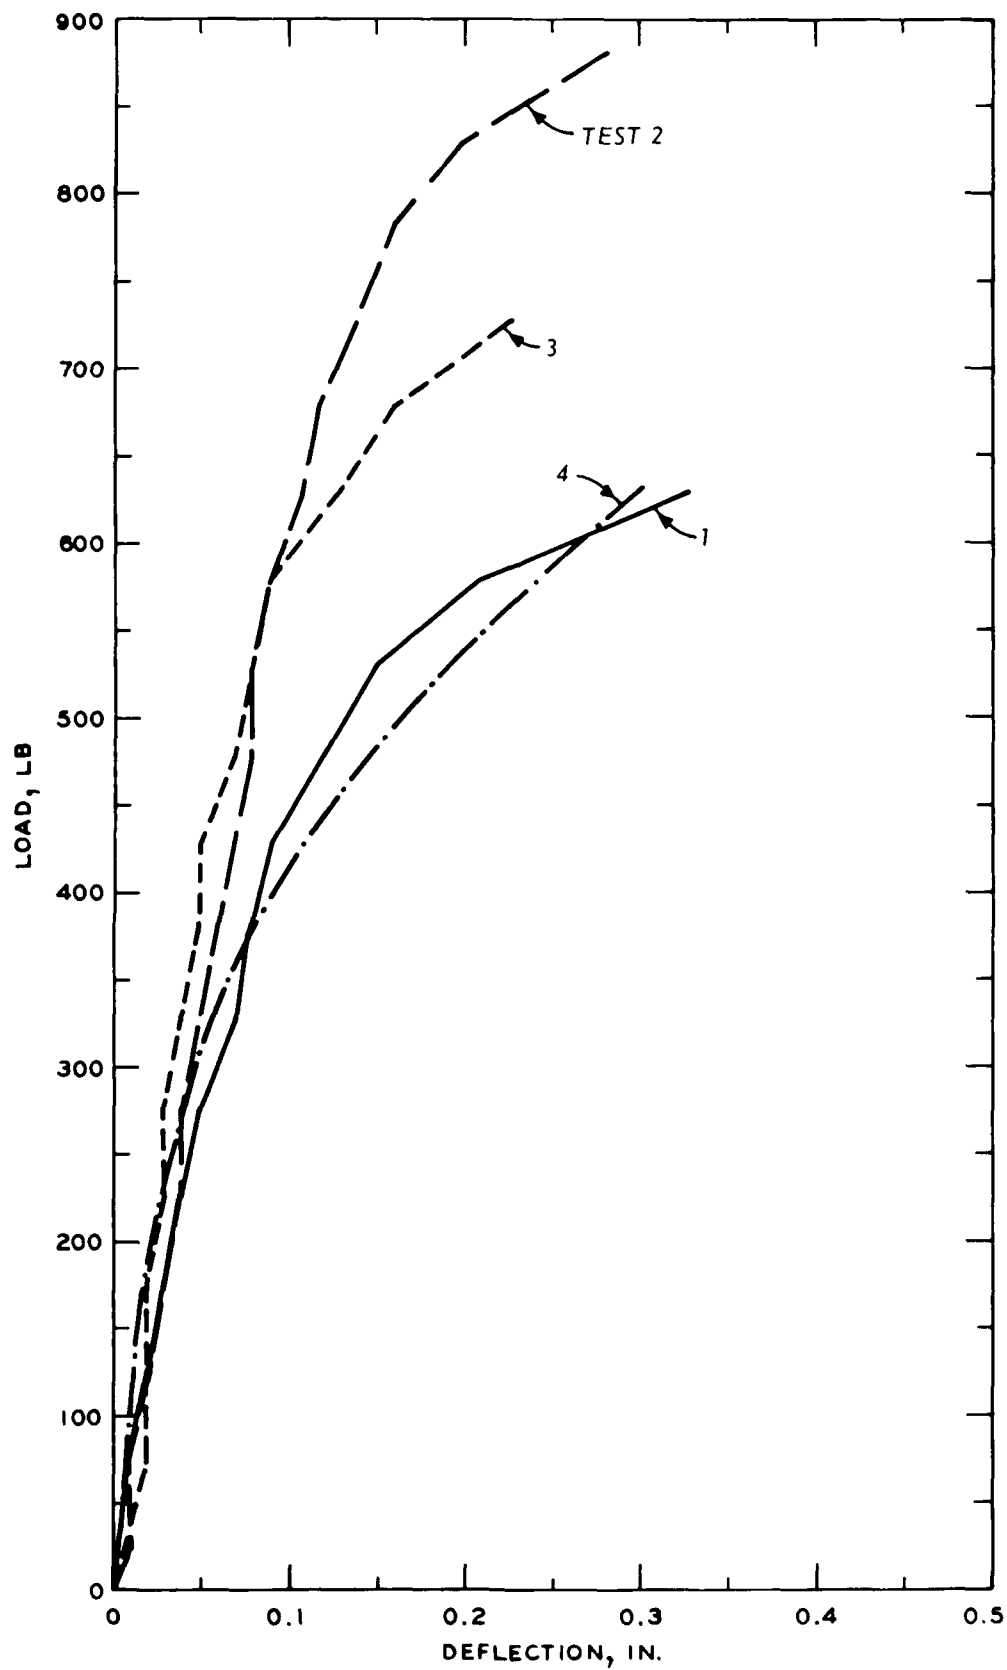
The restraint of the stud connection to the baseplate is shown in Figure 28. The setup used in testing this connection is shown in Figure 29. The above knowledge of material properties and restraint conditions allowed a solution by the finite element method.

Figure 28. Stud to base plate load deflection relations

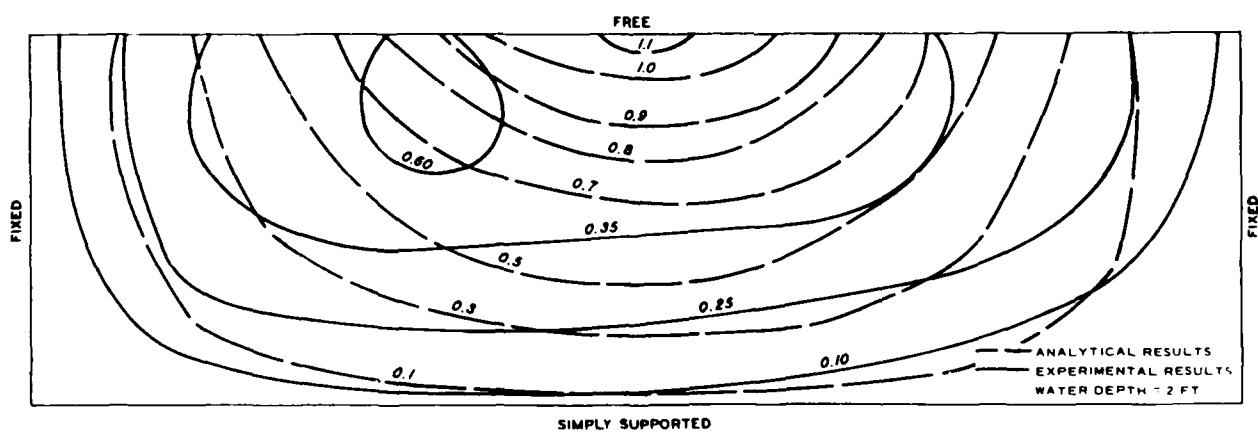
Since the wall tie restraints cannot be estimated, a comparison of experimental results (restrained by wall ties) and analytical results (without wall tie restraint) are presented in Figure 30. This comparison shows that analytical solutions are very promising. The deflections given by the analytical solution are somewhat greater than those from the experimental results, as would be expected. Since Wall 1 did not have roof rafters and ceiling joist restraints, the wall tie loads are not large relative to the water loading; therefore, the above comparison should be close.

Figure 30. Comparison of analytical and experimental results
(deflection is times thousandths of an inch)
