# CRREL REPORT 89-10

*Definition of research needs to address  
airport pavement distress in cold regions*

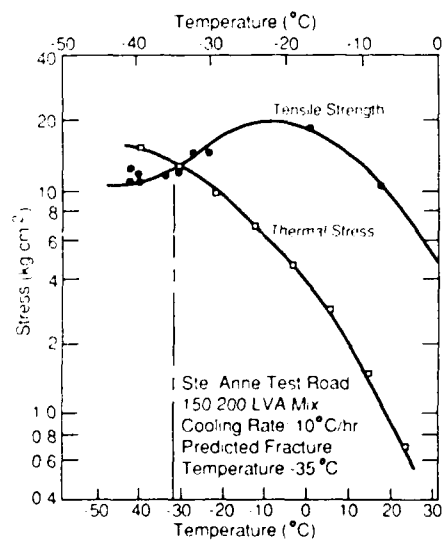
ture fracture cracks can occur in the surface layer as it contracts and the tensile stress (caused by the contraction) exceeds the tensile strength. The problem is compounded at lower temperatures as stress relaxation tendencies for the AC decrease and material stiffness increases. Further, tensile strengths increase with descending temperature but only to some limiting value, whereupon they decrease. This fact, coupled with the increase in tensile stress, with descending temperature, suggests the mechanism of crack formation shown in Figure 21. The relationships between tensile strength or thermal stress and temperature depend on physical properties of the AC mixture (e.g. cement type, aggregate, filler, additives, and so forth) as shown in Figure 22. Also, the age of the AC and the rate of temperature change influence the relationships shown. The interaction between all these variables is extremely complex and it may be difficult to create a unifying theory to fully describe the failure mechanism.

Figure 21. Variation in tensile strength and tensile stress as a function of temperature, indicating when fracture occurs (after Christison 1972).

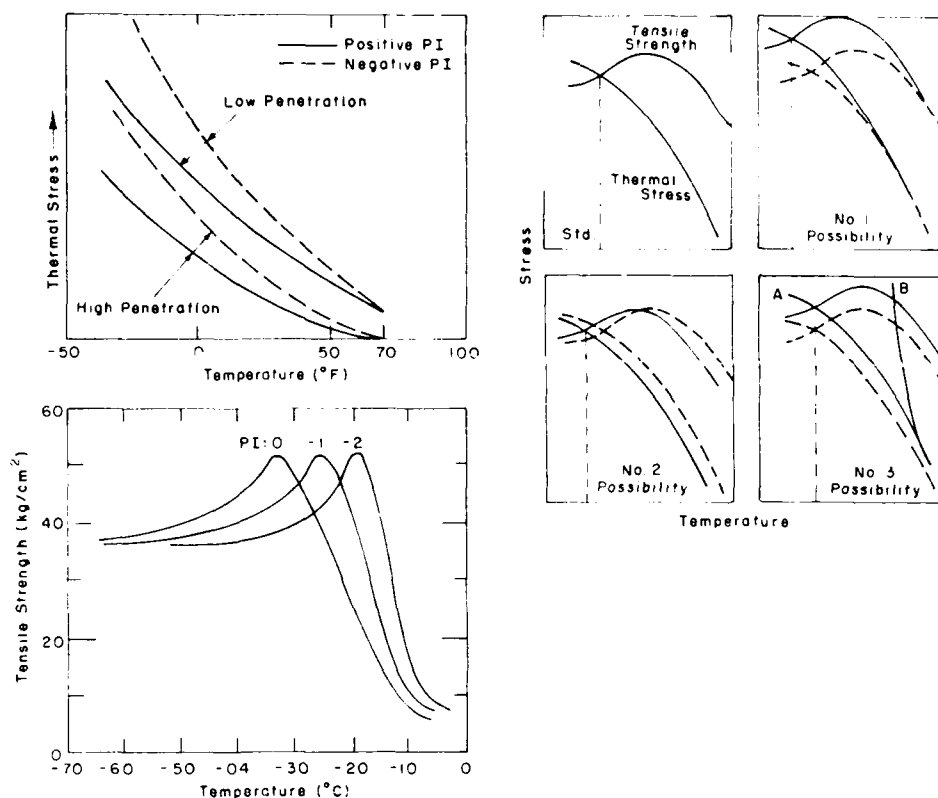
Figure 22. Schematic diagram indicating possible changes in the fracture temperature for changes in strength and stiffness.

ed with 1) lower temperatures, or 2) the fact that the asphalt cement hardens with age and changes the properties of the surface layer. With time, the crack spacing may decrease substantially and eventually create a complex pattern of transverse cracks exemplified in Figure 23.

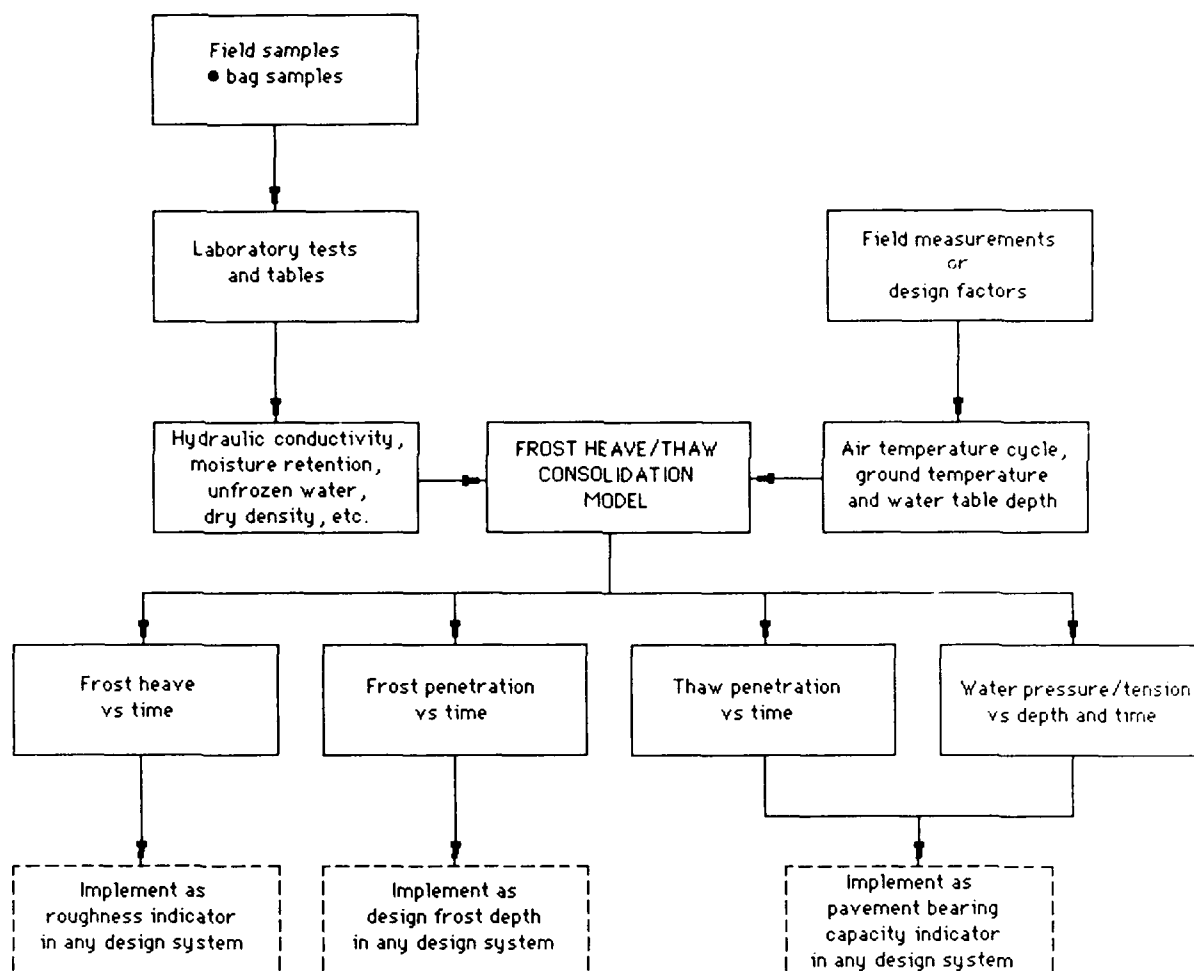
model to pavement design in seasonal frost areas is given in Figure 36. As may be noted, laboratory tests are required to create input data for the model.

Figure 36. Schematic illustration of the applications of a frost heave/thaw consolidation model to pavement design (after Guymon et al. 1986).

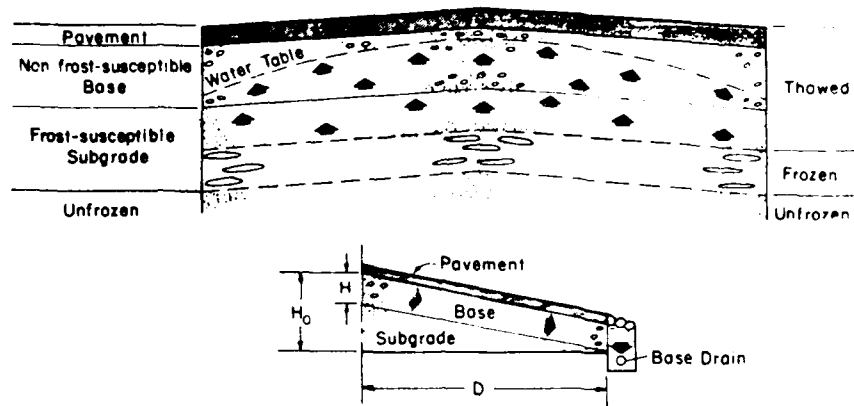
ground is frozen beneath and lateral redistribution of the water is often not possible because of slower thawing and/or less permeable soils in the vicinity of the shoulders). The situation points to the definite need for free-draining base and subbase courses and longitudinal drains to remove the thaw water in frost areas. Further, impedance of subsurface drainage elements caused by frozen soils must be considered in the design process (Berg and Johnson 1983).

Figure 37. Thaw water regime in a pavement structure underlain by frost-susceptible subgrade (after Berg and Johnson 1983).

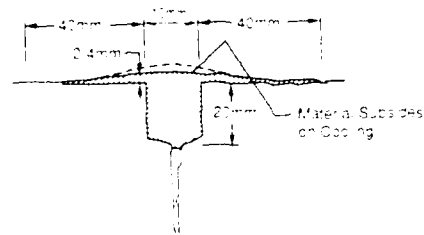
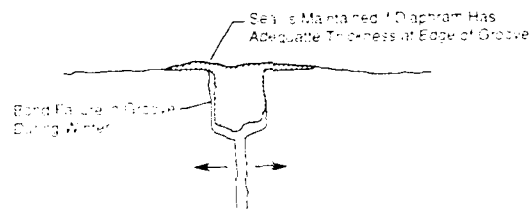
a. Typical sealed crack cross section.

c. Bond failure at groove.

Figure 46. Cross section of sealed crack and typical failure modes (after Evers and Lynch 1984).

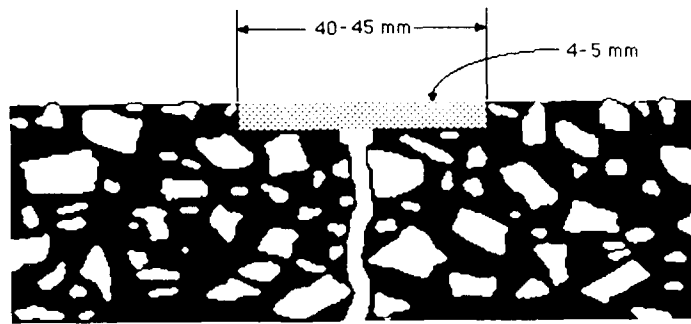
Figure 48. Cross sections of countersunk overband seal (after Evers and Lynch 1984).

Evers and Lynch (1984) also identify a new crack sealant geometry that maximizes the benefits of the overband seal, eliminates snowplow damage, and controls the width of the sealant spread. The geometry is shown in Figure 48. They note that countersinking the overband eliminates the need for a strike-off operation.
