MTL TR 89-90

# FAILURE ANALYSIS OF A MISSILE LOCKING HOOK FROM THE F-14 JET

VICTOR K. CHAMPAGNE, Jr. and GARY WECHSLER  
MATERIALS TESTING AND EVALUATION BRANCH

September 1989

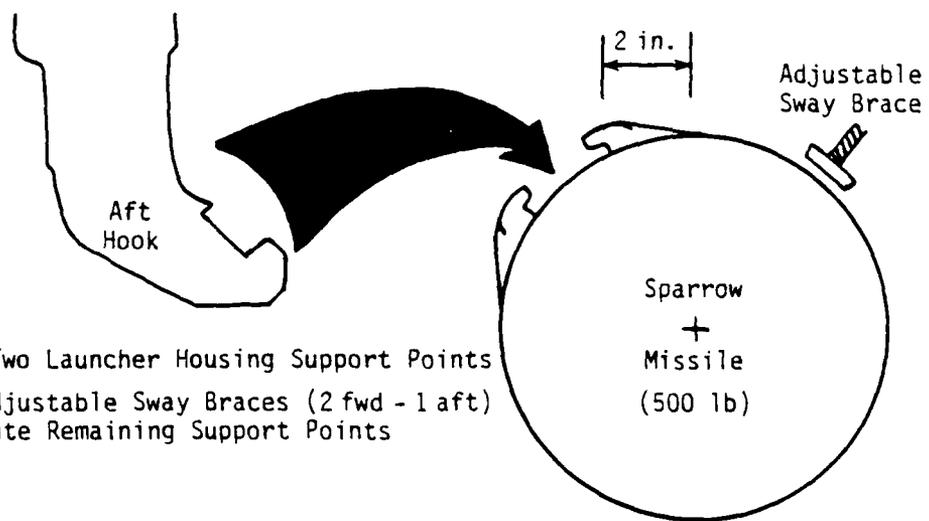
The hook is inserted into a mating component, located on the 500 lb Sparrow Missile (Figure 1b) providing support and stability. The contact areas between these parts are subjected to vibration and shock loading during all phases of flight, especially while landing the aircraft. This repeated motion caused mechanical wear at the interface.

Figure 1b. Schematic illustrating the locations of the support points on the Sparrow Missile.

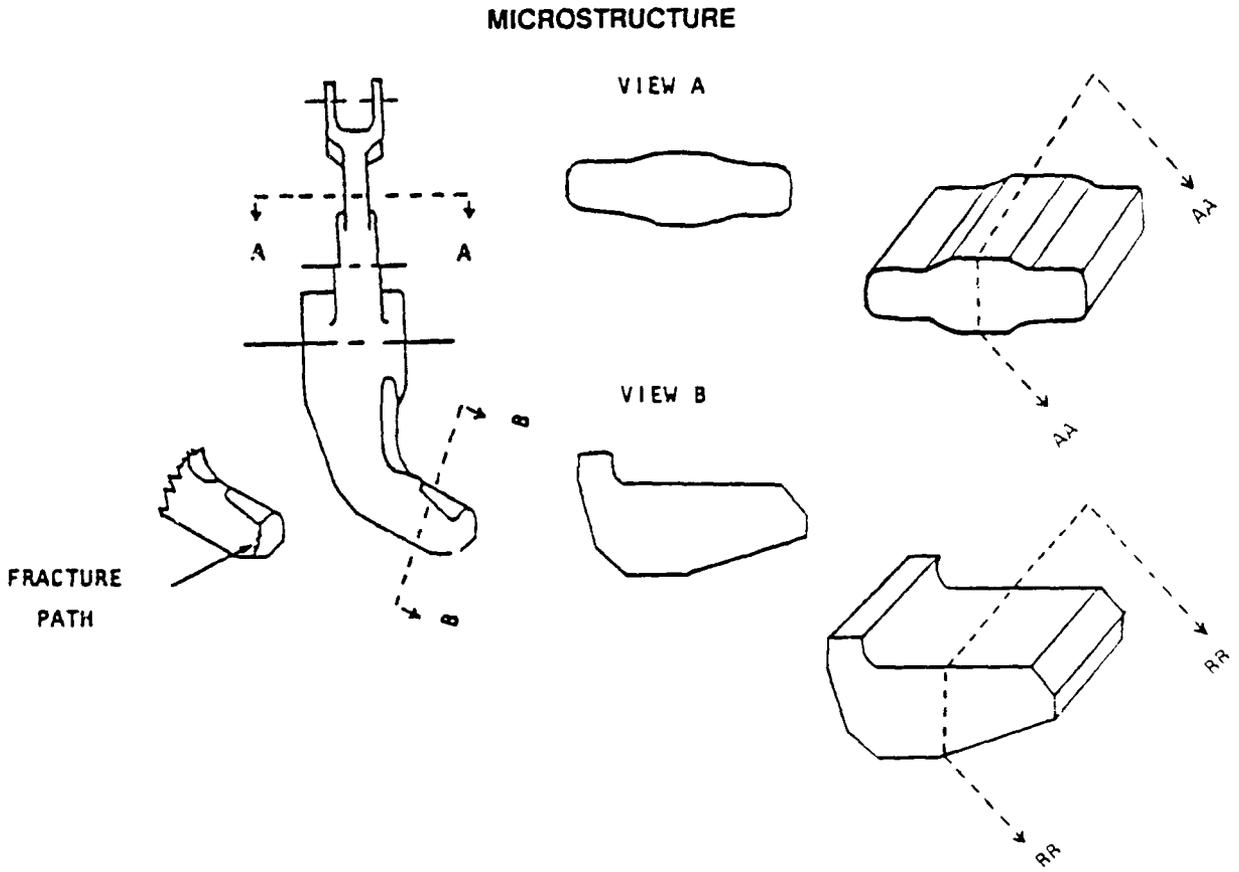
Figure 8. Schematic illustrating the areas where metallographic specimens were sectioned from the missile hook.

According to the specifications, the part is cadmium plated by vacuum deposition, per MIL-C-8837, to 0.0003 inch thick and primed, per MIL-P-23377, to 0.0006 to 0.0009 inch thick and subsequently painted with polyurethane, per MIL-C-81773, or with an acrylic lacquer, per MIL-L-81352, with the exception of the load-bearing area near the lip which is "Microlubed" to 0.0008 to 0.0012 inch thick. The "Microlube" coating is a proprietary process which includes deposition of a chromium-based alloy by ion displacement in a prescribed matrix followed by a duplex electro registration of a fluorocarbon polymer as a friction and corrosion inhibitor within the prescribed matrix. Specimens A and AA obtained from the component, as shown in Figure 8, will be used for analysis of the cadmium plating and the paint. Specimens B and BB will be utilized for examination of the "Microlube" coating.

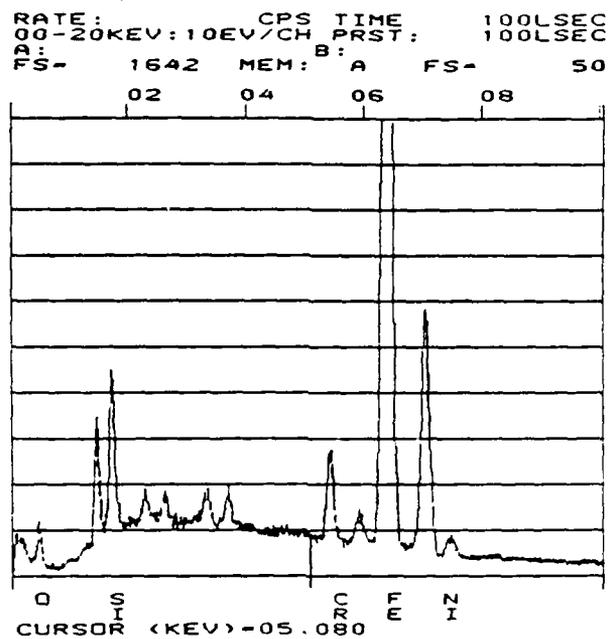
Energy dispersing spectroscopy (EDS) of the dark material produced spectra that contained those elements associated with the type of steel under investigation as well as oxygen (see Figures 17a and 17b). The black layer was concluded to have been a corrosion product, and not contaminants. The formation of this oxide layer was later attributed as having occurred during the slow propagation of a service-related fatigue crack. Figure 15 shows a series of fine progression marks, or beach marks, barely visible within Zone 1. These macroscopic features reveal successive positions of an advancing crack front and are associated with fatigue-fracture surfaces. Under microscopic examination, fatigue striations were observed within Zone 1. Striations often occur in fatigue fractures and are the result of a single cycle of loading. Figure 18 shows these striations, which extend horizontally across the fractograph. Corrosion products are visible in various locations of the figure. Excessive corrosion can mar the fracture surface making it nearly impossible to distinguish microstructural features and interpret topology. The fracture under investigation contained a significant amount of corrosion in Zone 1, which made fractographic observations difficult in that area, but also verified that this region was the result of a preexisting crack which had been exposed to the environment for a period of time.

Figure 17a. EDS spectra of Zone 1 showing the elemental constituents of 300M steel and oxygen.

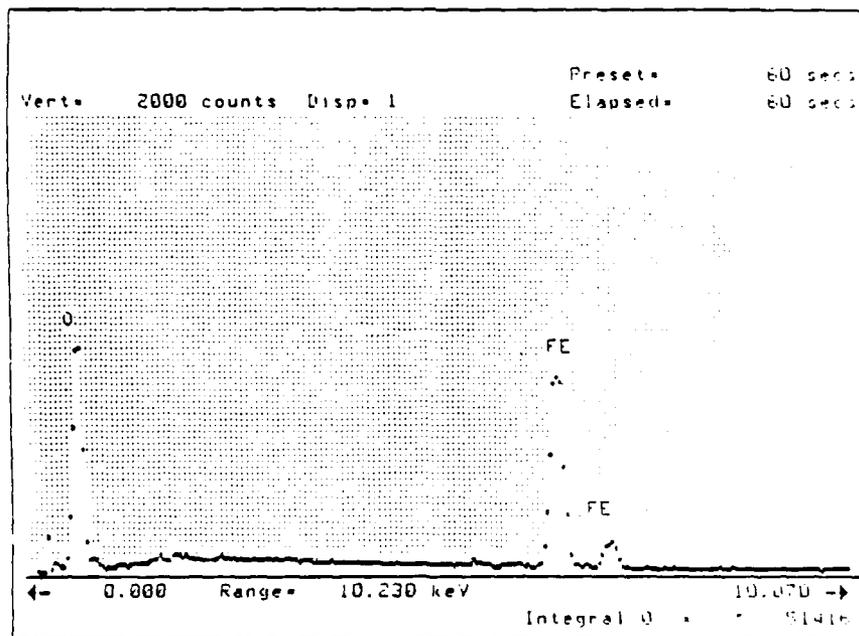
Figure 17b. EDS analysis of another region located in Zone 1 containing large amounts of iron and oxygen.

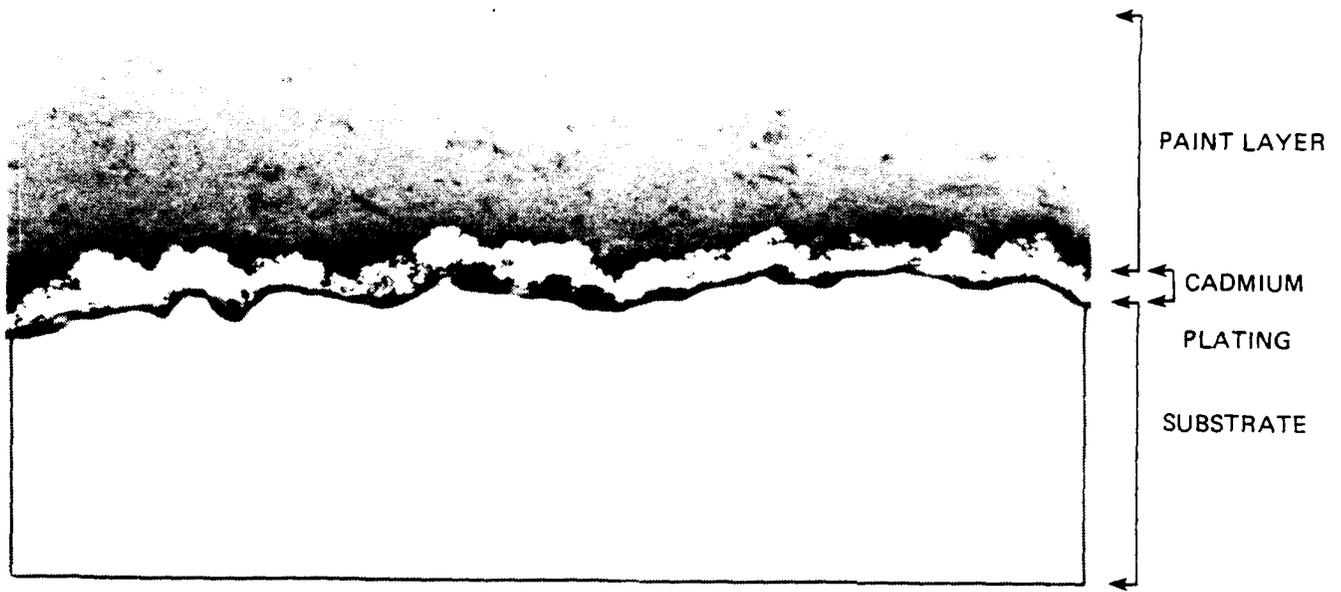
Specimens A and AA were utilized for microscopic examination of the cadmium plating and the paint. Figure 27 is an optical micrograph showing a typical cross-sectional view of the coatings. Regions of the cadmium layer were measured and found to have a thickness range of approximately 0.0003 to 0.0006 inches. These readings conformed to the requirements set forth in MIL-C-8837, Section 3.4.1, which stated that the thickness of the cadmium plating shall be 0.0003 inches, minimum. Figure 28 is a SEM micrograph also containing both coatings. The cadmium plating and the paint layer have been designated on the figure as Area 1 and Area 2, respectively. Further examination of these regions under high magnification revealed no significant signs of faulty adhesion, blistering, peeling, or misplating.

Figure 27. Optical micrograph of the cadmium plating and the paint, Mag. 500X.

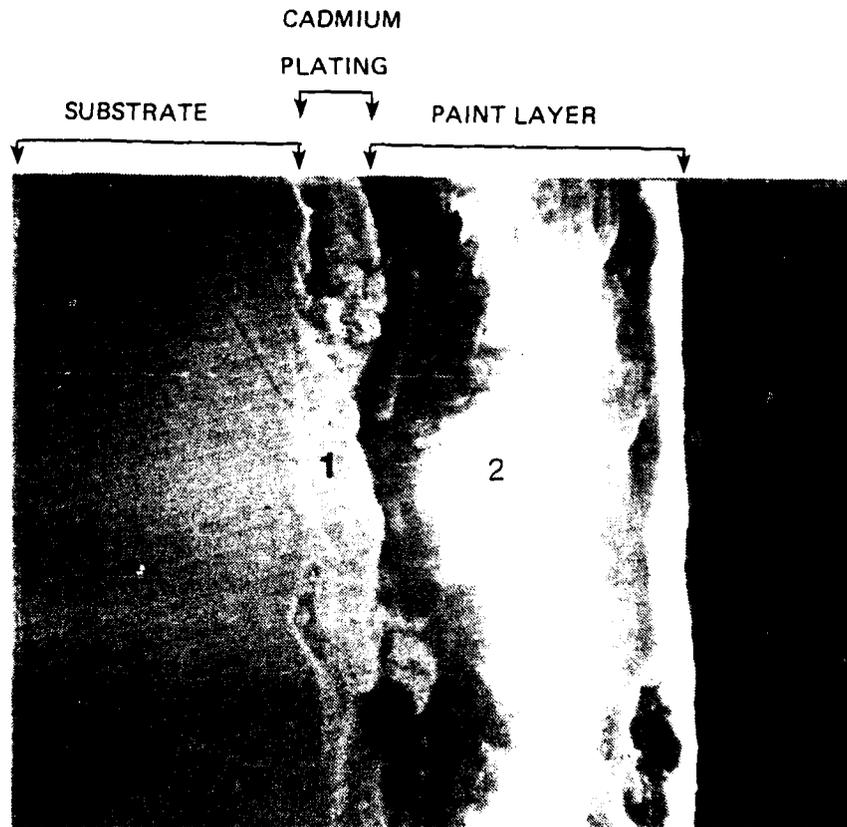
Figure 28. SEM micrograph of the cadmium plating (Area 1) and the paint (Area 2), Mag. 1000X.

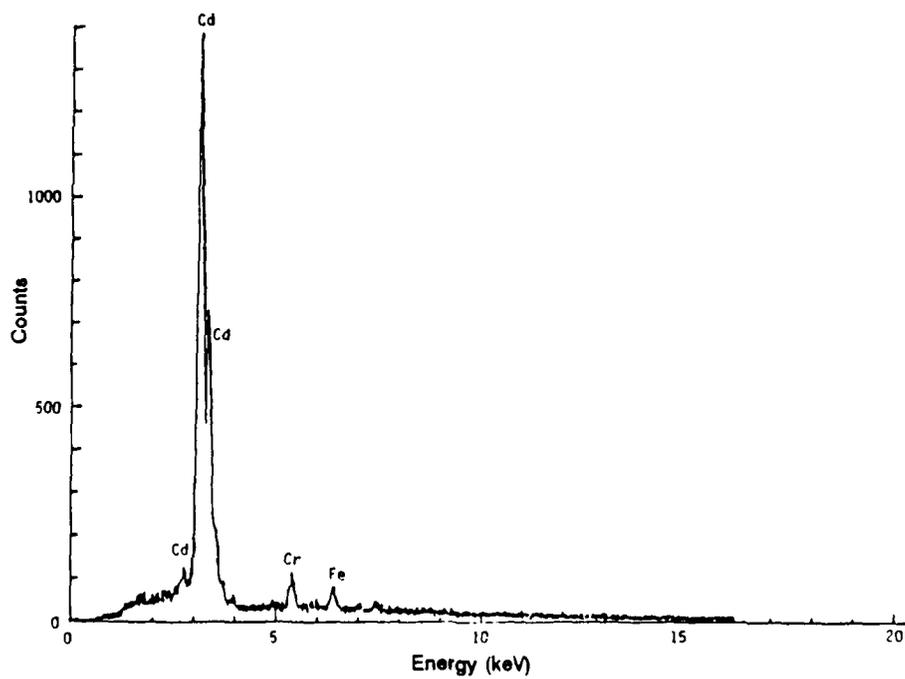
Elemental composition of the coatings was determined by electron dispersing spectroscopy. The resulting spectra obtained from these analyses are shown in Figures 29 and 30. EDS analysis of the paint (refer to Figure 29) revealed a large titanium (Ti) peak. Titanium dioxide is commonly used as a coloring agent in paint pigment. The trace of silicon (Si) detected may have represented extender pigments which are often composed of silicious matter or perhaps remnants of surface greases or lubricating oils that had also been analyzed. Figure 30 contains the spectra of the cadmium plating. The small chromium (Cr) peak, which appeared in both analyses, was indicative of the prior chromate treatment performed on the missile hook as required by MIL-C-8837. The substrate was chromated to retard or prevent formation of white corrosion product on surfaces exposed to certain environments, including marine atmospheres. The small amount of iron (Fe) was associated with the base metal (300M steel).

Figure 30. EDS spectra of the cadmium plating.

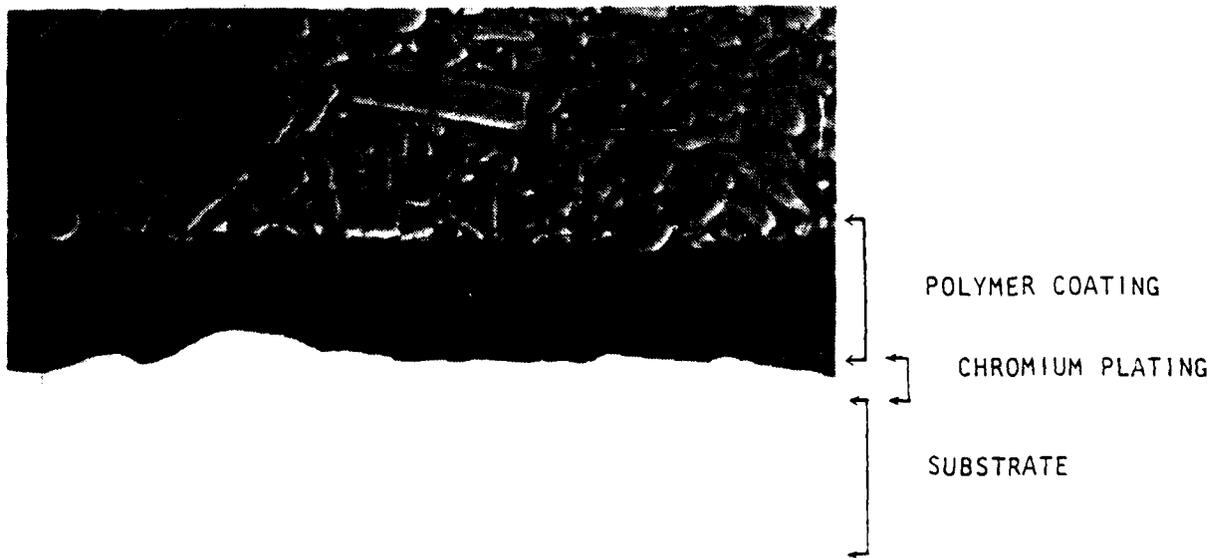
Figure 32 is a SEM micrograph showing the chromium and polymer layers. The engineering drawing for the missile hook, (reference Raytheon Drawing No. 685029, Figure 14), stated that the "Microlube" coating shall have a thickness of 0.0008 to 0.0012 inches. The chromium layer had a measured thickness of approximately 0.0004 to 0.0005 inches, while the polymer coating was approximately 0.0008 to 0.0014 inches thick. The total thickness of the "Microlube" coating was 0.0012 to 0.0019 inches, which exceeded the specification. Maximum thickness requirements are prescribed for coatings to insure proper adherence and coherence.

Figure 32. SEM micrograph of the chromium plating and the polymer layer which constitute the "Microlube" coating, Mag. 500X.

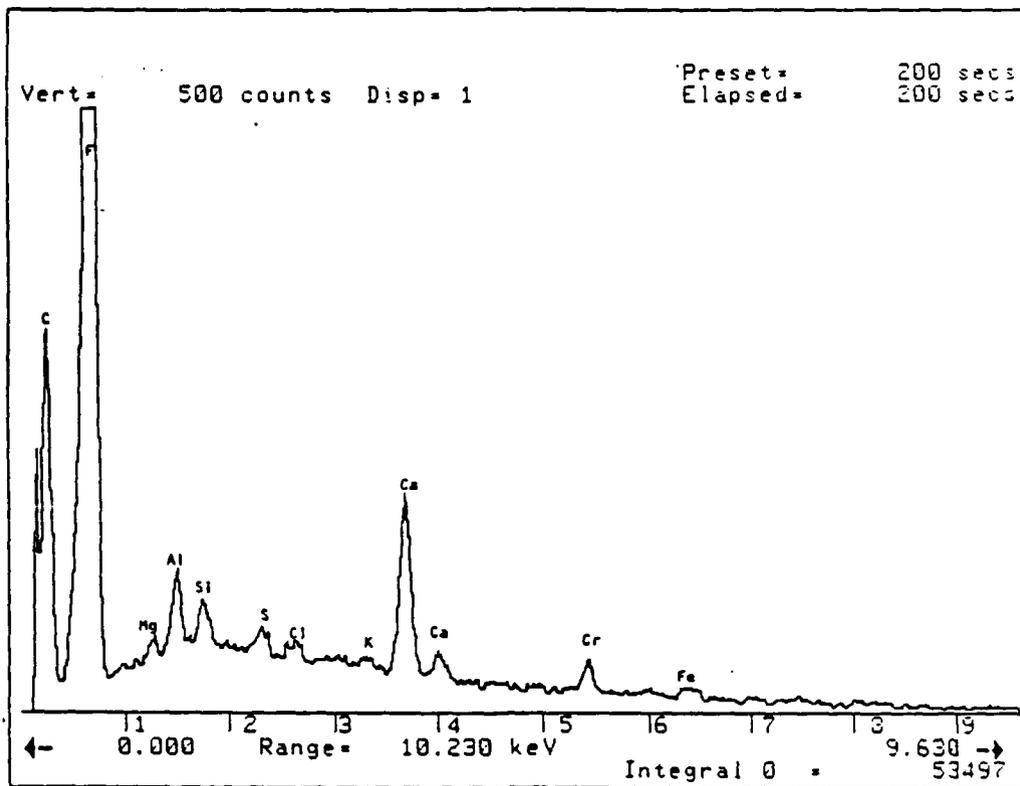
An EDS analysis was conducted of the chromium and polymer layers. Figures 33 and 34 show the resulting spectra obtained from these examinations. The spectra shown in Figure 33 contains those elements associated with the polymer coating. The fluorine (F) peak identifies the base material which is Teflon. Figure 34 contains a large amount of chromium (Cr) which characterizes the chromium plating.

Figure 33. EDS spectra of the polymer coating.

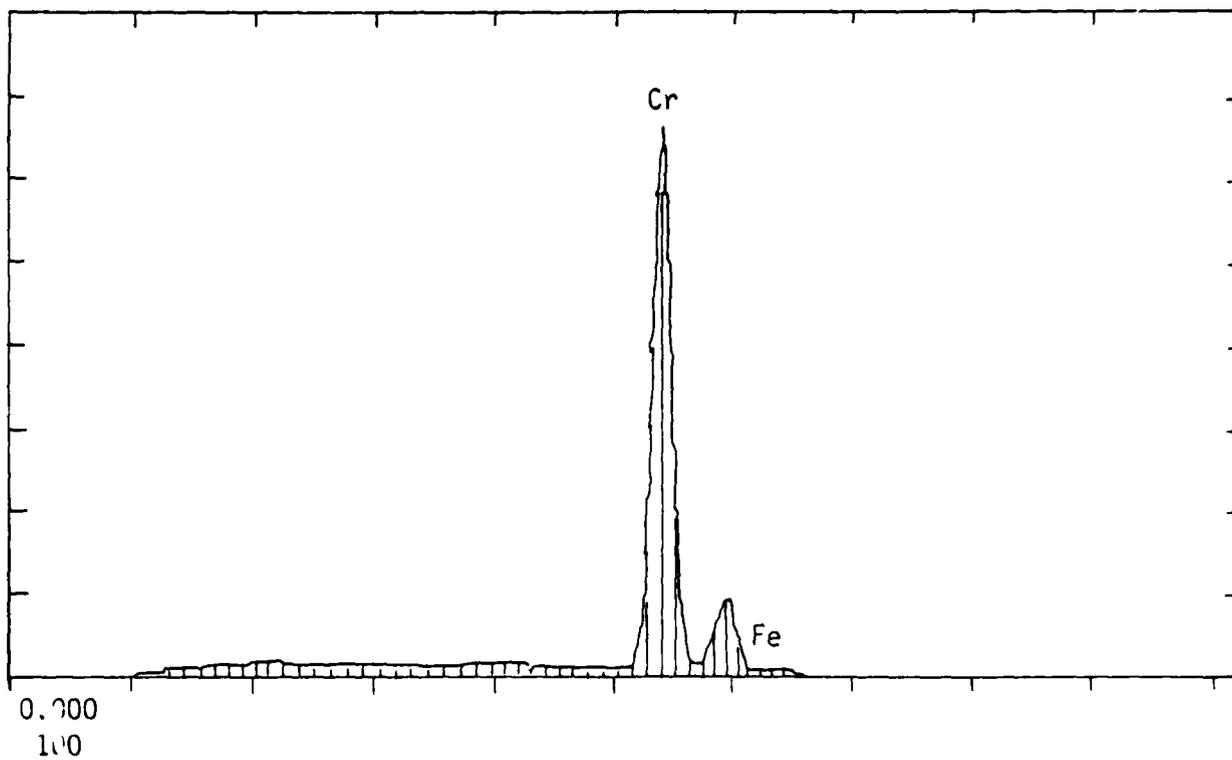
Figure 34. EDS spectra of the chromium plating.

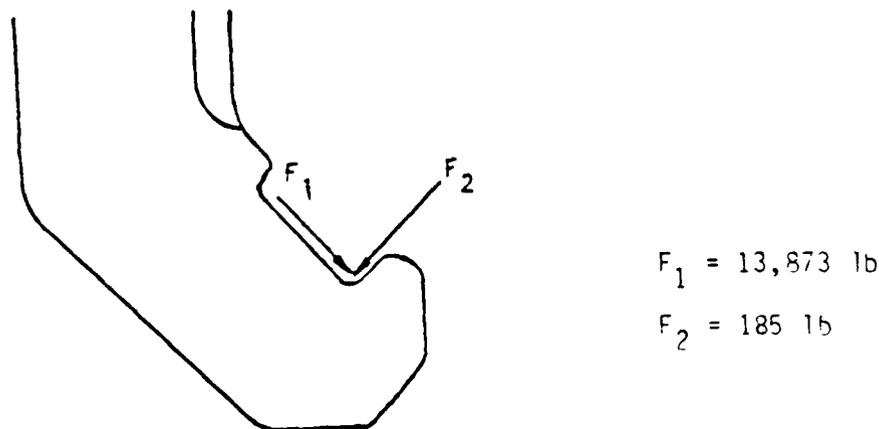
1. The operating loads were determined statically incorporating maximum service loads which included aerodynamic considerations such as "G" force as well as the weight distribution of the Sparrow Missile, as shown in Figure 35.

Figure 35. Static loading determined by analysis of maximum service loading, Reference 7. These loads were used to determine the operating stresses at the crack origin.

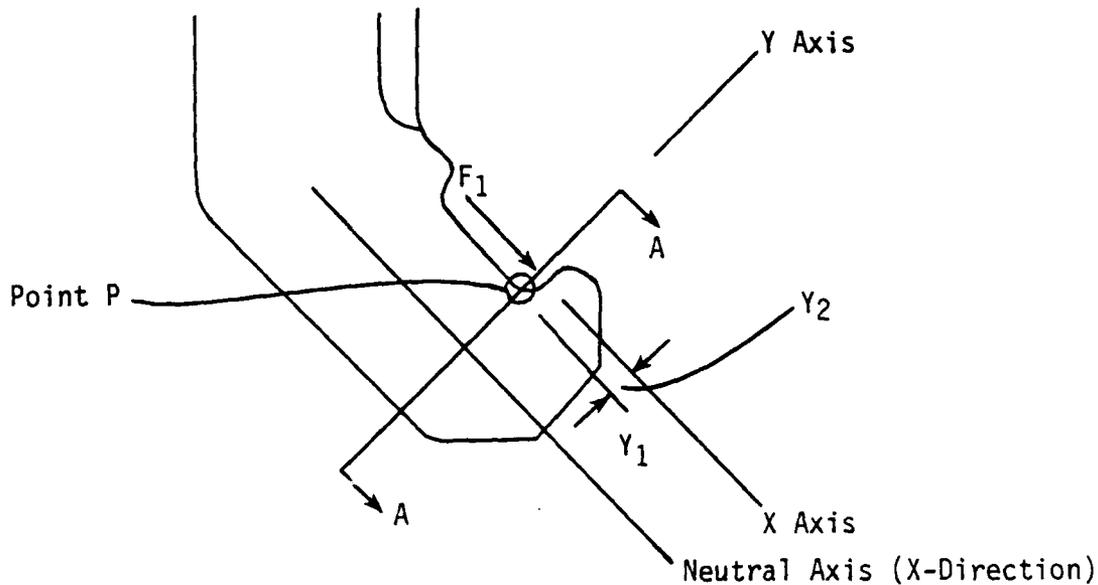
Figure 36. Face A-A is the surface perpendicular to the neutral axis on which  $\nabla_x$  and  $\nabla_y$  were calculated at point P.

In the X-direction, the stress ( $\nabla_x$ ) at the crack site (point P) was the result of the load,  $F_1$  and the moment,  $M_1$ . The moment,  $M_1$ , was caused by the eccentricity of  $F_1$  a distance  $Y_1$  from the neutral axis (X-direction), as shown in Figure 36, and determined to be ( $F_1 \times Y_1$ ).

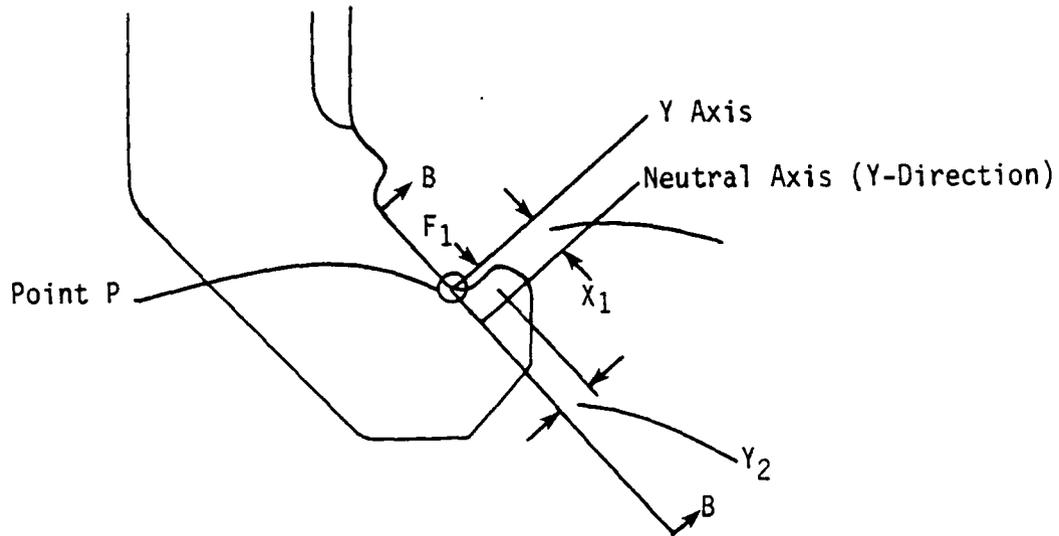
In the Y-direction, the stress at point P was the result of the load,  $F_1$ , and the moment,  $M_2$ , acting upon the tip of the missile hook. The moment,  $M_2$ , was caused by the eccentricity of  $F_1$  a distance of  $Y_2$  from the crack site, as shown in Figure 37, and determined to be ( $F_1 \times Y_2$ ).

Figure 37. The load  $F_1$  produces a moment about the neutral axis (Y-direction) which induces a stress  $\sigma_y$  at point P.

$$\begin{aligned} \nabla_y &= M_2 X / \text{Inertia}_{B-B} \\ &= 1469.27 (0.1045) / (0.00361) \\ &= 42.54 \text{ ksi} \end{aligned}$$

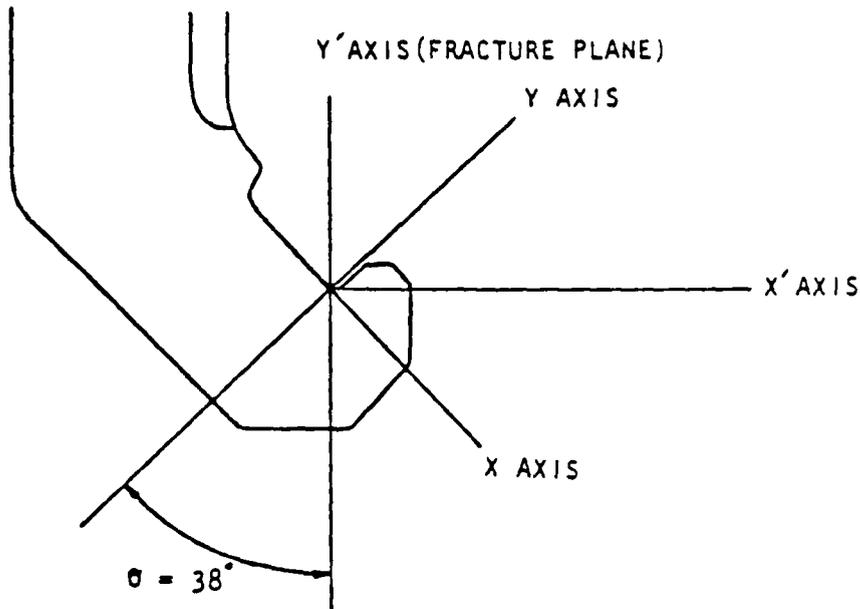
Figure 38. The angle between the fracture plane and the plane about which stresses were calculated.

Since the fracture plane did not coincide with Section A-A, see Figure 38, the stress across the fracture plane must have been greater than that across Section A-A. From this conclusion, the stress across the fracture plane can be approximated,  $\nabla_{x'} \geq \nabla_x$ . Therefore,  $\nabla_{x'} = 154.8$  ksi was used to calculate the critical crack stress intensity factor.

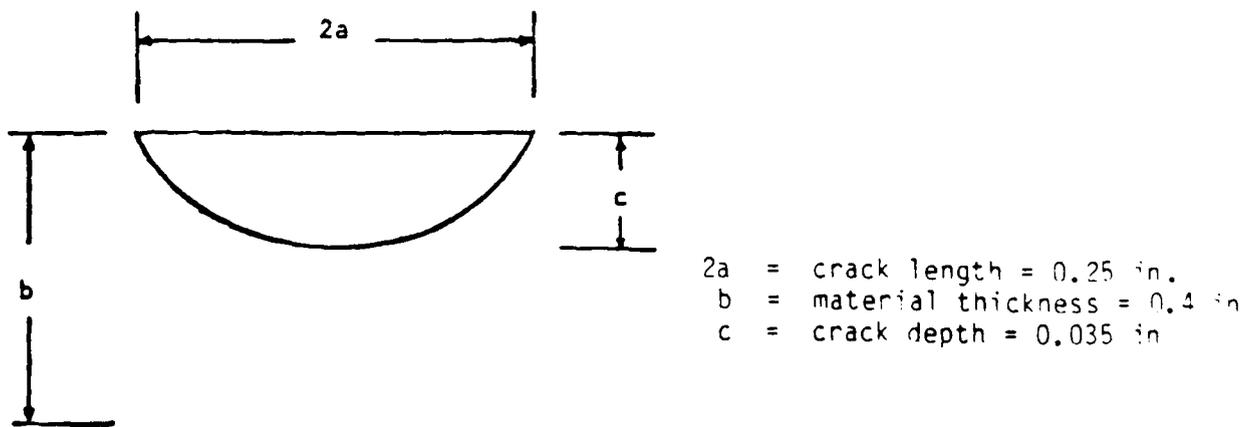
2. It was possible to measure the critical crack size from the failed component. This area had been previously identified as Zone 1 (see Figure 2) or the "thumbnail" crack region. The crack parameters and pertinent dimensions of the missile hook were obtained from measurements of the fracture surfaces, as shown in Figure 39.

Figure 39. Crack parameters measured from the fracture surface.

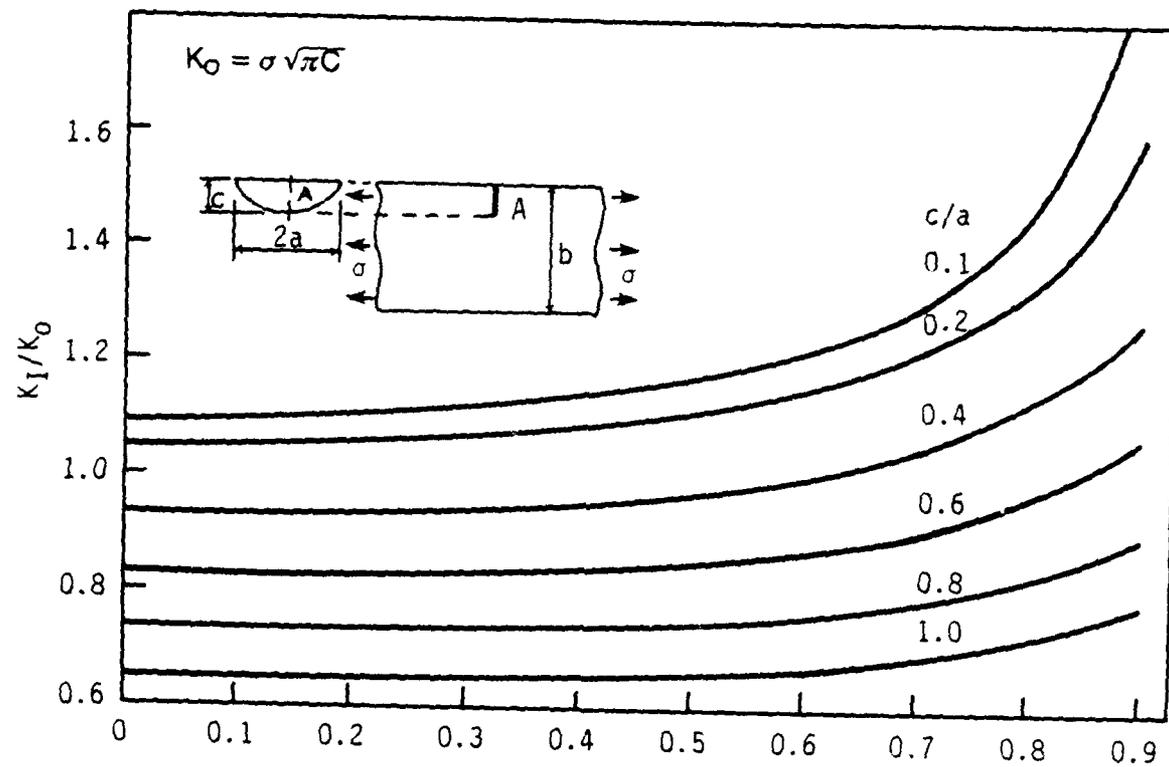
Based upon the type of loading, and the geometry of the crack and the missile hook, a model of a semielliptical crack in a slab subjected to a uniform uniaxial tensile stress was selected to determine the critical crack depth at which failure would occur. While this model is a simplification of the actual geometrical configuration of the crack and missile hook, the results obtained can be utilized to evaluate the relative toughness of the material. Since the crack depth,  $c$ , is very shallow compared to the length of the fracture ( $2a$ ), only the axial  $K_I$  stress intensity case was considered, as shown in Figure 40.

Figure 40. Graph relating stress intensity factor to crack parameter ratios, Reference 8.

A stress intensity factor  $K_I/K_0$  was determined graphically (Figure 40) from an established plot of values. This factor is based upon certain ratios of crack parameters.
