Applied Report 84

RAAF ORION AIRCRAFT A9-300
OXYGEN FIRE(U)

This report summarizes the findings of the investigation into the nature and cause of the fire in RAAF Orion aircraft A9-300. This aircraft was destroyed by fire which initiated in the oxygen system as the result of an explosion caused by metal ignition.

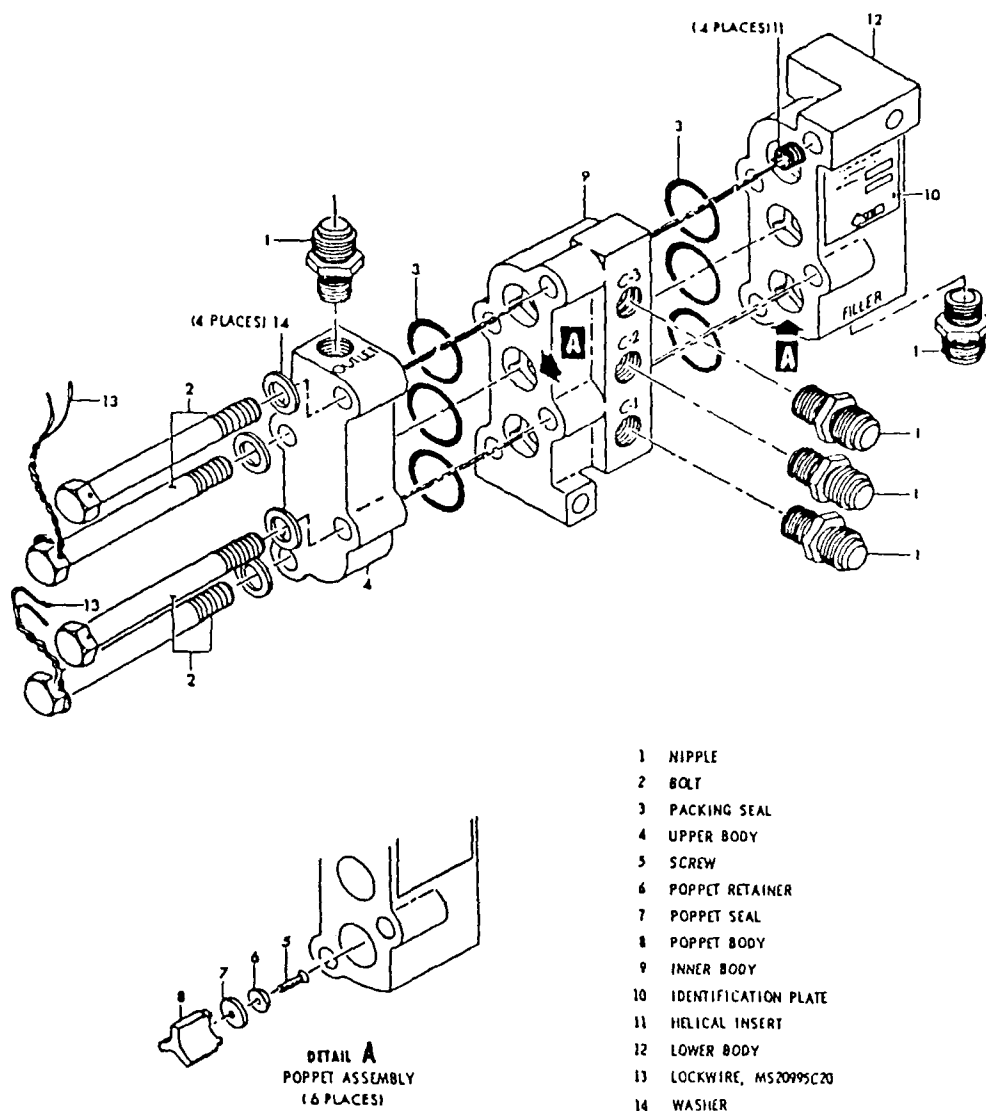
While the fire started in the pressure manifold check valve assembly, this unit, being located towards the side of the aircraft, was shielded from the later destructive effects of the fire. The part is composed of three manifold blocks bolted together and sealed by silicone rubber 'O' rings. (Figures 2 & 3). The central manifold has three separate chambers leading to the three storage cylinders; the outlet manifold leading to the pressure reducing regulators received only superficial damage. The filler manifold was extensively damaged.

FIGURE 3. AN EXPLODED VIEW OF THE HIGH PRESSURE OXYGEN
MANIFOLD AND CHECK VALVE ASSEMBLY.
NOT TO SCALE
