WRDC-TR-89-3075

FULL-SCALE BIRDSTRIKE TESTING OF IN-SERVICE
AGED F-111 ADBIRT WINDSHIELD TRANSPARENCIES

University of Dayton Research Institute
300 College Park Avenue
Dayton OH 45469

Interim Report for Period May 1985 - November 1987

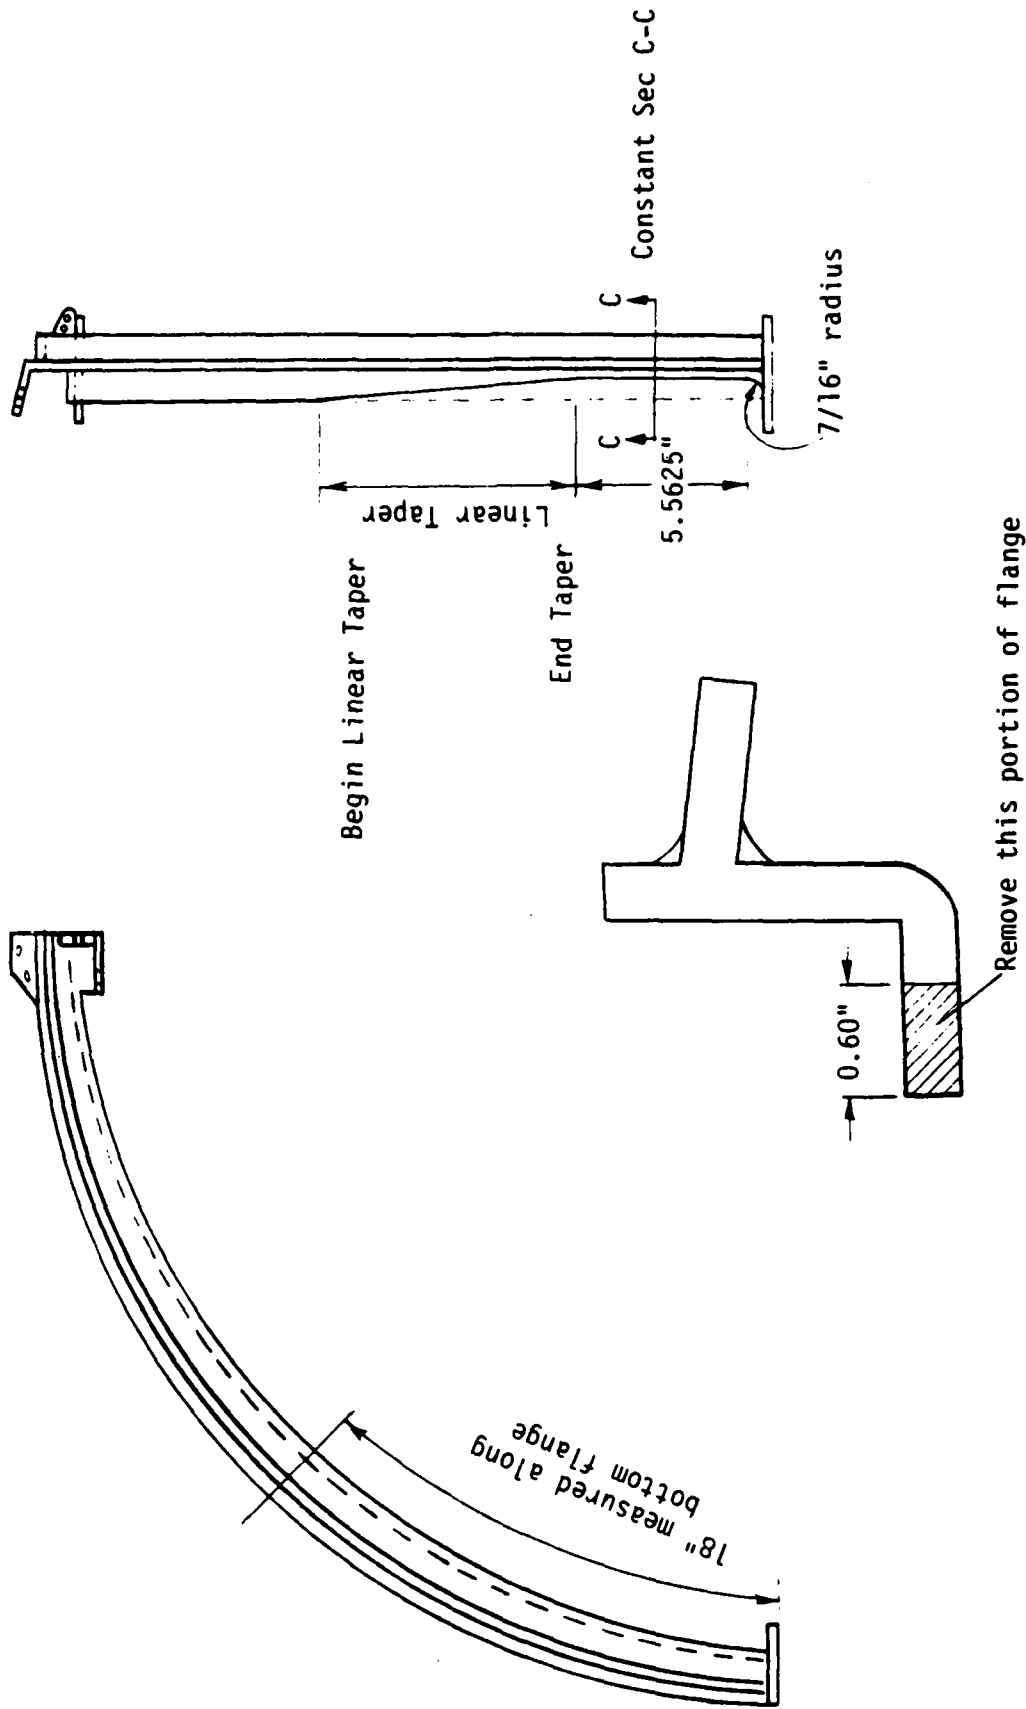
Figure 11. UDRI F-111 Aft Arch Taper Modification.

The UDRI test arch was analyzed to determine alternate methods to more closely match the overall section properties of the test arch to those of the production titanium arch. The modification selected is shown in Figure 11, and was made to all subsequent test arches. In addition, the arch to sill connection bolts and the arch to center beam connection bolt, which sheared in shot #1, were increased from 1/4 inch grade 8 bolts to 5/16 inch grade 8 bolts. Figure 12 presents a comparison of cross-section properties for the flight hardware and the modified test hardware.

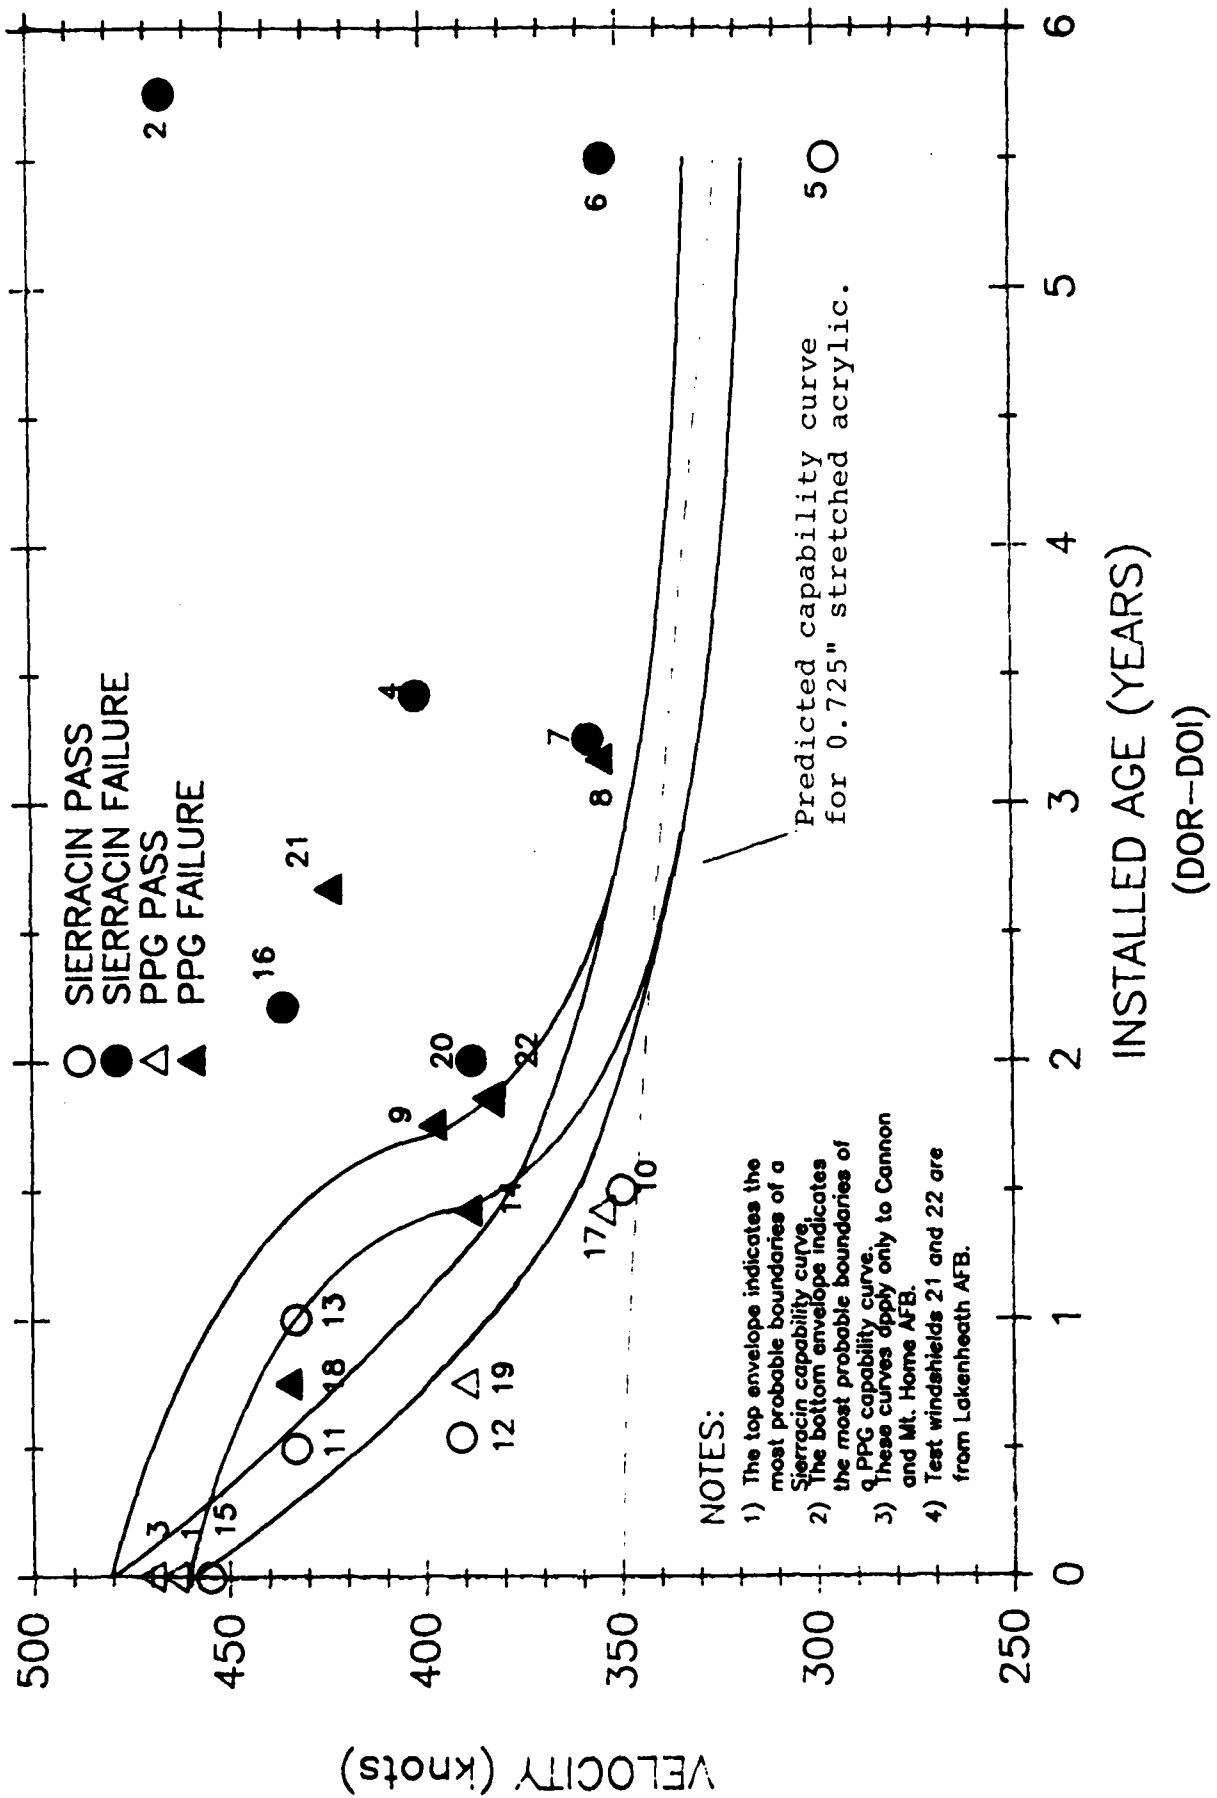
Figure 15. Capability Envelopes for Sierracin and PPG Transparencies.

These capabilities were determined from the test program. Actual baseline capability on flight structure is 490 knots. Because of the nature of the failures, it is not appropriate to scale up the capability for all age groups 20 knots.

than 1.5-2 years of installed age. For Sierracin shots 11, 13, 15, and 16, the edge attachment sheared 10-16 bolts behind the impact point without failing the edge attachment. For PPG shots 1, 3, and 18 the bolts yielded behind the impact point but did not fail, and the transparency started to tear through the bolt hole line. This difference in edge attachment performance may be partially attributed to a difference in transparency stiffness for the two vendors. The PPG transparencies appear to be more stiff than the Sierracin transparencies, accounting for lower loads transmitted to the arch; the stiffer window being a more efficient shell structure, thereby distributing the load more evenly. The less stiff Sierracin windshield allows more localized deformation and load concentration immediately behind the impact point, causing bolt failure. This bolt failure is unique to the UDRI test hardware and is attributable to flange and overall arch stiffness differences between the UDRI test hardware and the flight hardware. In addition, the canopy frame was not in intimate contact with the UDRI test aft arch, allowing more out-of-plane deformation in the UDRI aft arch than exists in the actual flight system.

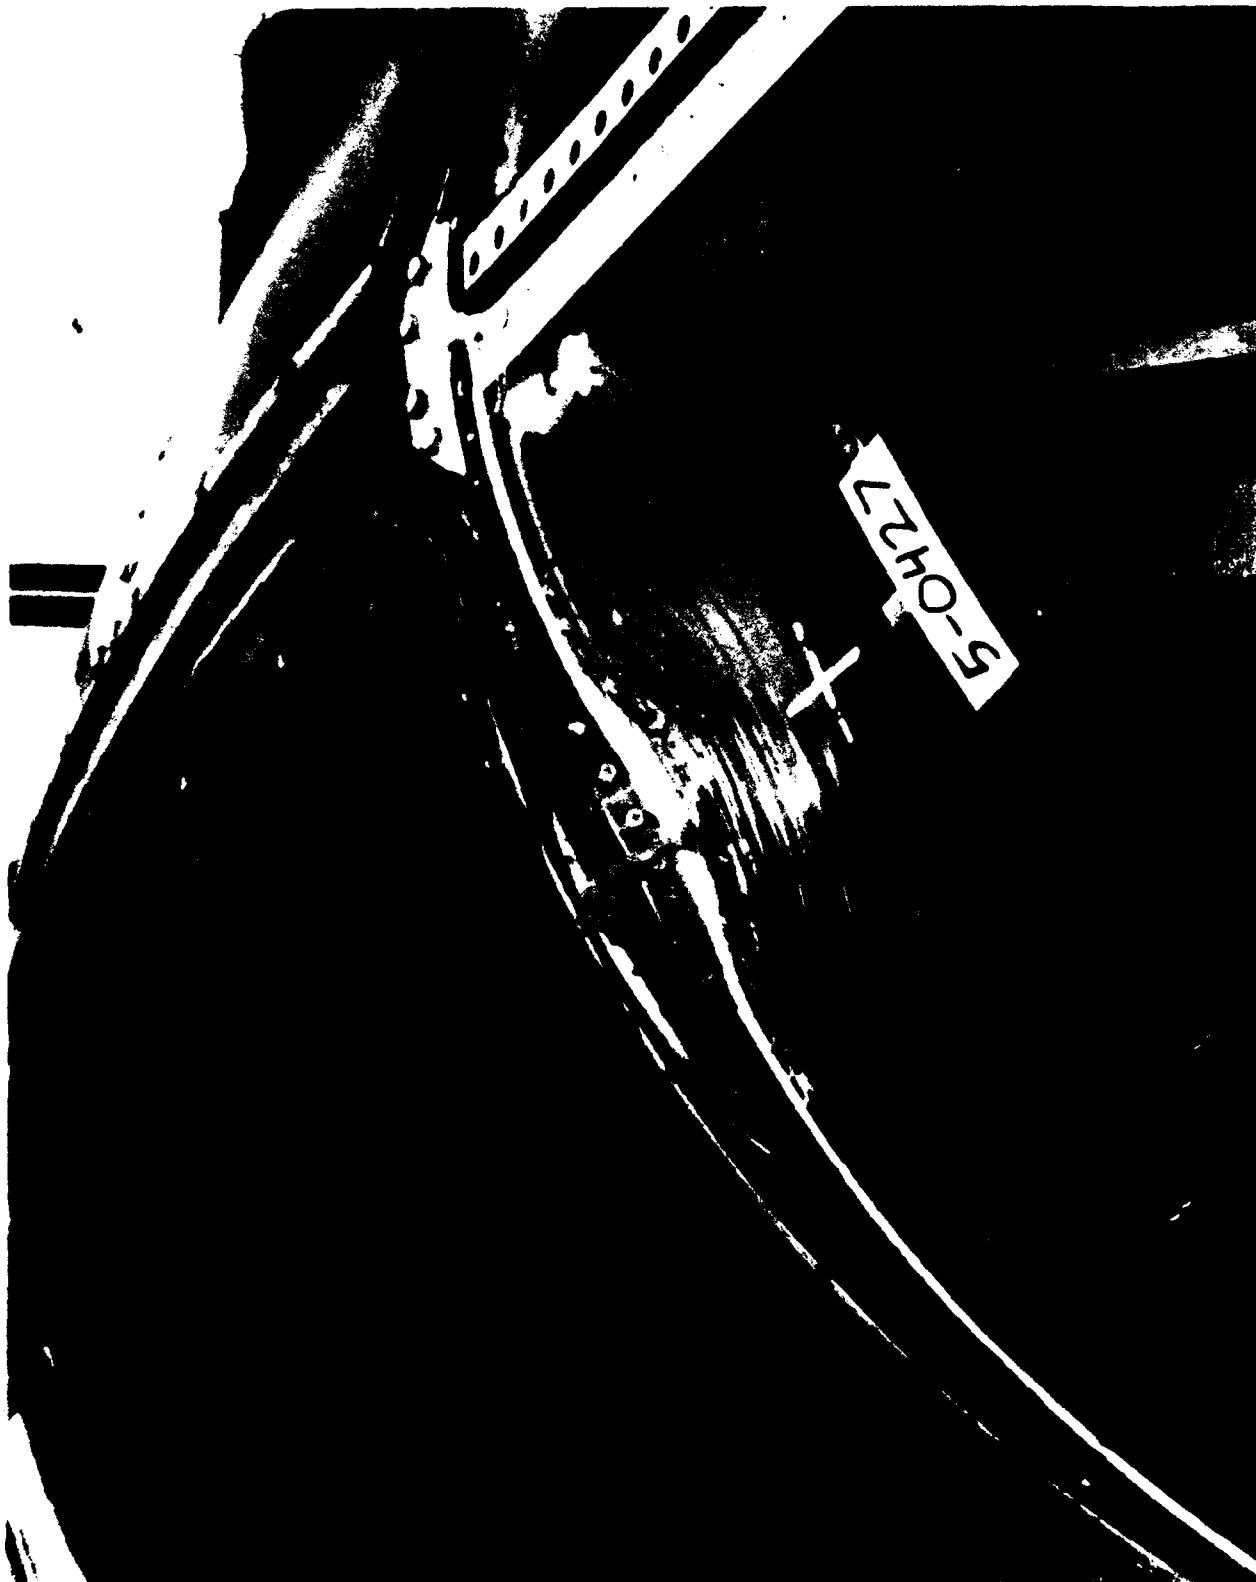
TEST NO. 1 SHOT NO. 5-0427

Forward arch flange appears to be too stiff--only very local rotation,
and not much rotation aft.
Stiffness of arch at sill appears to be too high causing excessive
side load and moment at sill
Pass - at 464 knots.

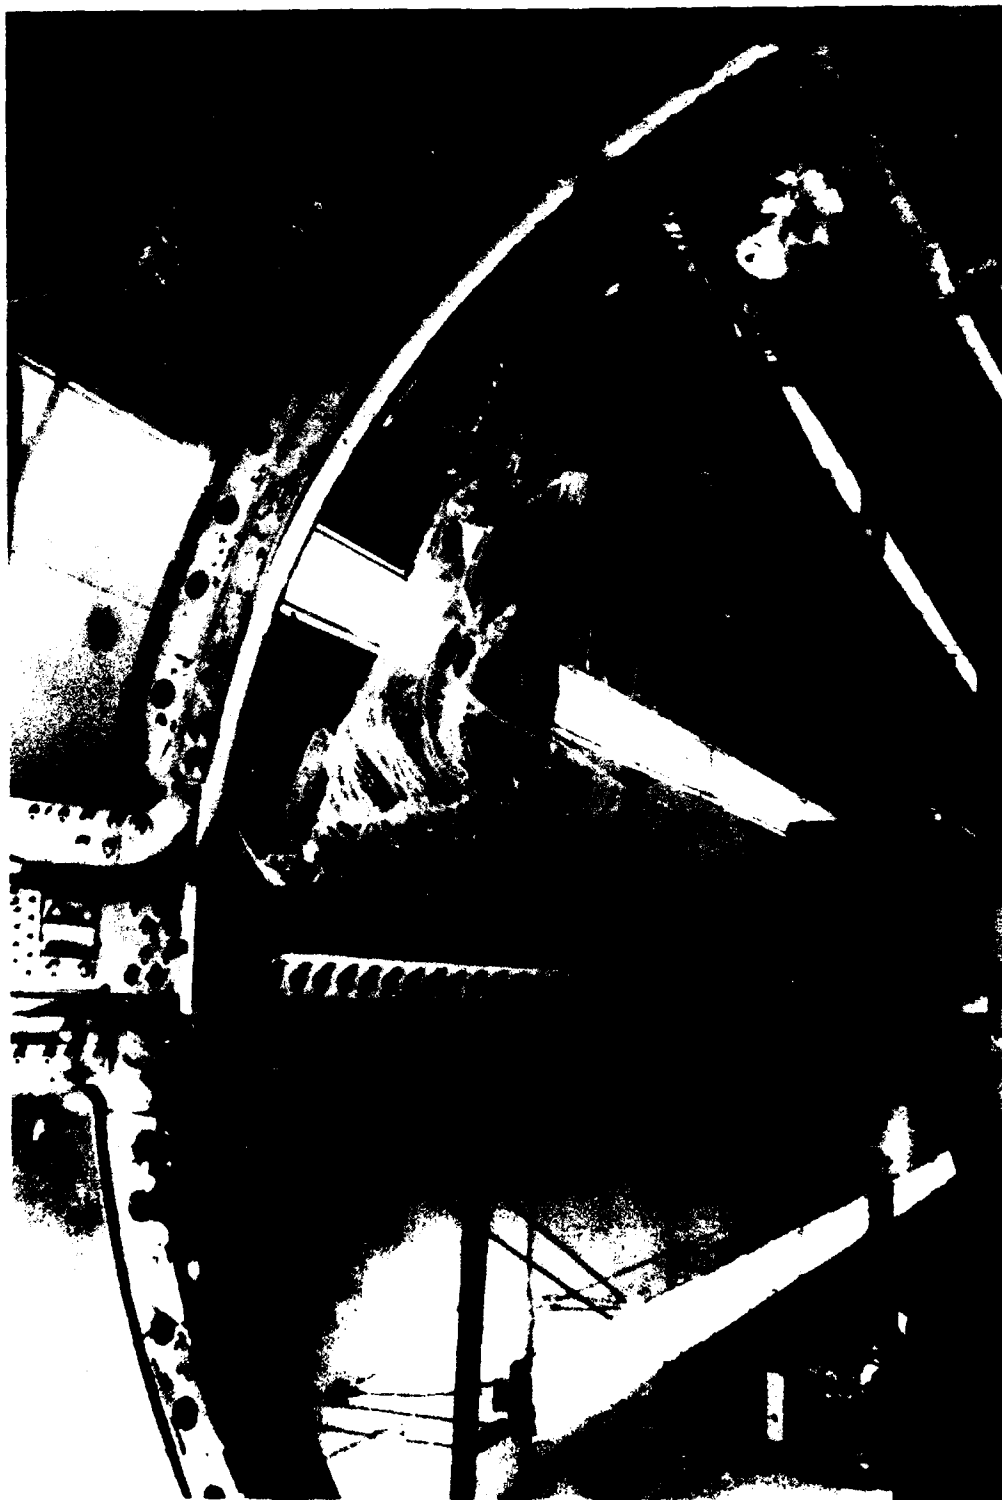
TEST NO. 2 SHOT NO. 5-0428

Brittle failure - Punched hole 7" x 17"

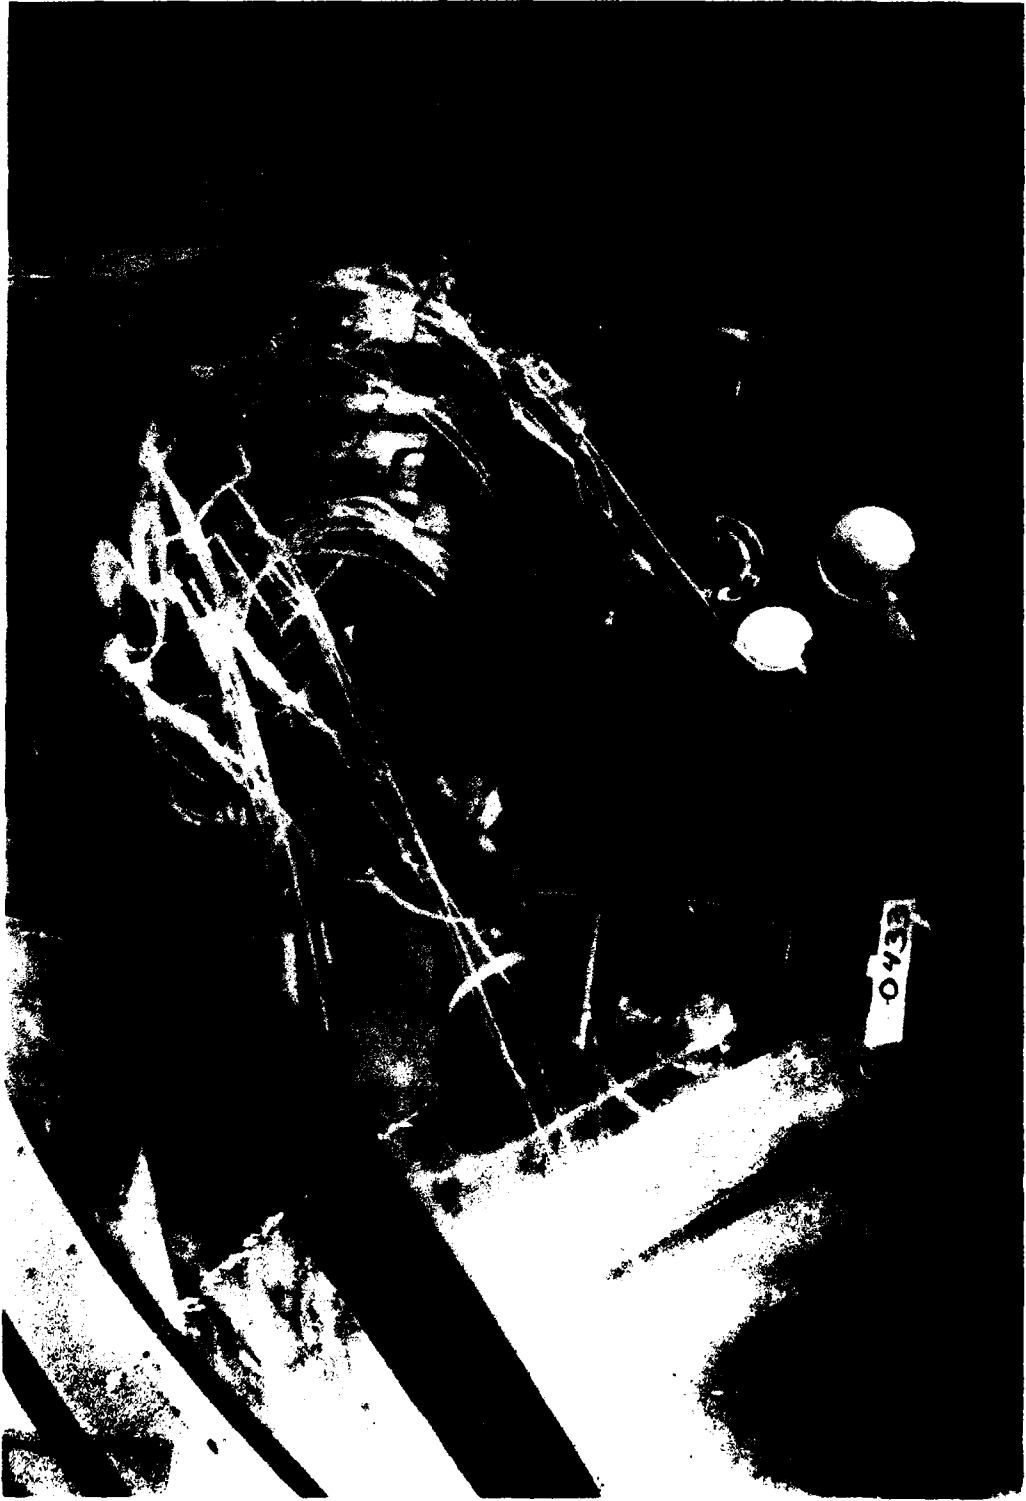
TEST NO. 7 SHOT NO. 5-0433

Windshield failed along aft arch through bolts 7-17

Extensive acrylic cracks, some poly cracking -- starting from bolt holes

Failure at 355 knots.

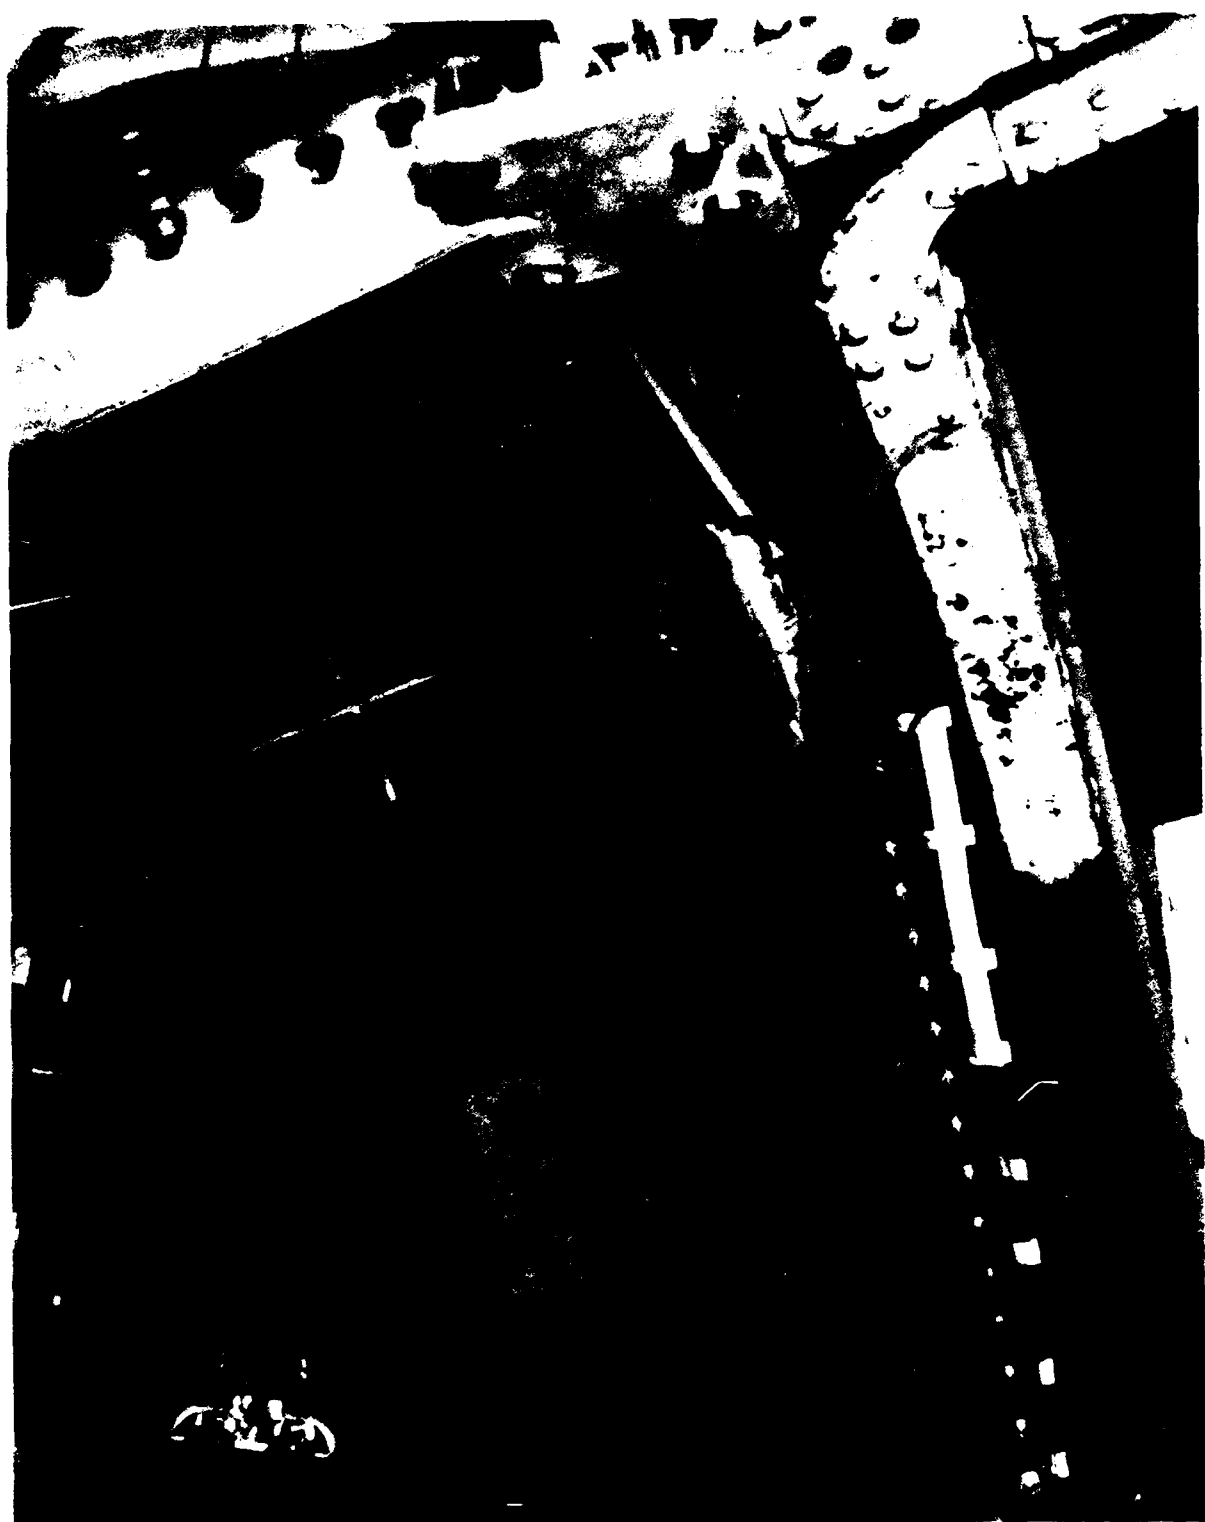
TEST NO. 15 SHOT NO. 5-0441

Moderate acrylic cracking.

Failure at 436 knots.

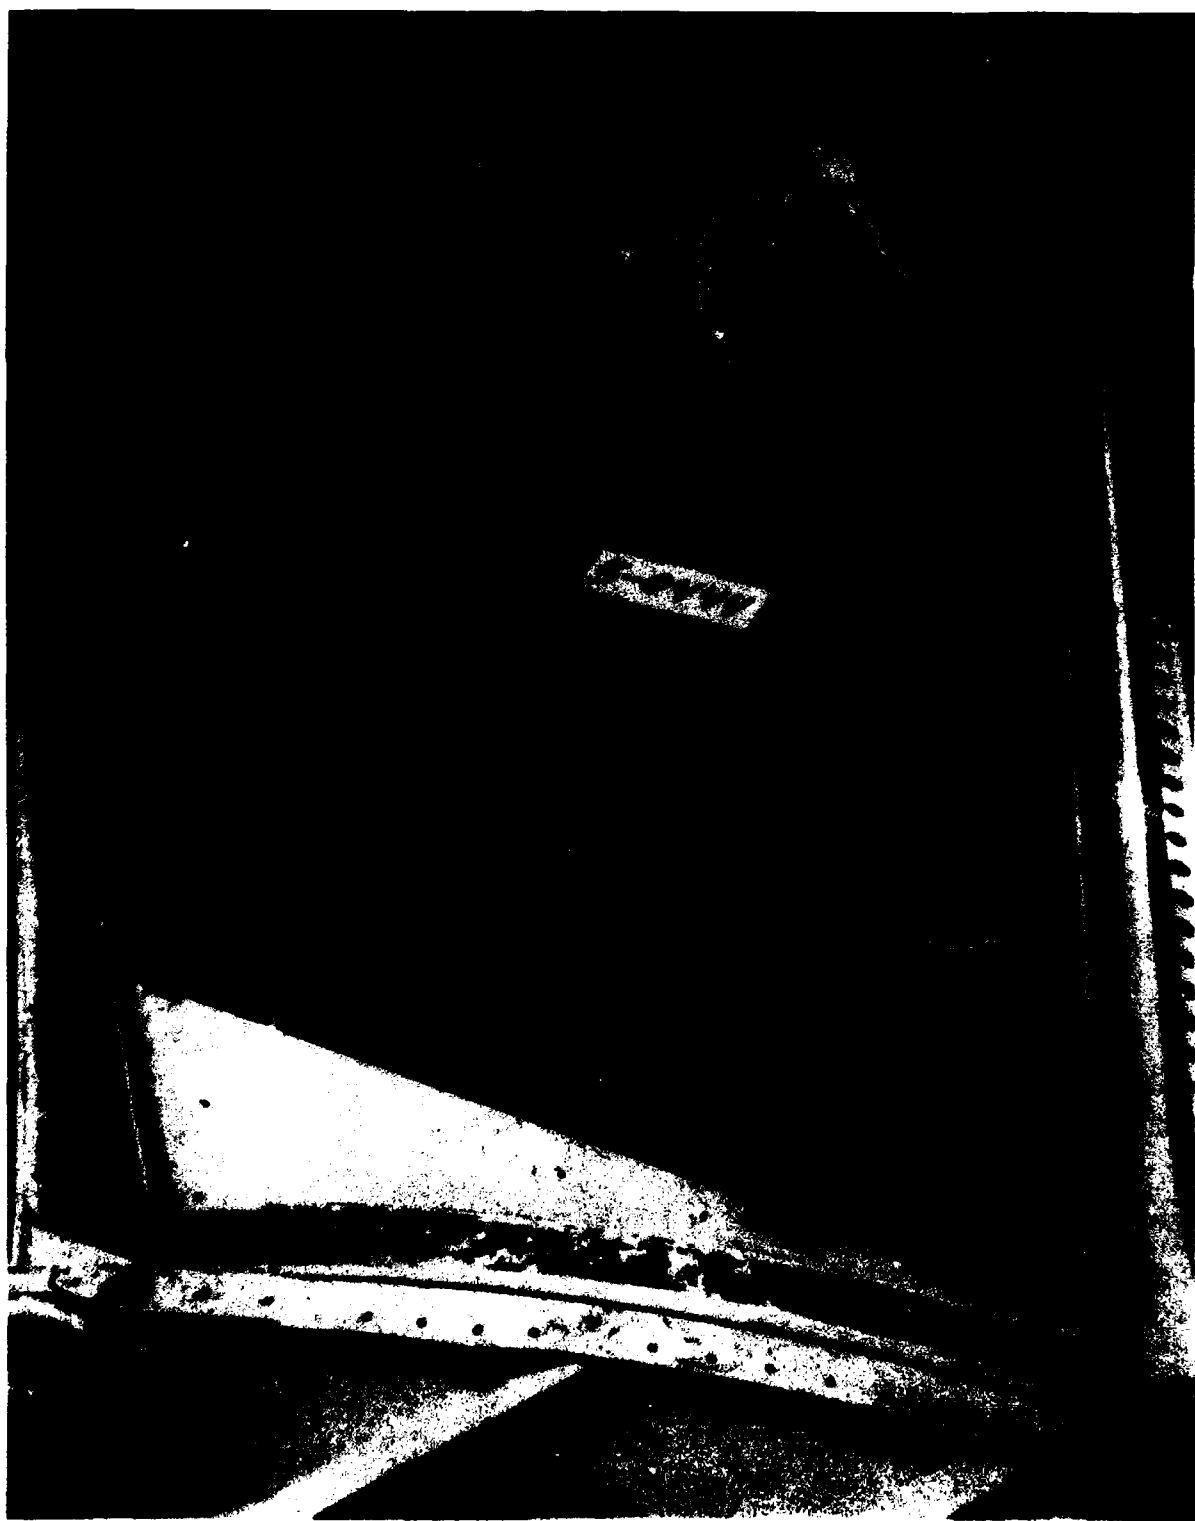
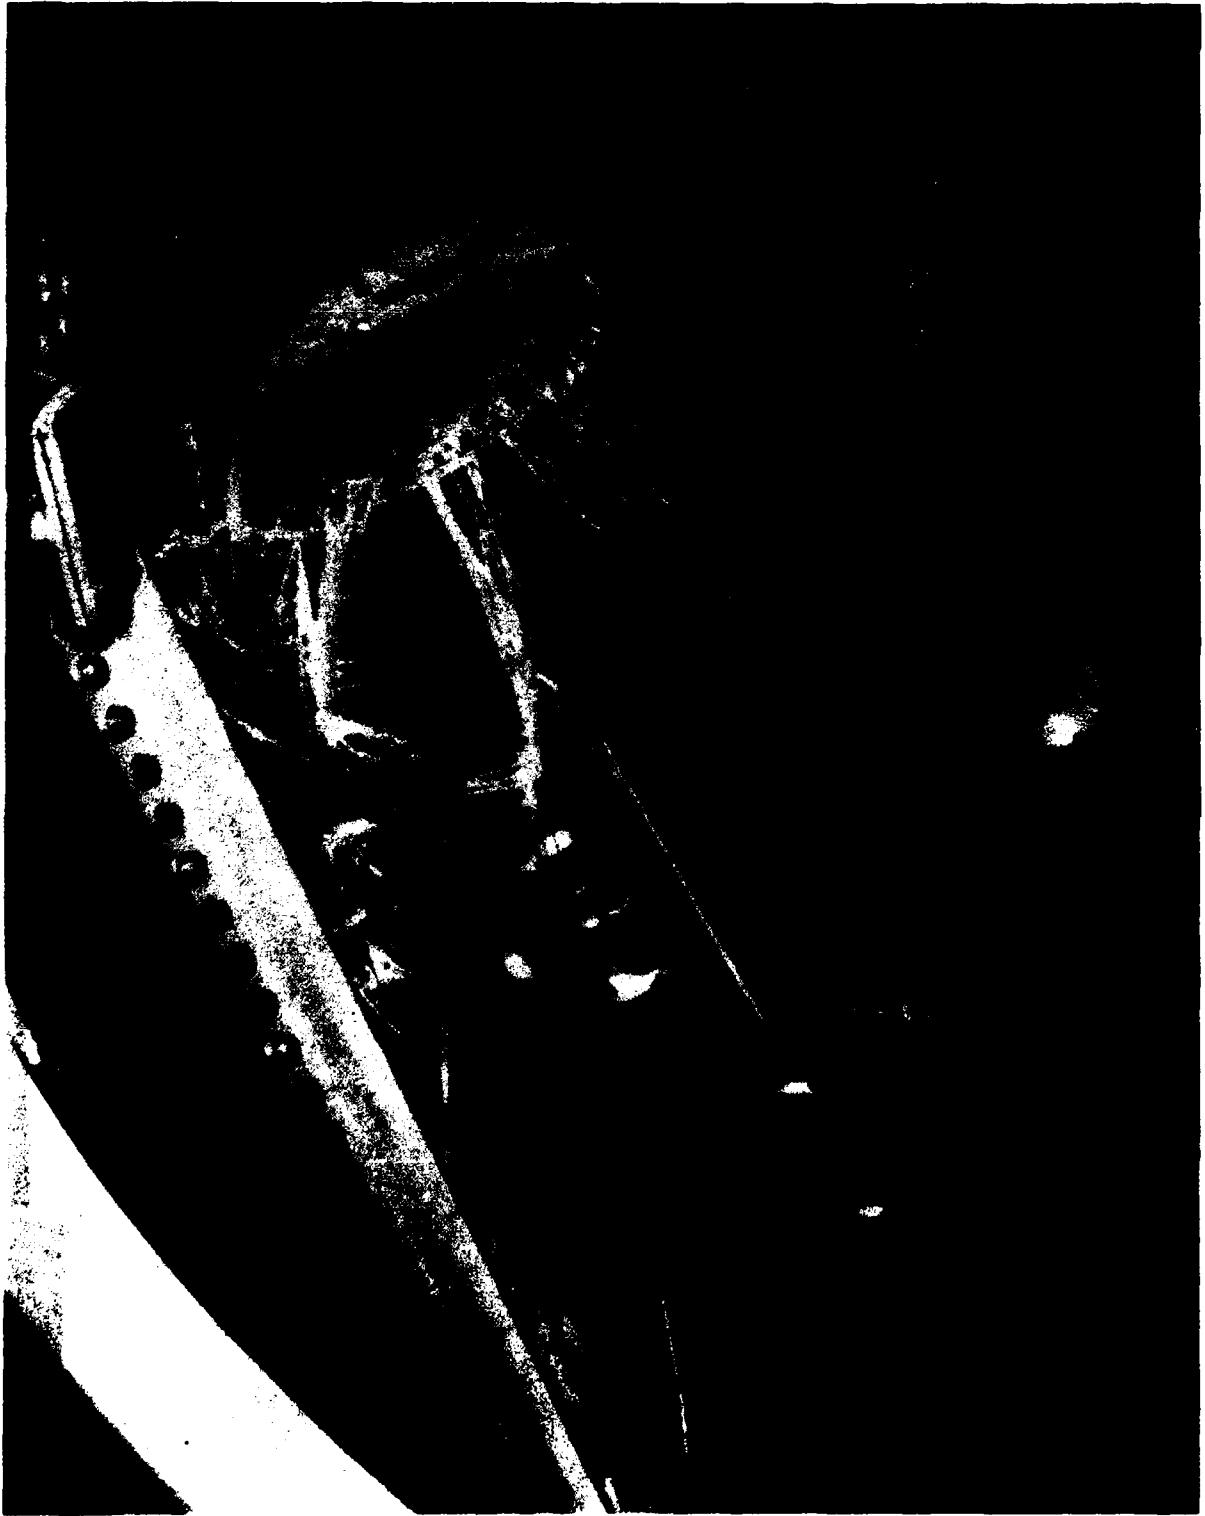
TEST NO. 18 SHOT NO. 5-0444

Fastener #1 on arch and #1 and 2 on center beam not in. Fasteners 3 and 4 on center beam replaced with #10 NAS 1203-15 screws. Windshield extremely oversized, very difficult to install--probable cause of premature in-service failure (crazing extensive), was stress on window during service. Windshield in compression at aft arch. Interior coating discolored white with scratches.

Extensive cracking of acrylic away from impact point.

Very unusual acrylic chipping at impact point caused by prestress compressive load.

No polycarbonate cracking.

Pass at 390 knots.

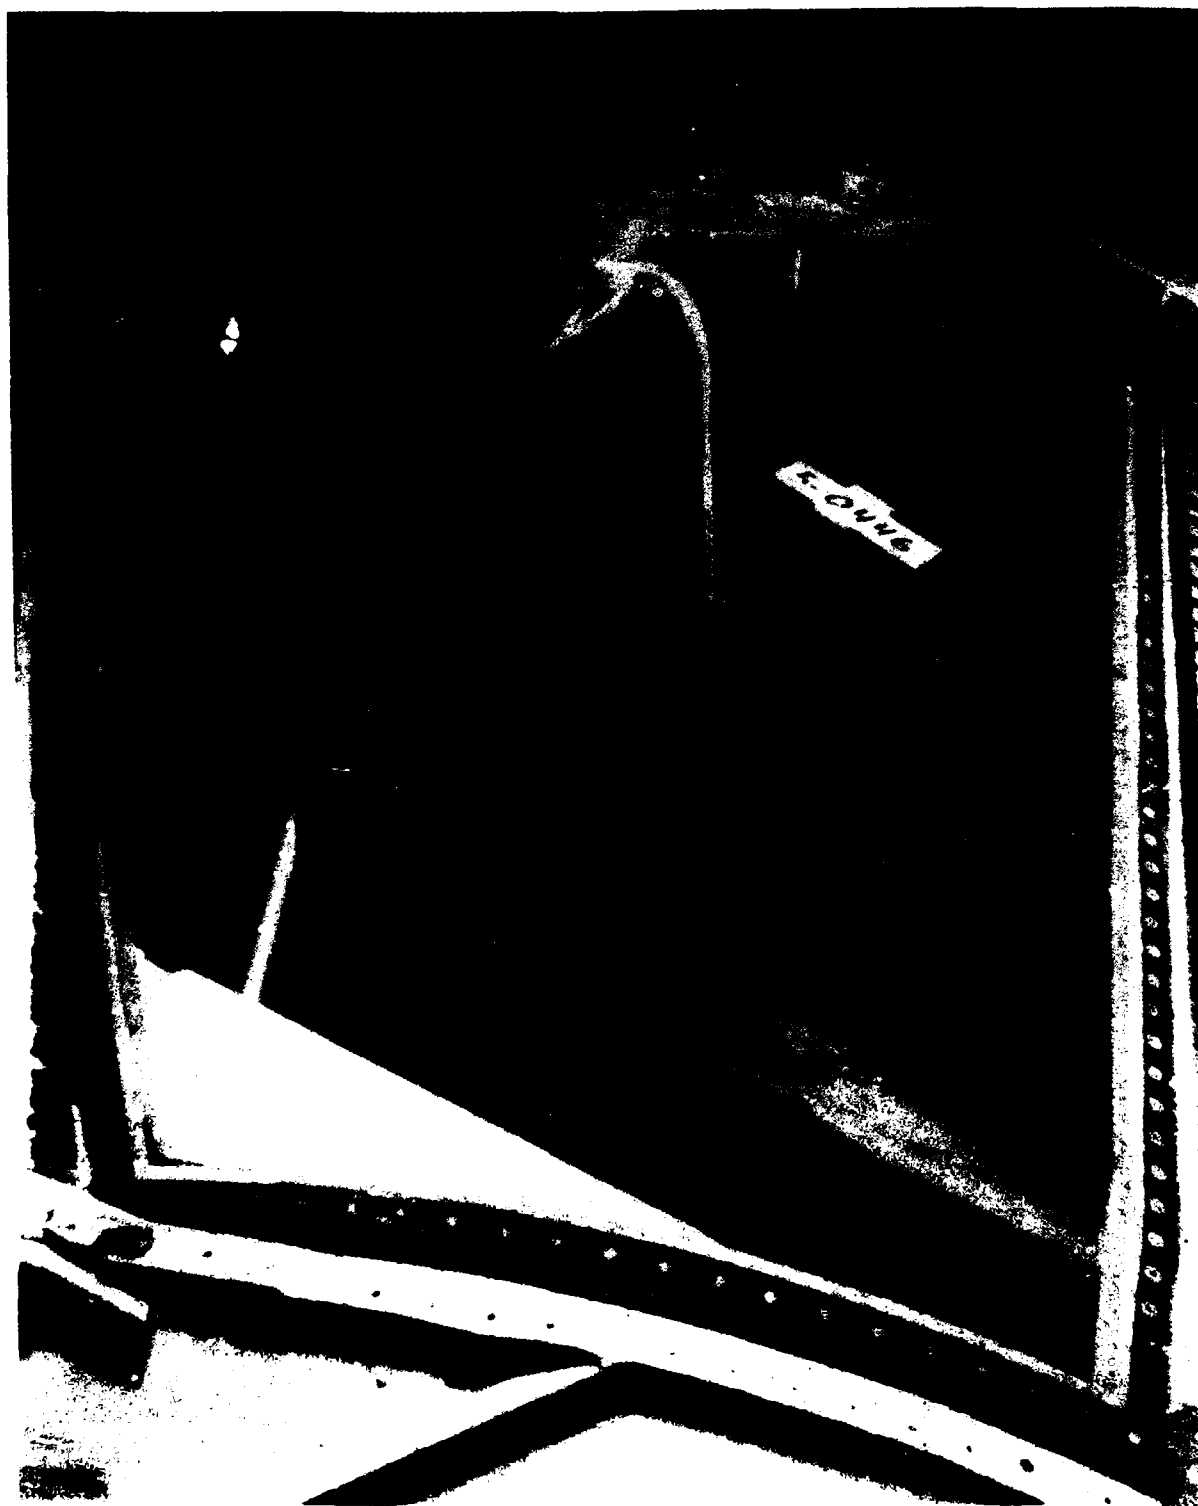
TEST NO. 20 SHOT NO. 5-0446

Acrylic cracked.

Poly cracks in both plies.

Many poly cracks radiating from bolt hole at upper inboard corner.

Failure at 424 knots.
