FAILURE ANALYSIS HANDBOOK

C. R. Walker, K. K. Starr

Pratt & Whitney
P.O. Box 109600
West Palm Beach, FL 33410-9600

August 1989

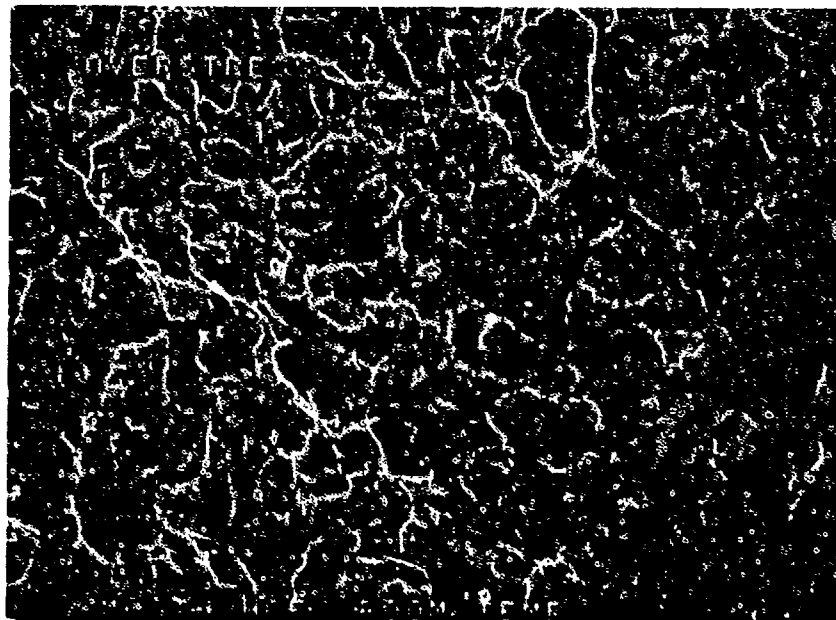
FAM 99435

FIGURE 1-22: Final overstress area exhibiting features similar to the room temperature tensile specimen. See Figure 1-5.

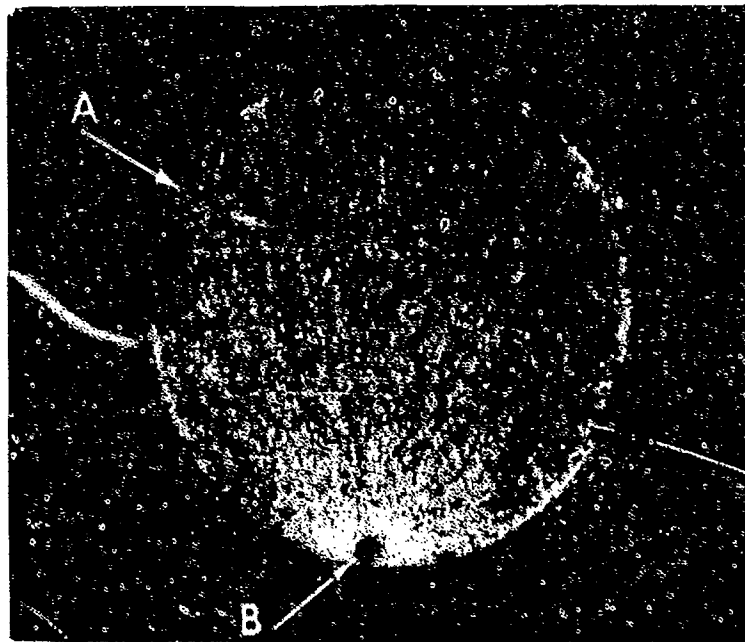
FAL 94291

FIGURE 1-24: Test results and fractography of M-50 316°C (600°F) smooth HCF test. The fracture is relatively flat with a small shear lip (arrow A) extending 90% of the way around the specimen. Features can be seen radiating from a subsurface origin (arrow B).

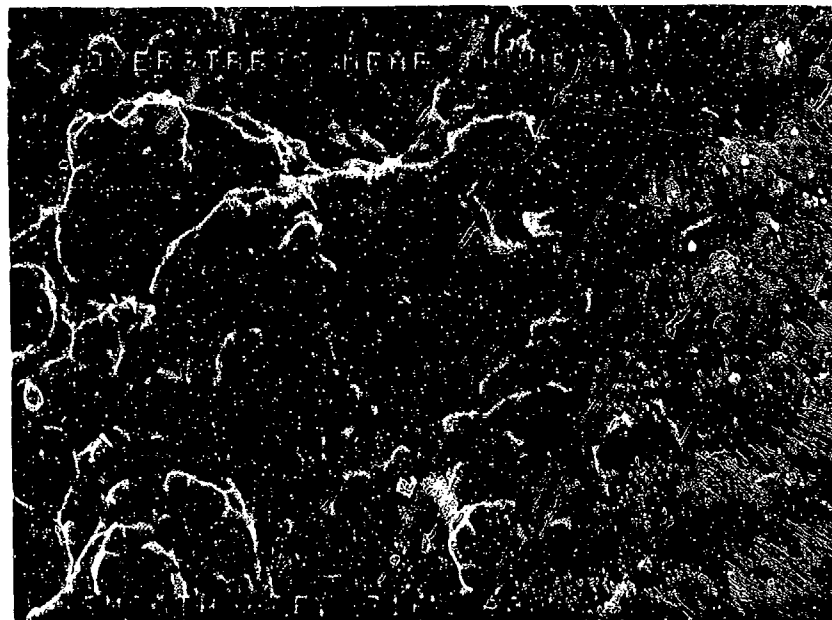
FAM 99417

FIGURE 1-31: Higher magnification view of the area shown in Figure 1-30.

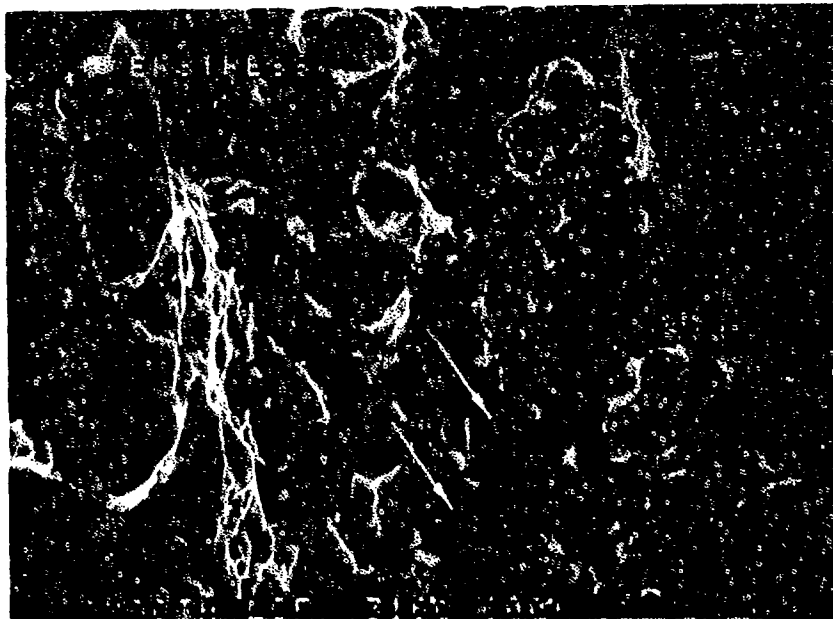
FAM 99442

FIGURE 1-41: Higher magnification photograph of the area shown in Figure 1-40. Fine overstress dimples, carbides and fractured carbides are visible (arrows).

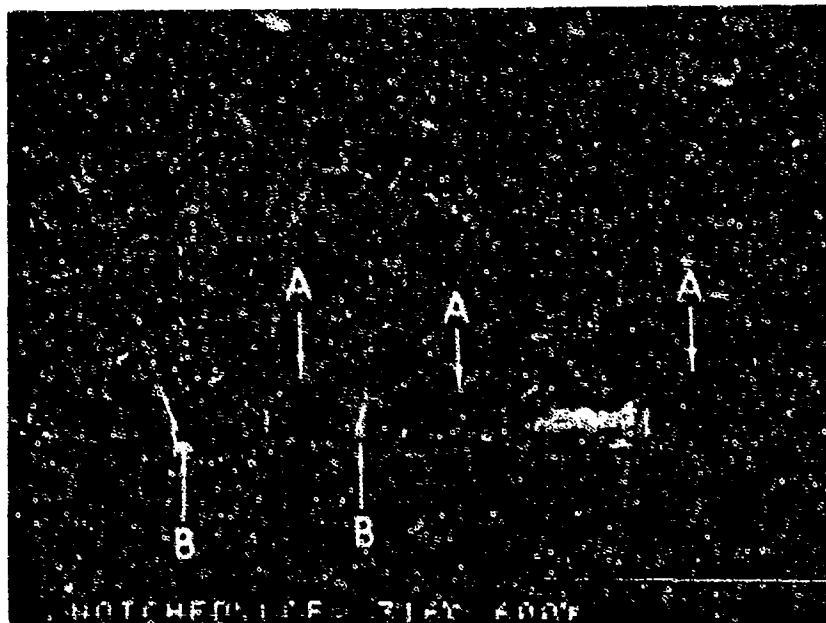
FAM 99423

FIGURE 1-47: Multiple origins at the surface of the specimen. The depth of the fatigue progression is shown by arrows A. Steps (arrows B) can be seen separating localized origins.

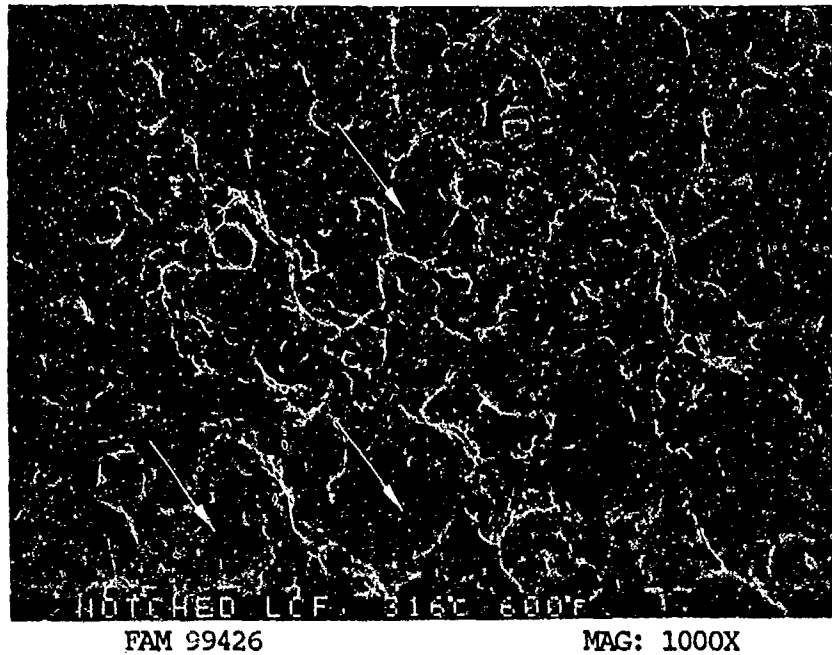
FIGURE 1-50: Final overstress area. Several carbides and cracked carbides are visible (arrows).

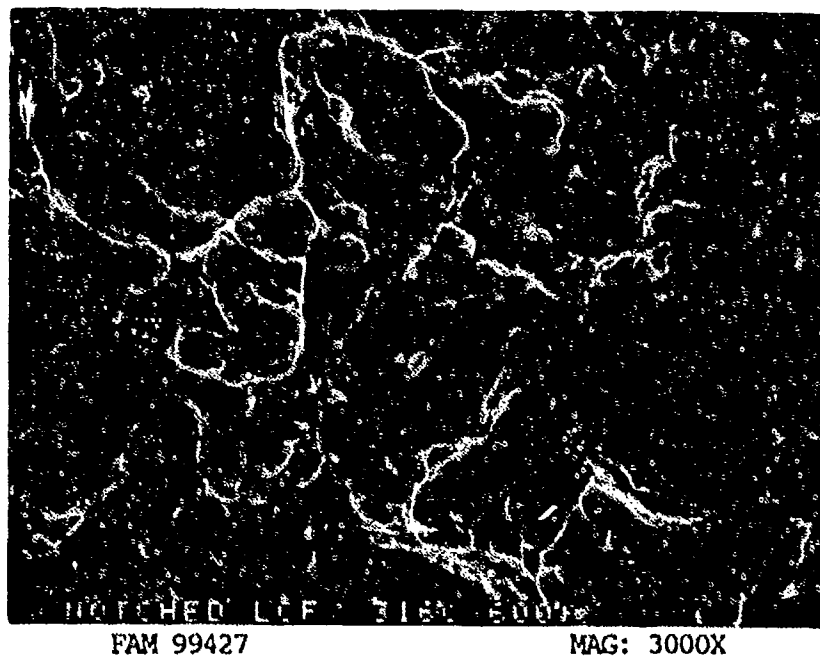
FIGURE 1-51: Higher magnification view of the area shown in Figure 1-50.

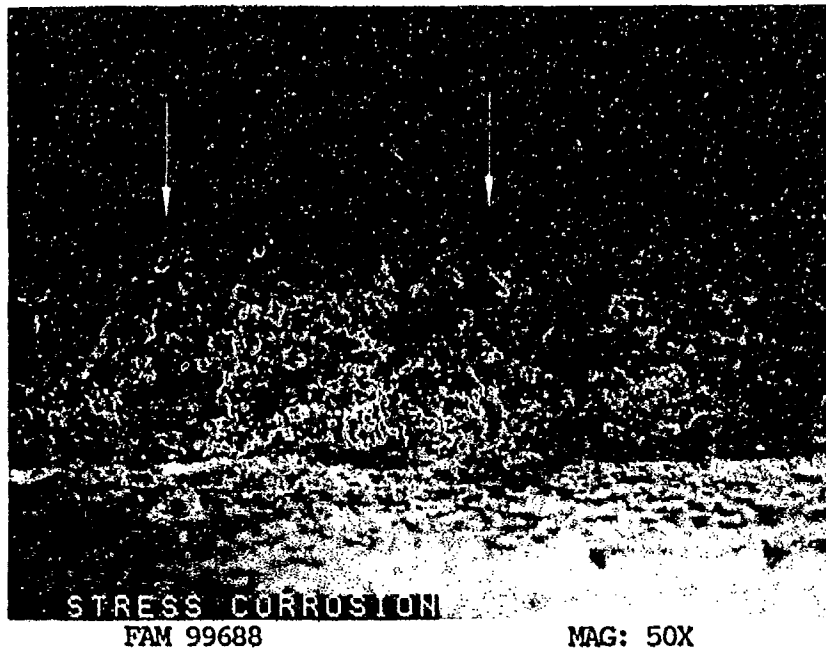
FIGURE 2-3: Low magnification photograph of the fracture surface exhibiting intergranular features. The final overstress area is visible as a thin band at the upper edge of the specimen (arrows).

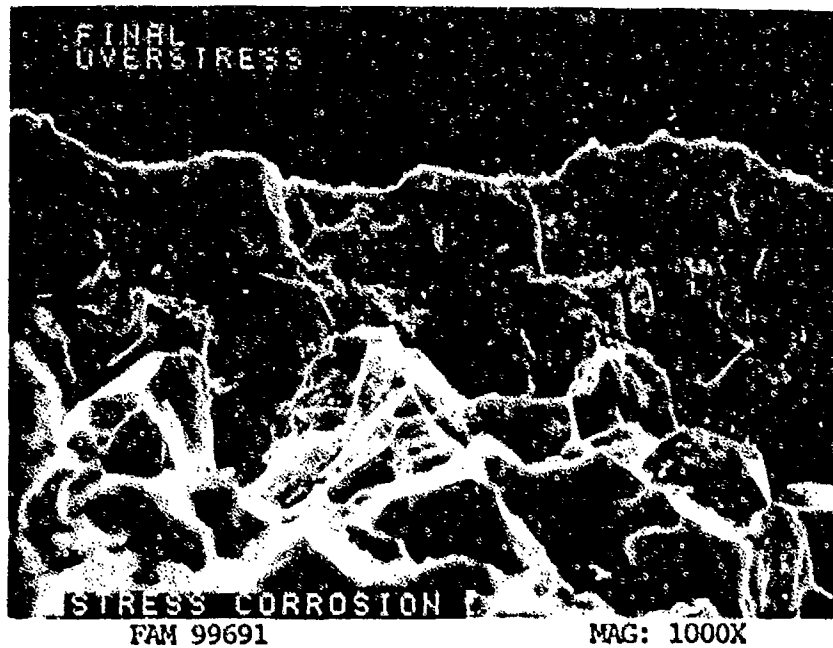
FIGURE 2-6: Final overstress area. The features have been smeared but remnant dimples appear to be present.

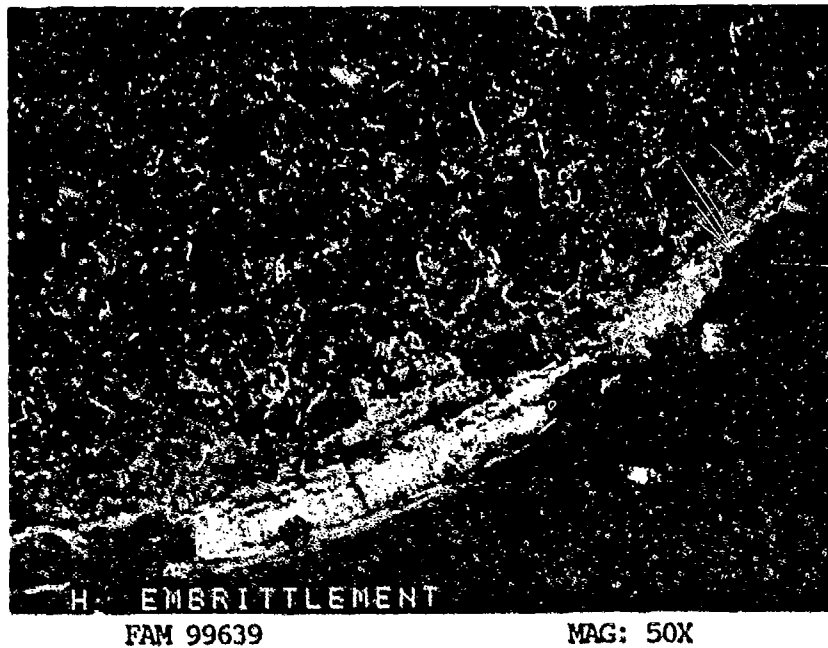
FIGURE 2-9: Low magnification photograph of the fracture surface exhibiting dimpled overstress with an intermittent shear lip (bracket) along the specimen surface. No clear evidence of embrittlement was observed.

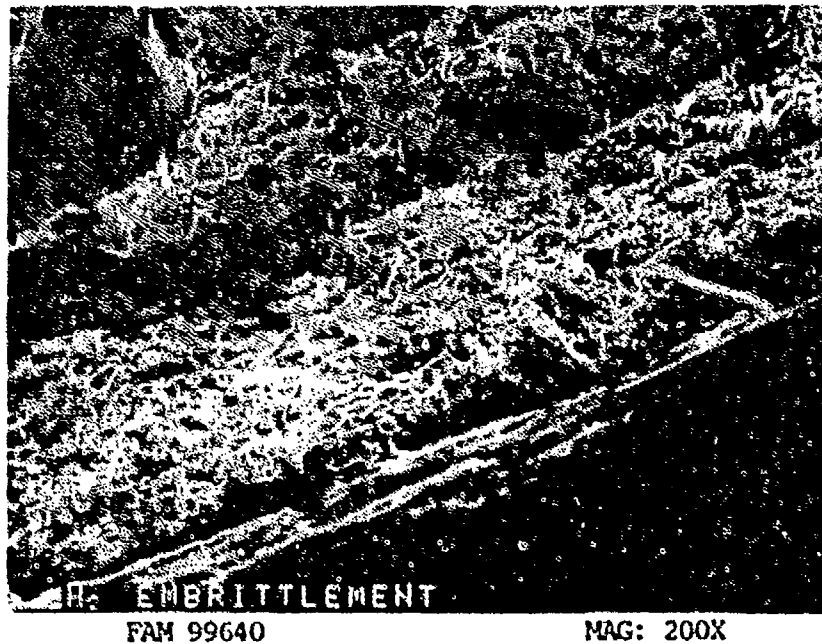
FIGURE 2-10: Higher magnification photograph of the edge of the specimen.

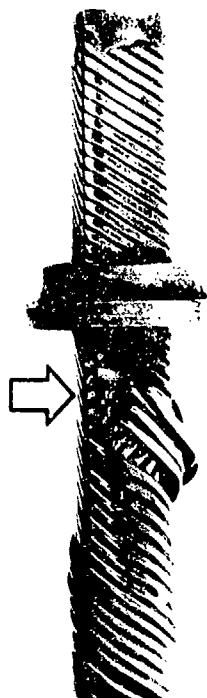
FAL 92140

SUMMARY: Five O.D. strands fractured by fatigue (probable LCF) with origins on their inside surfaces. The fatigue progressed 20-50% of the way through the strands. No material or microstructural anomalies were found.

FIGURE 2-16: Overall photograph of the end of the shaft showing five fractured strands (arrow).

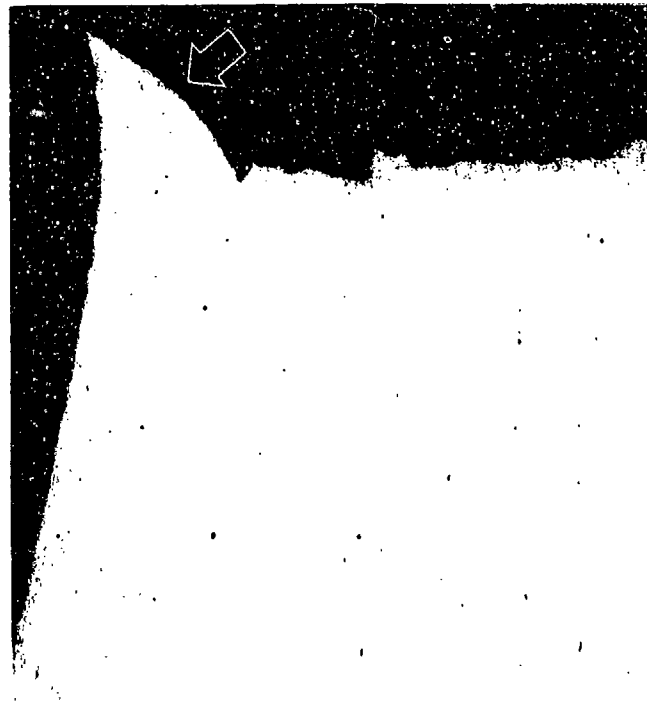
FIGURE 3-2: Optical photomicrographs showing the shear lip and deformation at the edge of the specimen (top). The shear lip is shown by an arrow. The center of the specimen exhibits transgranular overstress (bottom).

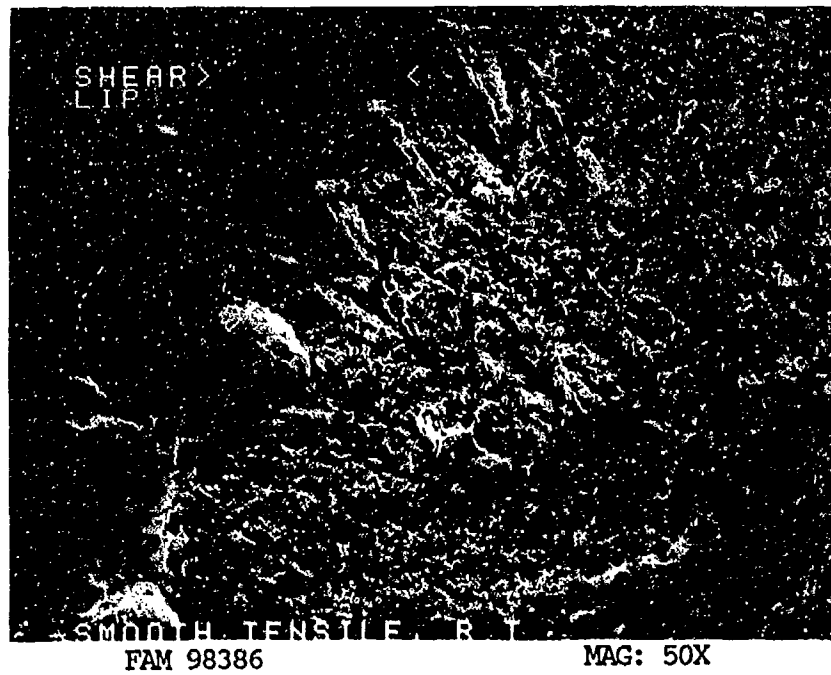
FIGURE 3-3: Low magnification view showing primary fracture area exhibiting secondary cracking and clearly defined final overstress area (shear lip).

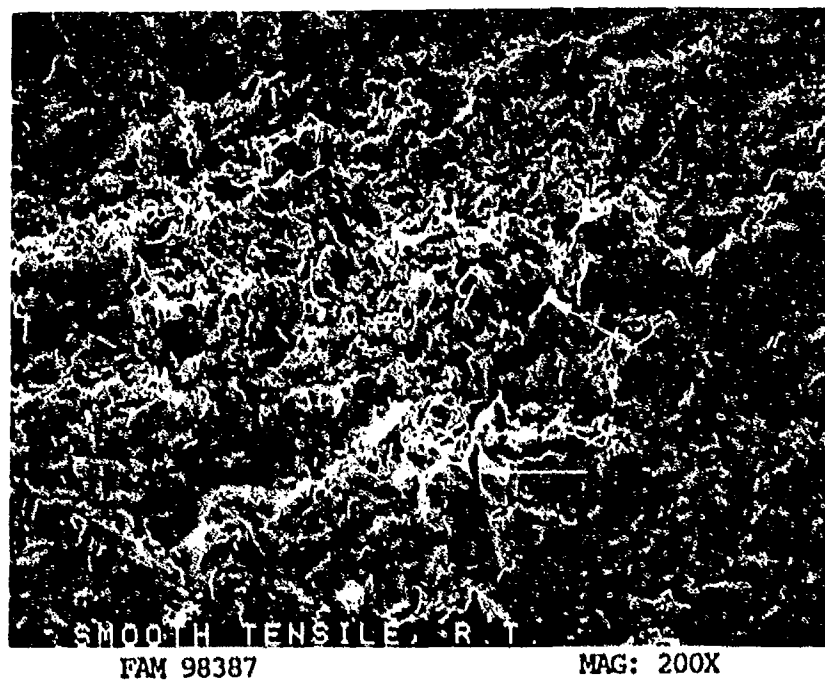
FIGURE 3-4: Dimpled overstress and secondary cracking (arrow) in the primary fracture area.

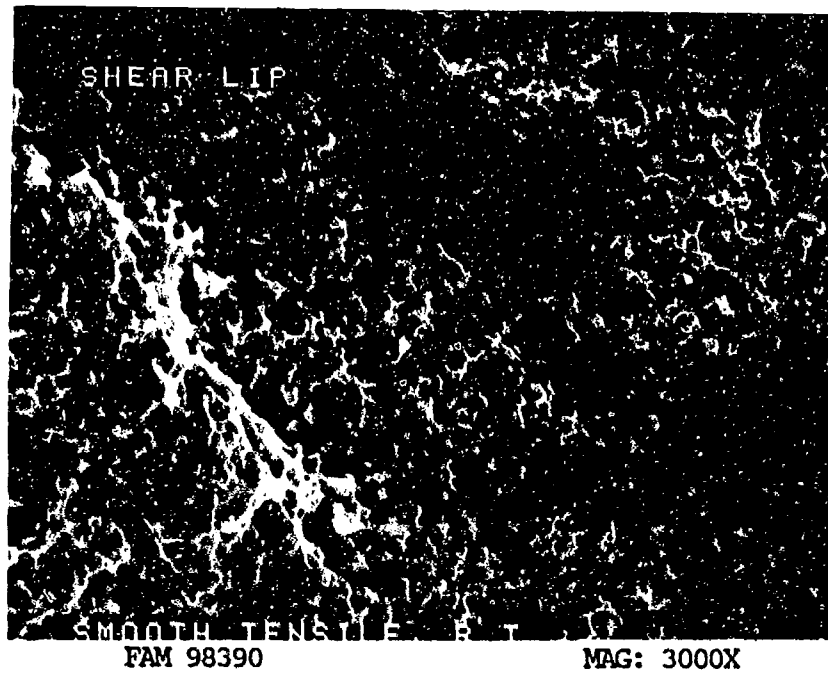
FIGURE 3-7: Fine shear dimples in the final overstress area. The directions of relative movement is shown by arrows.

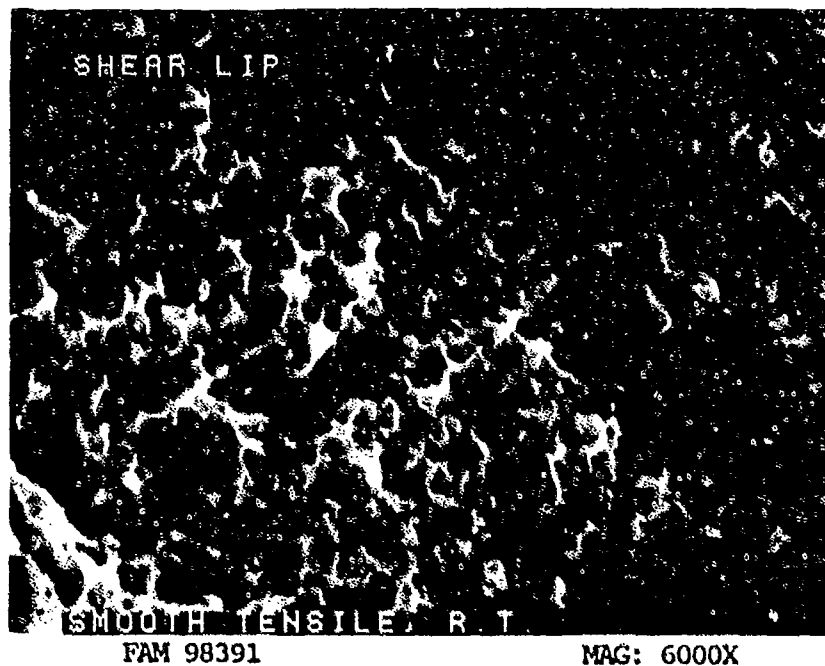
FIGURE 3-8: Fine shear dimples in the final overstress area.

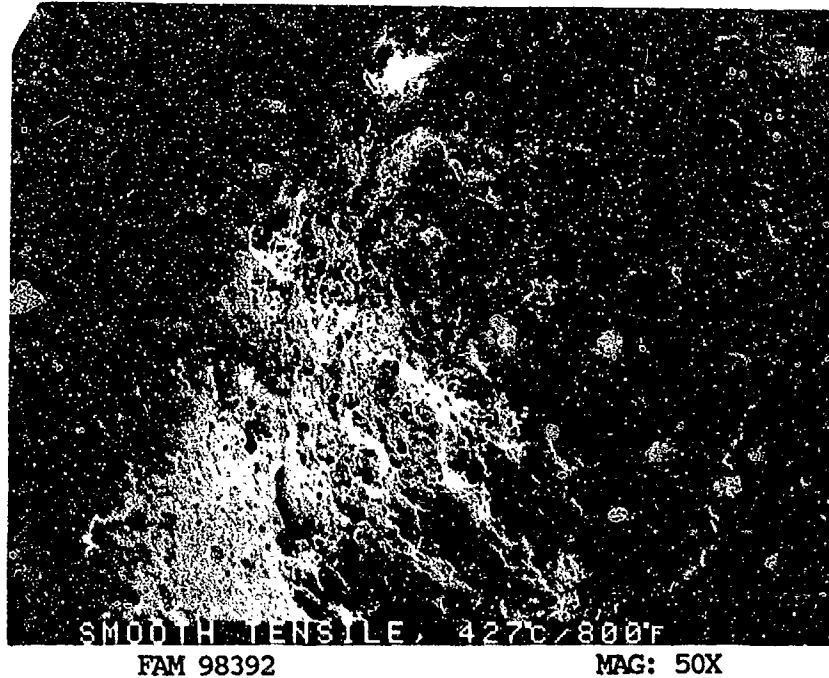
FIGURE 3-11: Low magnification view showing relatively small primary fracture area at the center of the fracture surface, with large area of final overstress (shear lip). The extent of the shear lip is shown by a bracket.

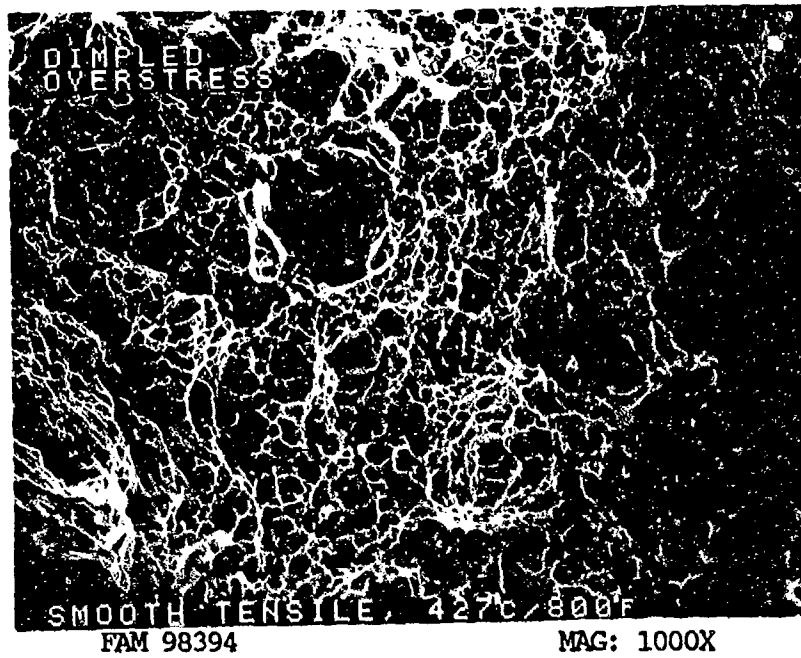
FIGURE 3-13: Fine equiaxed dimples and void coalescence (arrows) in the primary fracture area.

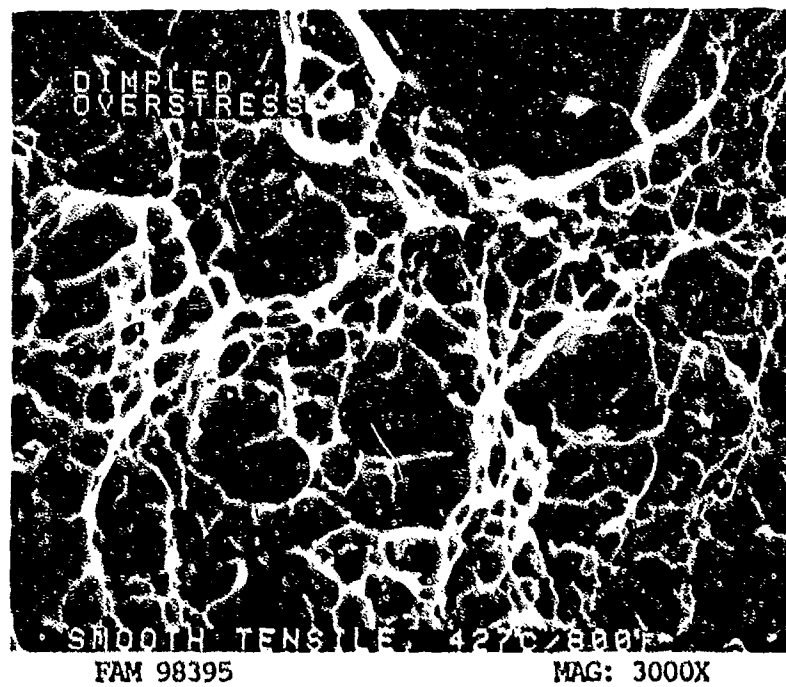
FIGURE 3-14: Fine equiaxed dimples in the primary overstress area.

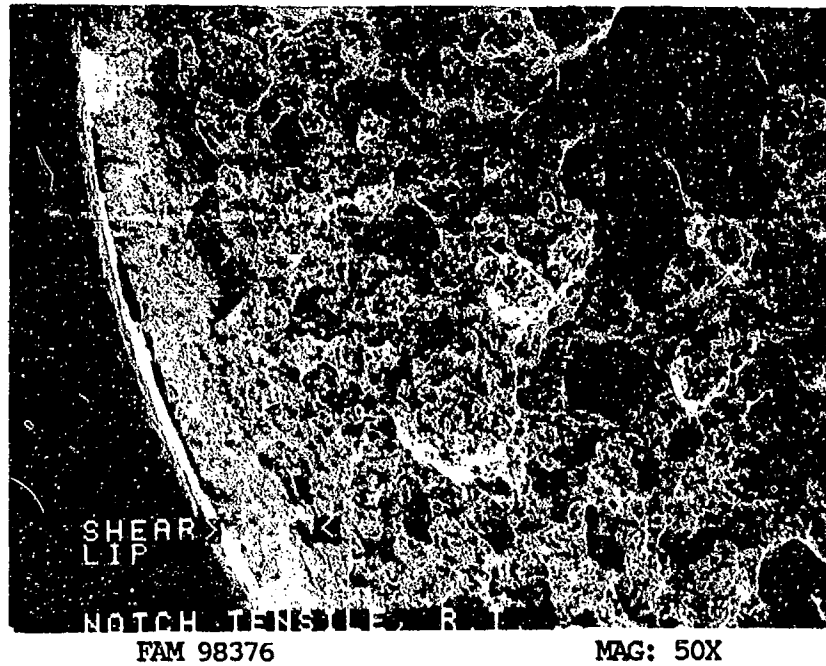
FIGURE 3-17: Low magnification photograph showing deep features in the primary overstress area and a small final overstress area (shear lip).

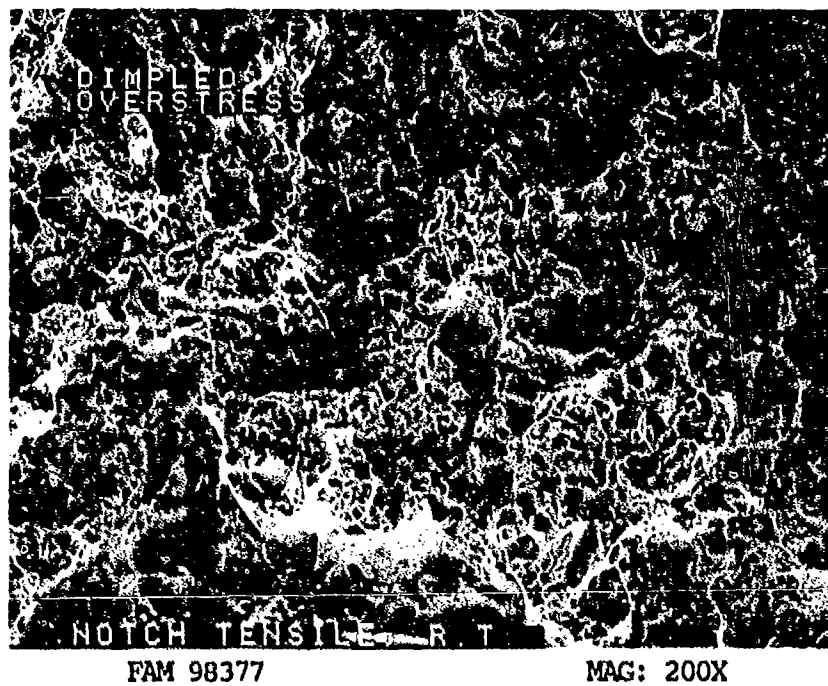
FIGURE 3-18: Shallow dimples and deep features in the primary overstress area.

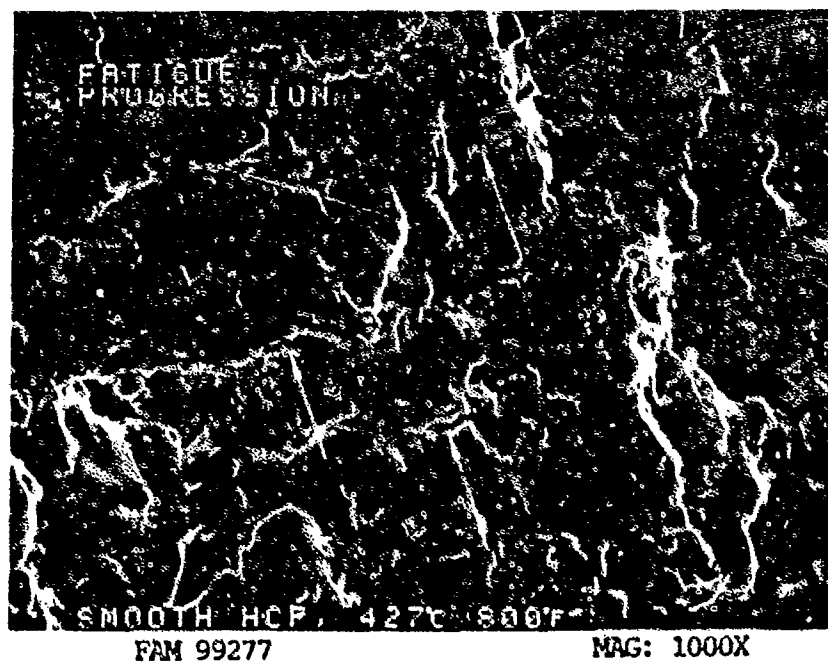
FIGURE 3-55: Fatigue progression zone exhibiting crack-like striations (arrows) with smear features perpendicular to them.

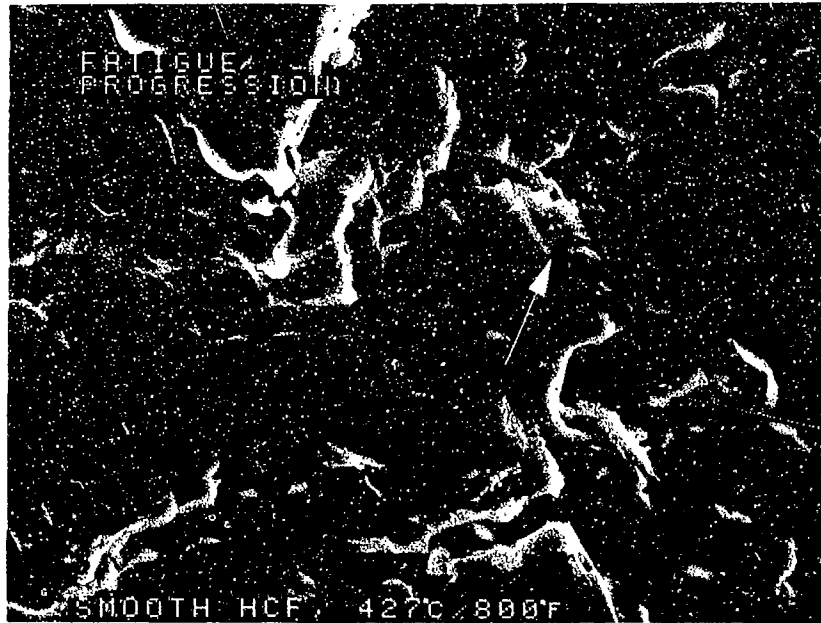
FAM 99278

FIGURE 3-56: Higher magnification view of the area shown in Figure 3-55. Fine remnant striations are visible between the cracks (arrow).

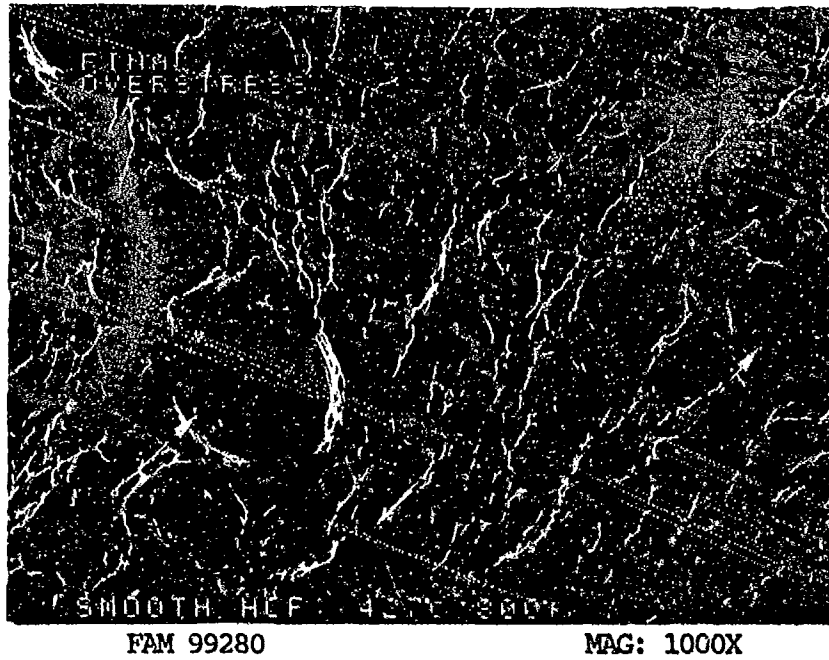
FIGURE 3-58: Dimpled overstress in the final fracture area. The dimples are coarser than on the room temperature specimen. Two voids are indicated by arrows.

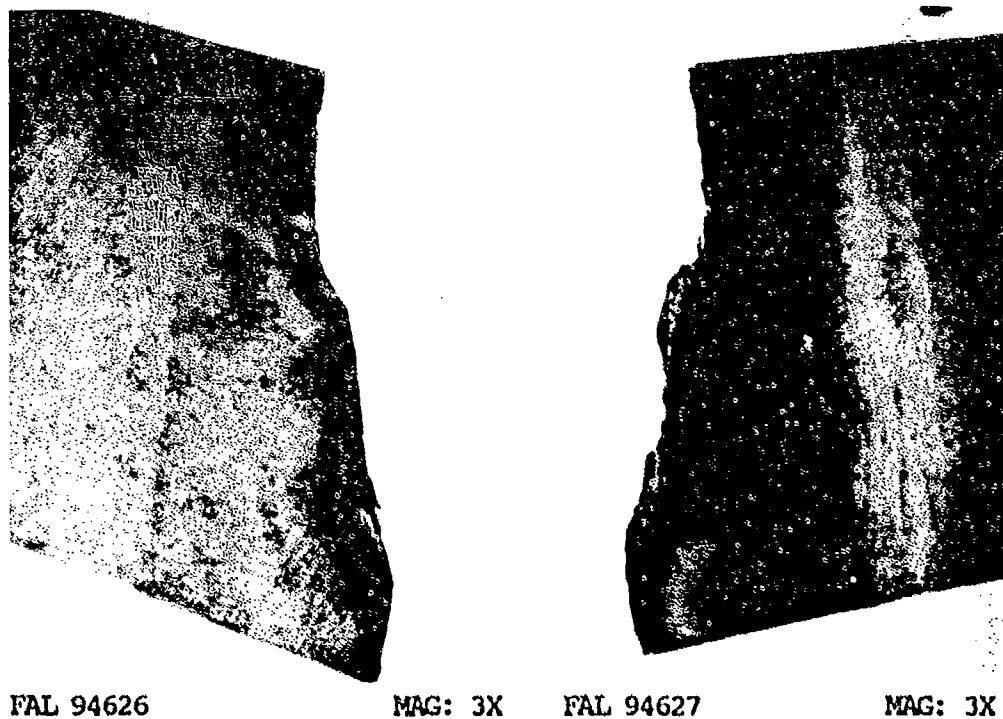
FIGURE 3-59: Test results and fractography of Custom 455 stress corrosion test flat plate specimen. The fracture is shown from the tension (left) and compression (right) sides. The tension side exhibited extensive attack and deposition of corrosion products. The compression side was relatively free of attack.

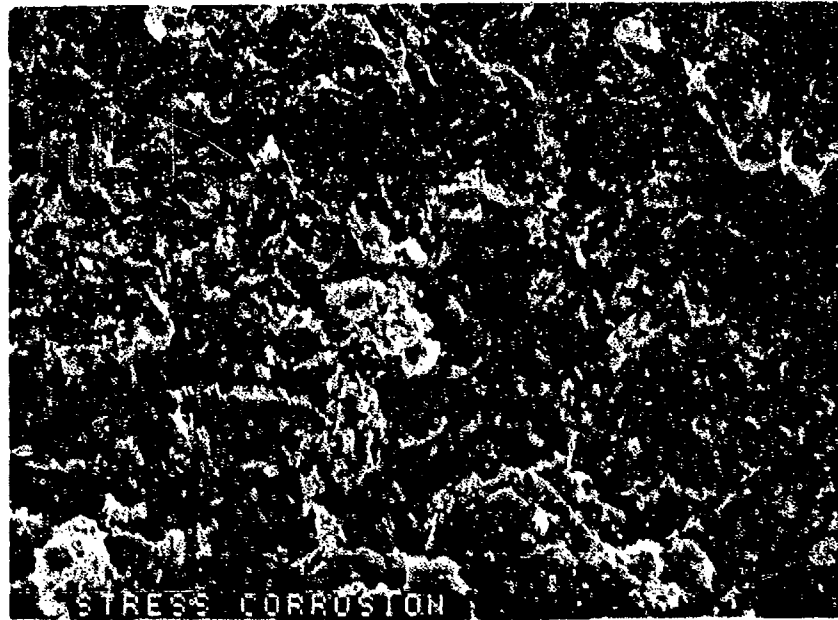
FAM 99699

FIGURE 3-62: Remnant feathery transgranular cleavage.

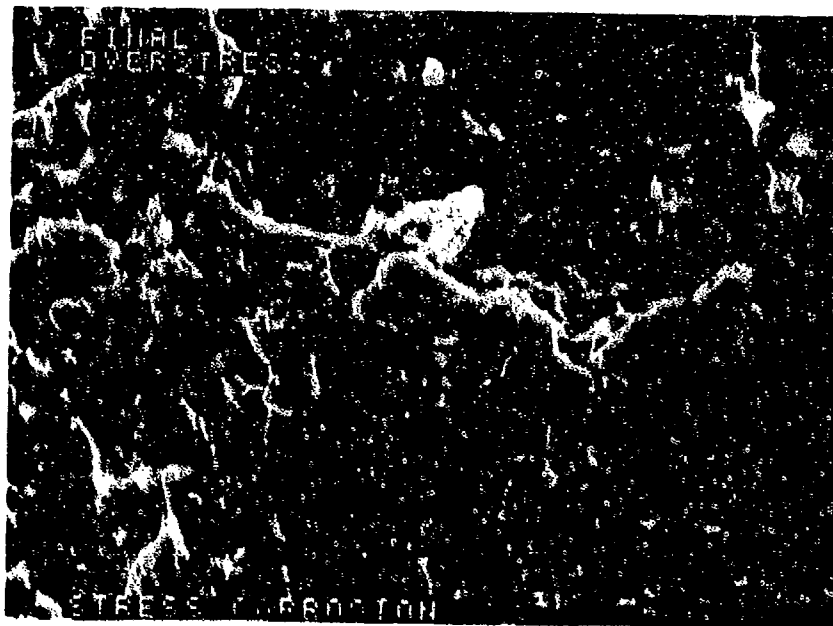
FAM 99695

FIGURE 3-66: Fine equiaxed dimpled overstress in the final fracture area.

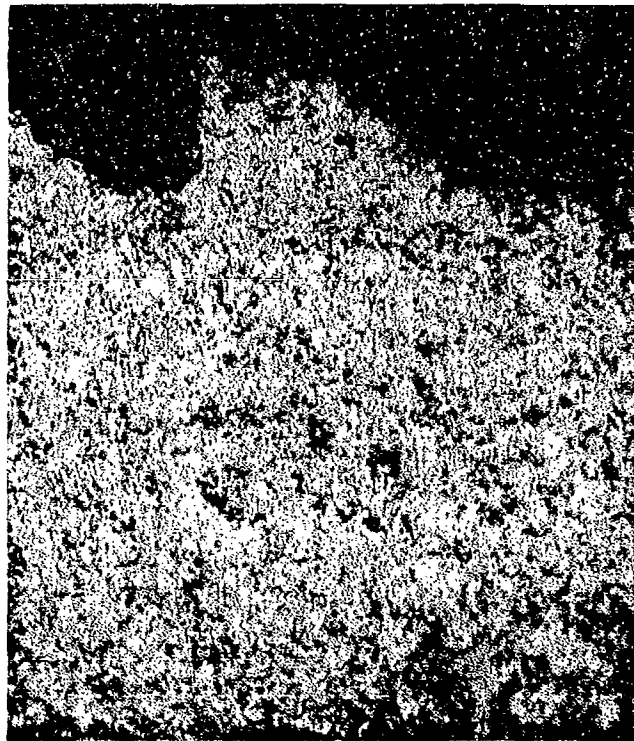
FIGURE 3-68: Optical photomicrographs showing transgranular fracture paths near the edge of the specimen (top) and the center of the specimen (bottom).

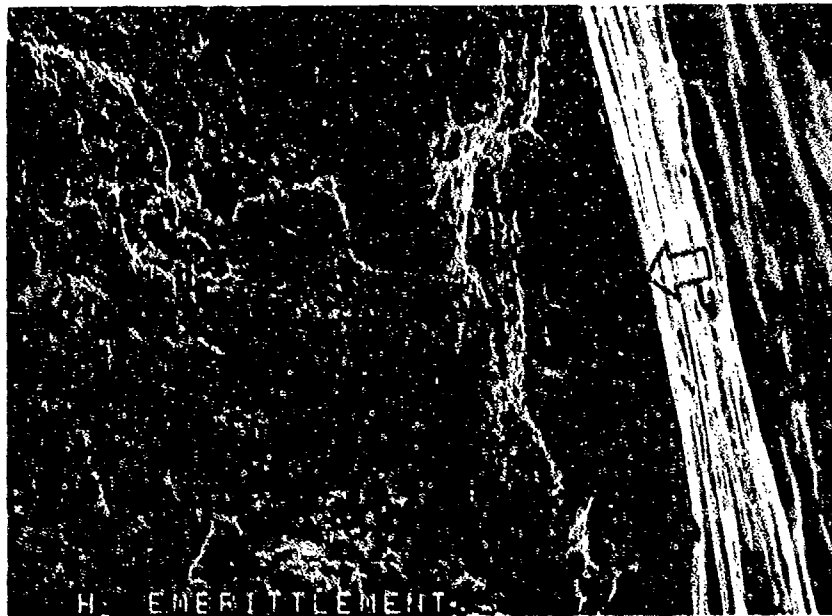
FAM 99646

FIGURE 3-70: Remnant feathery transgranular cleavage at the surface of the specimen (arrow).

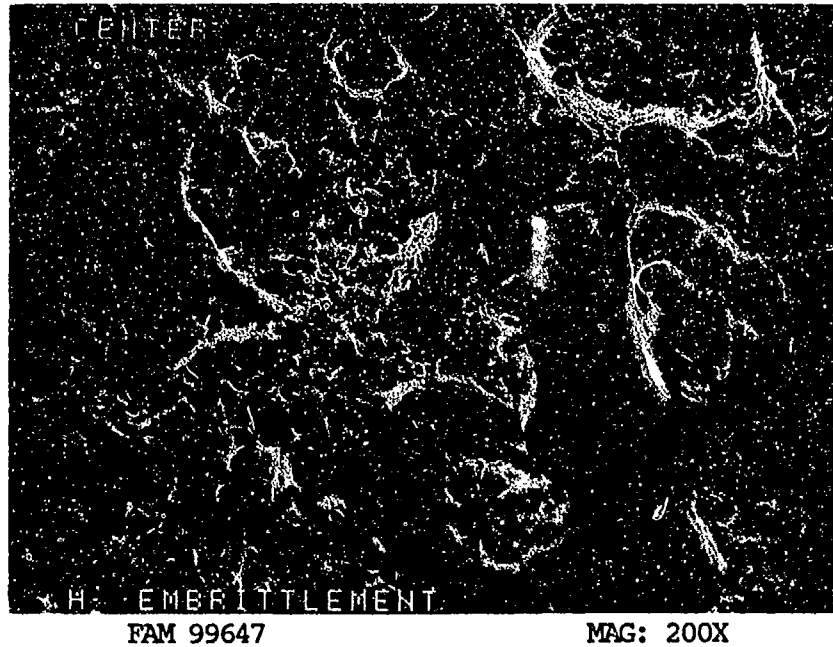
FIGURE 3-71: Fracture surface near the center of the specimen, exhibiting a mixture of dimpled overstress and patches of cleavage.

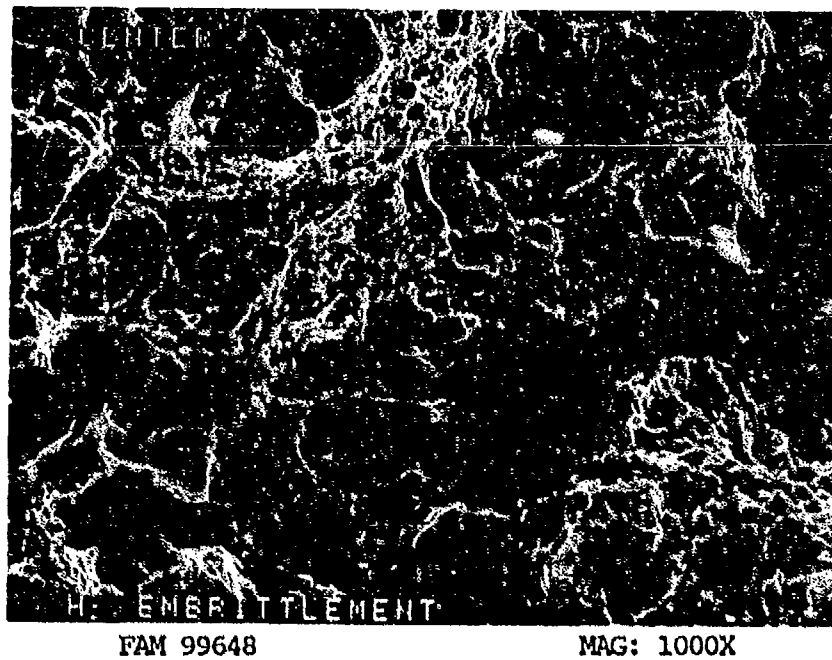
FIGURE 3-72: Higher magnification photograph of the area shown in Figure 3-71, exhibiting dimpled overstress with patches of feathery cleavage.

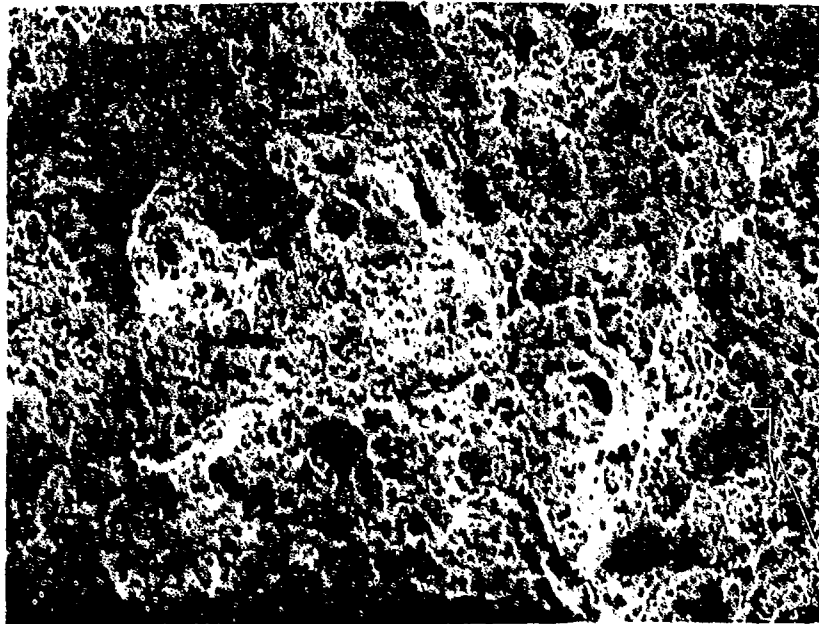
FAM 97966

Figure 4-4: Primary fracture area exhibiting dimpled overstress.

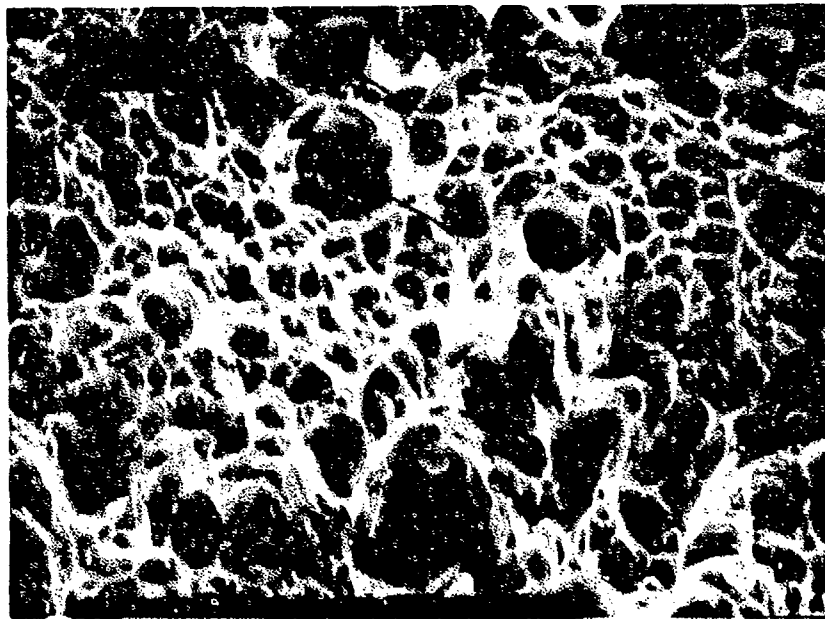
FAM 97968

Figure 4-6: High magnification photograph of fine dimples in the primary fracture area. Nucleating particles are visible at the bottoms of several dimples (arrows).

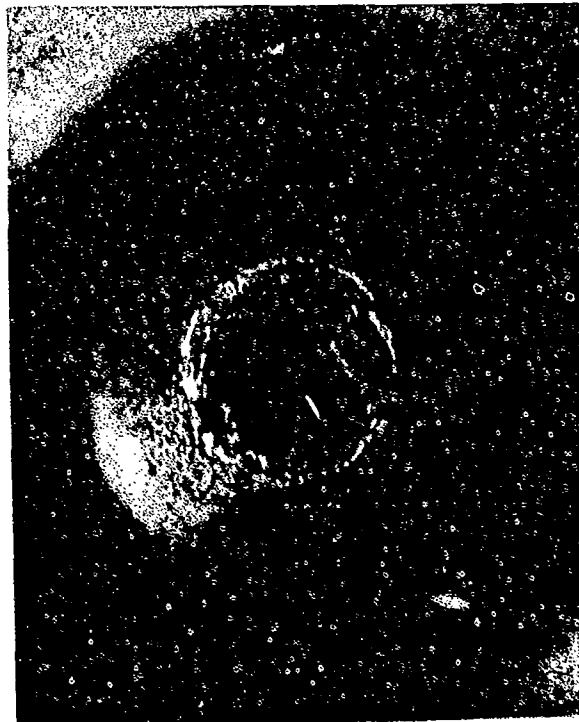
FAL 90295

Figure 4-10: Test results and fractography of 347 SST 816°C (1500°F) smooth tensile test. The specimen has no shear lip but experienced a large reduction of area (necking) before final overstress occurred.

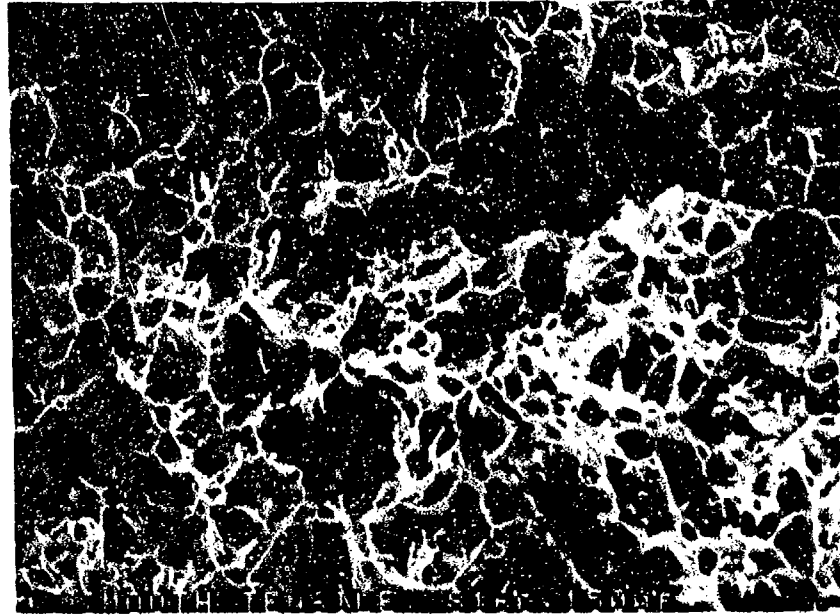
FAM 97993

Figure 4-14: Equiaxed dimples covered by a light oxide (charging).

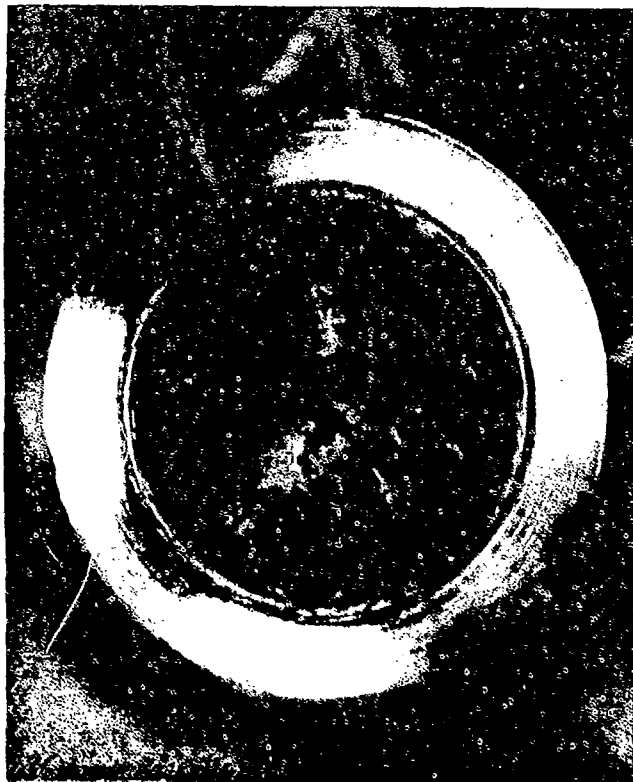
FAL 90293

Figure 4-16: Test results and fractography of 347 SST room temperature notched tensile test. Three large secondary cracks radiate from the center of the specimen fracture surface.

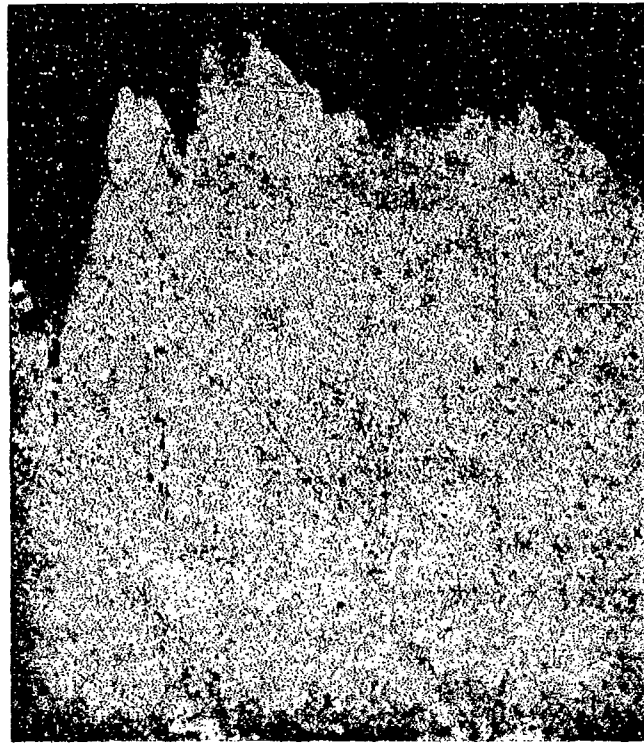
FIGURE 4-17: Optical photomicrographs of the center (top) and edge (bottom) of the fracture.

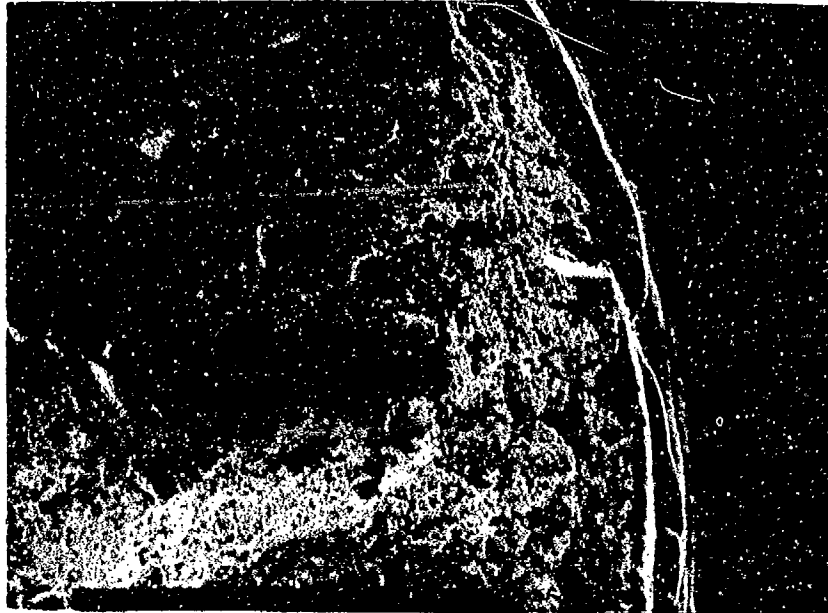
FAM 97984

Figure 4-18: Low magnification photograph showing primary dimpled overstress area and a narrow shear lip along the surface of the specimen.

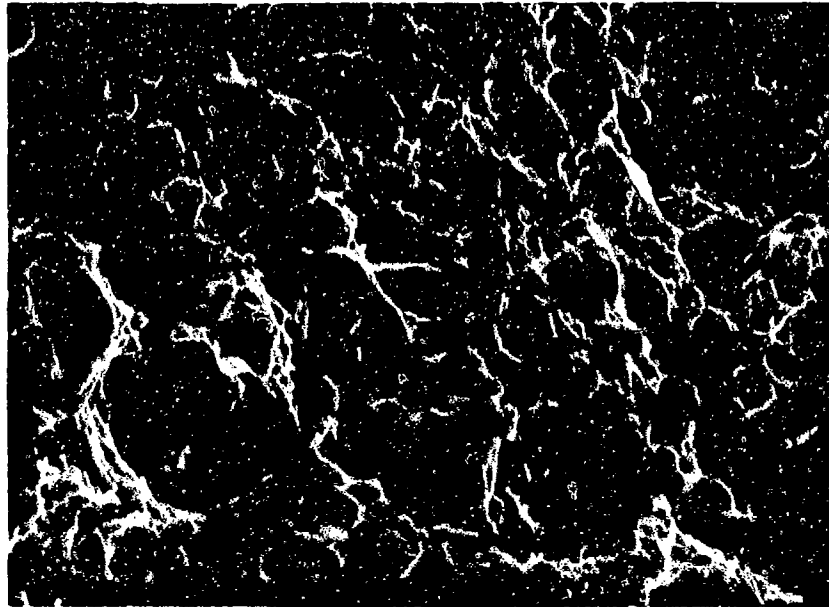
FAM 97988

Figure 4-20: Equiaxed dimpled overstress in the primary fracture area.

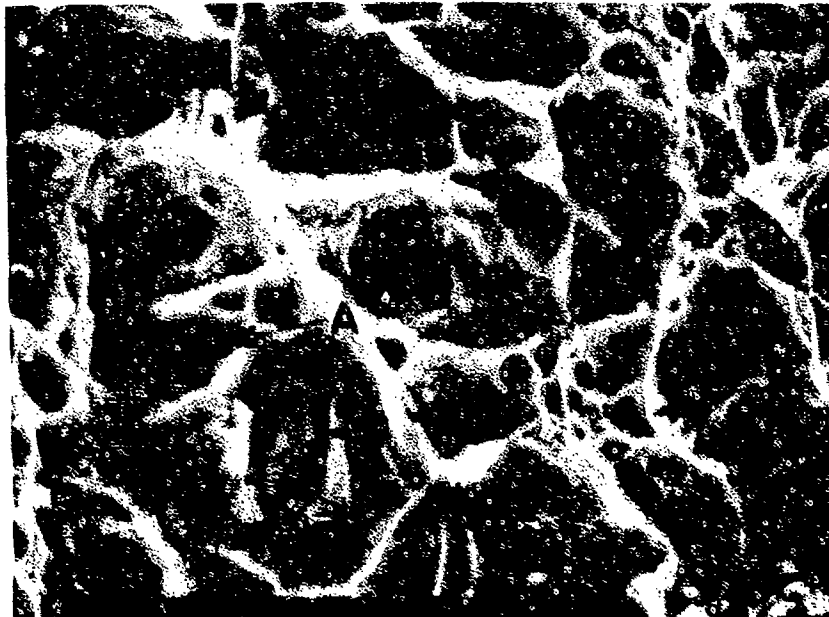
FAM 97989

Figure 4-21: High magnification view of equiaxed dimpled overstress showing particles in the centers of the dimples (arrow A). Fine dimples are visible in patches (arrow B).
