FAILURE ANALYSIS HANDBOOK

C. R. Walker, K. K. Starr

Pratt & Whitney
P.O. Box 109600
West Palm Beach, FL 33410-9600

August 1989

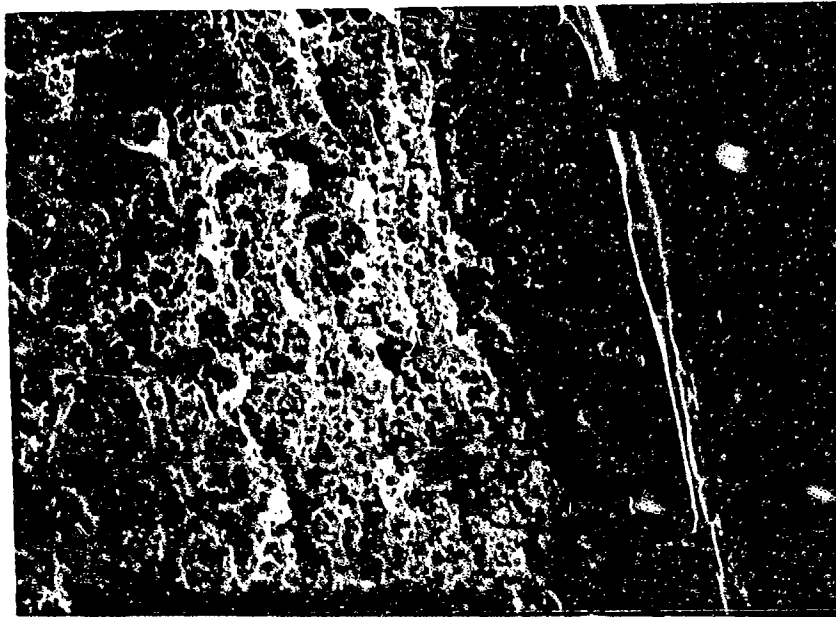
FAM 97985

Figure 4-22: Close-up view showing the shear lip (arrow).

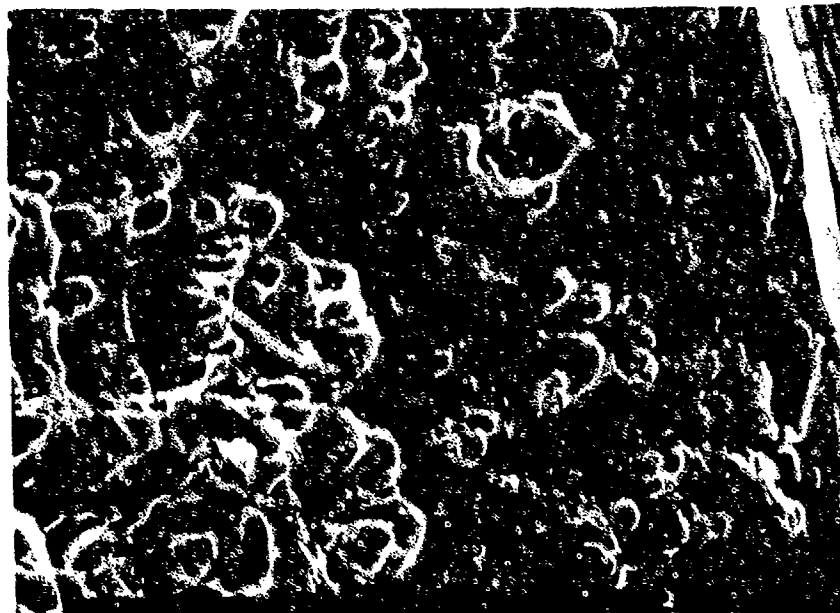
FAM 97986

Figure 4-23: Smeared shear dimples in the final overstress area.

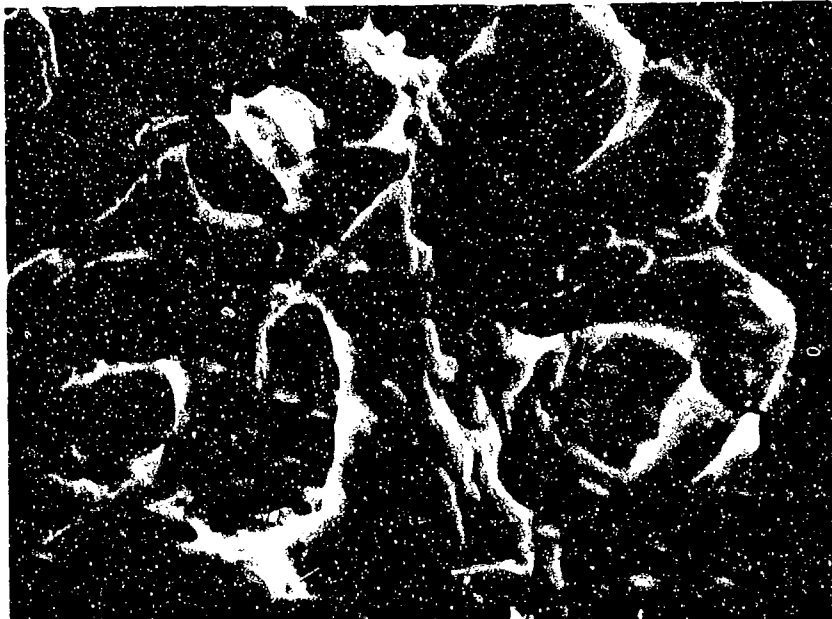
FAM 97987

Figure 4-24: High magnification photograph of the shear dimples shown in Figure 4-23.

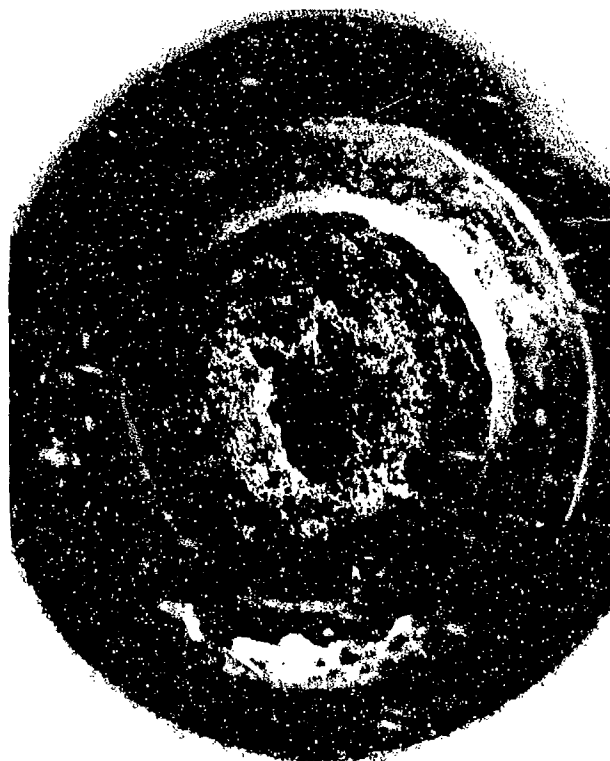
FAL 90294

Figure 4-25: Test results and fractography of 347 SST 816°C (1500°F) notched tensile test. This specimen fracture exhibits more depth in the features than the room temperature specimen (Figure 4-16).

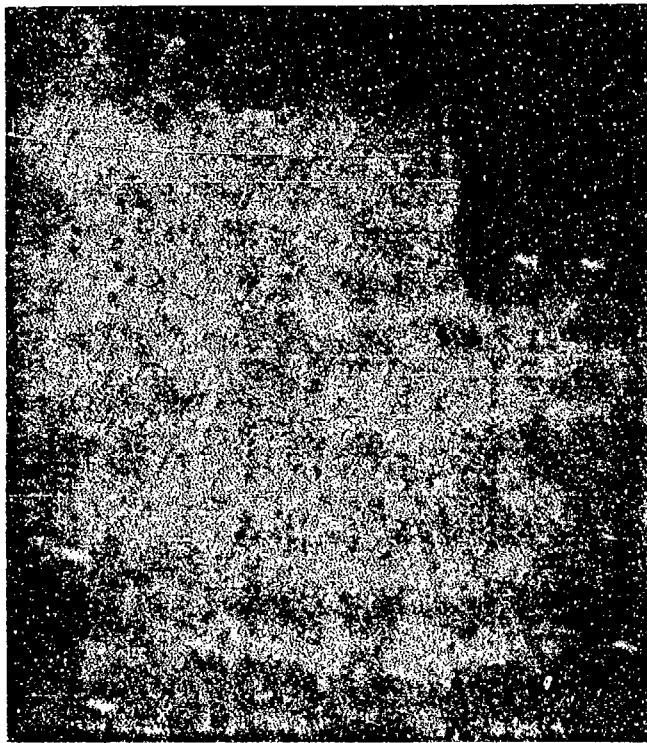
FIGURE 4-26: Optical photomicrographs of the center (top) and edge (bottom) of the fracture. This specimen exhibits more elongation and deeper voids at the fracture than the room temperature specimen. See Figure 4-17.

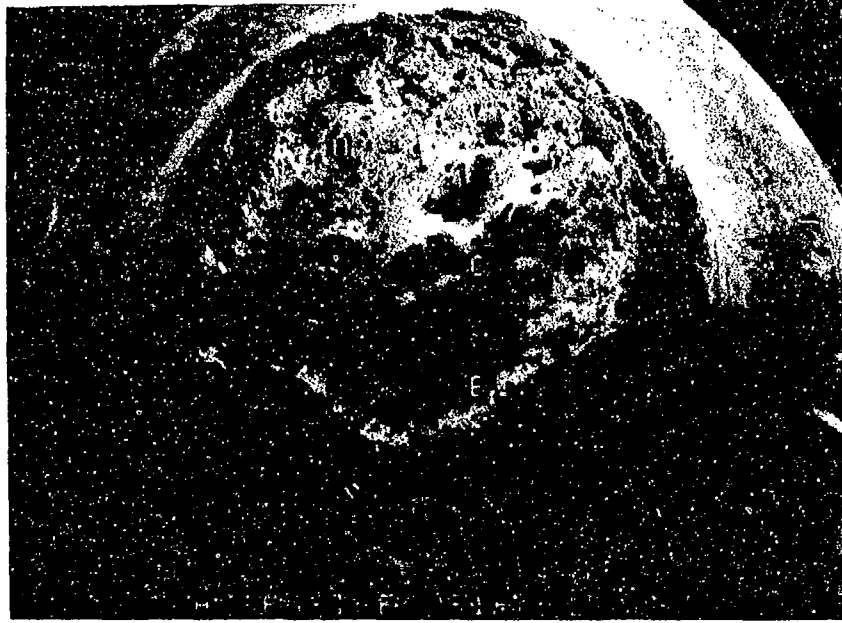
FAM 97995

Figure 4-27: Low magnification view showing dimpled overstress (A), shear (B) and axial shear (C).

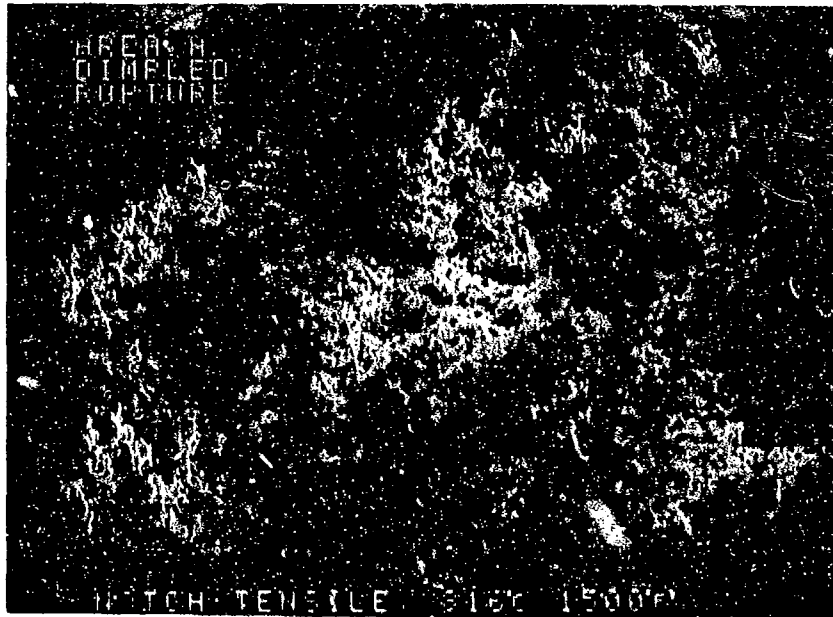
FAM 97996

Figure 4-28: View of area A showing fine dimpled overstress.

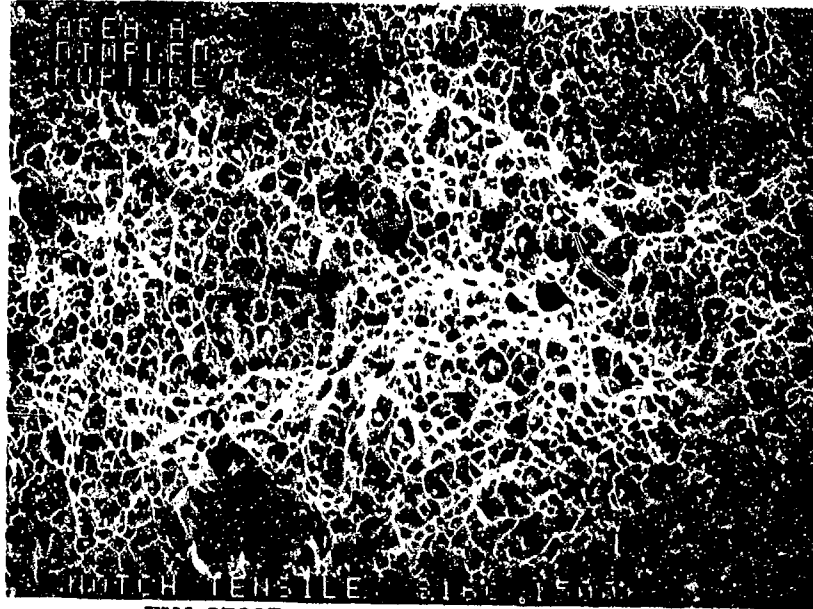
FAM 97997

Figure 4-29: Higher magnification photograph of area A, showing fine equiaxed dimples.

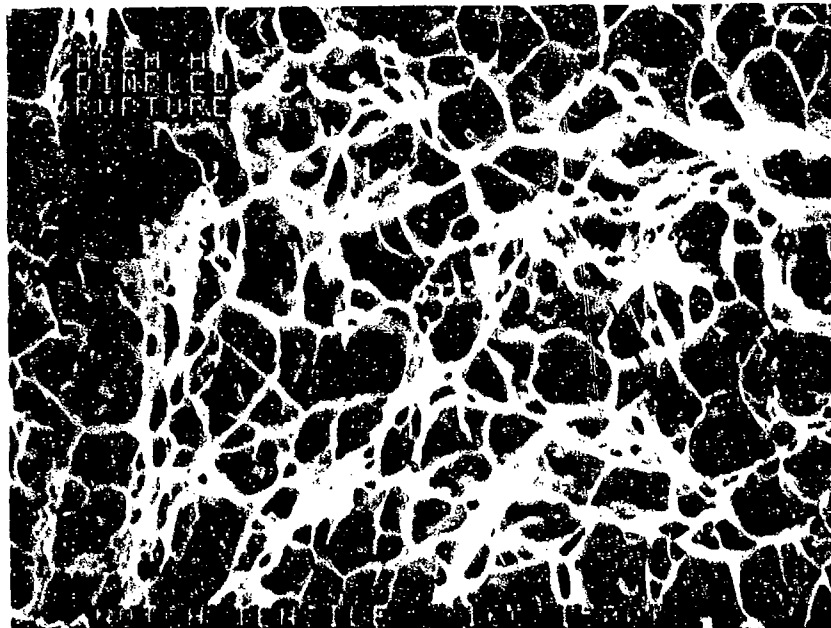
FAM 97998

Figure 4-30: High magnification view of area A showing equiaxed dimples and associated particles (arrows). The fracture surface is charging, indicating that it is lightly oxidized.

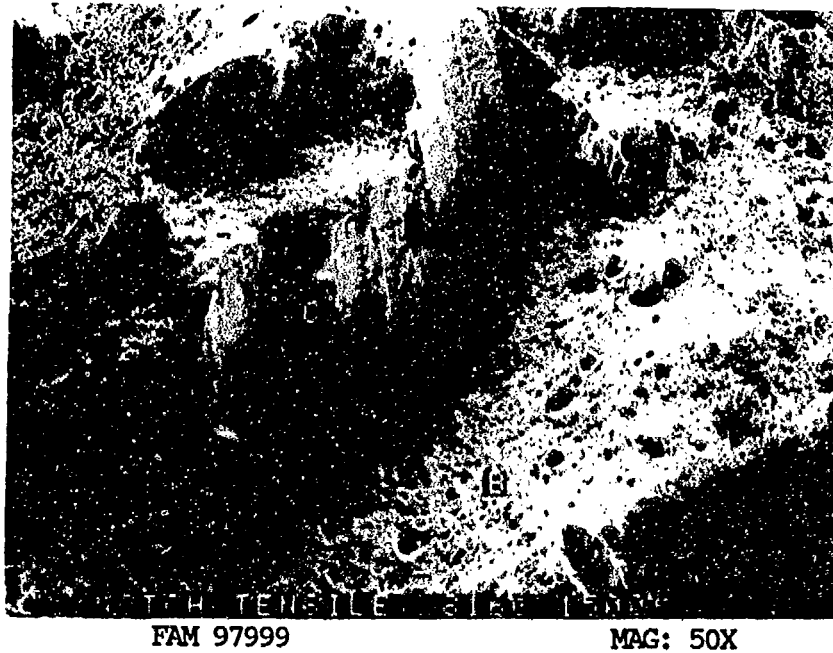
Figure 4-31: Higher magnification photograph of shear areas B and C.

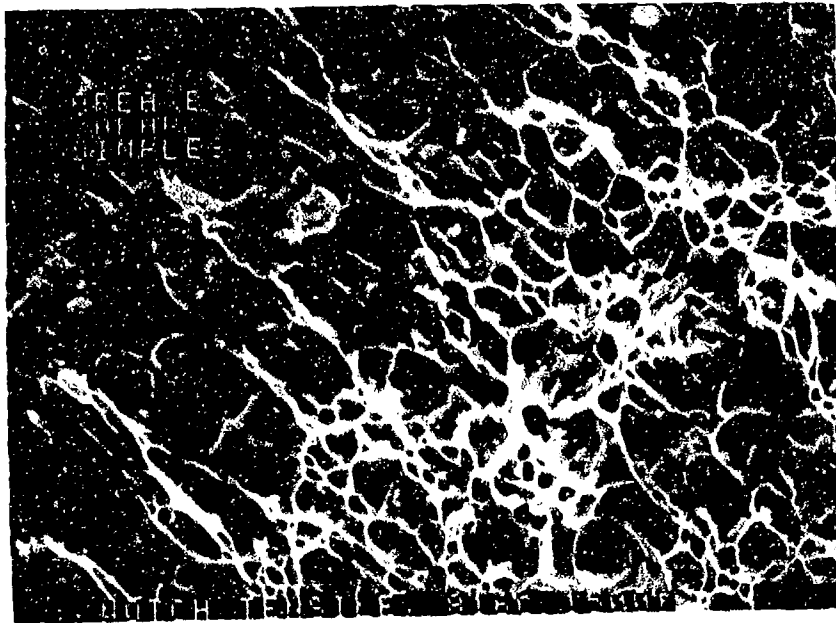
FAM 98001

Figure 4-33: High magnification view of area B showing lightly oxidized shear dimples. Arrows show the directions of relative motion.

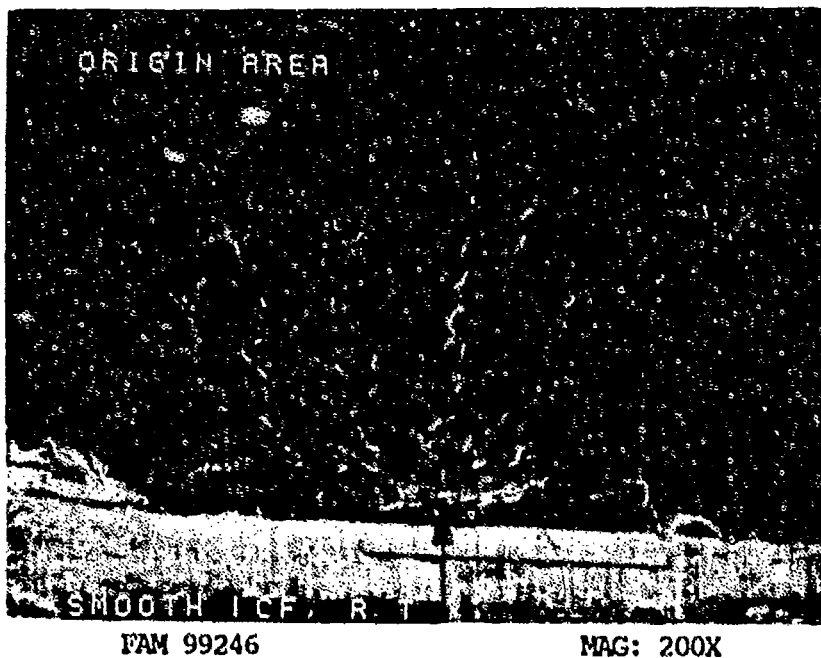
FIGURE 4-38: Fatigue features radiating from the origin (arrow). The dark patch at the surface (bracket) is a smear that occurred after the fracture.

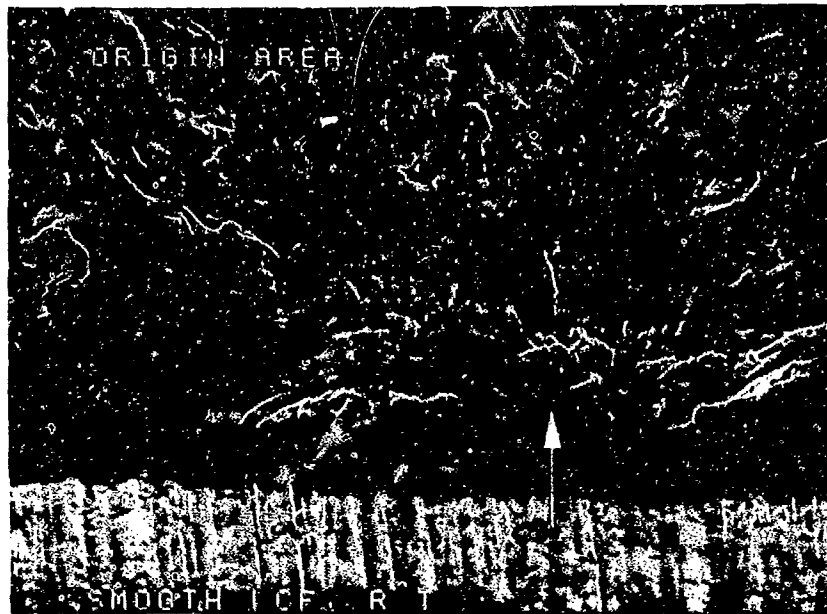
FAM 99247

FIGURE 4-39: Post-fracture smear at the fatigue origin. The features on the fracture were distorted when the smear occurred. Machining lines are visible on the surface adjacent to the fracture. The localized origin is indicated by an arrow.

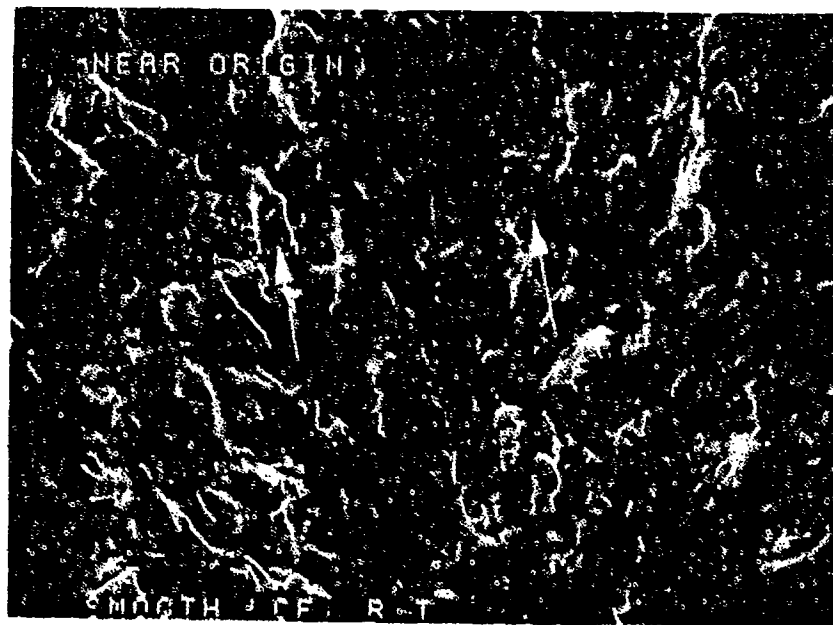
FAM 99248

FIGURE 4-40: Fatigue features near the origin area. Individual striations are barely resolvable (arrows).

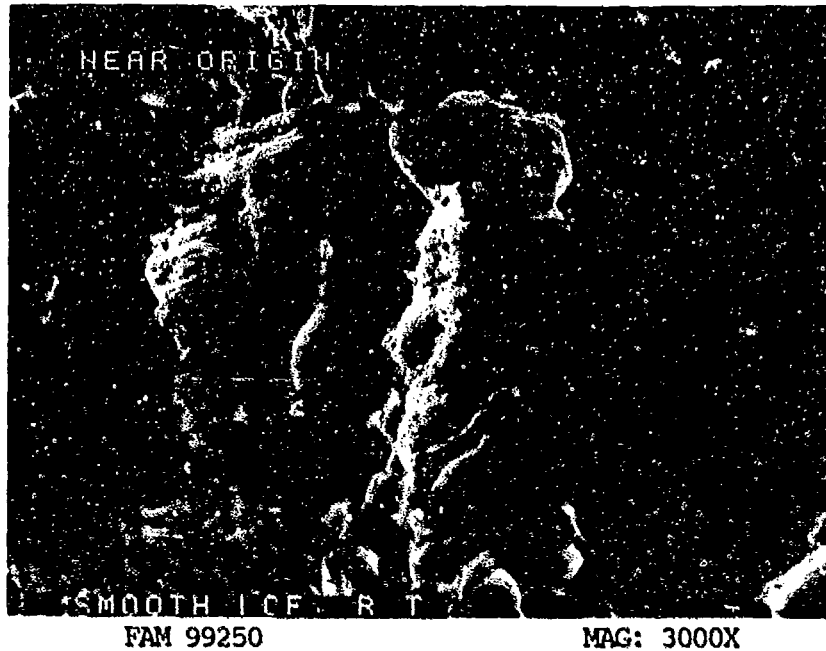
FIGURE 4-41: Fine fatigue striations and crack-like striations near the origin area. The fracture propagated from bottom to top of the photograph.

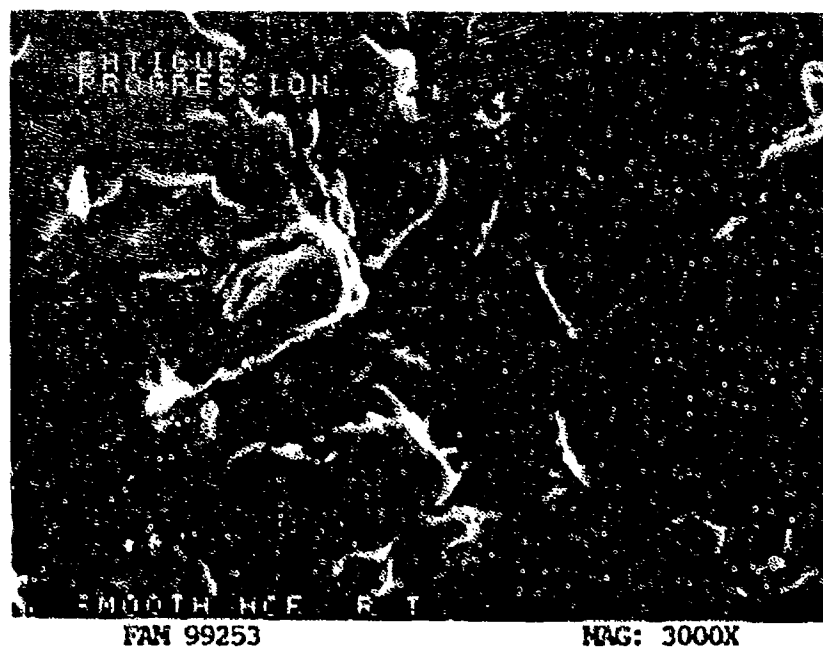
FIGURE 4-44: Higher magnification photograph of striations in the fatigue progression zone. See Figure 4-43.

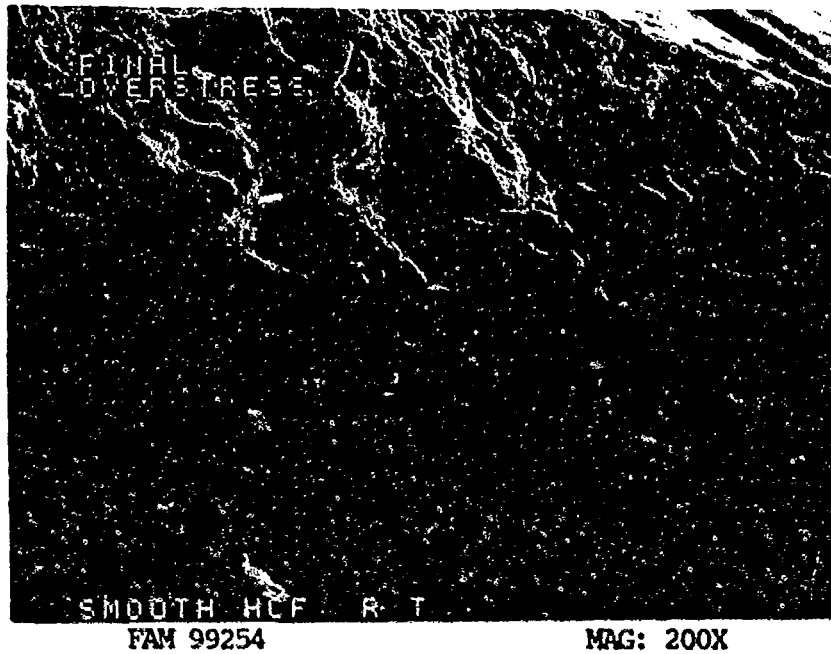
FIGURE 4-45: Final overstress area exhibiting a mixture of equiaxed dimples, shear dimples and cleavage.

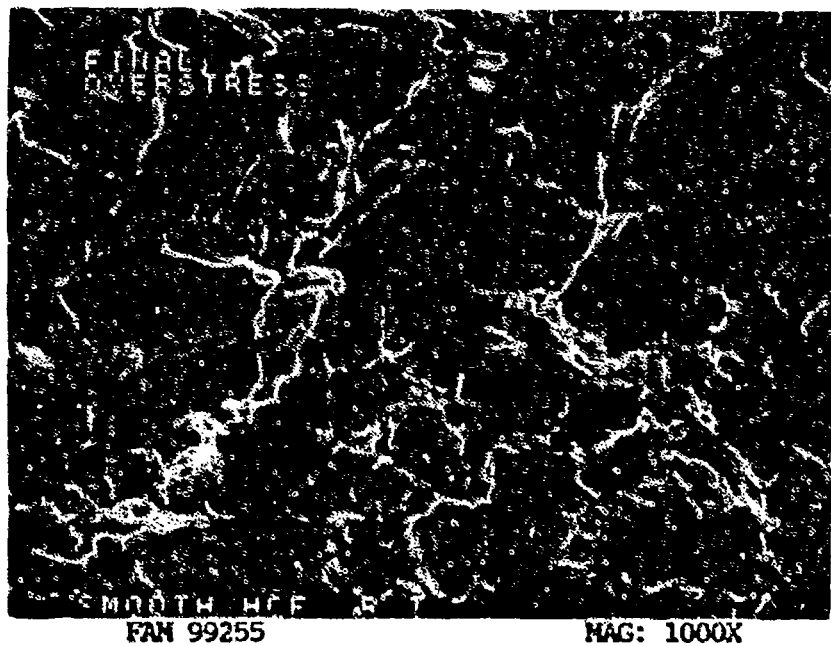
FIGURE 4-46: Dimpled overstress and tearing cleavage features (top of photograph) in the final overstress area.

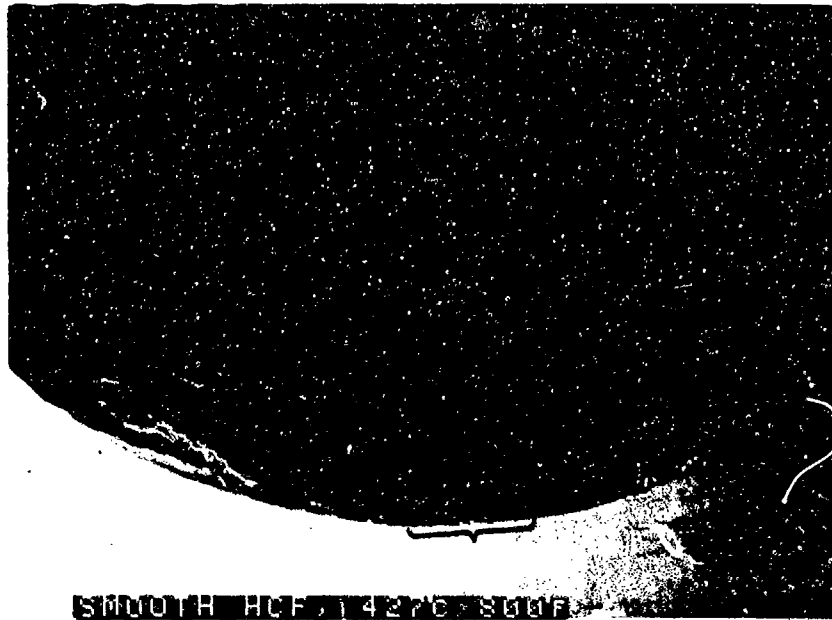
SMOOTH HCF 4276 8100F
FAM 99256 MAG: 50X

FIGURE 4-49: Low magnification photograph showing features radiating from a diffuse origin area (bracket).

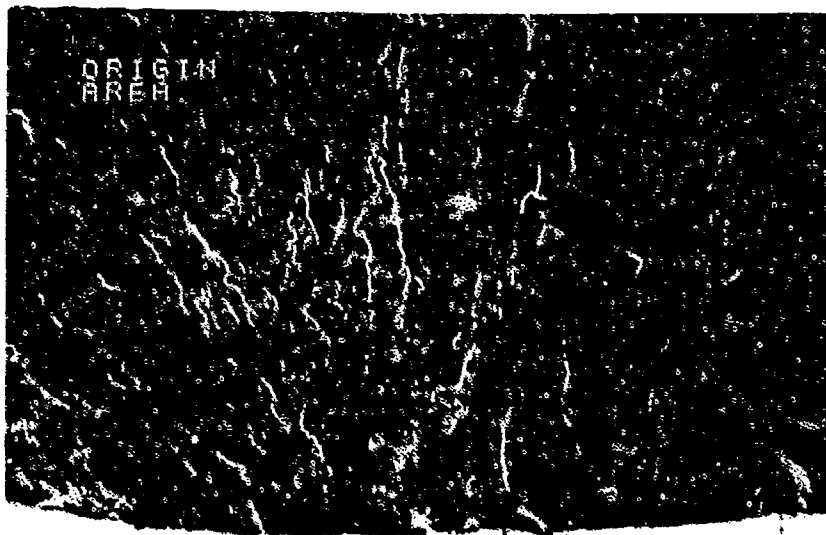
SMOOTH HCF 4276 8100F
FAM 99257 MAG: 200X

FIGURE 4-50: Fatigue features radiating from the origin. A small fatigue step, tear ridge (arrow) separates two localized origins that are close together on the surface of the specimen.

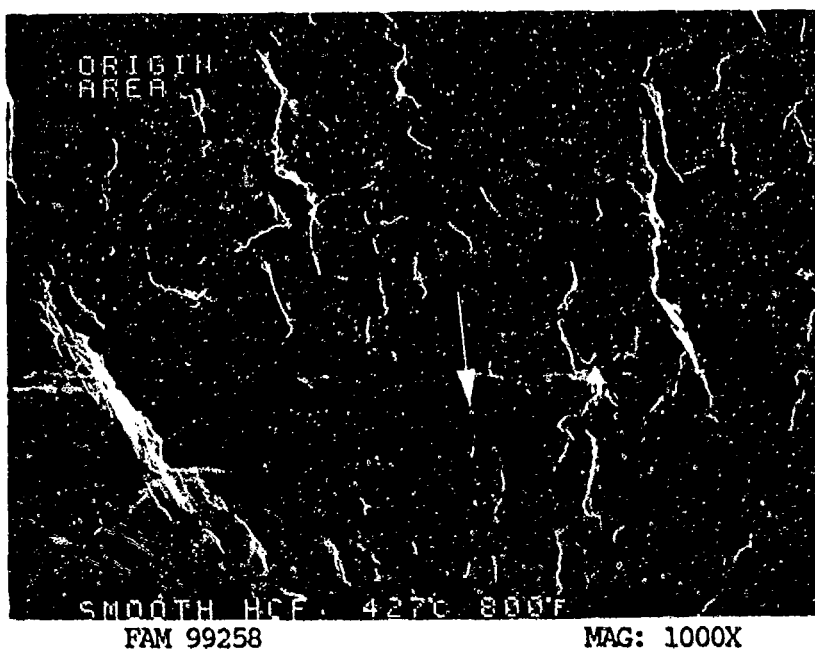
FIGURE 4-51: Striations and crack like striations near the origin area. Arrow perpendicular to the striations points back towards the origin.

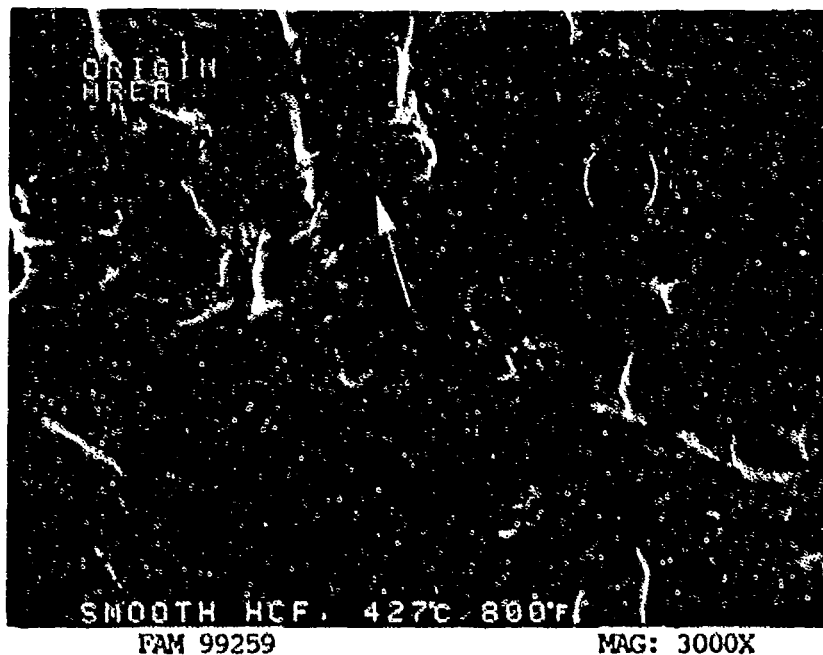
FIGURE 4-52: Fine fatigue striations and crack like striations (arrow) near the origin. Bracket contains five striations.

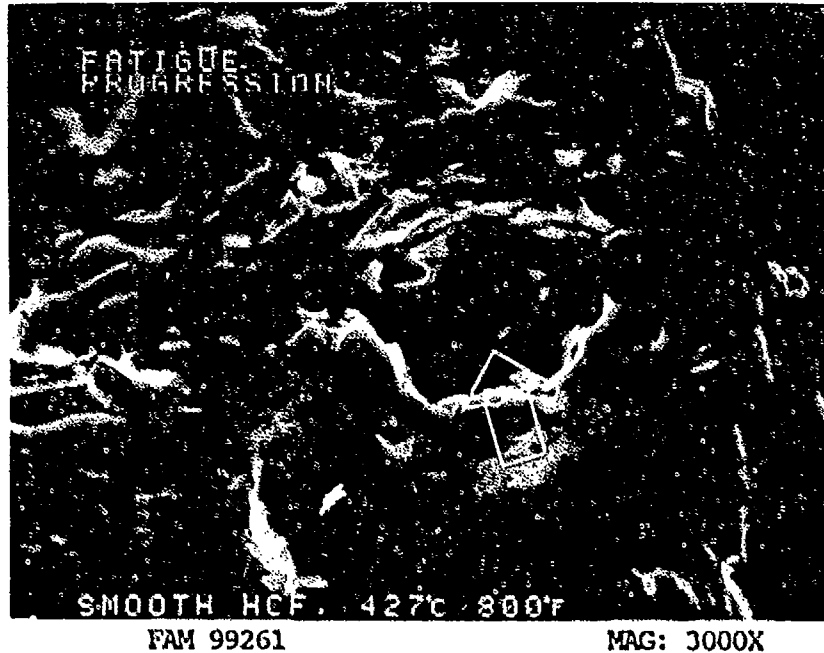
FIGURE 4-54: Higher magnification view of the flat fatigue progression area near the center of the specimen. The discontinuity in the striations (arrow) was probably caused by a carbide.

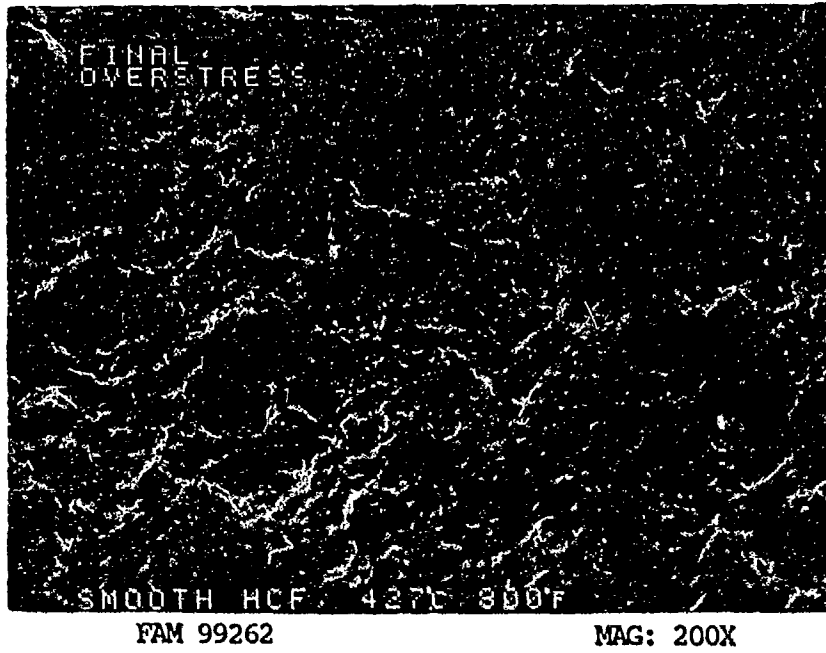
FIGURE 4-55: Final overstress area.

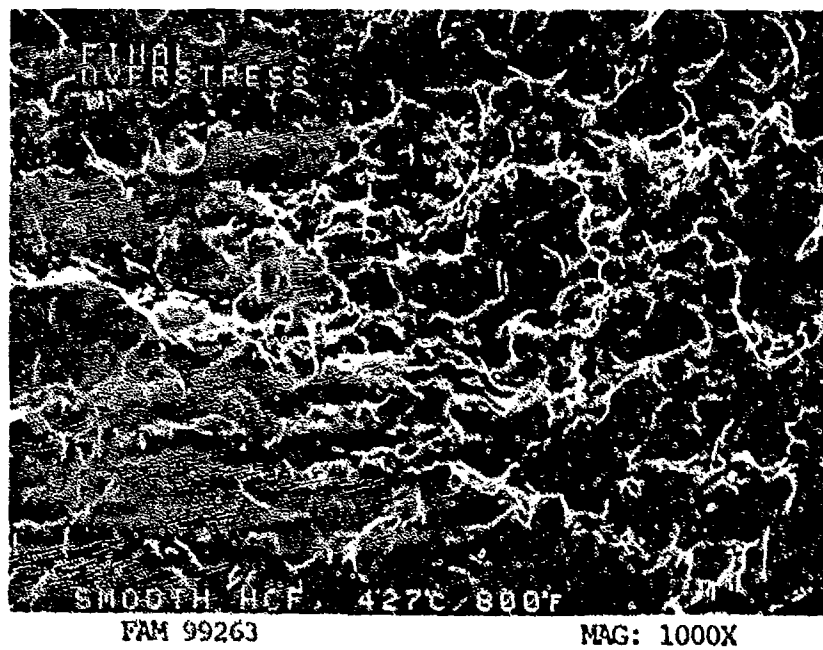
FIGURE 4-56: Dimpled overstress in the final overstress area.

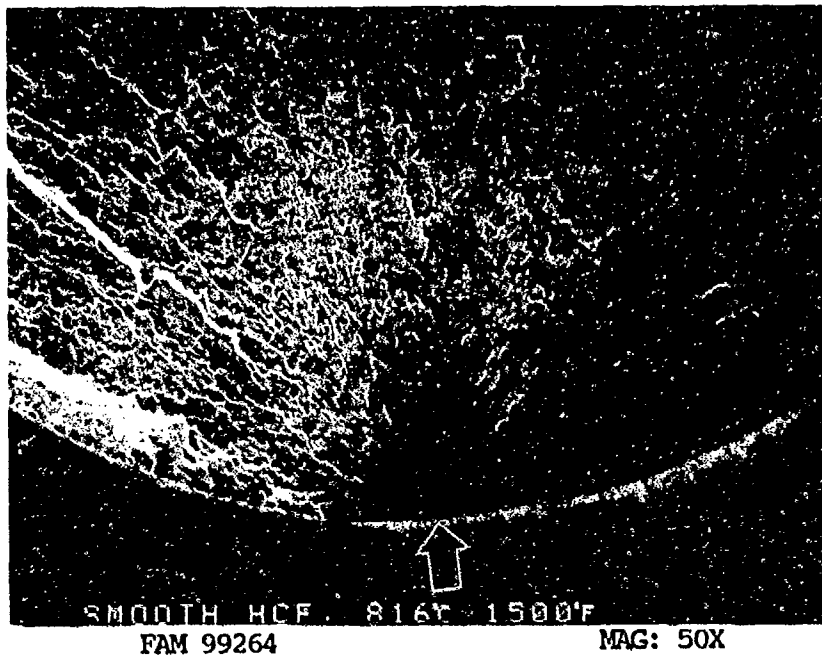
FIGURE 4-59: Low magnification photograph showing features radiating from a localized origin area (arrow, bottom center).

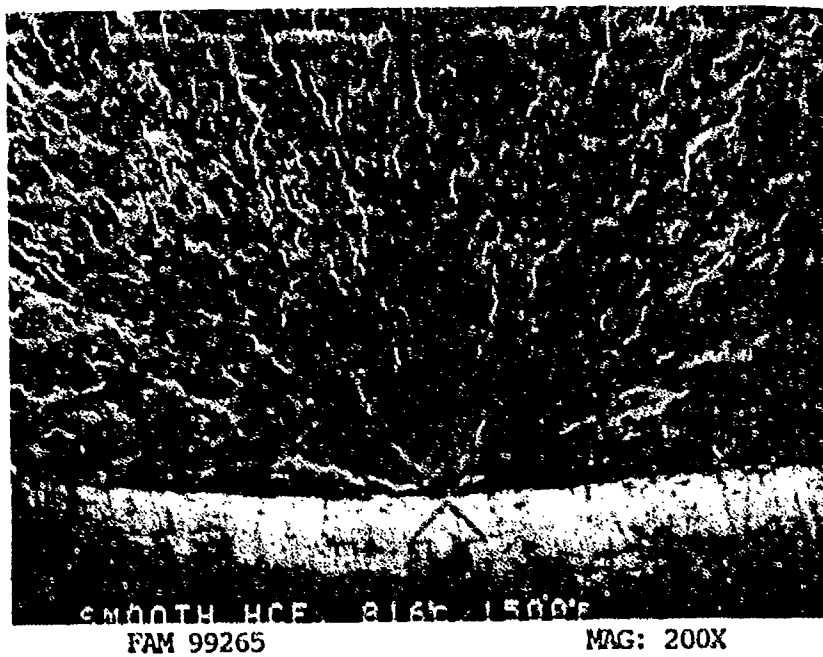
FIGURE 4-60: Fatigue features radiating from the origin (arrow).

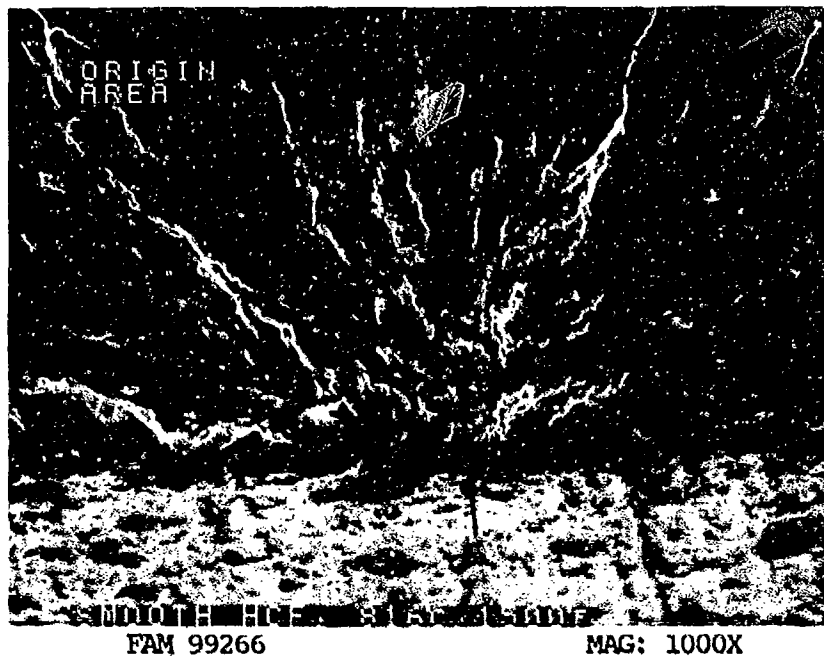
FIGURE 4-61: Higher magnification photograph of the localized origin, Figure 4-60, showing moderate oxidation and progression from a possible subsurface anomaly (arrow).

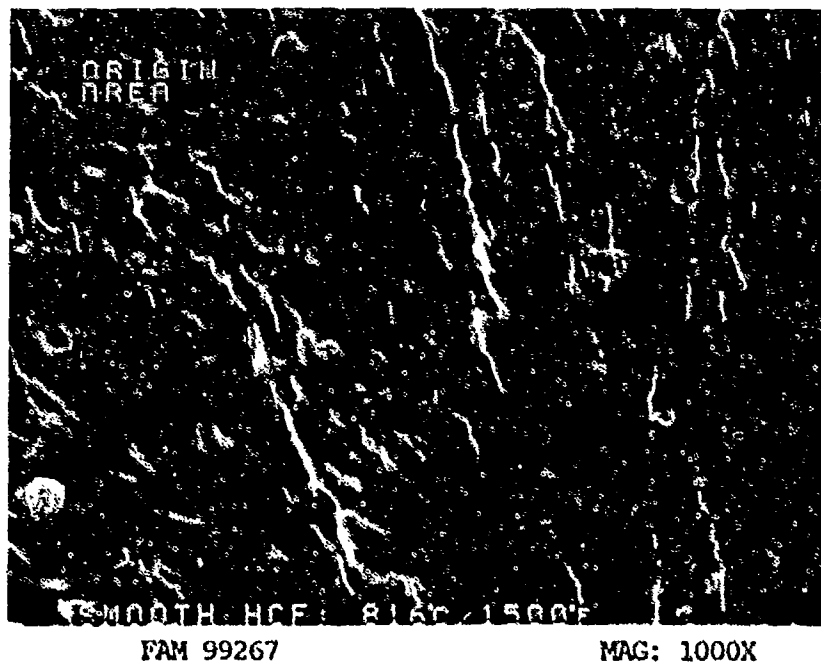
FIGURE 4-62: Flat oxidized features adjacent to the localized origin.

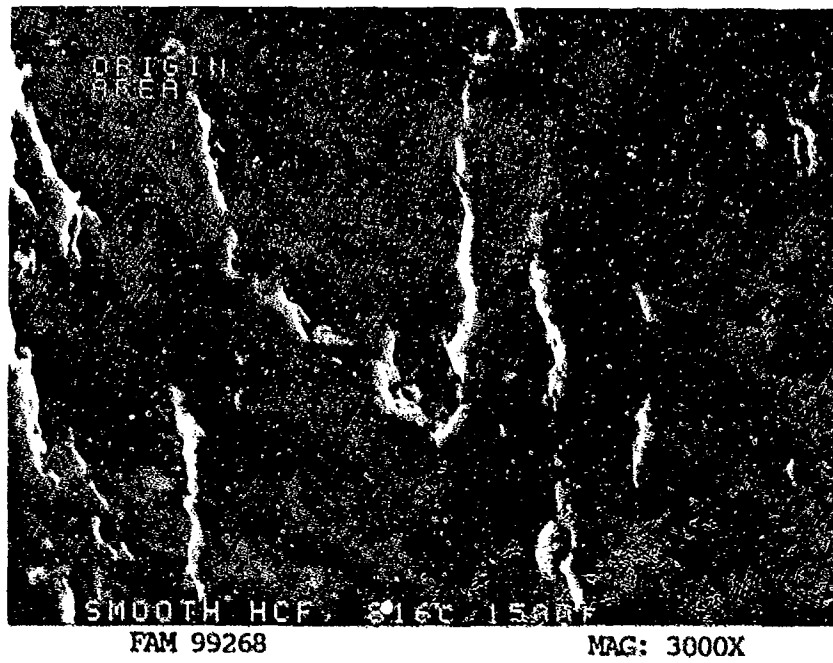
FIGURE 4-63: Heavily oxidized features near the origin area. Individual fatigue striations are not resolvable.

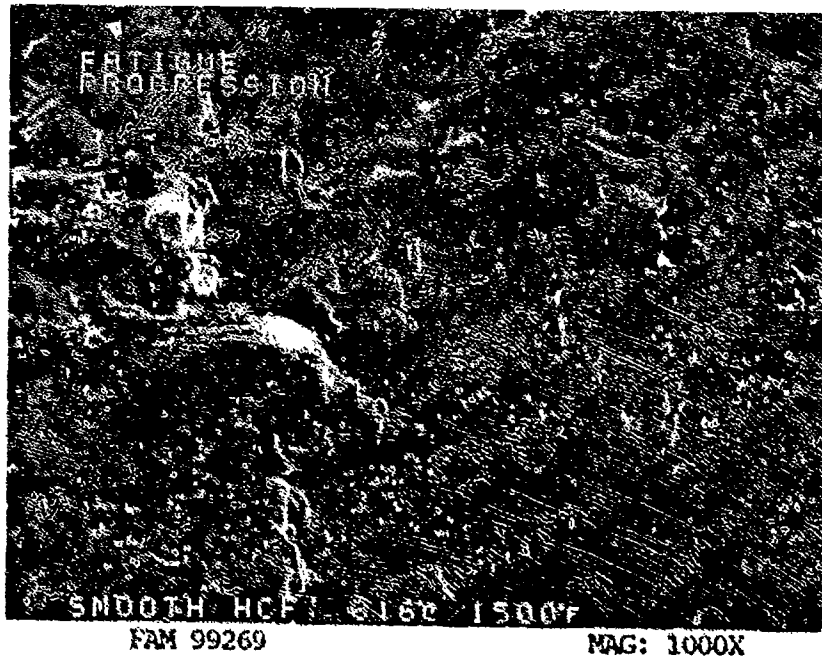
FIGURE 4-64: Relatively coarse striations and crack-like striations in the fatigue progression zone near the center of the specimen.

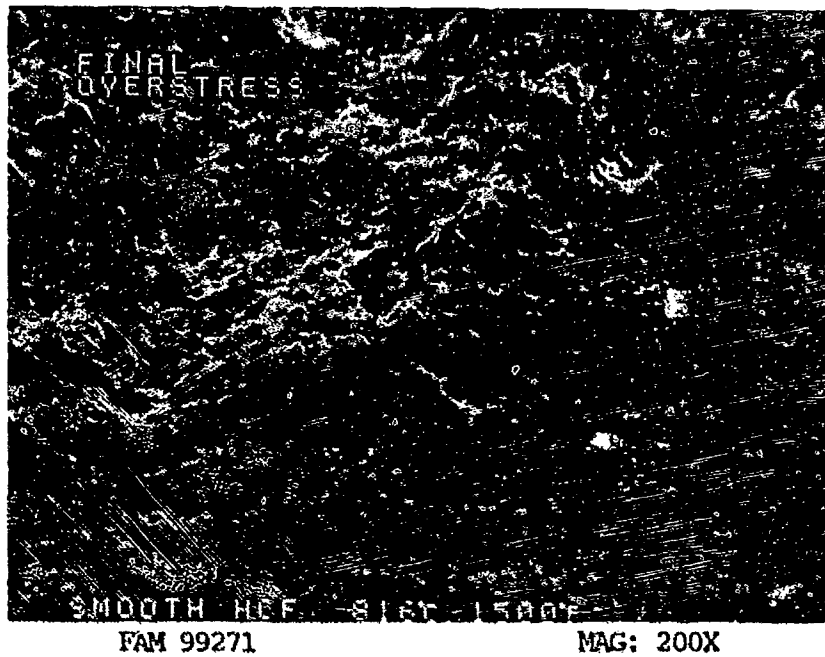
FIGURE 4-65: Dimpled overstress and void coalescence in the final overstress area.

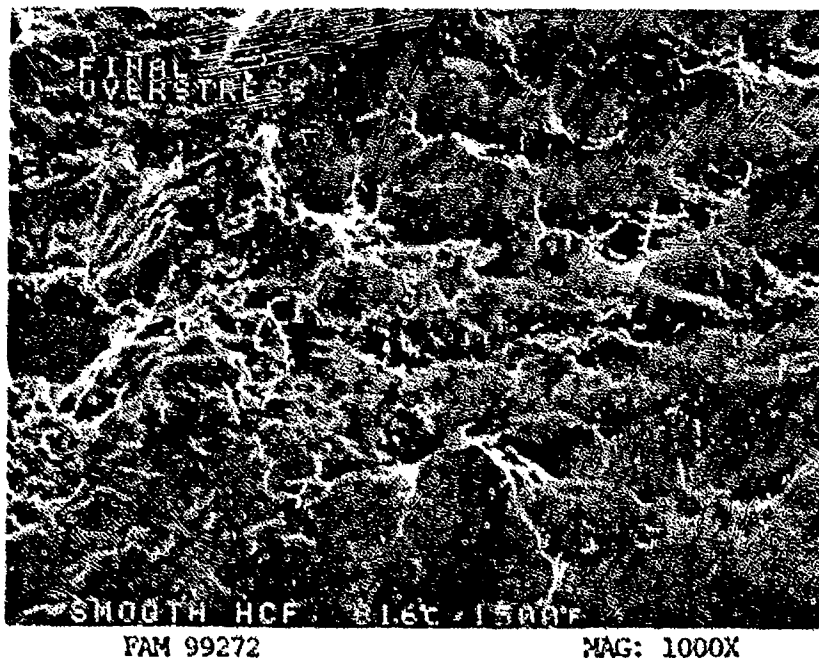
FIGURE 4-66: Oxidized, smeared and dimpled overstress in the final overstress area.

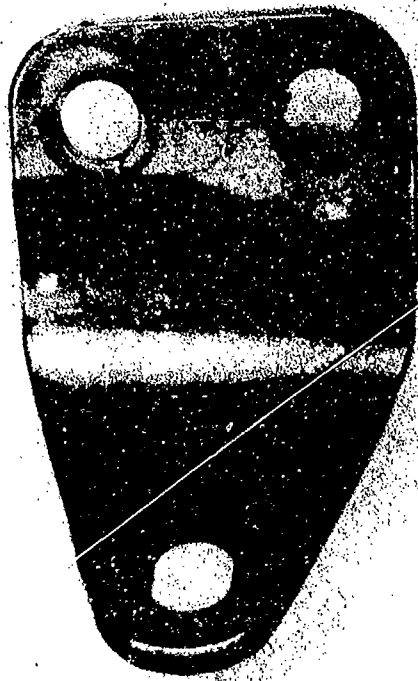
FAL 91683

SUMMARY: The bracket fractured by high cycle fatigue (HCF) propagating from multiple origins on both the inboard and outboard surfaces adjacent to an attachment bolt hole. The fracture surface exhibited a clearly defined shear lip near the center of the sample. This is indicative of reverse-bending loading. The lack of a large final overstress area indicates the nominal stress was low. The location of the origins was determined by the bolt head contact circle. No material or microstructural anomalies were found.

FIGURE 4-67: Overall photograph of the fractured bracket from the outboard side. The primary origins were located adjacent to one of the attachment bolt holes (arrow).

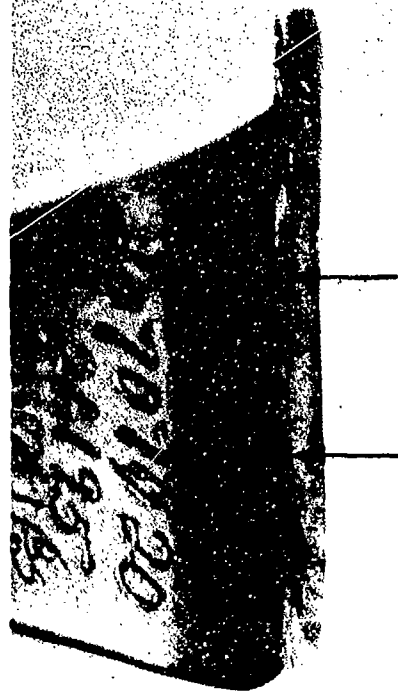
FAL 91684

FIGURE 4-68: Overall photograph of the fracture surface showing a well defined shear lip near the center (arrows).

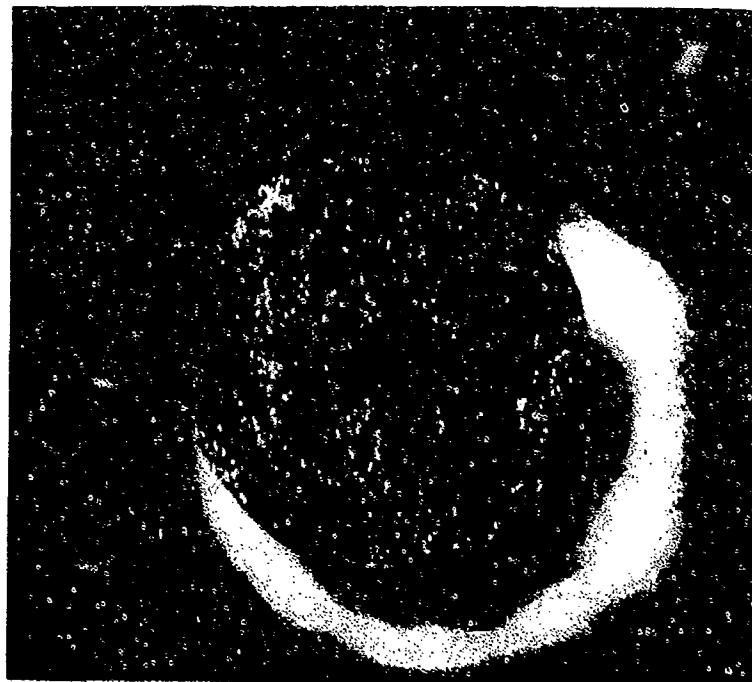
FAL 92496

FIGURE 5-1: Test results and fractography of A-286 room temperature smooth tensile test. The fracture appears granular with no shear lip visible.

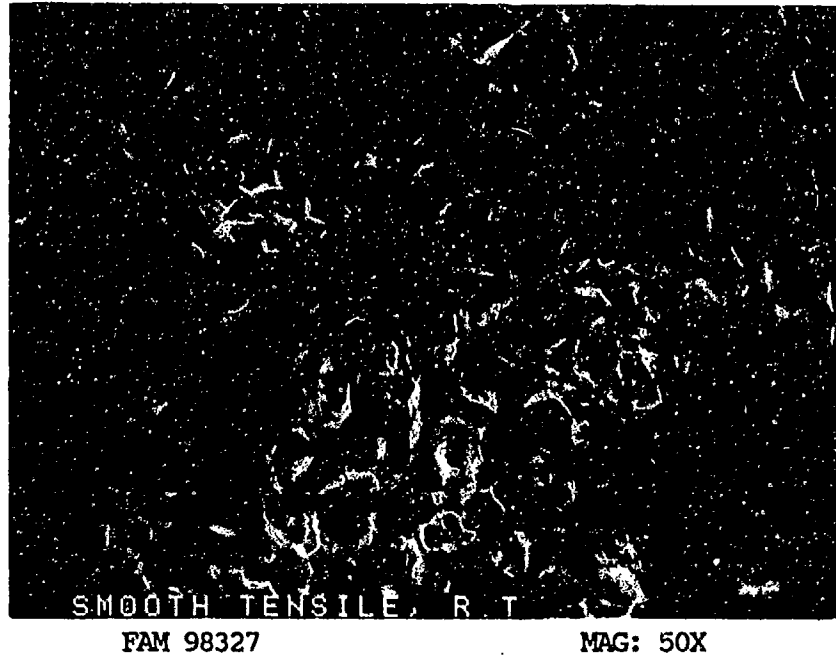
FIGURE 5-3: Low magnification photograph showing primarily intergranular overstress.

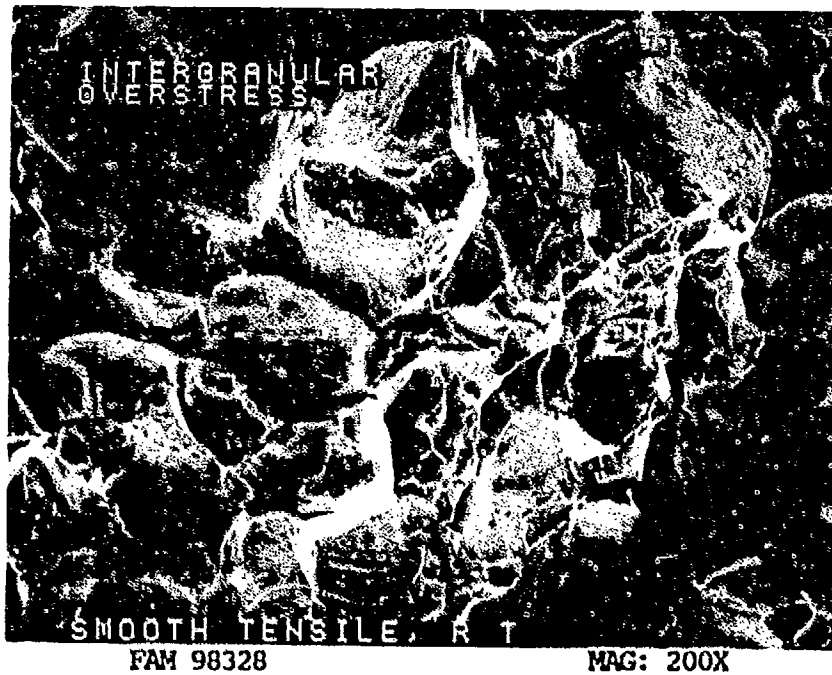
FIGURE 5-4: Intergranular overstress with some dimples at the grain boundaries (intergranular decohesion) (arrow).

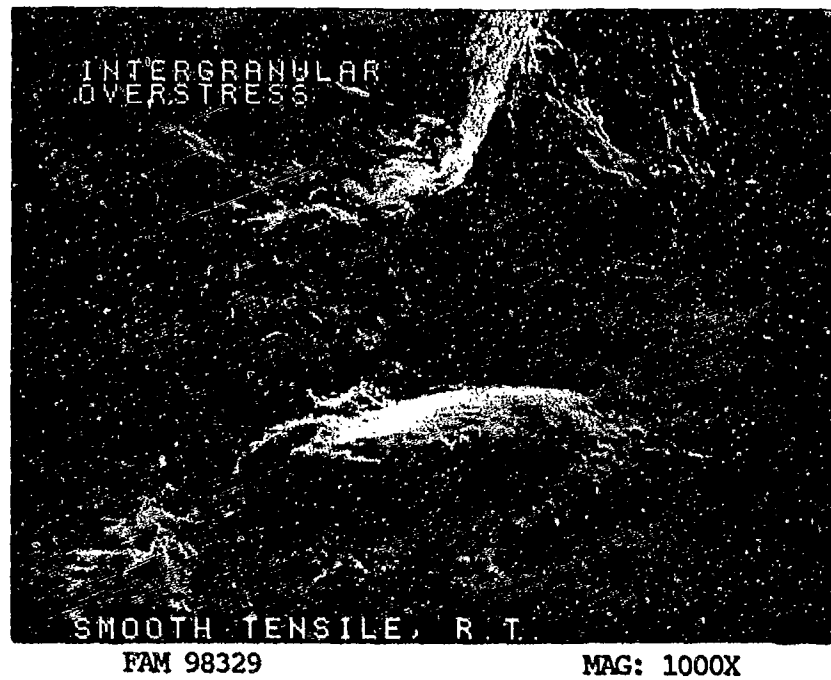
FIGURE 5-5: Intergranular overstress with slip lines present on the grain faces (arrow). These should not be confused with fatigue striations.

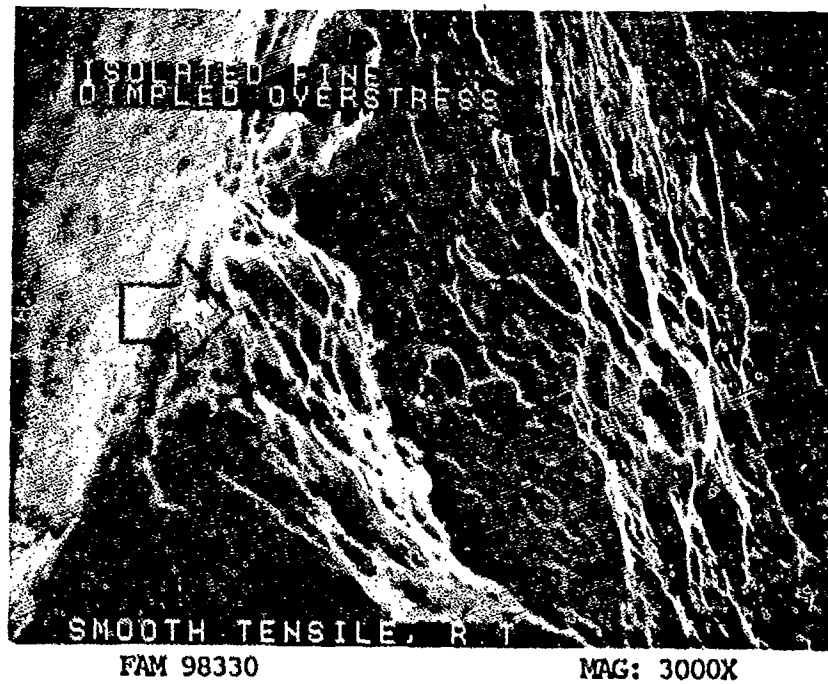
FIGURE 5-6: Isolated fine dimpled overstress at the grain boundaries (arrow).

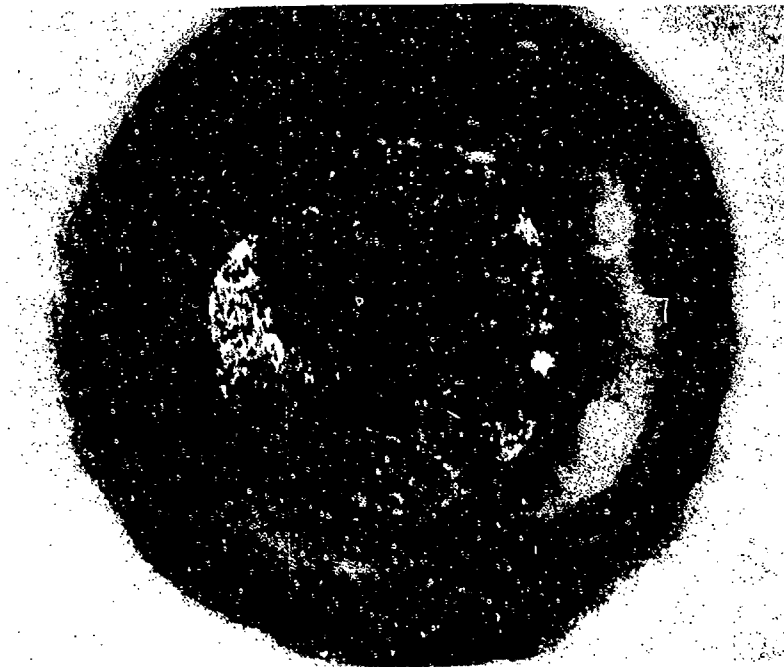
FAL 92497

FIGURE 5-7: Test results and fractography of A-286 704°C (1300°F) smooth tensile test. The fracture appears oxidized even at low magnification.
