FAILURE ANALYSIS HANDBOOK

C. R. Walker, K. K. Starr

Pratt & Whitney
P.O. Box 109600
West Palm Beach, FL 33410-9600

August 1989

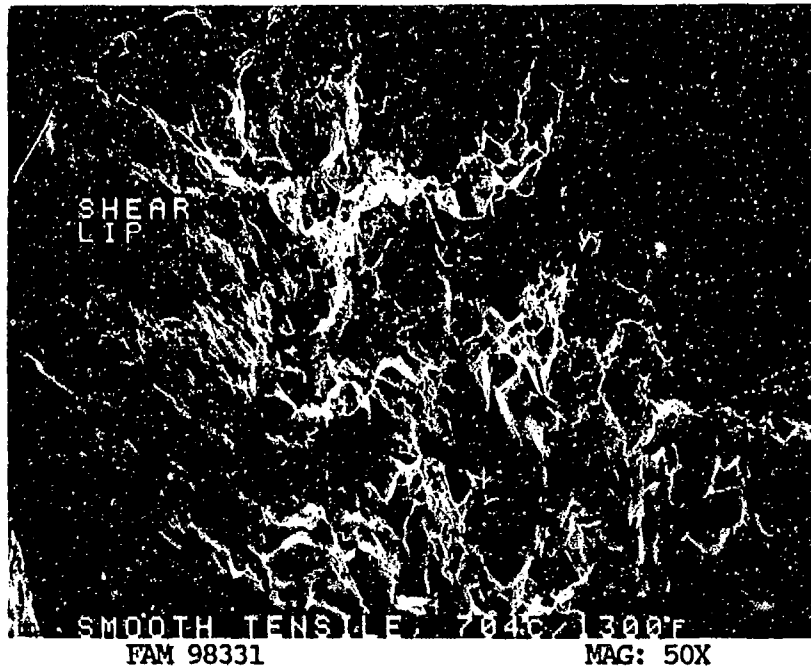
FIGURE 5-9: Low magnification photograph showing smeared shear lip area.

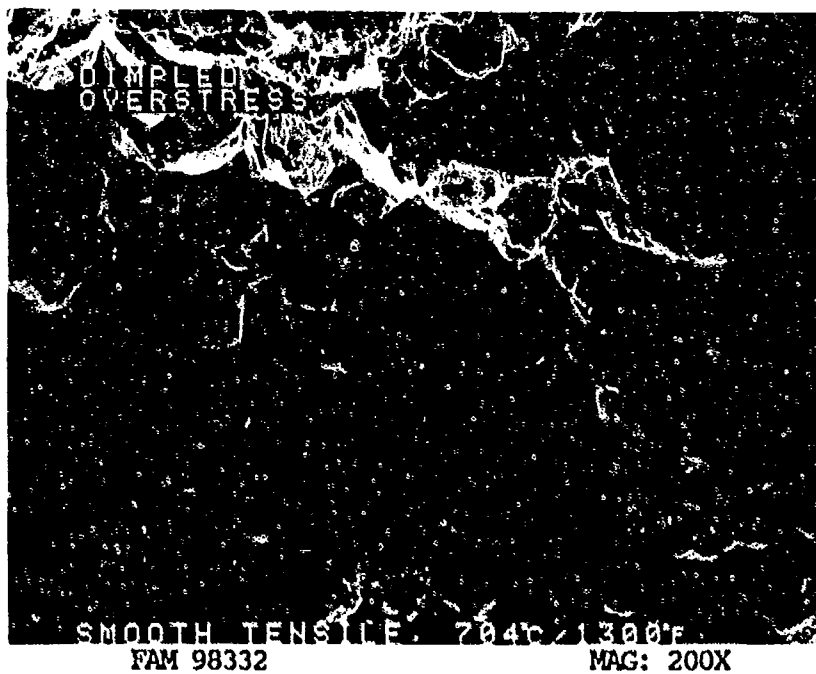
FIGURE 5-10: Mixture of fine and coarse dimpled overstress in the primary fracture area.

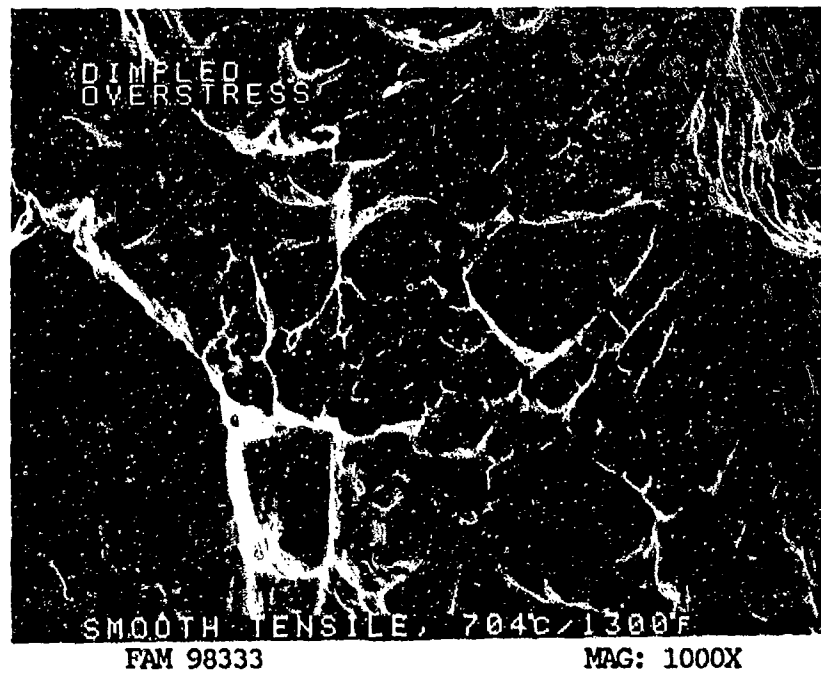
FIGURE 5-11: Mixture of coarse and fine shallow dimples in the primary fracture area. A light oxide covers the fracture surface.

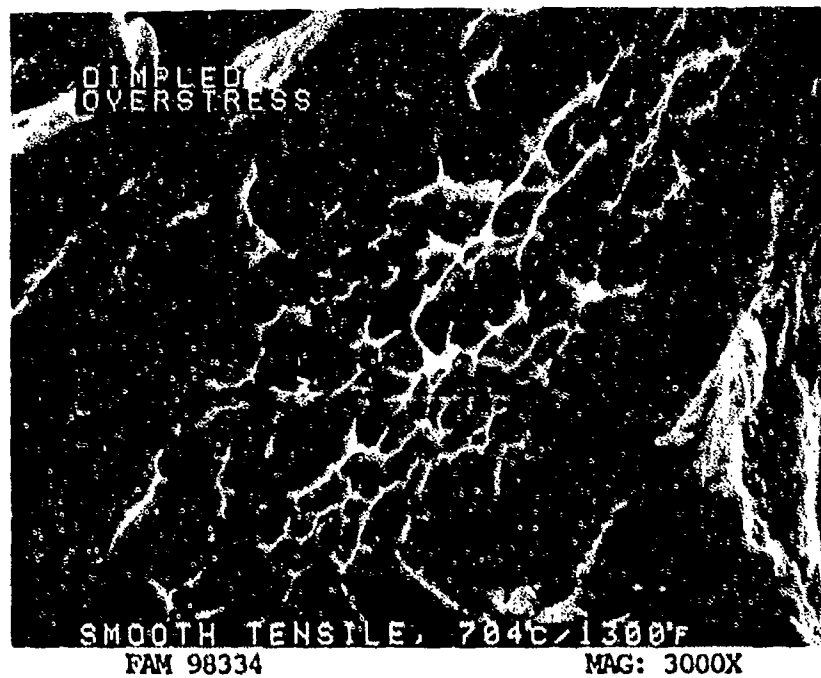
FIGURE 5-12: Patches of fine equiaxed dimples in the area shown in Figure 5-11.

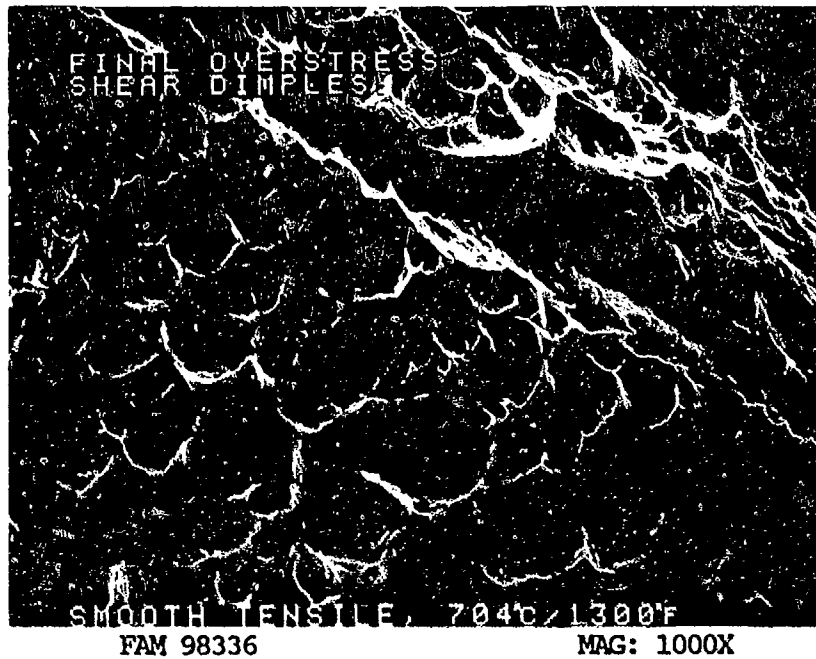
FIGURE 5-13: Oxidized shear dimples in the final overstress area. Arrows show the directions of relative motion.

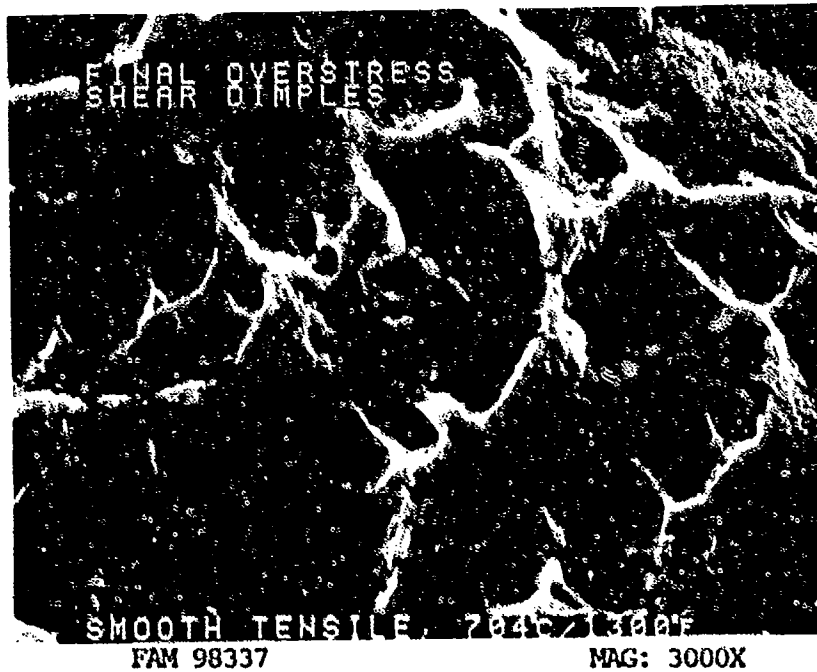
FIGURE 5-14: Oxidized shallow shear dimples in the final overstress area.

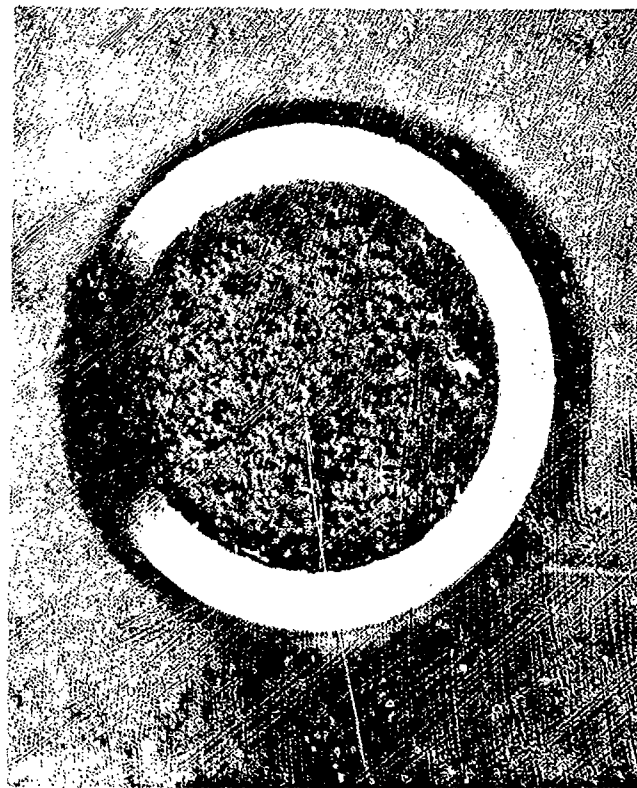
FAL 92498

FIGURE 5-15: Test results and fractography of A-286 room temperature notched tensile test. No shear lip is visible.

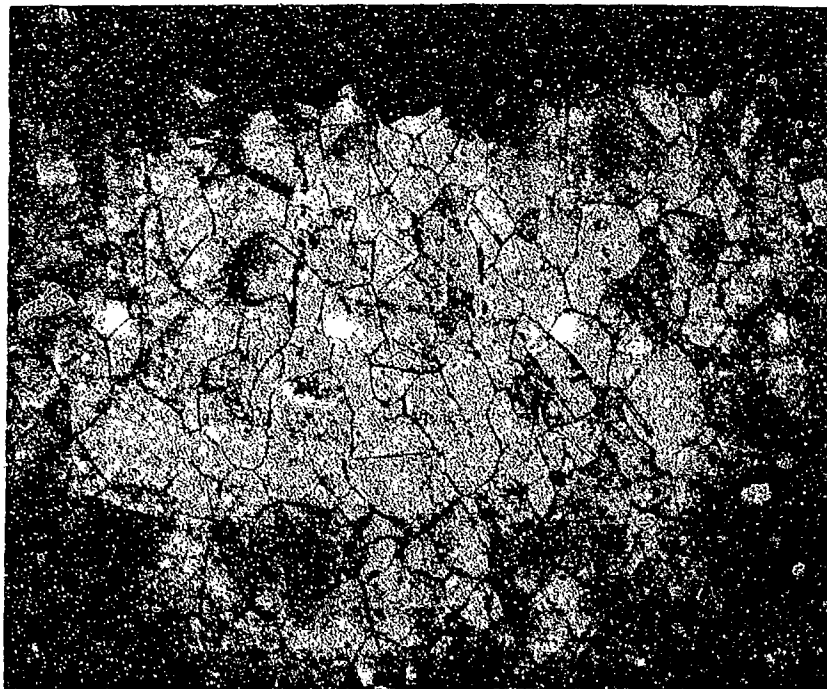
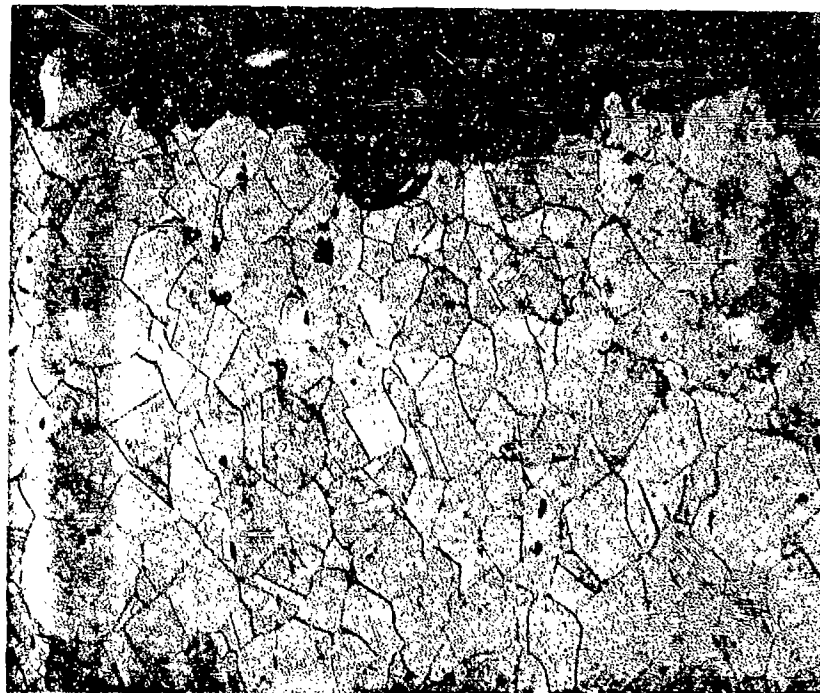
FIGURE 5-16: Optical photomicrographs of the center of the fracture. Very little grain deformation is visible and only one area exhibits secondary grain boundary separation. Compare with the smooth tensile specimens, Figures 5-2 and 5-8.

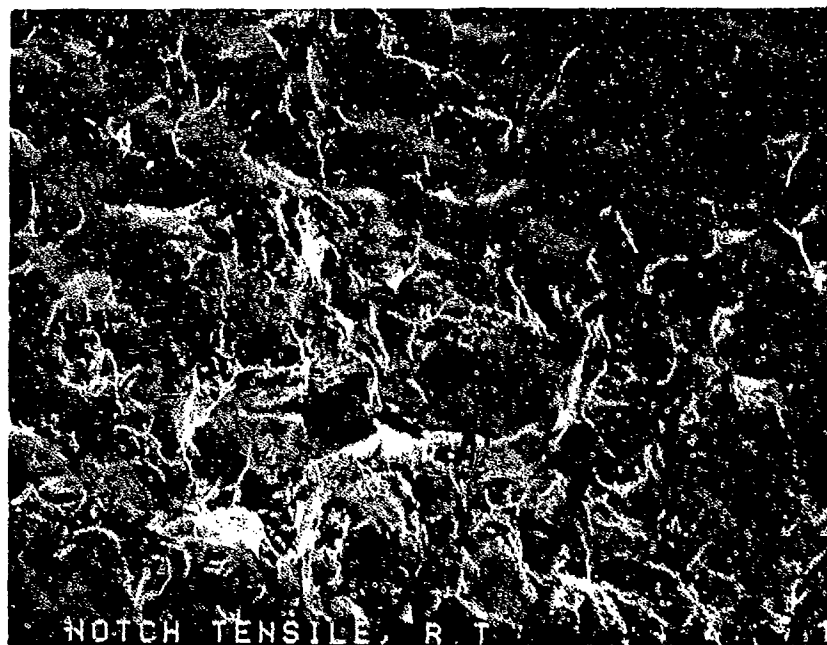
FAM 98317

FIGURE 5-18: Mixture of dimpled overstress (arrow A), cleavage (arrow B) and void formation (arrow C).

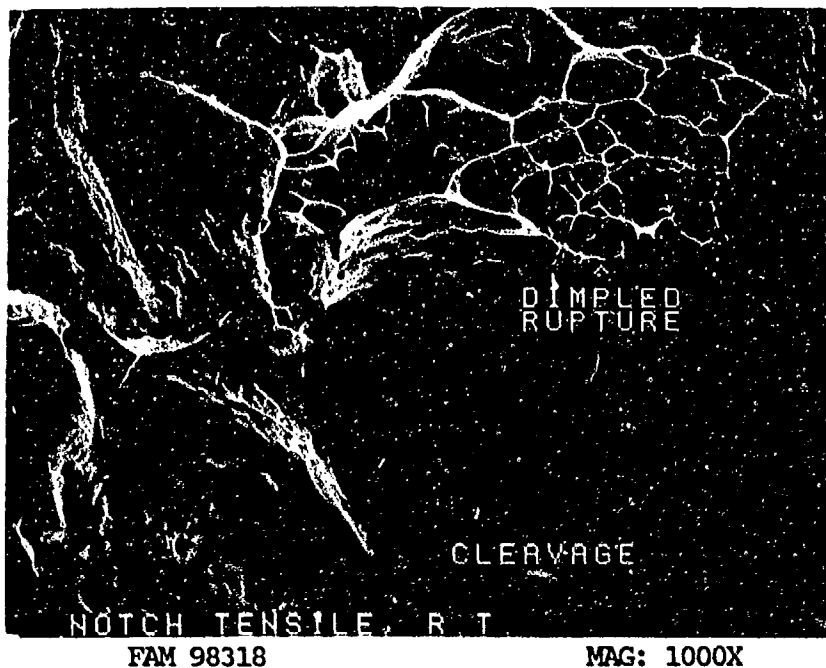
FIGURE 5-19: Mixture of dimpled overstress and quasi-cleavage (mixed mode overstress). Fine slip lines are visible on the cleavage planes (brackets). These should not be confused with fatigue striations.

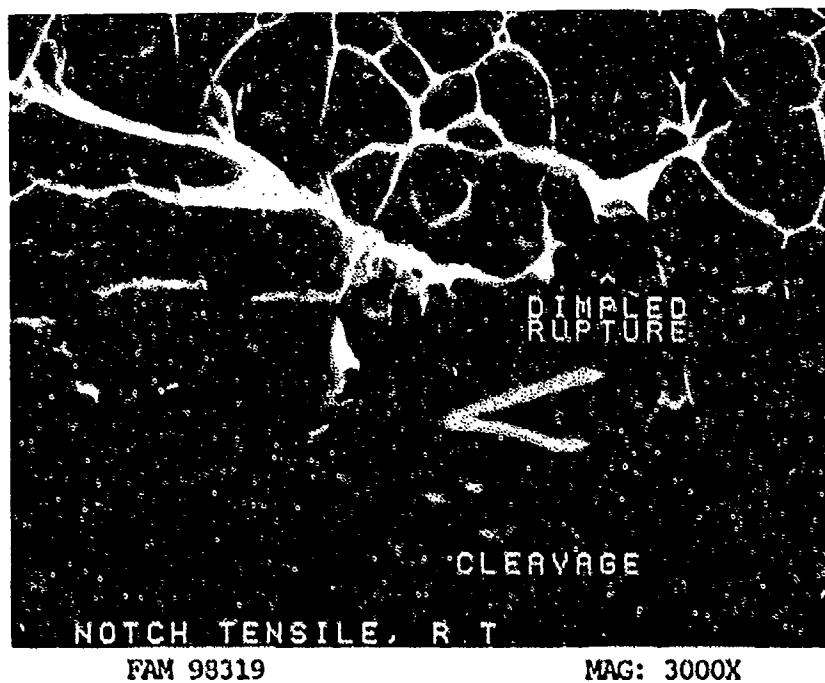
FIGURE 5-20: Boundary between dimpled overstress and a cleavage plane.

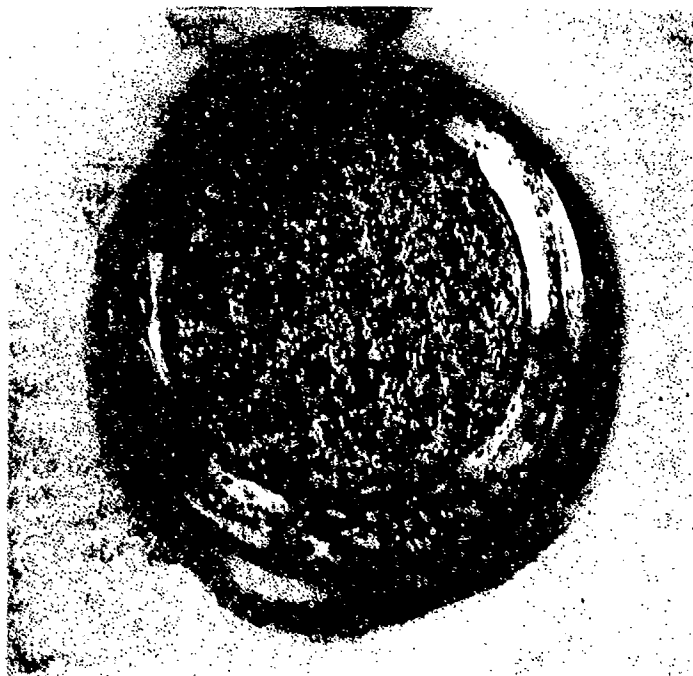
FAL 92499

FIGURE 5-21: Test results and fractography of A-286 704°C (1300°F) notched tensile test. The fracture appears oxidized even at low magnification.

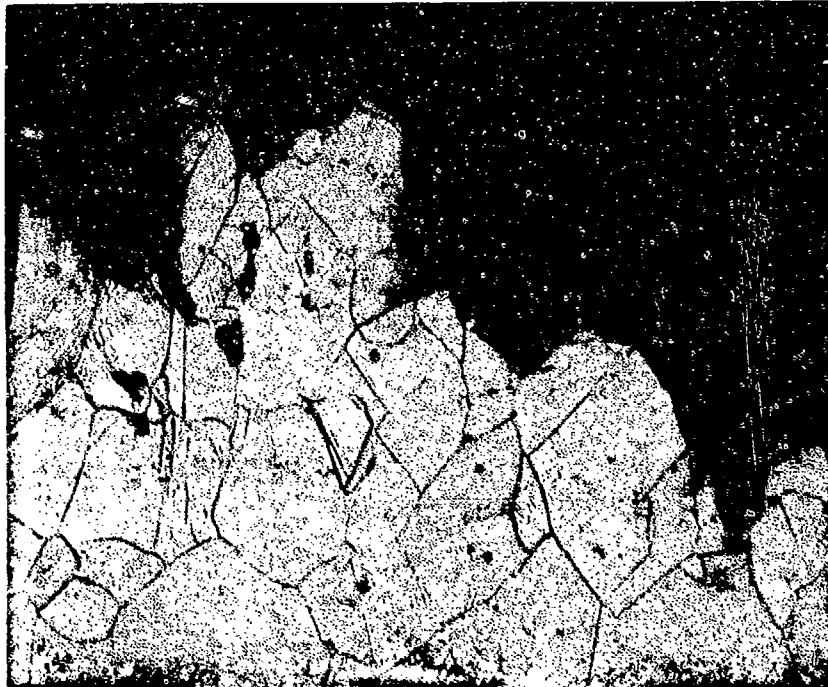
FIGURE 5-22: Pair of increasing magnification optical photomicrographs of the center of the fracture. More grain deformation is visible than in the room temperature notched tensile specimen. There is still very little secondary grain boundary separation. Compare with the smooth tensile specimens, Figures 5-2 and 5-8.
Etchant: 15ml HCl, 10ml HNO₃, 10ml acetic acid

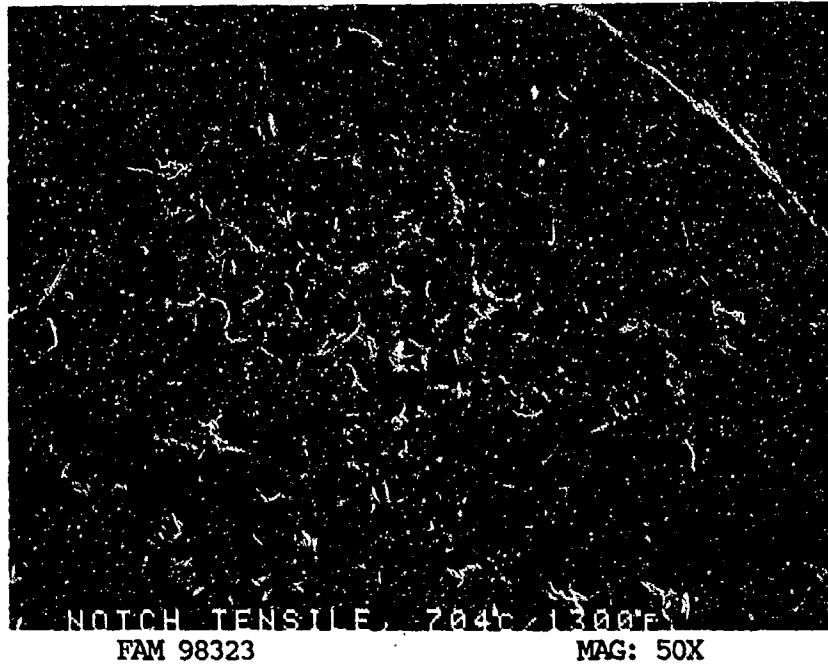
FIGURE 5-23: Low magnification photograph showing an intergranular appearance with some secondary cracking (arrow).

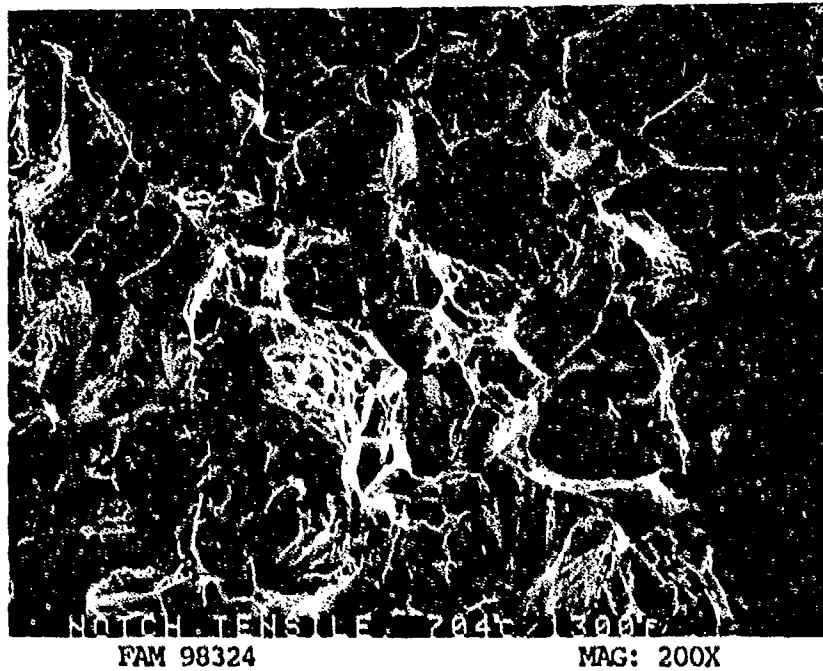
FIGURE 5-24: Mixture of transgranular and intergranular features.

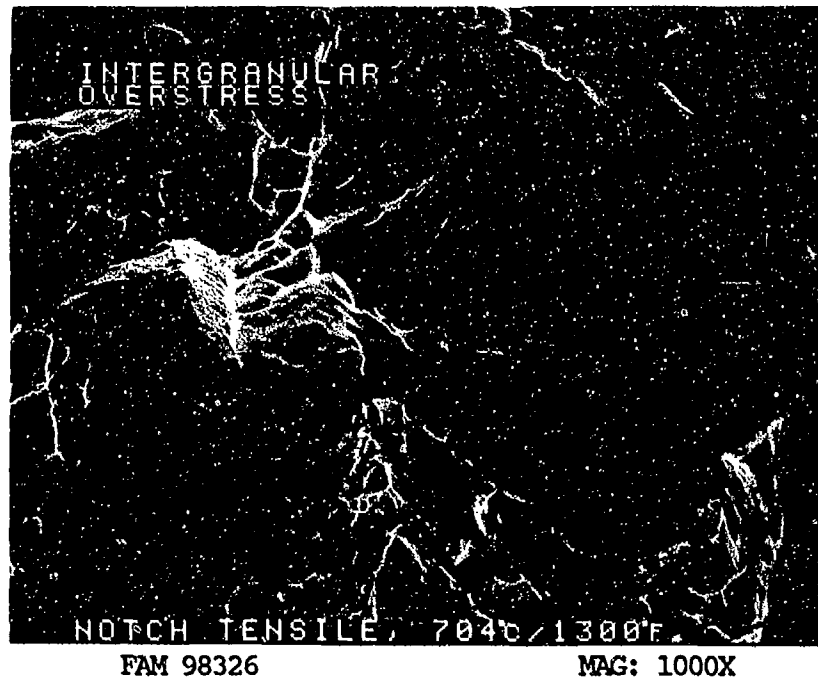
FIGURE 5-25: Mixture of cleavage and intergranular overstress with some grain boundary separation. Fine, shallow dimples are visible on some of the grain faces (arrow).

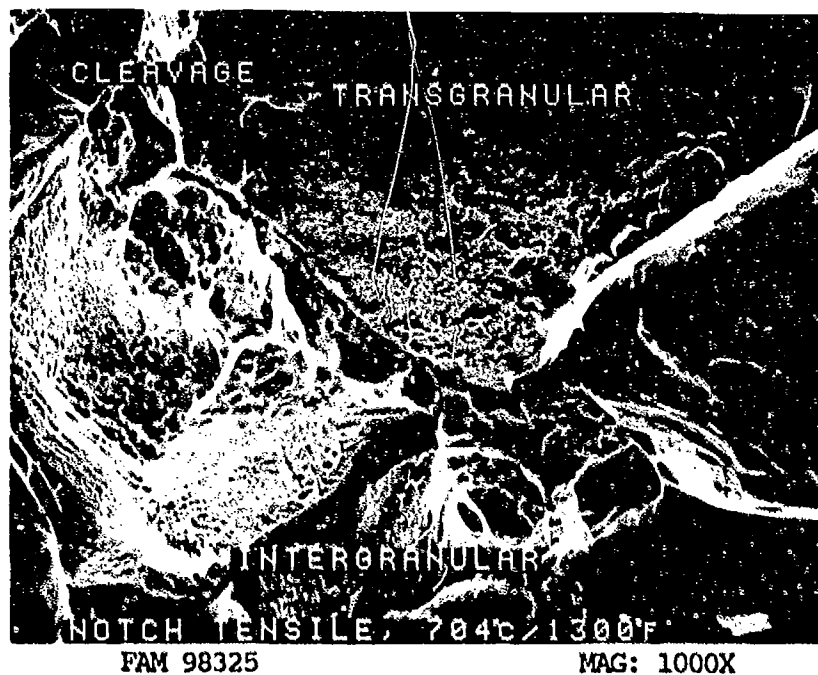
FIGURE 5-26: Higher magnification photo showing area of probable quasi-cleavage.

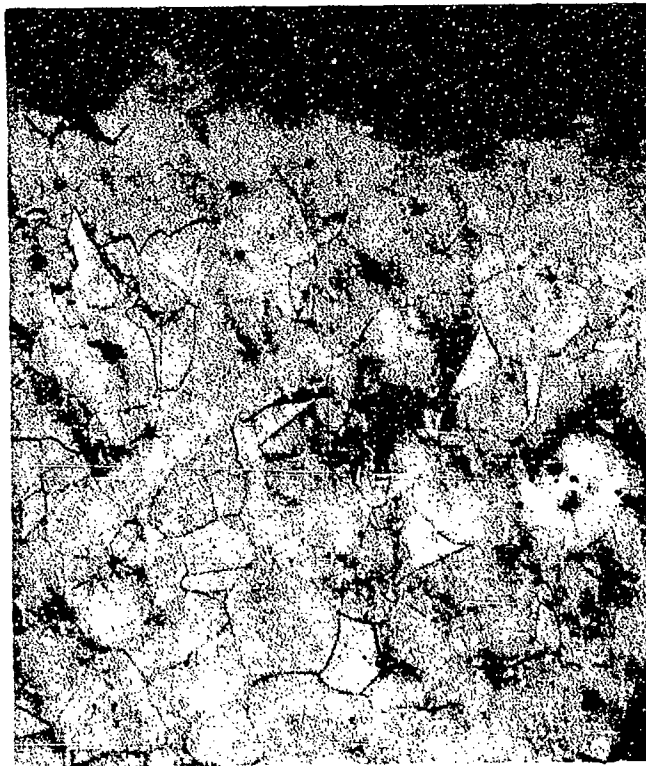
FAM 100294

FIGURE 5-28: Optical photomicrographs of the center of the fracture (top) and the gage section (bottom). Both the primary fracture path and secondary cracks along the gage section (arrow, bottom) are intergranular.

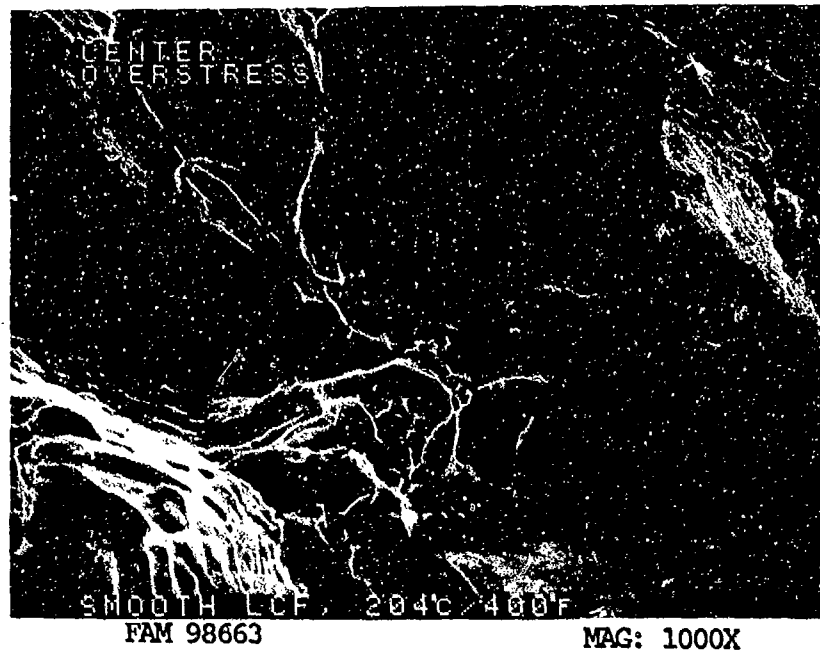
FIGURE 5-67: Overstress features near the center of the specimen are a mixture of intergranular rupture and dimpled overstress.

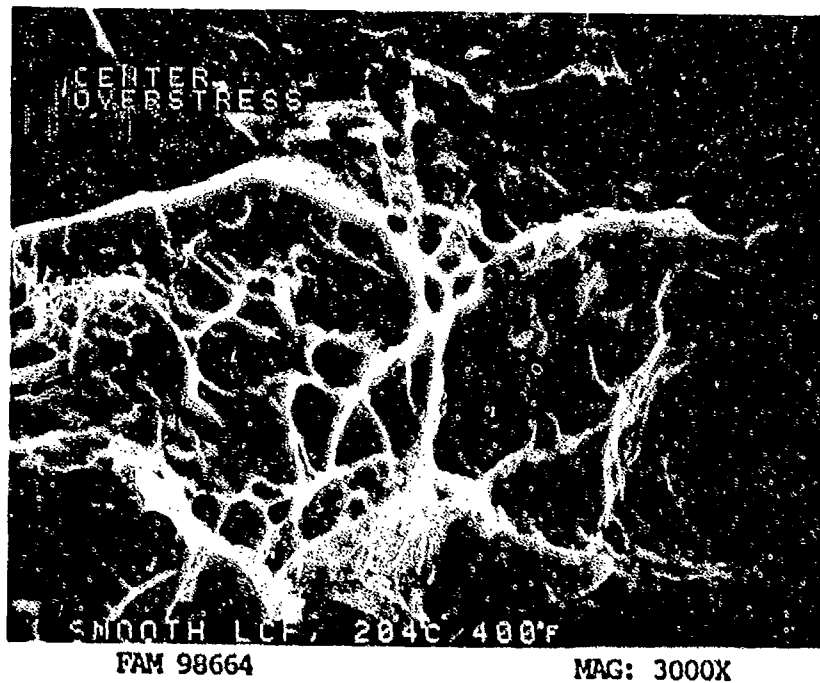
FIGURE 5-68: Dimpled overstress near the center of the specimen. A carbide is visible at the bottom of a dimple (arrow).

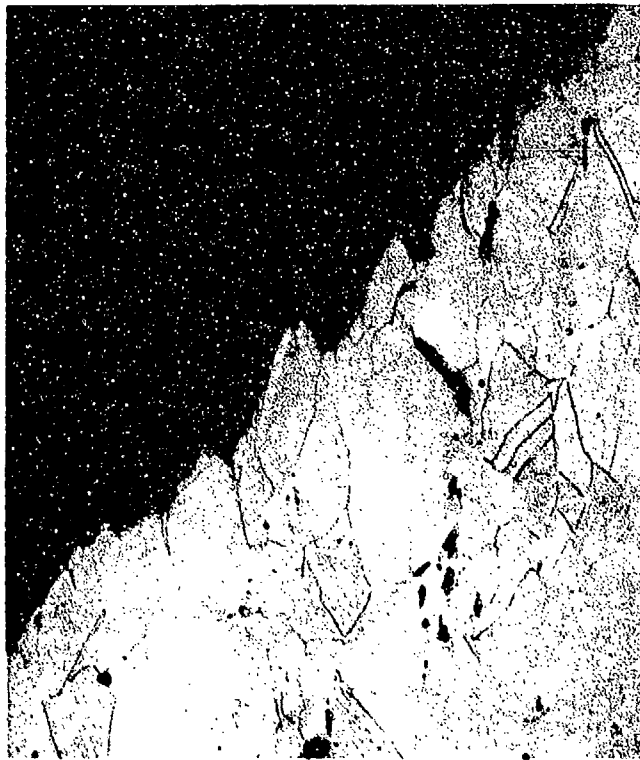
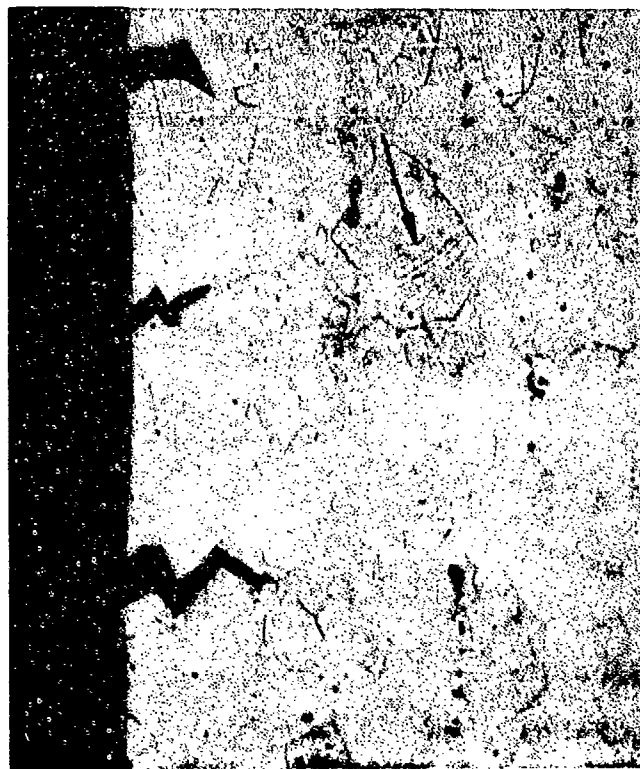
FIGURE 5-70: Optical photomicrographs showing the final overstress area (top) and intergranular secondary cracks (bottom). The final overstress area exhibits grain elongation and some strain lines. Compare with the 400° F specimen (Figure 5-63). Strain lines are also visible in isolated grains along the gage section (arrow).

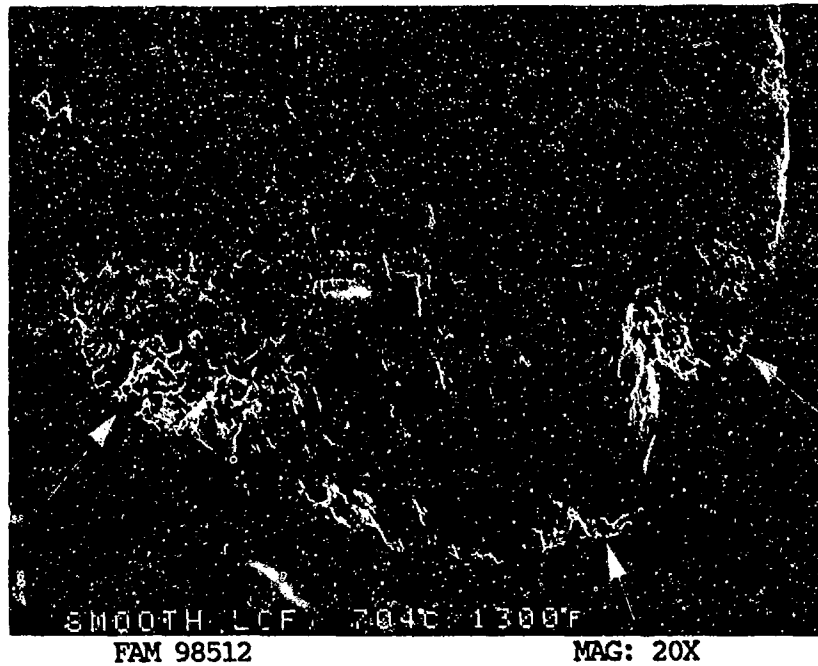
FIGURE 5-71: Overall photograph showing several fatigue origins that exhibit a granular appearance (arrows). Some secondary cracking is also visible on the specimen surface.

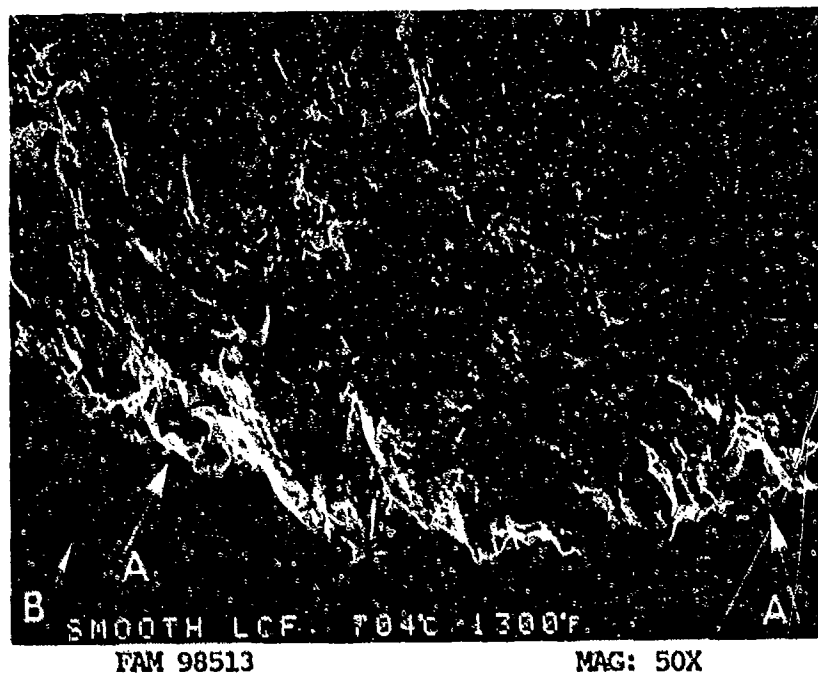
FIGURE 5-72: Photograph showing two small fatigue zones (arrows A). Secondary cracking (arrow B) is visible adjacent to the primary fracture.

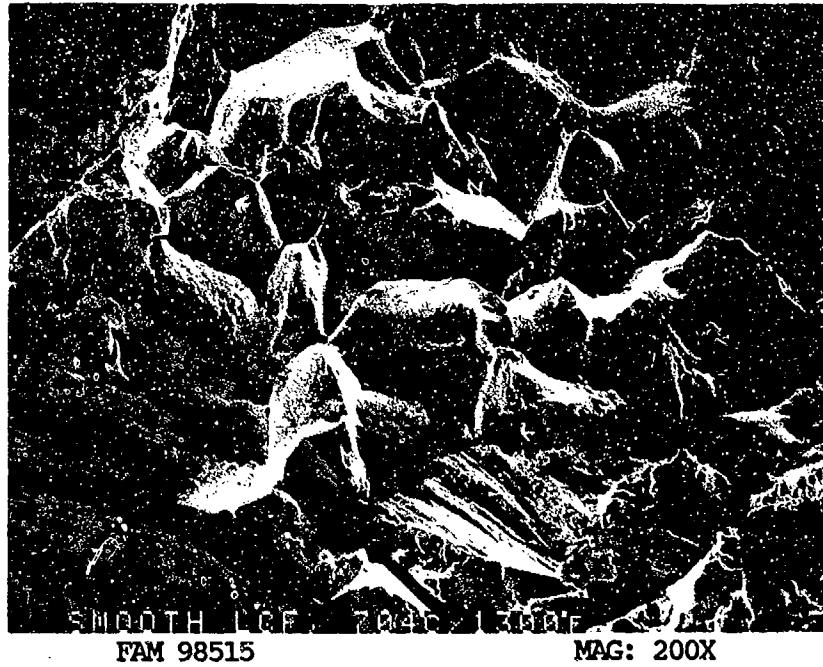
FIGURE 5-73: Intergranular appearance of the initial fatigue progression.

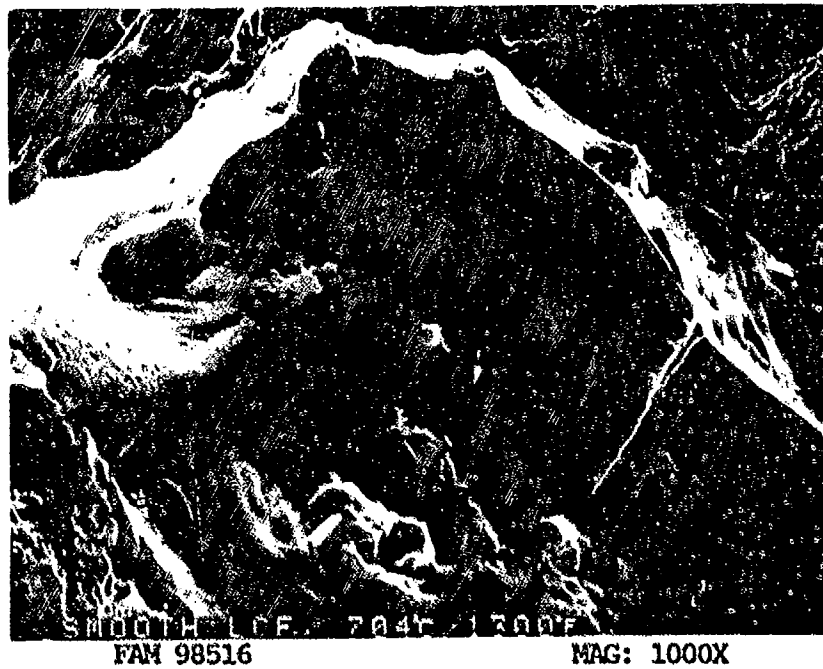
FIGURE 5-74: Remnant features indicative of fatigue. An arrow indicates the direction of propagation.

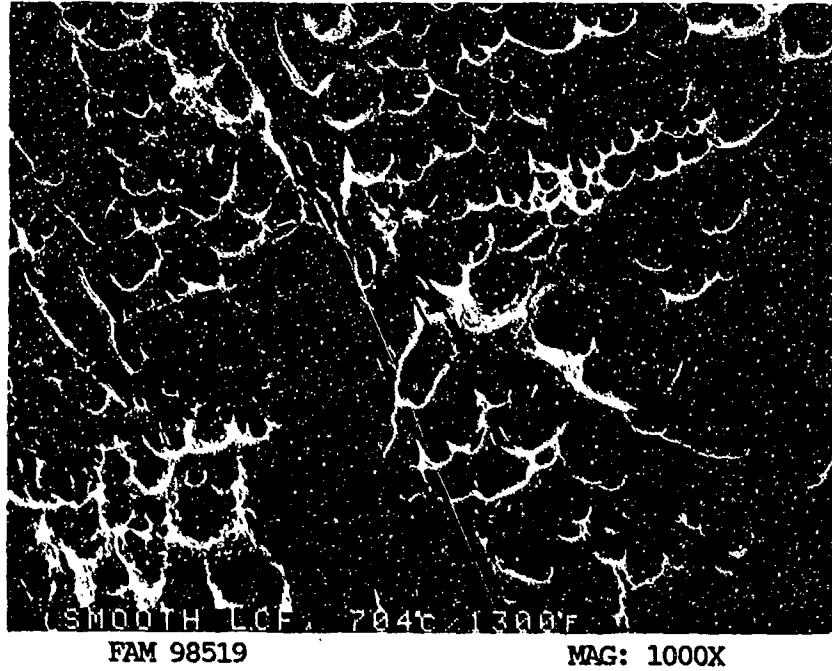
FIGURE 5-75: Shear dimples in the final overstress area. Arrows indicate the directions of relative motion.

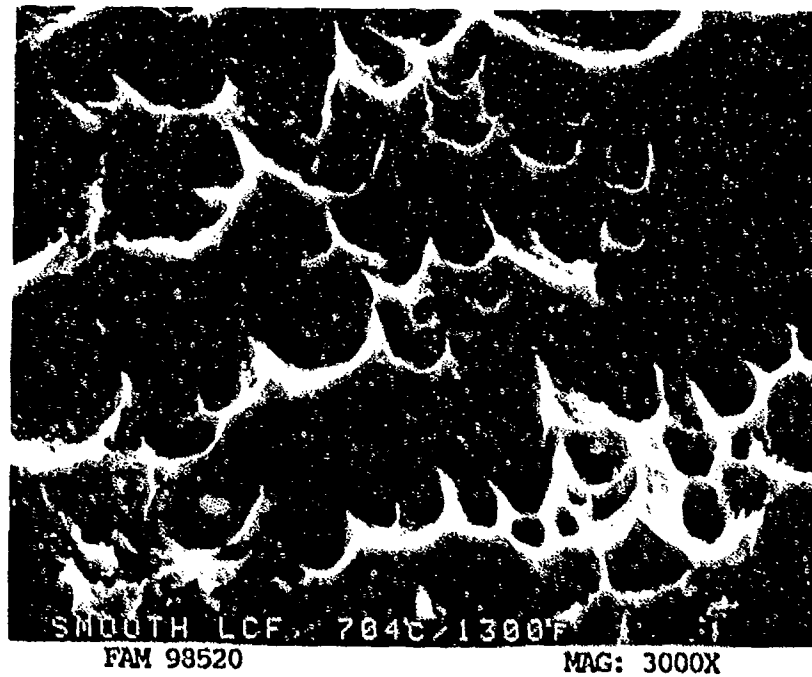
FIGURE 5-76: High magnification photo of the shear dimples shown in Figure 5-75.

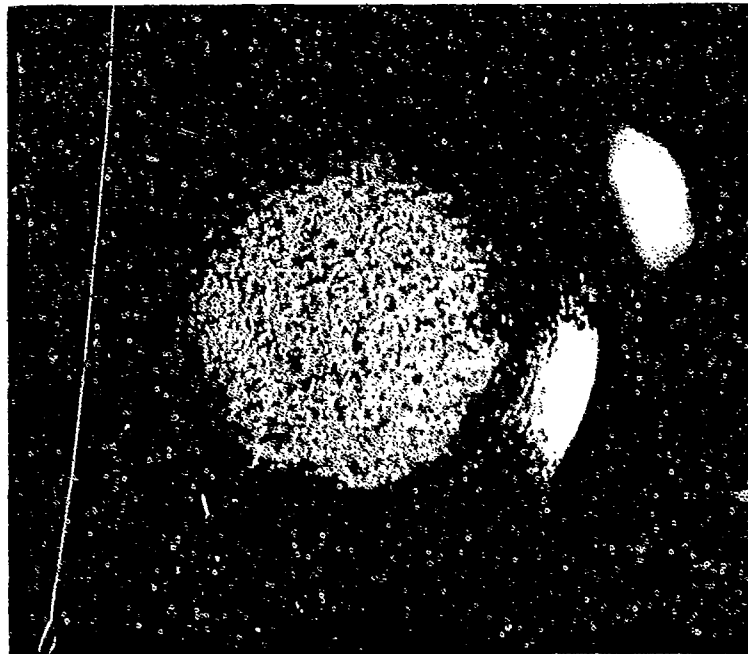
FAL 93217

FIGURE 5-81: Test results and fractography of A-286 hydrogen embrittlement test. No shear lip is visible but the O.D. of the fracture has a jagged appearance.

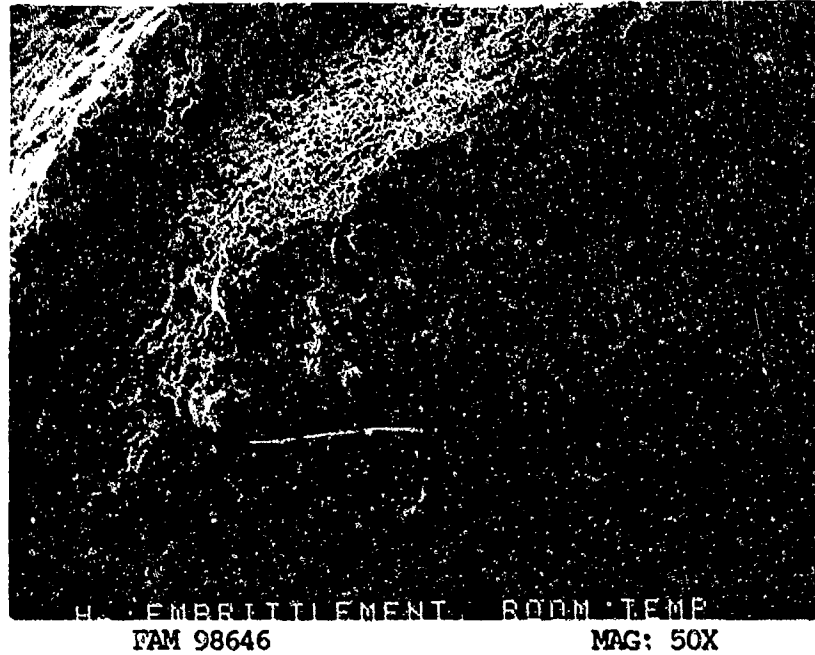
FIGURE 5-83: Low magnification photograph near the edge of the specimen.

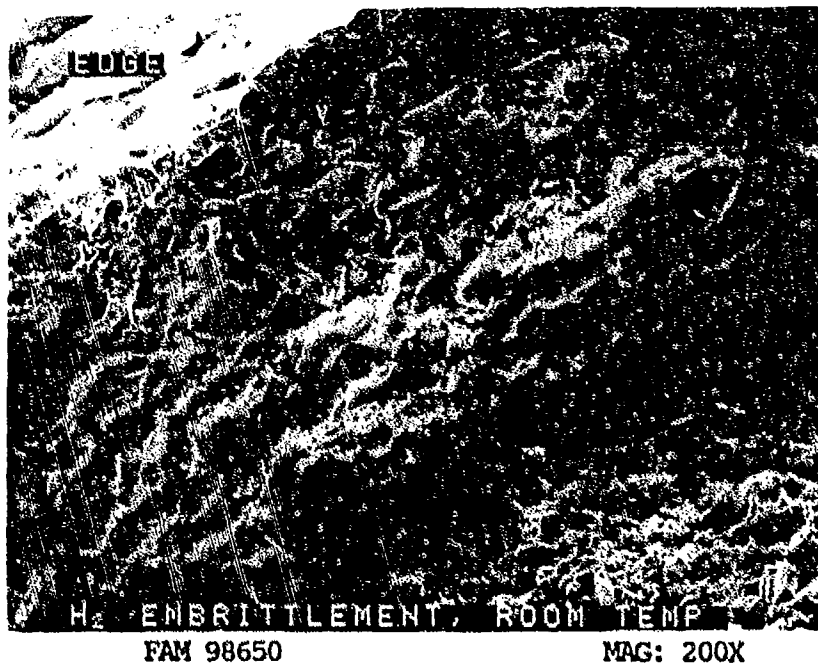
FIGURE 5-84: Lip at the outside edge of the specimen, exhibiting jagged steps.

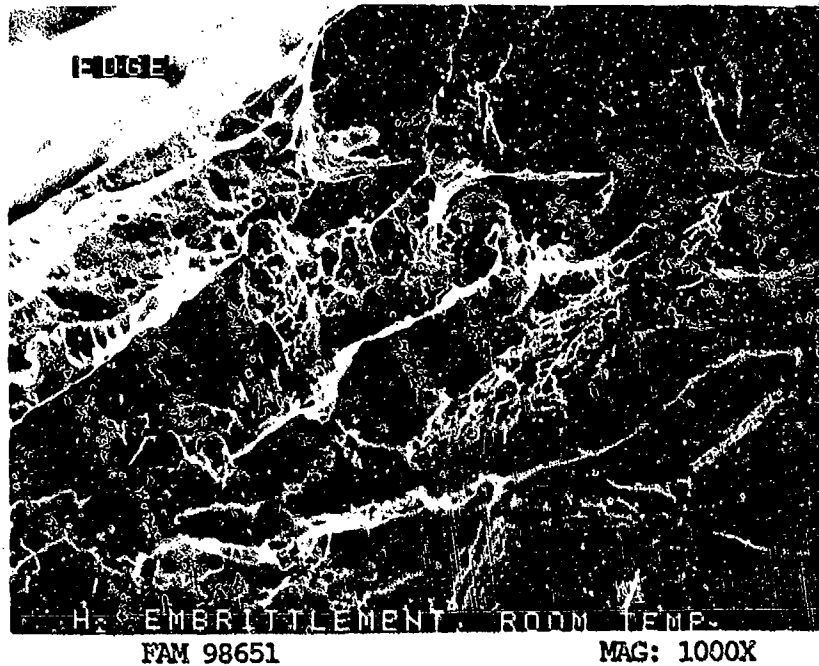
FIGURE 5-85: Jagged steps near the edge of the specimen. The steps contain small dimples and patches of cleavage.

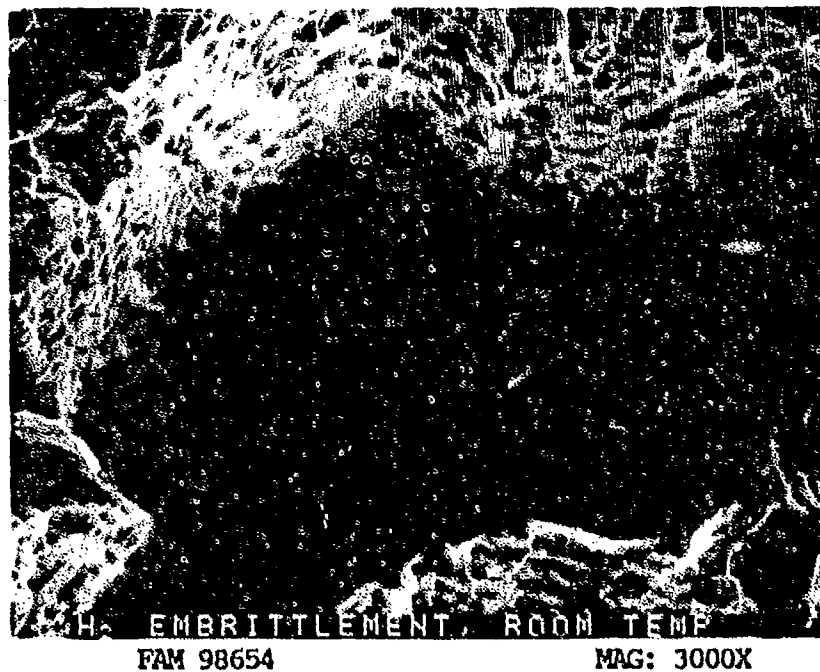
FIGURE 5-86: Higher magnification photograph of the area shown in Figure 5-85, showing steps near the edge containing dimples.

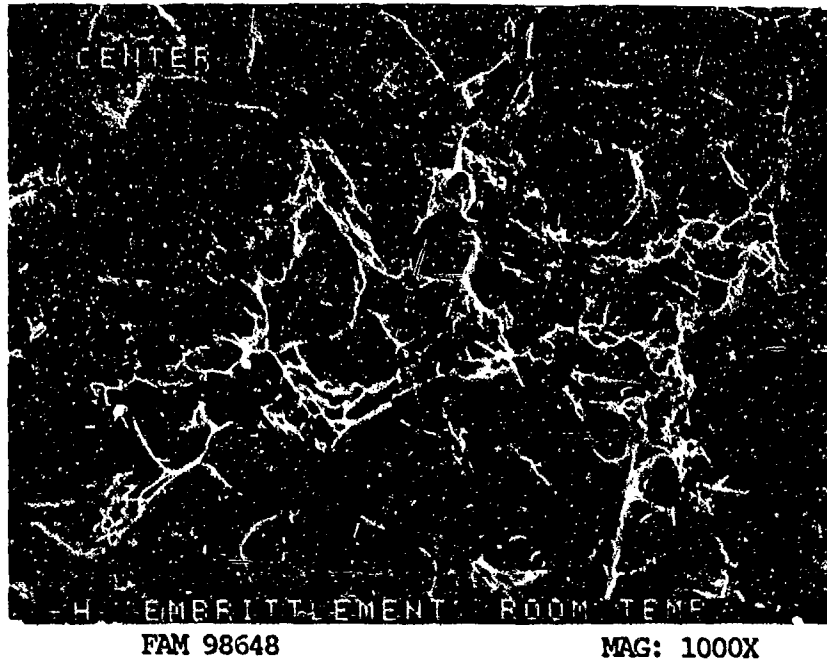
FIGURE 5-87: Final overstress area near the center of the fracture surface. Several cracked carbides are visible (arrows).

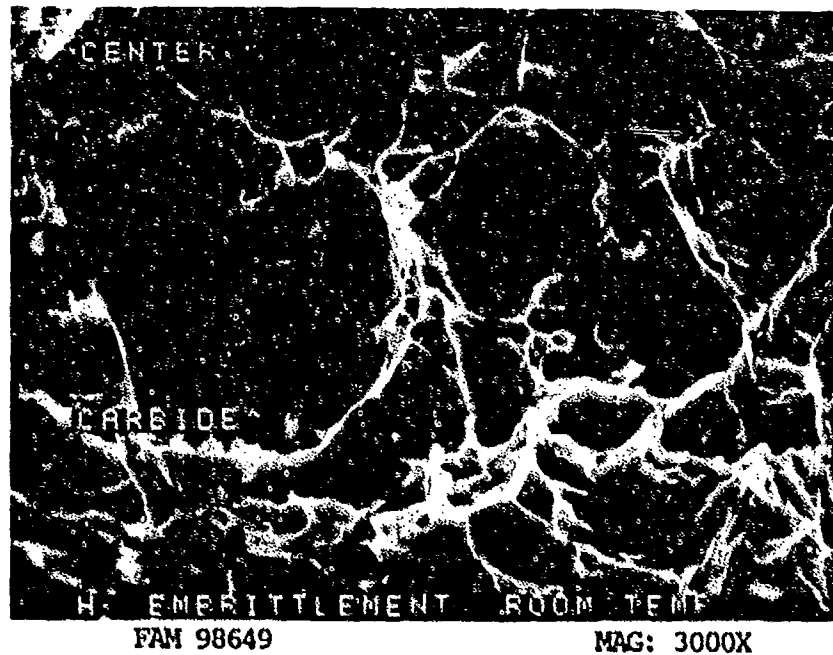
FIGURE 5-88: Dimpled overstress features in the center of the fracture. A cracked carbide is visible.

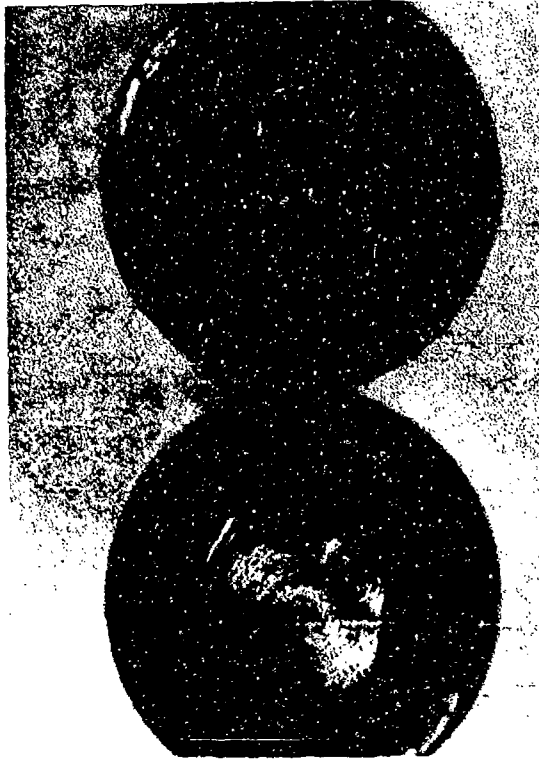
FAL 87136 MAG: 6X

SUMMARY: The fracture of bolts A1 and A2 (Figure 5-89) was attributed to torsional overstress of the material. Both of the bolts were being loosened when the fracture occurred. This was determined by examination of the elongated shear dimples at the periphery of the mating fracture surfaces (Figures 5-91 and 5-92). No material or microstructural defects were found.

FIGURE 5-89: Overall photographs of bolts A1 and A2. The torsional nature of the fractures is clearly visible.

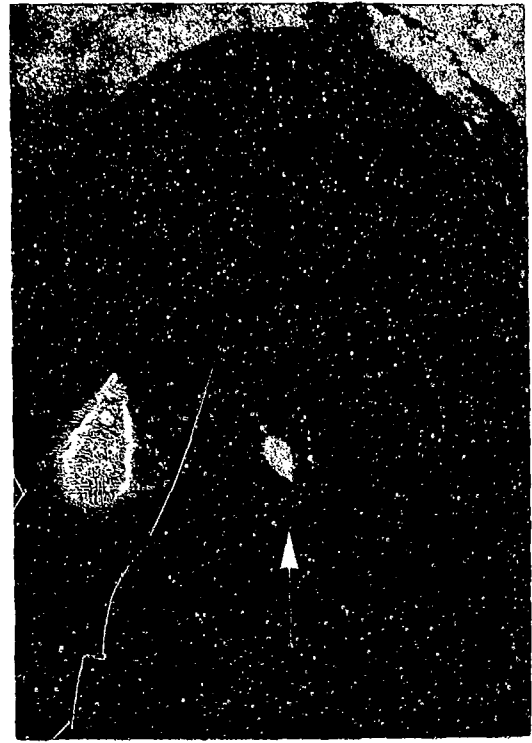
FAL 93389 MAG: 20X

FIGURE 5-90: Overall photograph of the fracture surface on tail cone bolt A1. The final overstress area is shown by an arrow.

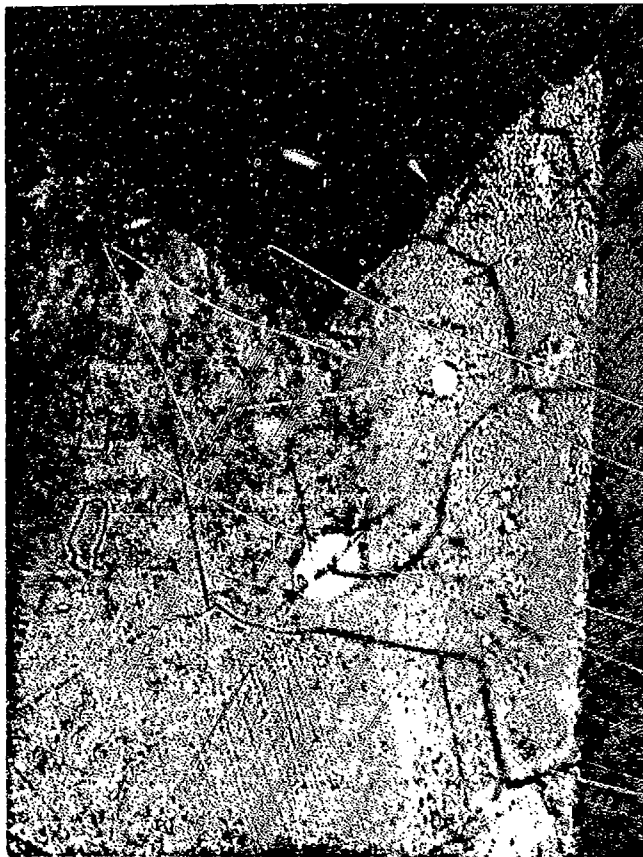
FAM 99792

FIGURE 6-2: Optical photomicrograph showing the faceted, transgranular fracture path at the fatigue origin (arrow).

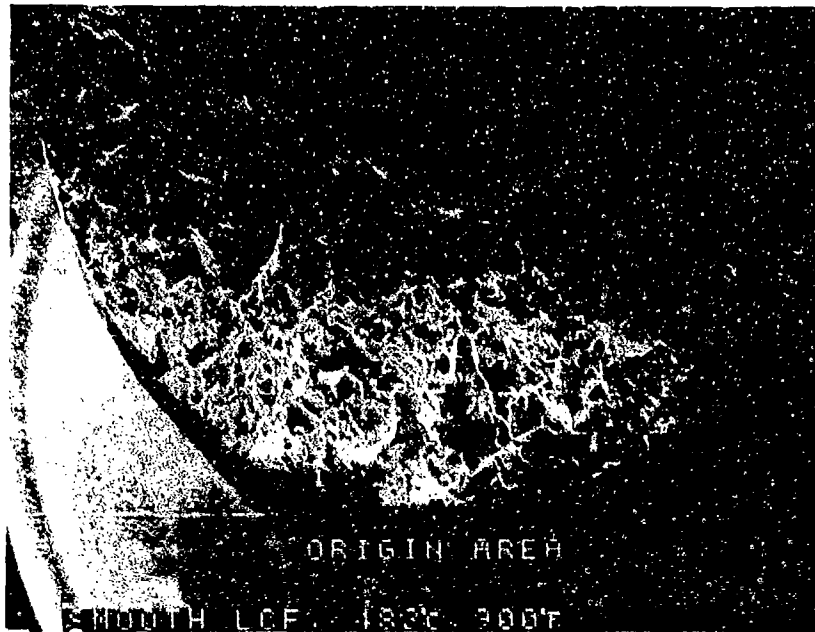
FAM 98500

FIGURE 6-3: Low magnification photograph showing a faceted fatigue progression area at the surface of the specimen.
