FAILURE ANALYSIS HANDBOOK

C. R. Walker, K. K. Starr

Pratt & Whitney
P.O. Box 109600
West Palm Beach, FL 33410-9600

August 1989

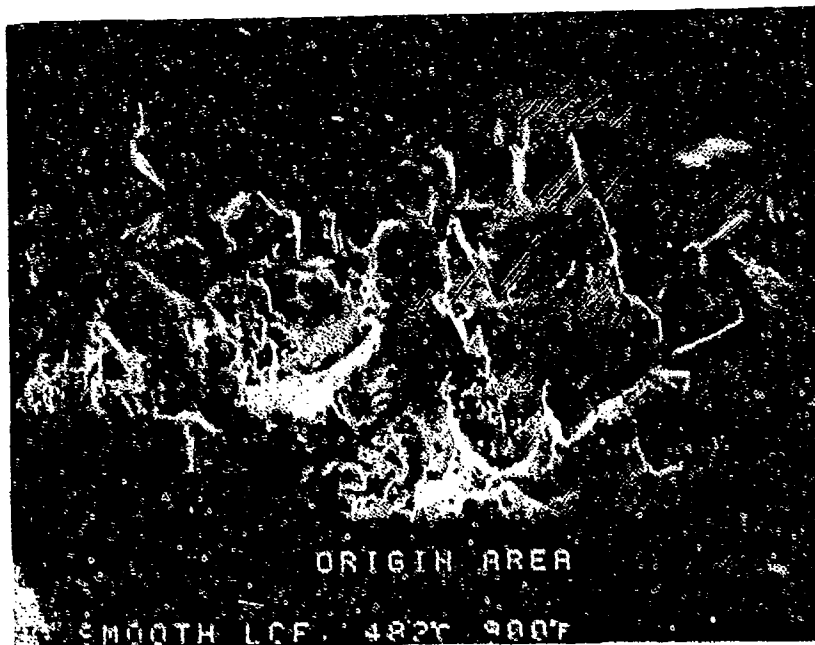
FAM 98501

FIGURE 6-4: Higher magnification photograph of the fatigue progression area shown in Figure 6-3.

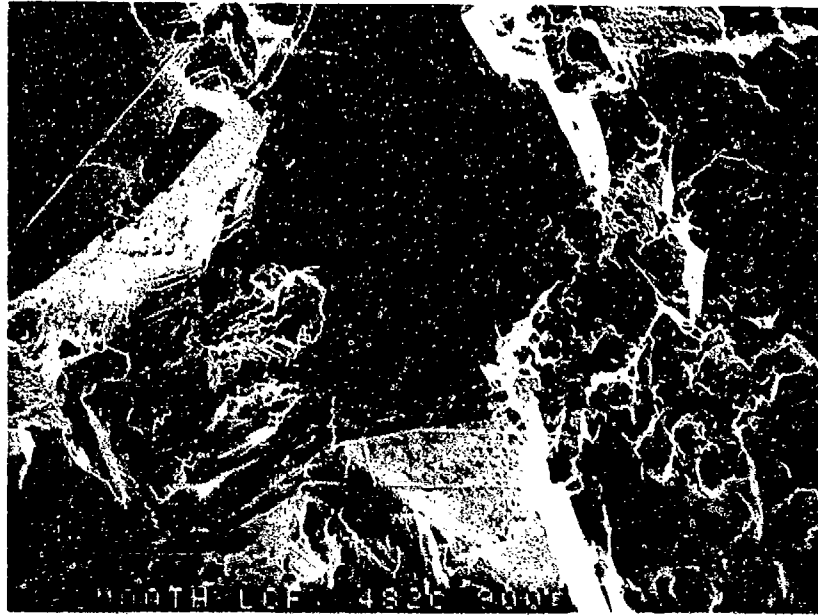
FIGURE 6-5: Higher magnification photograph of the fatigue thumbnail showing a faceted granular appearance. Slip lines are visible on the larger facets. These should not be confused with fatigue striations.

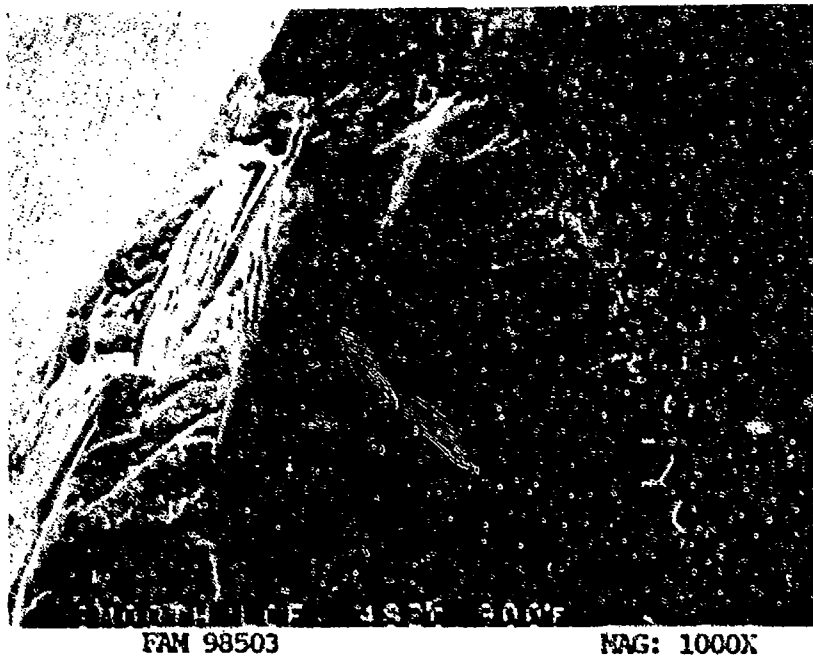
FIGURE 6-6: A small patch of fatigue striations is visible between facets. The direction of progression is shown by an arrow.

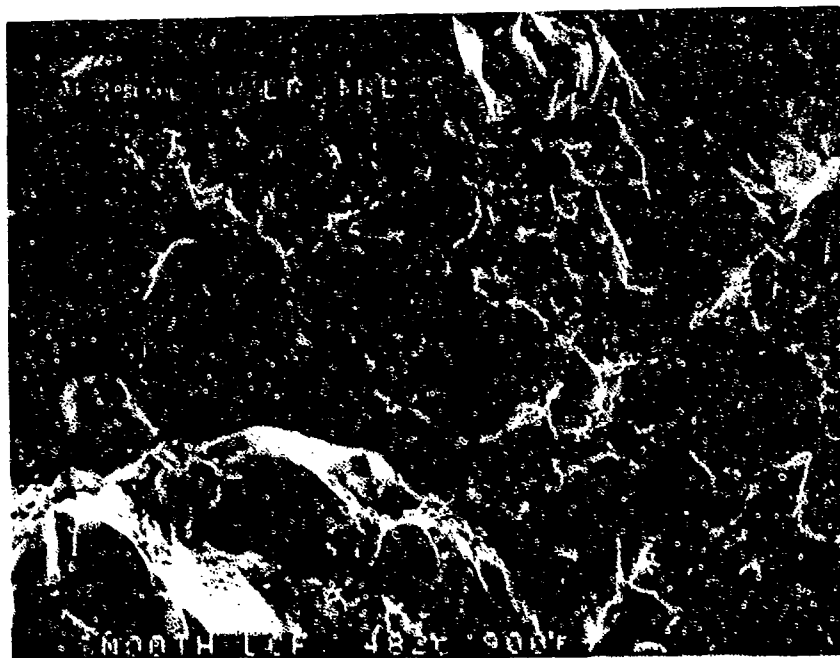
FAM 98507

FIGURE 6-8: Final overstress area exhibiting a mixture of intergranular cleavage and transgranular dimpled overstress (mixed mode overstress).

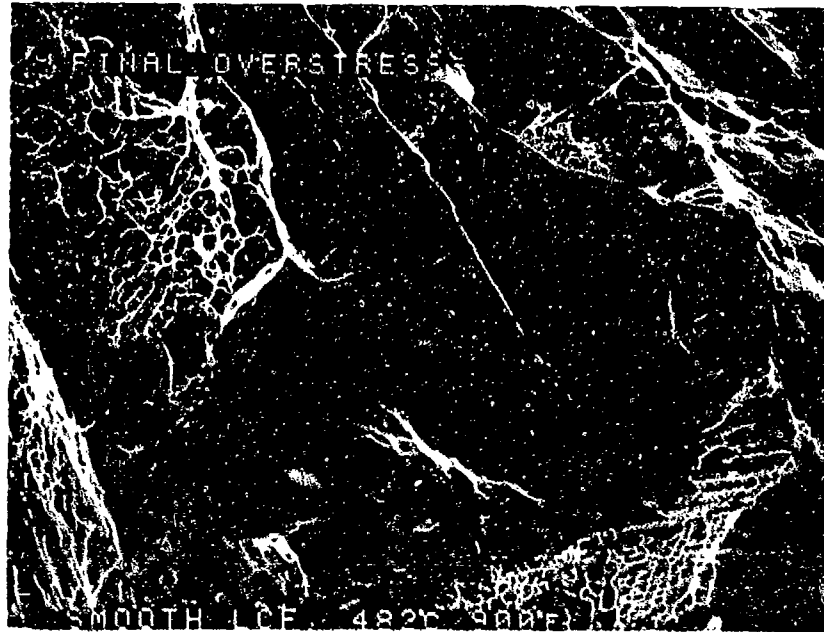
FAM 98509

FIGURE 6-9: Mixture of dimpled overstress and cleavage in the final overstress area.

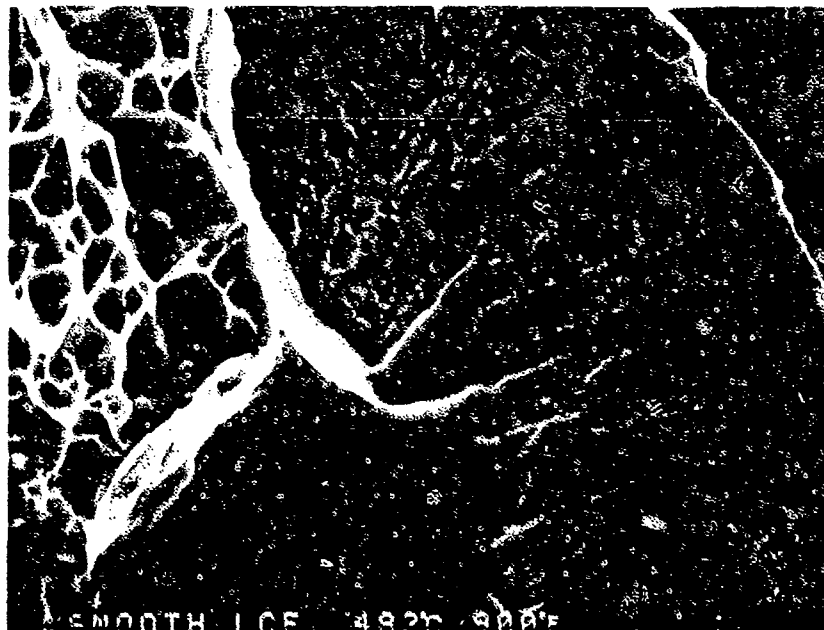
FAM 98510

FIGURE 6-10: Higher magnification photograph of the area shown in Figure 6-9. The striation-like lines are the result of slip and have very fine dimples between them. A possible isolated patch of fatigue striations is visible at the bottom center of the photograph (arrow).

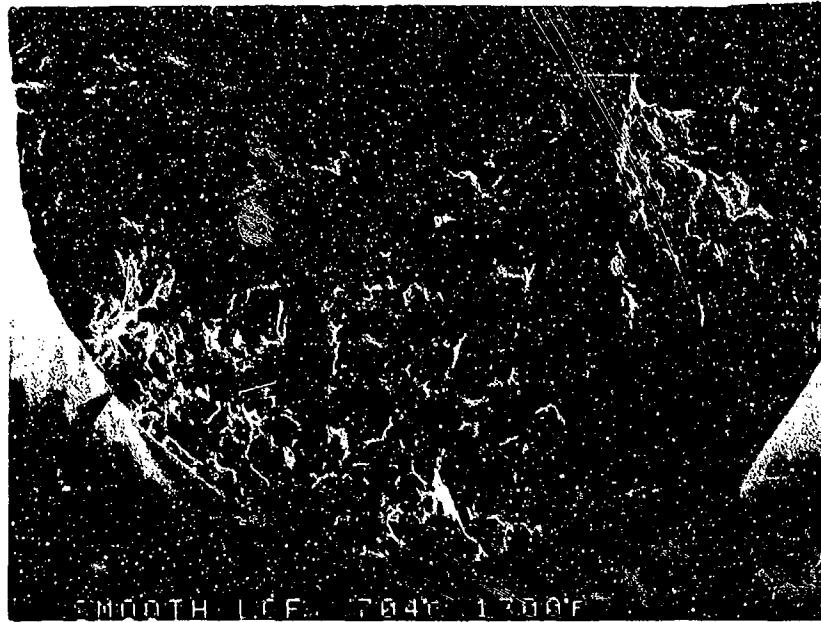
FAM 98732

FIGURE 6-13: Low magnification photograph showing several stage I fatigue facets at origin sites (arrows).

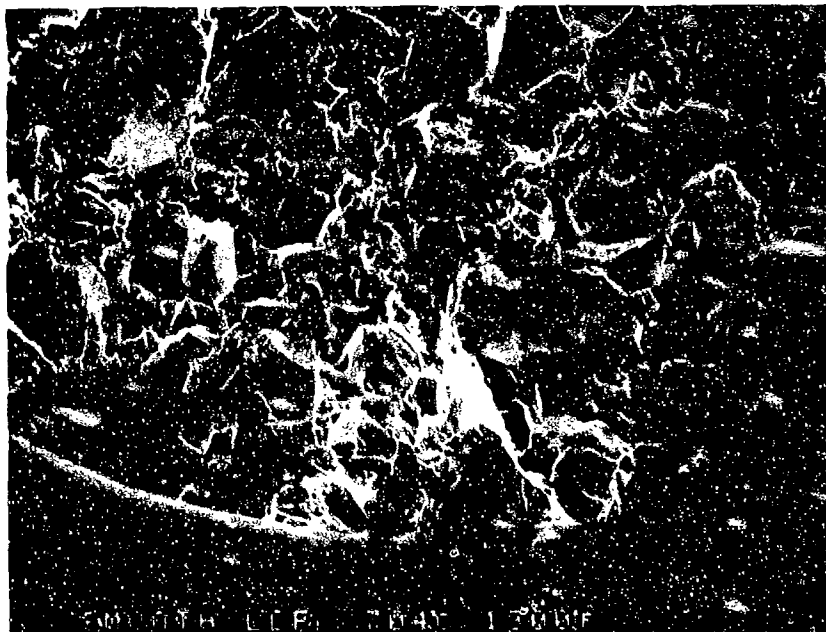
FAM 98733

FIGURE 6-14: Higher magnification photograph of a fatigue thumbnail area. The fracture surface is a collection of fatigue facets.

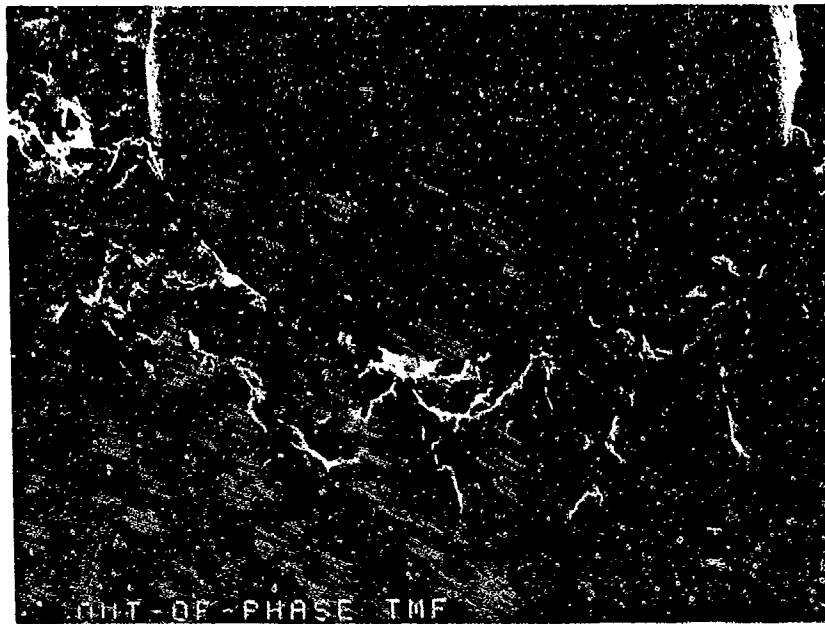
FIGURE 6-29: Low magnification view of a fatigue thumbnail area.

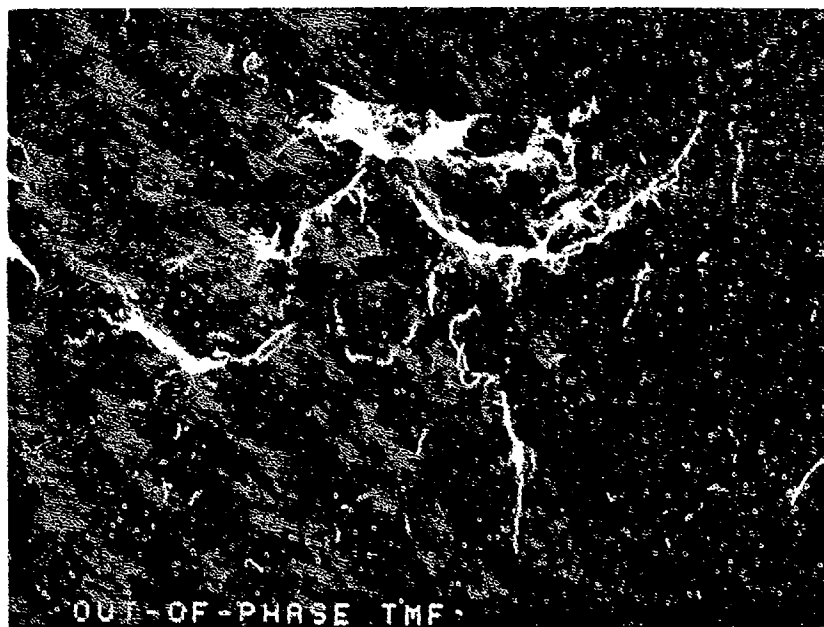
FIGURE 6-30: Oxidized fatigue thumbnail area. The flat oxidized appearance indicates O.D. origins (bottom). No localized origins are discernible.

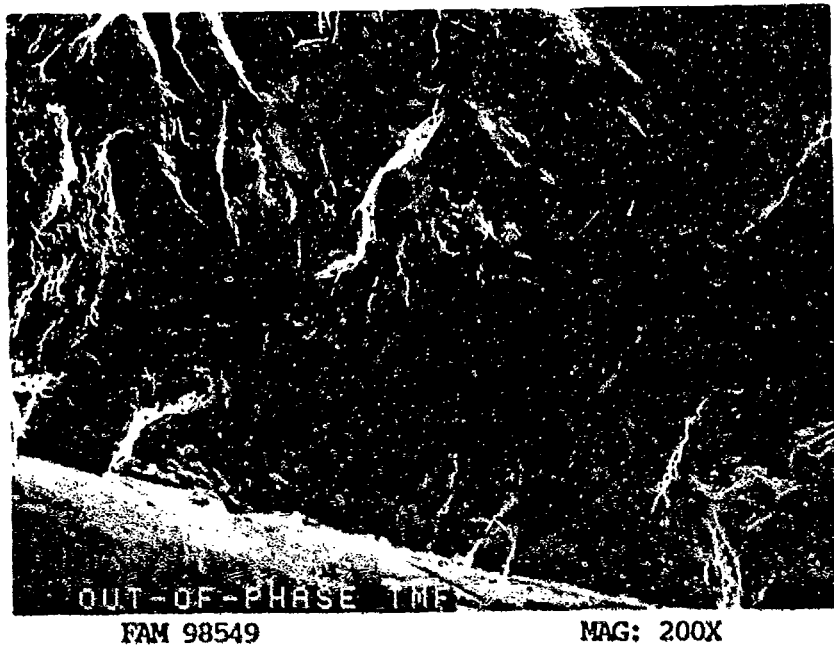
FIGURE 6-31: Fatigue thumbnail region showing remnant fatigue features (arrow).

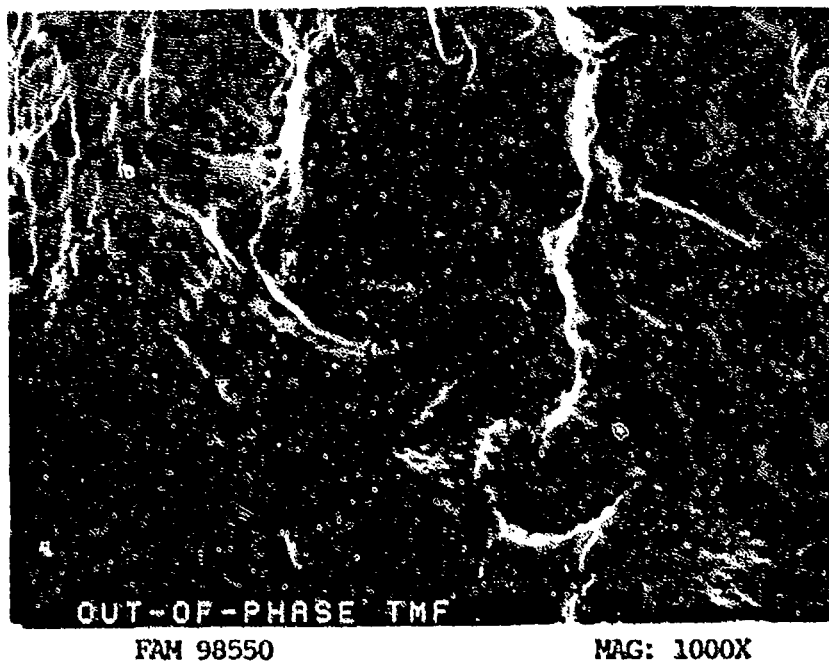
FIGURE 6-32: Heavily oxidized fatigue striations. Bracket contains five striations.

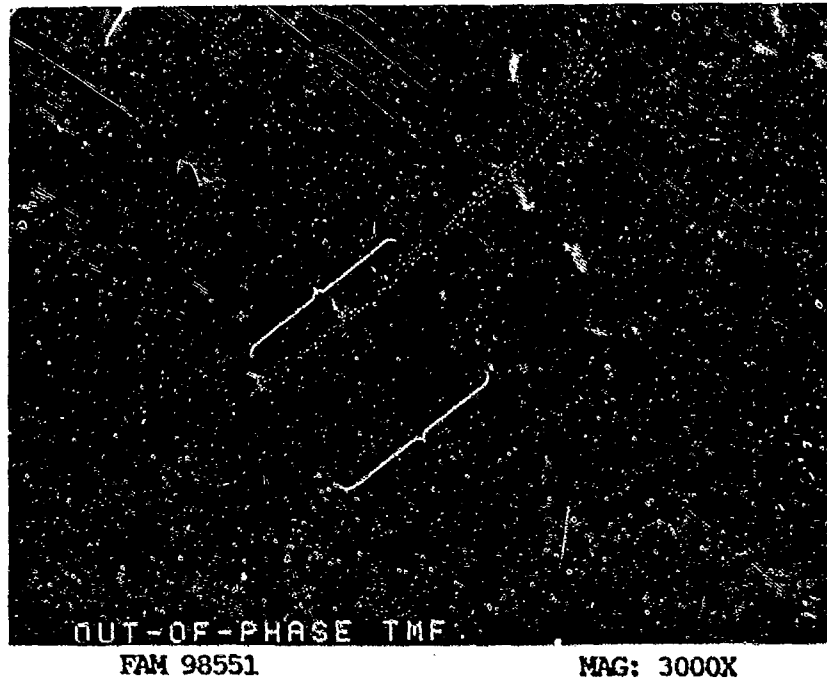
FIGURE 6-33: High magnification photograph of heavily oxidized fatigue striations. Brackets contain four striations.

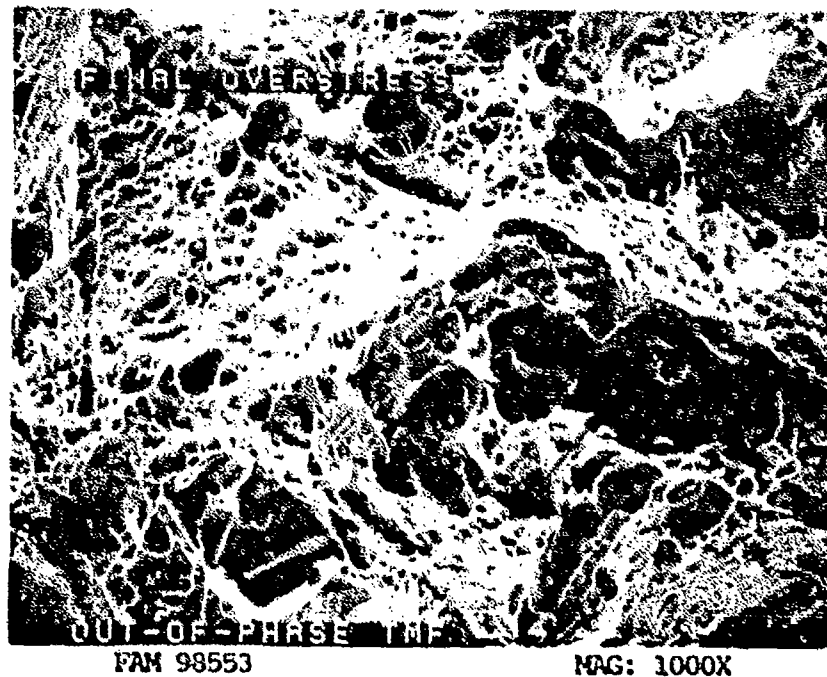
FIGURE 6-34: Dimpled overstress with small areas of cleavage (arrow) in the final overstress area.

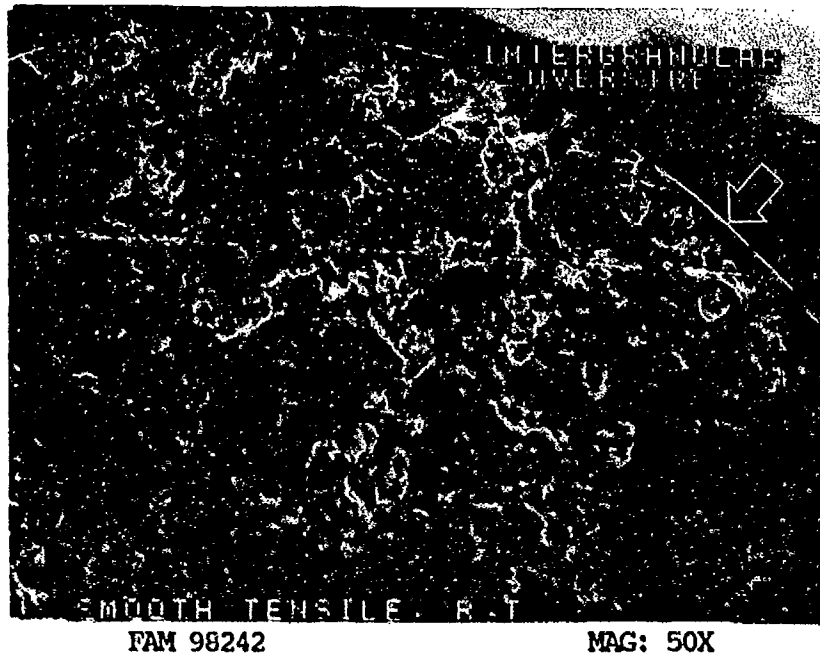
FIGURE 7-3: Low magnification photograph showing intergranular overstress in the primary fracture area and a narrow, discontinuous band of final overstress (shear lip) along the surface of the specimen (arrow).

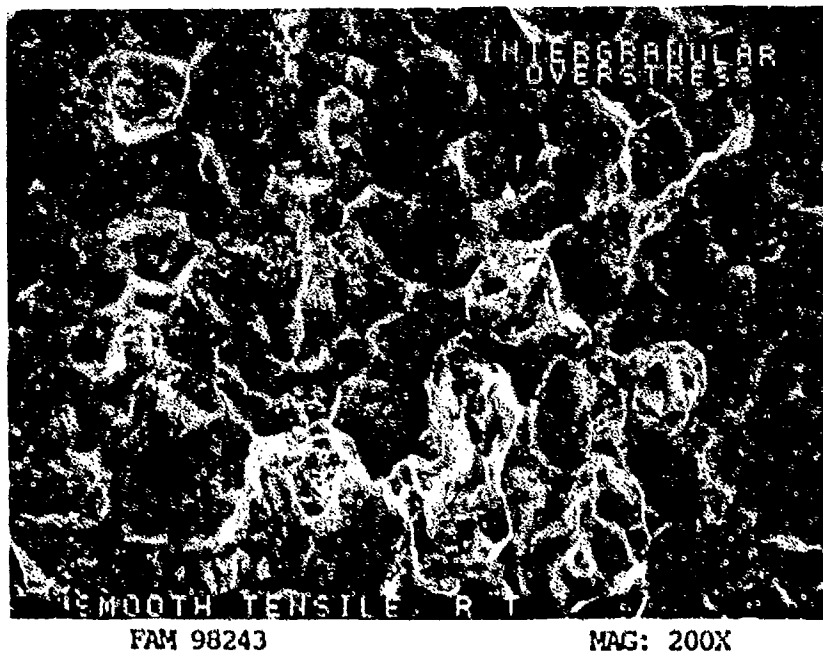
FIGURE 7-4: Intergranular overstress in the primary fracture area.

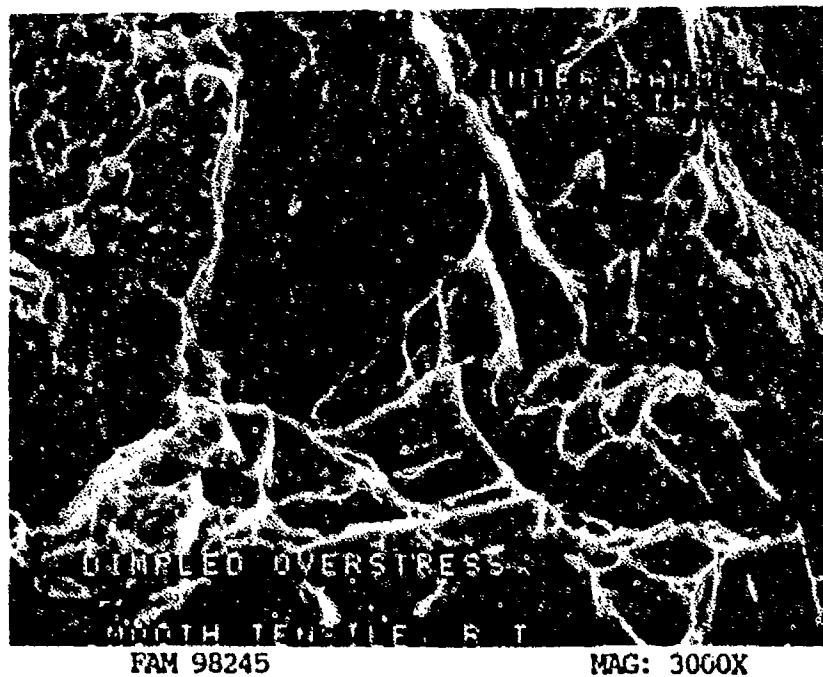
FIGURE 7-6: Higher magnification photograph of the area shown in Figure 7-5, exhibiting shallow dimples on the grain faces (arrow A) and coarser dimples at the grain edges (arrow B).

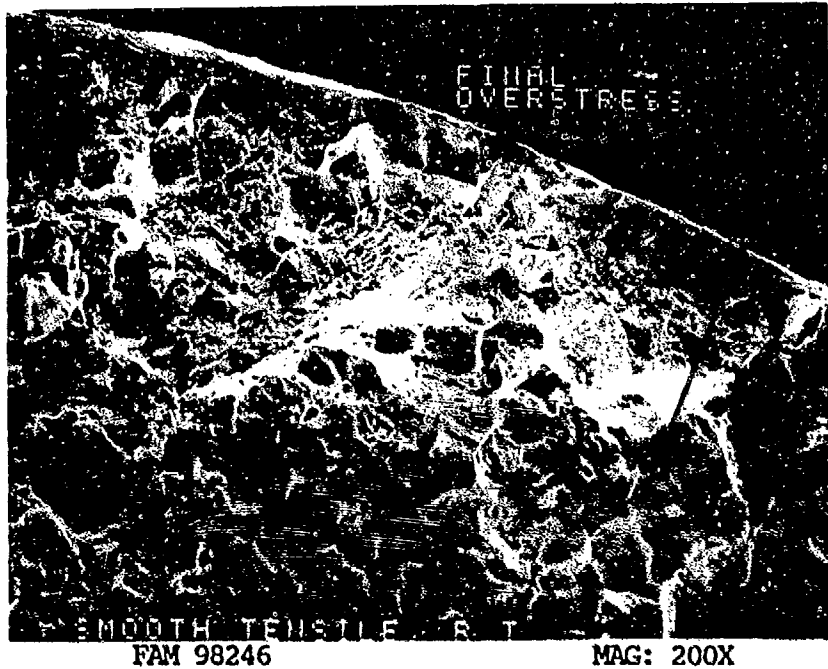
FIGURE 7-7: Final overstress area (shear lip) along the edge of the specimen. Bracket indicates the extent of the shear lip.

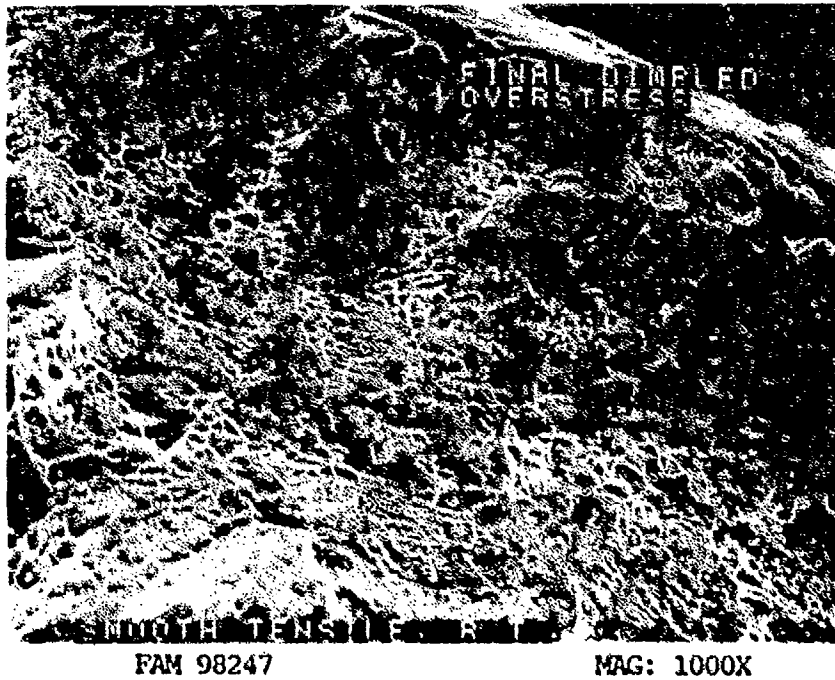
FIGURE 7-8: Sheared shallow shear dimples in the final overstress area (shear lip).

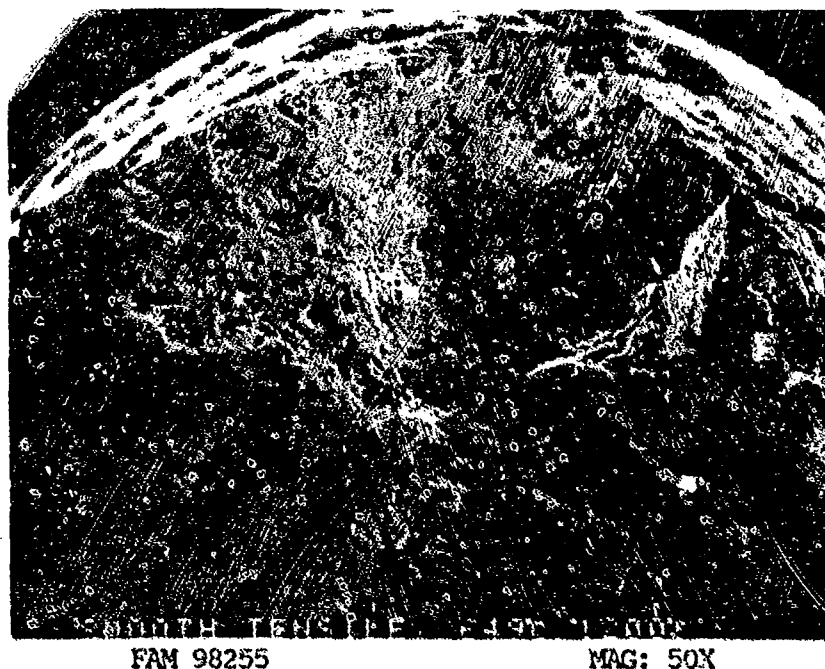
FIGURE 7-11: Low magnification view showing the depth and angularity of the fracture surface. No shear lip is present.

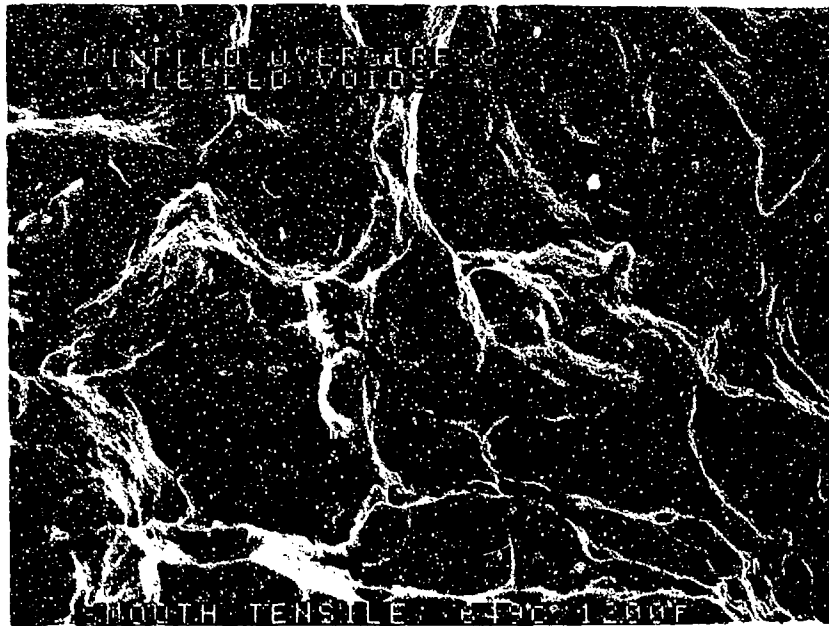
FIGURE 7-13: Dimpled overstress and void coalescence (arrows) covered with a uniform oxide.

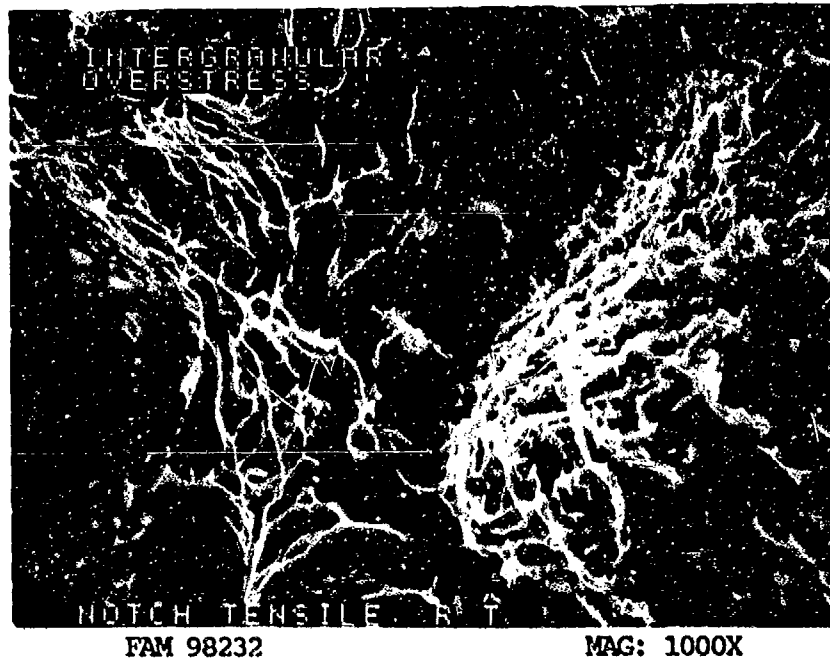
FIGURE 7-19: Intergranular overstress with both fractured and non-fractured carbides visible (arrows).

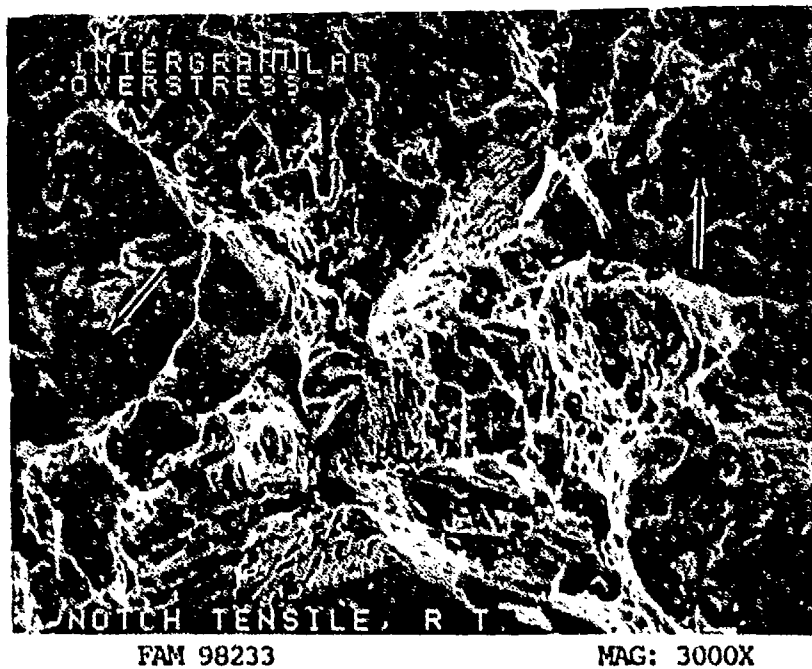
FIGURE 7-20: Fine randomly shaped dimples on the grain faces.

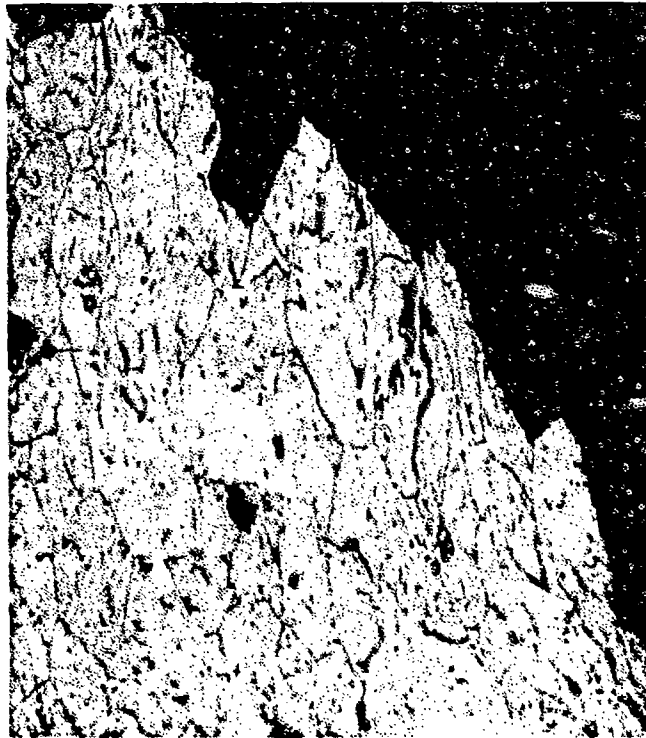
FIGURE 7-22: Optical photomicrographs showing a predominantly transgranular fracture path (top). Compare with the room temperature specimen. Unlike the room temperature specimen, significant plastic deformation is visible at the base of the notch (bottom).

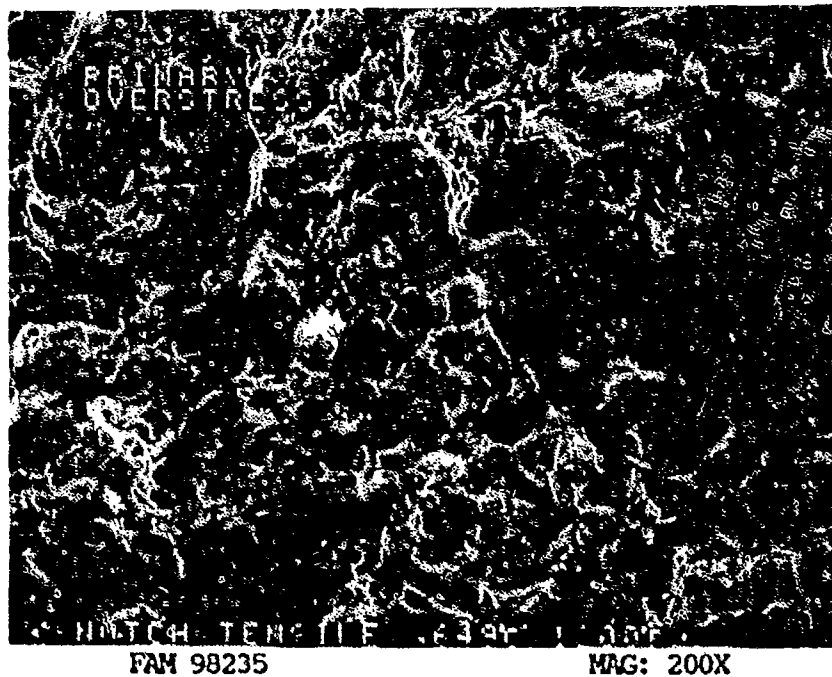
FIGURE 7-24: Primary overstress area exhibits light oxidation covering a mixture of transgranular and intergranular dimpled overstress.

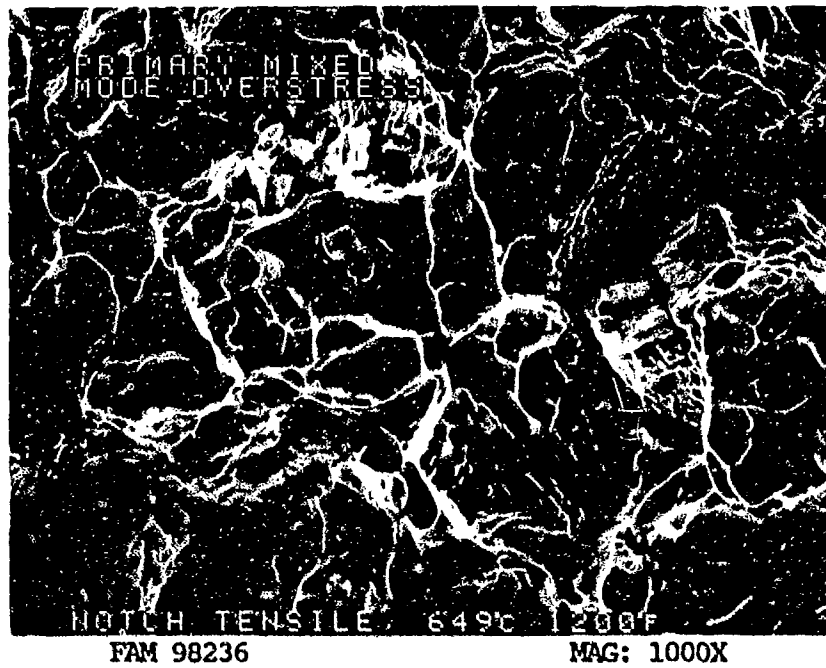
FIGURE 7-25: Mixed mode overstress in the primary overstress area. The fracture exhibits both intergranular overstress (arrow) and transgranular dimpled overstress.

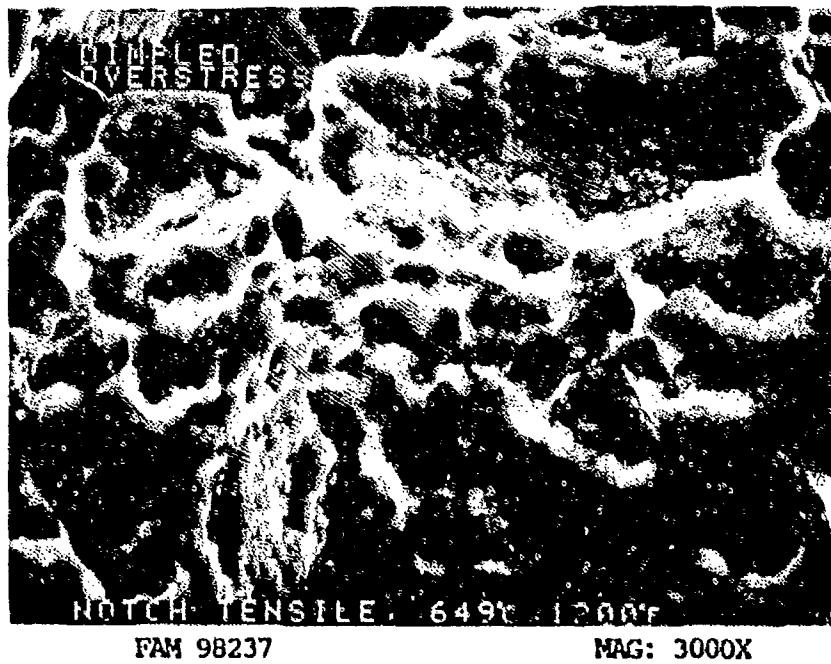
FIGURE 7-26: Moderately oxidized, transgranular dimpled overstress.

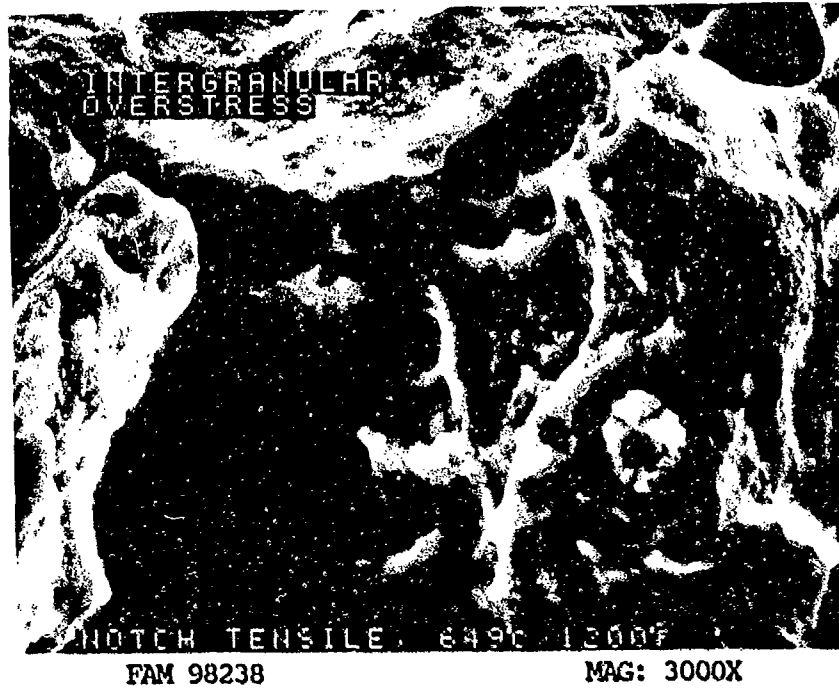
FIGURE 7-27: Oxidized, intergranular overstress.

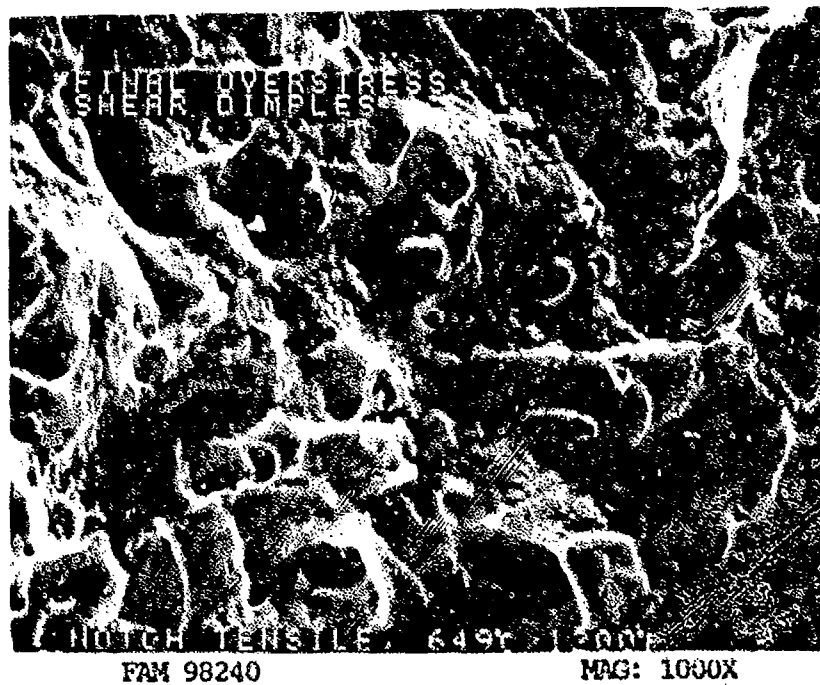
FIGURE 7-28: Oxidized shear dimples in the final overstress area (shear lip). The directions of relative motion are shown by arrows.

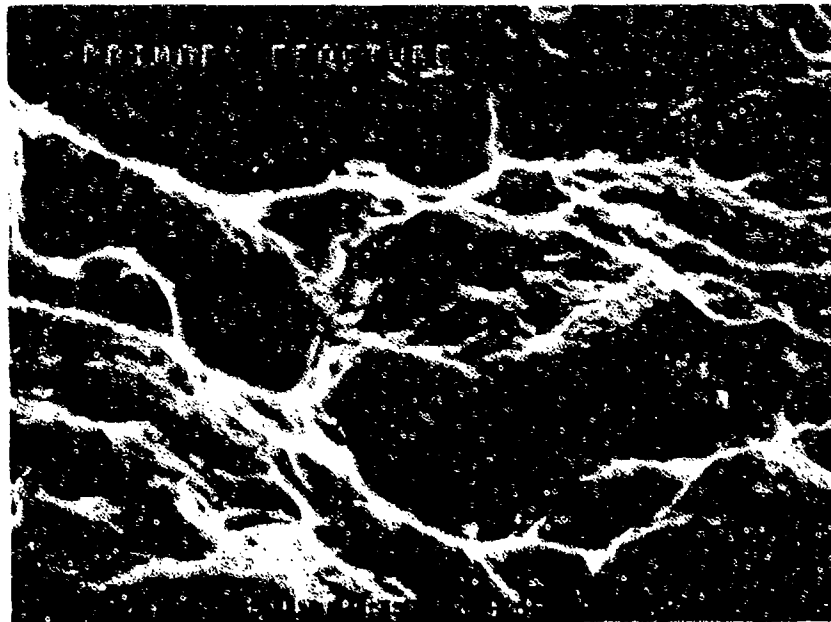
FAM 98263

FIGURE 7-34: Moderately oxidized primary fracture area.

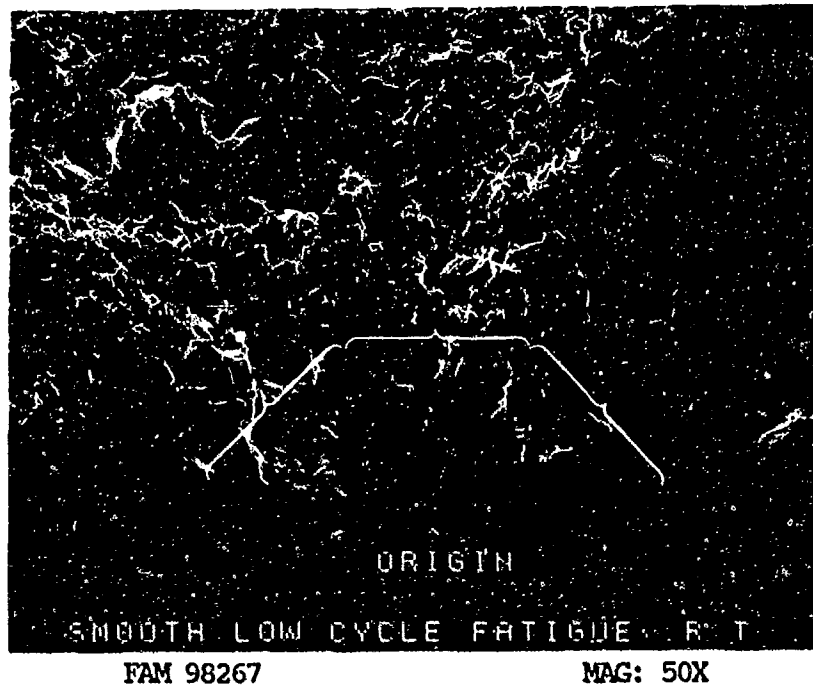
FIGURE 7-39: Low magnification view showing a fatigue origin. Fatigue propagation occurred in small patches near the surface of the specimen. The remainder of the fracture surface is a mixture of transgranular and intergranular overstress (mixed mode). Brackets show the extent of the fatigue.

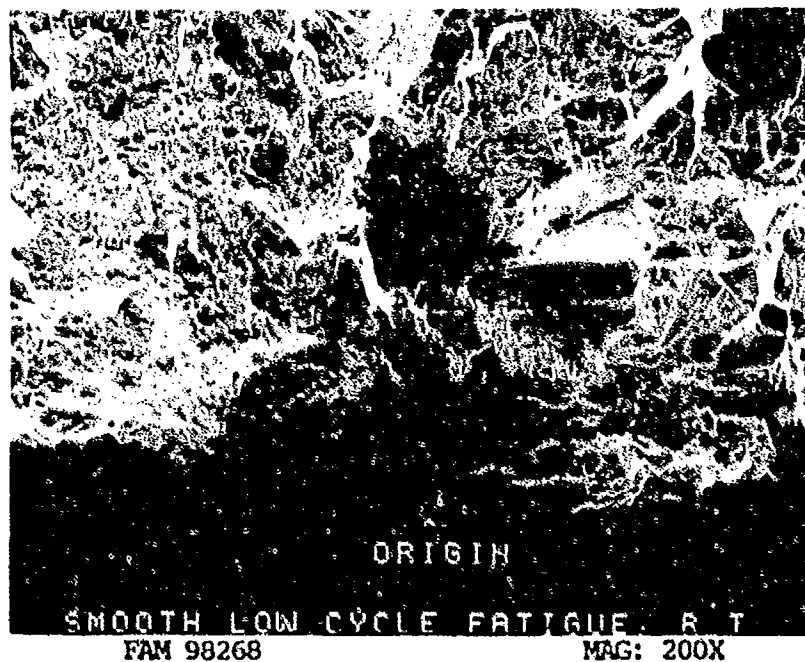
FIGURE 7-40: Fracture origin shown in Figure 7-39, exhibiting smooth cleavage facets (Stage I fatigue).

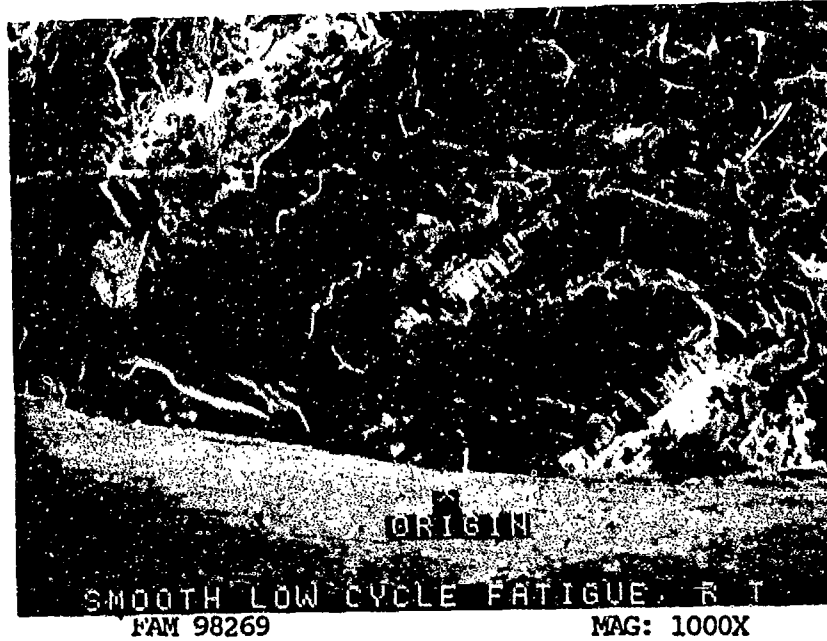
FIGURE 7-41: Higher magnification photograph of the origin area (Stage I fatigue facet) shown in Figure 7-40. The origin exhibits cleavage with bands of cyclic features (arrows).

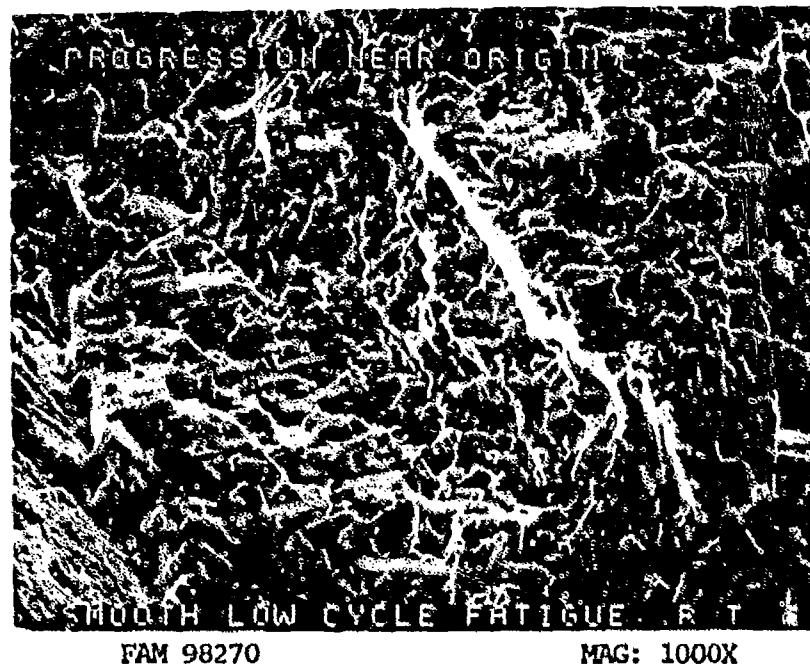
FIGURE 7-42: Fatigue progression near the origin.

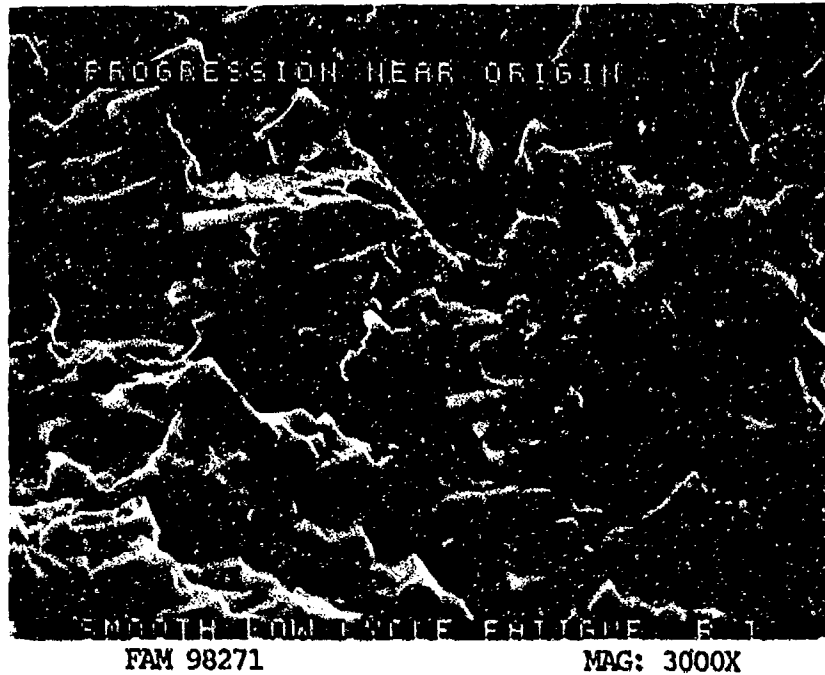
FIGURE 7-43: Fatigue progression near the origin exhibits parallel features (remnant striations) perpendicular to the direction of propagation. The direction of propagation is shown by an arrow.

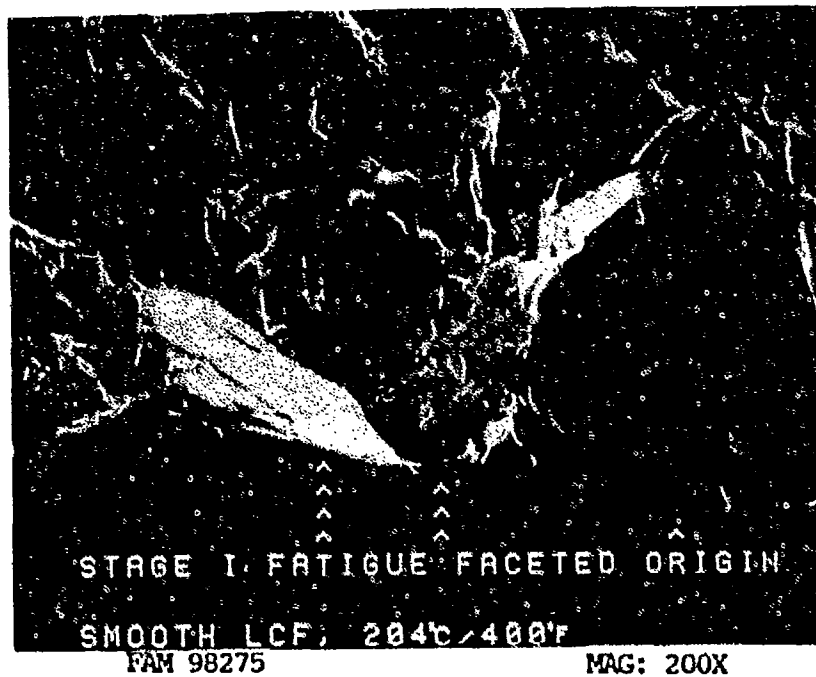
FIGURE 7-47: Smooth facets indicative of Stage I fatigue at an origin area.

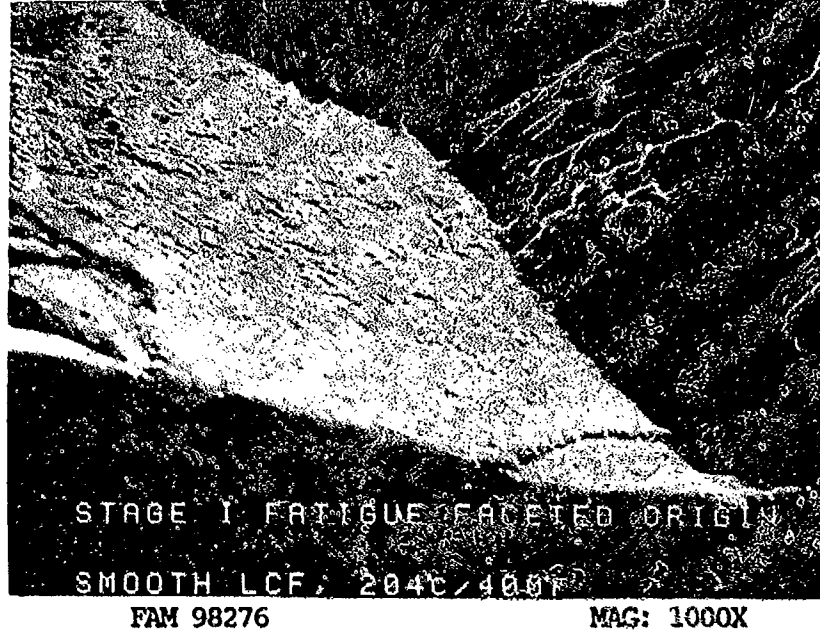
FIGURE 7-48: High magnification view of the origin area. No fatigue features are visible on the Stage I facet.

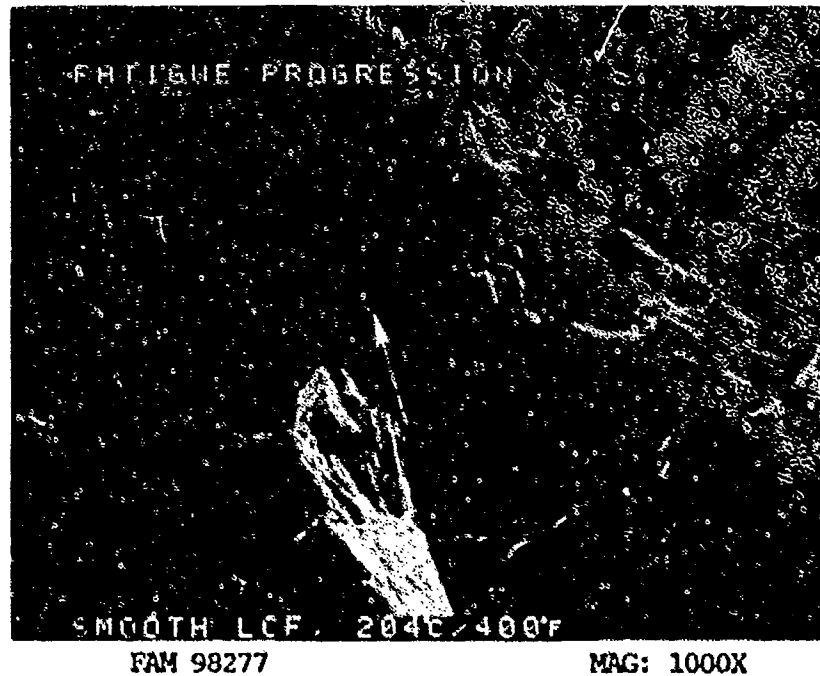
FIGURE 7-49: Fatigue progression near the origin area. Fatigue striations are visible on some of the Stage I facets (arrow).

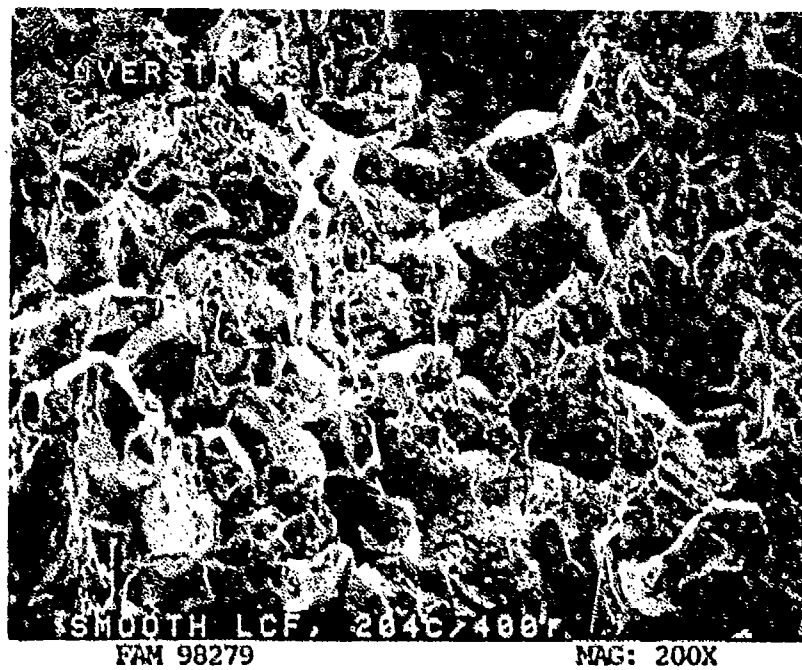
FIGURE 7-51: Intergranular overstress with grain boundary separation in the final overstress area.

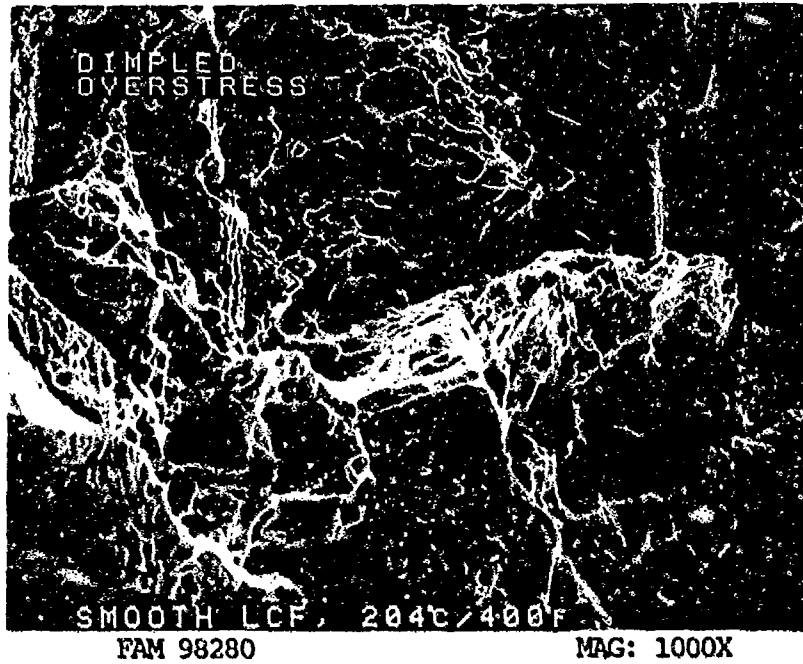
FIGURE 7-52: Dimpled intergranular overstress in the final overstress area. Grain faces are covered with randomly shaped dimples.
