FAILURE ANALYSIS HANDBOOK

C. R. Walker, K. K. Starr

Pratt & Whitney
P.O. Box 109600
West Palm Beach, FL 33410-9600

August 1989

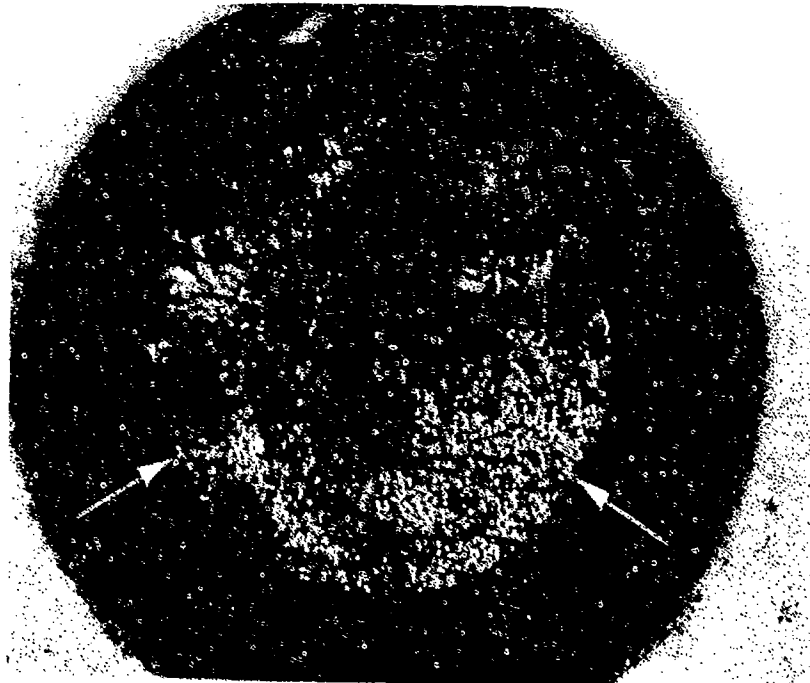
FAL 92383

FIGURE 7-53: Test results and fractography of Incoloy 909 649°C (1200°F) smooth LCF test. Several fatigue progression thumbnails appear as shiny faceted areas (arrows). The remainder of the fracture surface has a dull granular appearance.

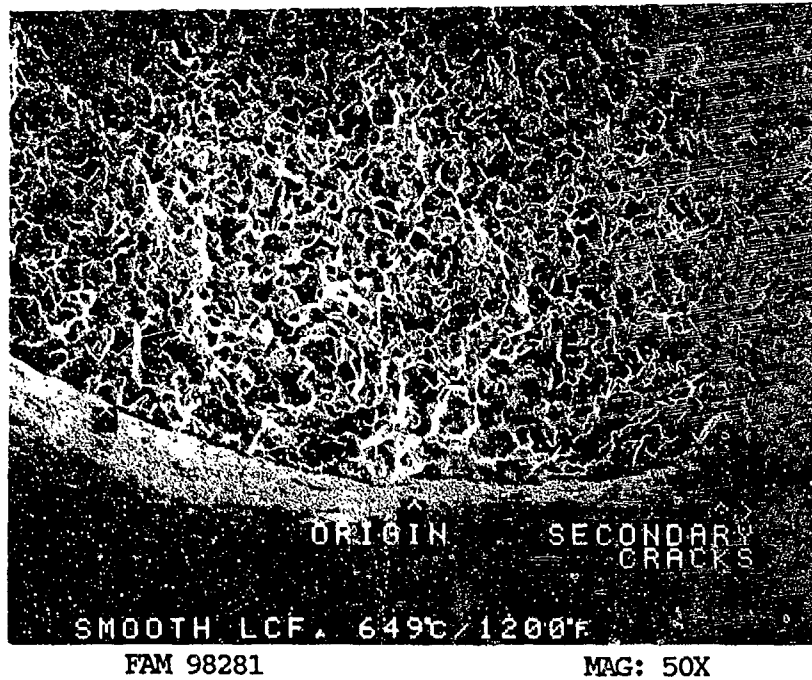
FIGURE 7-55: Low magnification view showing several fatigue origins and secondary cracking on the outside surface of the specimen. The fracture surface appears to be oxidized.

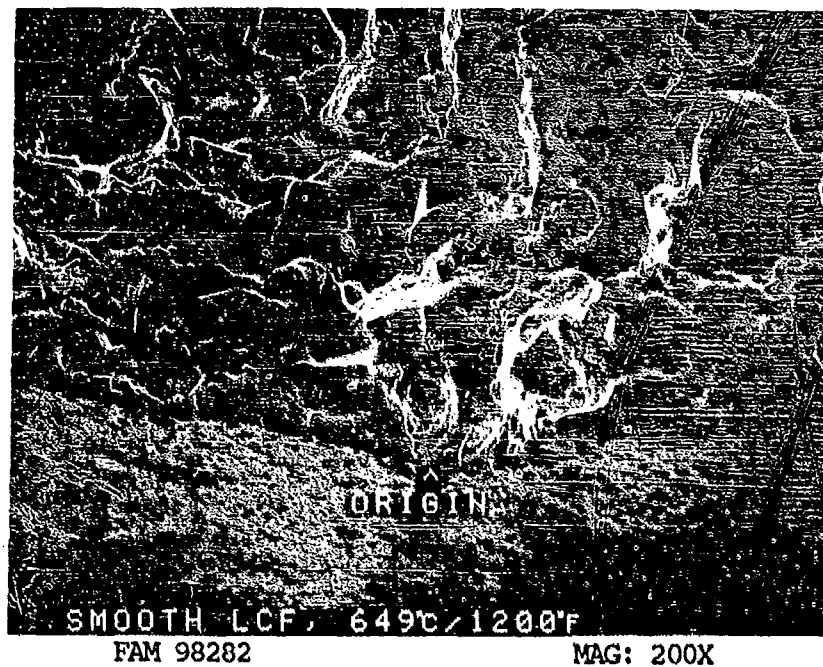
FIGURE 7-56: Oxidized fatigue origin shown in Figure 7-55.

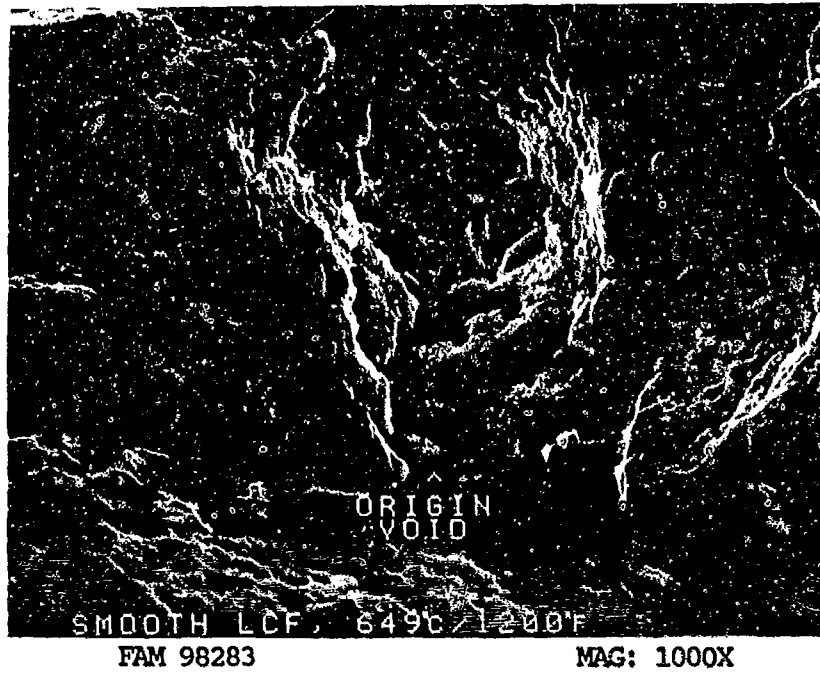
FAM 98283

FIGURE 7-57: High magnification photograph reveals that the fatigue originated at a slightly subsurface void. The void produced a stress concentration.

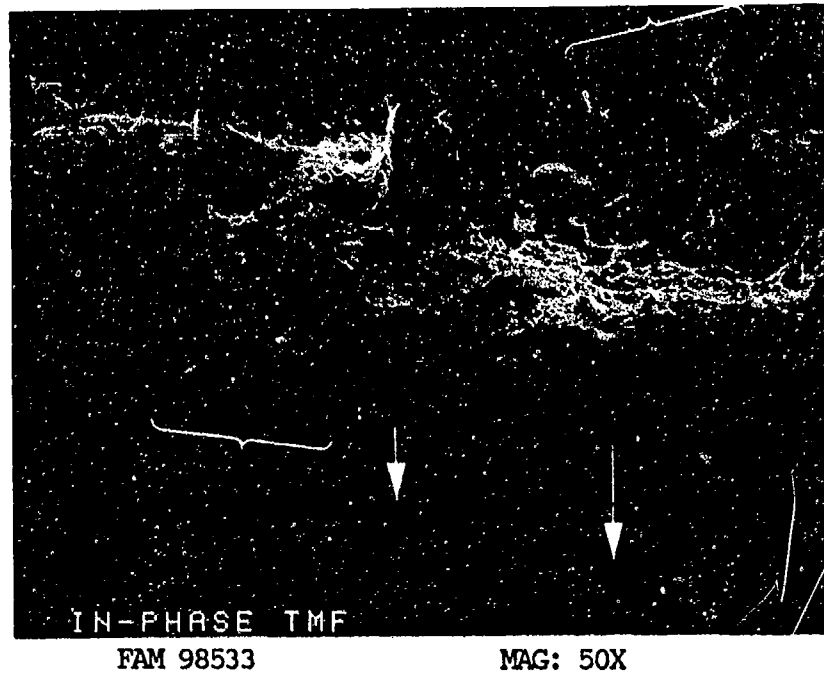
FIGURE 7-61: Low magnification photograph showing TMF origins (brackets) on both the I.D. and O.D. surfaces of the specimen, and secondary cracking on the O.D. surface (arrows). The origin areas appear to be faceted.

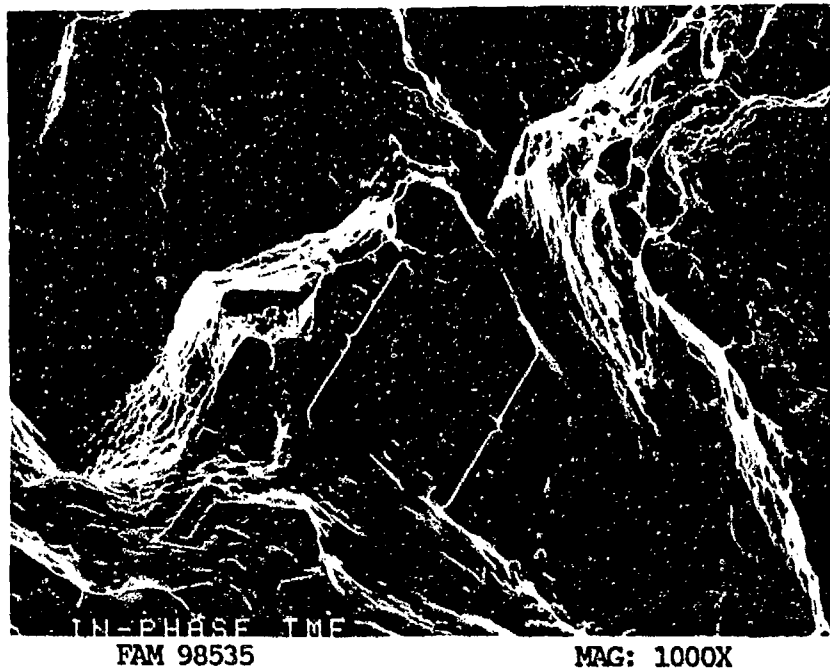
FIGURE 7-63: Oxidized fatigue striations near the I.D. surface of the specimen (brackets).

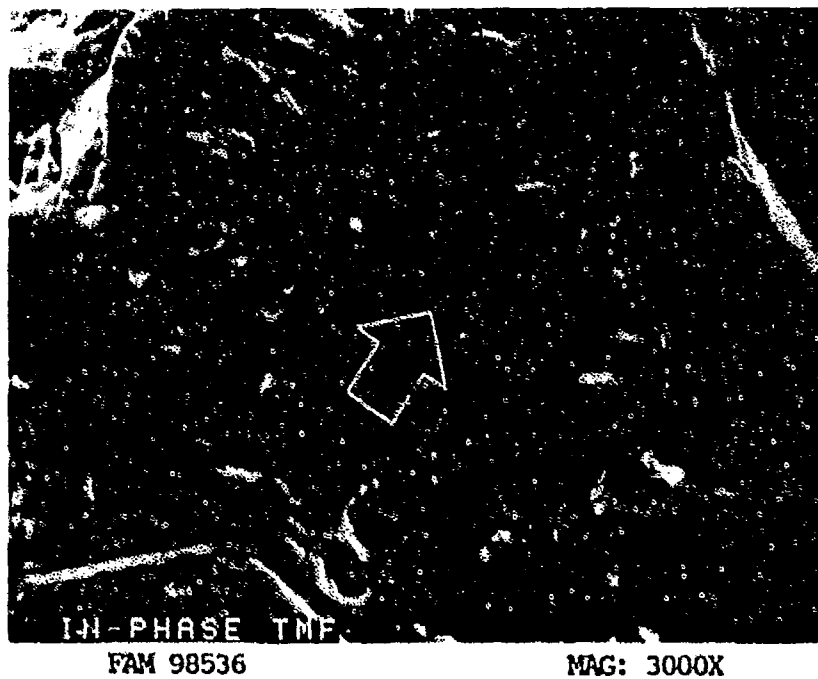
FIGURE 7-64: High magnification photograph showing oxidized fatigue striations (Figure 7-63). Arrow shows the direction of propagation.

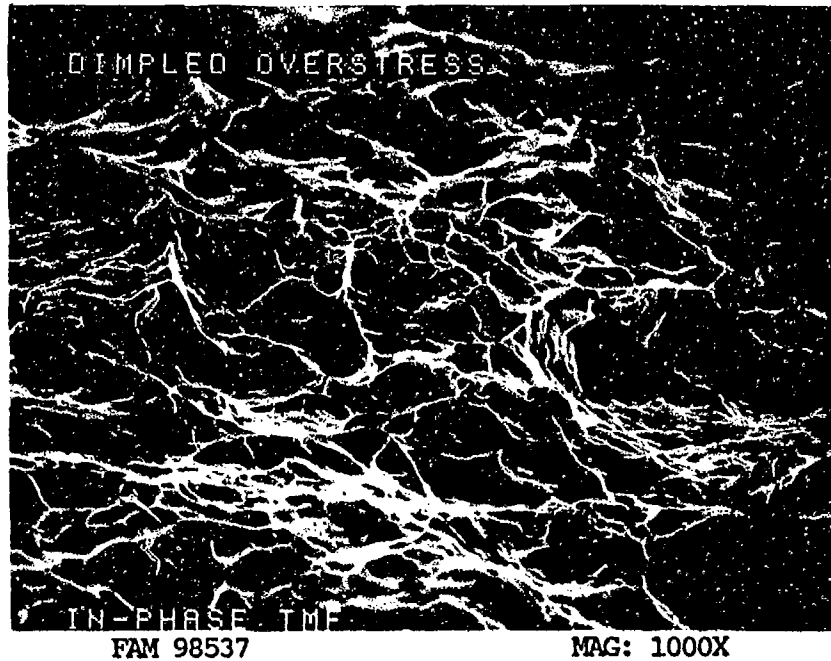
FIGURE 7-65: Dimpled overstress near the center of the fracture surface.

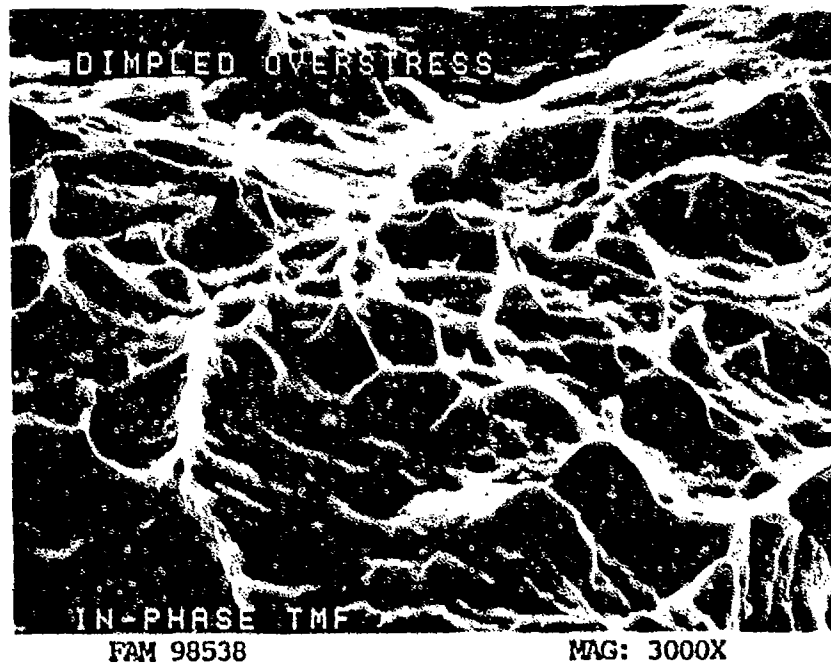
FIGURE 7-66: Higher magnification photograph of the area in Figure 7-65, showing oxidized dimpled overstress near the center of the fracture surface.

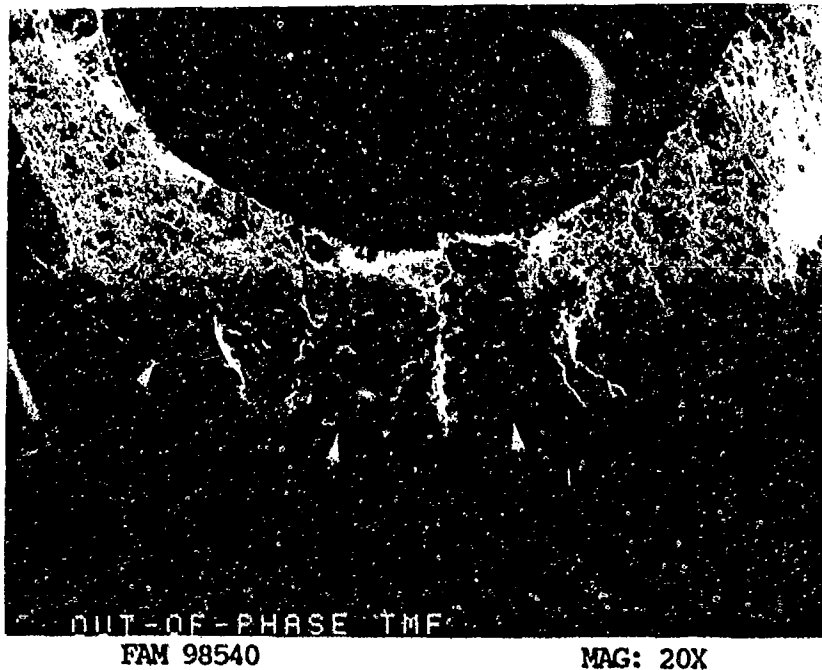
FIGURE 7-70: Low magnification view showing several fatigue origins on the O.D. surface of the specimen (arrows).

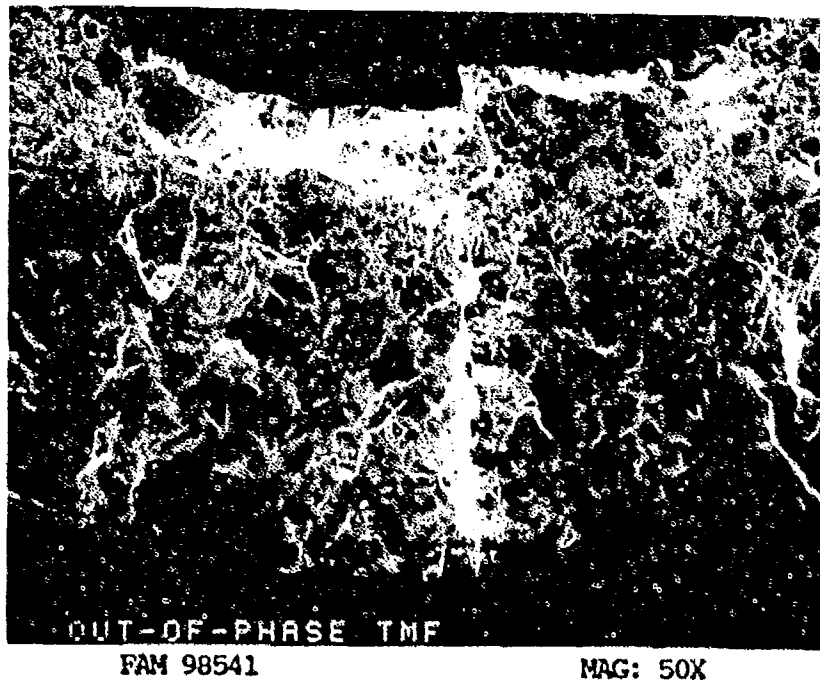
FIGURE 7-71: TMF origin on the O.D. surface of the specimen. The fatigue progression area appears smooth and oxidized.

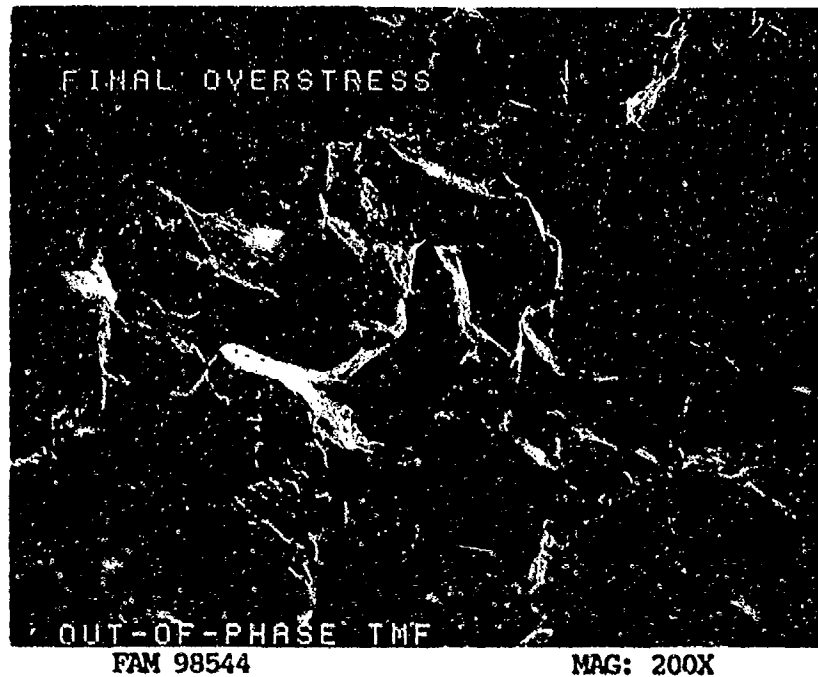
FIGURE 7-74: Final overstress area exhibits a mixture of transgranular and intergranular overstress (mixed mode).

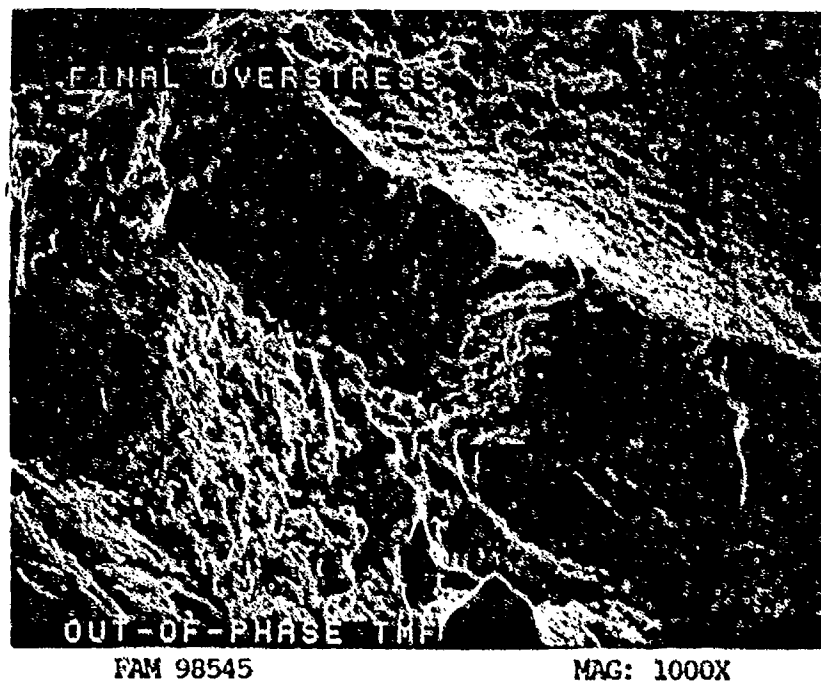
FIGURE 7-75: Higher magnification photograph of the area shown in Figure 7-74, showing a mixture of transgranular and intergranular overstress.

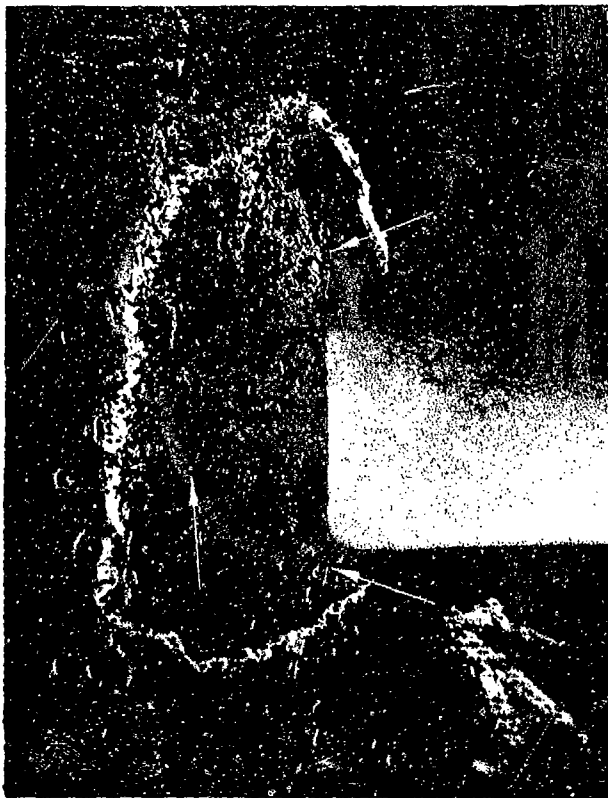
FAL 87682

SUMMARY: The cracking associated with the duct segment attachment window was the result of TMF. Distressed areas between the tip shroud segments also appeared to be thermally induced, with evidence of local hot spots exceeding 1350^oF (maximum metal temperature). Erosion by hot gases also contributed to the problem. The variation in the hardness readings was attributed to local hot spots. No contributing material or microstructural defects were found.

FIGURE 7-77: Close-up view of the duct segment attachment window exhibiting cracking (arrows).

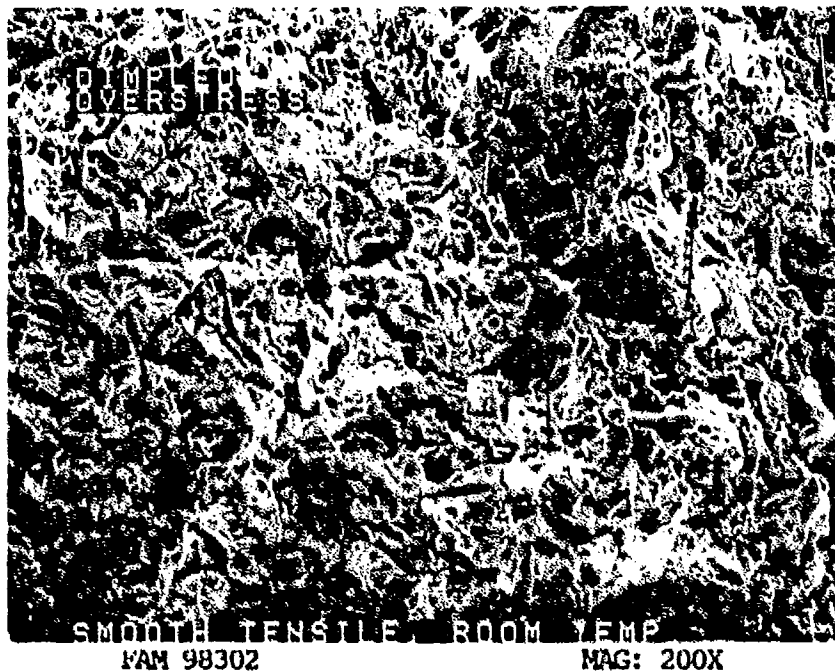
FIGURE 8-4: Dimpled overstress with some grain boundary separation (arrows) in the primary fracture area. At least two elongated voids are visible (arrow A). These are also visible in the metallographic cross section (Figure 8-2).

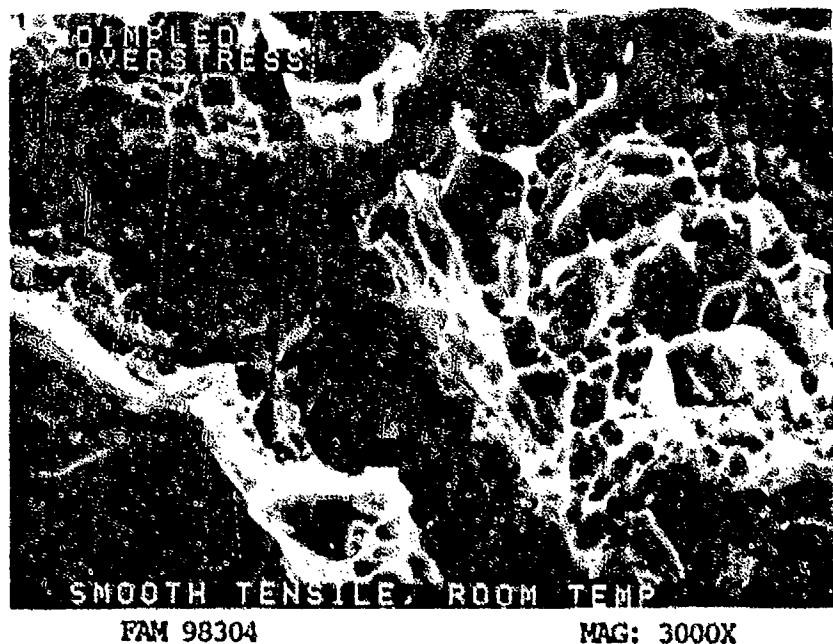
FIGURE 8-6: Grain boundary separation at a triple point. An elongated tubular void is visible near the center of the photograph (arrow).

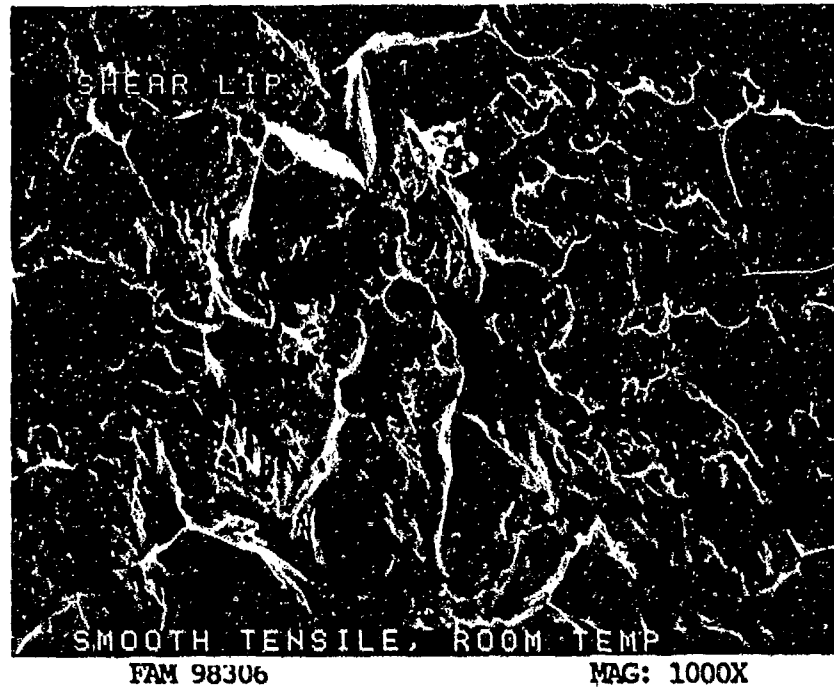
FIGURE 8-7: Shear features in final overstress area. The directions of relative motion are shown by arrows. Areas of smear are separated by patches of fine shear dimples.

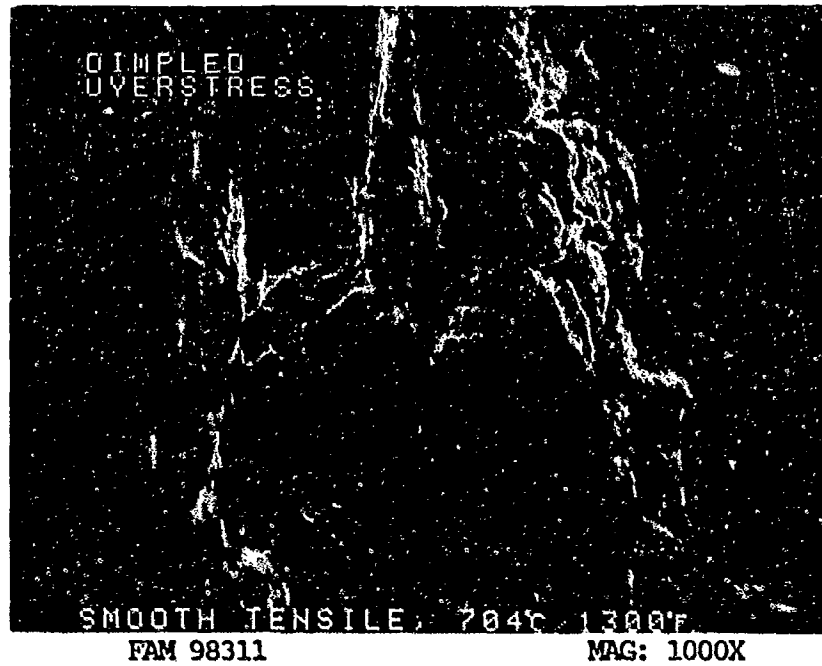
FIGURE 8-13: Mixture of coarse and fine dimpled overstress. A light oxide is now visible on the fracture surface.

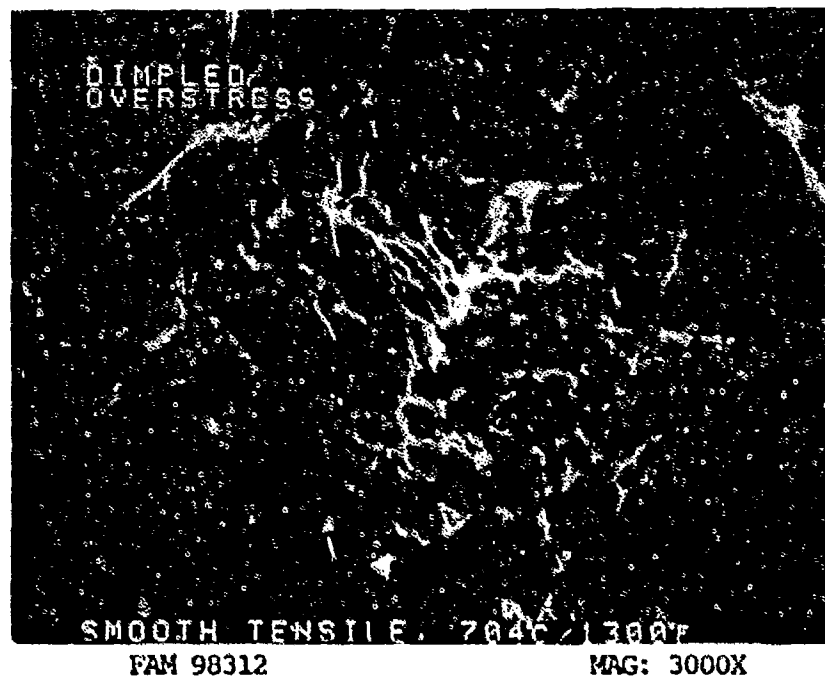
FIGURE 8-14: Fine oxidized dimples on coarse ductile features.

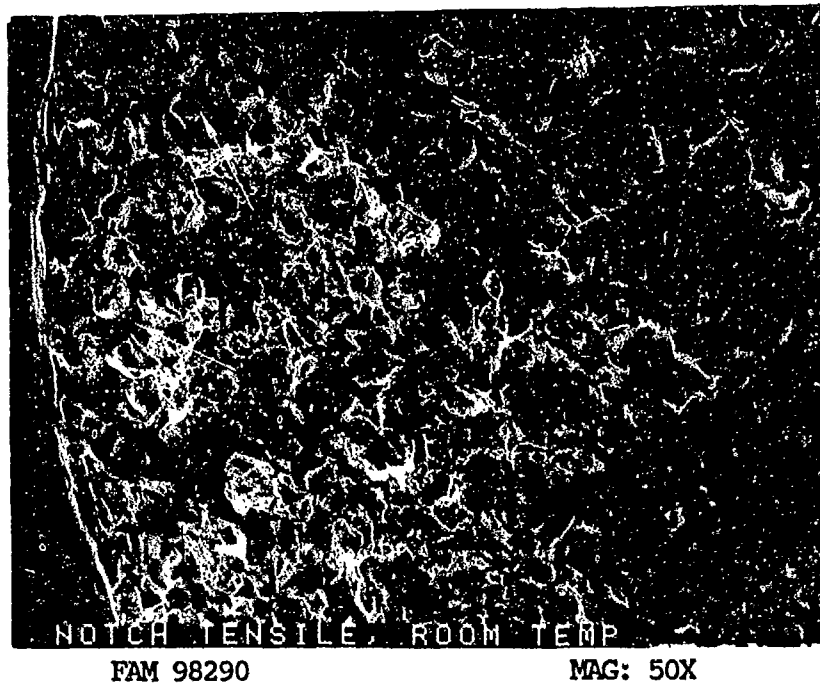
FIGURE 8-17: Low magnification view showing a mixture of intergranular (white arrows) and transgranular (black arrows) overstress features.

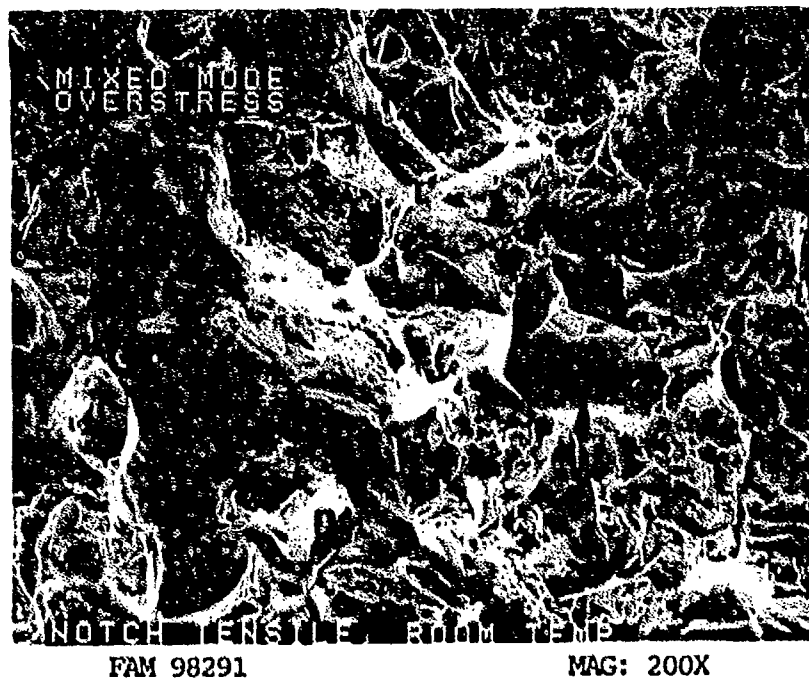
FIGURE 8-18: Mixed mode overstress exhibiting areas of transgranular dimpled overstress (arrow A) cleavage (arrows B) and intergranular overstress (arrow C).

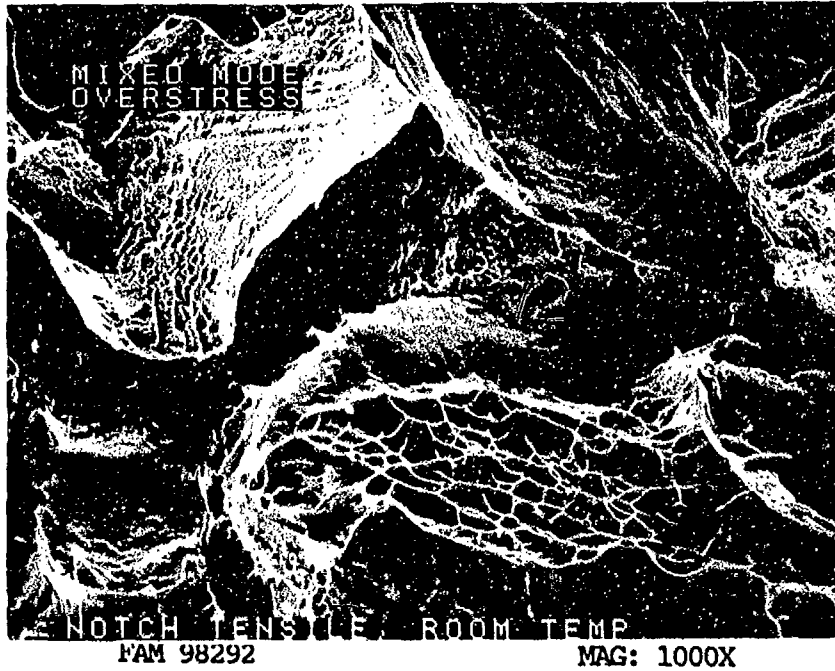
FIGURE 8-19: Mixed mode overstress. Slip lines are visible on several cleavage facets (arrows). These should not be confused with fatigue striations.

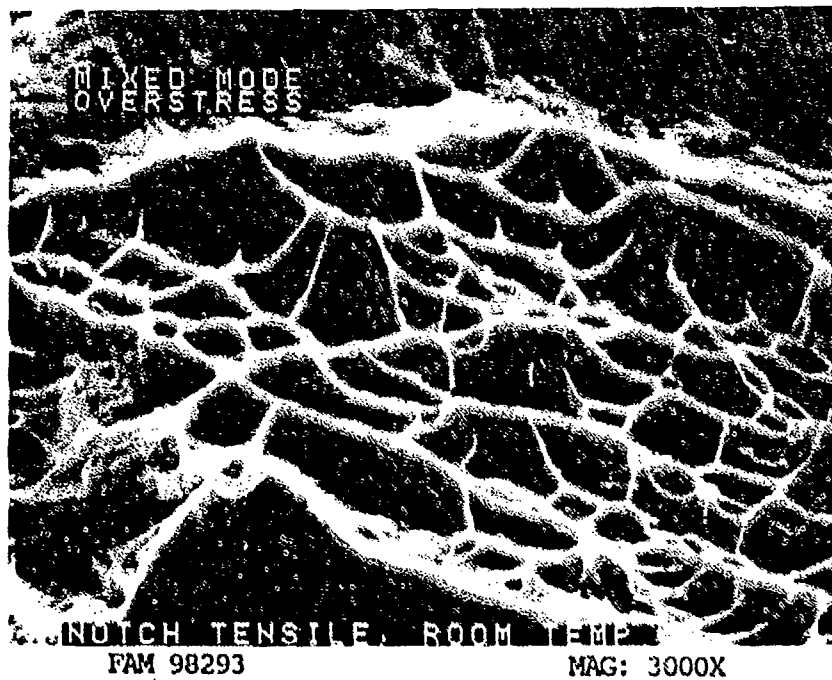
FIGURE 8-20: Shallow equiaxed tensile dimples between intergranular and transgranular cleavage.

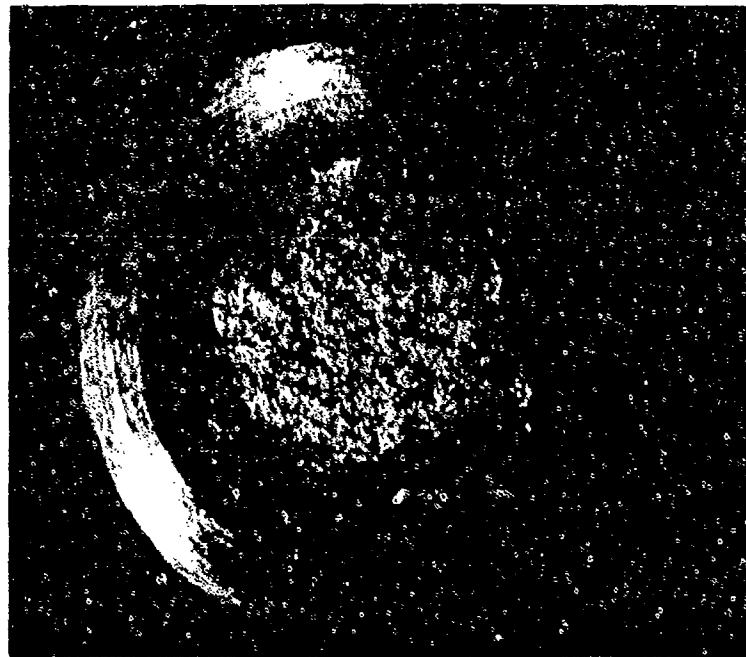
FAL 92444

FIGURE 8-21: Test results and fractography of Inconel 600 704°C (1300°F) notched tensile test. The fracture exhibits oxidation and deeper features than the room temperature specimen (Figure 8-15). The center of the specimen is relatively flat compared to the edges.

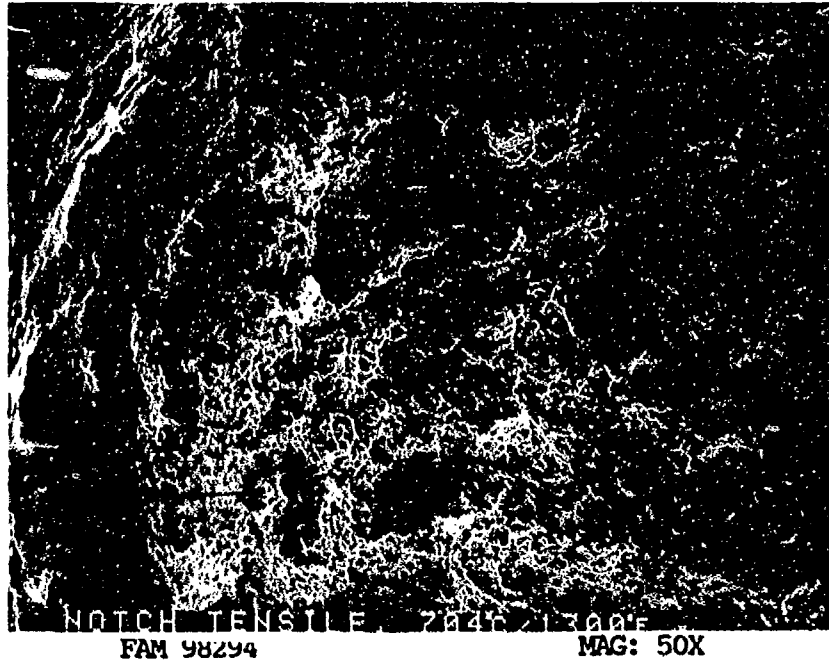
FIGURE 8-23: Low magnification view showing deep features near the edge (arrows). The center of the specimen is relatively flat (dimpled overstress).

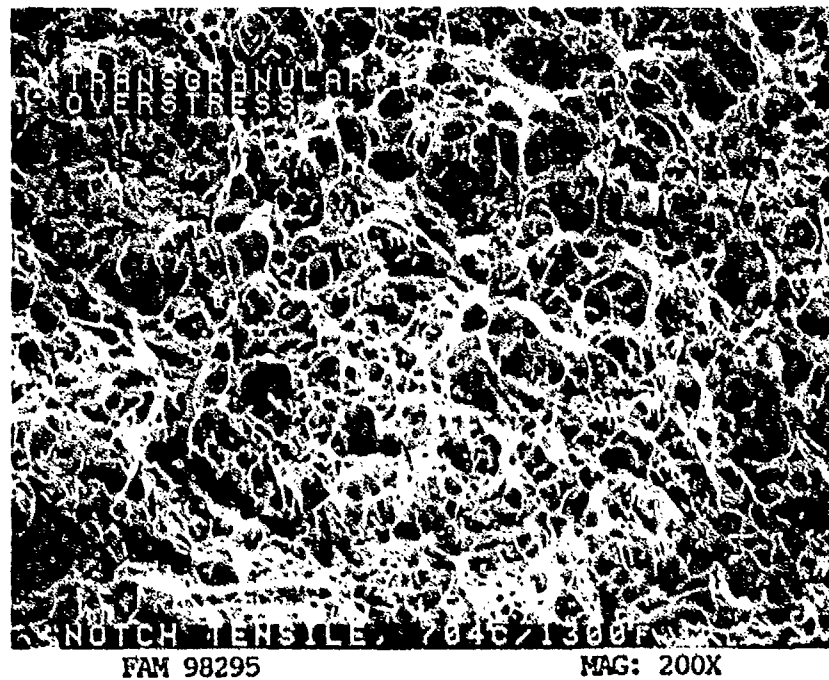
FIGURE 8-24: Primarily transgranular dimpled overstress with some void coalescence (arrows) in the center of the specimen. These voids are visible in the metallographic cross section (Figure 8-22).

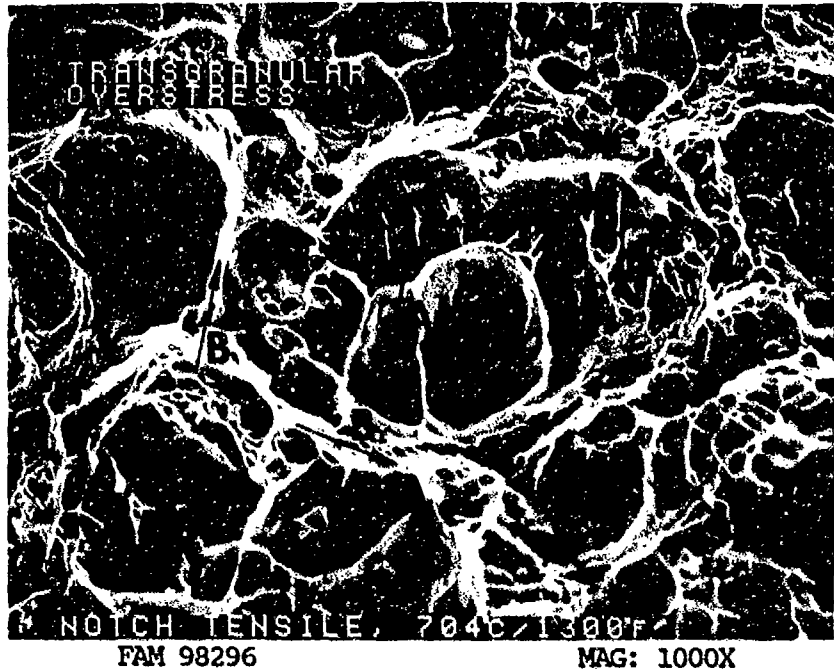
FIGURE 8-25: Transgranular cleavage overstress with some fine dimples. Slip lines are visible on some of the cleavage facets (arrows A). Tear ridges separate the areas of cleavage (arrows B).

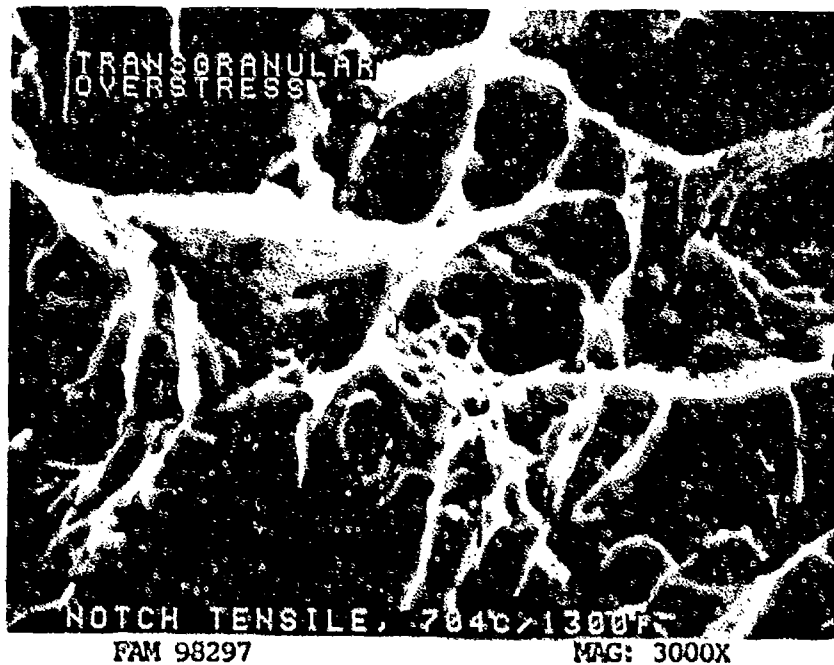
FIGURE 8-26: Transgranular cleavage facets with a few fine dimples in between (arrow).

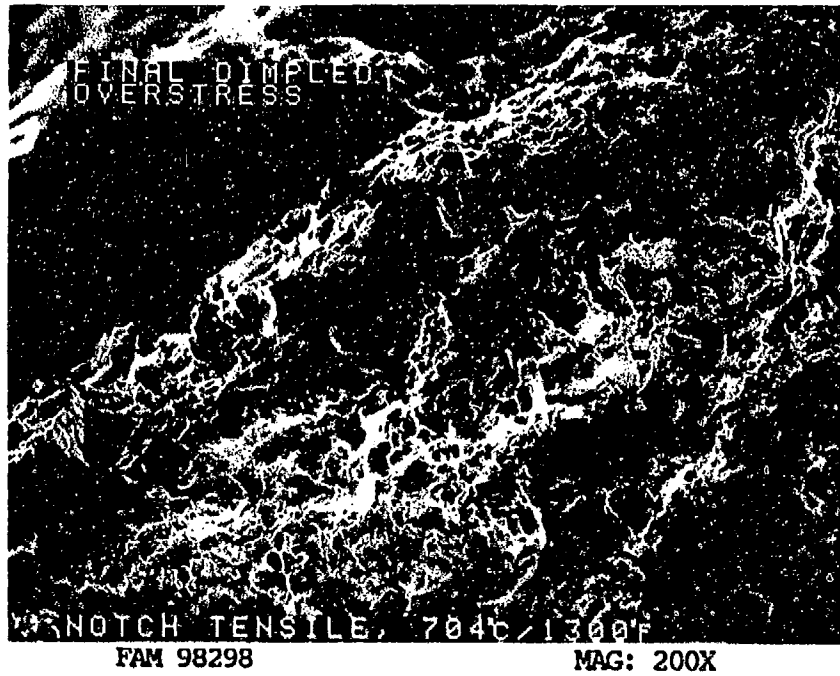
FIGURE 8-27: Mixture of dimpled overstress and fine cleavage in the final overstress area.

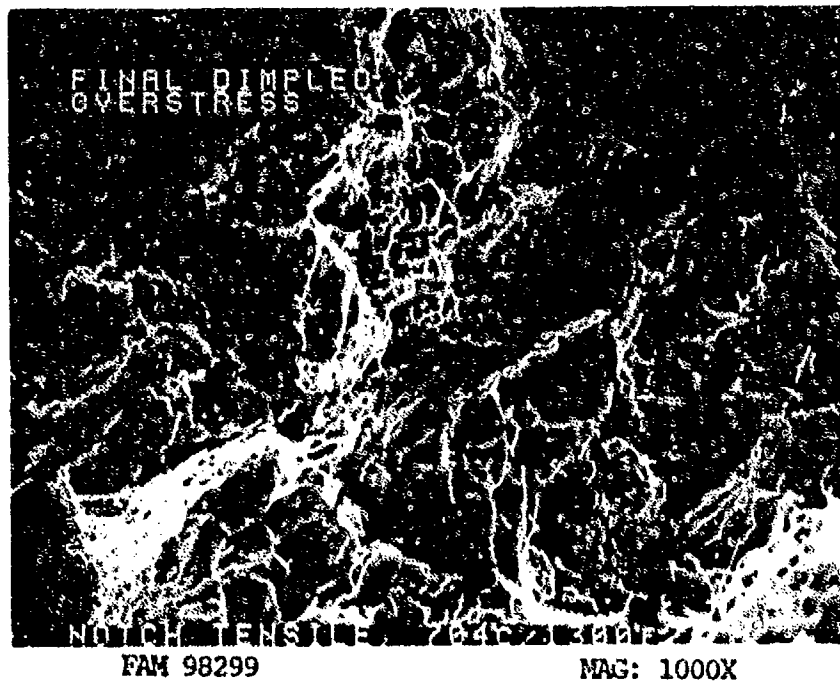
FIGURE 8-28: Higher magnification photograph of the area shown in Figure 8-27 showing fine randomly shaped dimples and fine cleavage (arrow). A light oxide is visible.

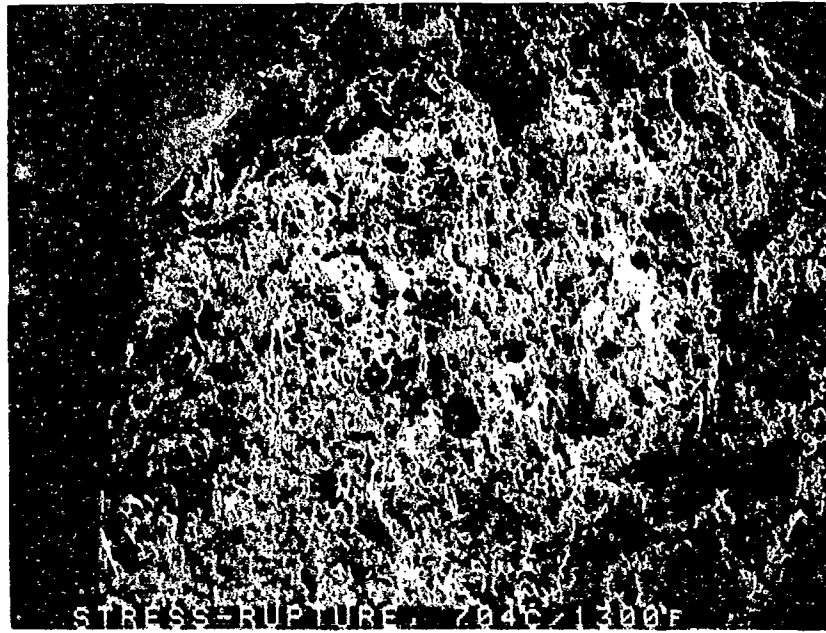
FIGURE 8-31: Low magnification view showing heavily oxidized deep dimples and voids. The oxide charges under the electron beam giving the fracture a bright appearance.

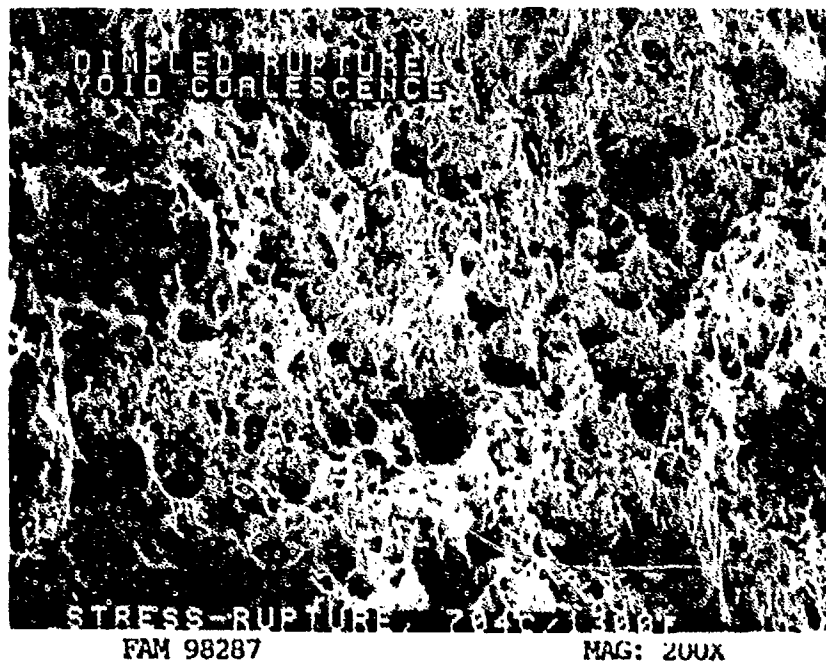
FIGURE 8-32: Dimpled rupture with void coalescence.

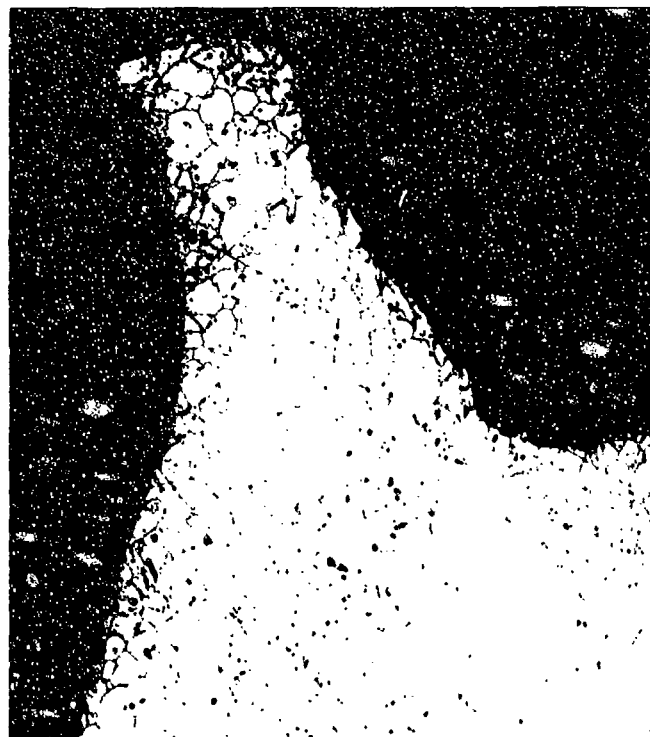
FIGURE 8-36: Optical photomicrographs showing the fatigue progression (top) and final overstress area (bottom). The fatigue progression is transgranular and propagates on a plane perpendicular to the stress axis.

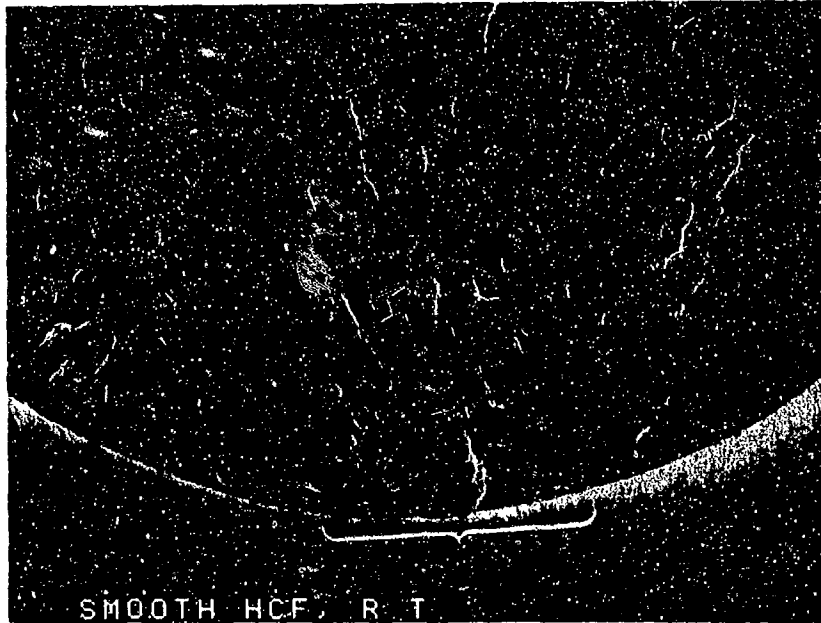
FAM 99297

FIGURE 8-37: Overall photograph of the origin area and initial fatigue progression zone. The fracture propagated from a relatively localized origin area but not from a point origin. Features are visible radiating from the area (bracket).

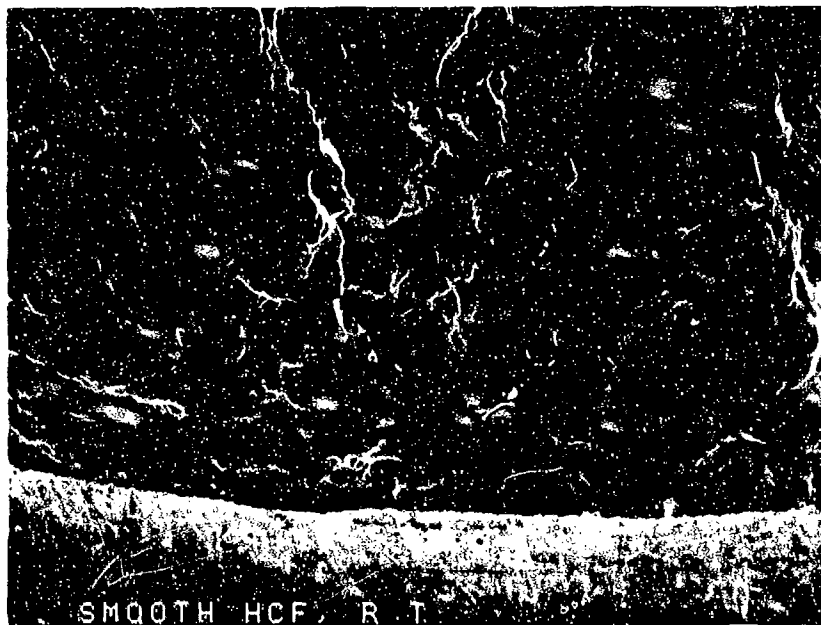
FAM 99298

FIGURE 8-38: Higher magnification photograph of the localized origin area exhibiting feathery cleavage.

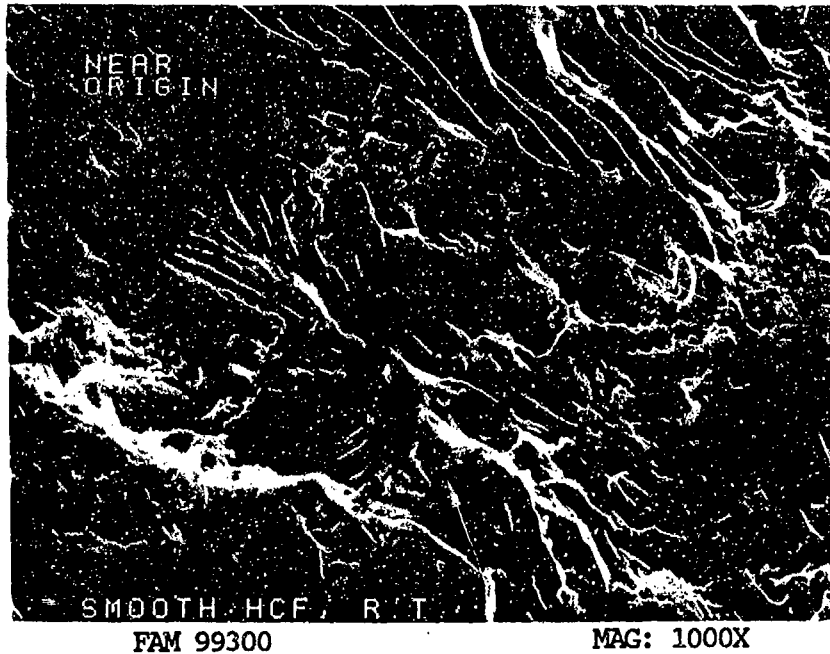
FIGURE 8-39: Fatigue progression near the origin. Fine striations are barely resolvable on fatigue plateaus (arrows).

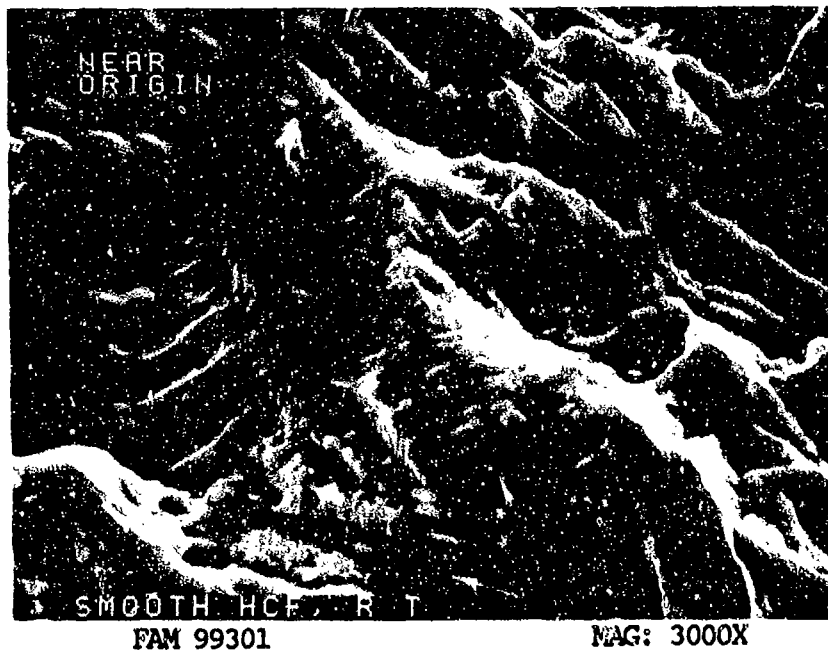
FIGURE 8-40: Higher magnification photograph of the area shown in Figure 8-39. Striations are clearly visible with very fine striations present on adjacent plateaus (arrows). Striations are visible with several orientations, indicating local propagation in several directions.

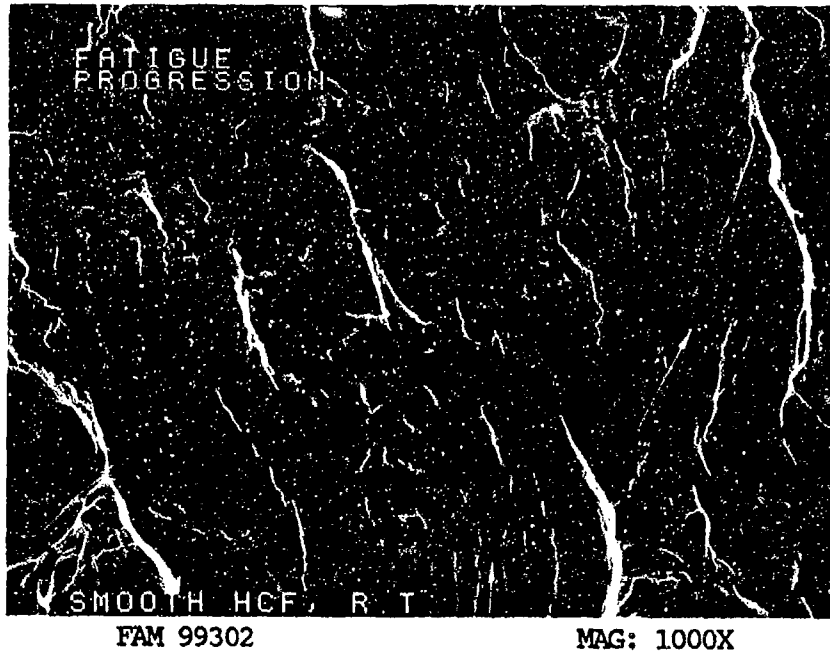
FIGURE 8-41: Fatigue progression zone exhibiting many changes of progression plane (plateaus). Arrows indicate directions of local progression.

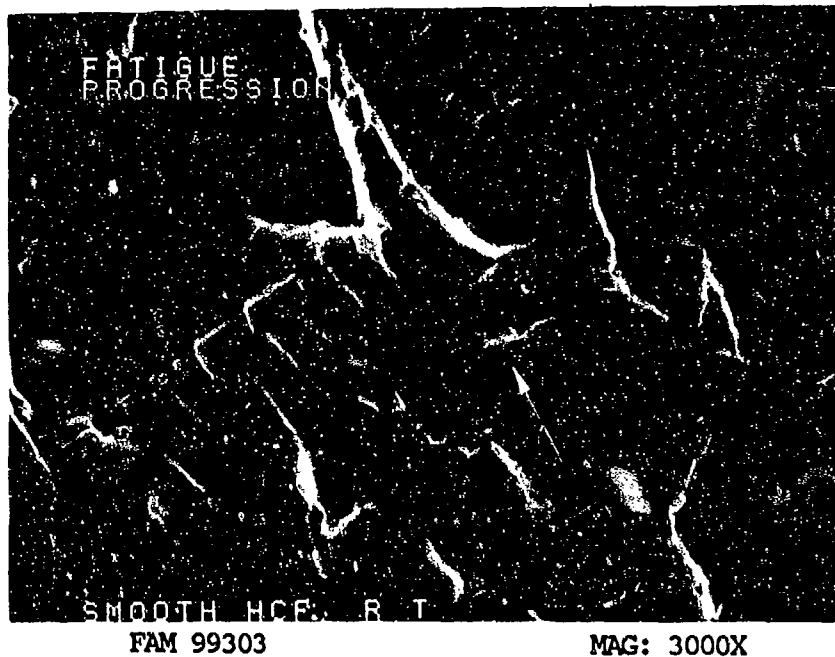
FIGURE 8-42: Mixture of coarser crack-like striations and very fine striations in the fatigue progression zone. The direction of propagation is shown by an arrow.
