FAILURE ANALYSIS HANDBOOK

C. R. Walker, K. K. Starr

Pratt & Whitney
P.O. Box 109600
West Palm Beach, FL 33410-9600

August 1989

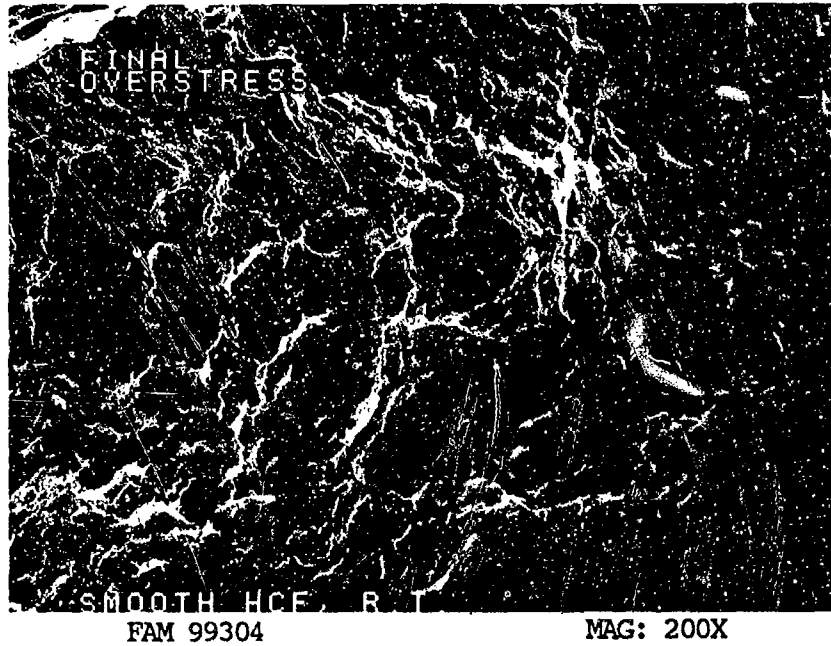
FIGURE 8-43: Final overstress area. No shear lip is present.

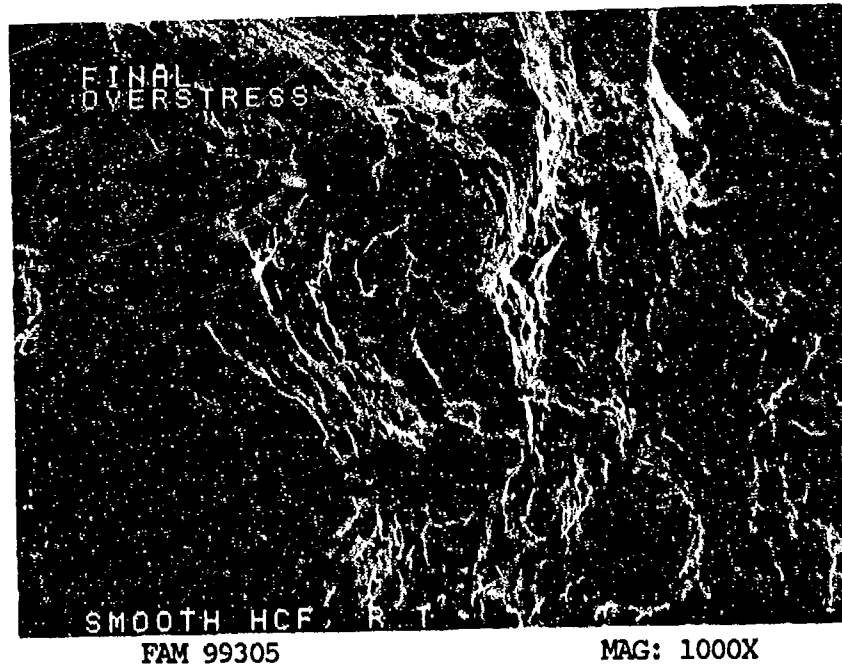
FIGURE 8-44: Dimpled overstress in the final overstress area shown in Figure 8-43. Fine dimples are visible.

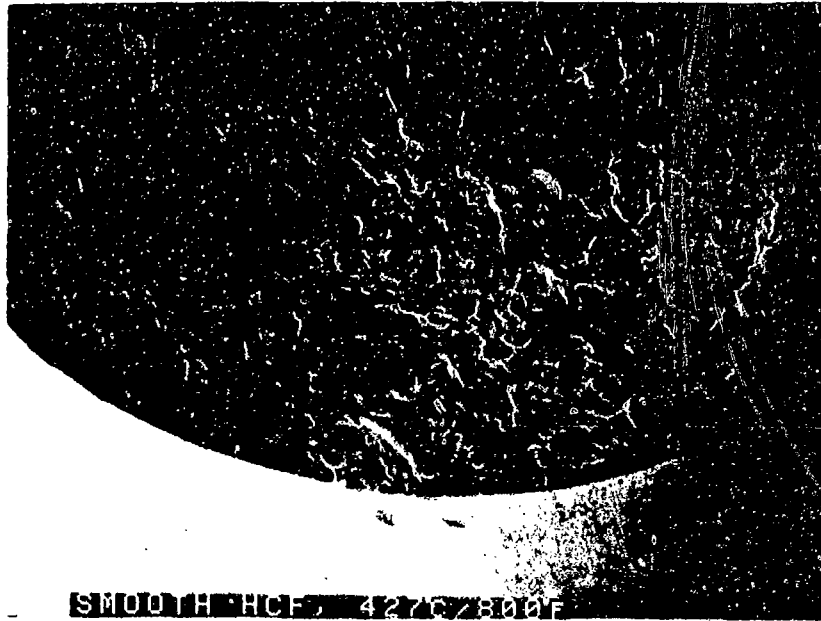
FAM 99315

FIGURE 8-47: Overall photograph of the origin area and initial progression zone. The fracture propagated from a relatively localized origin area but not from a point origin, much like the room temperature specimen.

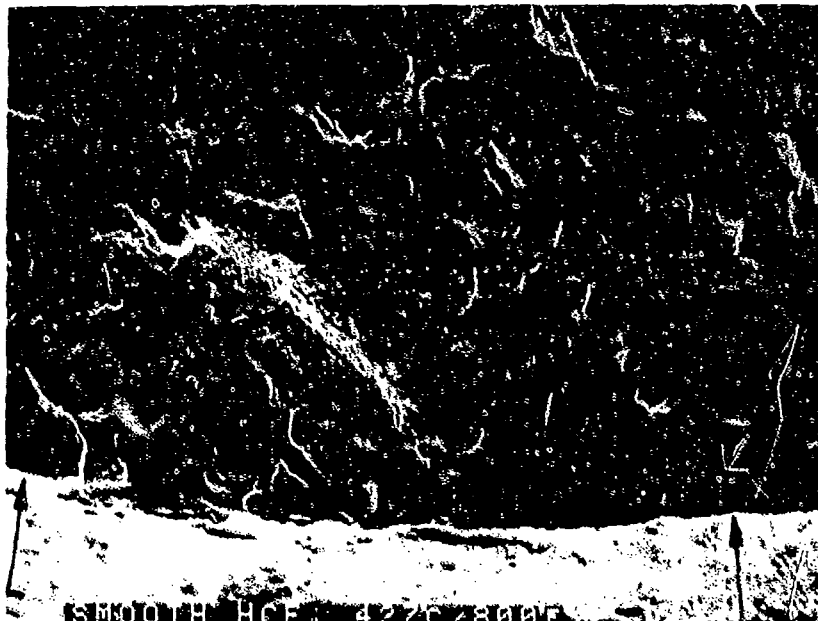
FAM 99316

FIGURE 8-48: Higher magnification photograph of the localized origin area. Several stage I fatigue facets are visible at the surface (arrows).

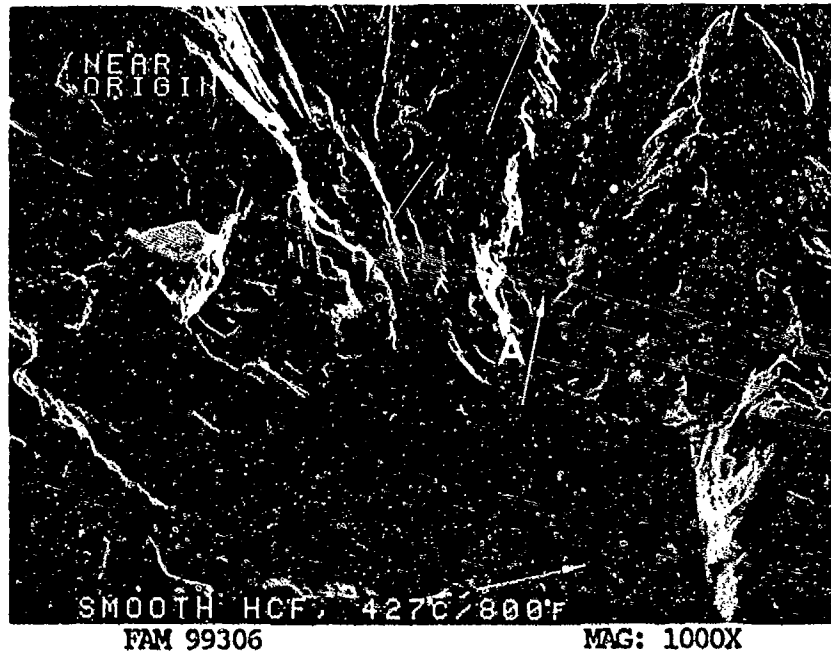
FIGURE 8-49: Fatigue progression near the origin. Fine striations are barely resolvable on fatigue plateaus (arrow A). A stage I fatigue facet is visible at the bottom of the photograph (arrow). No striations are visible on this facet.

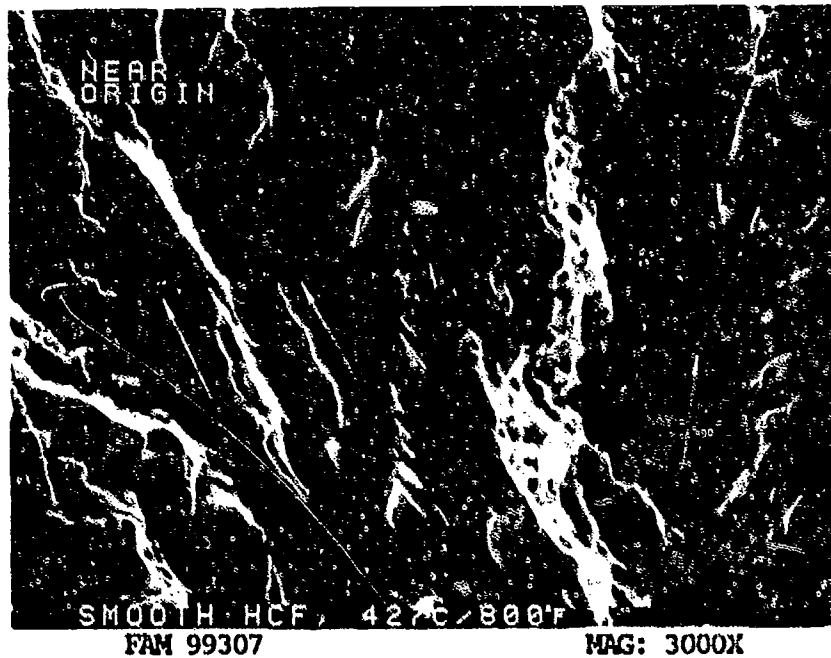
FIGURE 8-50: Higher magnification photograph of the area shown in Figure 8-49. Striations are clearly visible on planes (plateaus) propagating from the stage I facet. The directions of propagation on the various plateaus are shown by arrows.

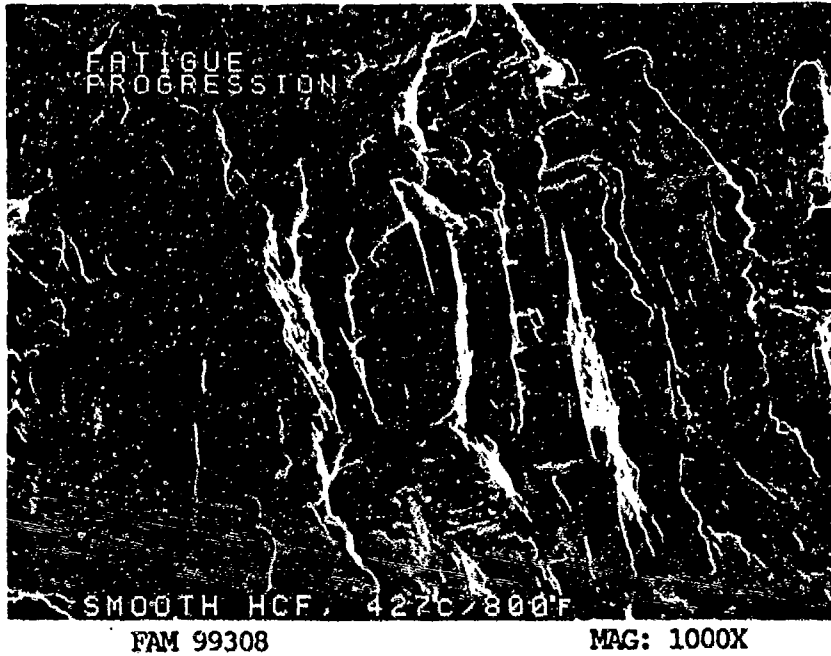
FIGURE 8-51: Fatigue progression zone exhibiting many changes of progression planes (plateaus). Fine striations are not resolvable.

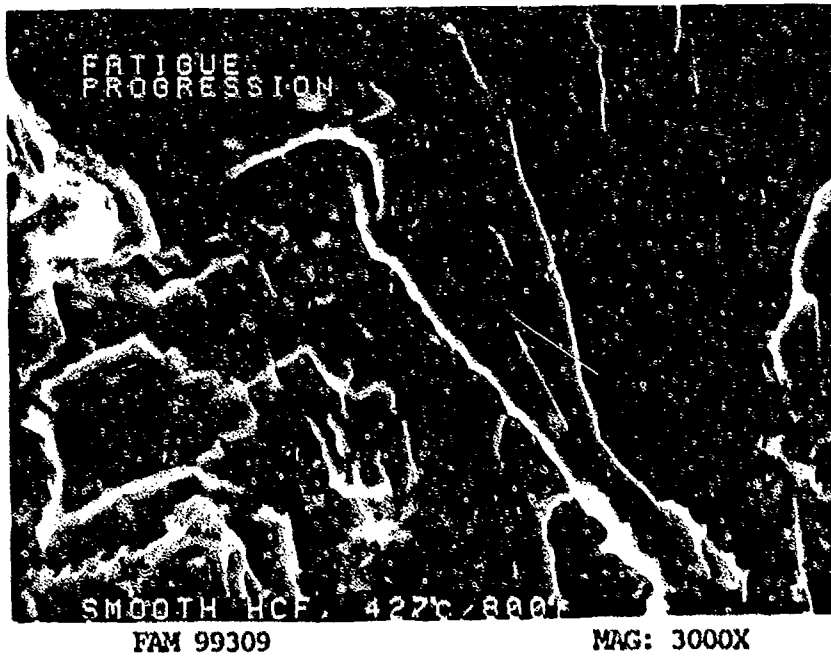
FIGURE 8-52: Fine striations in the fatigue progression zone. The direction of propagation is shown by an arrow.

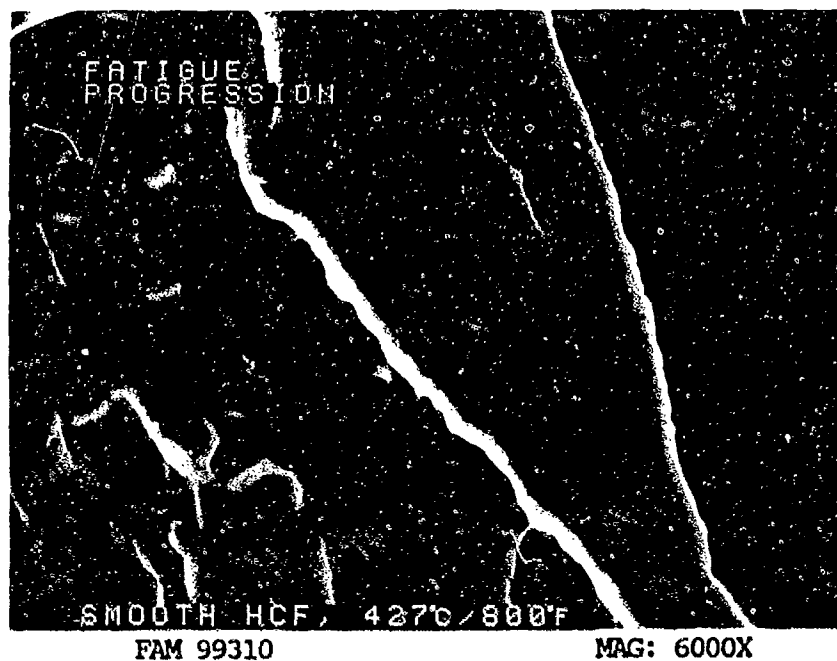
FIGURE 8-53: Higher magnification photograph of the area shown in Figure 8-52. Individual striations are not resolvable.

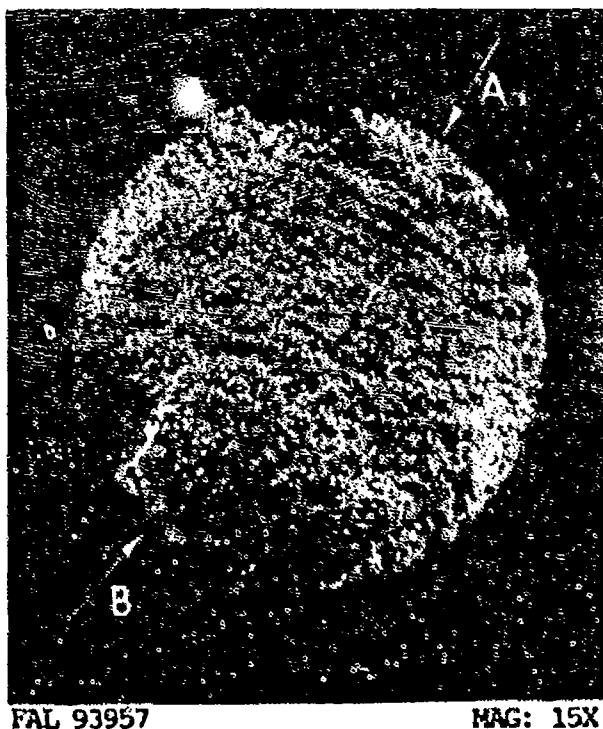
FIGURE 8-56: Test results and fractography of Inconel 600 704°C (1300°F) smooth HCF test. The specimen exhibits fatigue progression over 90 percent of the fracture. Arrest marks are clearly visible over the final third of the progression. The origin is shown by arrow B. The final overstress area appears as a small thumbnail (arrow A).

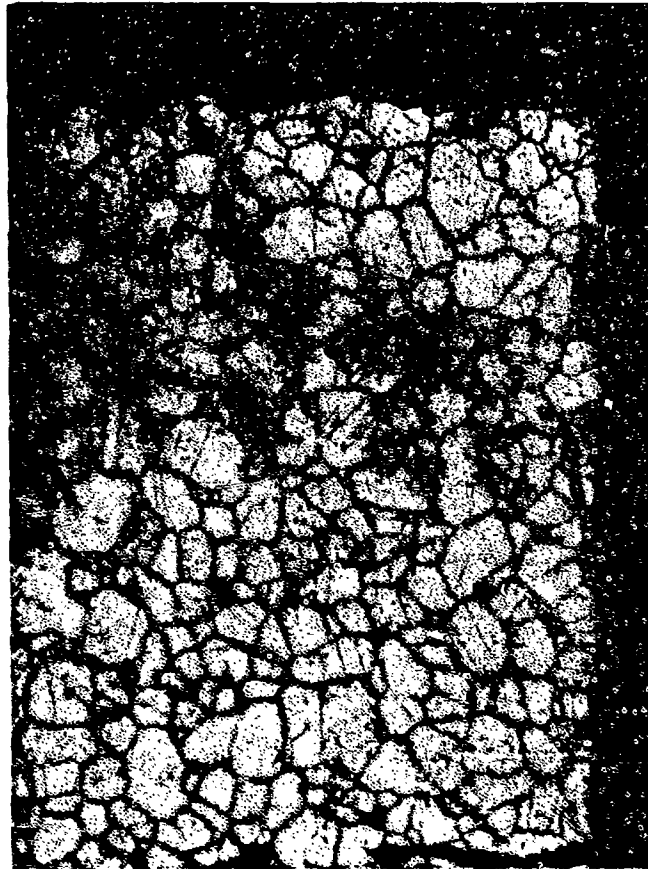
FAM 99848

FIGURE 8-57: Optical photomicrograph showing the origin and initial fatigue progression areas. The fracture propagated transgranularly. Numerous secondary cracks are visible adjacent to the primary fracture (arrows).

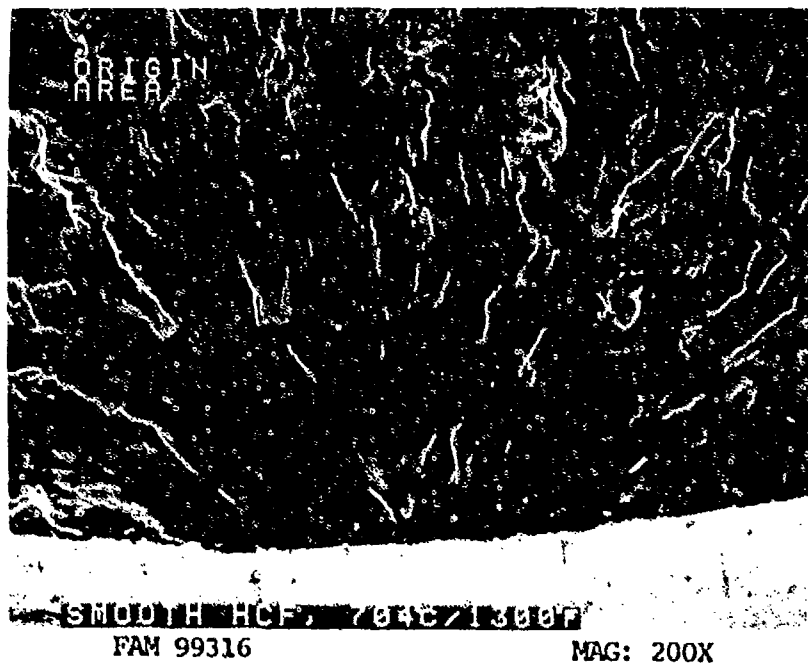
FIGURE 8-59: Higher magnification photograph of the localized origin area. The fracture appears relatively flat near the origin. Compare the appearance of this single origin with the diffuse origins on the room temperature and 800°F specimens (Figures 8-37 and 8-47).

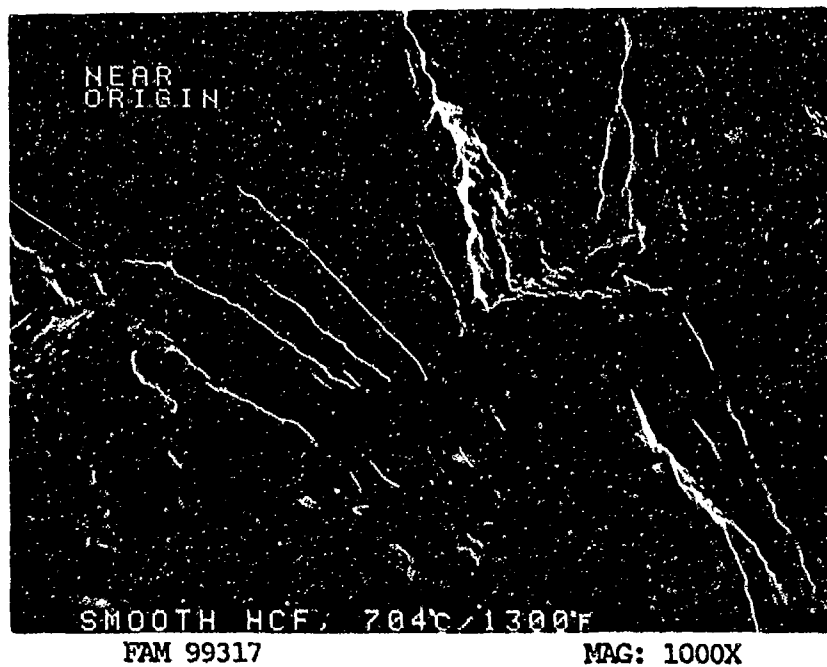
FIGURE 8-60: Fatigue progression near the origin. Fine striations are barely resolvable on fatigue plateaus separated by steps (arrow).

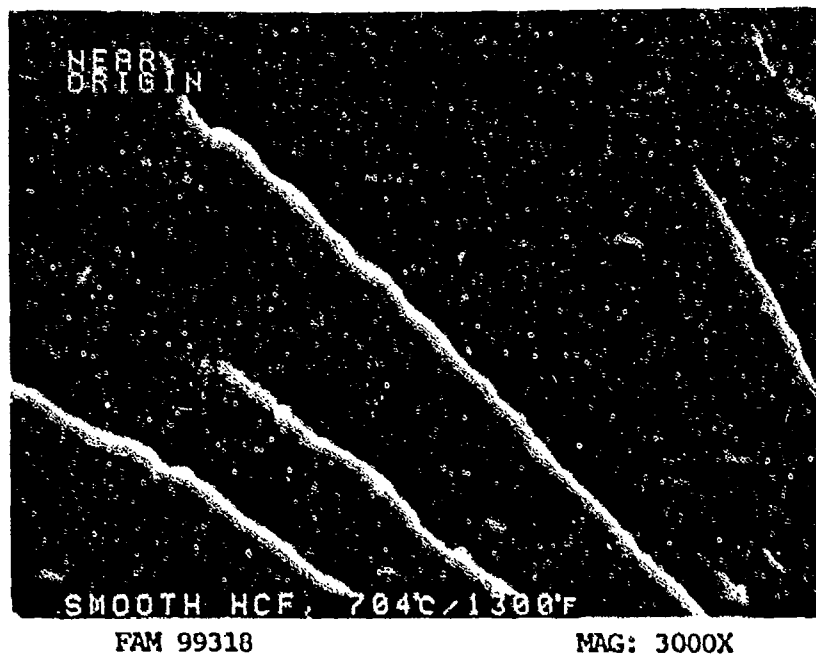
FIGURE 8-61: Higher magnification photograph of the area shown in Figure 8-60. Striations are clearly visible although not individually resolvable. The direction of propagation is shown by an arrow.

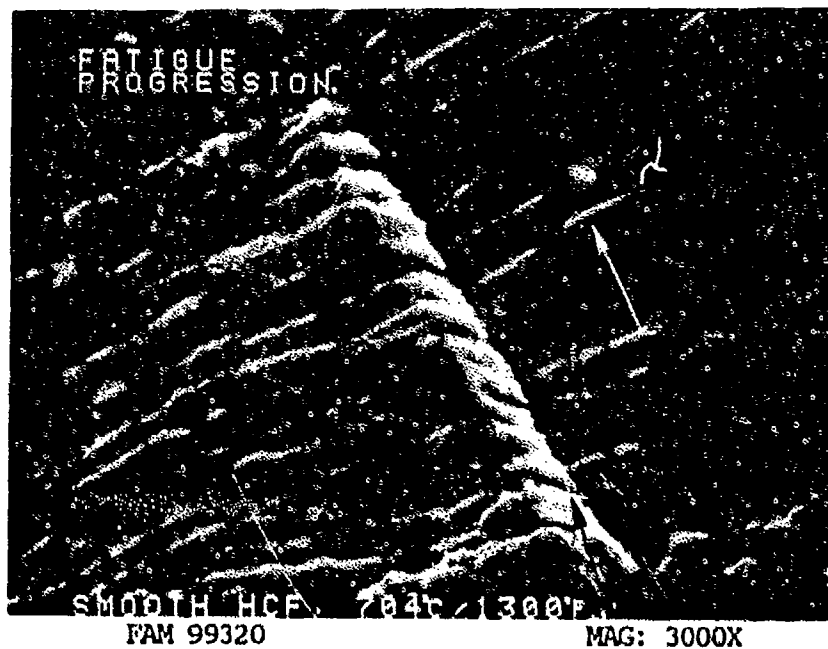
FIGURE 8-63: Higher magnification view of the area shown in Figure 8-62 showing coarser oxidized striations. The direction of propagation is shown by a white arrow. Note that striations progress over a step (black arrow) joining active fatigue progression planes.

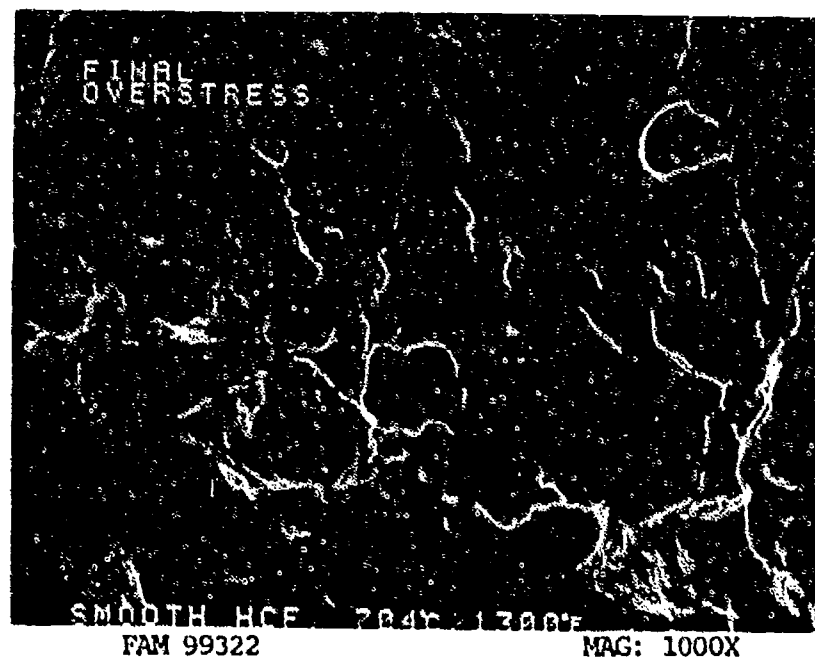
FIGURE 8-65: Oxidized overstress with no interpretable features.

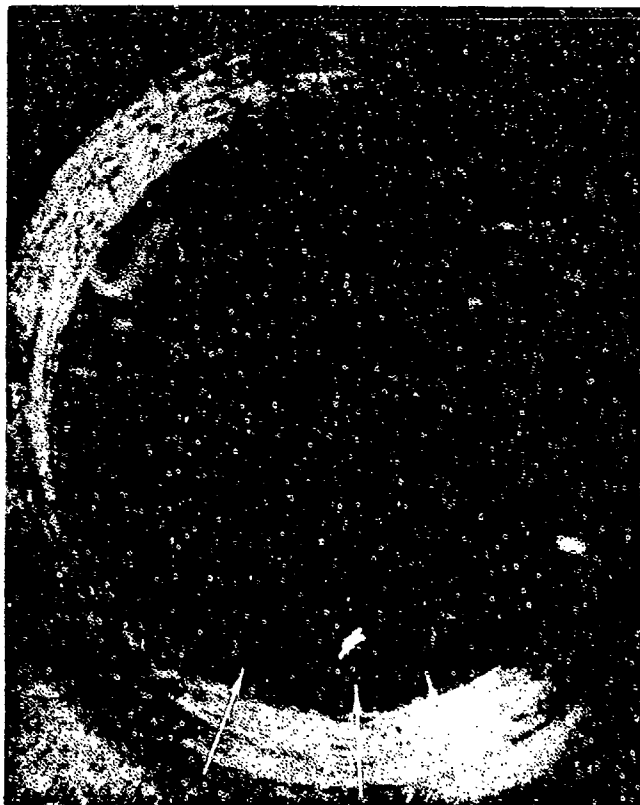
FAL 93954

FIGURE 8-66: Test results and fractography of Inconel 600 room temperature notched HCF test. The specimen exhibits fatigue progression over 90 percent of the fracture. Fatigue steps are visible at the surface of the specimen indicating propagation from multiple origins (white arrows). The final overstress area appears as a small thumbnail (black arrow).

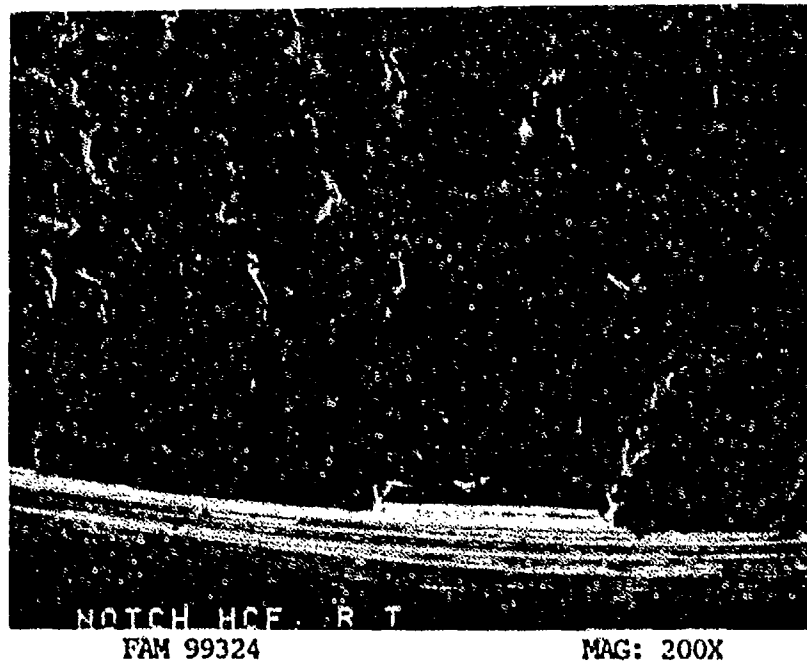
FIGURE 8-69: Higher magnification photograph of one localized origin area (bracket).

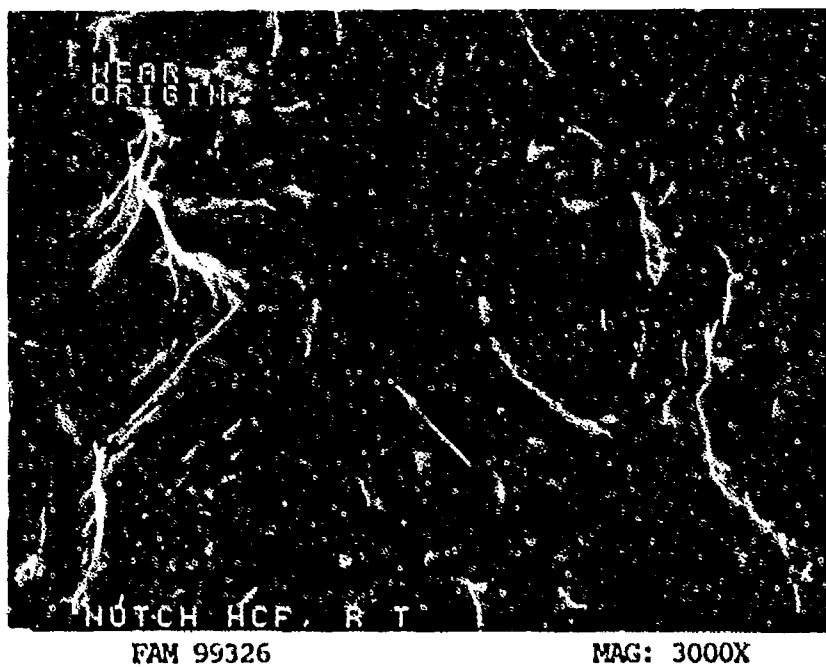
FIGURE 8-71: Higher magnification photograph of the area shown in Figure 8-70. Striations are visible on several plateaus. The direction of propagation is shown by an arrow.

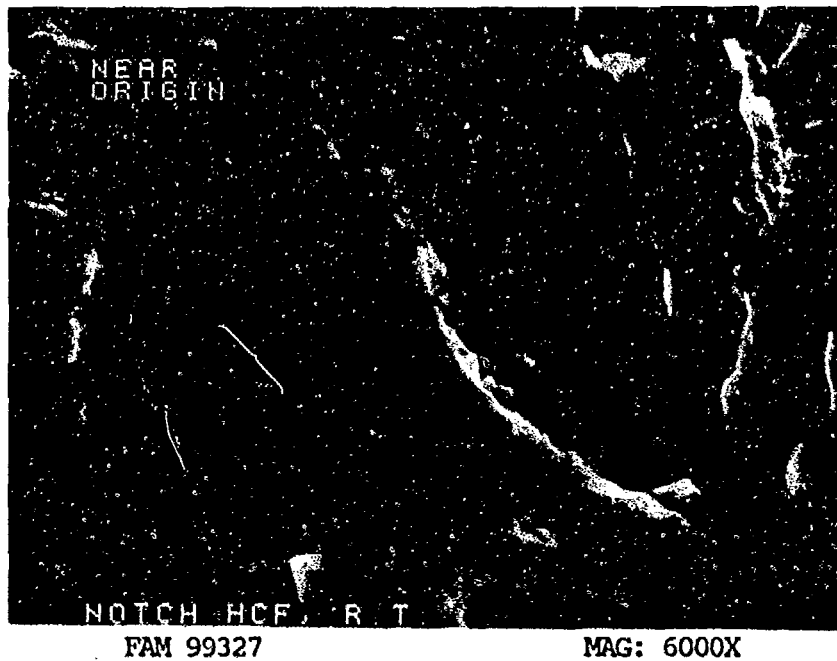
FIGURE 8-72: Higher magnification photograph showing fine striations in the area shown in Figure 8-71. Individual striations are barely resolvable. Bracket contains 10 striations.

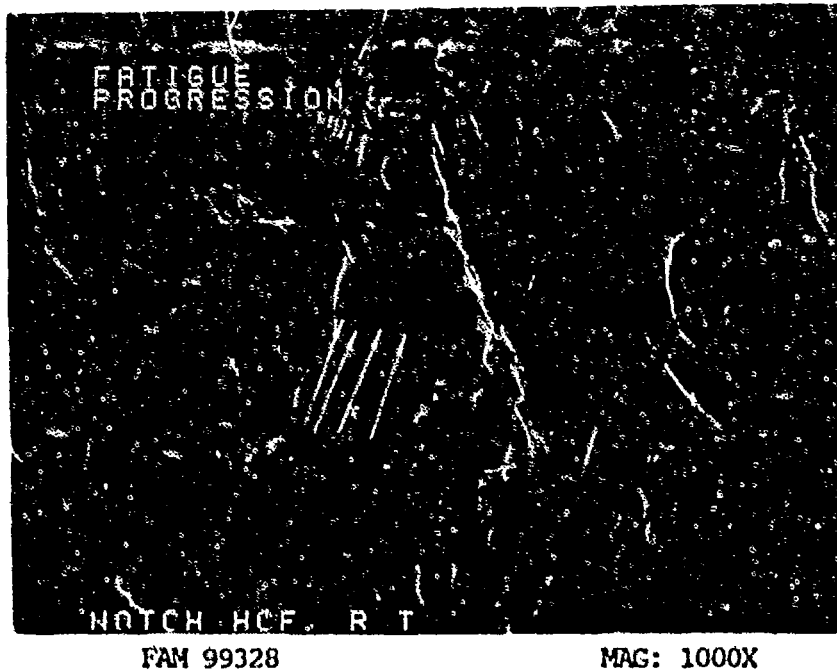
FIGURE 8-73: Small parallel fatigue plateaus in the fatigue progression zone (arrows).

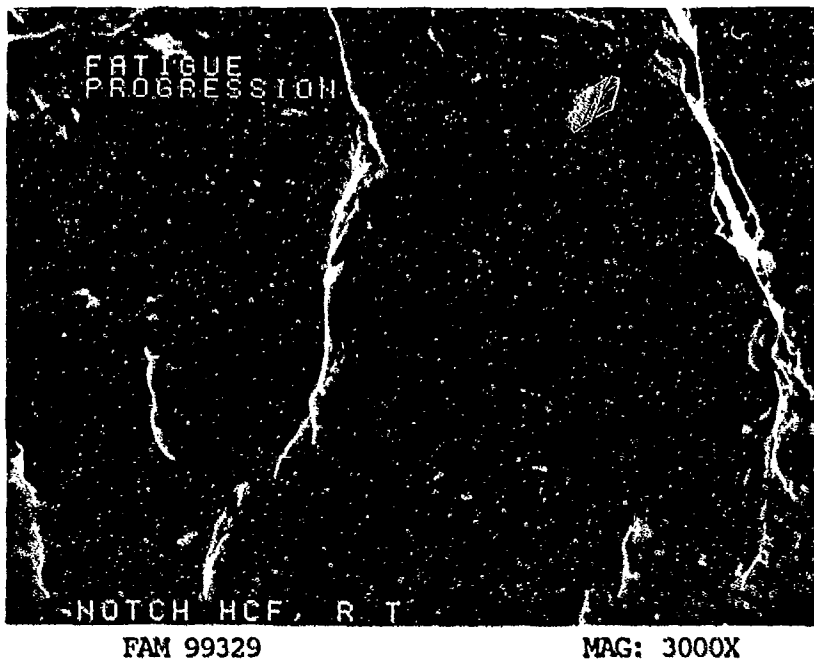
FIGURE 8-74: Higher magnification photograph of the area shown in Figure 8-73. Fine fatigue striations are visible on the plateaus. The direction of propagation is from bottom to top of the photograph.

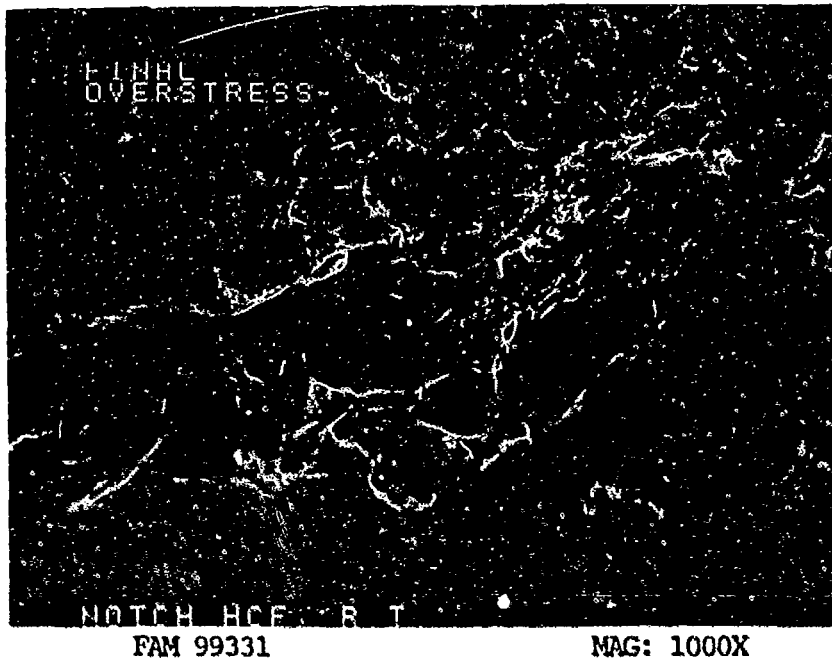
FIGURE 8-76: Oxidized final overstress area exhibiting dimpled overstress with small patches of cleavage.

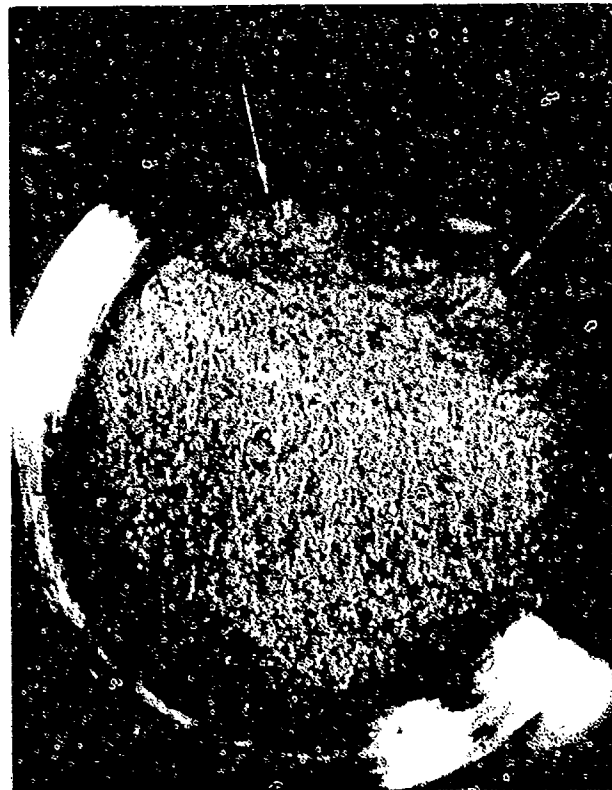
FAL 94245

FIGURE 8-77: Test results and fractography of Inconel 600 427°C (800°F) notched HCF test. The specimen exhibits fatigue progression over 80 percent of the fracture. Fatigue steps are visible at the surface of the specimen indicating propagation from multiple origins. The final overstress area is indicated by arrows.

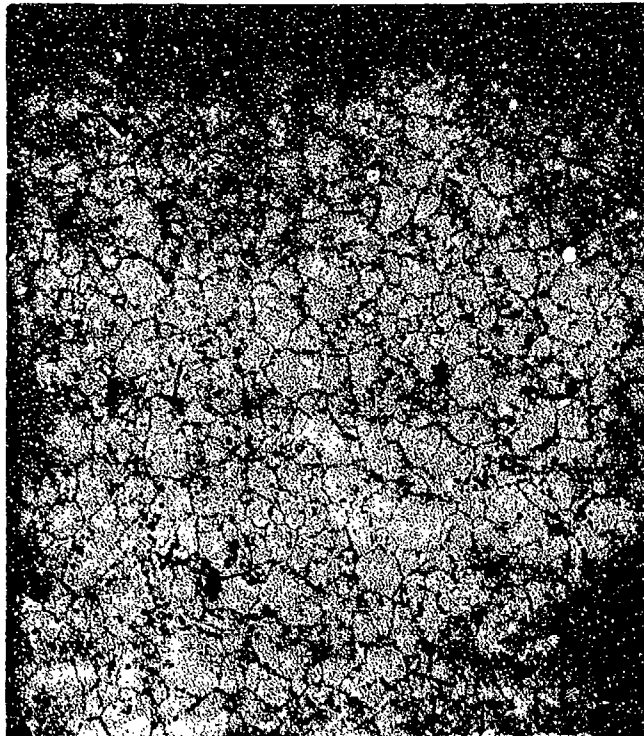
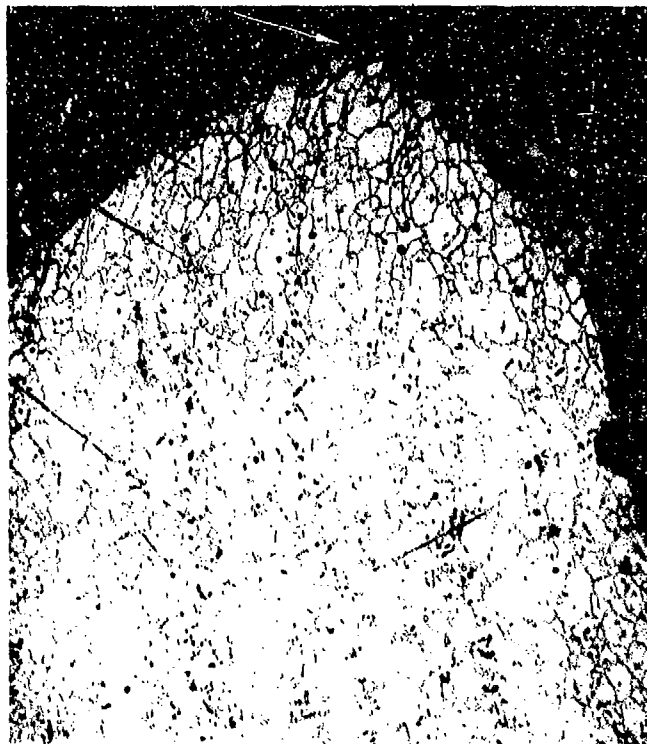
FIGURE 8-78: Optical photomicrographs showing transgranular fatigue progression area (top) and final overstress area (bottom). Significant grain elongation is visible in the final overstress area (arrow).

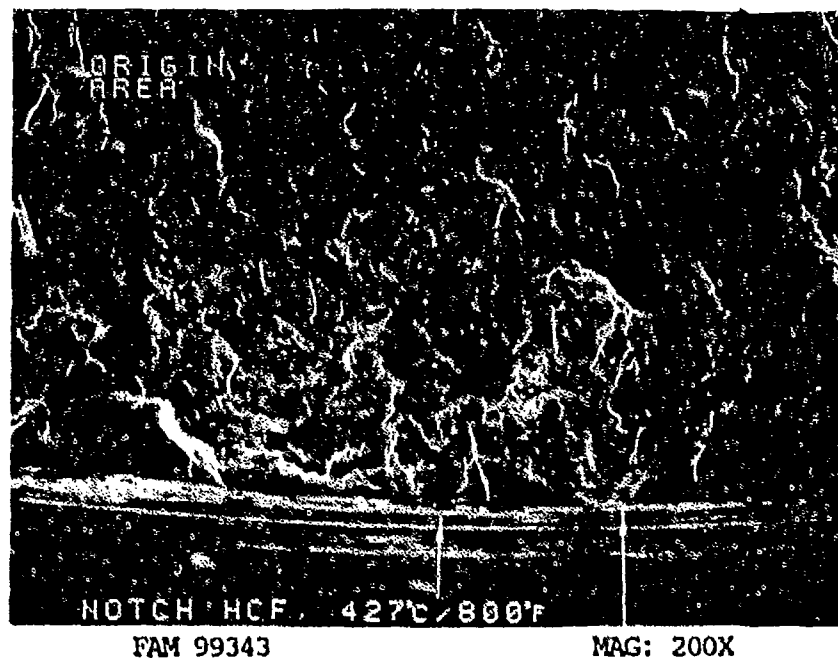
FIGURE 8-80: Higher magnification photograph of one localized origin area. Two stage I fatigue facets are visible at the surface (arrows).

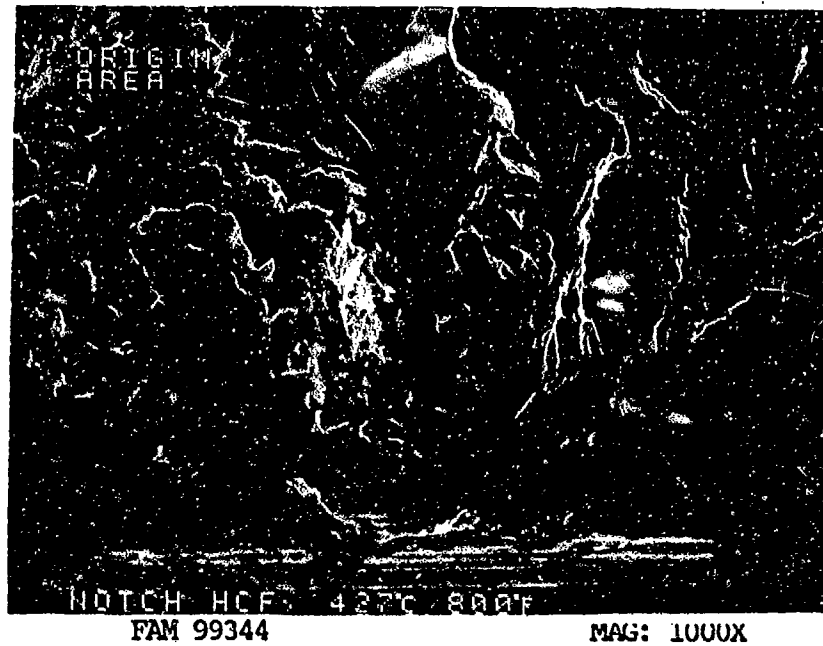
FIGURE 8-81: Higher magnification photograph of a localized origin. A stage I facet and initial progression near the origin are visible. No striations are visible on the stage I fatigue facet.

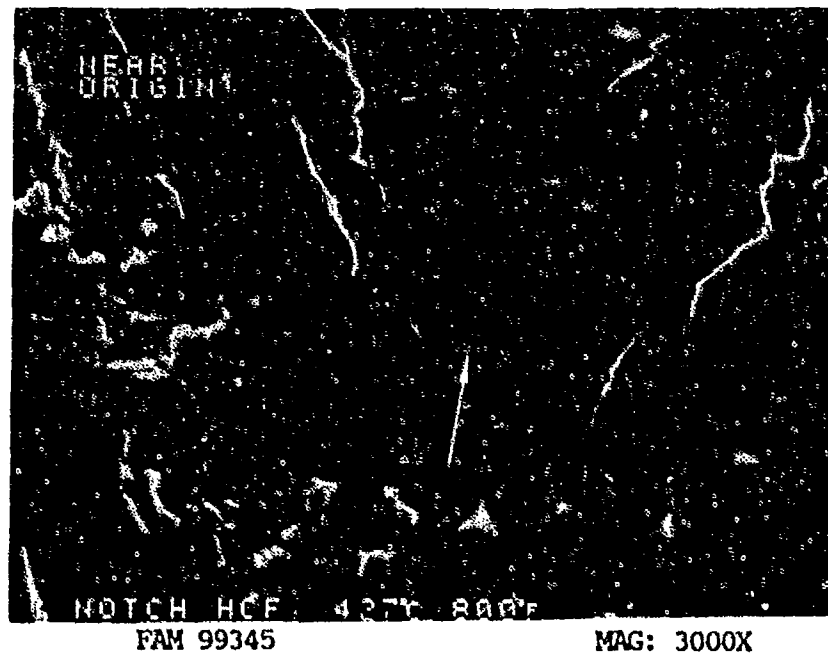
FIGURE 8-82: Higher magnification photograph of the area shown in Figure 8-81. Striations are visible on several plateaus. The direction of propagation is shown by an arrow.

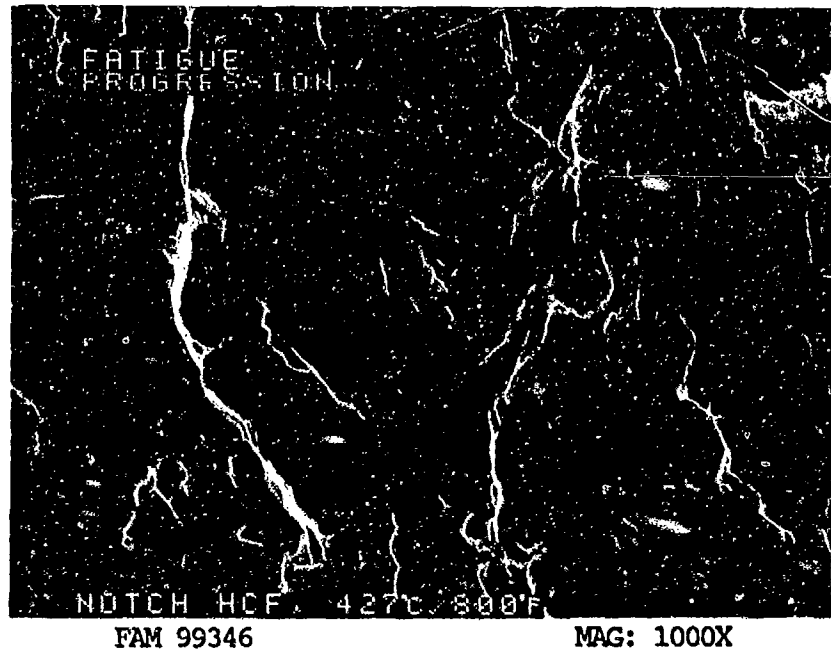
FIGURE 8-83: Fatigue progression exhibiting striations on several plateaus. The general direction of propagation is from bottom to top of the photograph.

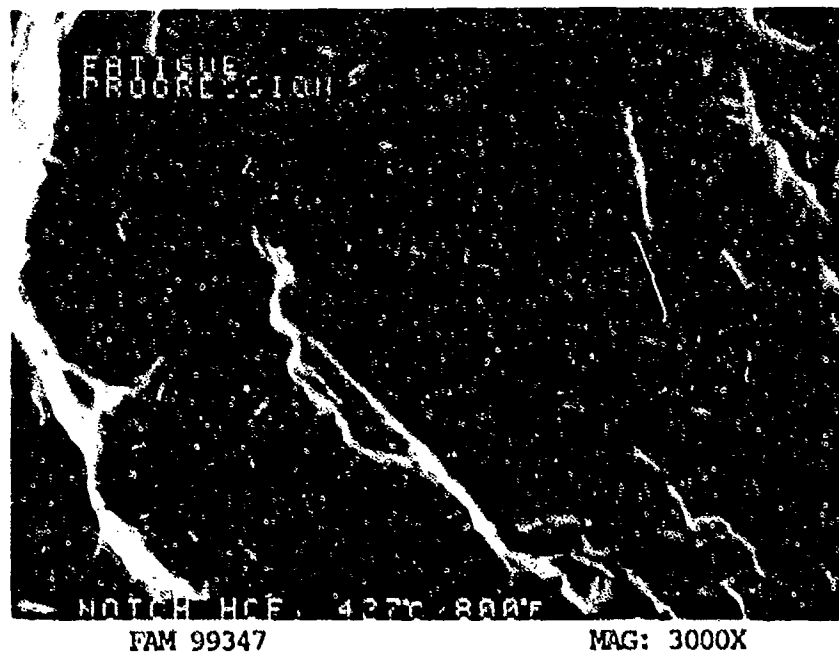
FIGURE 8-84: Higher magnification photograph of the fatigue striations in the progression zone (Figure 8-83). Brackets contain ten striations.

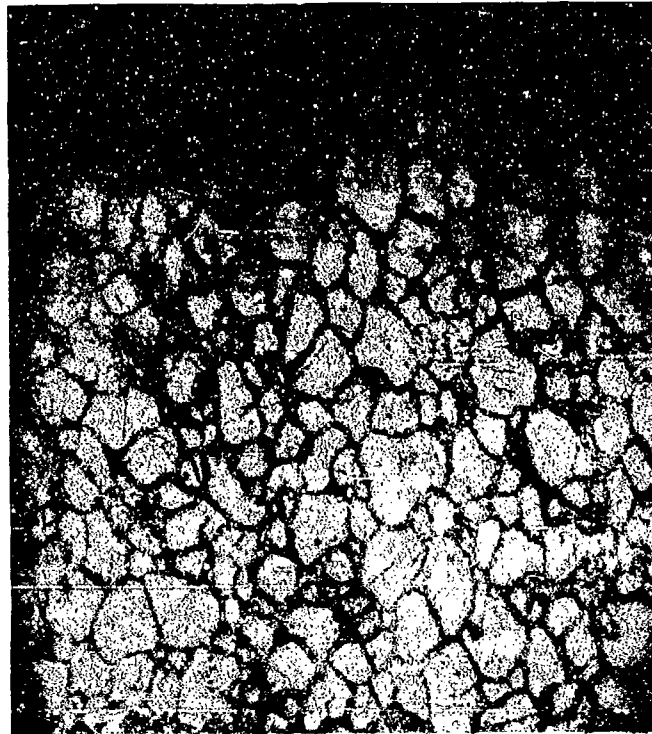
FIGURE 88: Optical photomicrographs showing fatigue progression area (top) and final overstress area (bottom). Compare the appearance of the grain boundaries with those in Figure 8-78, tested at 800° F.

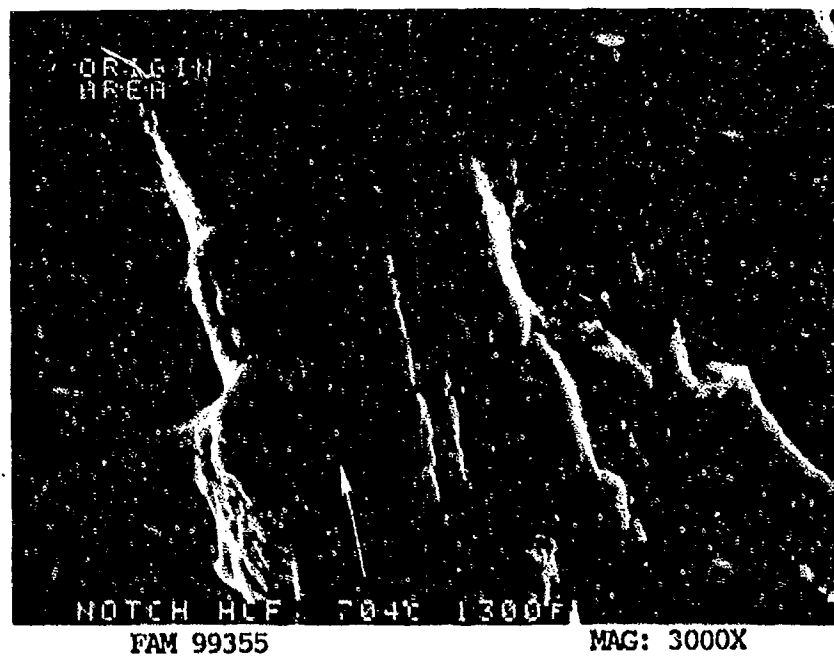
FIGURE 8-92: Higher magnification photograph of the area shown in Figure 8-91. Remnant striations are visible on several plateaus. The direction of propagation is shown by an arrow.

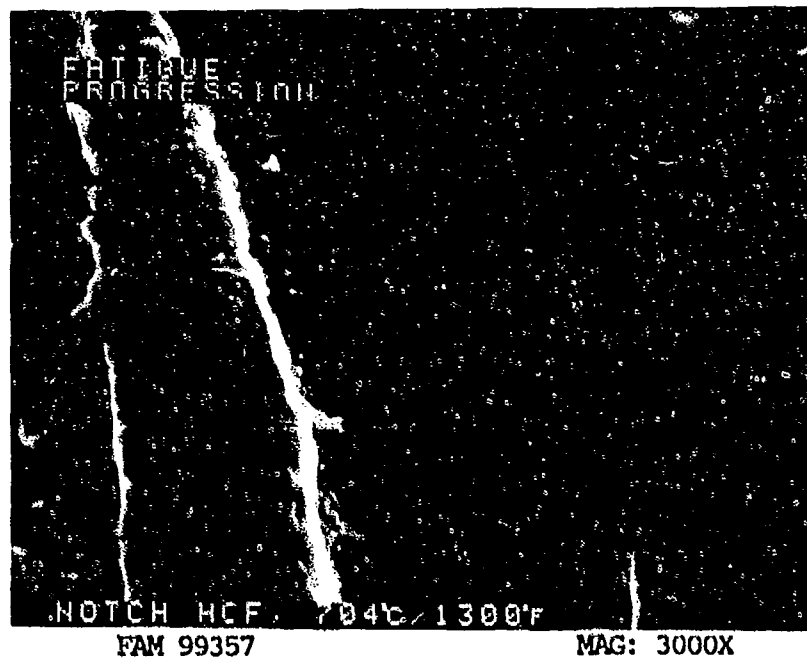
FIGURE 8-94: Higher magnification photograph of the area shown in Figure 8-93. Well developed oxidized fatigue striations are visible in the progression zone.

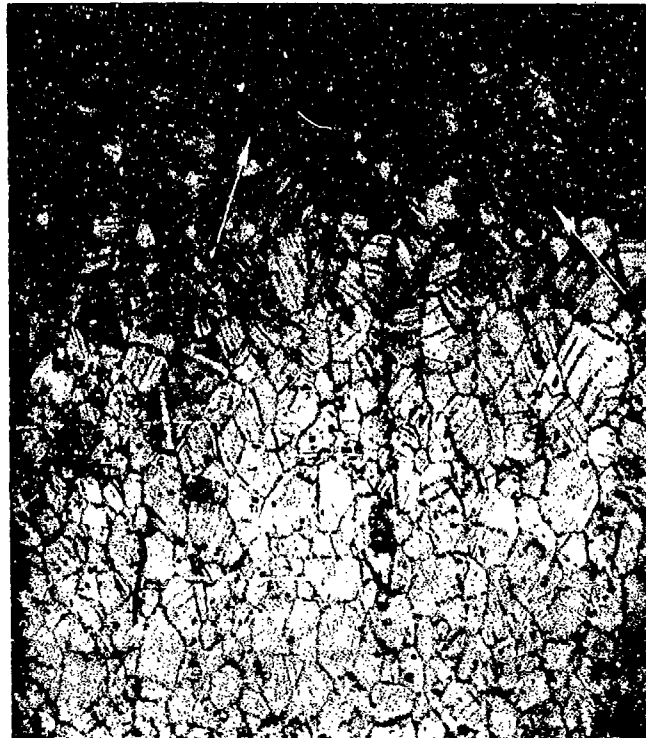
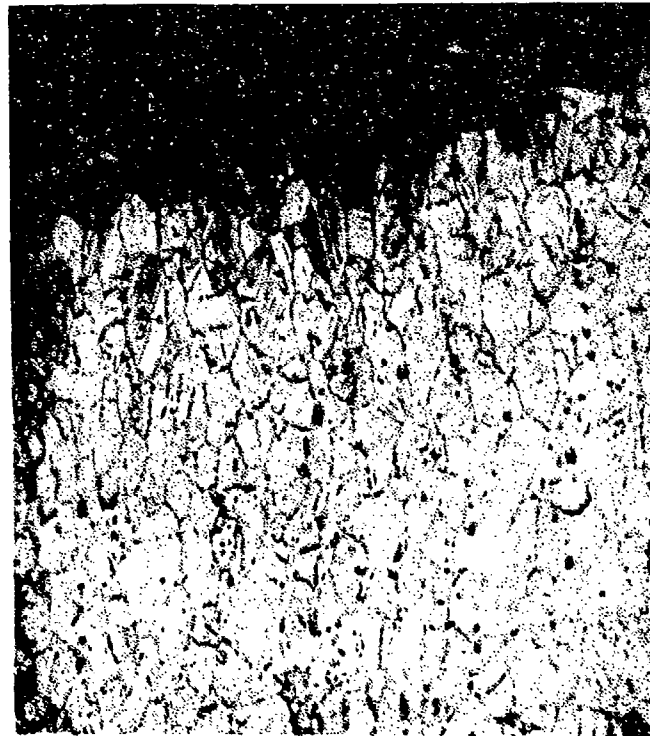
FIGURE 8-98: Optical photomicrographs showing the fatigue progression area (top) and the final overstress area (bottom). Heavy strain lines are visible in the fatigue area (arrows) with fewer strain lines present in the overstress. These are produced by slip as the stress is cycled above and below the yield point. Figure 8-46 exhibits no strain lines because HCF loading does not surpass the yield point.

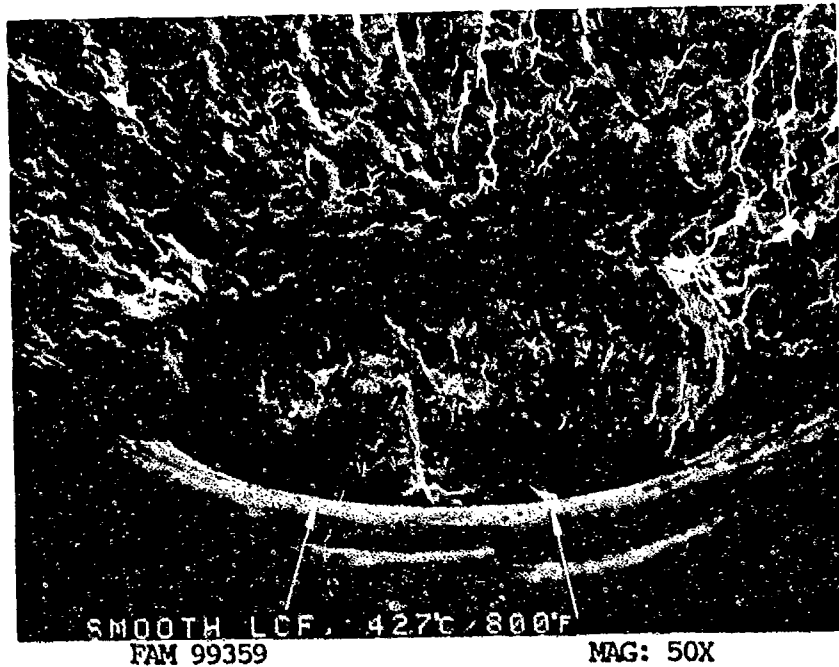
FIGURE 8-99: Overall photograph of the origin area exhibiting a thumbnail. Two local origins are visible (arrows) with features radiating from them.

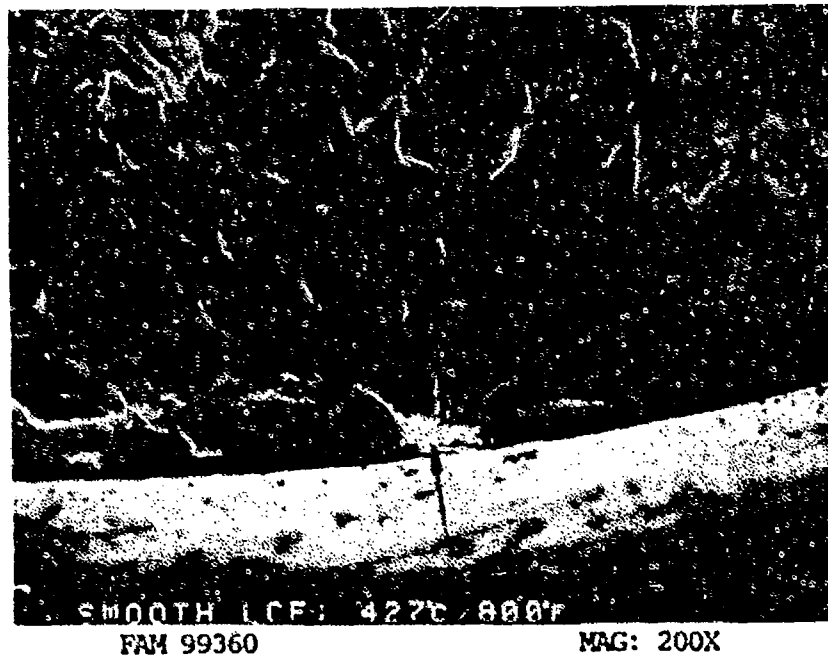
FIGURE 8-100: Higher magnification photograph of one local origin area. A stage I fatigue facet is visible at the surface (arrow). Feathery cleavage features radiate from the origin.

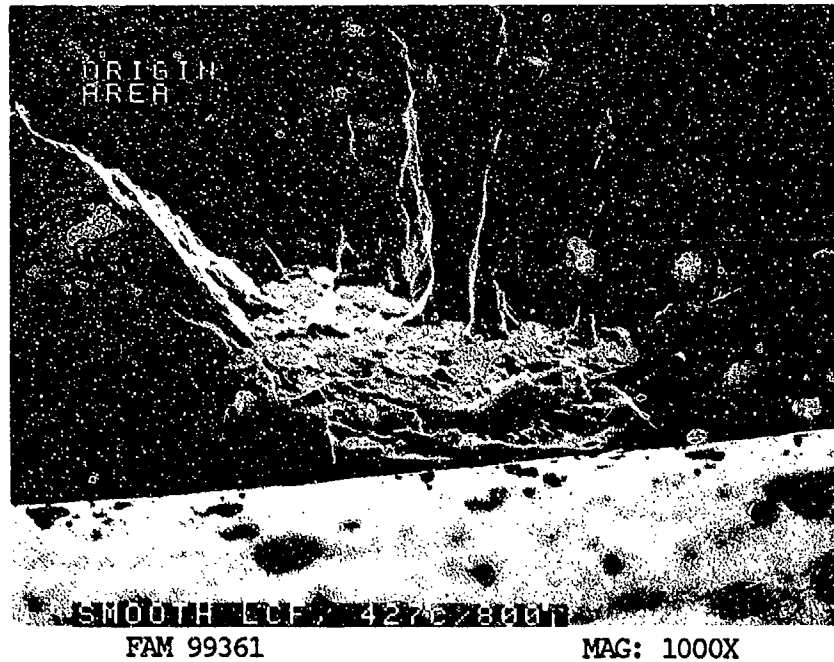
FIGURE 8-101: Higher magnification photograph of the origin area exhibiting a stage I fatigue facet at the surface. Striations and patches of feathery cleavage are visible adjacent to the stage I facet. No striations are visible on the facet.

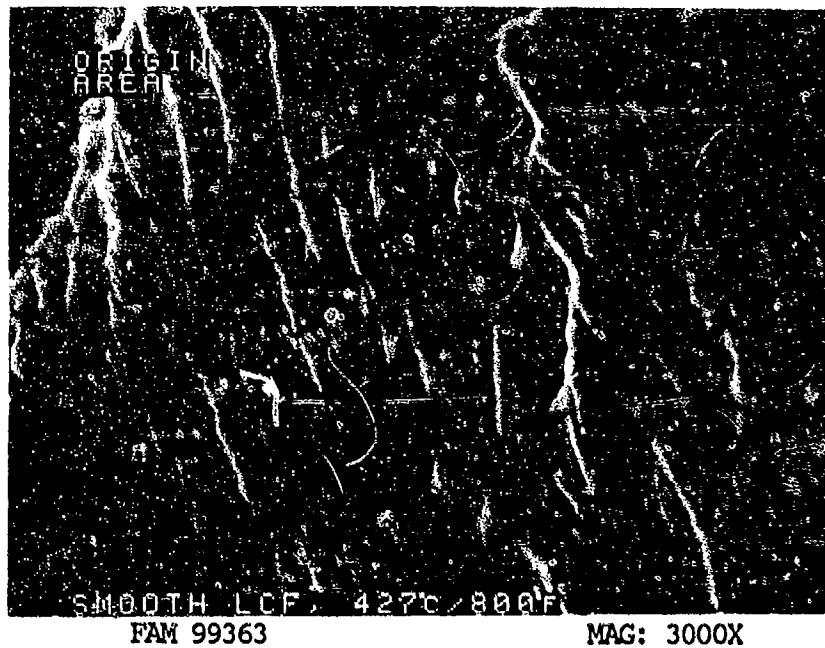
FIGURE 8-102: Higher magnification photograph of the area shown in Figure 8-101. Coarse striations are visible superimposed on fine feathery cleavage.
