FAILURE ANALYSIS HANDBOOK

C. R. Walker, K. K. Starr

Pratt & Whitney
P.O. Box 109600
West Palm Beach, FL 33410-9600

August 1989

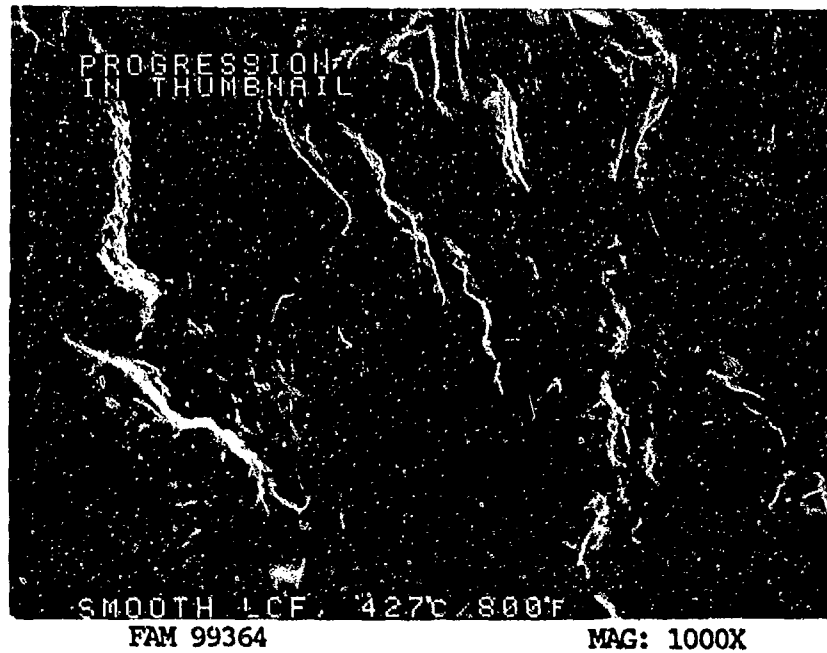
FIGURE 8-103: Fatigue progression zone in the thumbnail area exhibiting many changes of progression planes (plateaus) and feathery type cleavage.

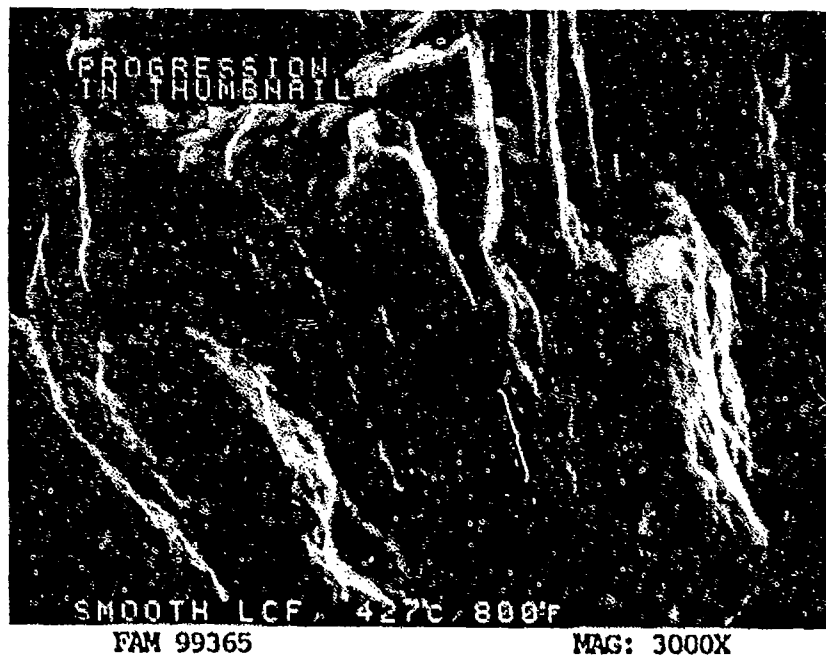
FIGURE 8-104: Fatigue striations in the area shown in Figure 8-103. Individual striations are barely resolvable. Bracket contains ten striations.

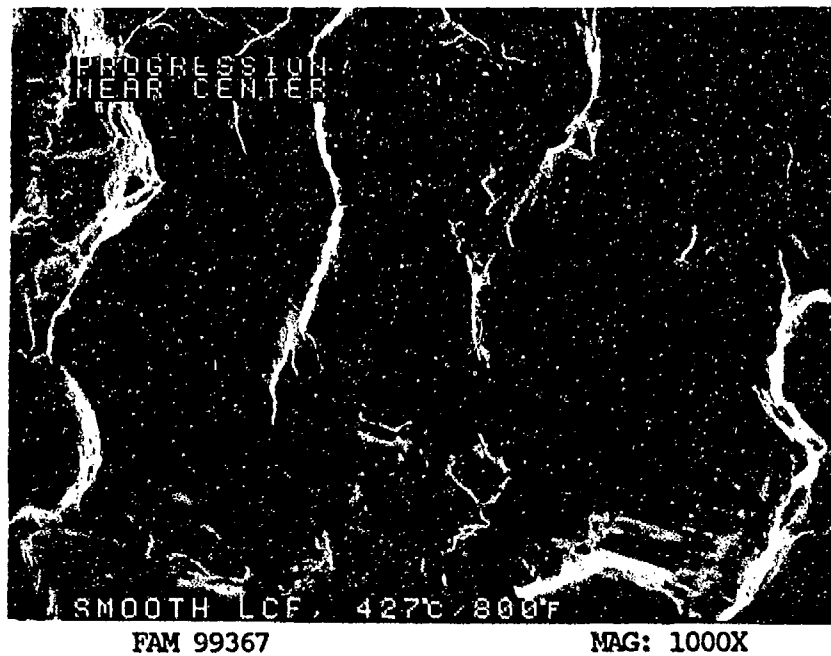
FIGURE 8-105: Fatigue progression near the center of the specimen. The features are coarser than those in the thumbnail area.

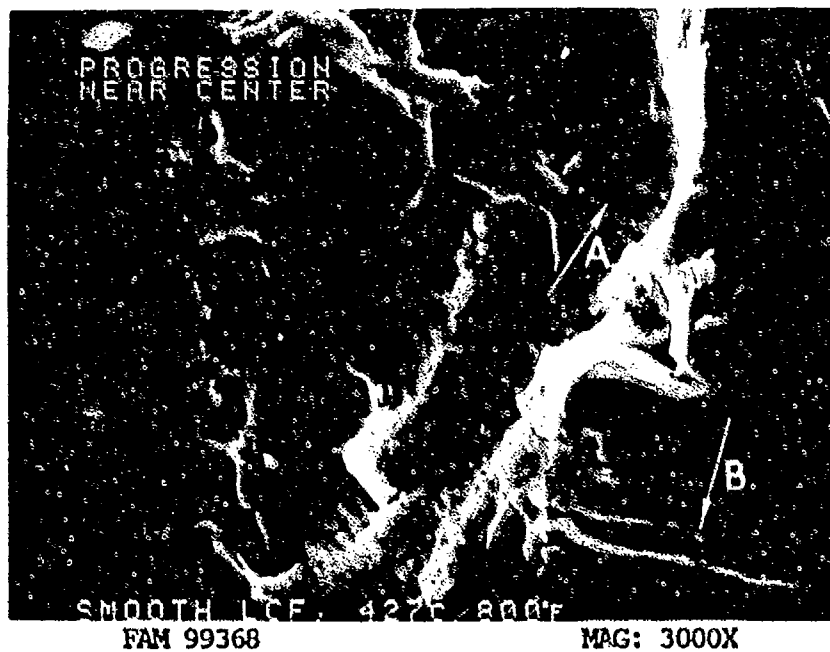
FIGURE 8-106: Higher magnification photograph of the area shown in Figure 8-105 showing remnant striations (arrow A) and crack-like striations (arrow B).

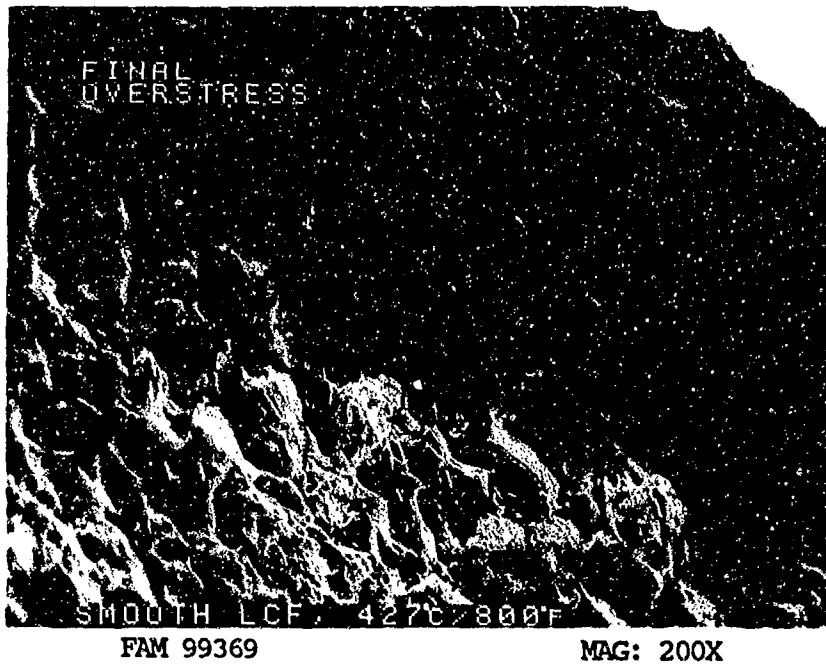
FIGURE 8-107: Final overstress area.

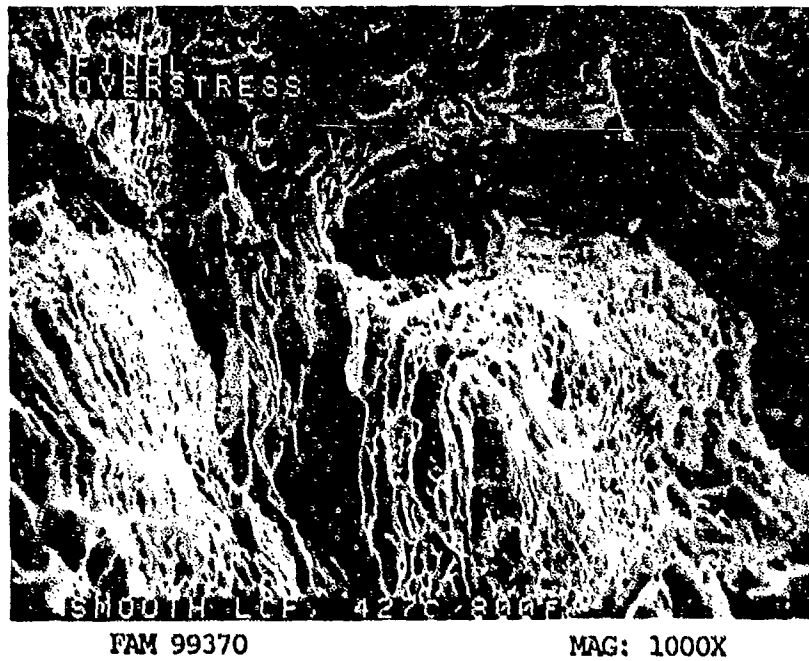
FIGURE 8-108: Mixture of dimpled overstress and cleavage in the final overstress area shown in Figure 8-107. Fine dimples are visible.

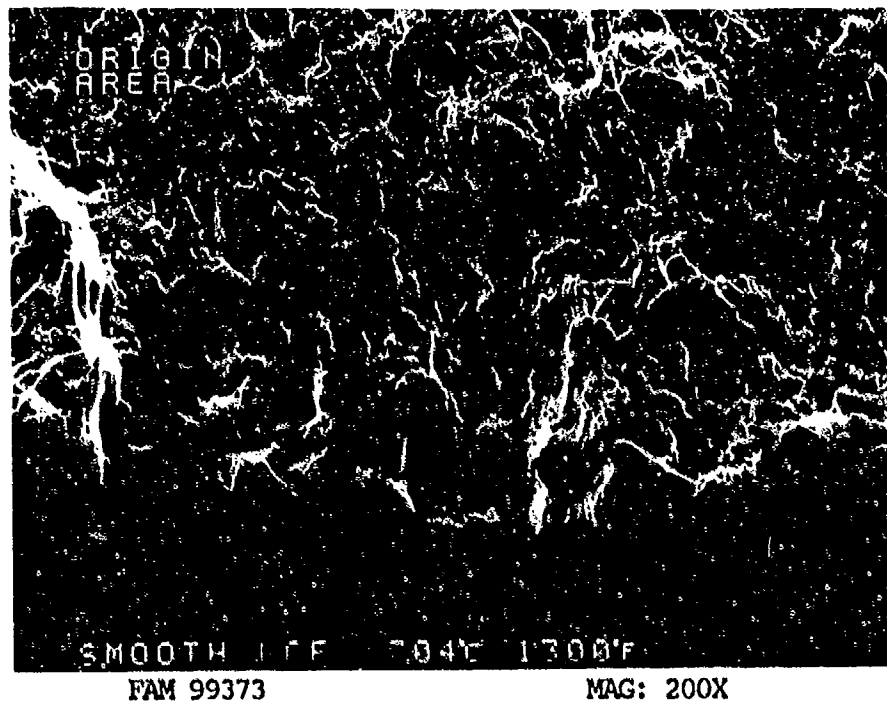
FIGURE 8-112: Higher magnification photograph of one localized origin area.

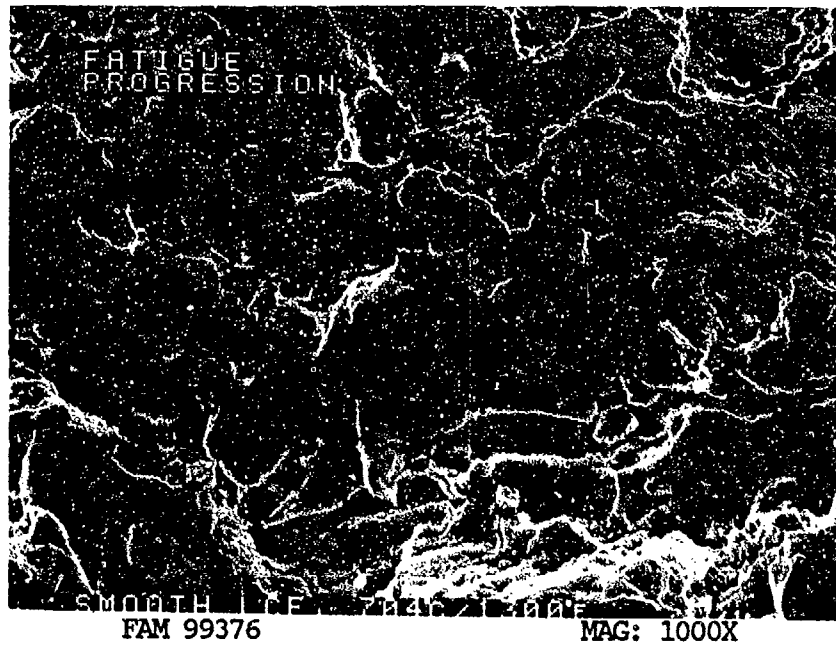
FIGURE 8-115: Fatigue progression zone exhibiting oxidized remnant fatigue the features (arrows).

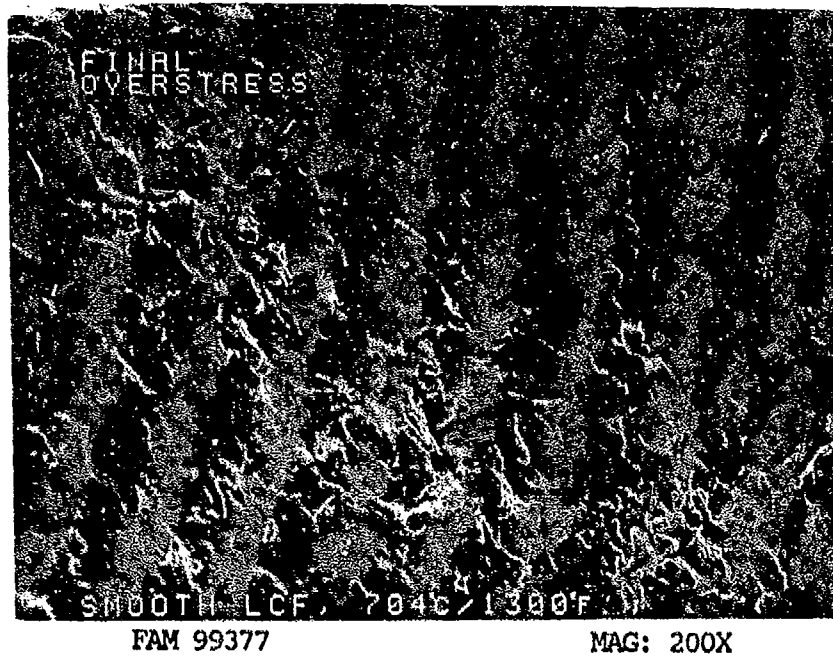
FIGURE 8-116: Final overstress area exhibiting no shear lip.

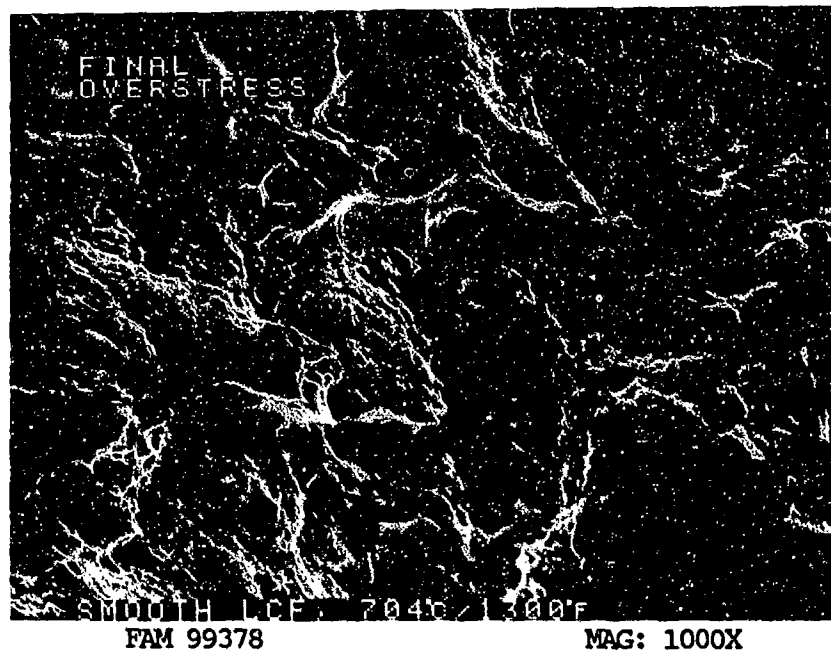
FIGURE 8-117: Dimpled overstress in the final overstress area.

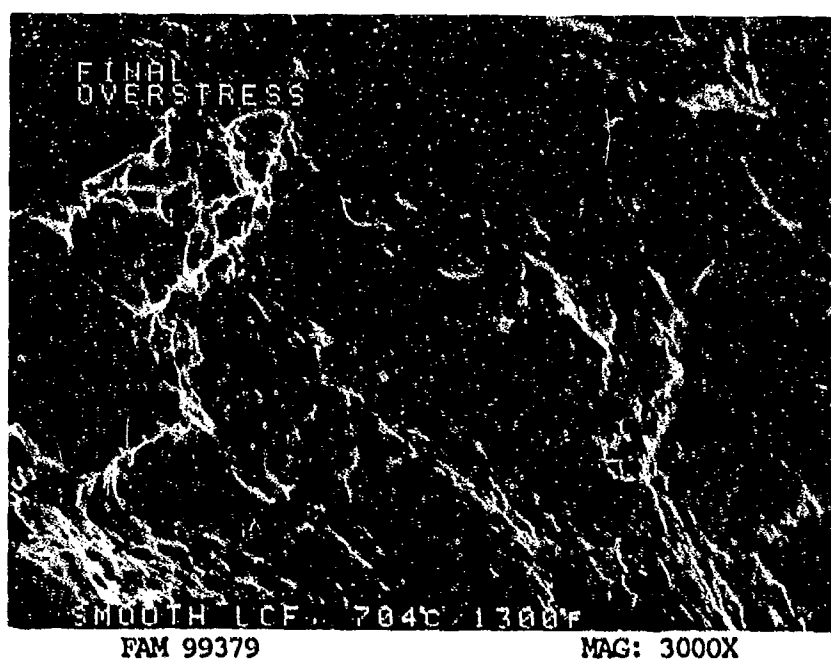
FIGURE 8-118: Higher magnification photograph of the area shown in Figure 8-117 showing fine oxidized dimpled overstress.

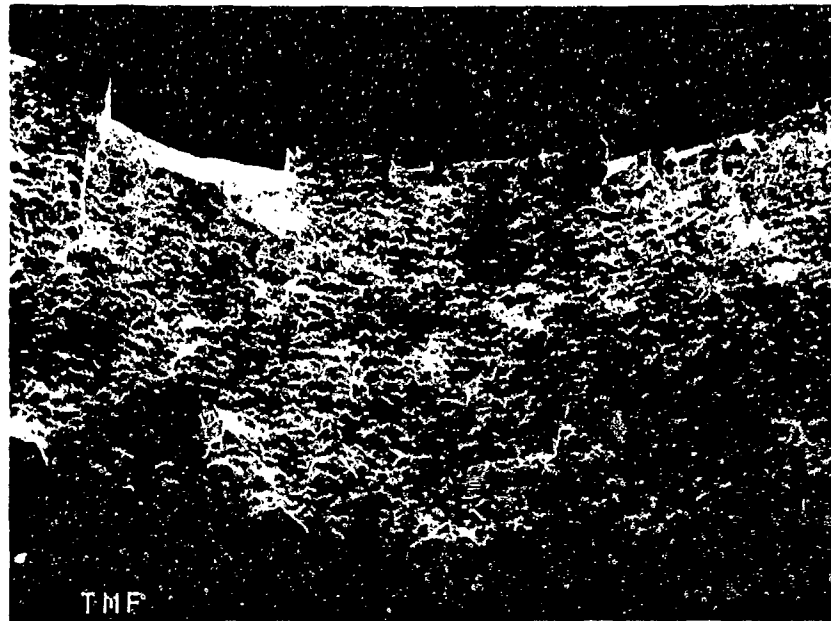
FAM 100448

FIGURE 8-121: Overall photograph of the fracture surface showing tensile overstress features with no fatigue present.

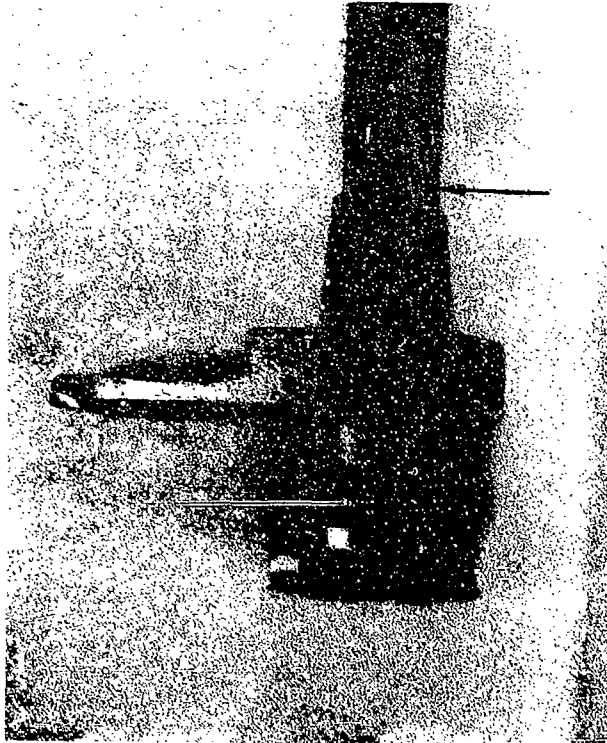
FAL 80846

SUMMARY: Transverse cracking of the number one bearing oil pressure tube was the result of liquid metal embrittlement by silver braze. The embrittlement probably occurred during manufacture when the braze joint was overheated, allowing the braze metal to penetrate the grain boundaries and reduce their strength. The part should not see the temperatures required for braze melting to occur in service. No other material or microstructural anomalies were found in the base metal.

FIGURE 8-123: Overall view of the end pressure tube containing the crack (arrow). The tube has been sectioned for examination.

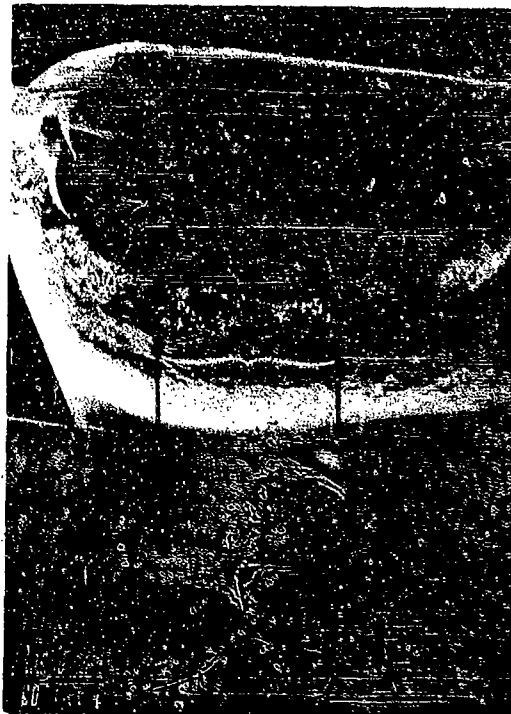
FAL 93465

FIGURE 8-125: Overall photograph of the opened crack surface (arrows).

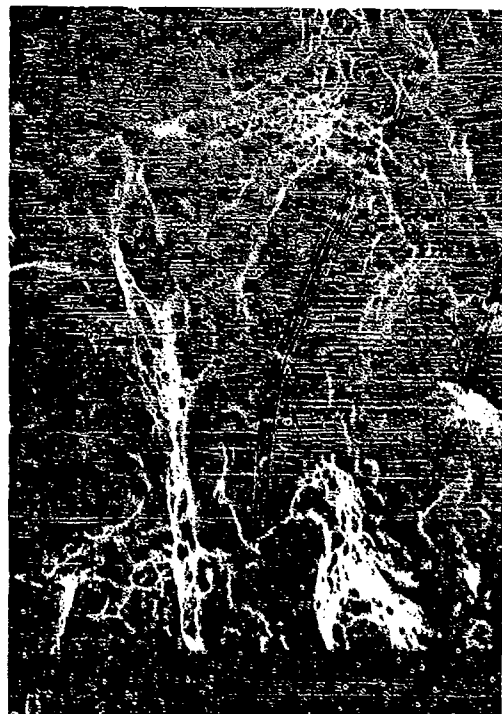
FAL 93463

FIGURE 8-126: Ductile overstress dimples. The fracture generally appeared to be intergranular.

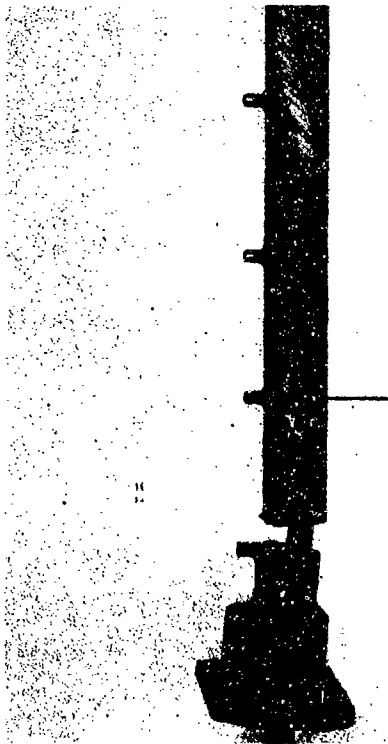
FAL 89206

SUMMARY: The fracture adjacent to the first (outboard) hypo-tube and the crack adjacent to the second hypo-tube were the result of liquid metal embrittlement (stress alloying). This resulted when the silver base braze used to join the hypo-tubes to the shell melted. The liquid silver alloy penetrated along the grain boundaries of the Inconel 600 causing them to become weak and crack. It could not be determined whether the embrittlement occurred during manufacturing or was due to engine operation. The estimated gas path temperature in this area was determined to approach the temperature required to remelt the braze.

FIGURE 8-128: Overall photograph of the pressure probe rake showing the fracture adjacent to the first hypo-tube and a crack at the second hypo-tube (arrow).

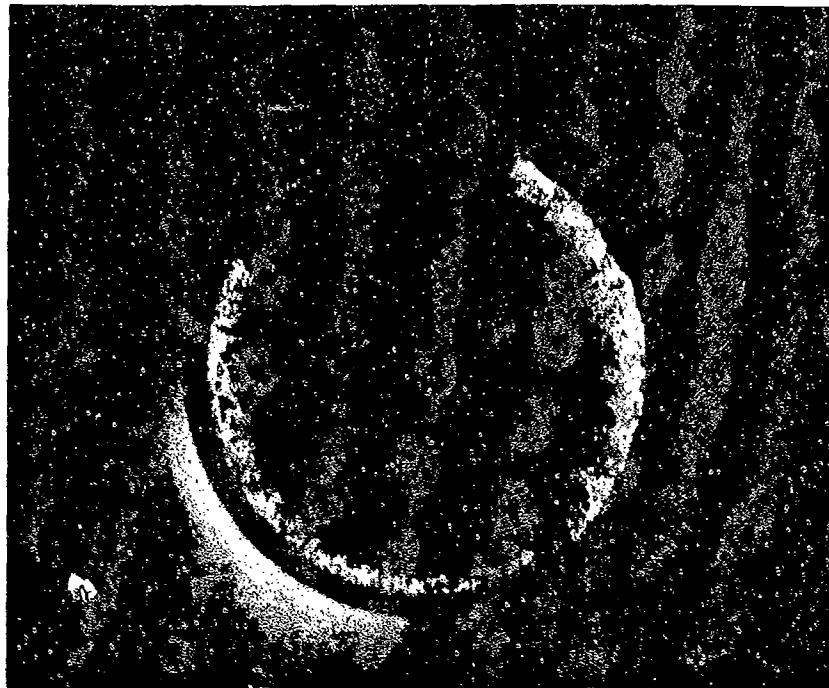
FAL 92553

Figure 9-1: Test results and fractography of Inconel X-750 room temperature smooth tensile test. The final overstress area (shear lip) appears shiny due to smearing. The center of the specimen has a granular appearance.

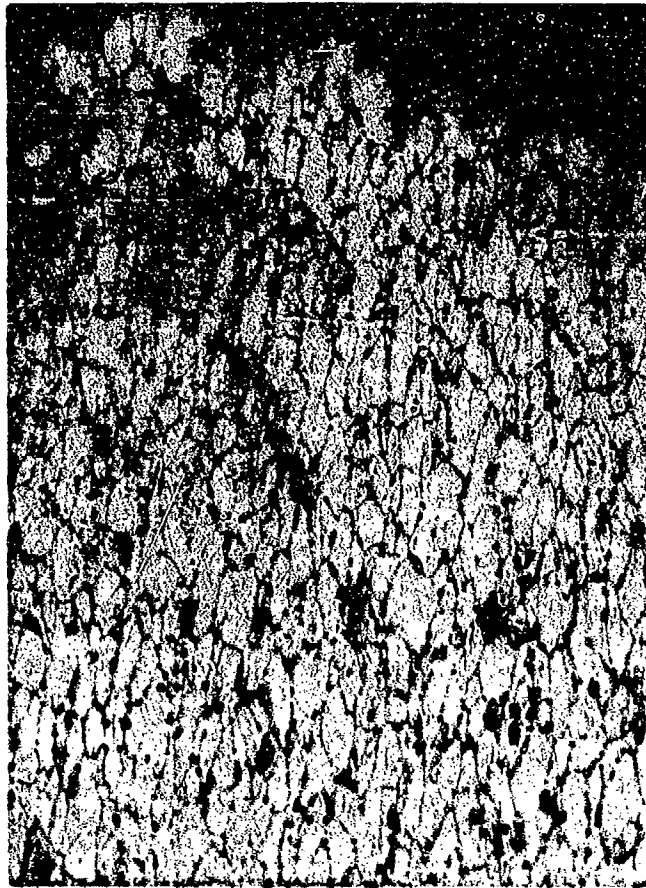
FAM 99833

FIGURE 9-2: Optical photomicrograph showing the primary fracture area exhibiting a mixed transgranular and intergranular fracture path. Carbides are visible dispersed throughout the microstructure.

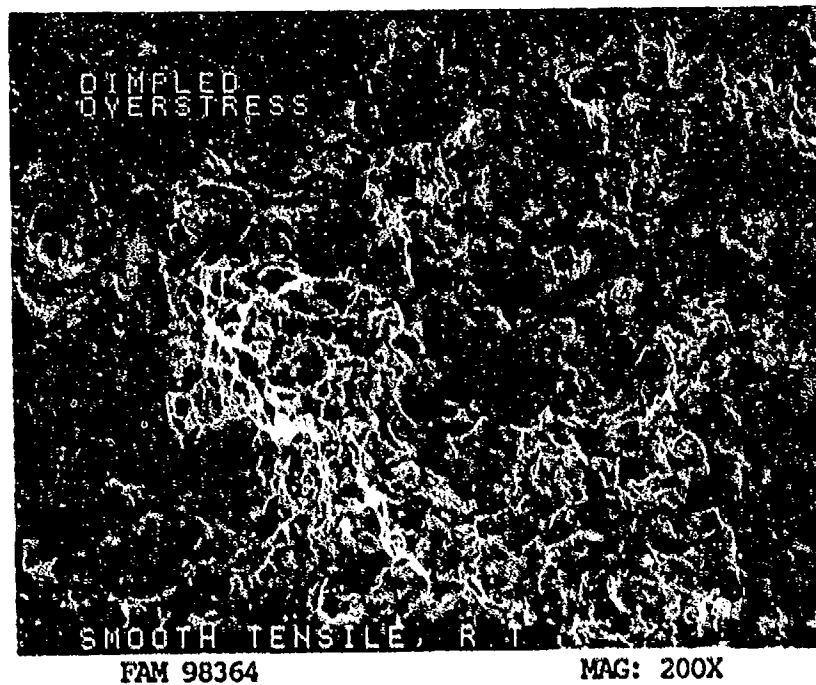
FIGURE 9-4: Primary fracture area exhibiting dimpled overstress with slight intergranular character.

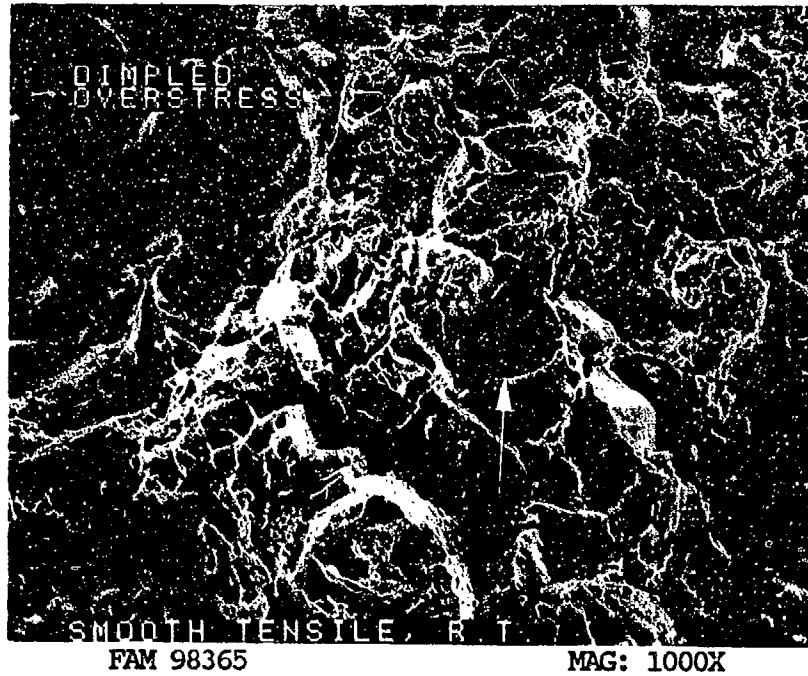
FIGURE 9-5: Fine equiaxed dimples with slight intergranular appearance. Fractured carbides are visible in some areas (arrow).

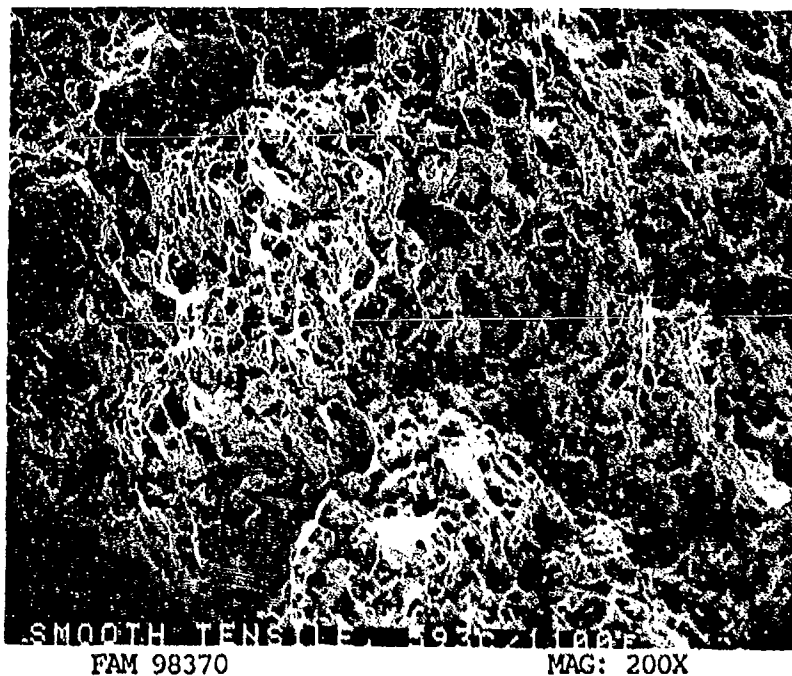
FIGURE 9-12: Dimpled overstress in the primary fracture area.

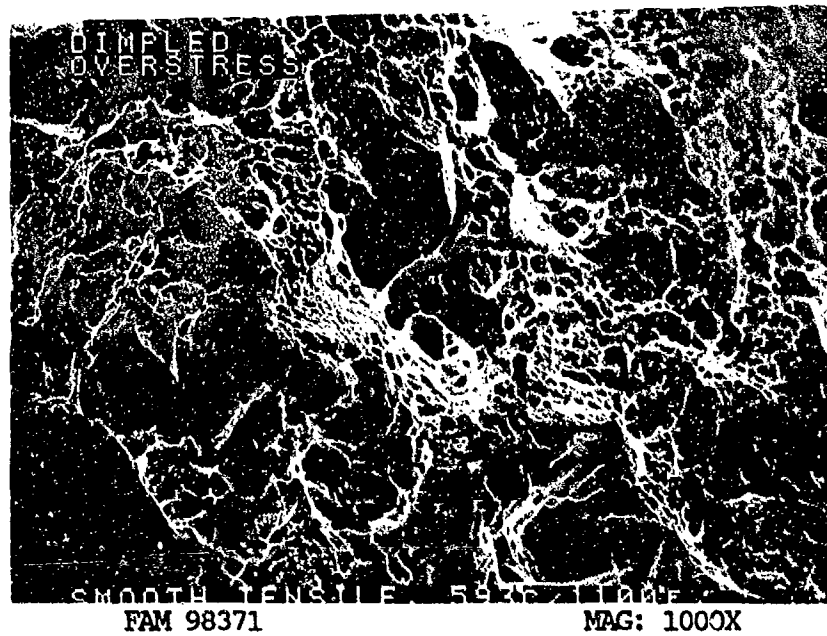
FIGURE 9-13: Fine equiaxed dimples in the primary fracture area. A fractured carbide is visible (arrow).

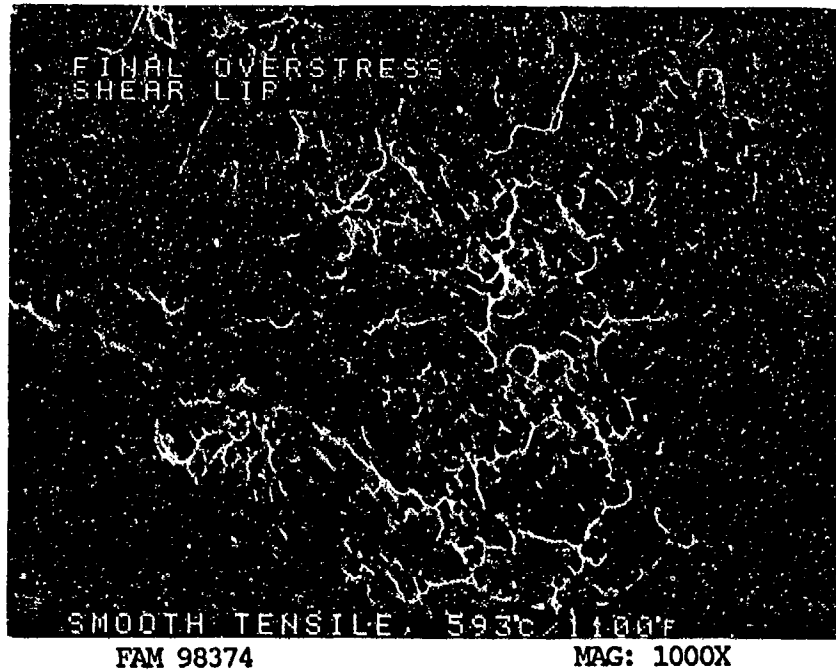
FIGURE 9-15: Fine smeared shear dimples in the final overstress (shear lip) area.

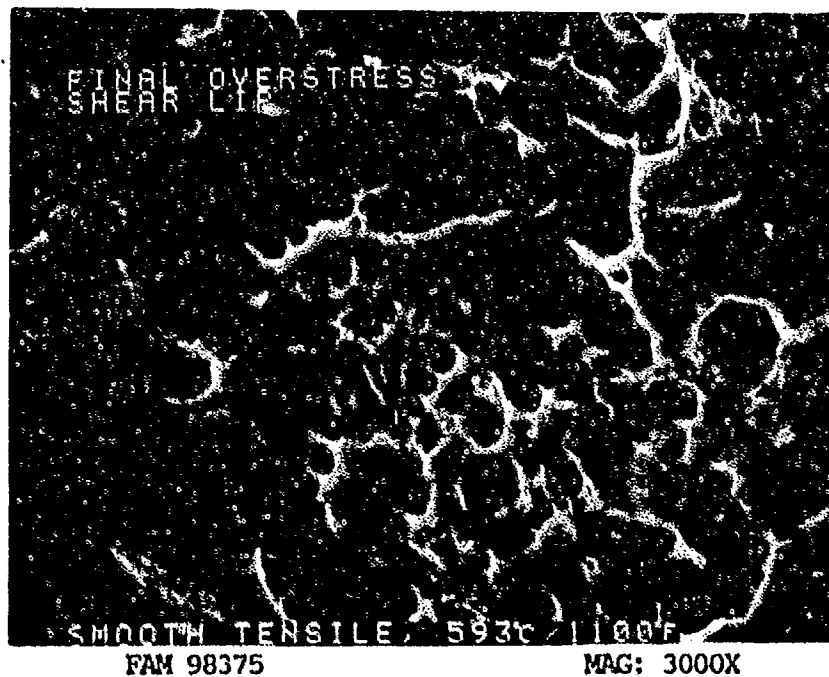
FIGURE 9-16: Higher magnification photograph of the area shown in Figure 9-15, showing fine shear dimples.

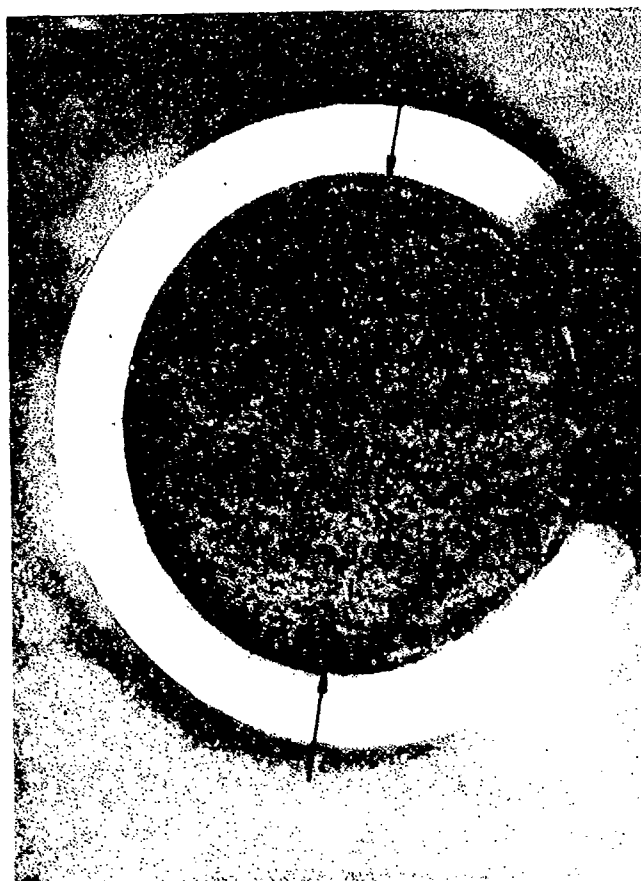
FAL 92551

FIGURE 9-17: Test results and fractography of Inconel X-750 room temperature notched tensile test. A very small discontinuous shear lip is visible (arrows) along the edge of the specimen.

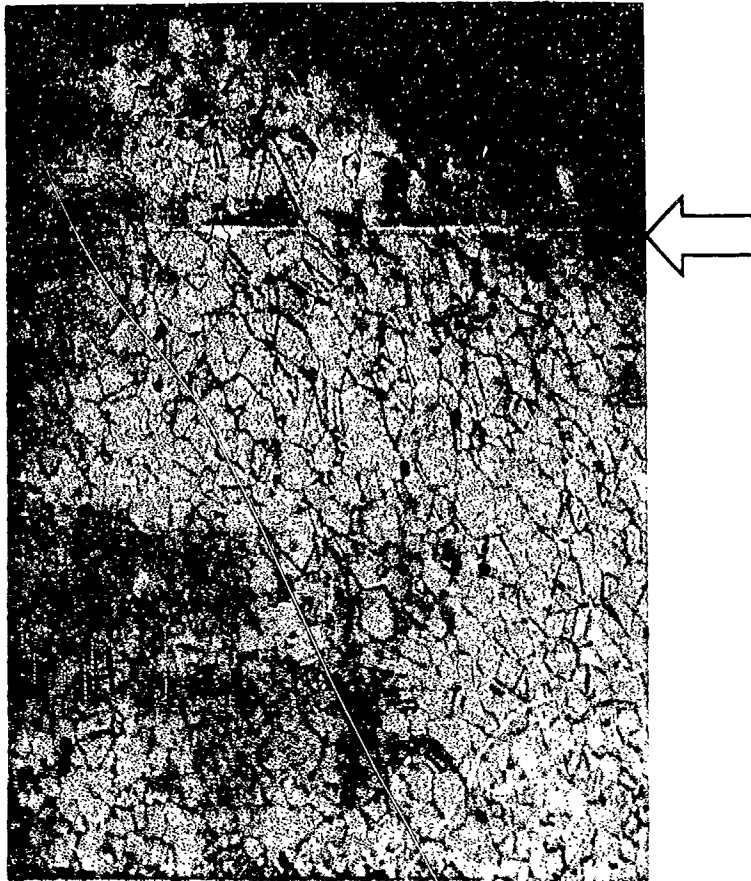
FAM 99830

FIGURE 9-18: Optical photomicrograph showing the primary fracture area on the left side of the photograph and the final overstress area at the base of the notch on the right side of the photograph (arrow). The fracture propagated in both transgranular and intergranular modes. The grains in the final overstress area exhibit some plastic deformation.

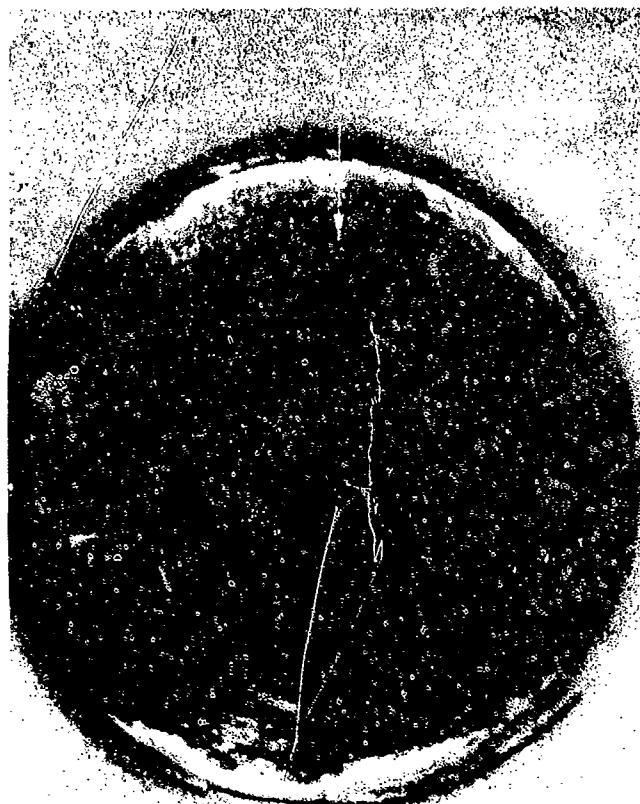
FAL 92550

FIGURE 9-23: Test results and fractography of Inconel X-750 593°C (1100°F) notched tensile test. A discontinuous narrow shear lip is visible along the surface (arrows). The specimen appears oxidized.

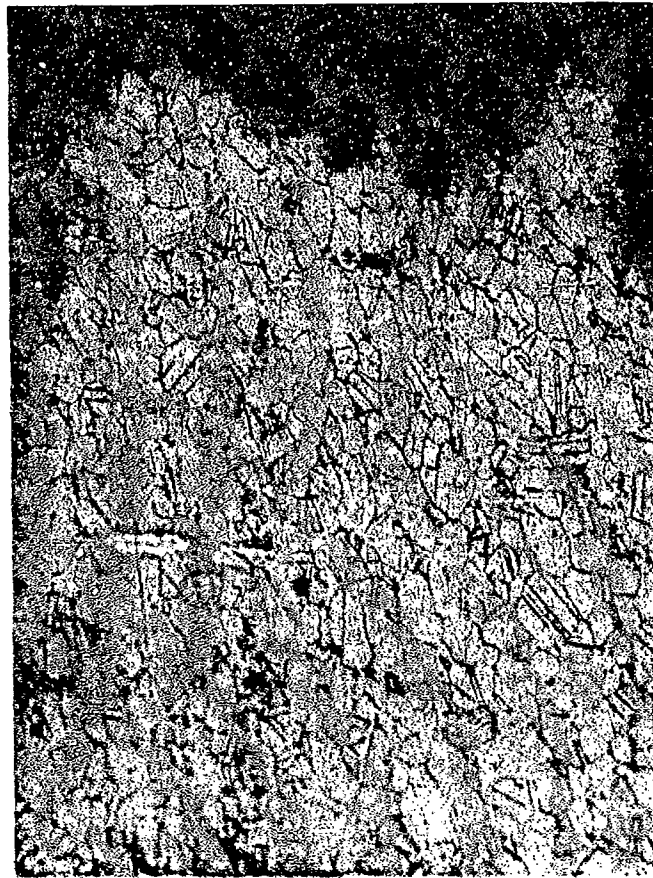
FAM 99828

FIGURE 9-24: Optical photomicrograph showing the primary fracture area on the left side of the photograph and the final overstress area (shear lip) at the base of the notch (arrow) on the right side of the photograph. The fracture propagated predominantly in an intergranular mode. The grains in the final overstress area exhibit some plastic deformation.

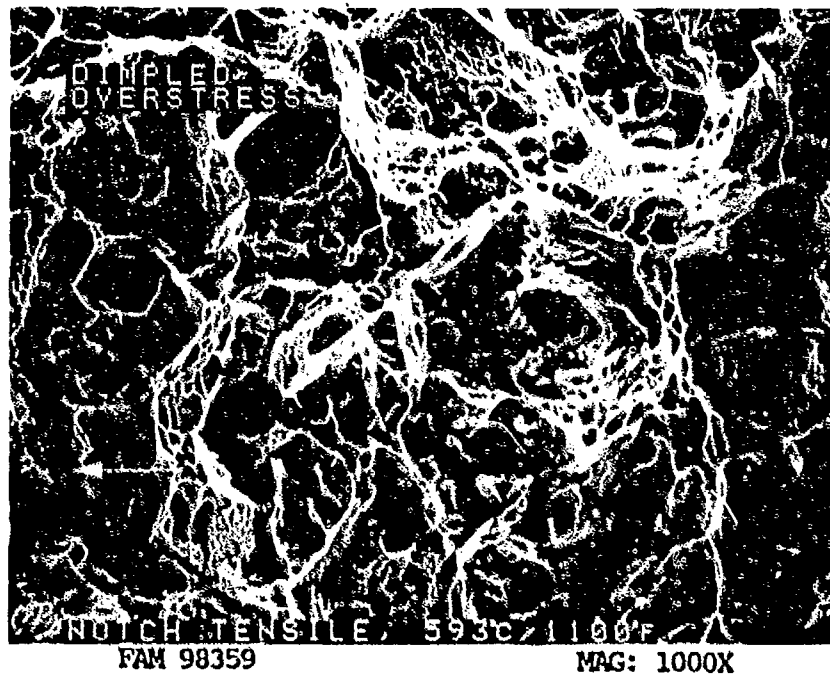
FIGURE 9-28: Mixed mode overstress exhibiting equiaxed dimpled overstress and small cleavage features in the primary fracture area. Secondary grain boundary separation is visible (arrow).

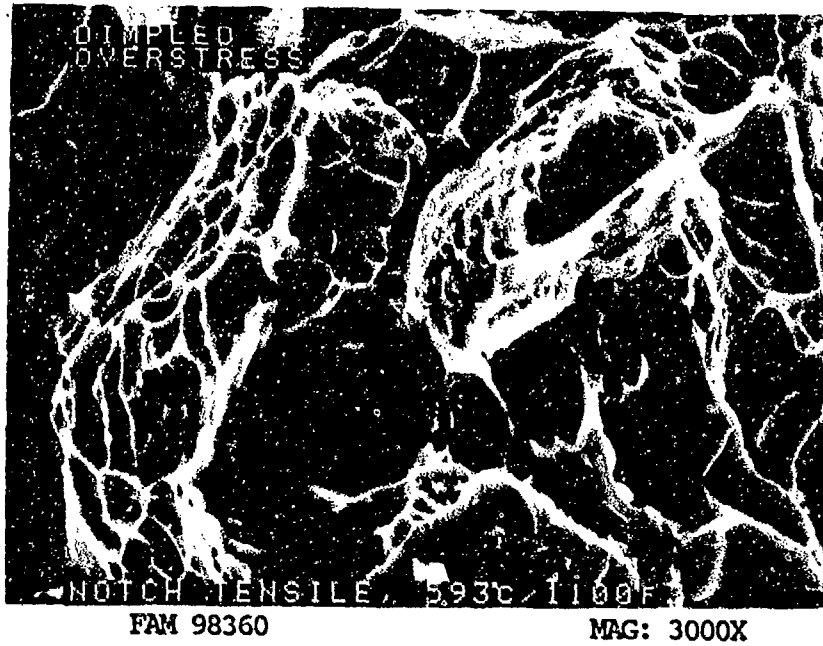
FIGURE 9-29: High magnification photograph showing dimples and fine cleavage features near the center of the specimen.

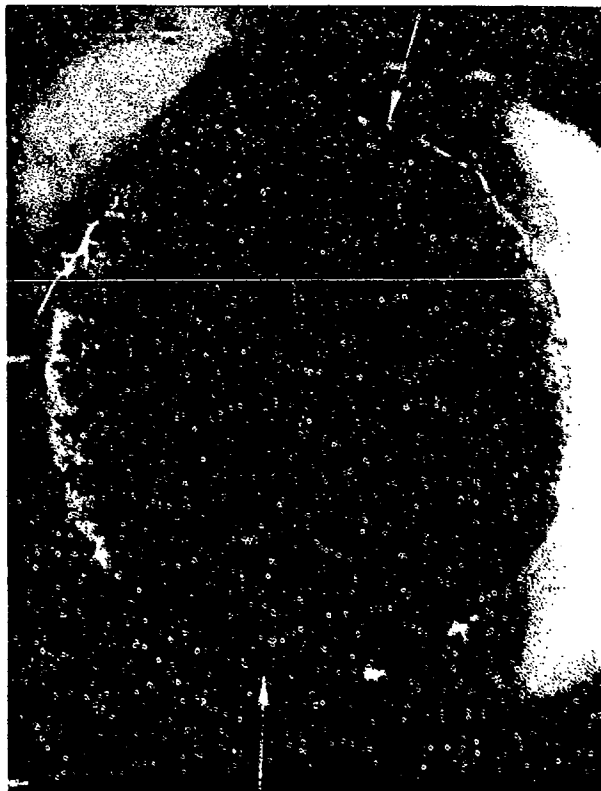
FAL 93826

FIGURE 9-30: Test results and fractography of Inconel X-750 593°C (1100°F) stress rupture test. The fracture exhibits a shear lip (arrows) with coarse oxidized features in the center of the specimen.

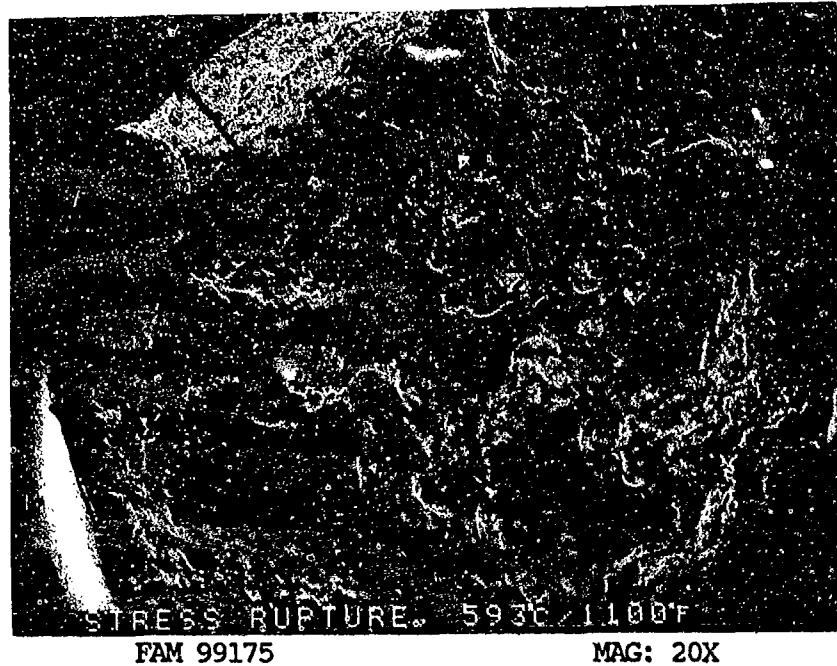
FIGURE 9-32: Low magnification view showing deep features in the primary rupture area and a large final overstress area (shear lip) along the outside surface of the specimen (brackets).

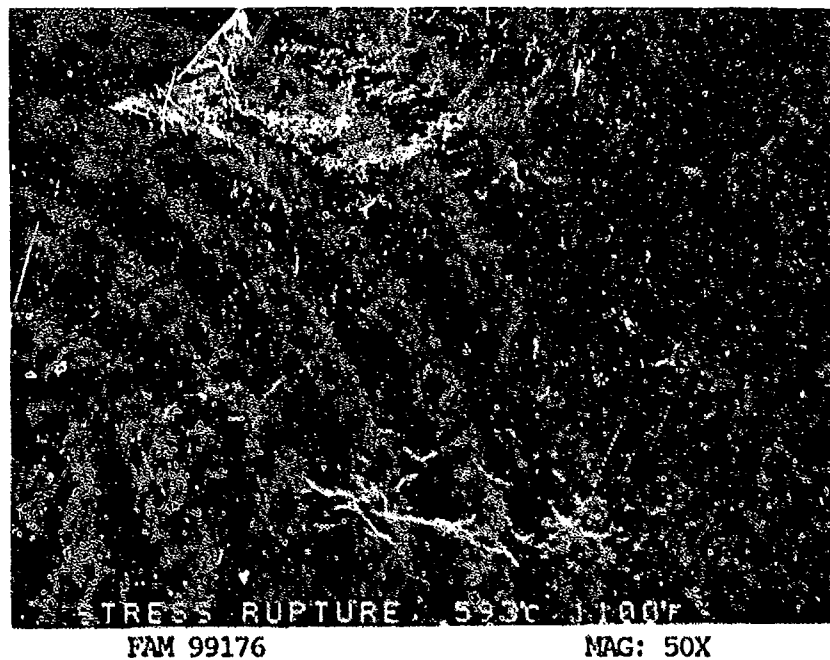
FIGURE 9-33: Large final overstress area (shear lip) along the outside surface. The shear lip was present in all areas but size and direction (up or down) varied.

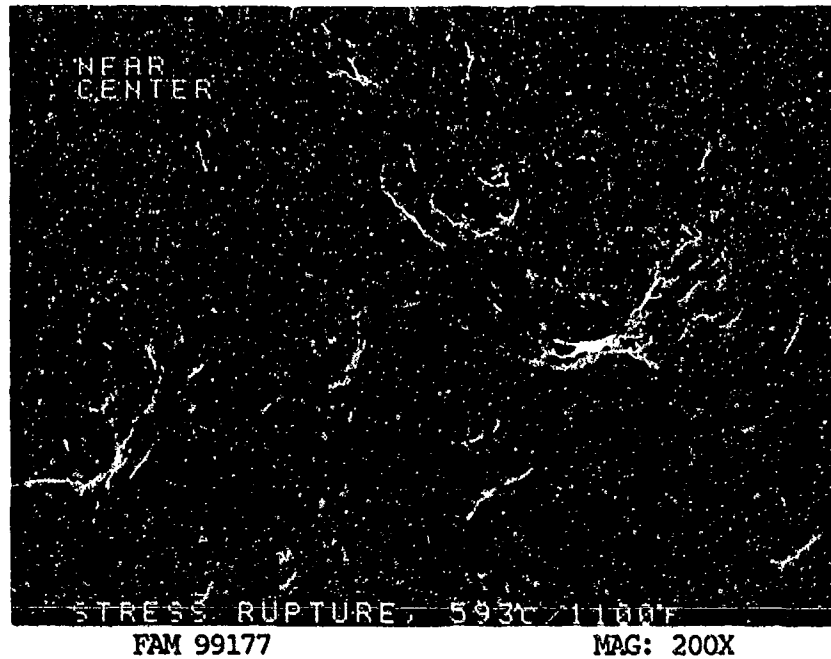
FIGURE 9-34: Oxidized dimpled rupture with void coalescence in the primary fracture area.

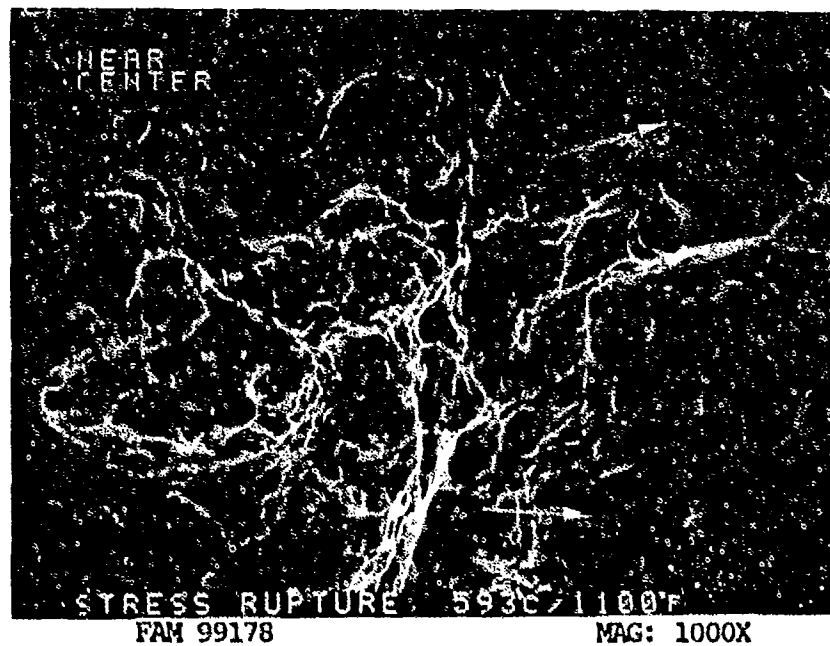
FIGURE 9-35: Higher magnification photograph of the area in Figure 9-34, showing coarse dimpled rupture with areas of void coalescence. The entire fracture surface is covered by a light oxide. Deep voids are shown by arrows.

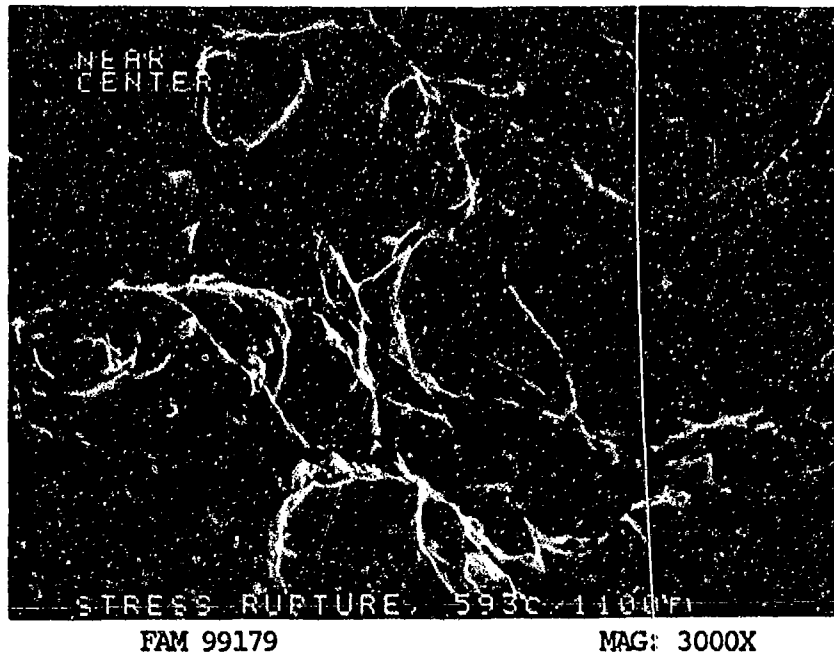
FIGURE 9-36: High magnification photograph showing coarse oxidized dimples with some finer dimples in between.

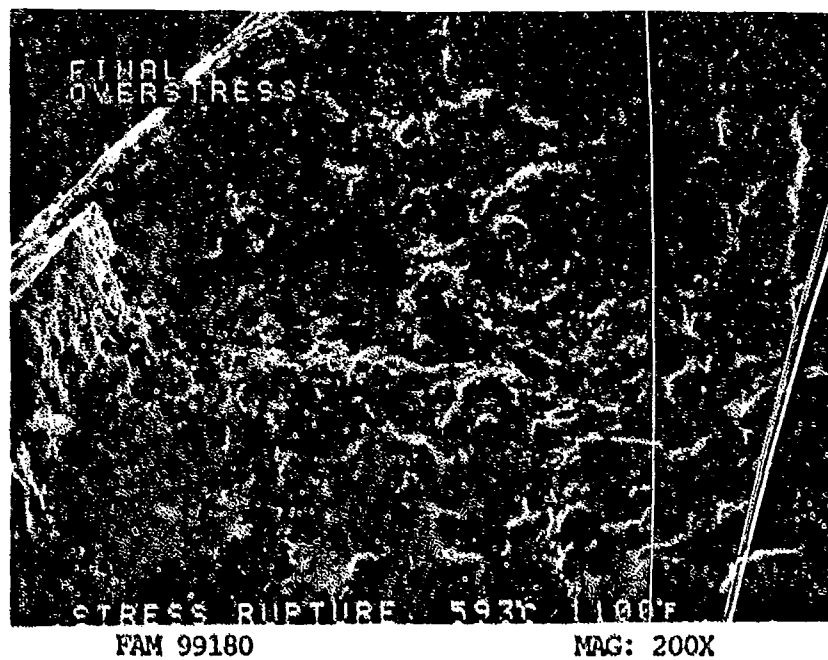
FIGURE 9-37: Final overstress area along the edge of the specimen.

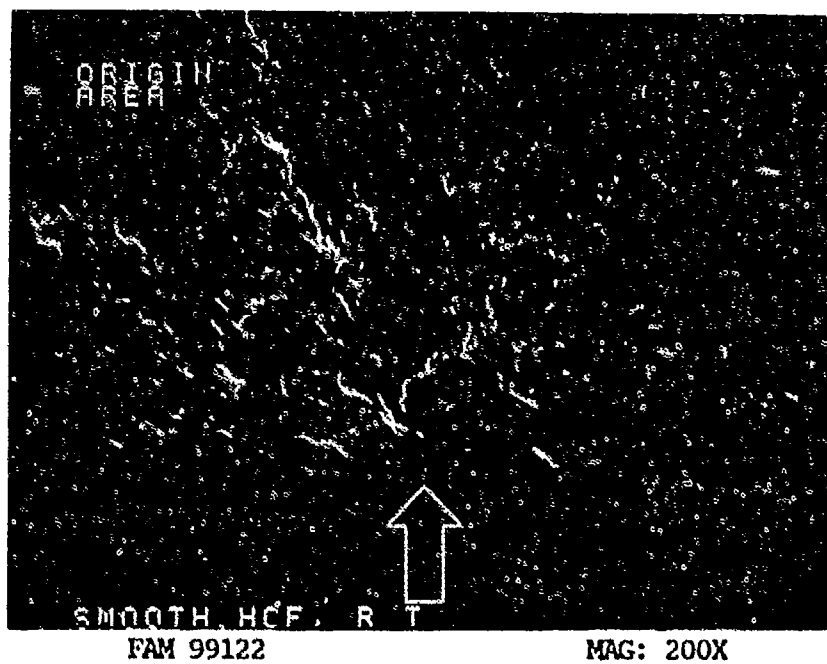
FIGURE 9-42: Higher magnification photograph of the origin area shown in Figure 9-41. A stage I fatigue facet is visible at the localized origin (arrow).

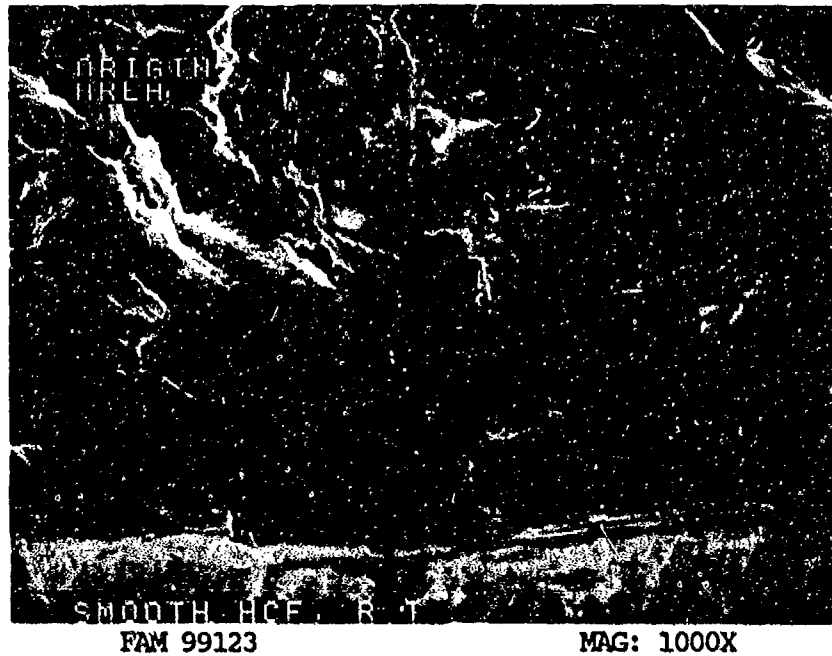
FIGURE 9-43: Stage I fatigue facet at the localized origin (see Figure 9-42). No defects are visible.

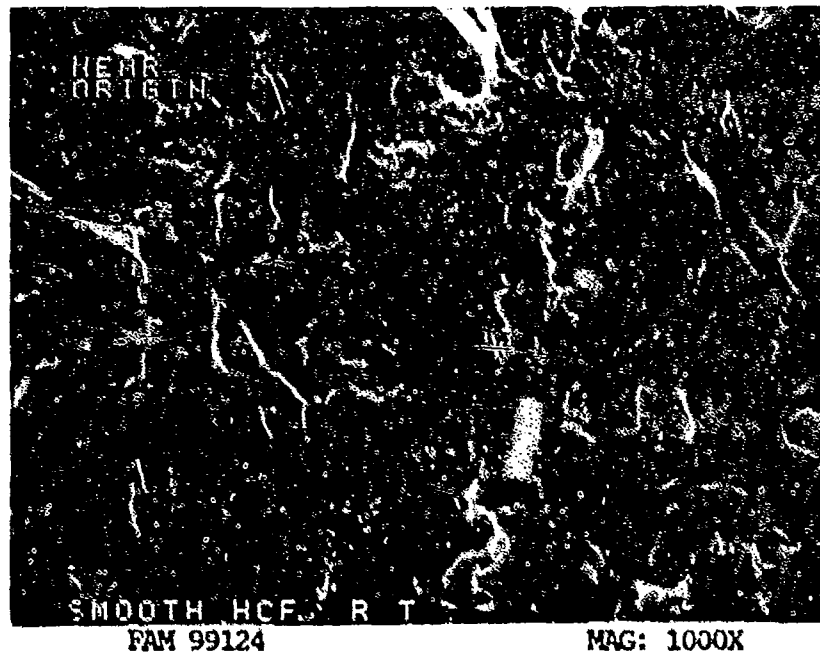
FIGURE 9-44: Photograph showing cleavage features near the origin. No striations are visible.
