FAILURE ANALYSIS HANDBOOK

C. R. Walker, K. K. Starr

Pratt & Whitney
P.O. Box 109600
West Palm Beach, FL 33410-9600

August 1989

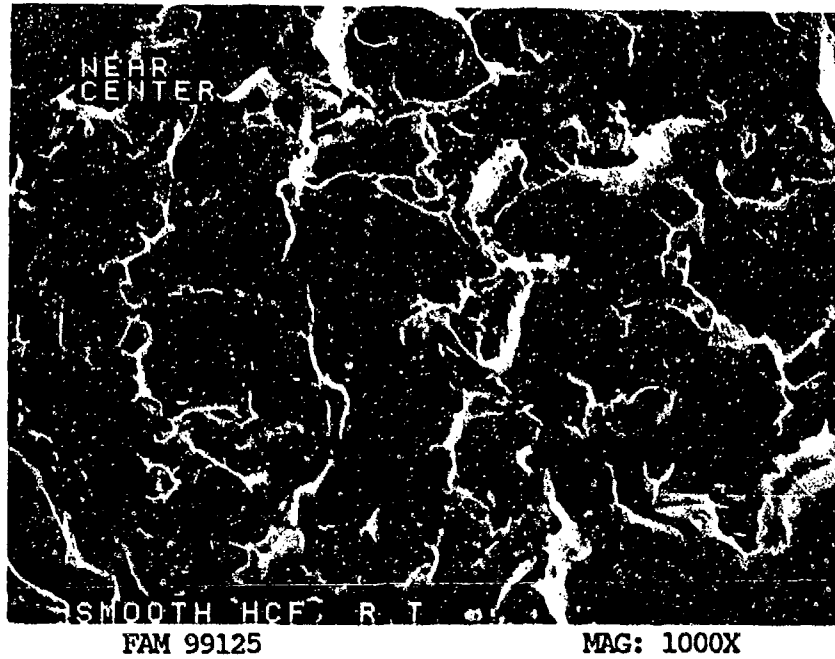
FIGURE 9-45: Fatigue striations near the end of the fatigue progression area. The direction of propagation is from bottom to top of the photograph.

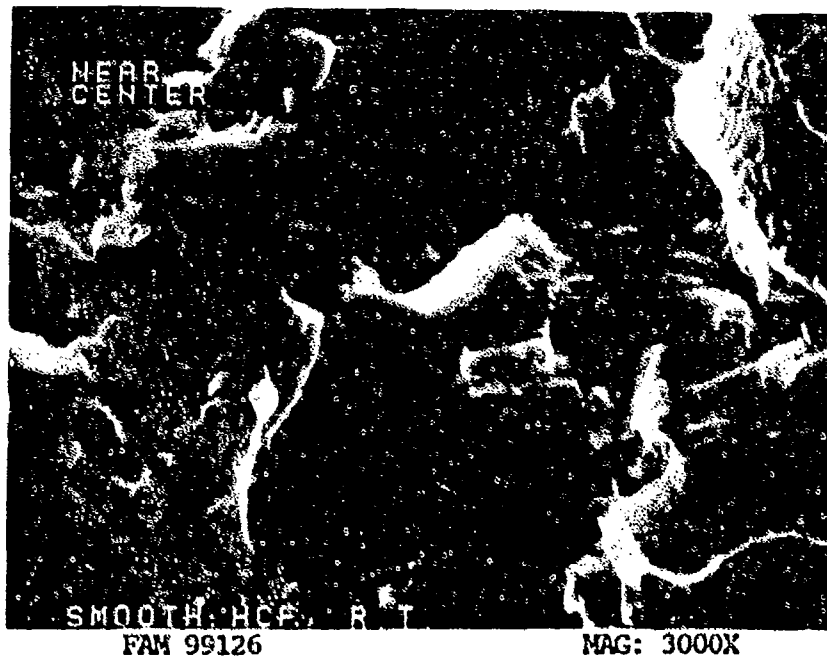
FIGURE 9-46: Higher magnification photograph of the area shown in Figure 9-45, showing fatigue striations near the center of the specimen in the fatigue progression area.

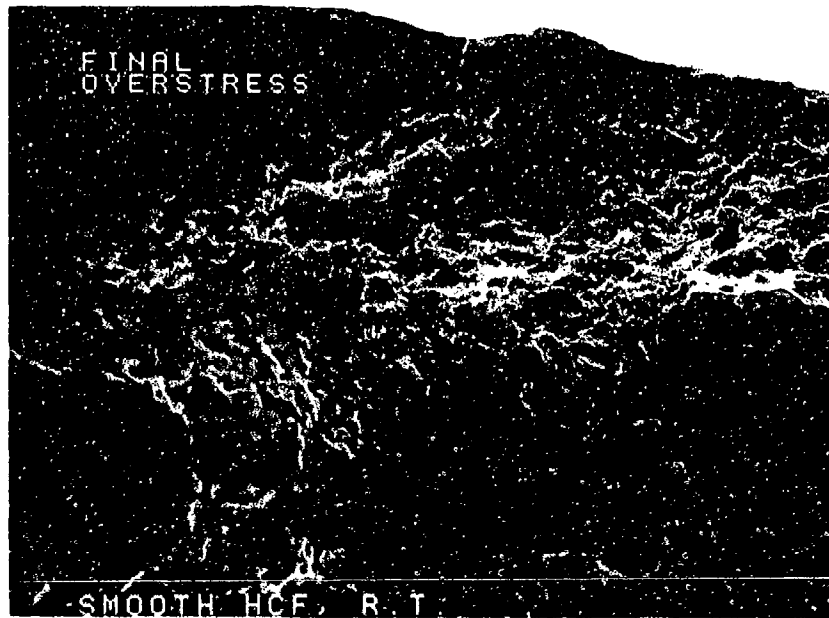
FAM 99127

FIGURE 9-47: Dimpled overstress in the final fracture area.

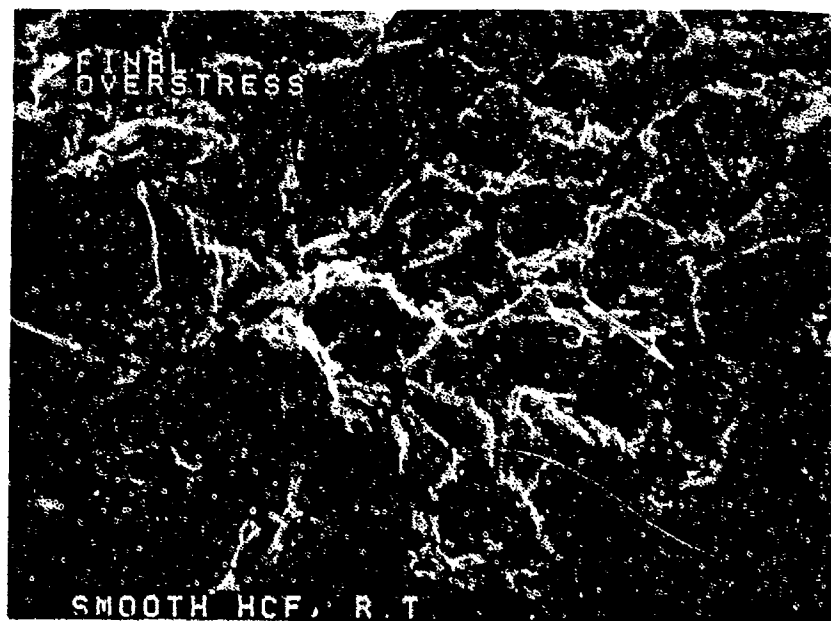
FAM 99128

FIGURE 9-48: Fine dimpled overstress with coarse features in the final fracture area. Cracked carbides are visible in several locations (arrow).

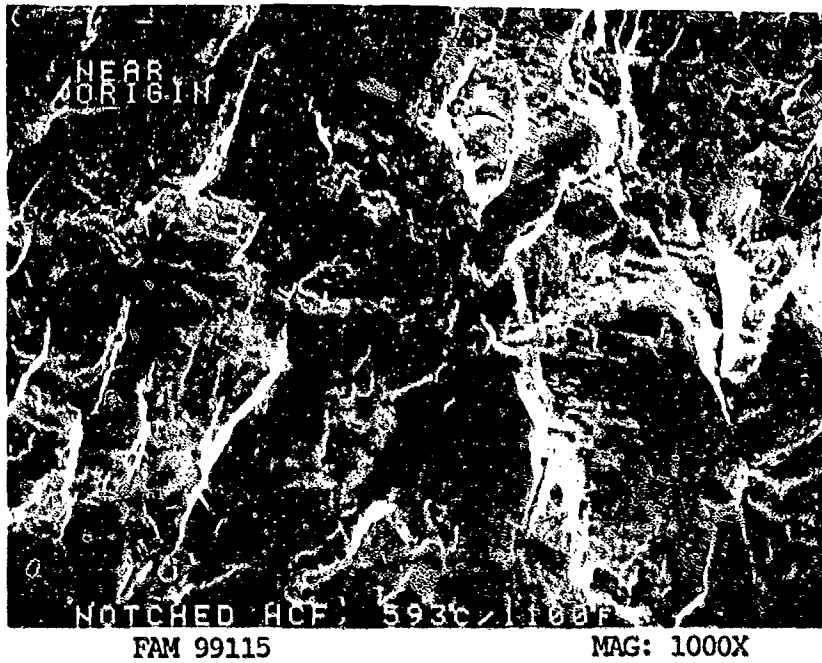
FIGURE 9-90: Fatigue striations near the origin area.

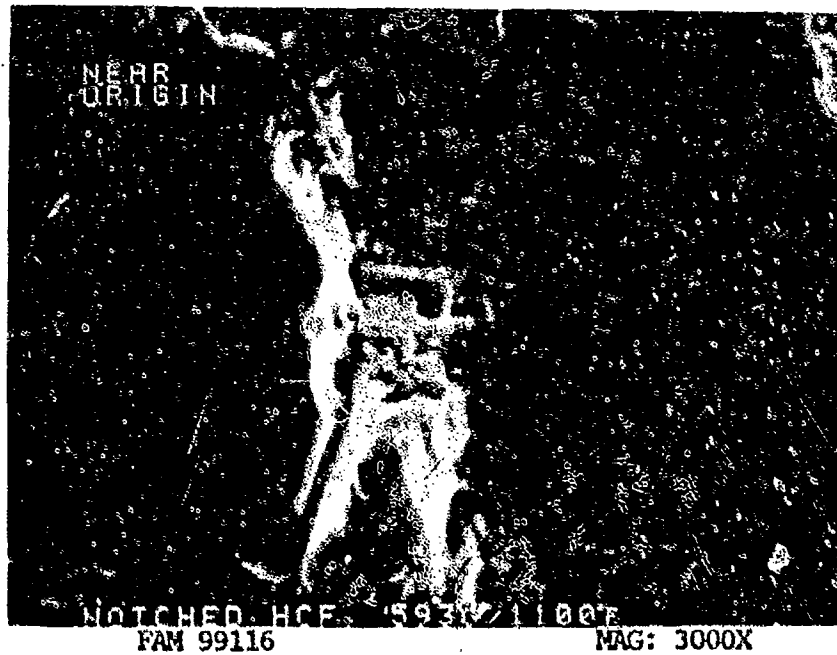
FIGURE 9-91: Higher magnification photograph of the area in Figure 9-90, showing fine oxidized fatigue striations. The direction of propagation is from bottom to top of the photograph.

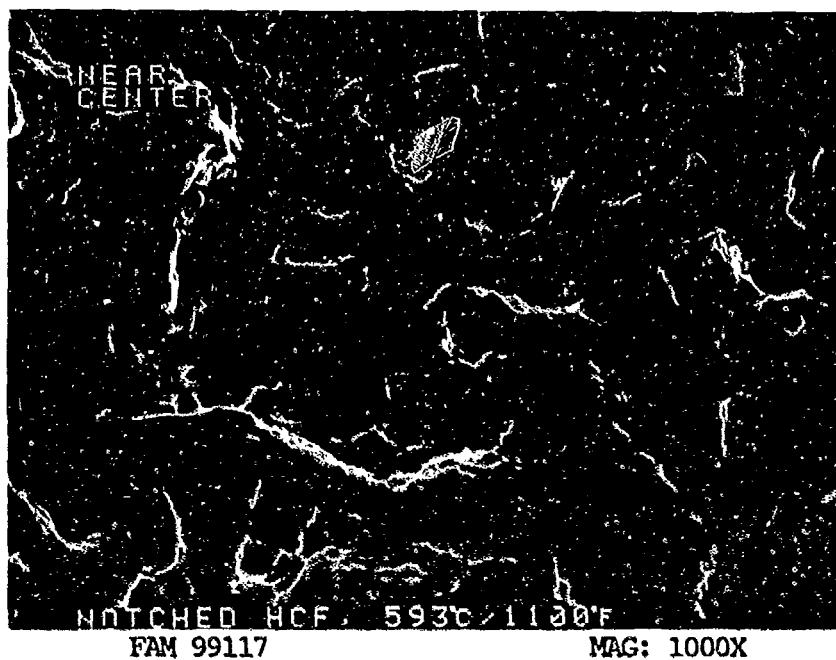
FIGURE 9-92: Coarser fatigue striations near the center of the specimen in the fatigue progression area. The fatigue propagated from bottom to top of the photograph.

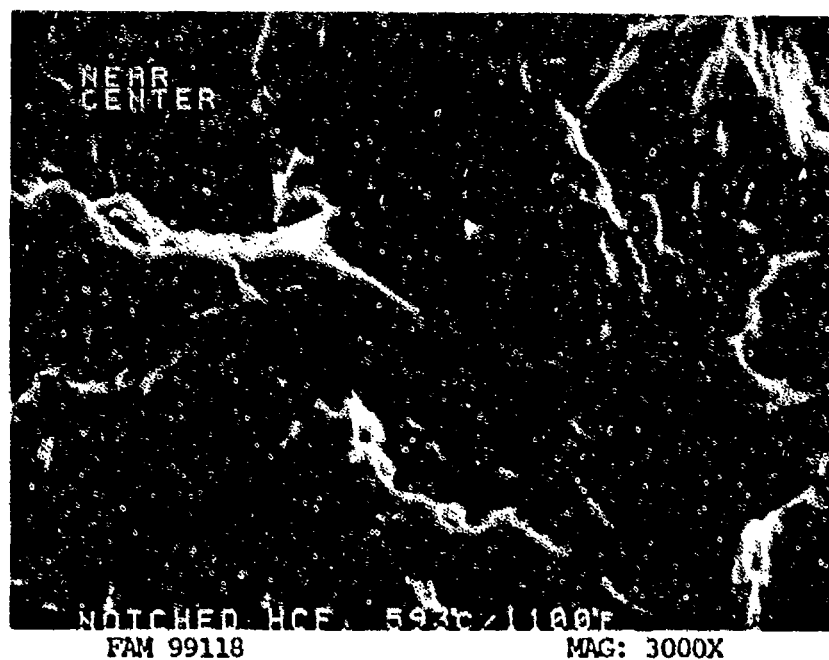
FIGURE 9-93: Higher magnification view of the fatigue striations shown in Figure 9-92.

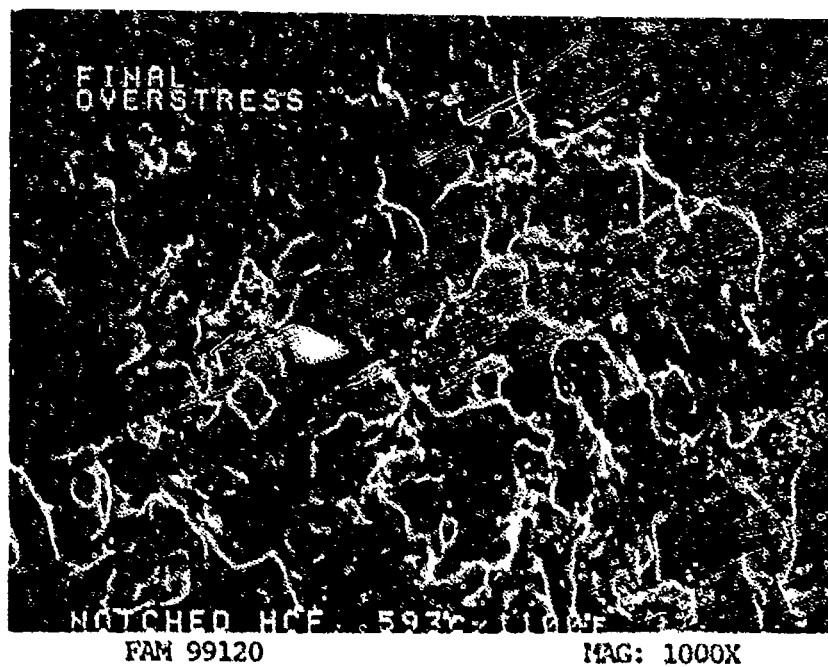
FIGURE 9-95: Higher magnification photograph of the area in Figure 9-94, showing a mixture of oxidized smear and dimpled overstress features.

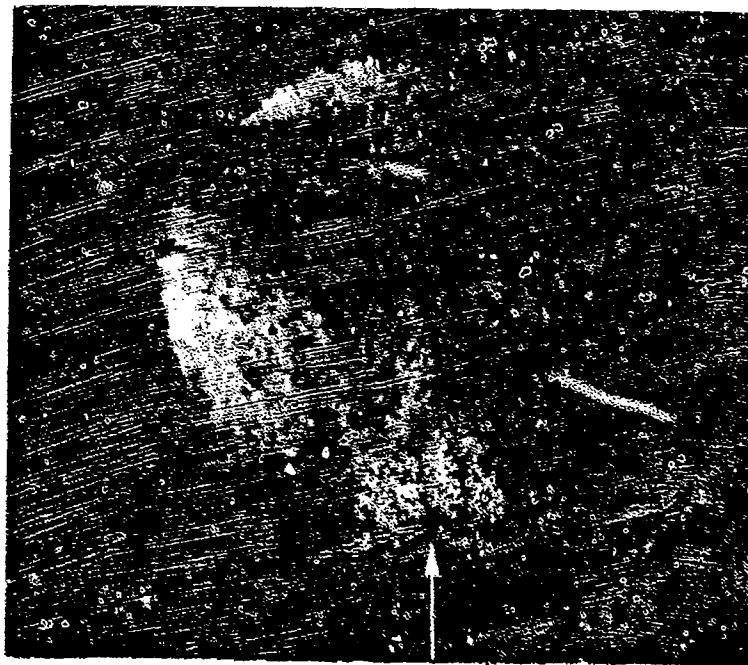
FAL 93234

FIGURE 9-96: Test results and fractography of Inconel X-750 260°C (500°F) smooth LCF test. The origin and fatigue progression (arrow) occurred on a plane perpendicular to the stress axis. The remainder of the fracture occurred on a plane approximately 45° to the stress axis.

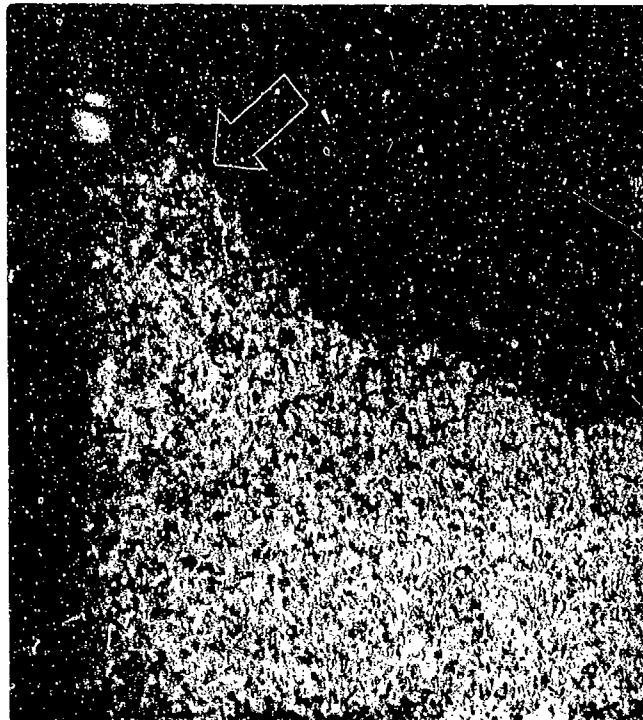
FIGURE 9-97: Optical photomicrographs showing the fatigue progression area (top) and the final overstress area (bottom). The fatigue progression exhibits more variation in elevation than on the HCF specimens (Figures 9-50 and 9-53), but remains roughly perpendicular to the stress axis. A shear lip is visible in the final overstress area (arrow).

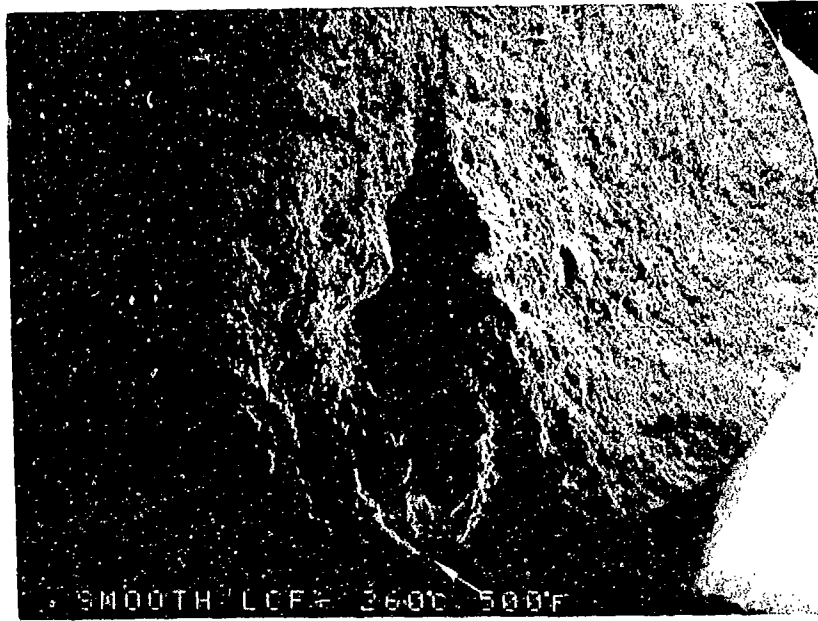
FAM 98709

FIGURE 9-98: Overall photograph showing the origin area (arrow) and the fatigue progression area on a plane approximately perpendicular to the stress axis. The remainder of the fracture is at a 45° angle to the stress axis.

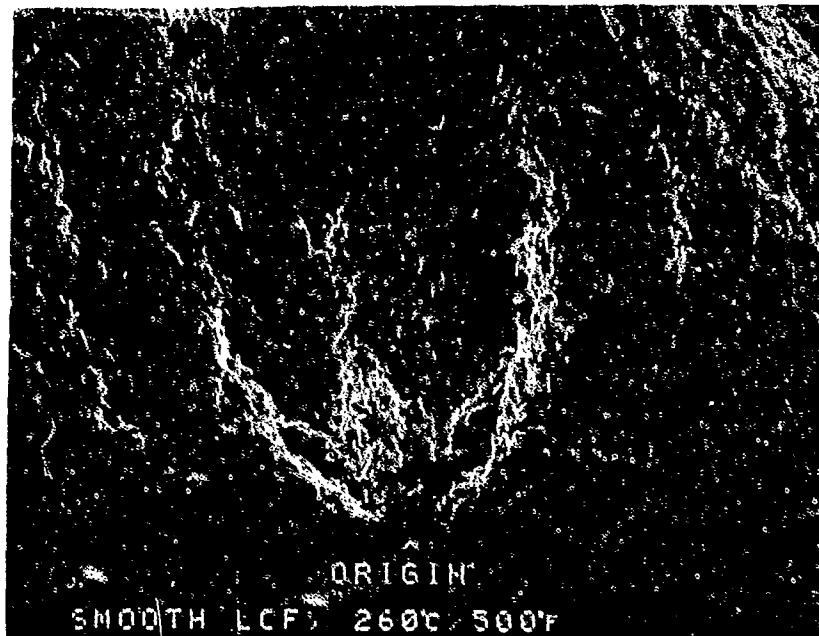
FAM 78710

FIGURE 9-99: Higher magnification photograph of the origin area. The fatigue thumbnail is faintly visible (brackets).

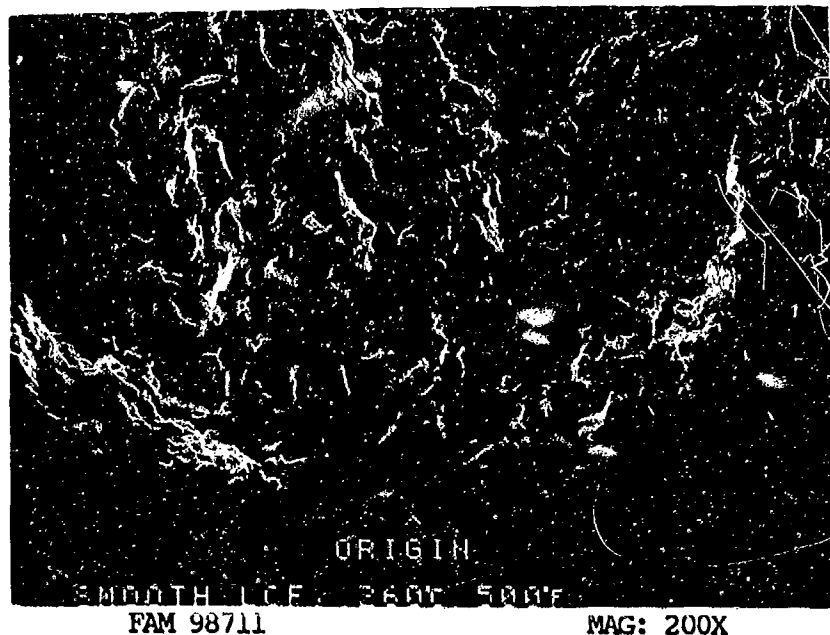
FIGURE 9-100: A small inclusion is visible at the origin. Fracture features radiate from this point. The inclusion appears darker than the background in the secondary electron image mode, indicating that it is of lower atomic number than the base material.

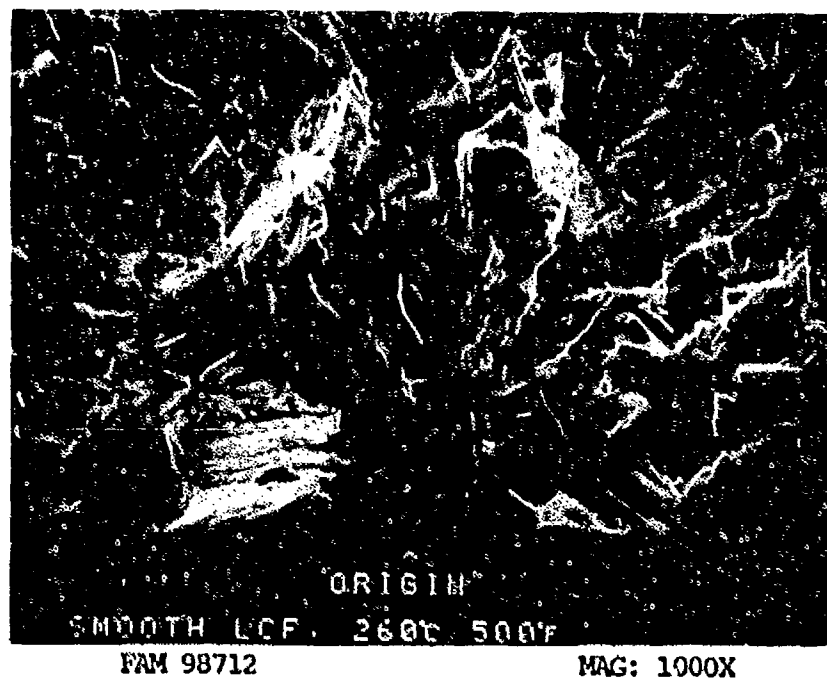
FIGURE 9-101: Higher magnification photograph of titanium-rich inclusion that acted as the origin. Scanning electron microscope/X-ray energy spectroscopy (SEM/XES) analysis determined the composition.

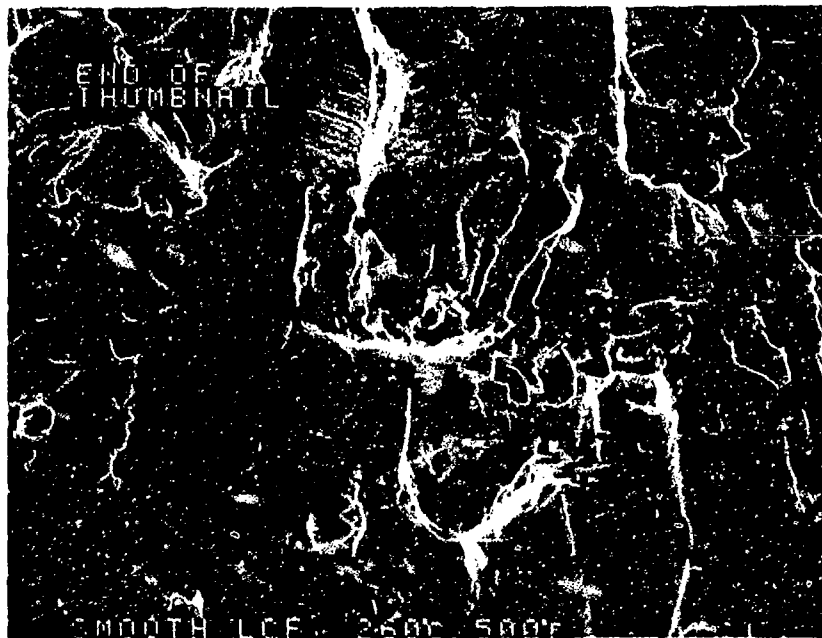
FAM 98716

FIGURE 9-102: Fatigue striations near the end of the thumbnail. The direction of propagation is from bottom to top of the photograph. The direction of local propagation varies slightly on different plateaus.

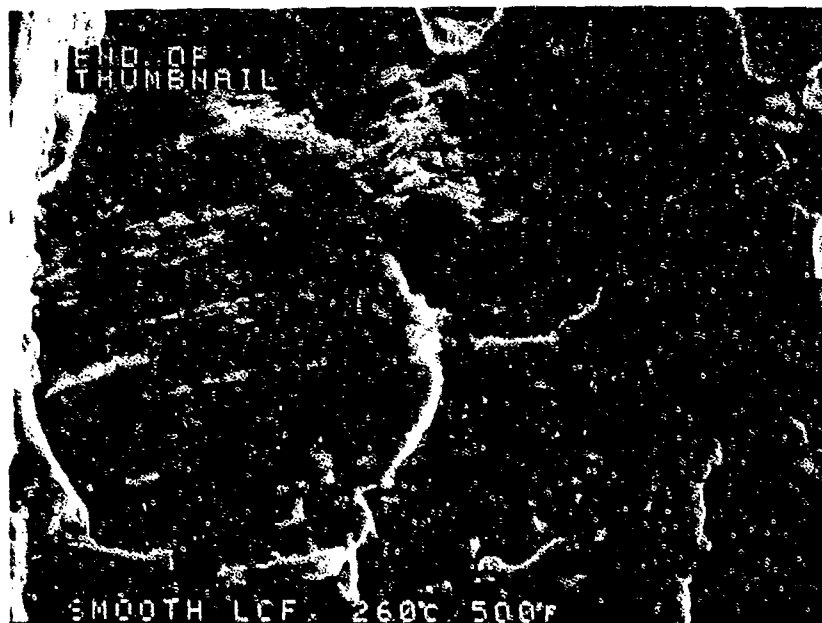
FAM 98717

FIGURE 9-103: Higher magnification photograph of the upper right corner area of Figure 9-102, showing well developed fatigue striations at the end of the thumbnail. Bracket contains ten striations.

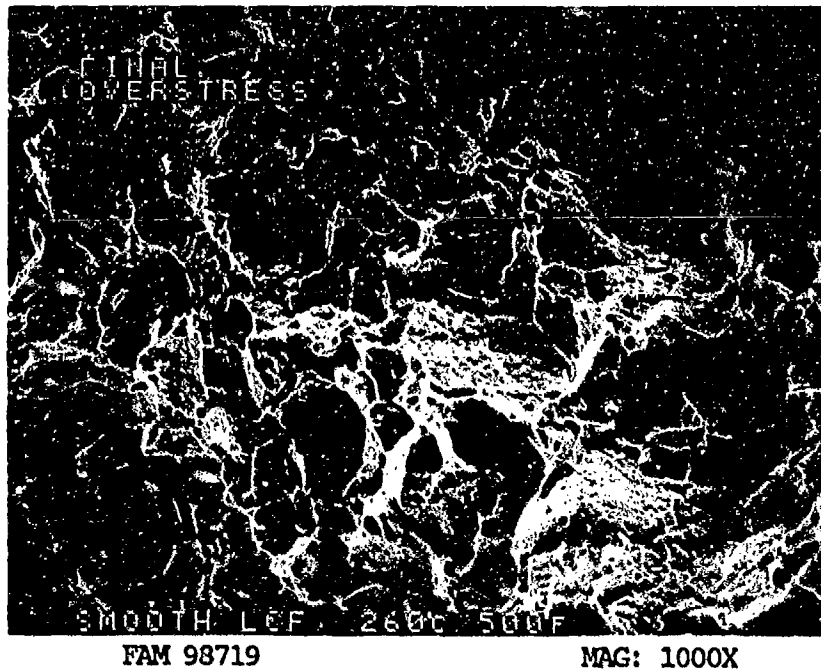
FIGURE 9-104: Dimpled overstress in the final fracture area.

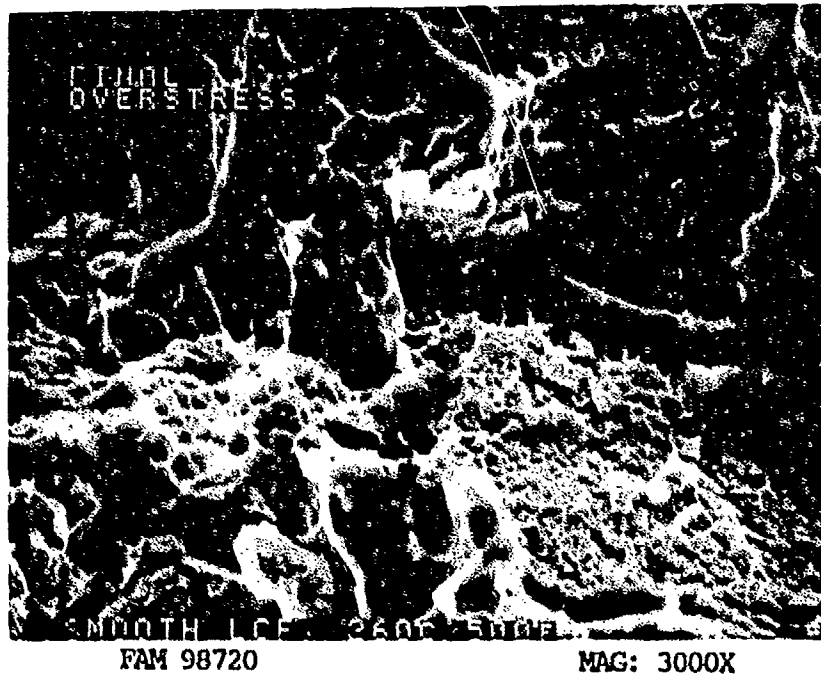
FIGURE 9-105: Fine dimpled overstress in the final fracture area. Cracked carbides are visible in several locations (arrows).

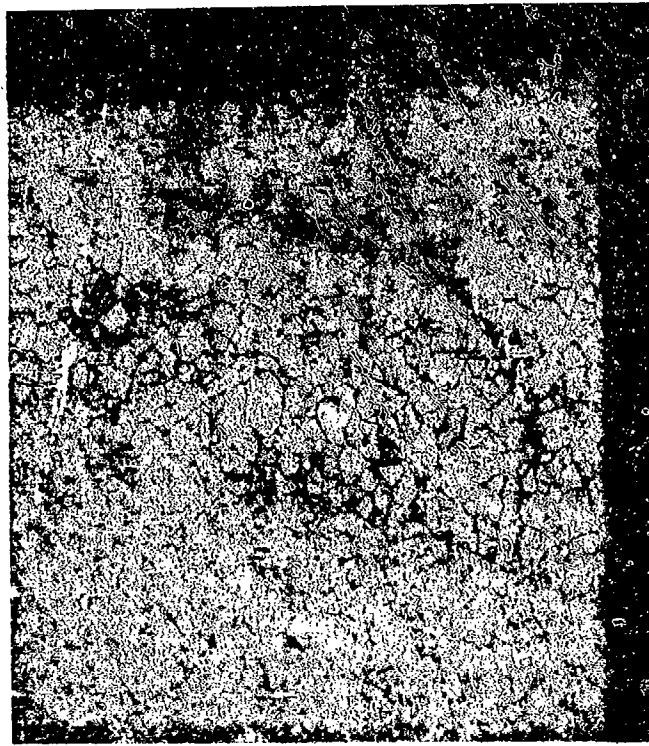
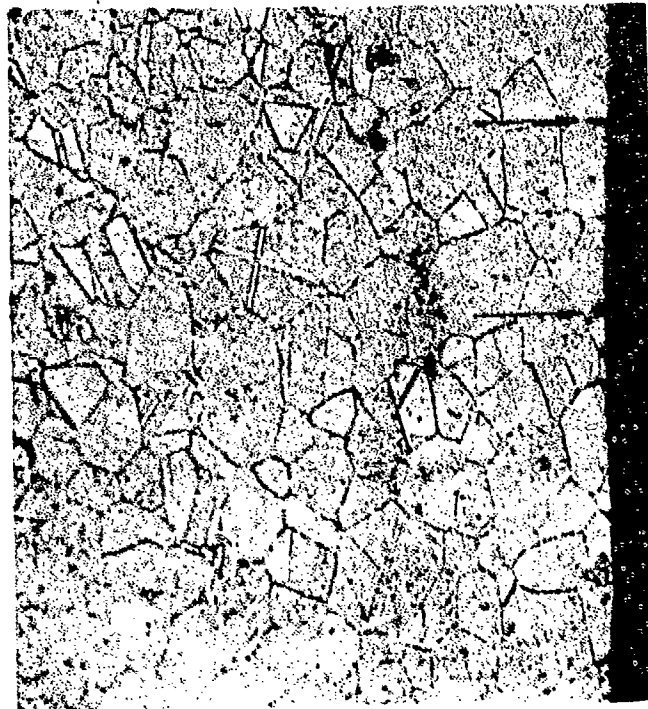
FIGURE 9-107: Optical photomicrographs showing the primary fatigue progression area (top) and grain boundary oxidation along the test specimen gage area (bottom). The grain boundaries are less distinct than in the lower temperature specimens (Figure 9-98) and exposed grain boundaries along the gage area have been oxidized (arrows, bottom).

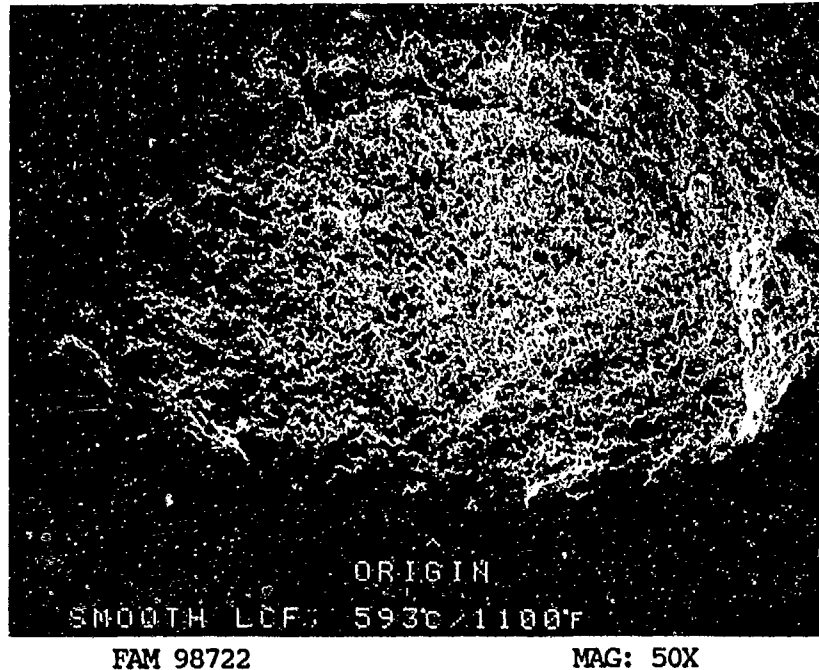
FIGURE 9-108: Low magnification photograph of the larger thumbnail. The localized origin area is indicated by an arrow.

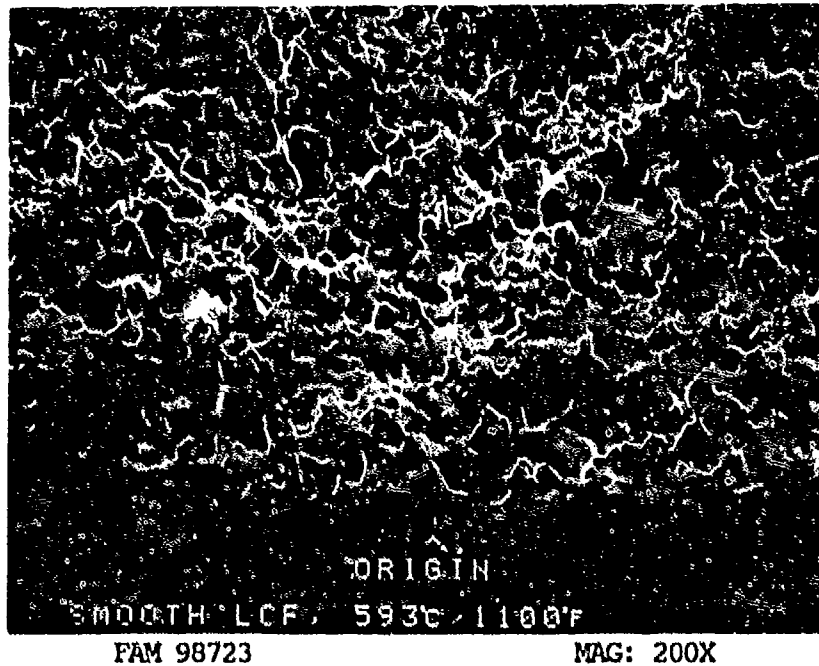
FIGURE 9-109: Higher magnification view of the origin area shown in Figure 9-108. The fracture surface within the thumbnail has a granular appearance.

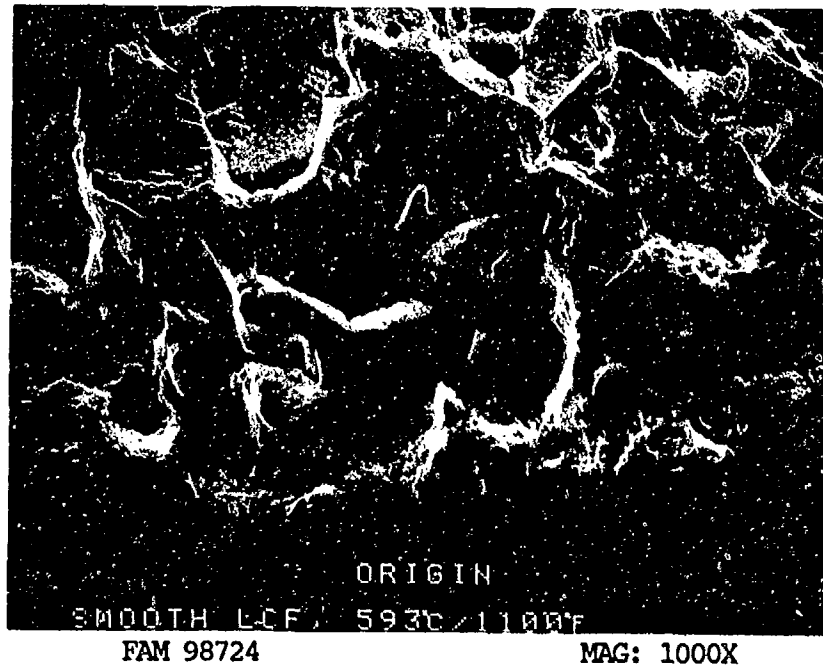
FIGURE 9-110: Higher magnification photograph of the origin area. The fracture appears to be intergranular within the thumbnail and is moderately oxidized. No striations are visible in the immediate origin area.

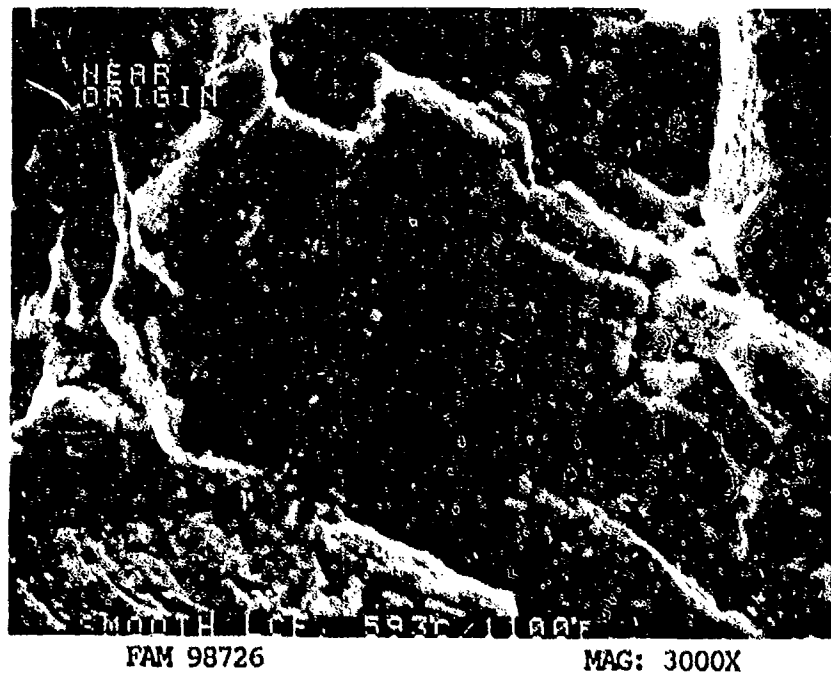
FIGURE 9-111: Oxidized fatigue striations near the origin. The direction of propagation is shown by an arrow.

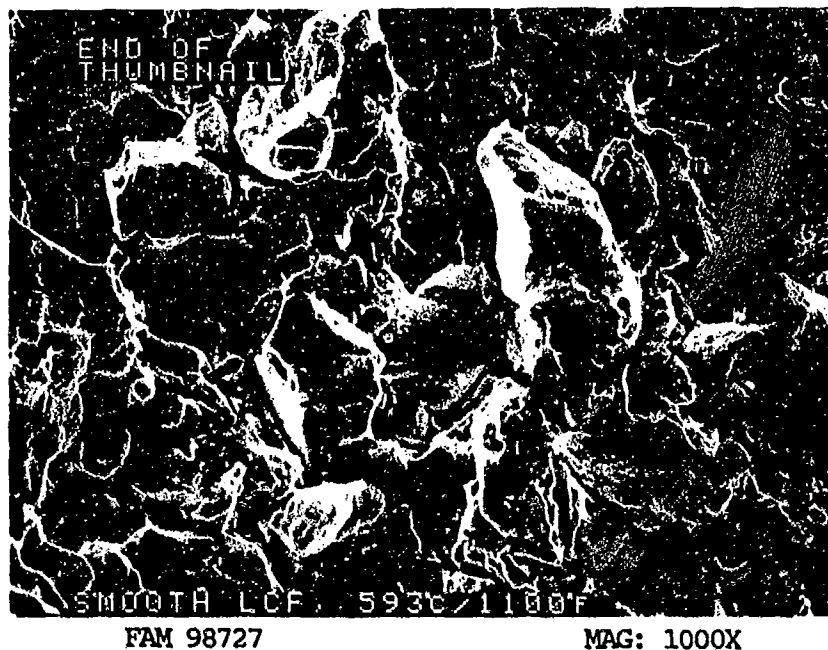
FIGURE 9-112: Grain boundary separation near the end of the thumbnail. Some remnant fatigue features are visible (arrows A). Grain boundary separation has occurred in several areas (arrows B).

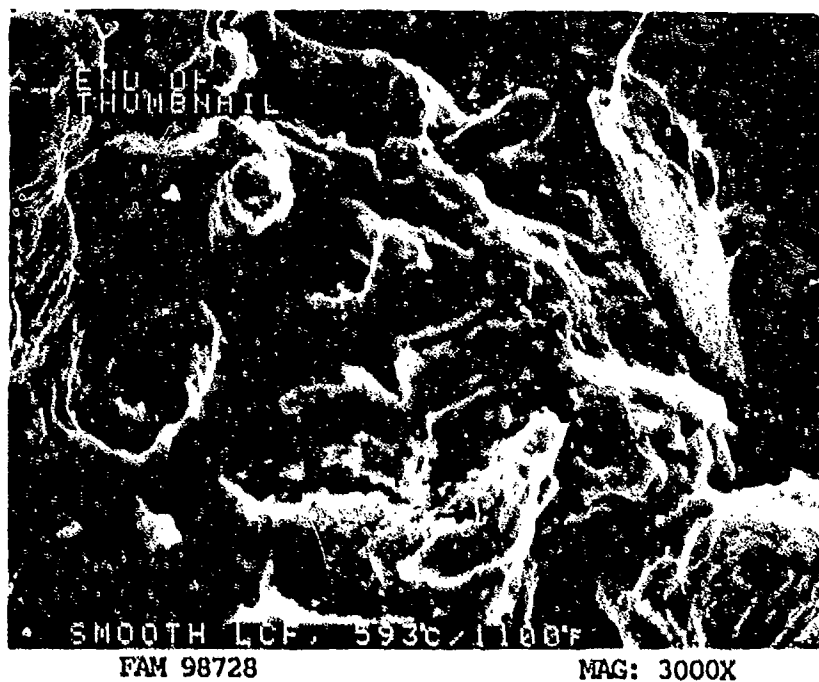
FIGURE 9-113: Higher magnification photograph of the area shown in Figure 9-112, showing remnant fatigue features.

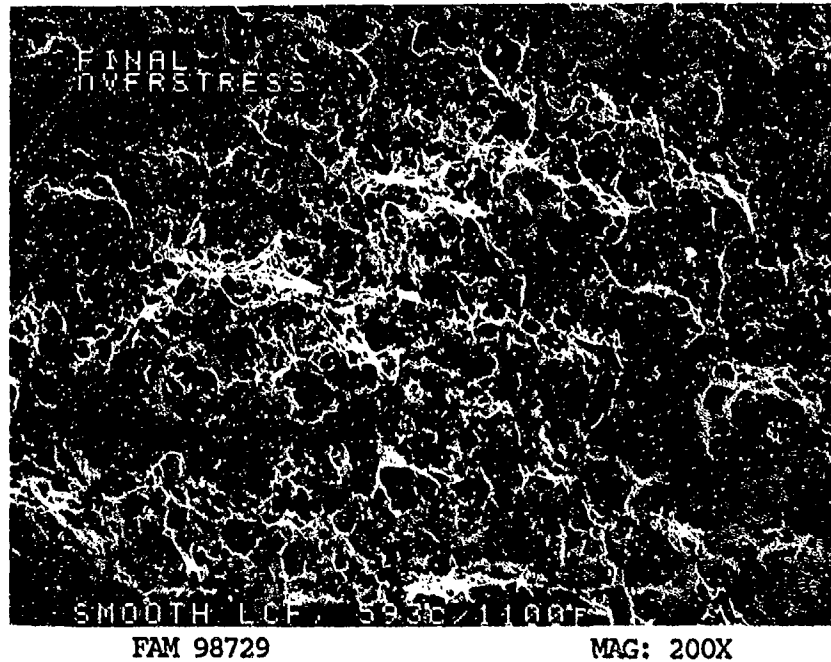
FIGURE 9-114: Transgranular dimpled overstress in the final fracture area.

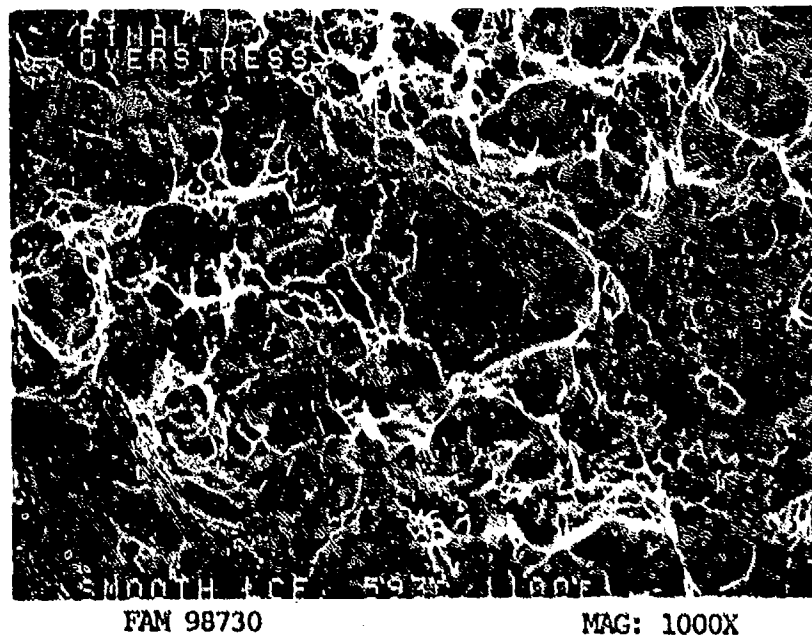
FIGURE 9-115: Higher magnification photograph of the area shown in Figure 9-114, showing transgranular dimpled overstress. The surface contains both very fine and coarser dimples.

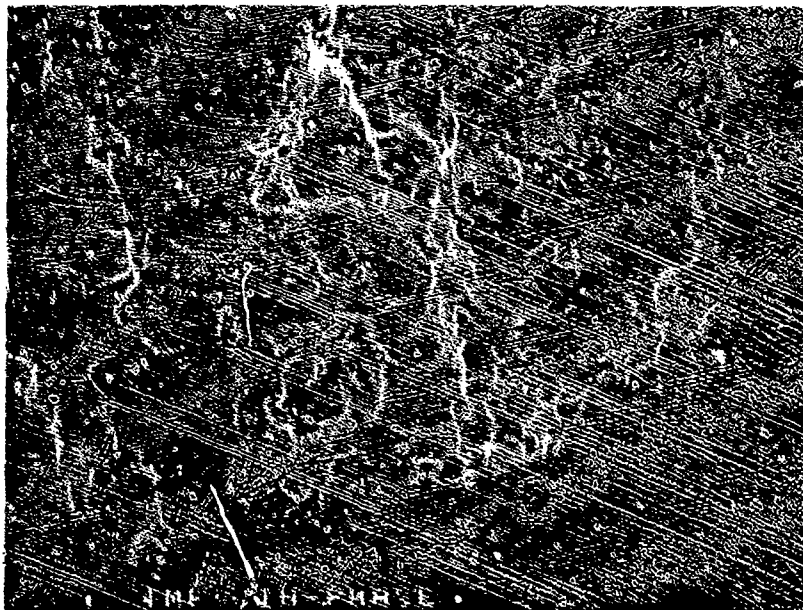
FAM 99457

FIGURE 9-119: Higher magnification view of the fatigue progression zone shown in Figure 9-118. The fracture has oxidized areas and is intergranular in appearance.

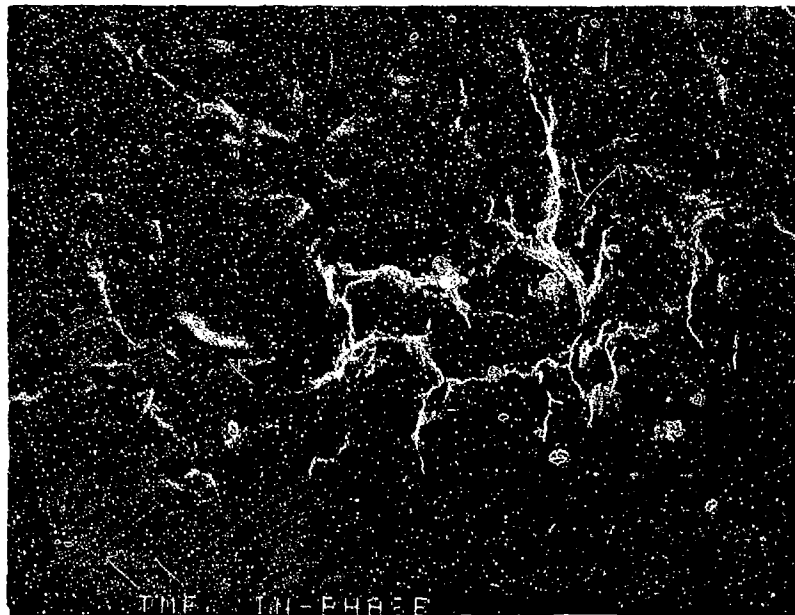
FAM 99458

FIGURE 9-120: High magnification photograph of the origin area. The fracture is heavily oxidized and intergranular within the thumbnail.

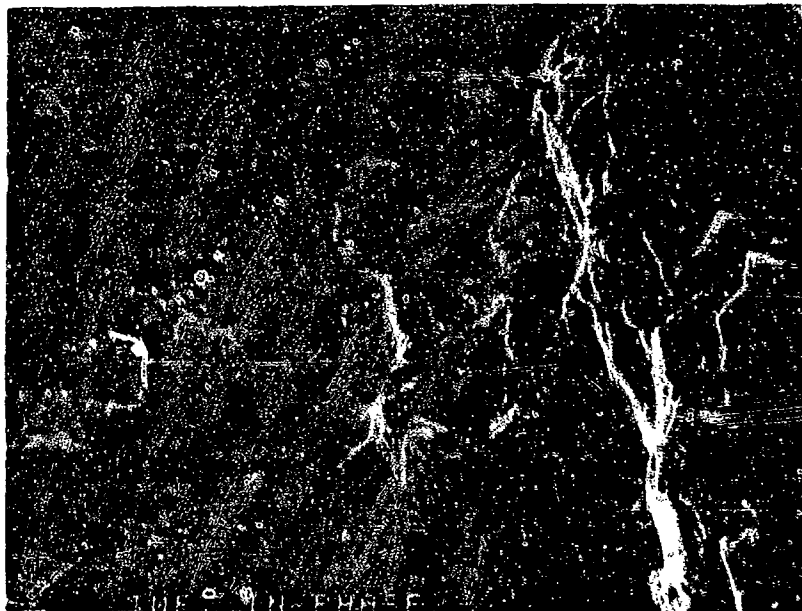
FAM 99459

FIGURE 9-121: Heavily oxidized fatigue progression zone. No features are discernible.

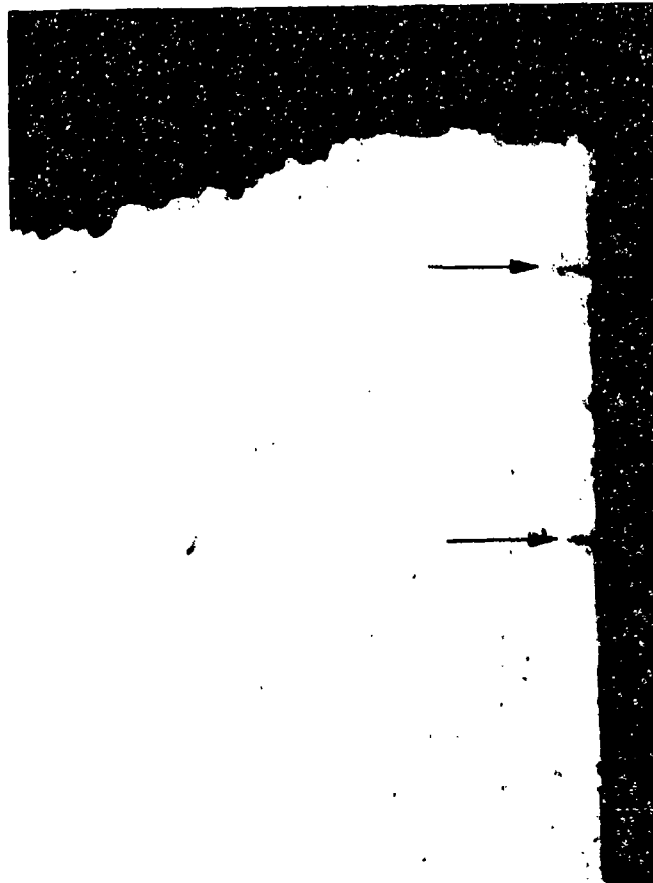
FAM 100283

FIGURE 9-125: Optical photomicrograph showing the primary fracture and V-shaped secondary cracks (arrows) along the specimen gage area. These oxidized secondary cracks are indicative of TMF.

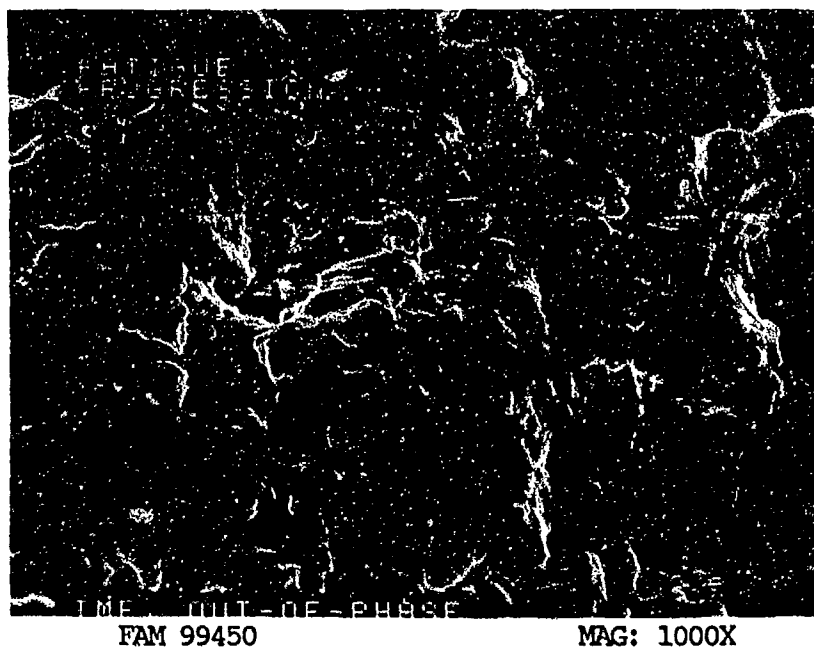
FIGURE 9-128: Coarse oxidized striations in the fatigue progression zone. The propagation is from bottom to top of the photograph.

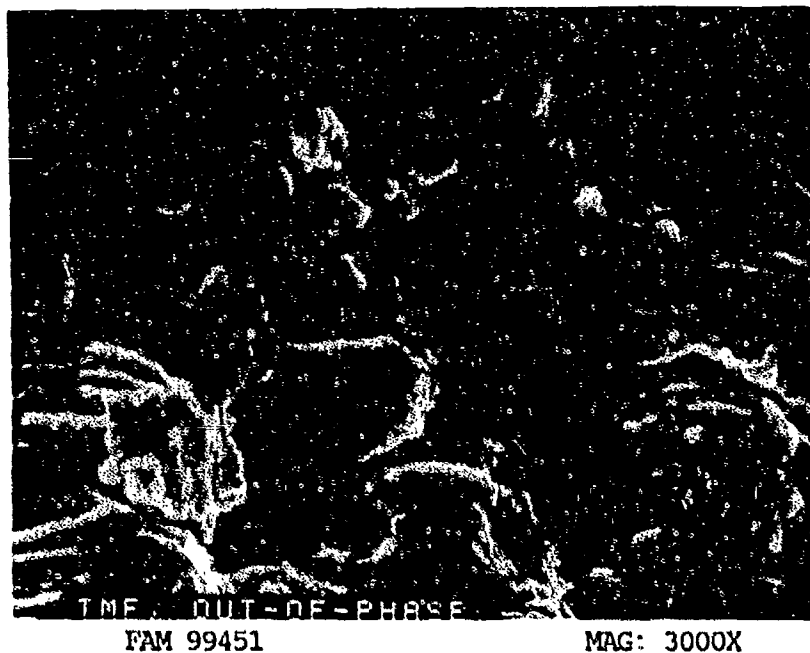
FIGURE 9-129: Higher magnification photograph of the area shown in Figure 9-128, showing both oxidized striations and crack-like striations.

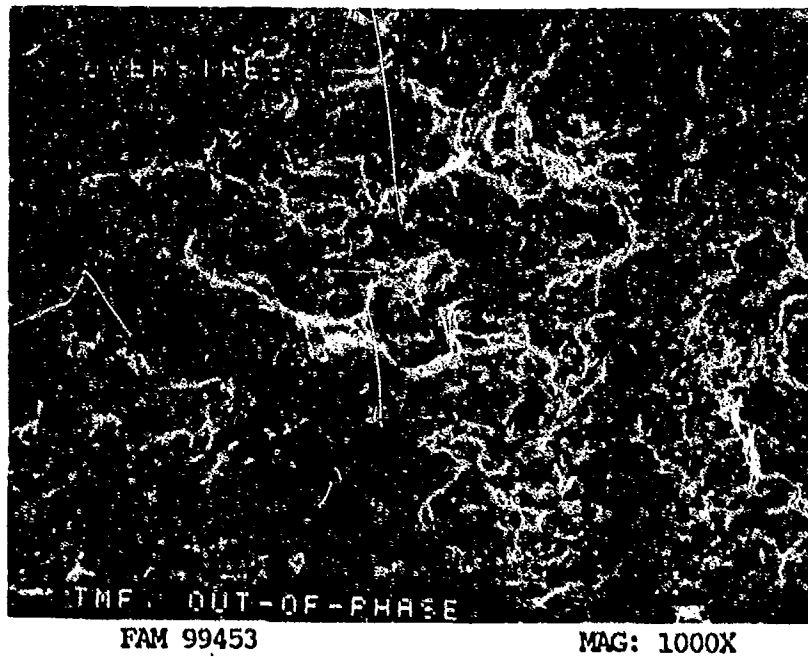
FIGURE 9-131: Fine oxidized dimpled overstress in the area shown in Figure 9-130.

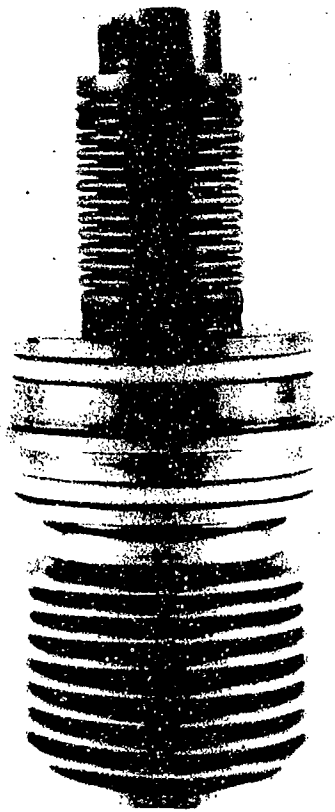
FAL 88632

SUMMARY: The crack in the second convolution of the small bellows of the quick fill bellows assembly was the result of fatigue (probable HCF) progressing from multiple origins on the O.D. surface. The crack extended 0.45 inch in length and was predominantly transgranular. No material defects were found. The hardness was HRC 36-39 in the flat sections of the bellows and HRC 40-44 in the bends. This variation in hardness was attributed to work hardening that probably occurred during manufacturing.

FIGURE 9-133: Overall photograph of the quick fill bellows assembly. The crack is in the small bellows (top).

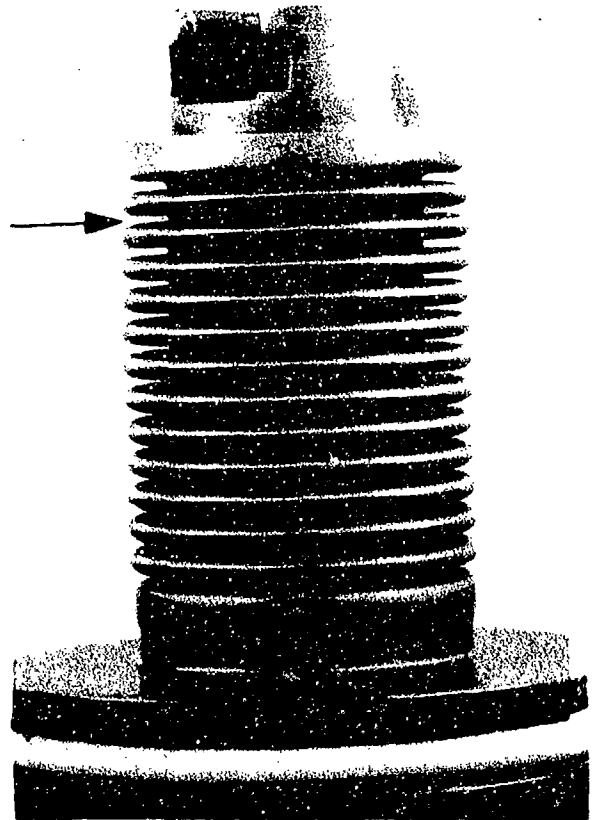
FAL 88633

FIGURE 9-134: Close-up of the small bellows. Arrow indicate the location of the crack in the second convolution.

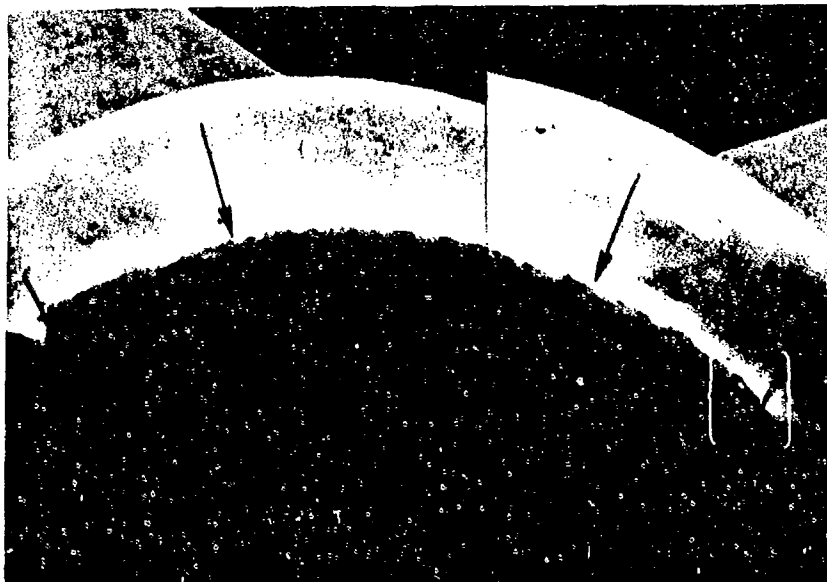
FAL 93341

FIGURE 9-135: Composite SEM photograph of the opened crack surface. The extent of the fatigue is shown by black brackets. Fatigue origins were on the O.D. surface (arrows).

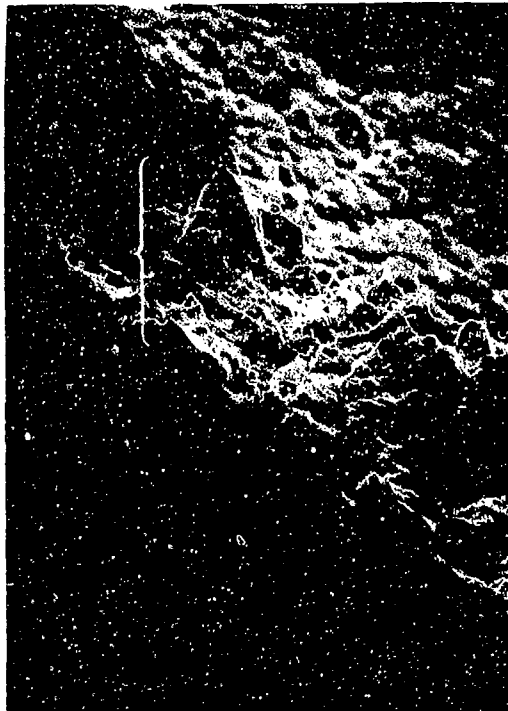
FAL 93345 MAG: 300X

FIGURE 9-136: SEM photograph of the opened crack surface. The location of photograph 122 is shown by a bracket.

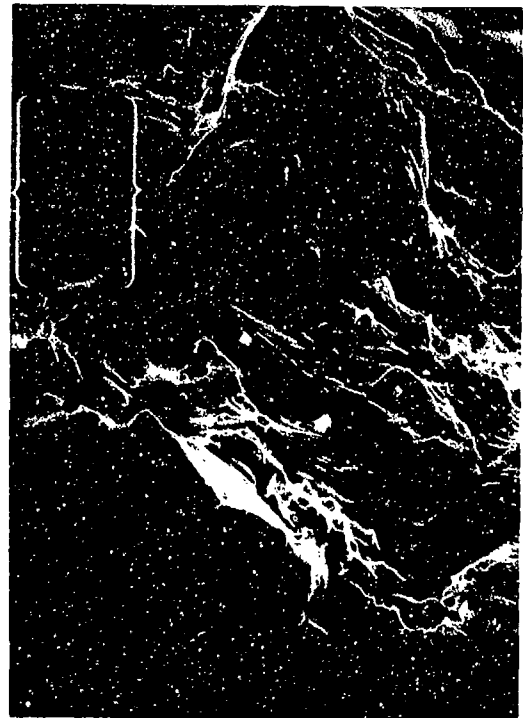
FAL 93346 MAG: 1000X

FIGURE 9-137: Photograph 122 relatively fine fatigue striations indicating propagation from the O.D. surface.
