FAILURE ANALYSIS HANDBOOK

C. R. Walker, K. K. Starr

Pratt & Whitney
P.O. Box 109600
West Palm Beach, FL 33410-9600

August 1989

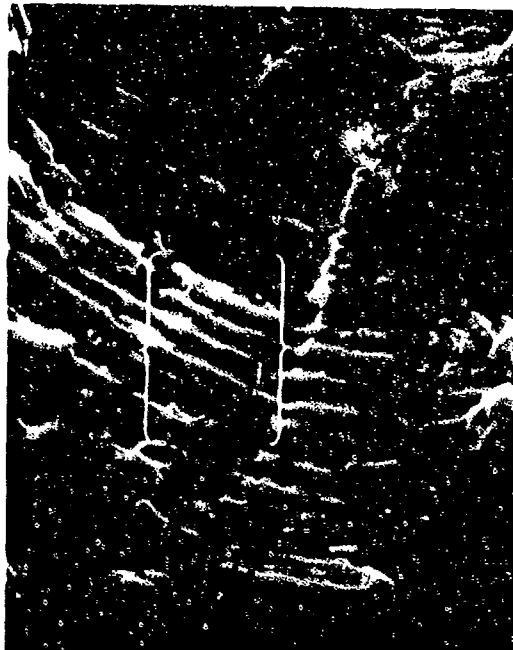
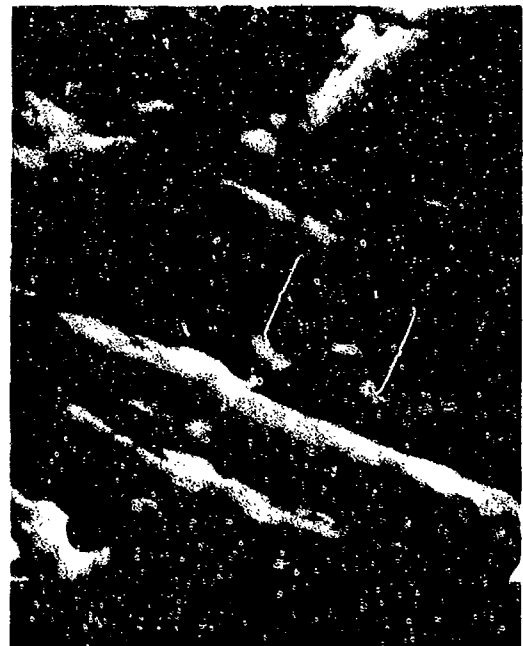
FIGURE 9-138: Higher magnification photograph of the fatigue striations. The curvature of the striations with their concave side up indicates propagation from top to bottom of the photograph.

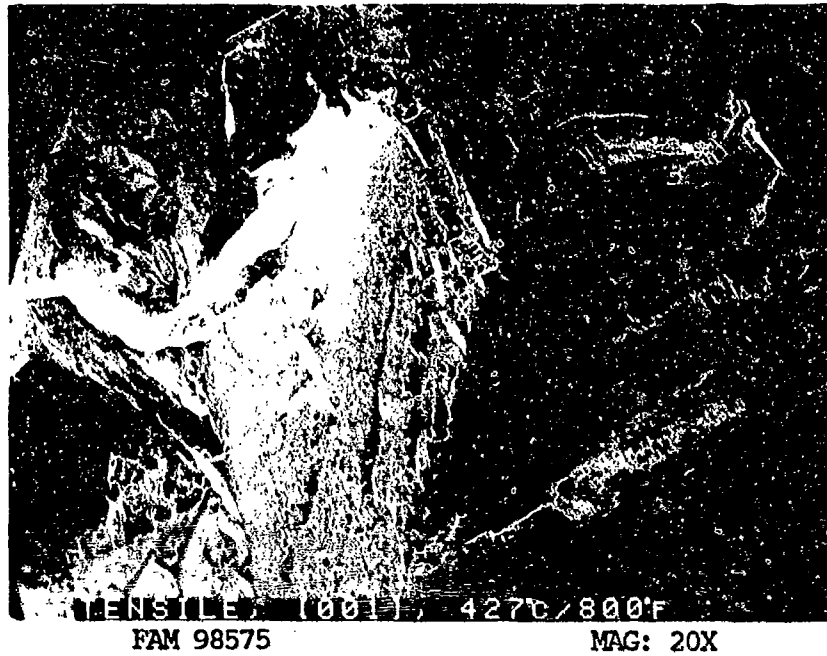
FIGURE 10-3: Low magnification photograph showing the faceted appearance of the fracture. This is the result of fracture along close-packed crystallographic planes.

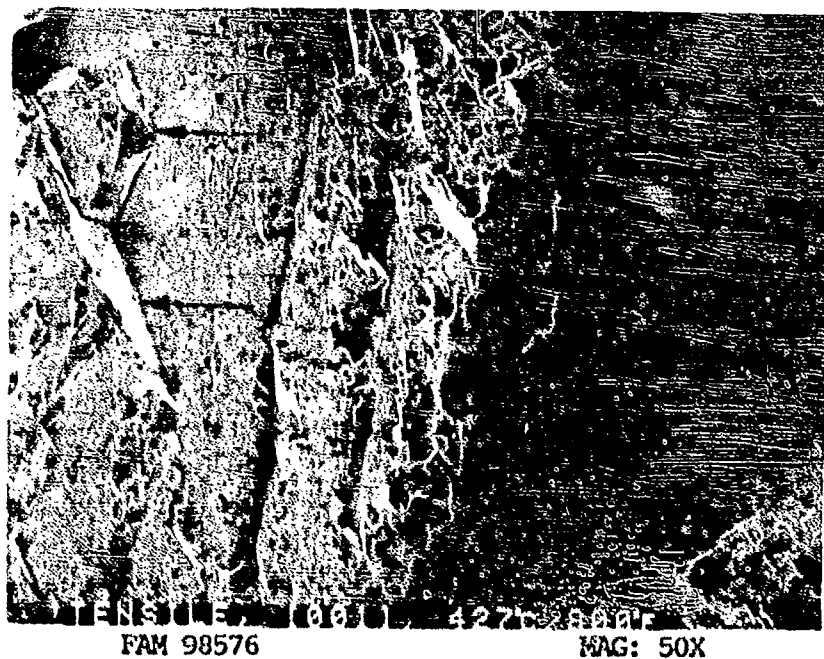
FIGURE 10-4: Higher magnification photograph of the area shown in Figure 10-3, showing abrupt changes in fracture path (arrows) associated with fracture along close-packed planes.

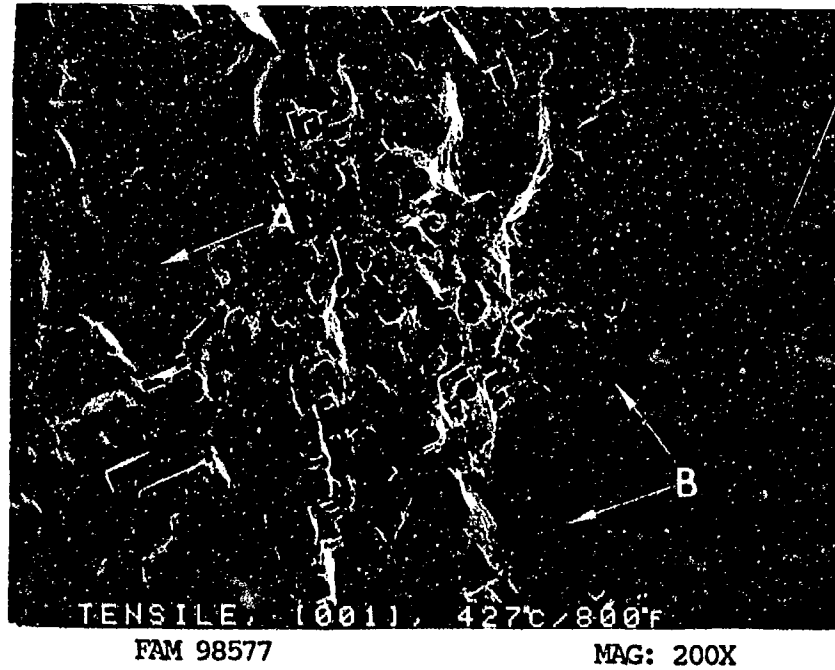
FIGURE 10-5: Higher magnification photograph showing cleavage fracture (arrow A) with patches of dimpled overstress (arrows B).

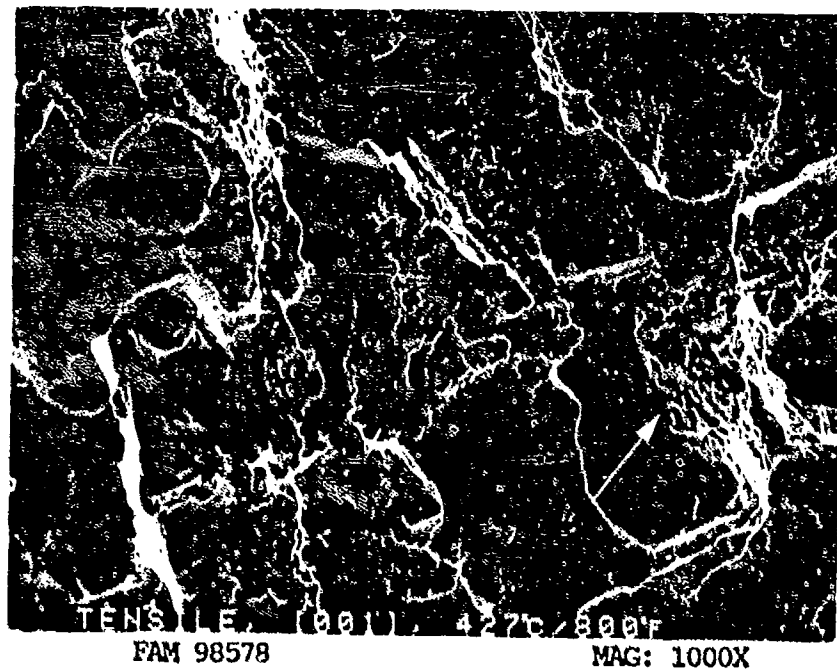
FIGURE 10-6: Higher magnification photograph of the area shown in Figure 10-5, showing dimpled overstress (arrow) between areas of cleavage.

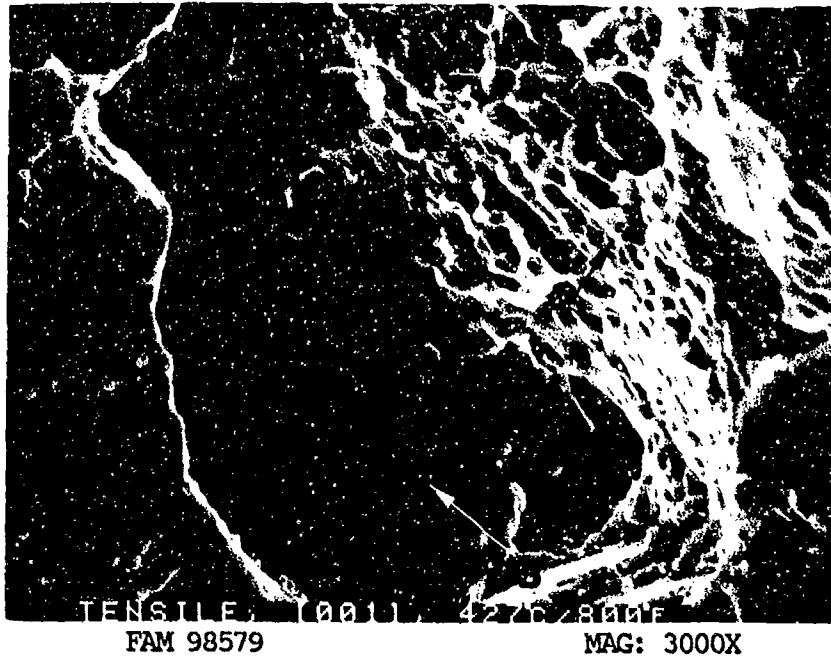
FIGURE 10-7: Mixture of dimpled overstress (arrow A) and cleavage (arrow B) features. The microstructural constituent gamma prime is visible on the cleavage facets, appearing as small squares on the surface (blocky appearance).

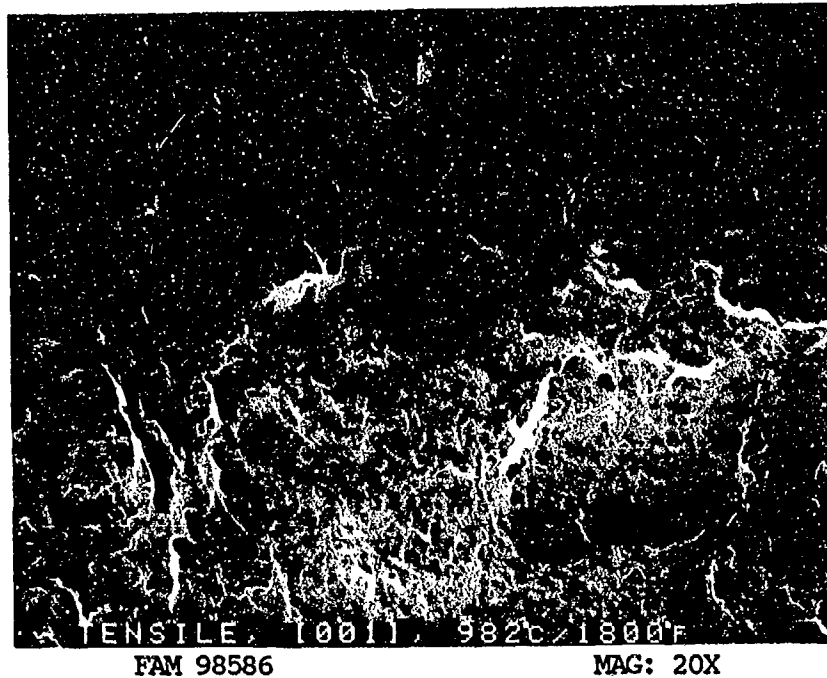
FIGURE 10-10: Low magnification photograph showing the non-crystallographic nature of the fracture. Compare with the 800°F specimen, Figures 10-3 through 10-5.

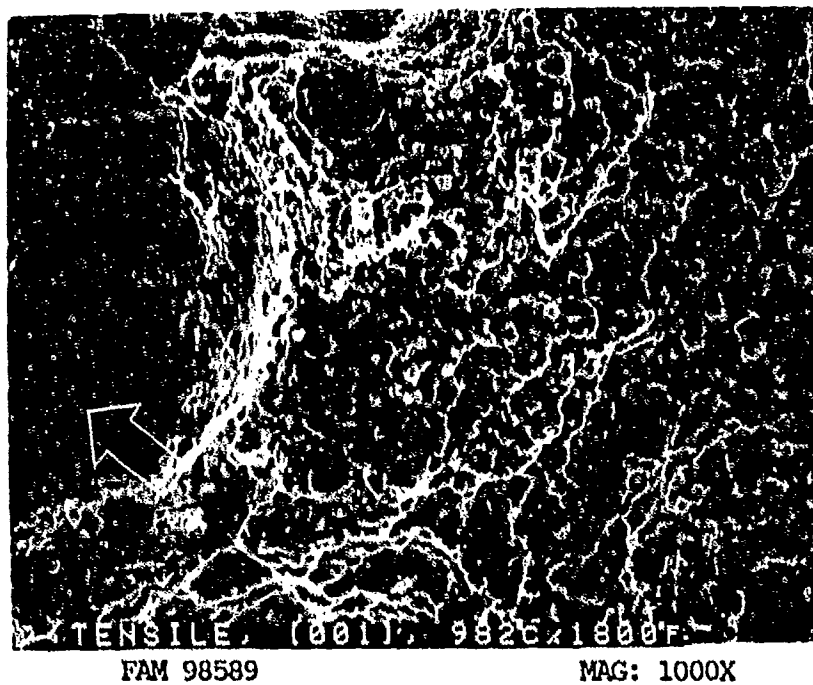
FIGURE 10-13: Oxidized overstress features with some void coalescence (arrow).

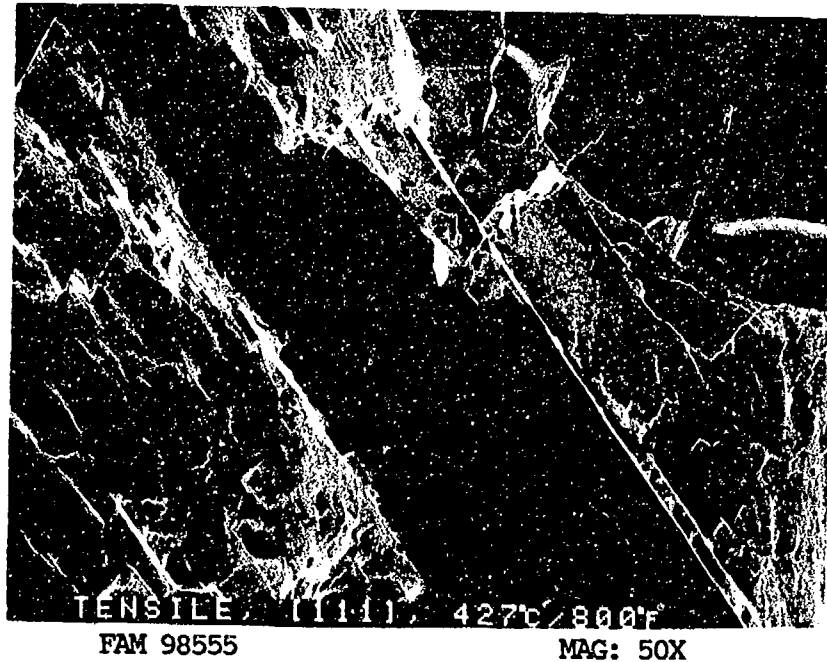
FIGURE 10-16: Low magnification photograph showing faceted crystallographic nature of the fracture surface. The faceting occurs when a specimen fractures along crystallographic planes oriented for maximum resolved shear stress.

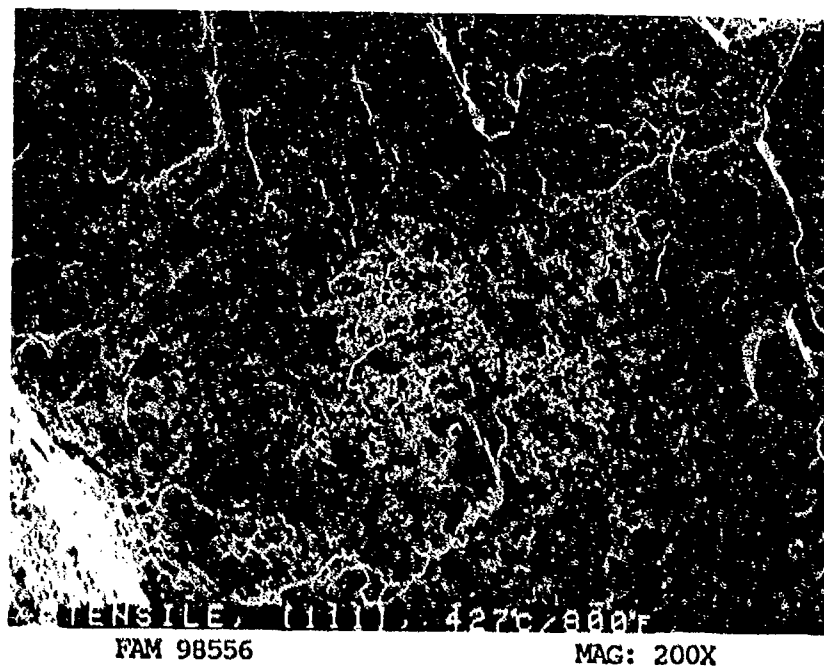
FIGURE 10-17: Cleavage fracture along crystallographic planes.

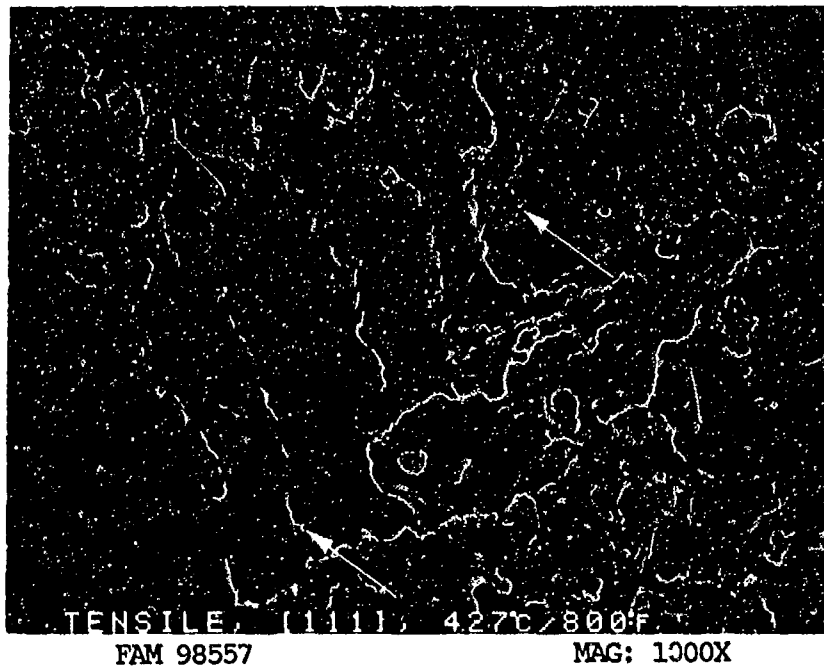
FIGURE 10-18: Higher magnification photograph showing cleavage fracture. Slip lines are visible (arrows).

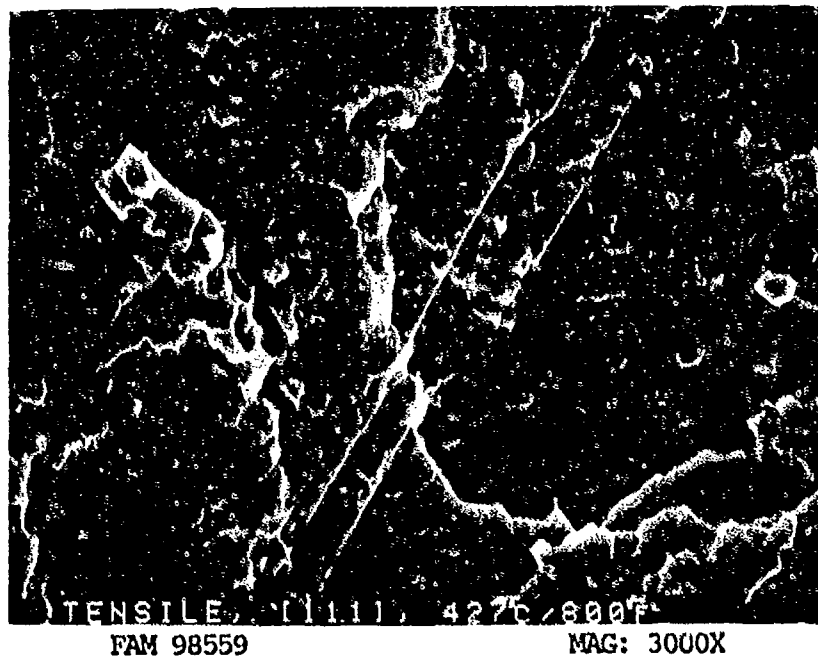
FIGURE 10-19: Cleavage fracture associated with gamma prime precipitates. These precipitates produce a blocky appearance on the fracture surface.

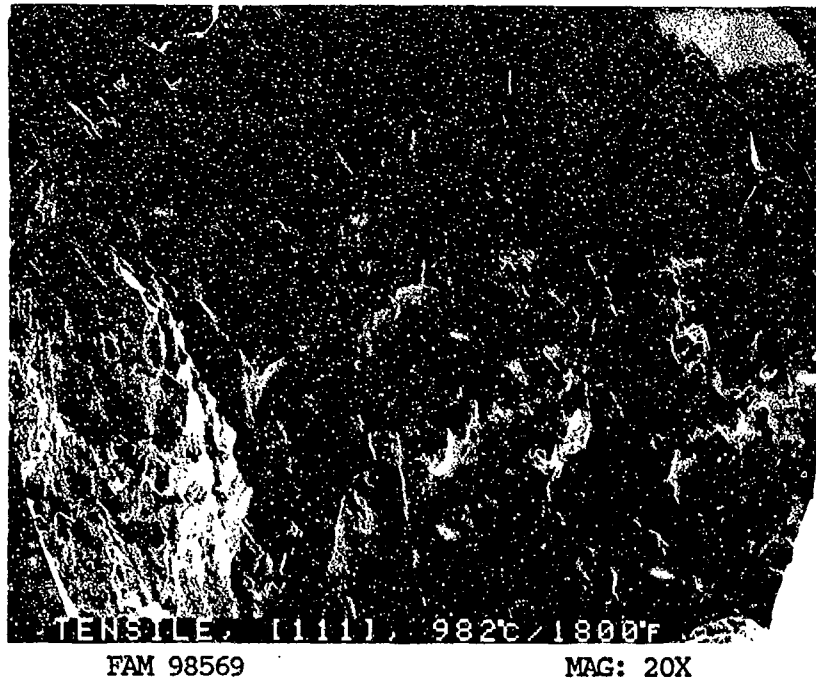
FIGURE 10-22: Low magnification photograph showing jagged appearance of the fracture.

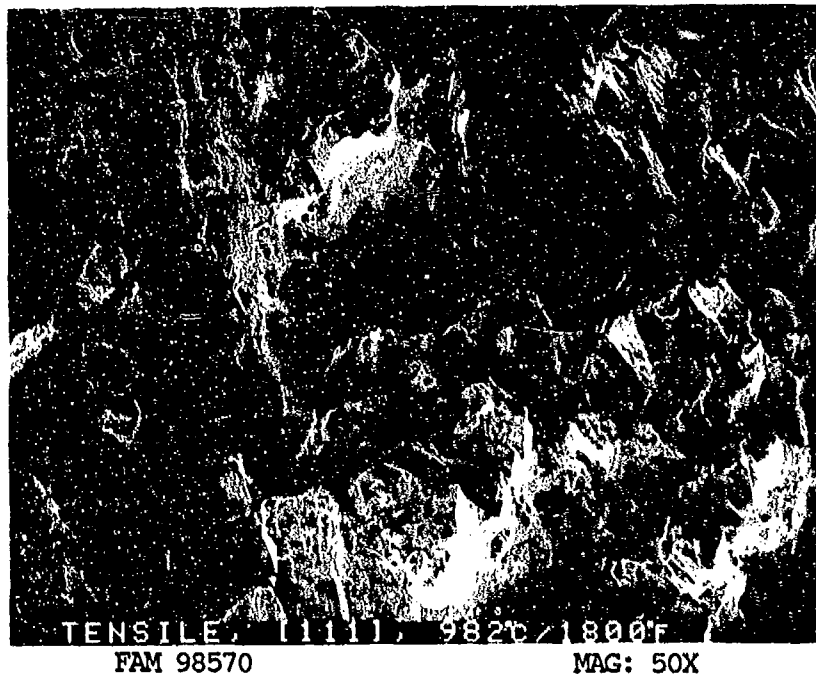
FIGURE 10-23: Oxidized fracture surface with deep jagged appearance resulting from localized cleavage along crystallographic planes. Compare this appearance with the 800°F specimen (Figures 10-16 through 10-19).

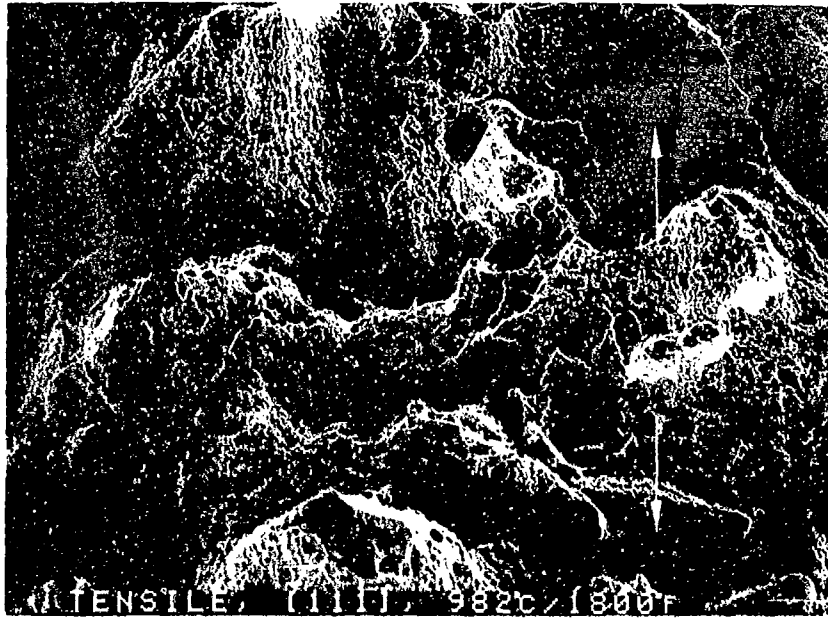
FAM 98571

FIGURE 10-24: Higher magnification photograph of the area shown in Figure 10-23, showing oxidized overstress features. At this magnification cleavage is visible (arrows).

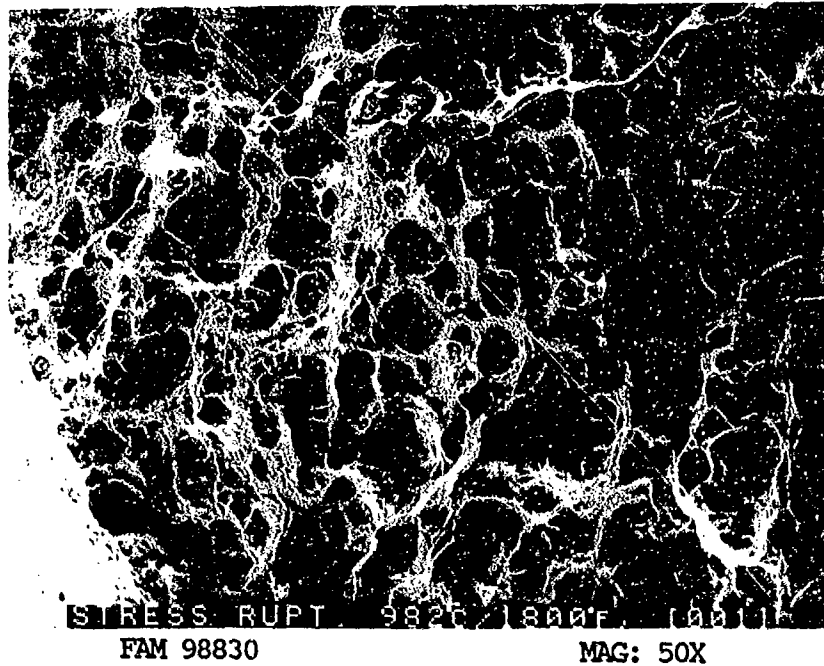
FIGURE 10-28: Low magnification photograph showing granular appearance.

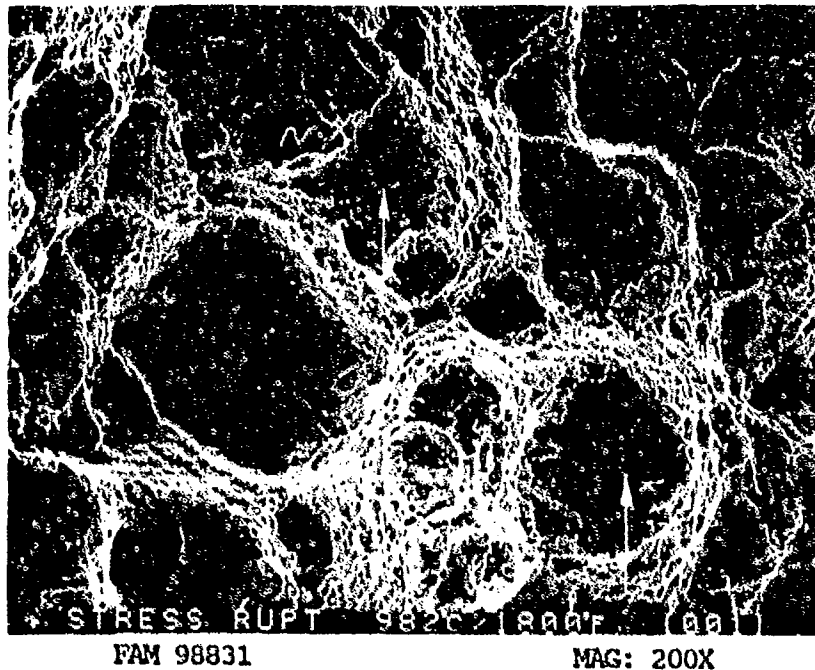
FIGURE 10-29: Higher magnification photograph showing islands of lightly oxidized fracture surrounded by heavily oxidized overstress features. Many of the islands have voids at their centers (arrows)

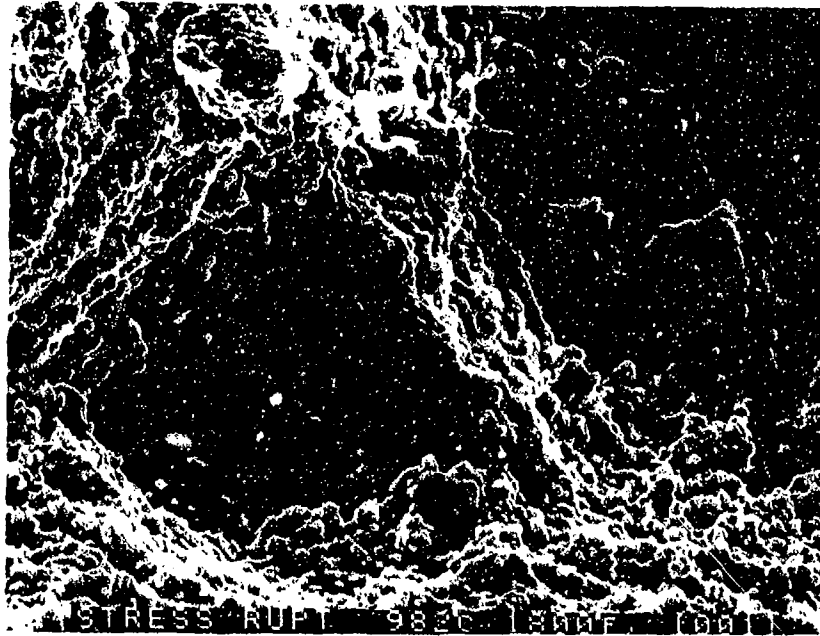
FAM 98833

FIGURE 10-30: Higher magnification photograph showing oxidized overstress features between smoother, evenly oxidized islands with voids at their centers. These voids are visible in the metallographic cross section (Figure 10-27).

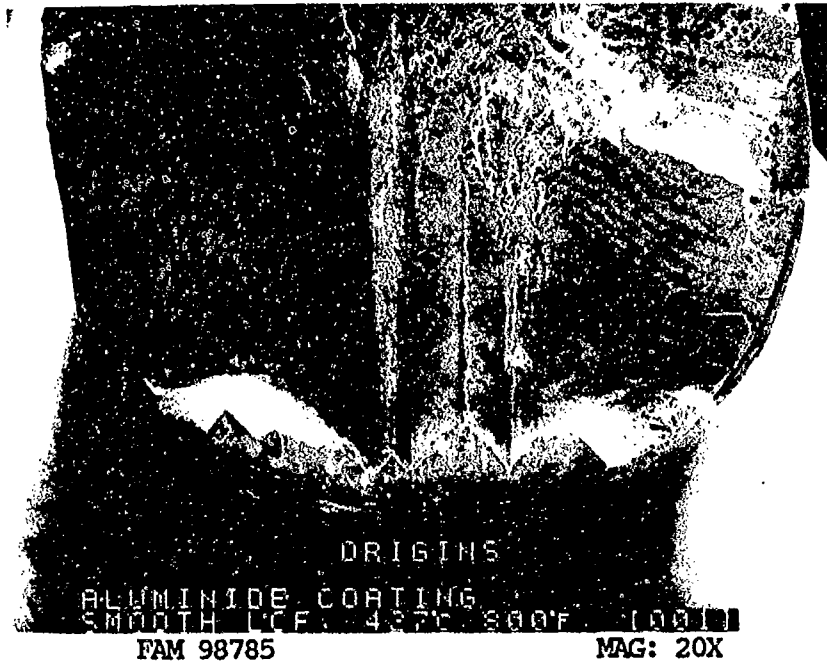
FIGURE 10-33: Low magnification photograph showing arrest marks (arrows A) indicating fatigue propagation from several origins near the bottom of the photograph (arrows B).

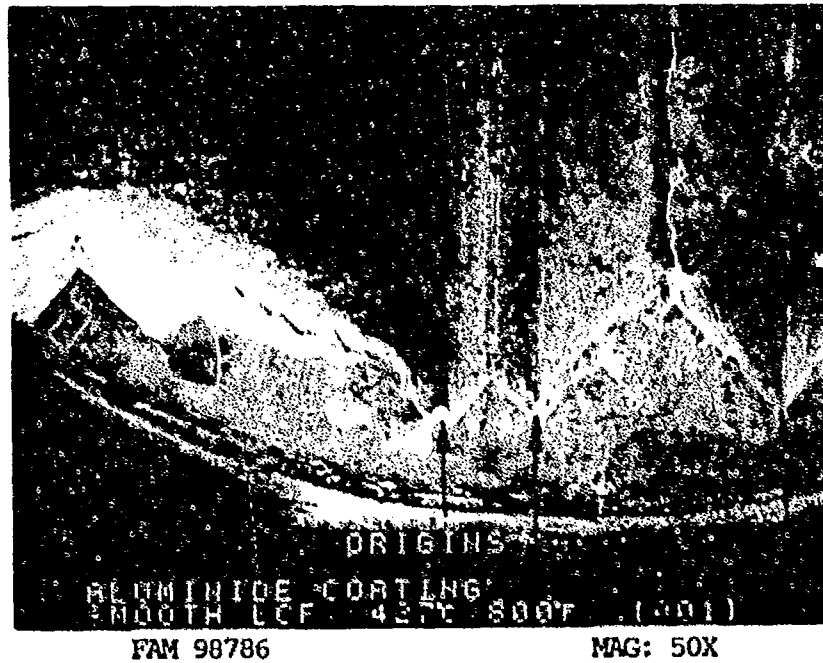
FIGURE 10-34: Higher magnification photograph showing three fatigue origins near the surface of the specimen (arrows).

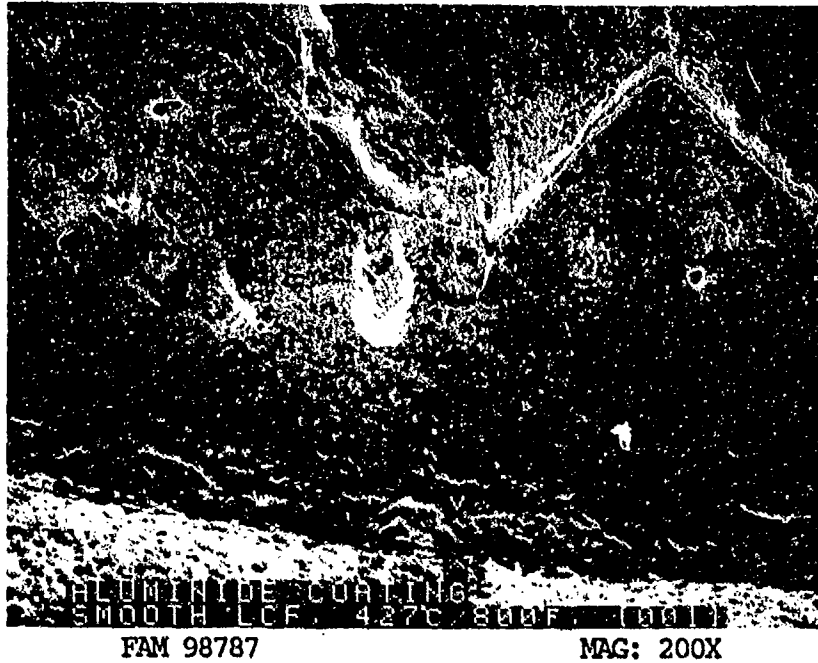
FIGURE 10-35: Close-up photograph of the origin area shown in Figure 10-34. The extent of the coating is shown by arrows.

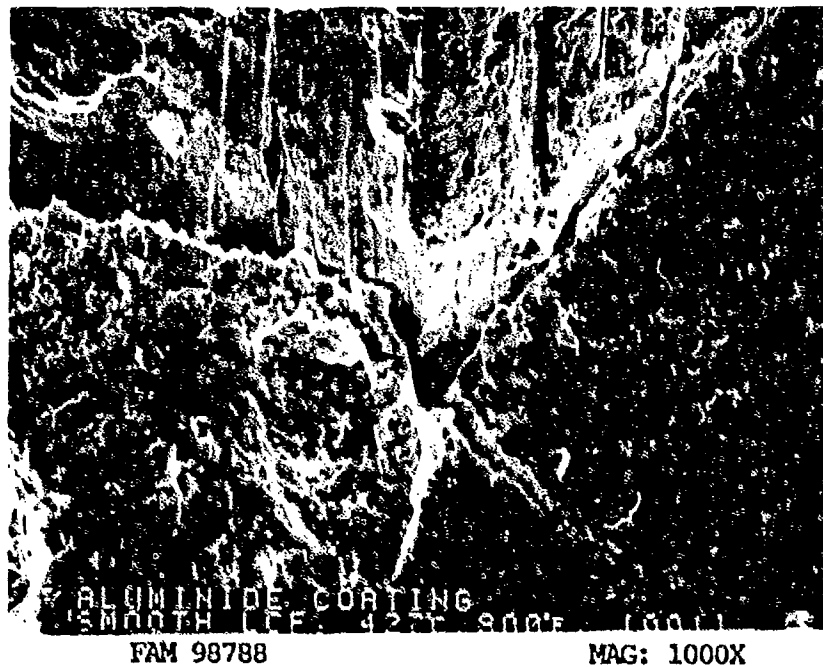
FIGURE 10-36: Higher magnification photograph showing oxidized fatigue features near the origin area. Three remnant fatigue striations are contained in a bracket.

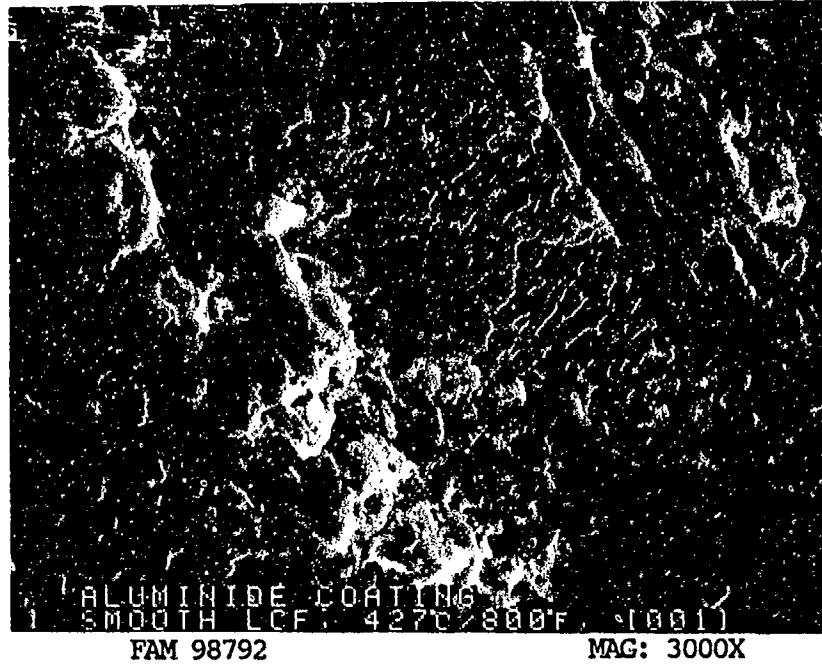
FIGURE 10-39: High magnification photograph showing the smeared striations from Figure 10-38.

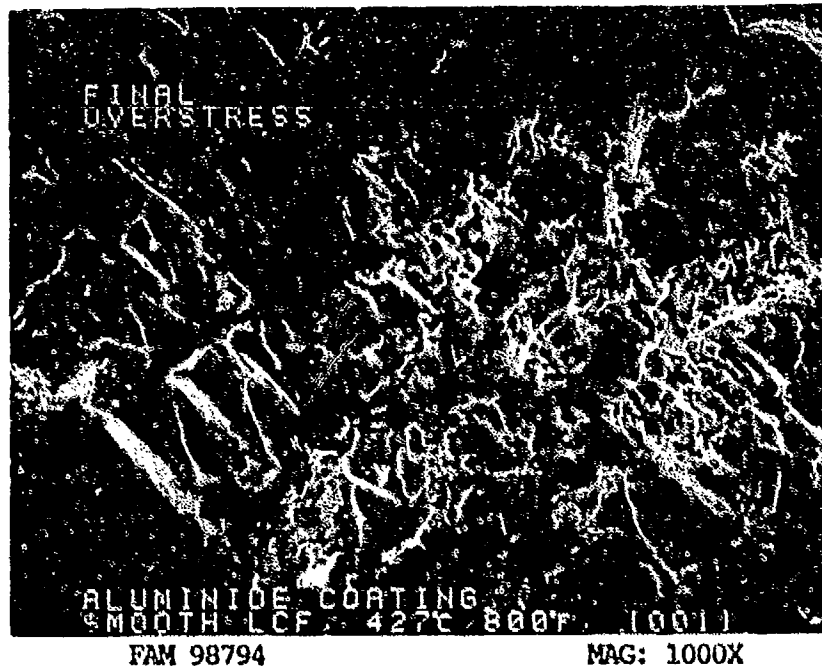
FIGURE 10-40: Final overstress area consisting of cleavage facets.

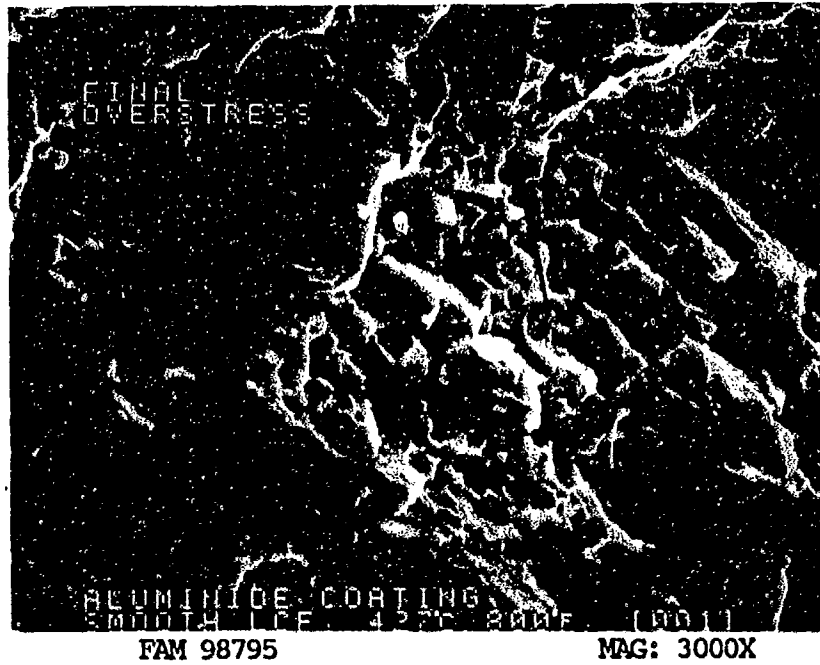
FIGURE 10-41: Final overstress area exhibiting gamma prime microstructural constituent on the fracture surface (arrows).

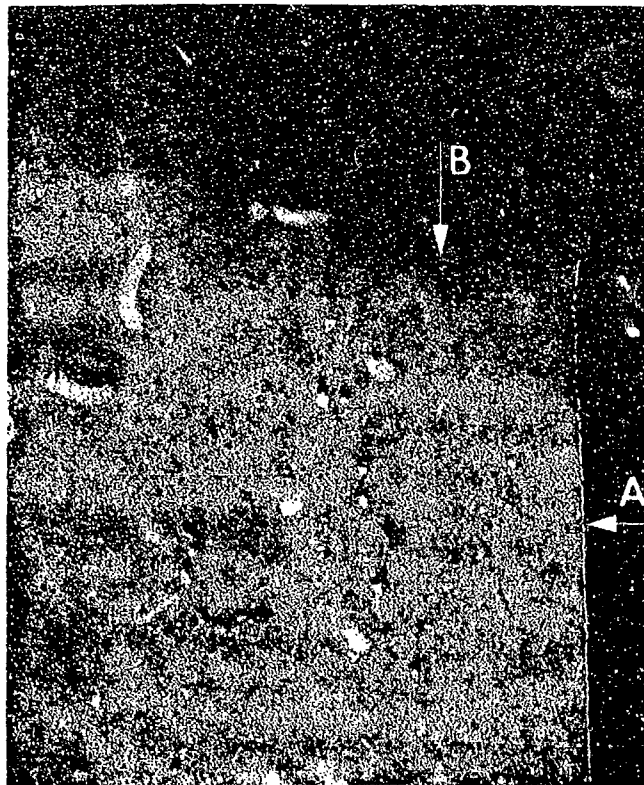
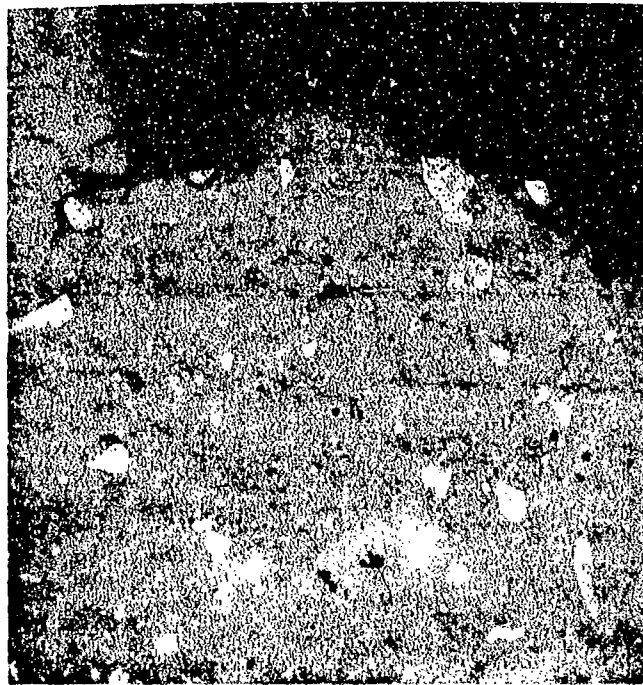
FIGURE 10-43: Optical photomicrographs showing fatigue propagation area (top) and final overstress area (bottom). The fatigue progression is flatter while the overstress is more jagged. A thin alloy depleted layer is visible on the exposed gage section (arrow A) and on the fatigue progression area (arrow B). The fatigue area was exposed to the high temperature oxidizing environment (hot air) during propagation.

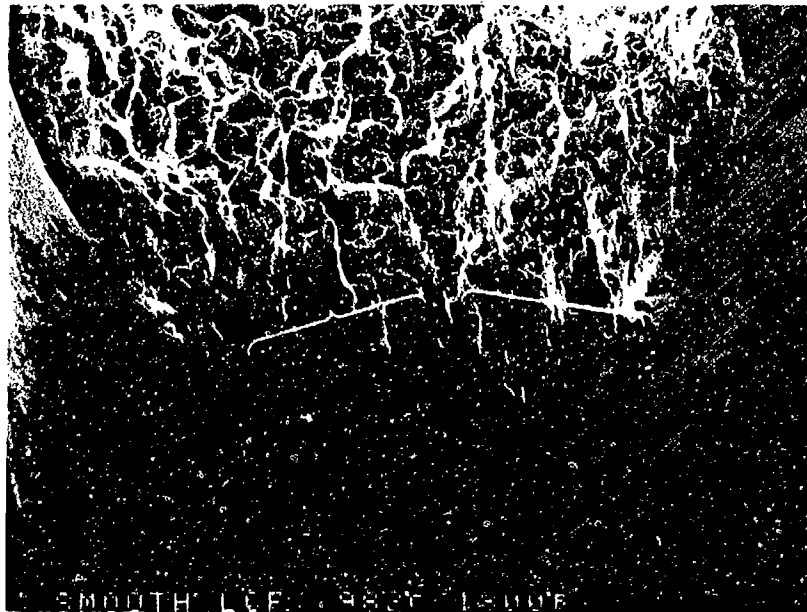
FAM 98803

FIGURE 10-44: Low magnification photograph showing smooth fatigue progression near the bottom of the photograph (brackets).

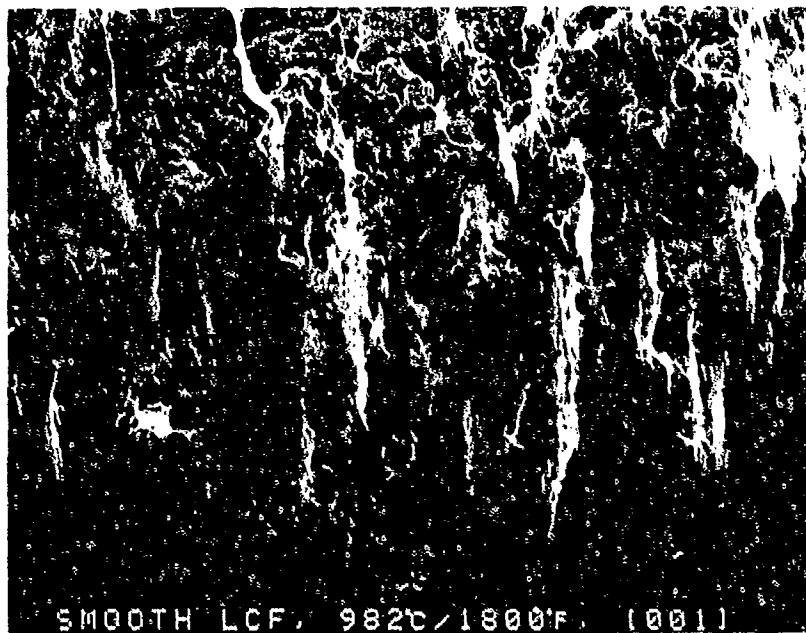
FAM 98804

FIGURE 10-45: Close-up photograph of the fatigue thumbnail area. The diffuse origin area is located at the bottom of the photograph.

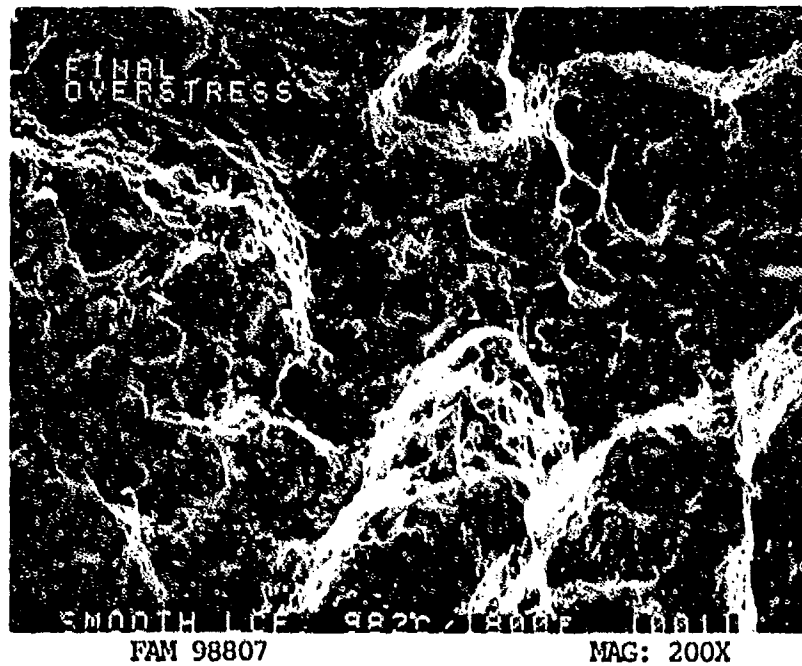
FIGURE 10-47: Oxidized final overstress area.

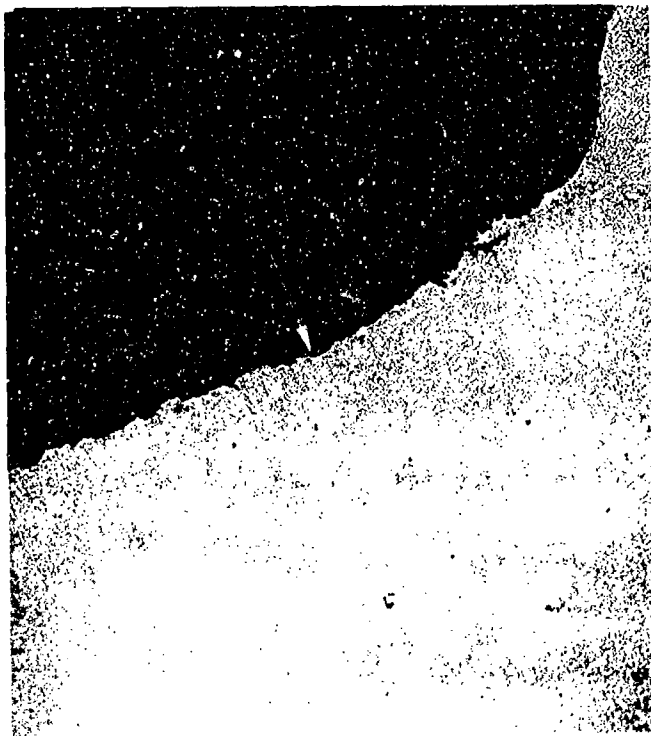
FIGURE 10-50: Optical photomicrographs showing the primary fatigue progression area (top) and secondary cracks along the specimen gage (bottom). Both the cracks and the fatigue portion of the fracture surface exhibit thin alloy depleted layers that appear as white-etched areas along the exposed surfaces (arrows). Dark gray colored oxides are visible on top of the alloy depletion layers .

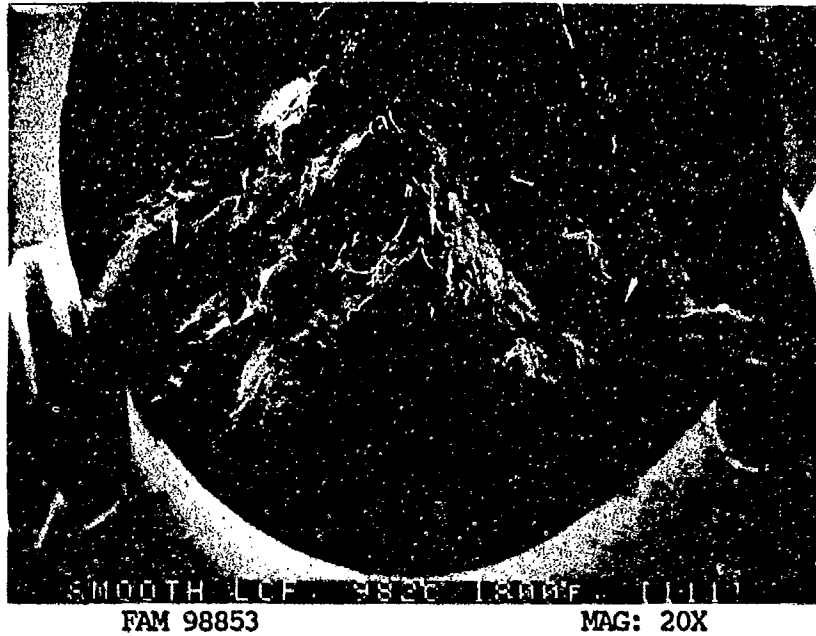
FIGURE 10-51: Low magnification photograph showing smooth fatigue area located near the bottom of the photograph. Arrows indicate the extent of the fatigue. The fracture propagated from multiple origins.

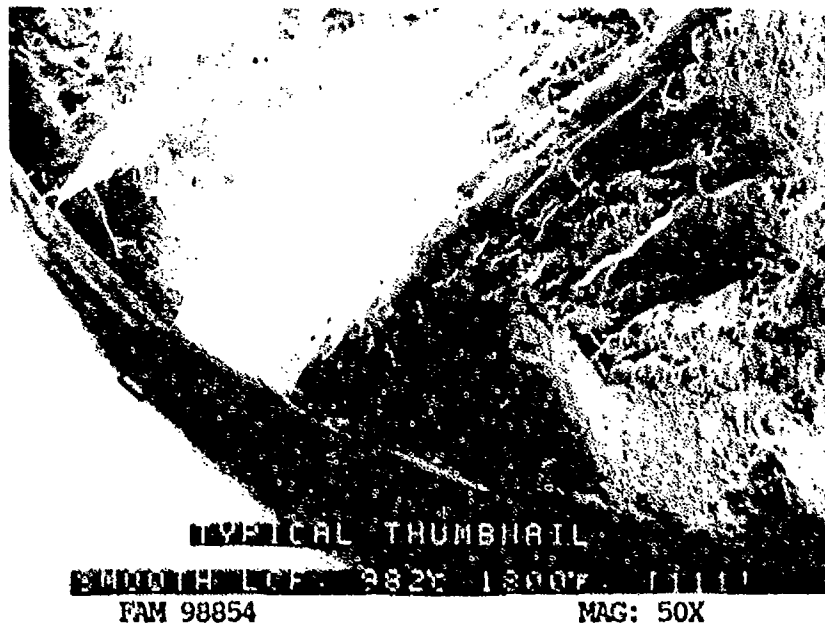
FIGURE 10-52: Close-up photograph showing a typical origin area. A localized origin is indicated by an arrow.

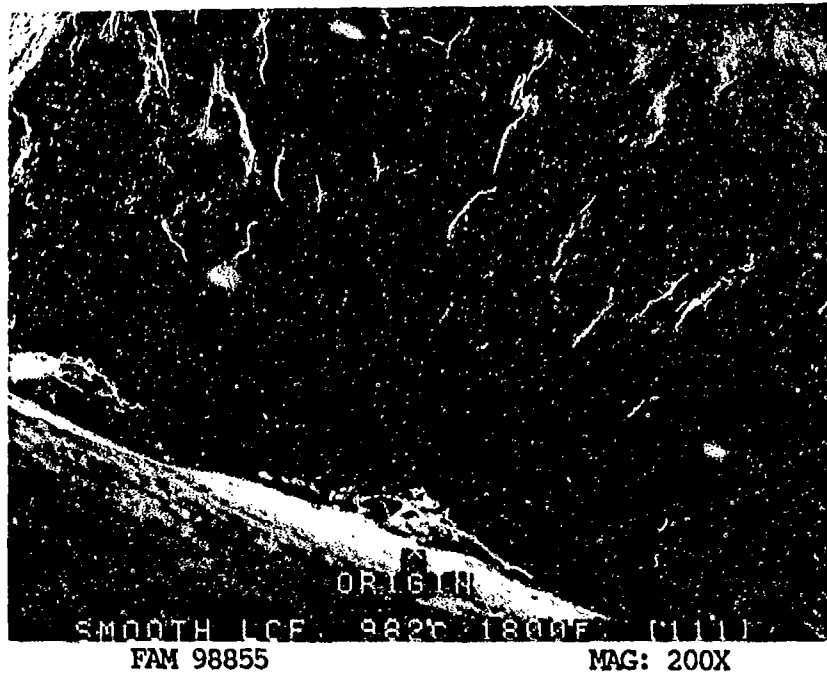
FIGURE 10-53: Higher magnification photograph of the area shown in Figure 10-52, showing a small void at the origin. No striations are visible in the origin area.

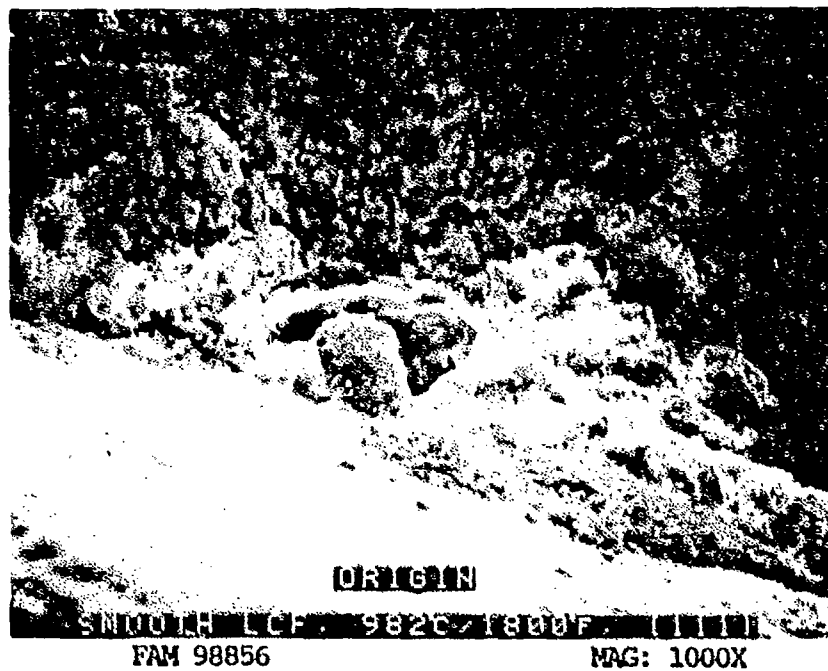
FIGURE 10-54: Small oxidized void at the origin.

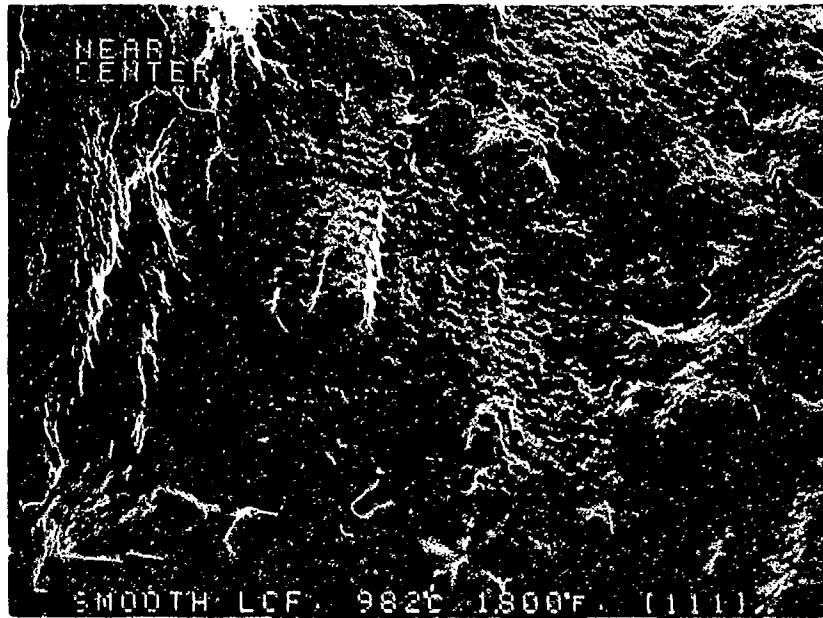
FAM 98859

FIGURE 10-55: Fatigue progression near the center of the fracture surface. Coarse striations are visible. The direction of propagation is shown by an arrow.

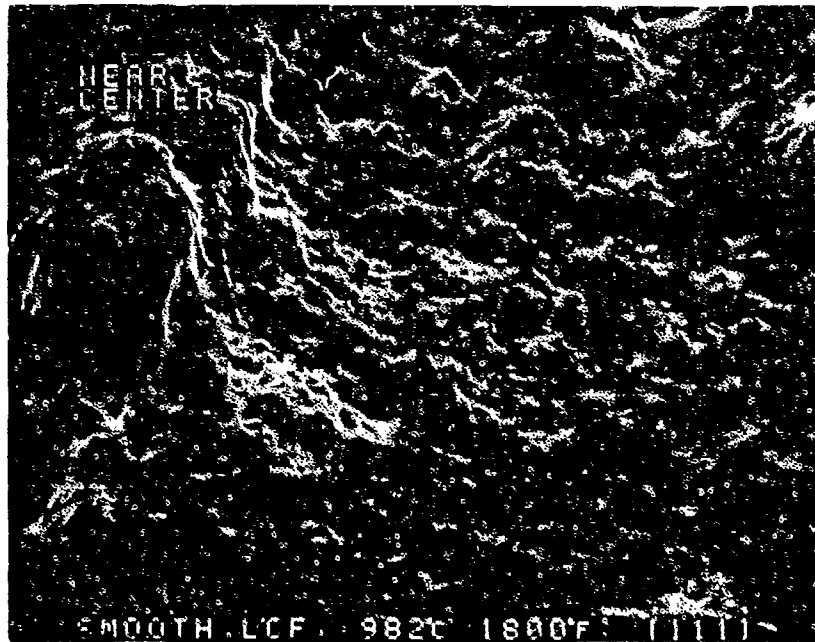
FAM 98860

FIGURE 10-56: Higher magnification photograph of the coarse oxidized striations shown in Figure 10-55.

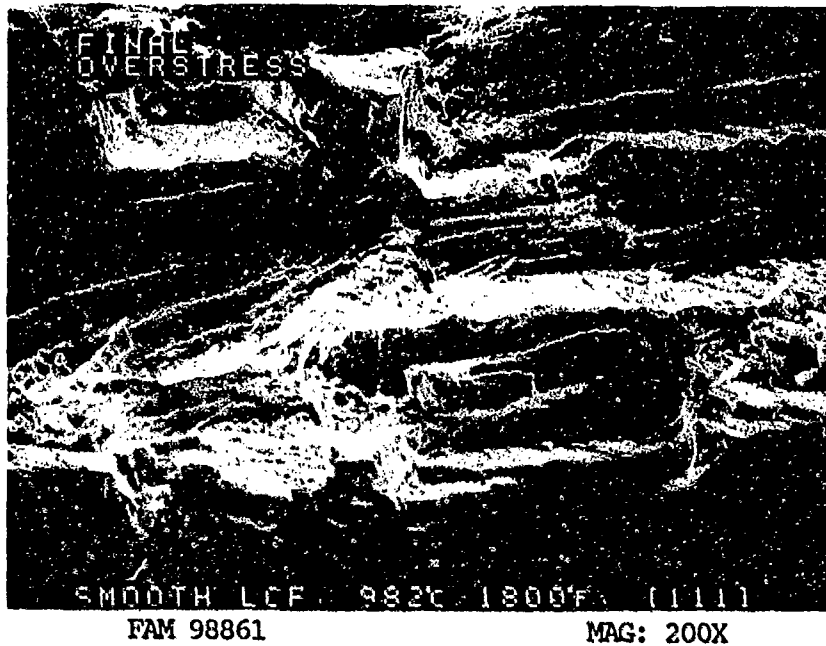
FIGURE 10-57: Cleavage features in the final overstress area.

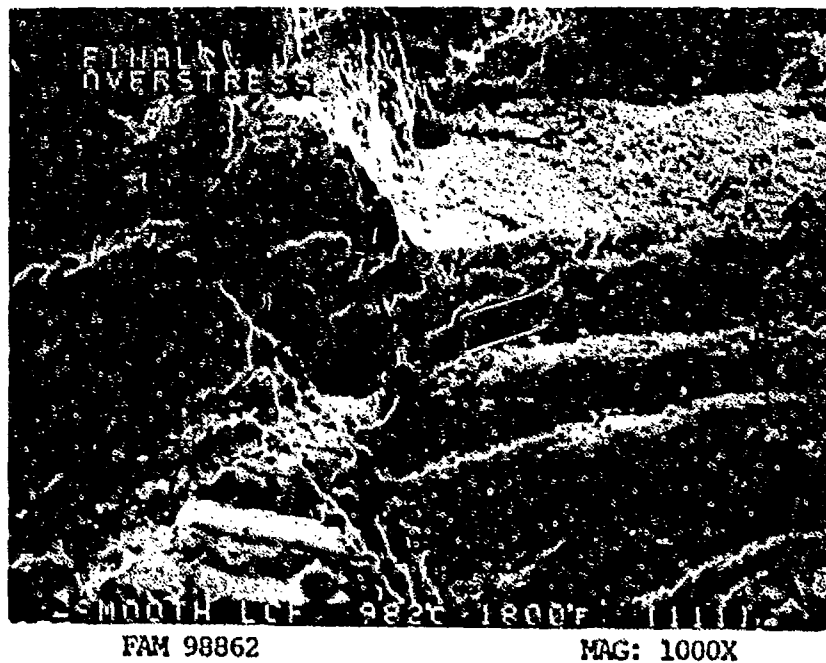
FIGURE 10-58: Higher magnification photograph of the area shown in Figure 10-57, showing oxidized cleavage features. Two small patches of fan-shaped cleavage are indicated by arrows.

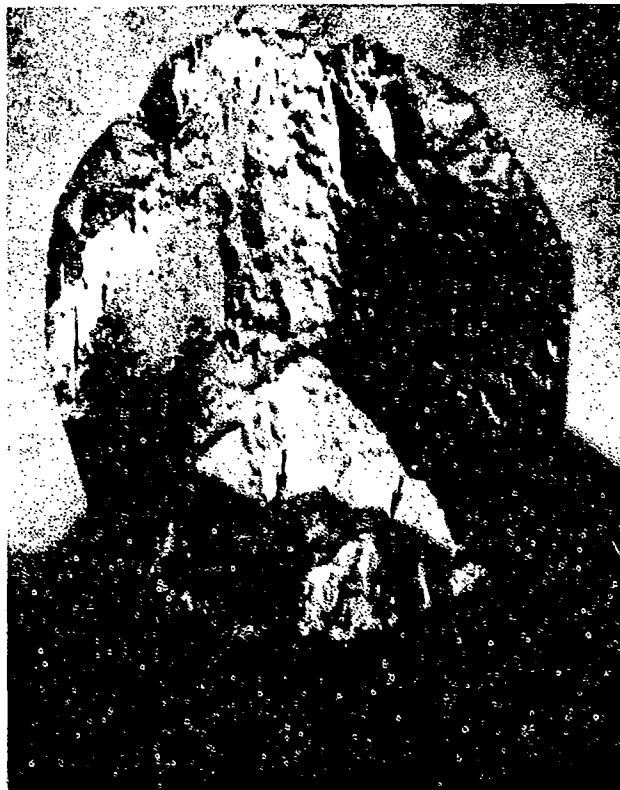
FAL 93404

FIGURE 10-59: Test results and fractography of FWA 1480/[001] Out-of-Phase TMF test. An oxidized (dark) fatigue progression zone is visible at the bottom of the photograph. Arrows indicate the extent of the fatigue.
