FAILURE ANALYSIS HANDBOOK

C. R. Walker, K. K. Starr

Pratt & Whitney
P.O. Box 109600
West Palm Beach, FL 33410-9600

August 1989

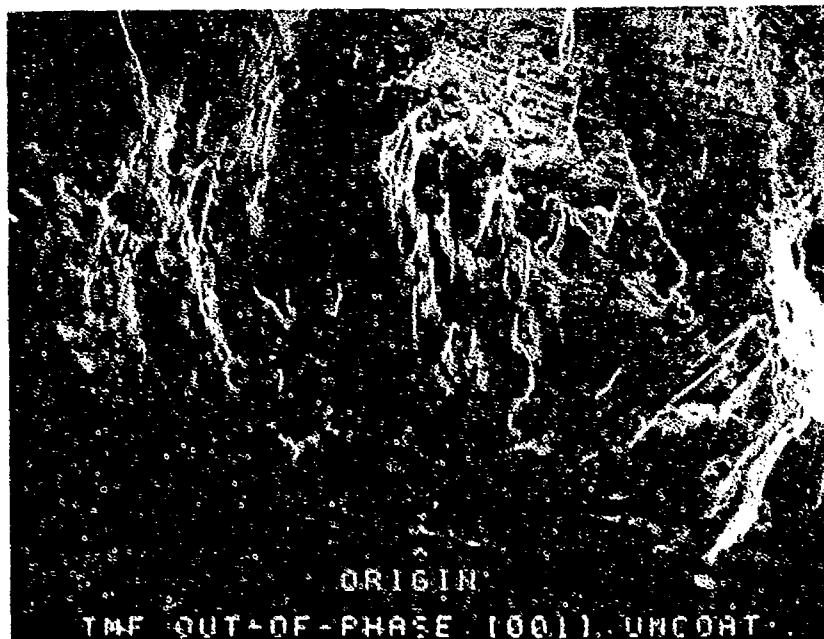
FAM 98839

FIGURE 10-62: Higher magnification photograph of the origin area. A void open to the surface is the local origin site (arrow).

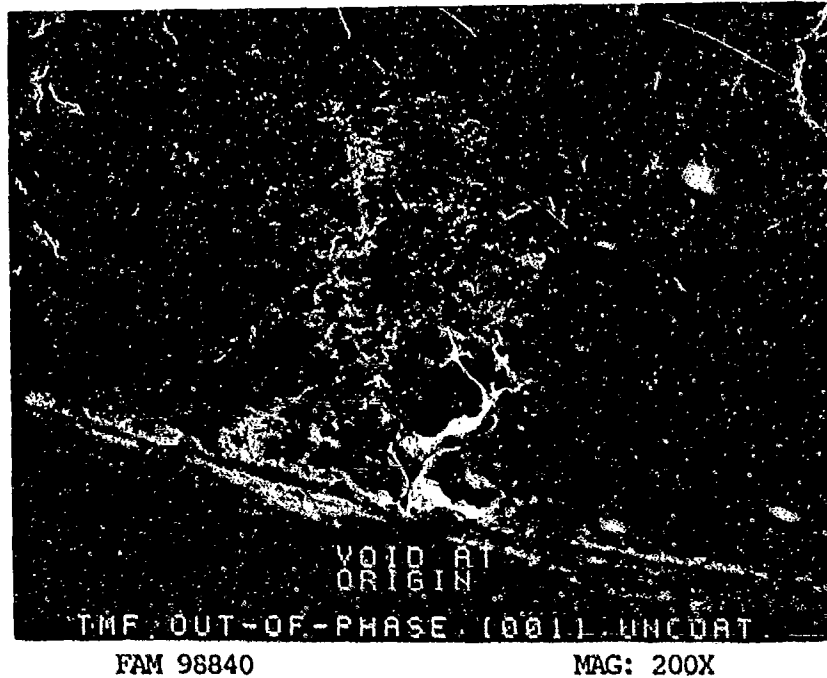
FIGURE 10-63: Close-up photograph of the surface connected void at the origin shown in Figure 10-62. No fatigue striations are visible adjacent to the void.

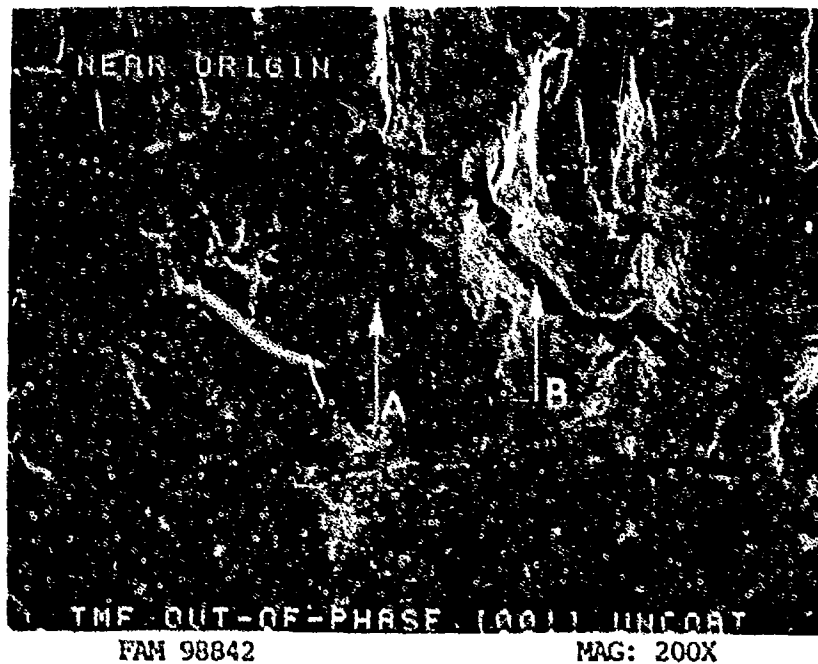
FIGURE 10-64: Remnant fatigue features near the origin. The direction of propagation is shown by arrow A. Arrow B shows a large secondary crack perpendicular to the direction of propagation.

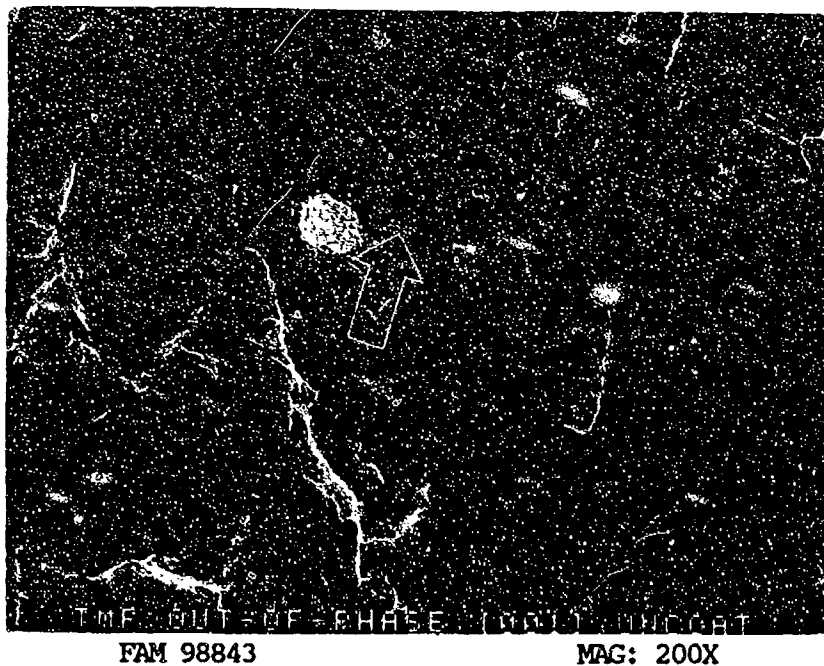
FIGURE 10-65: Fatigue features in the thumbnail area. The direction of propagation is shown by an arrow.

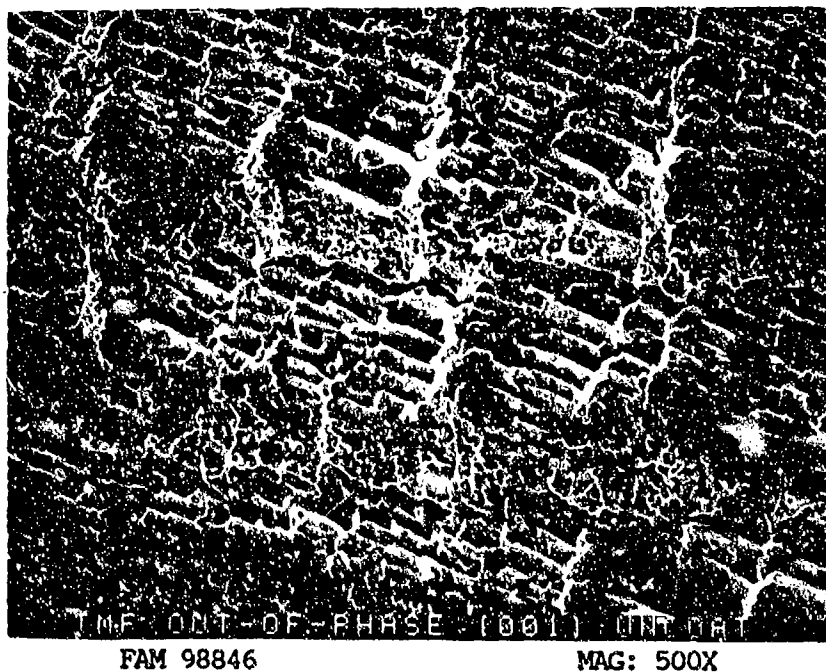
FIGURE 10-66: Higher magnification photograph of the fatigue features shown in Figure 10-65. Note presence of terrace steps separated by smoother, oxidized regions.

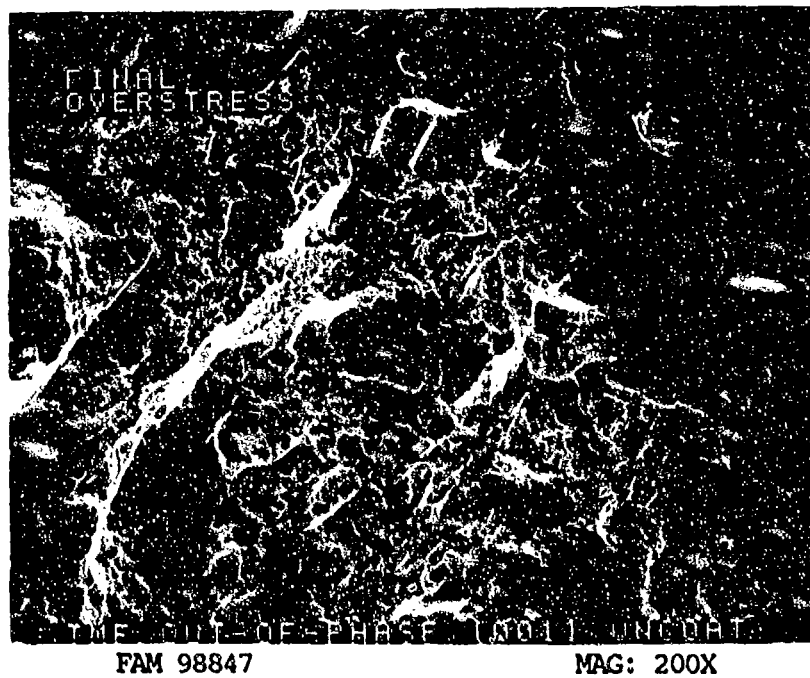
FIGURE 10-68: Final overstress area.

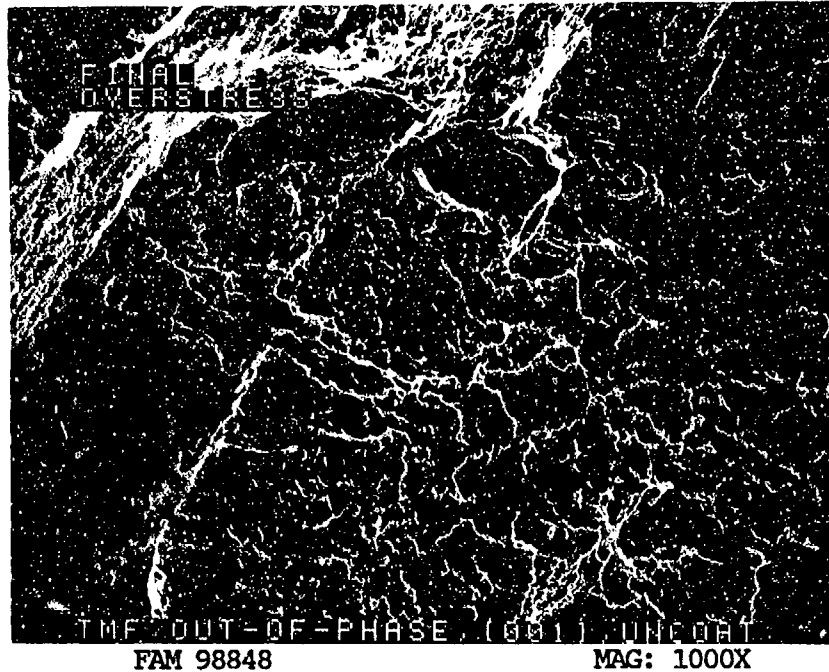
FIGURE 10-69: Higher magnification photograph of the area shown in Figure 10-68, exhibiting fine dimpled overstress associated with Gamma Prime phase and patches of feathery cleavage (arrows).

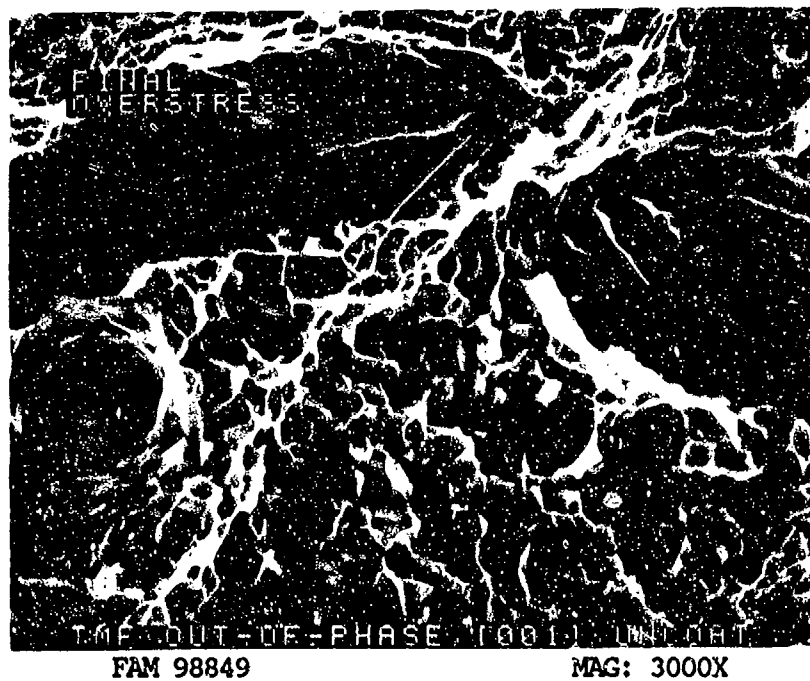
FIGURE 10-70: Very fine dimpled overstress between patches of feathery cleavage. The Gamma Prime phase in the microstructure is visible in the dimpled areas.

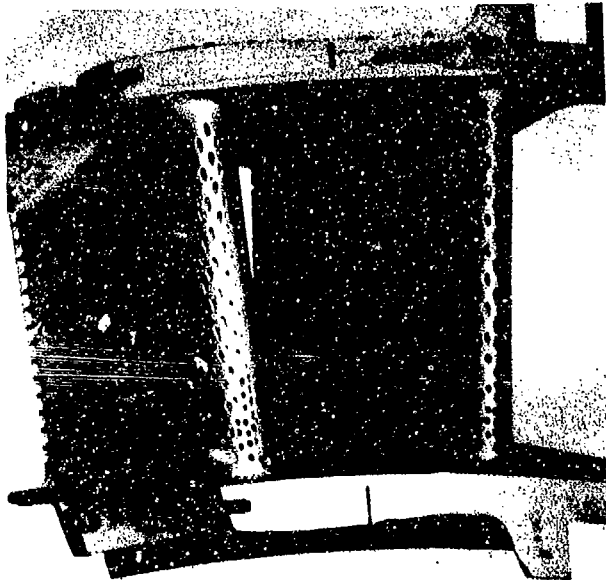
FAL 88111

SUMMARY: First stage turbine vane exhibited microcracks in the laser drilled cooling holes on the airfoil surface. The opened crack surfaces were shallow and heavily oxidized. The only fracture features visible were mud-cracks commonly associated with TMF. The second stage turbine vane had tight cracks running roughly axially in the airfoil/platform fillet. The opened crack surfaces were oxidized but exhibited several very clear sets of arrest lines (beach marks).

FIGURE 10-71: Overall photograph of the first stage turbine vane, forward looking aft. Microcracks propagated from the corners of the cooling holes.

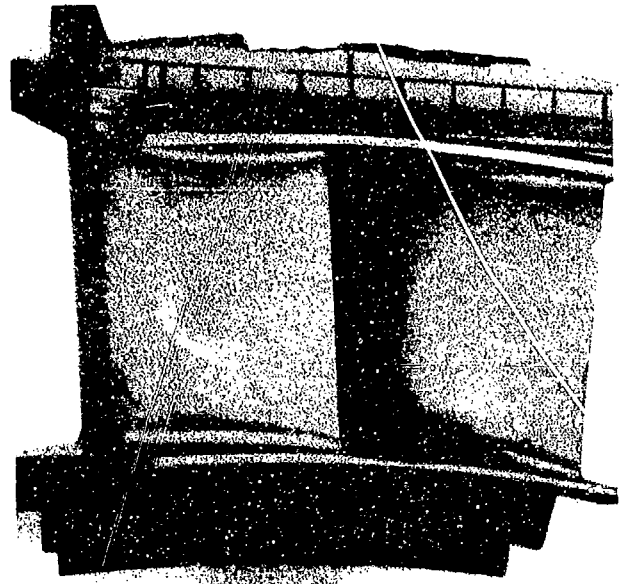
FAL 88112

FIGURE 10-72: Aft view of the first turbine vane.

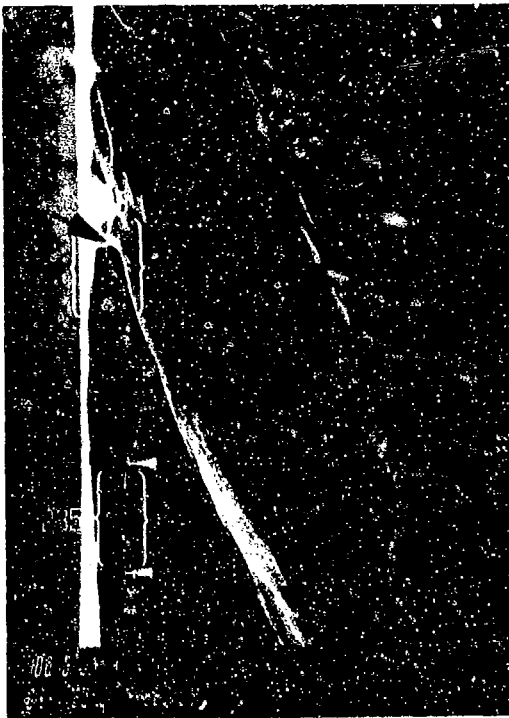
FAL 93448

FIGURE 10-73: Photograph showing shallow TMF crack surface originating in the corner of cooling hole (black arrow). The crack then propagated from multiple origins on the outside surface (left).

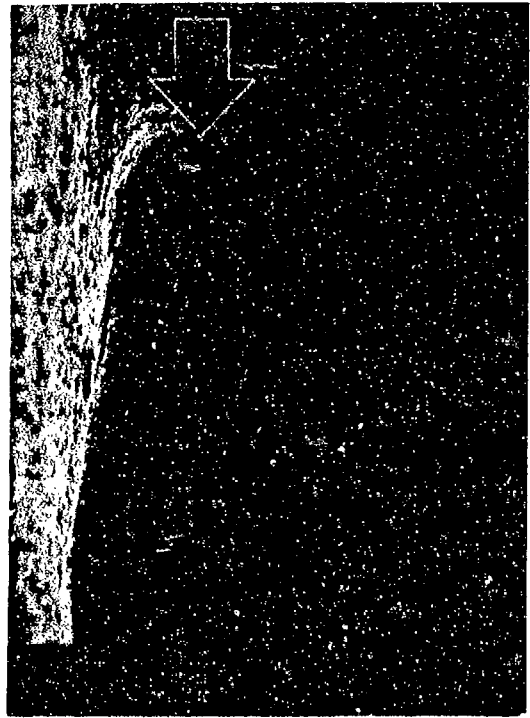
FAL 93449

FIGURE 10-74: Close-up of the primary origin area exhibiting only heavy oxidation.

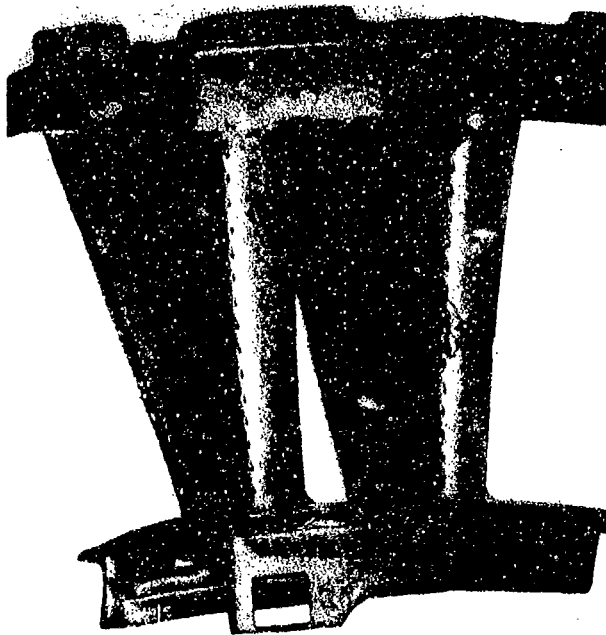
FAL 88115

FIGURE 10-75: Overall photograph of the second stage vane, forward looking aft.

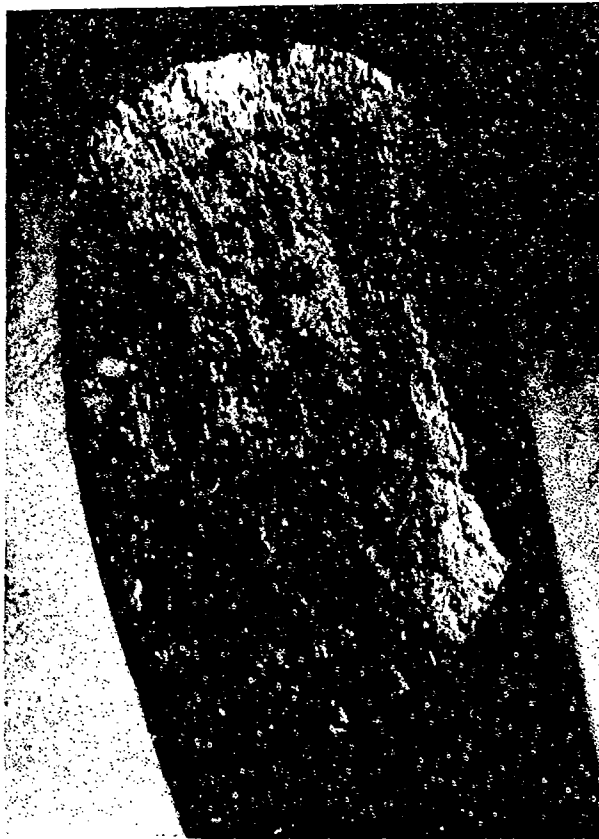
FAL 94242

FIGURE 11-1: Test results and fractography of MP-159 593°C (1100°F) smooth tensile test. The fracture surface was oriented at an angle of approximately 45° to the stress axis.

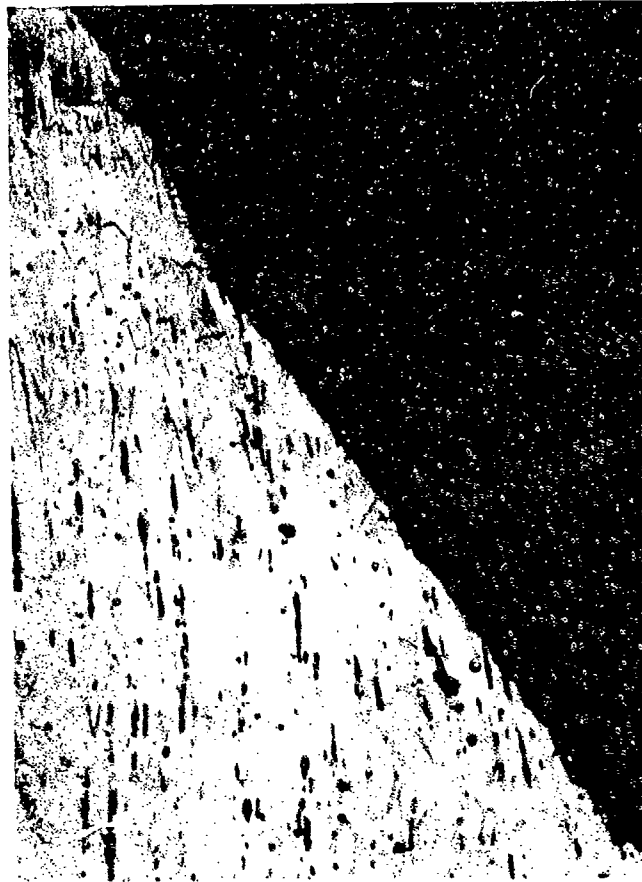
FAM 100288

FIGURE 11-2: Optical photomicrograph showing grain deformation along the fracture surface which is oriented at an angle to the primary stress axis. The fracture was predominantly transgranular.

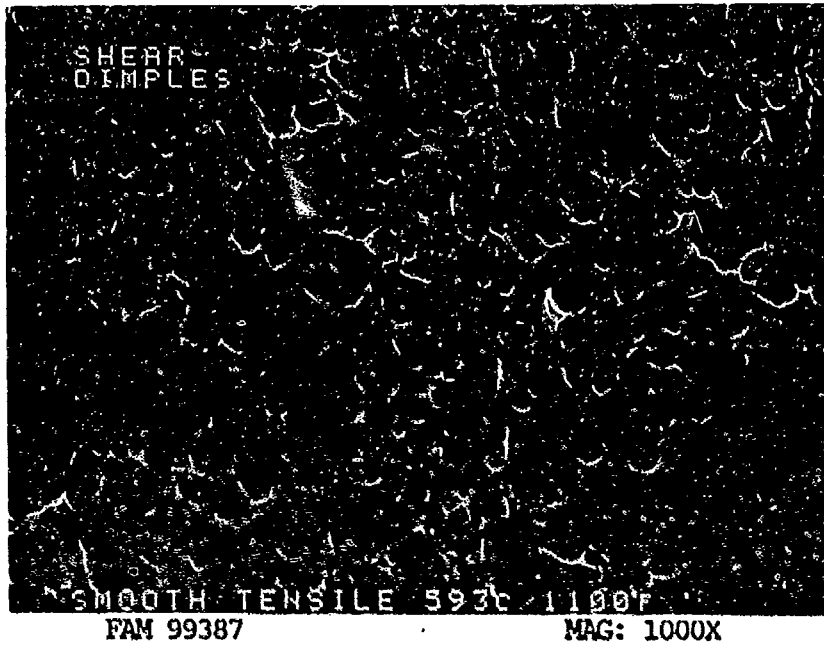
FIGURE 11-5: Shear dimpled overstress.

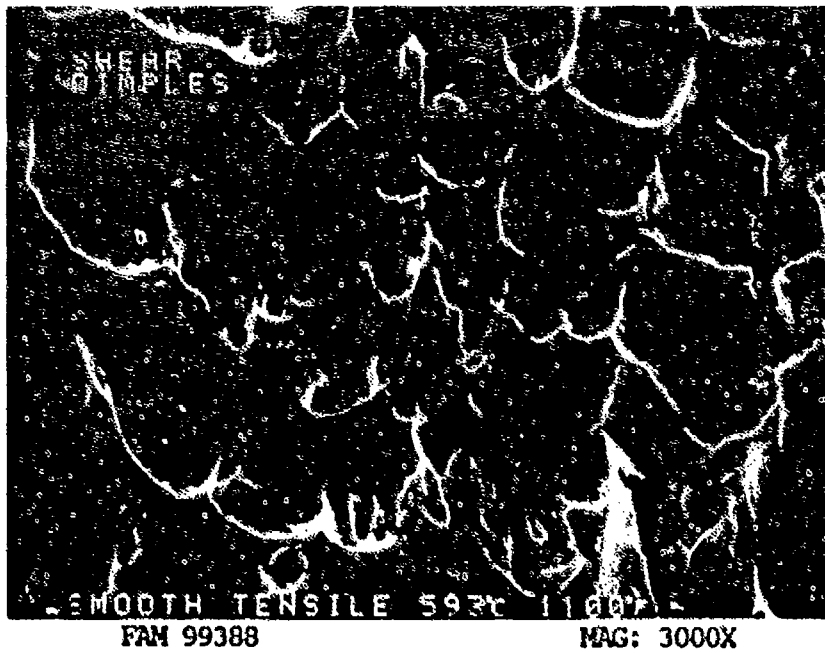
FIGURE 11-6: Higher magnification photograph of shallow shear dimpled overstress that covered the entire fracture surface.

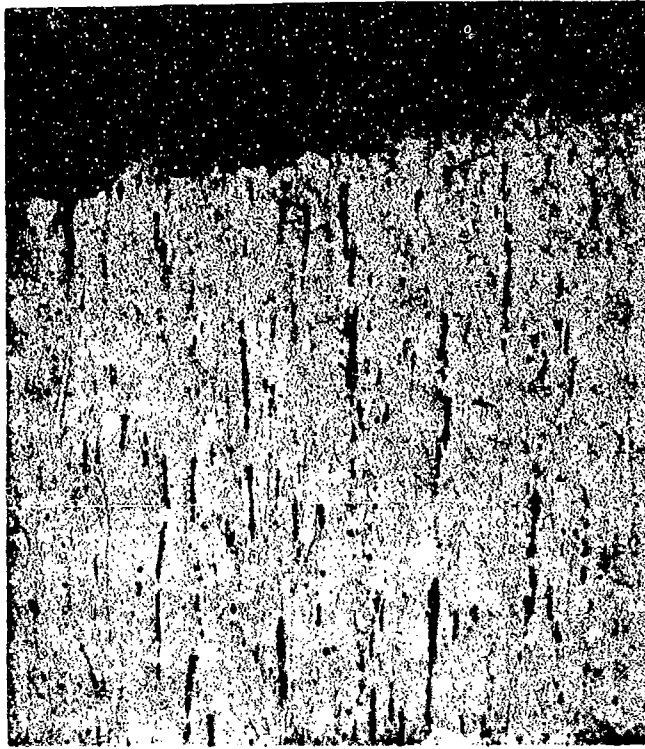
FIGURE 11-8: Optical photomicrographs showing the center (top) and edge (bottom) of the fracture. The fracture path is transgranular with dimples visible (arrows).

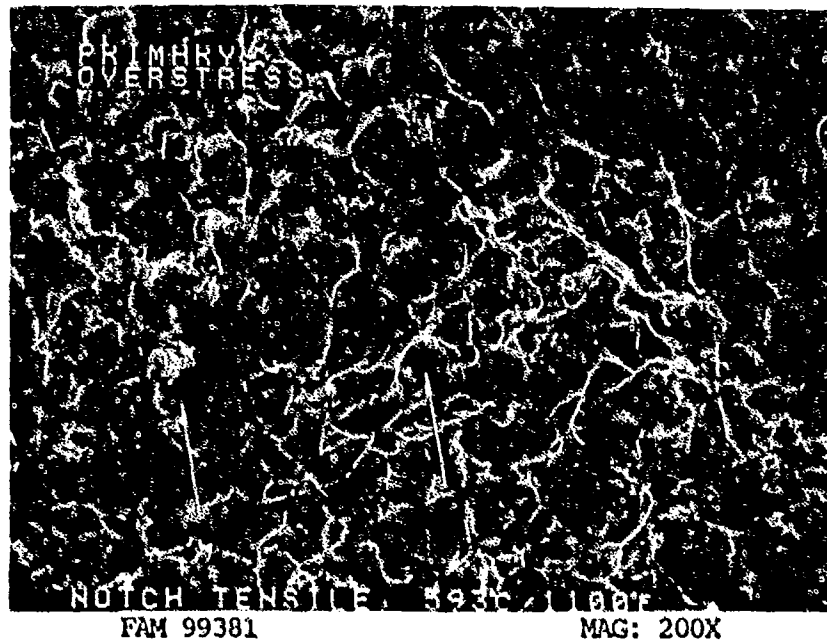
FIGURE 11-10: Coarse dimpled overstress with voids at the bases of dimples (arrows).

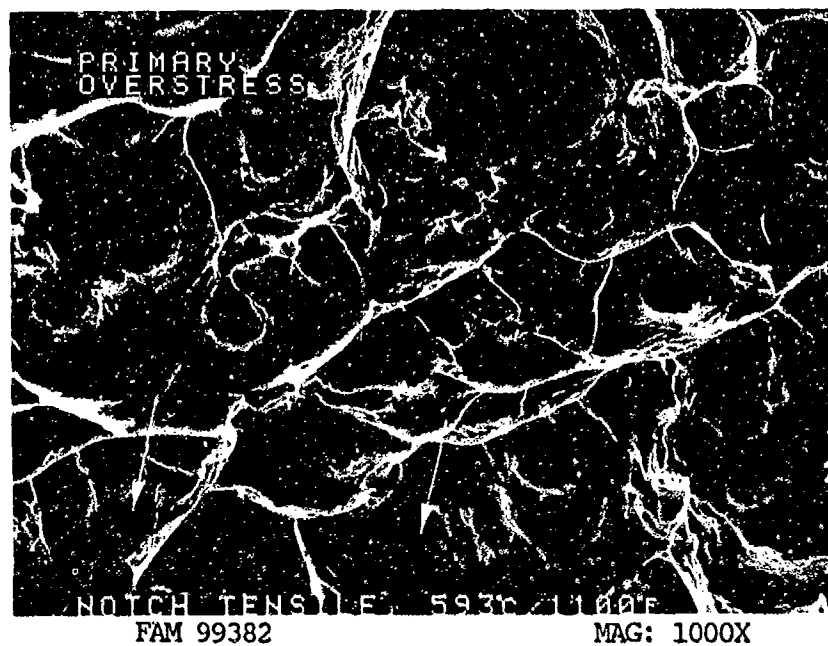
FIGURE 11-11: Higher magnification photograph of the area shown in Figure 11-10, exhibiting a mixture of large shallow dimples and deep voids. Second phase particles (carbides) are visible in several locations (arrows). The entire fracture surface is covered by a light oxide.

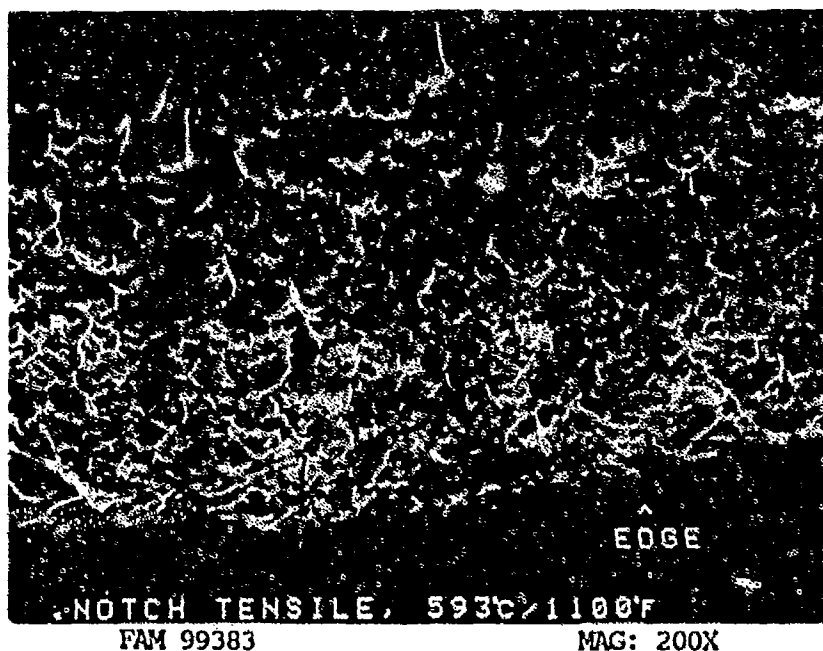
FIGURE 11-12: Shallow dimples in the final overstress area near the edge of the specimen.

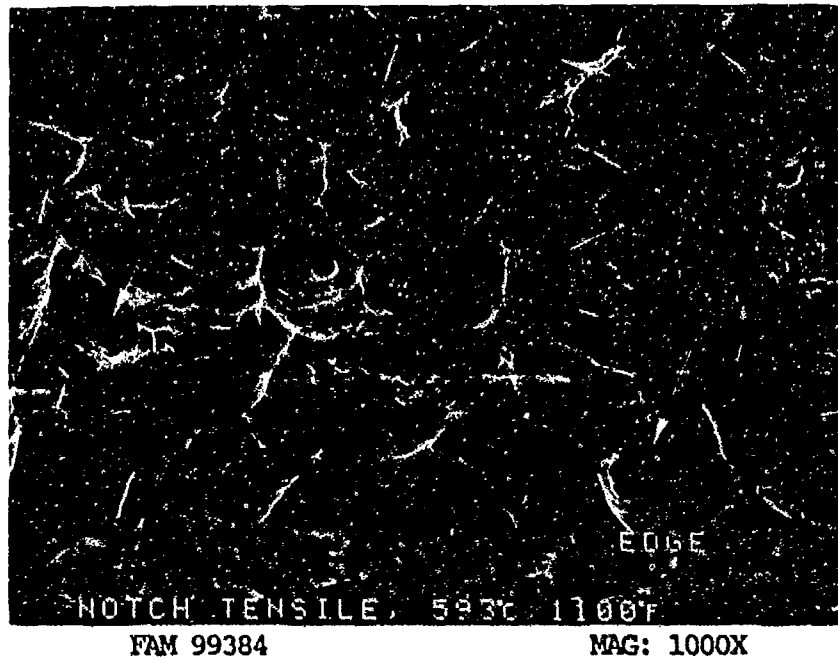
FIGURE 11-13: Shallow dimples in the final overstress area. Deep voids are visible in several locations (arrows).

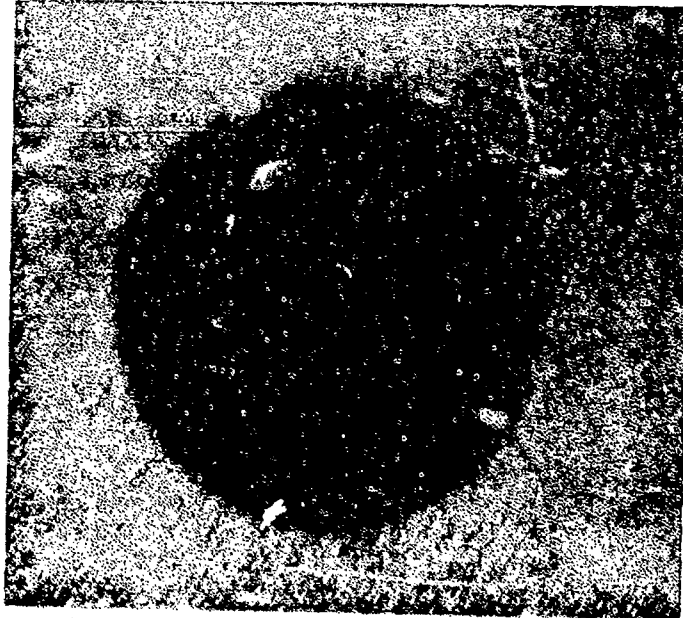
FAL 93236

FIGURE 11-14: Test results and fractography of MP-159 649°C (1200°F) stress rupture test. The fracture surface appears oxidized and has deep fractures.

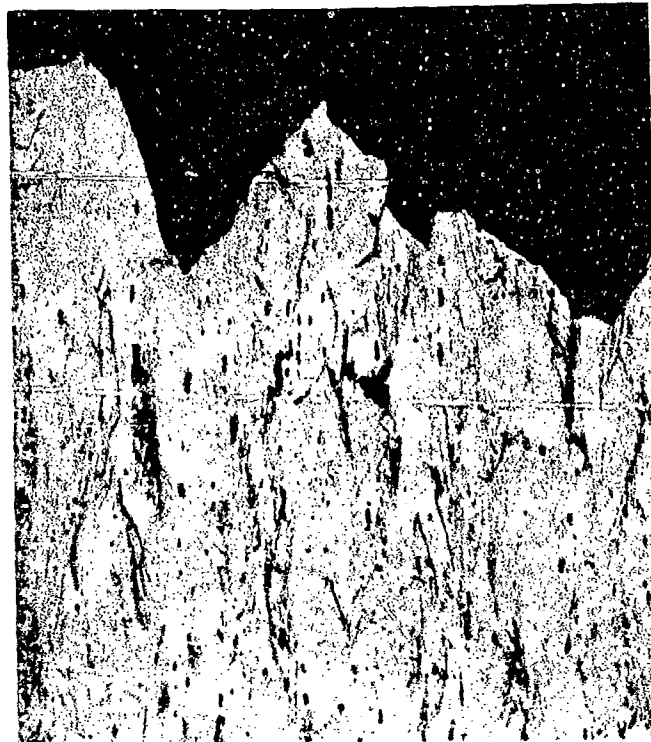
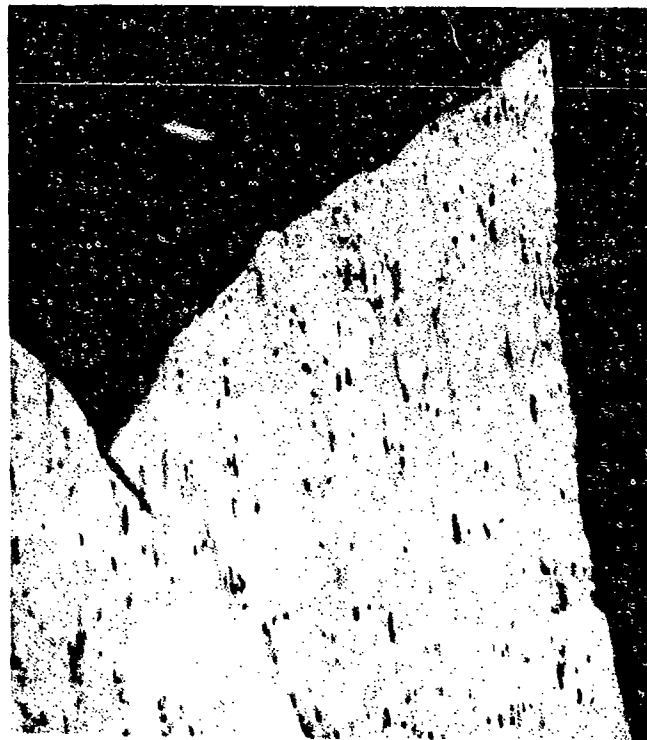
FIGURE 11-15: Optical photomicrographs of the center (top) and an edge (bottom) of the specimen, exhibiting intergranular dimpled overstress in the center and a large, well defined shear lip at the edge.

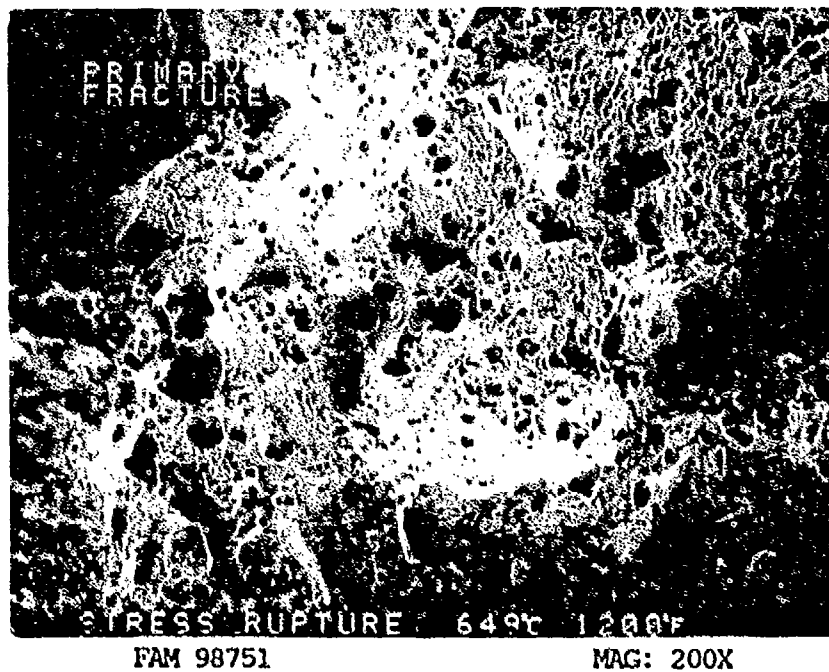
FIGURE 11-17: Higher magnification view of the primary fracture area in the center of the specimen. Dimpled overstress and void coalescence is clearly visible.

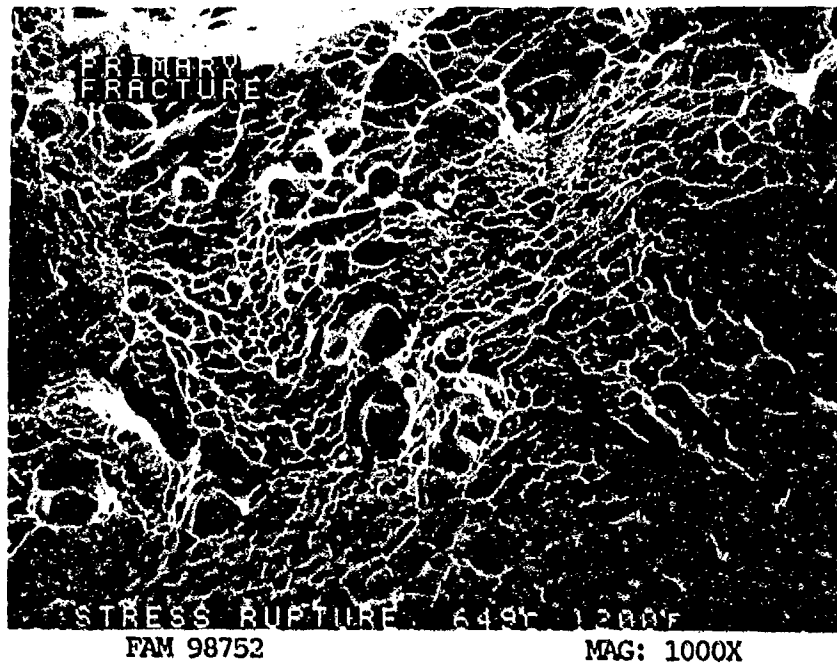
FIGURE 11-18: Shallow dimpled overstress with void coalescence (arrows A) near the center of the specimen in the primary fracture area. Several carbides are visible (arrows B).

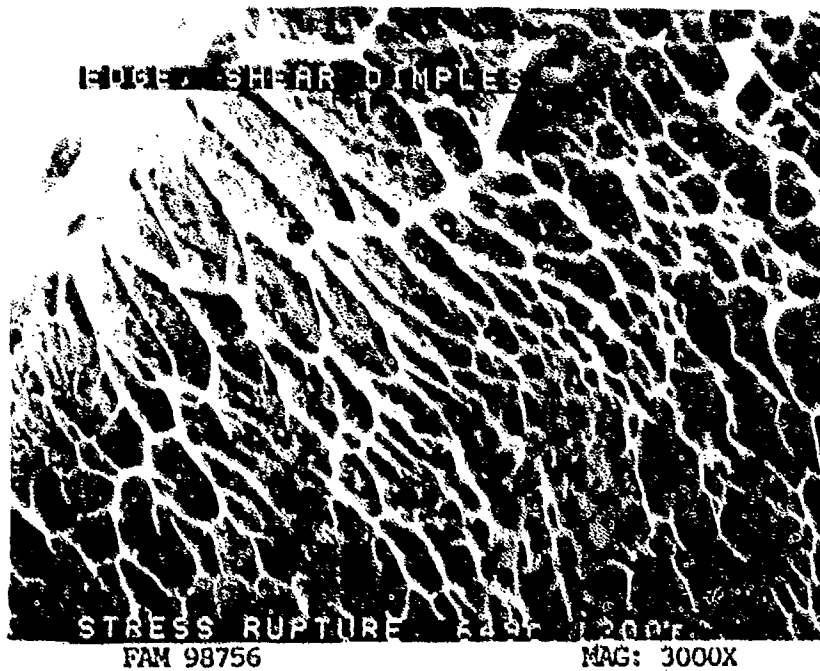
FIGURE 11-21: Higher magnification photograph of the specimen edge, Figure 11-20, showing shallow shear dimples.

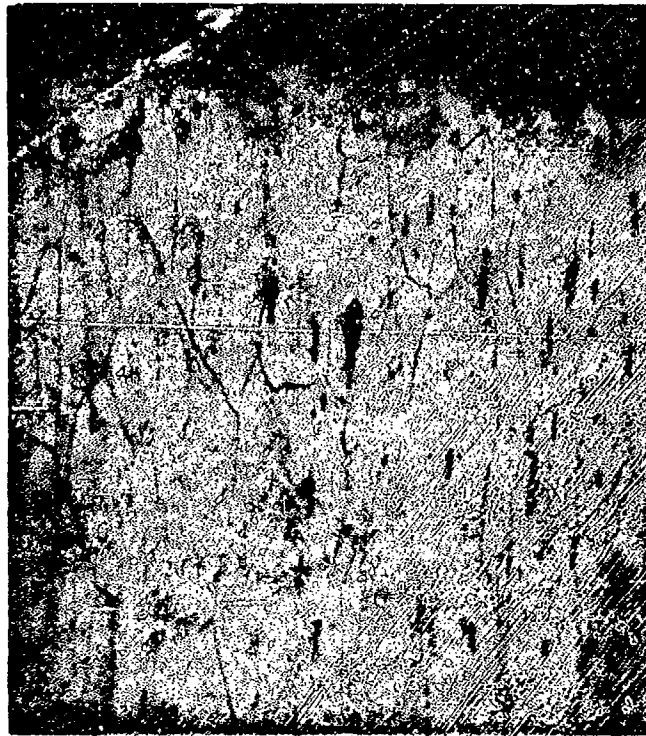
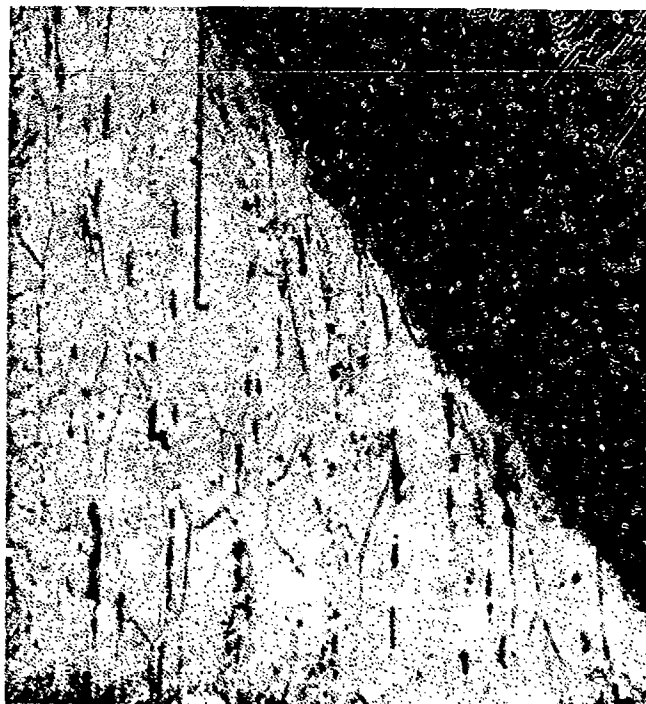
FIGURE 11-23: Optical photomicrographs showing the fatigue progression area (top) and the final overstress area (bottom). The fatigue progressed on a plane perpendicular to the stress axis with little grain deformation in the grains adjacent to the fracture. The fracture path is predominantly transgranular. Final overstress occurred at an angle to the primary stress axis and was accompanied by grain elongation (bracket, bottom).

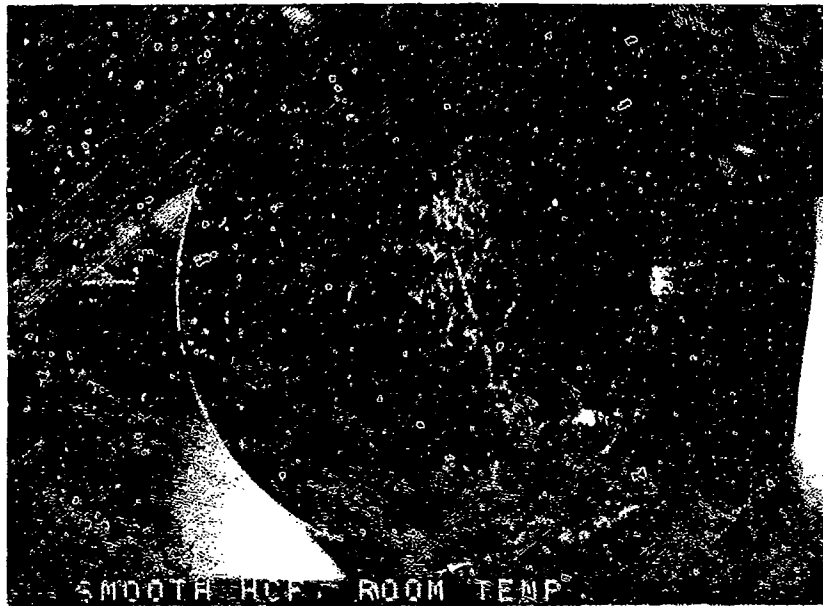
FIGURE 11-24: Low magnification photograph showing fatigue initiation (arrow) and progression on a plane approximately perpendicular to the stress axis. The fatigue progression area appears to be more granular than the surrounding overstress area. The final overstress fracture occurred at an angle. Features can be seen radiating from the origin area.

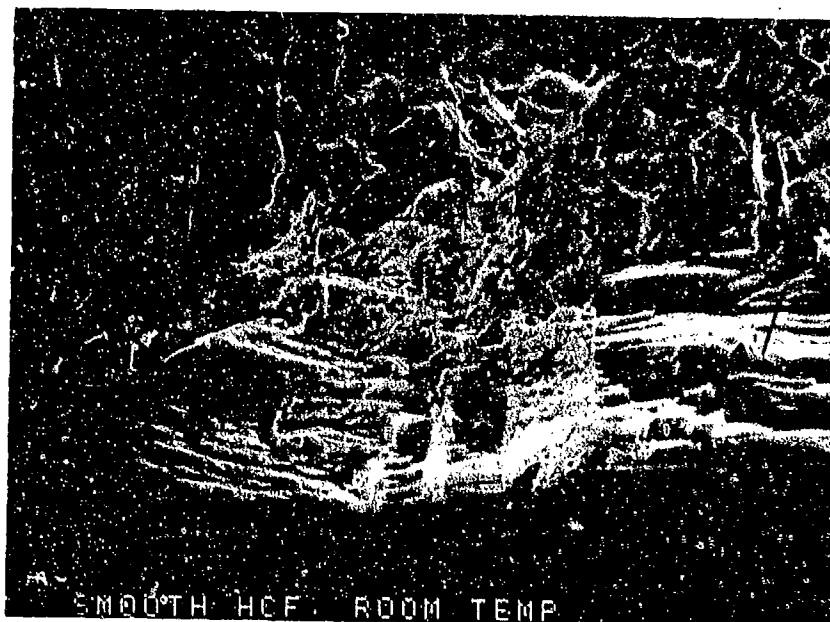
FIGURE 11-27: Higher magnification view of the origin area shown in Figure 11-26, exhibiting a faceted appearance. A void is visible (arrow, right) but it does not appear to have contributed to fatigue initiation.

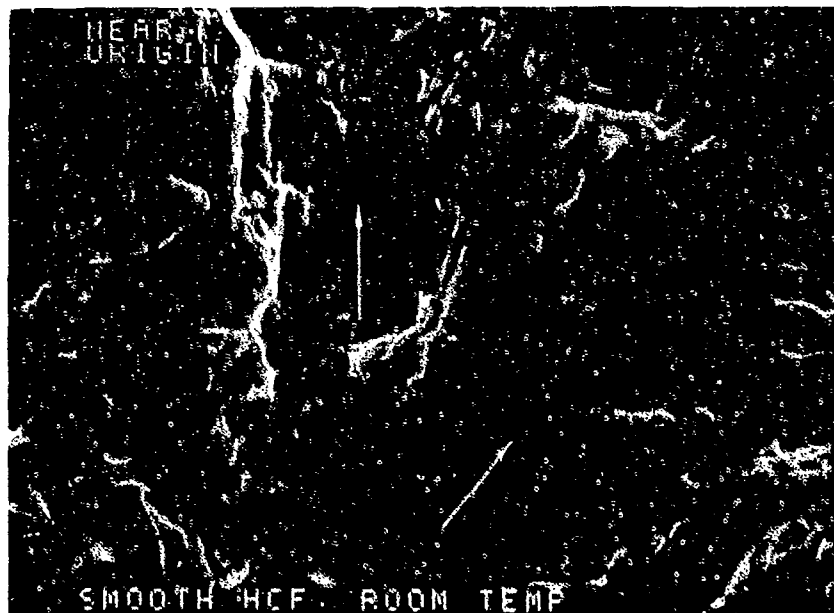
FIGURE 11-29: Higher magnification view of the fatigue progression near the origin area showing fine fatigue striations on numerous plateaus (arrows). Individual striations are not resolvable.

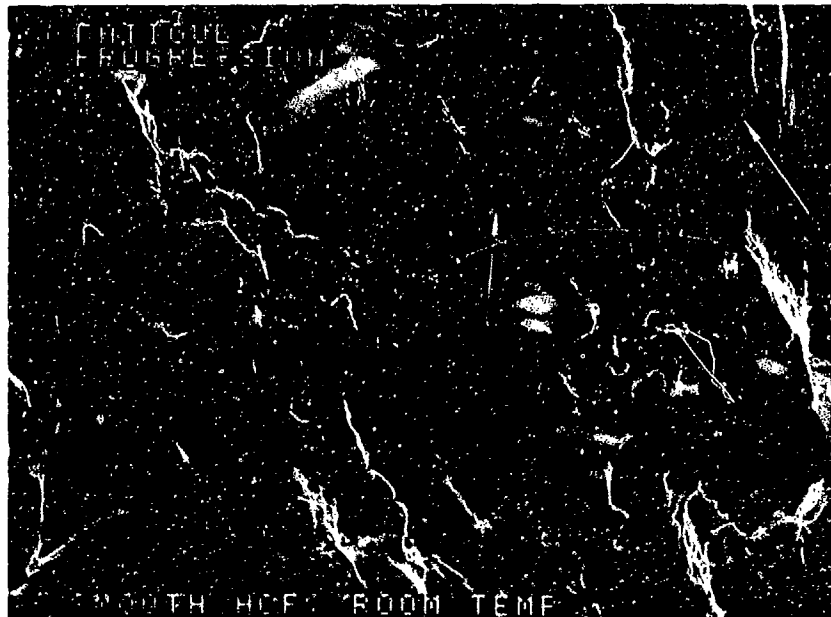
FIGURE 11-30: Fatigue progression area away from the origin showing coarser striations and crack-like striations, indicating localized propagation in several directions (arrows).

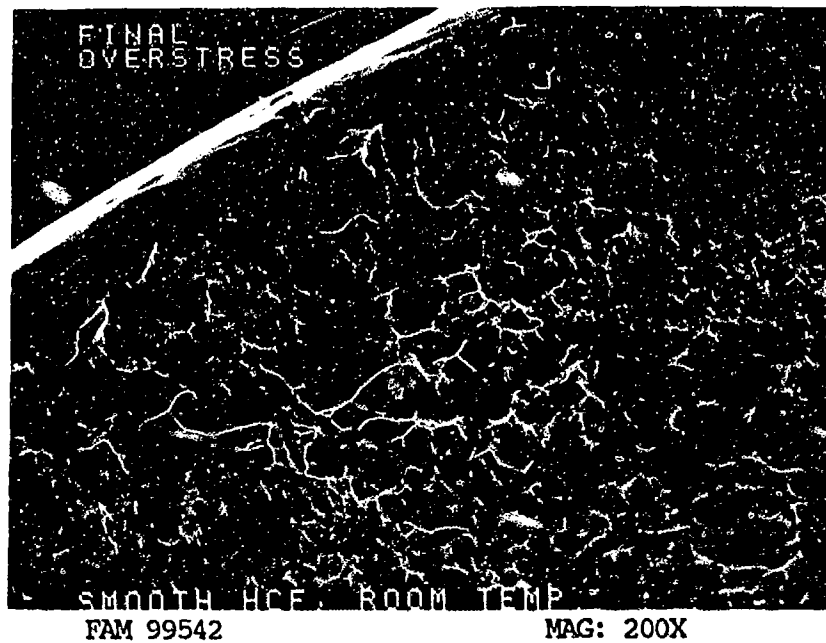
FIGURE 11-32: Final overstress area showing a mixture of equiaxed and shear dimples.

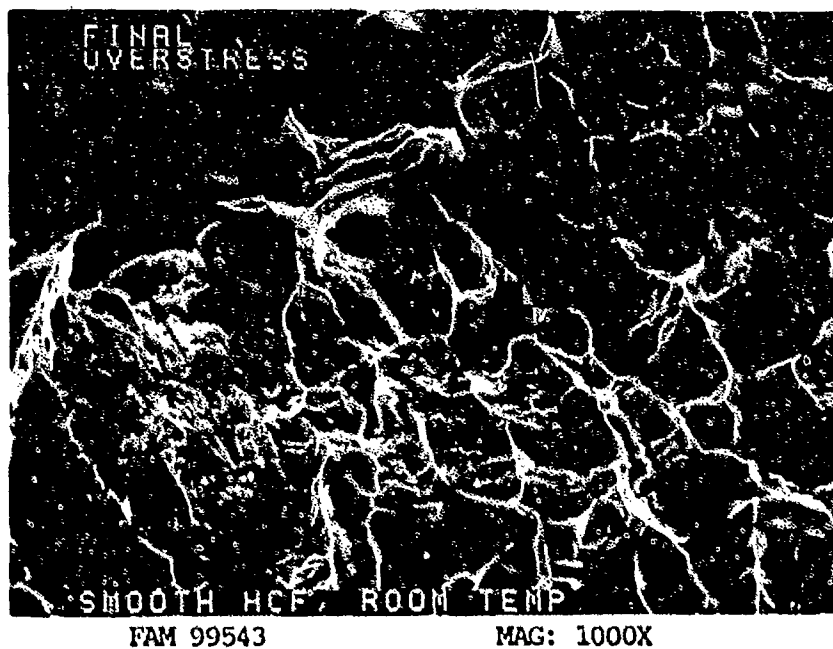
FIGURE 11-33: Higher magnification view of the area shown in Figure 11-28 showing remnant shear dimples and voids (arrow A). Serpentine glide ripples are visible in the dimples (arrow B).

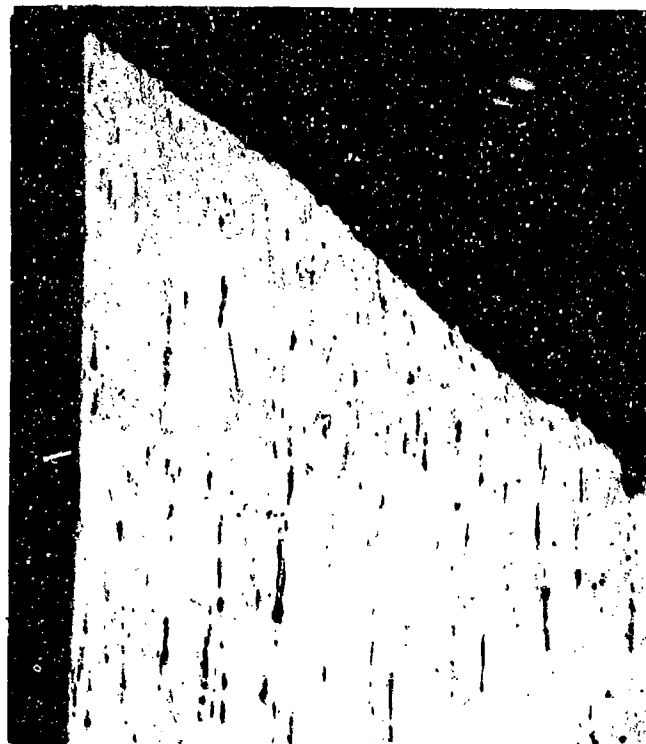
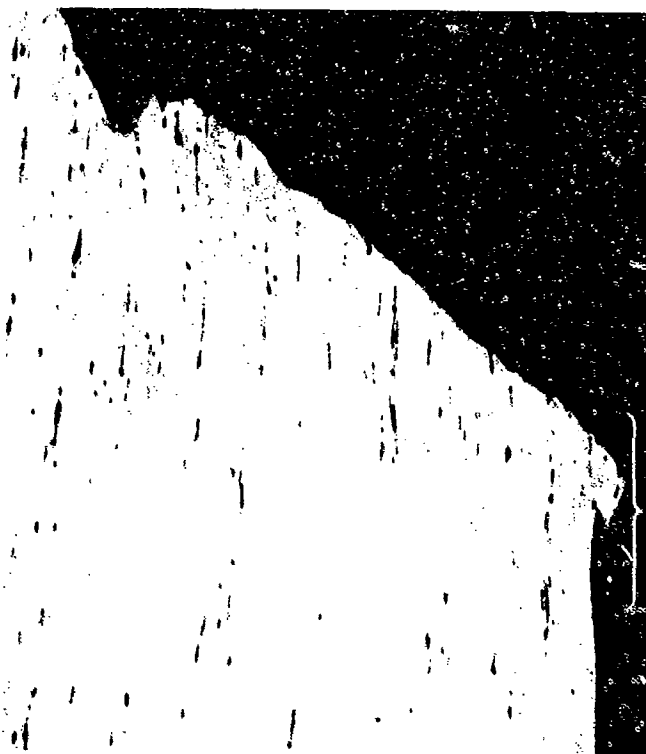
FIGURE 11-35: Optical photomicrographs showing the fatigue progression area (top) and the final overstress area (bottom). The fatigue progressed with little grain deformation in the grains adjacent to the fracture. Final overstress was accompanied by grain elongation (bracket, bottom).

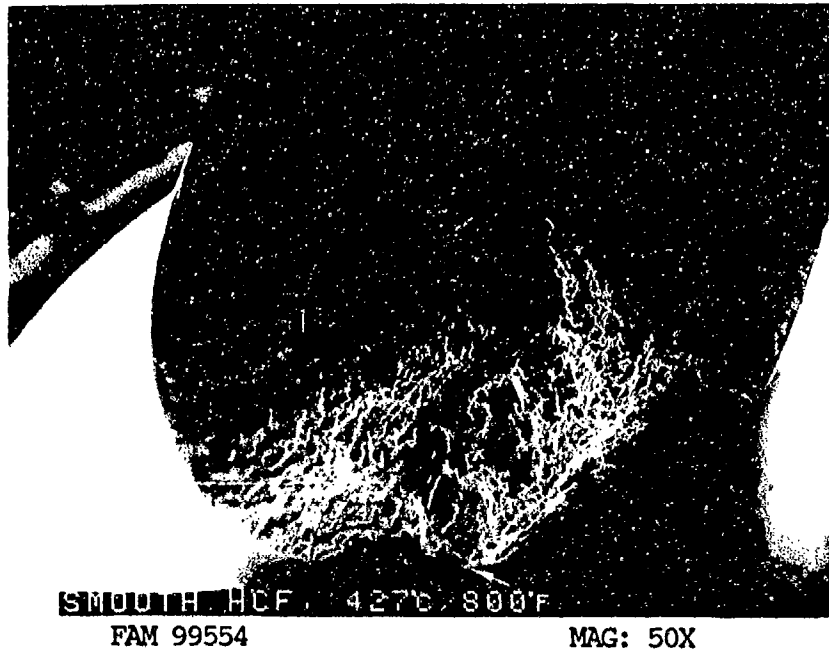
FIGURE 11-36: Low magnification photograph showing fatigue initiation and progression on a plane approximately perpendicular to the stress axis. The fatigue progression area appears to be more granular than the surrounding overstress area. The final overstress occurred at an angle to the stress axis. An arrow indicates the origin area.

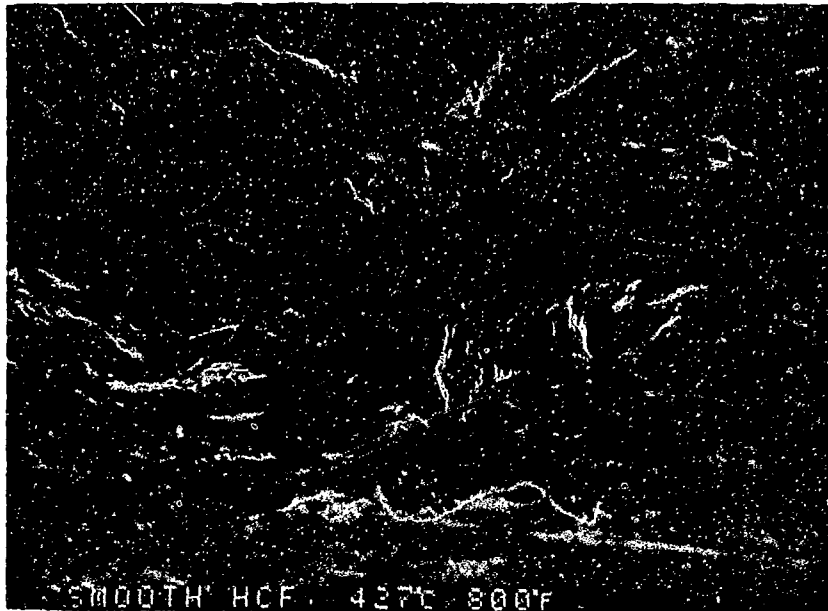
FIGURE 11-38: High magnification view of the origin area shown in Figure 11-37.

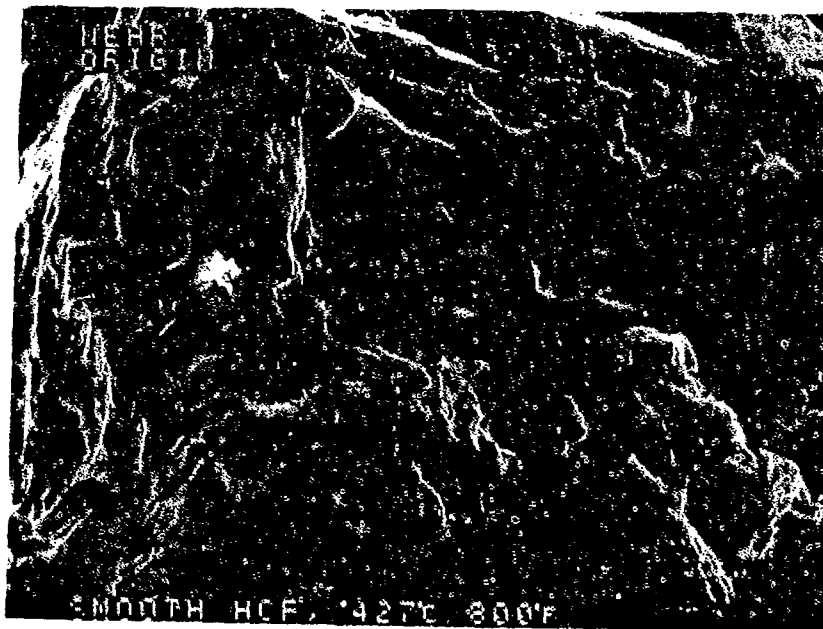
FIGURE 11-39: Area adjacent to the origin area exhibiting very fine striations on several plateaus.

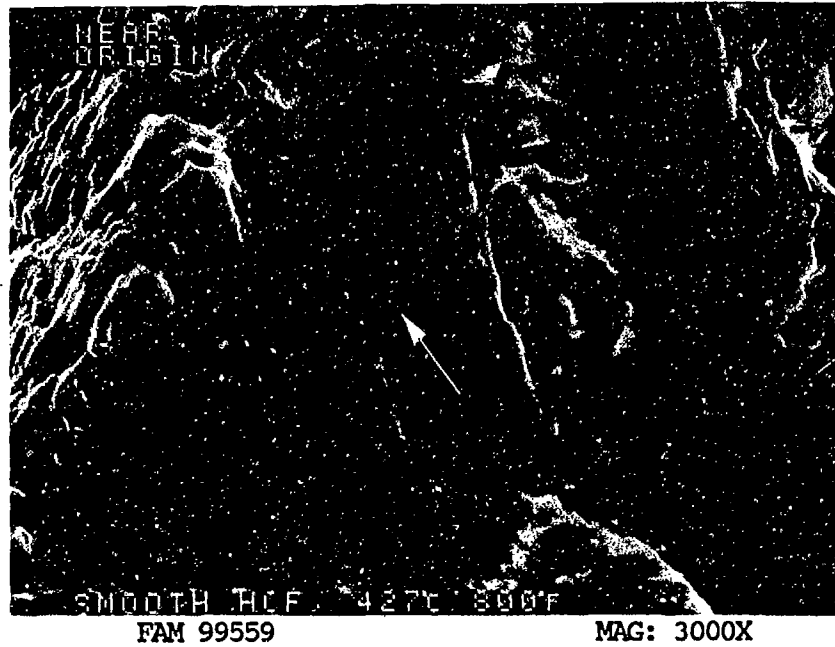
FIGURE 11-40: Higher magnification view of the area shown in Figure 11-39. Fine fatigue striations are visible on several plateaus separated by fatigue steps. The direction of propagation is shown by an arrow.
